PUBLIC ARTWORK CONDITION ASSESSMENT CITY OF ROCKVILLE, MD

City of Rockville, City Hall
111 Maryland Avenue
Rockville, MD 20850

Debora Rodrigues
Catherine Hayes
Past Matters, LLC
107 E Montgomery Street
Baltimore, MD

July 2017

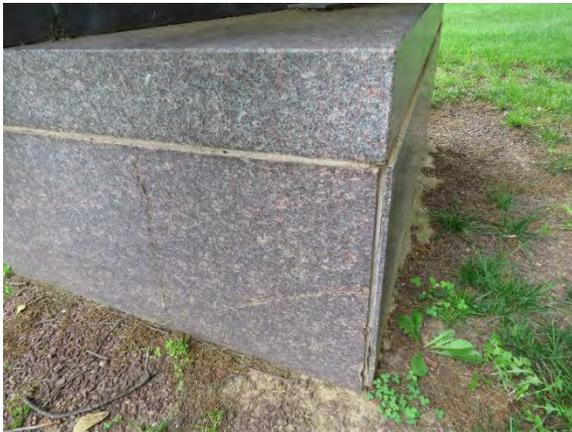
Dirt and grime on base, along with failing caulk within the joints.

5. Remove existing sealant from joints of granite base and provide new sealant similar in color to existing, or as approved by the City of Rockville.
6. Inject cracks with a conservation-grade micro-injection grout (Jahn or comparable).

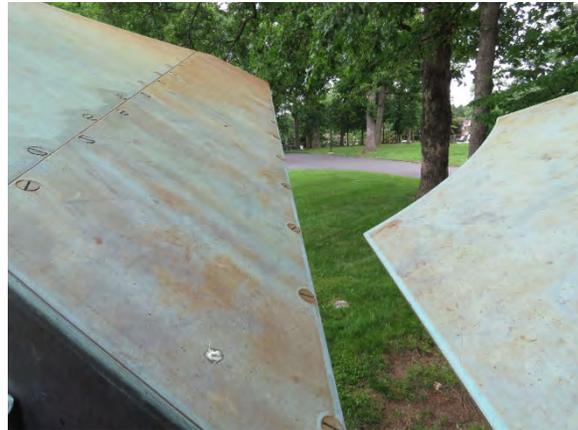
Corrosion on top of sculpture, with staining.

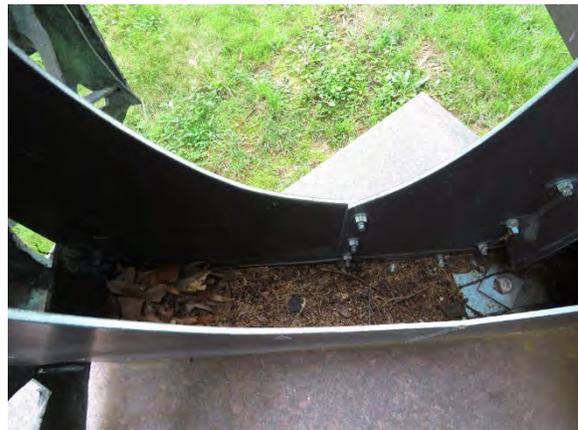
Collection of dirt and debris within shelter pockets of the sculpture.

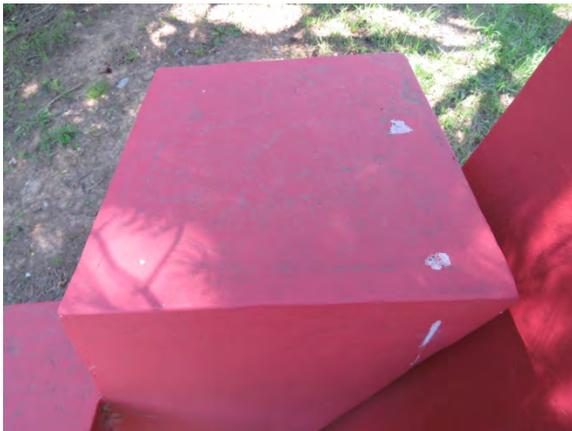
Bird guano on vertical surface and two losses in the paint and dirt deposition on horizontal surface.

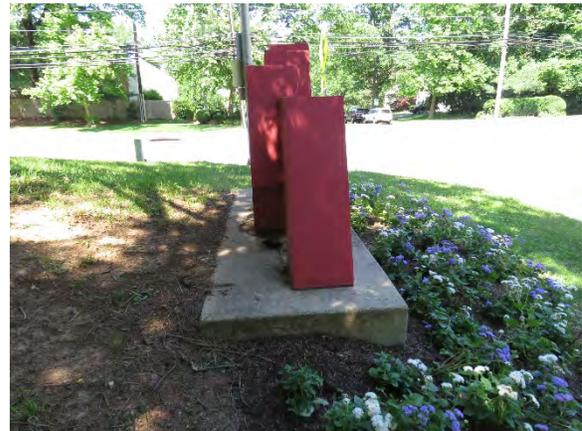
Location of the sculpture on the small hill, with the back side of the concrete base fully embedded in eroded hill soil.

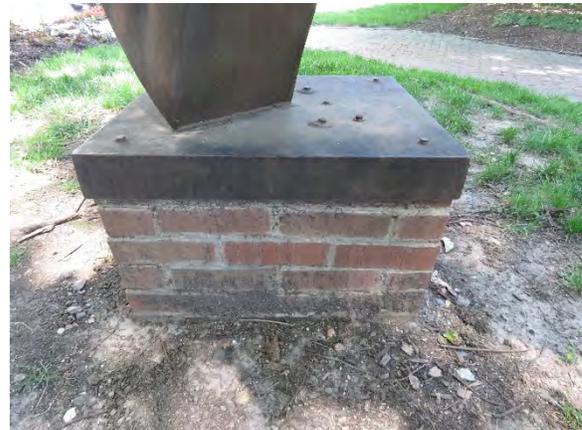
The sculpture rests on a steel base that is anchored to a red-brick pedestal.

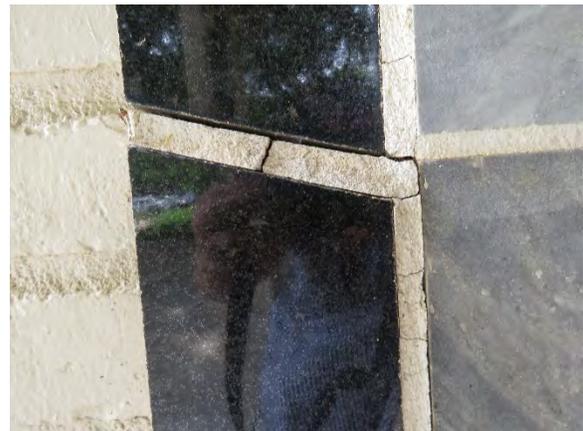
Cracking of mortar at joints, with loss of adhesion.

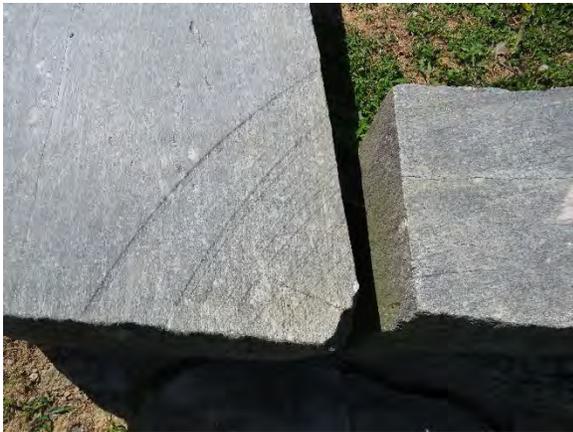
Linear abrasions in stone, possibly from quarrying or installation.

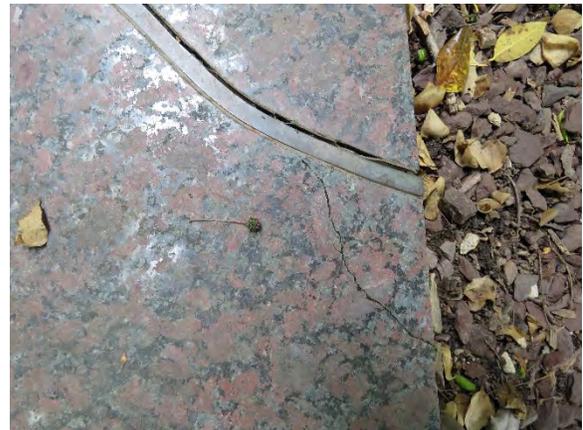
Tarnishing of brass band, deterioration of caulk at seams, and small crack in granite.

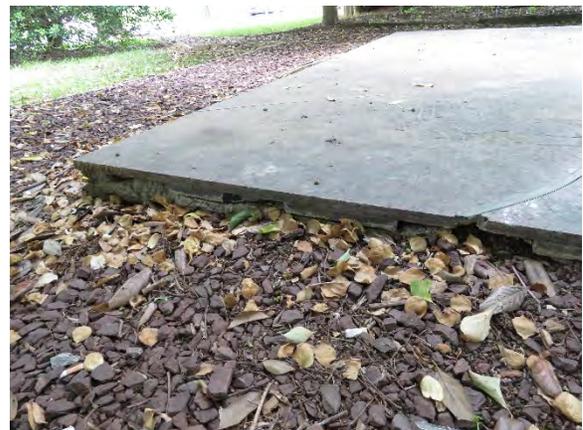
Losses in the concrete foundation, with damage to stone at edge.

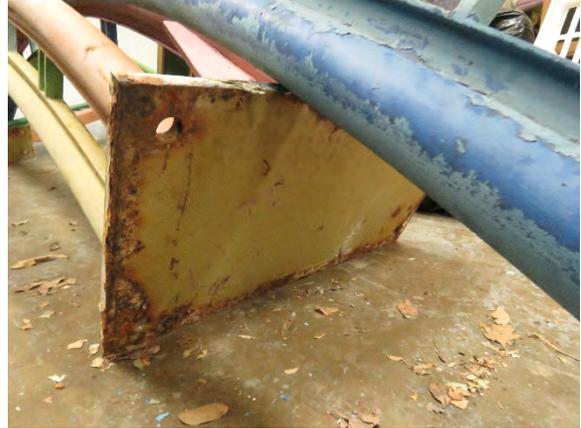
At least two painting campaigns on the section of blue arch, with the top layer noticeably failing. Significant corrosion of base plates, with loss of paint.

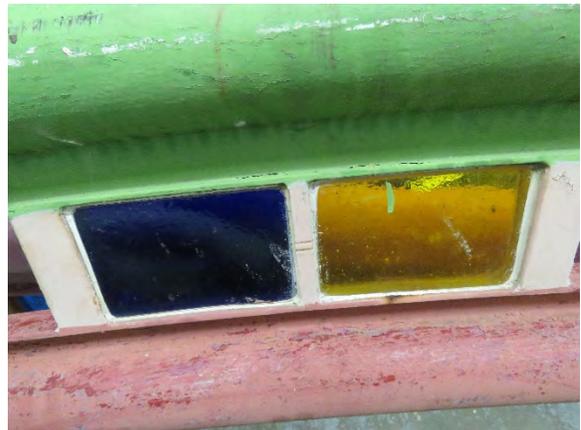
Paint accretion on glass, from not providing proper protection during re-painting.

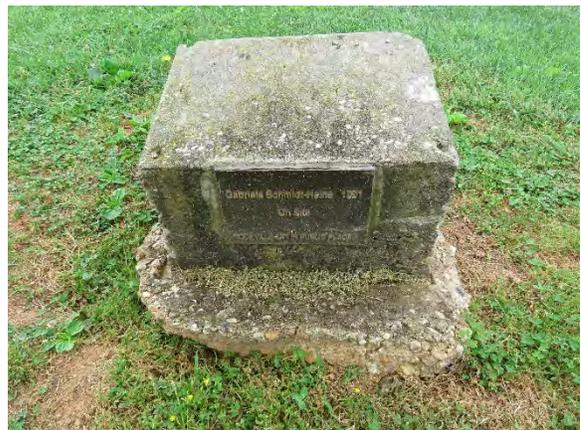
Name plaque, with considerable soiling, biological growth, and damage on both concrete and bronze. Note exposure of concrete foundation.

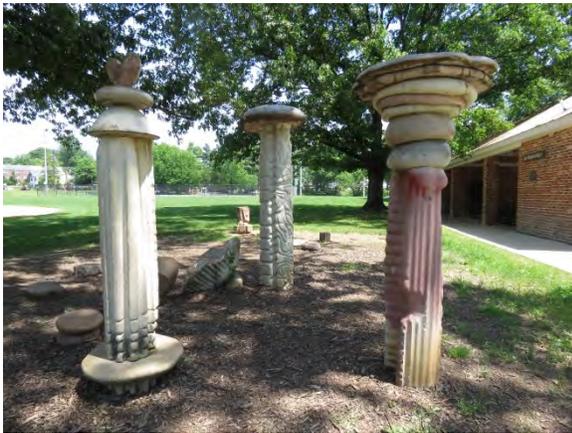
Three columns in various states of deterioration. Note red paint accretion from graffiti on the one on the right.

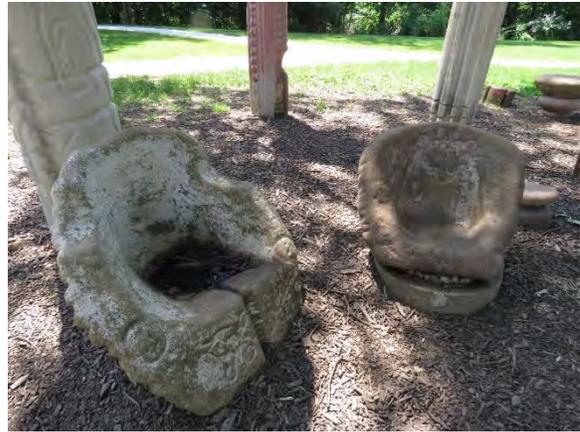
Two seats, with considerable loss of finishes. Note pooling of water on left seat, indicating poor drainage.

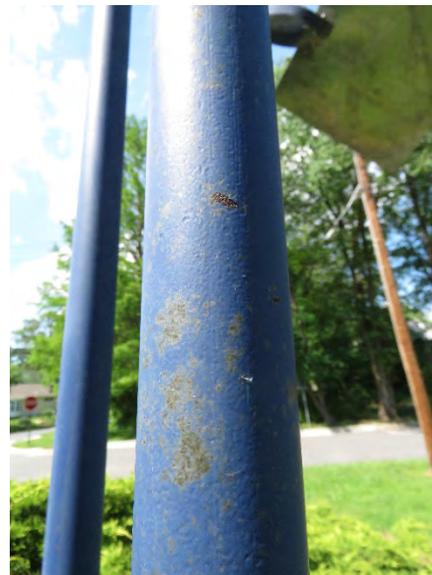
Loss of blue paint finish, with minimal corrosion in areas of exposed steel.

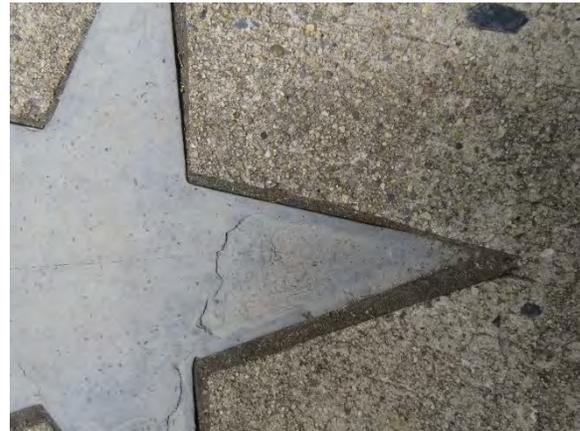
Typical loss to embedded slate stars.

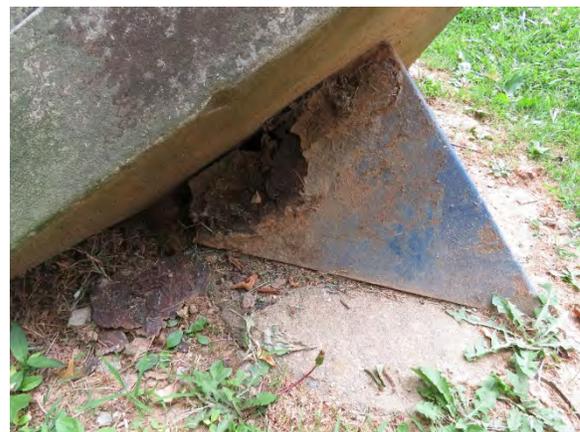
Significant deterioration of metal component at the dragon's tail, leading to loss of material. Note encroaching plant growth.

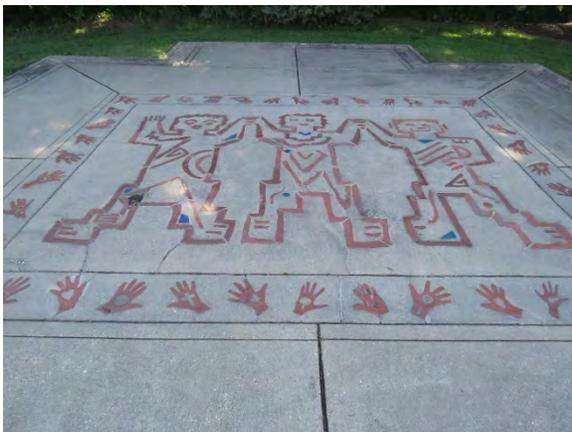
Cracks in a handprint with loss of glazing and tile and pink paint accretions.

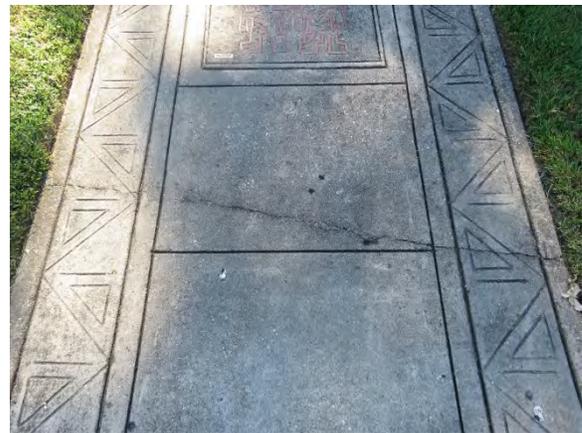
Crack running through the west sidewalk.

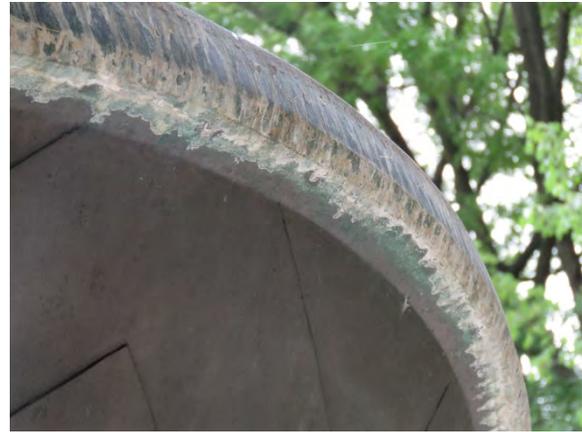
Water stains/drip marks around the border of the bronze basin.

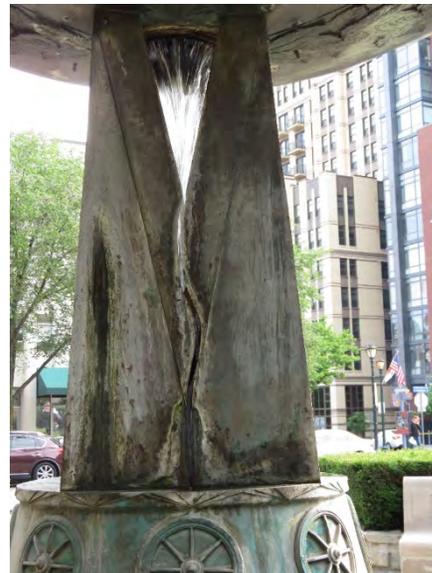
Staining, corrosion, minerals, and biological growth.

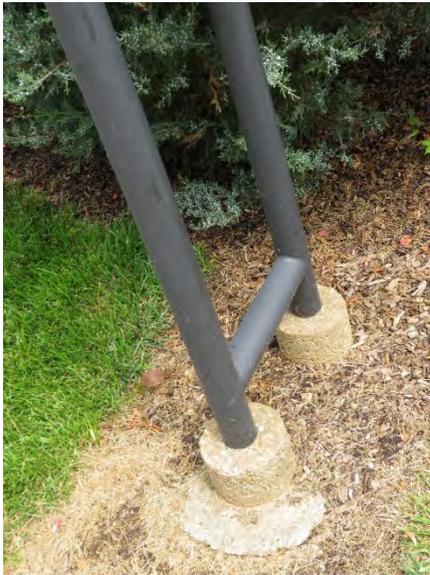
Dull, weathered paint with minor scratches and exposed foundation from soil erosion.

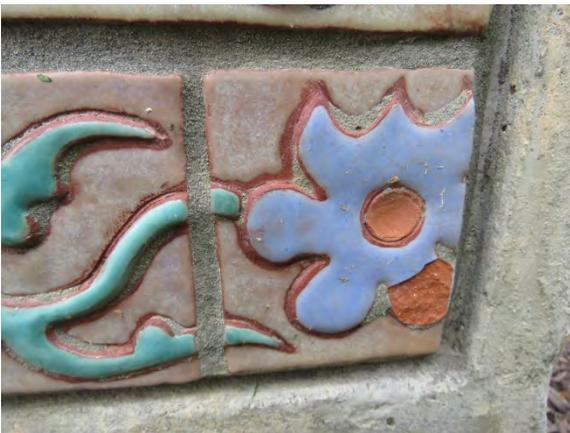
Losses in tile most are likely due to water ingress under the cracked glaze and freeze/thaw cycles.

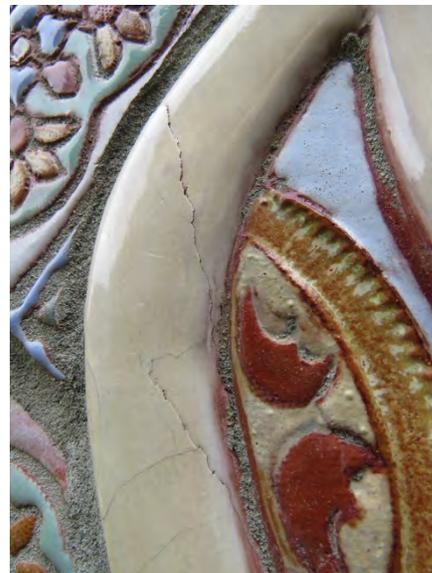
Cracking with material displacement indicates site of pending loss once colder weather arrives.

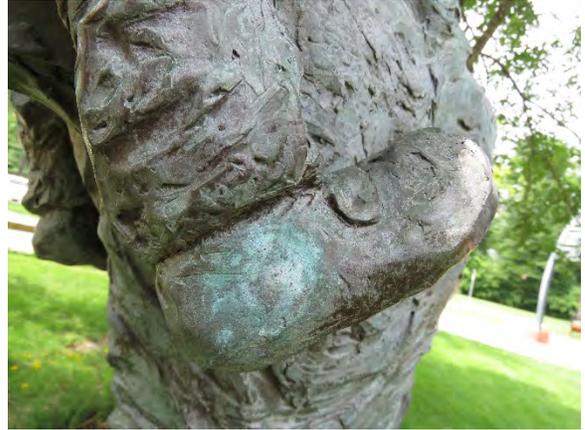
Bright green corrosion on the proper right foot of the child.

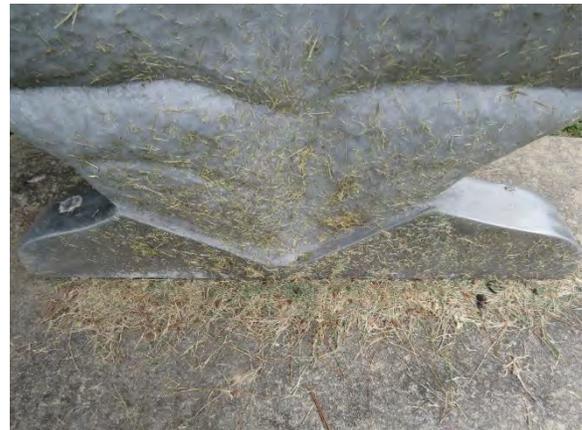
Accumulation of grass clippings from mowing activity and pine needles from adjacent trees.

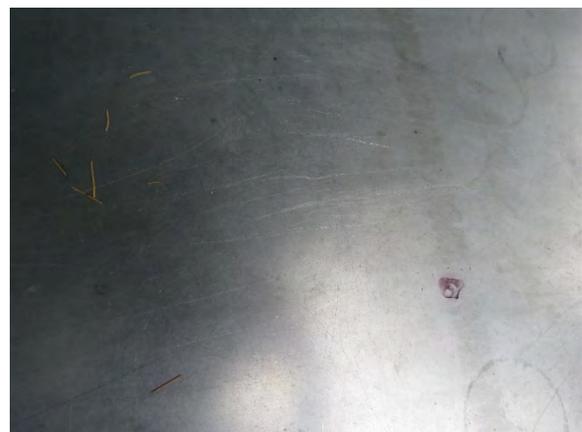
Scratches, ring stains, and bird guano on the seat of American Holly.

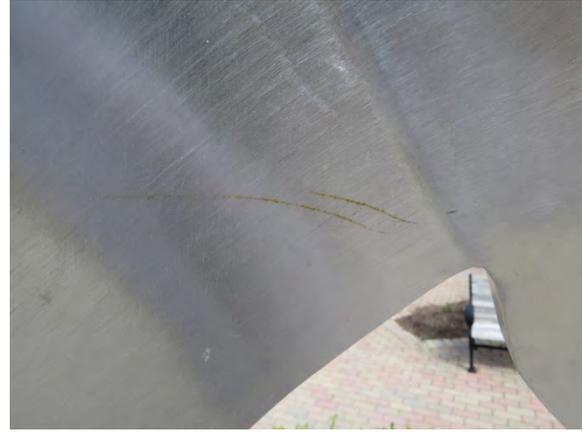
Scratch with associated corrosion.

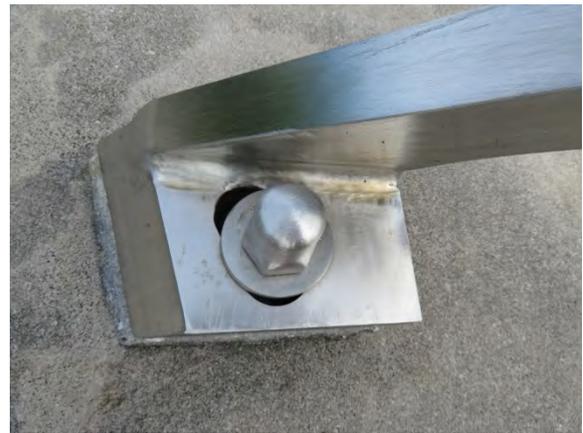
Figural mount plate with enlarged, unsealed hole where water can pool and promote corrosion.

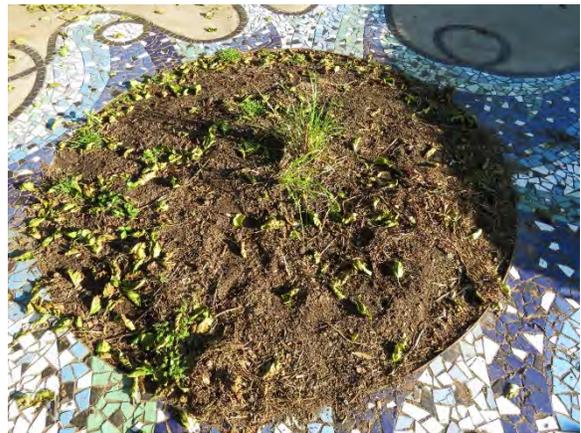
Sparse planted garden with loose soils spilling over onto the mosaic.

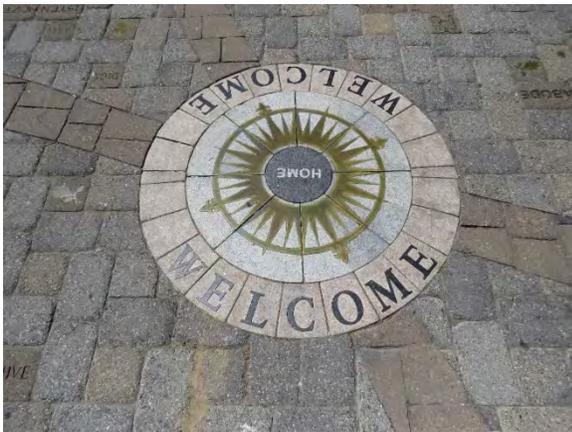
Central compass rose and interesting reddish-brown pavers.

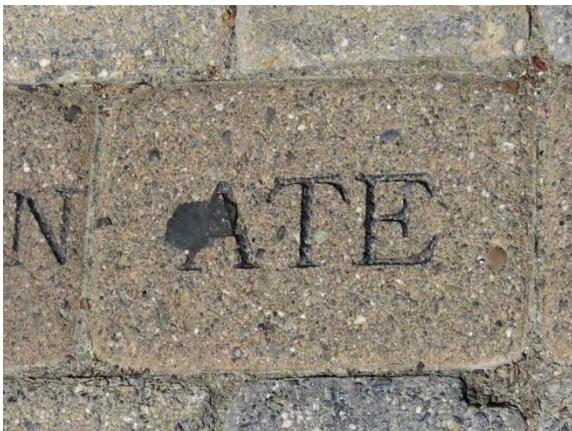
Close-up view showing black-stained text with gum accretion. Note slight fading of black staining.

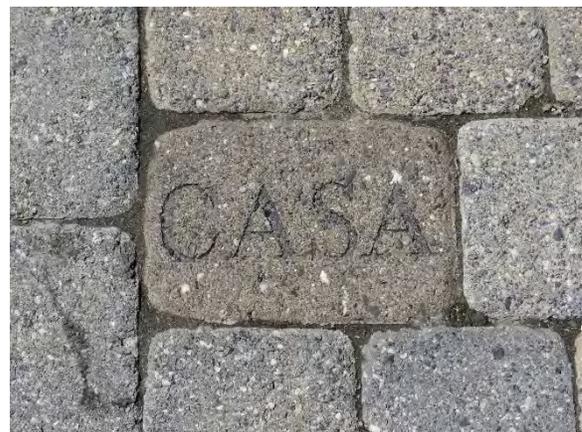
Text inscription with fading of black finishes.

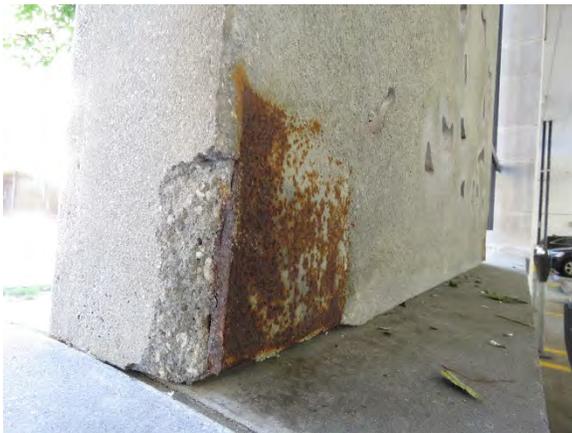
Corrosion of iron bracket has caused staining and spalling at the corner.

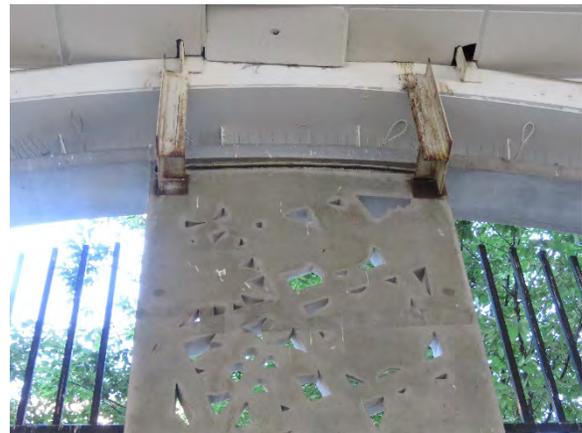
Corrosion and paint loss of iron brackets holding the top of a grill. Note heavy accumulation of bird droppings.

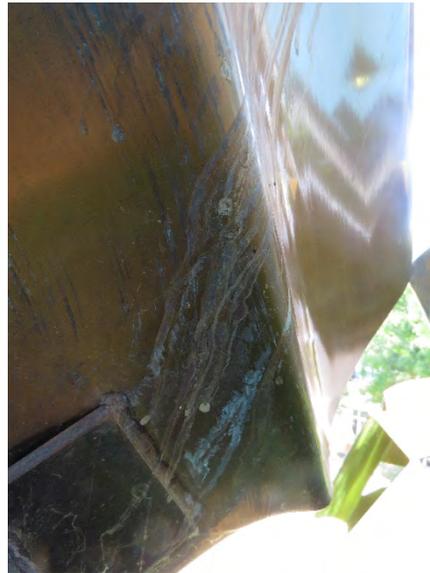
Rain runoff, promoting corrosion of bronze and streaky appearance.

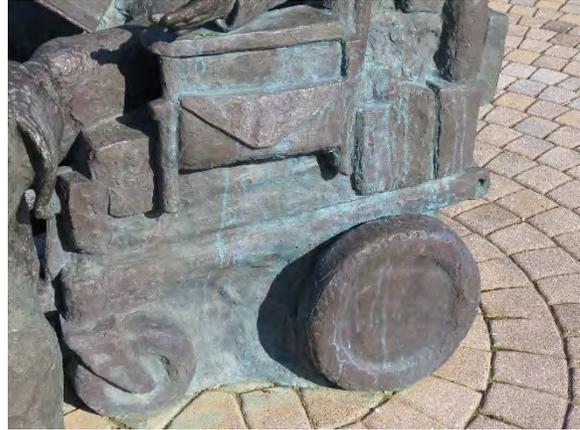
Bright blue-green corrosion on the side of the wheelchair.

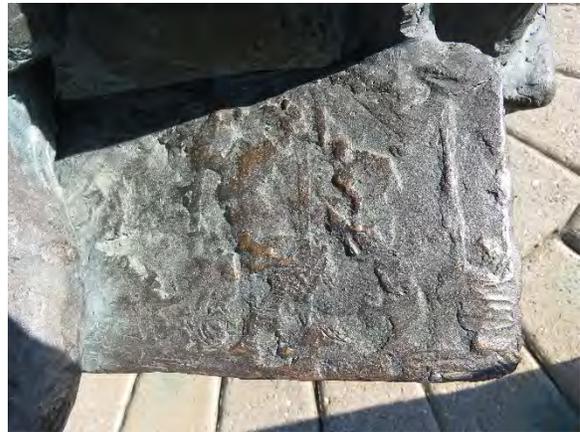
Areas exhibiting wear of the patina layer, with exposure of bright metal.

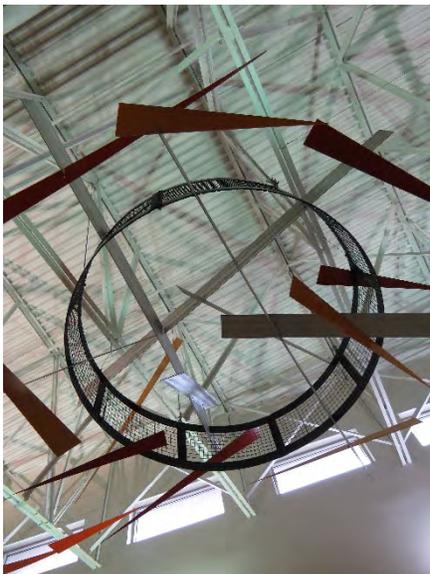
The central "magnet," a stainless steel mesh ring. A deflated balloon can be seen on the left side, entangled in the mesh.

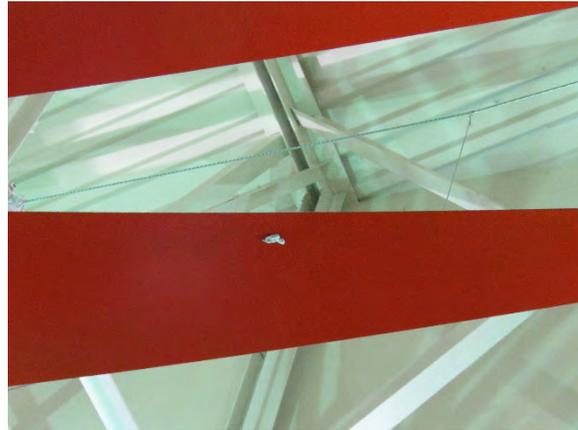
Piece of gum stuck to the underside of the arrow.

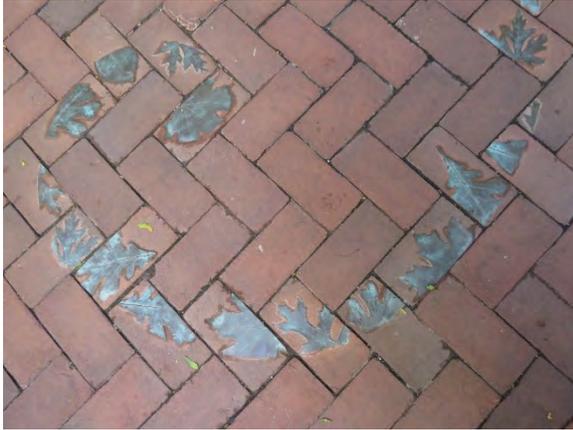
The bronze oak leaves on the sidewalk, with tarnishing and corrosion.

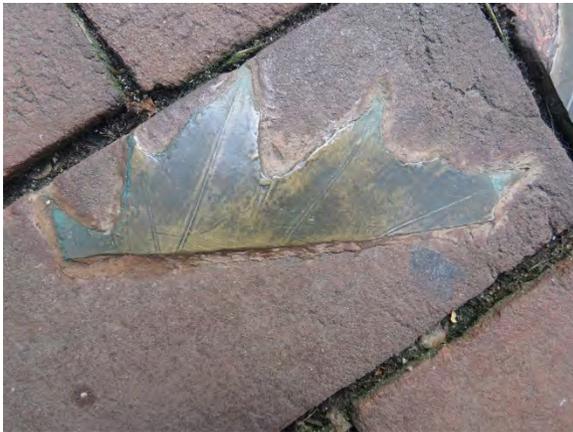
Some of the leaves are worn down to bright bare metal.

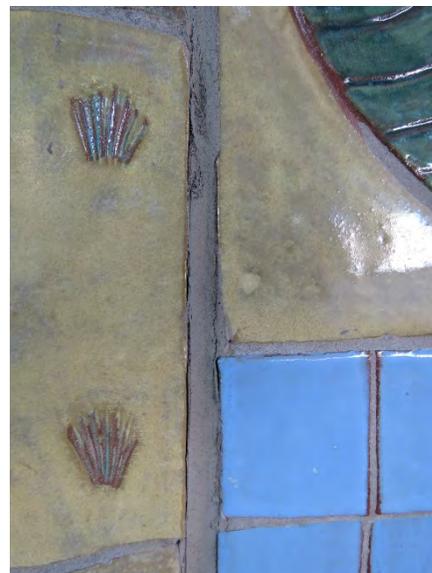
Deteriorating caulking at expansion joint is separating from the edges of the tiles.

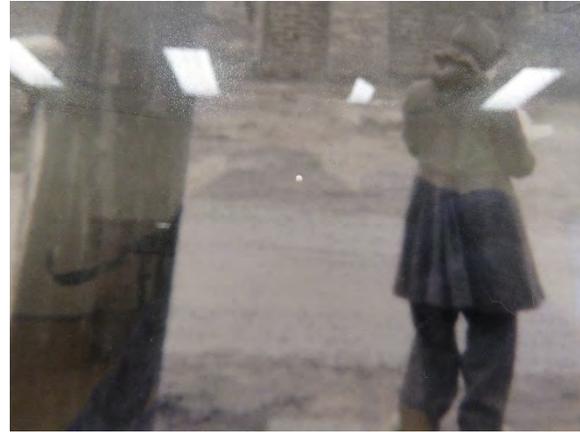
White speck of paint on the glazing material.

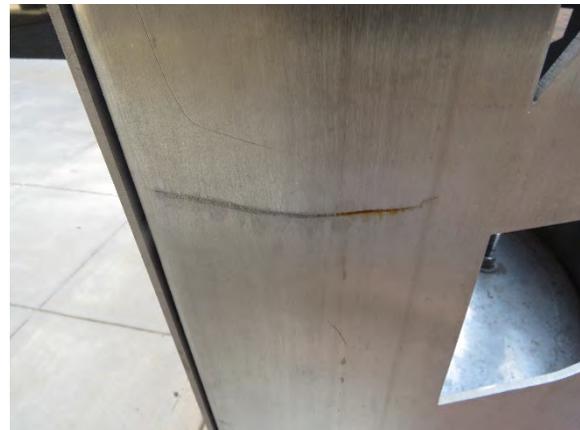
Heavy scratch with associated corrosion. Note the streaky surface from atmospheric soiling.

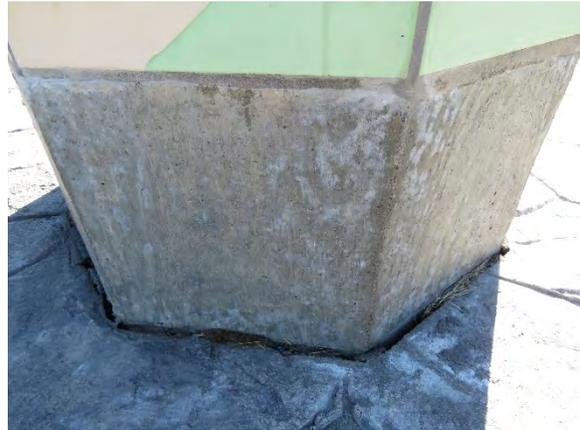
Efflorescence on concrete. Note loss of sealant at base, with biological growth.

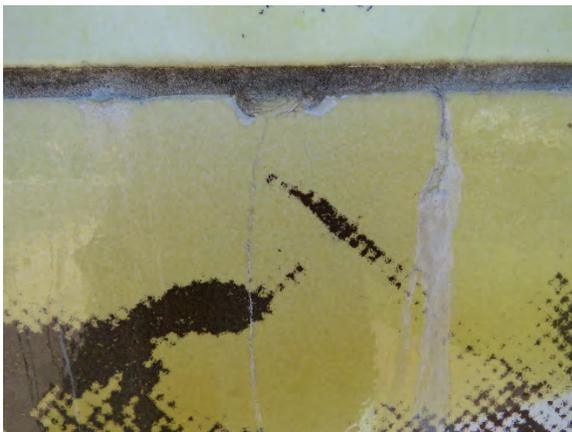
Small losses and cracking of tile, with efflorescence.

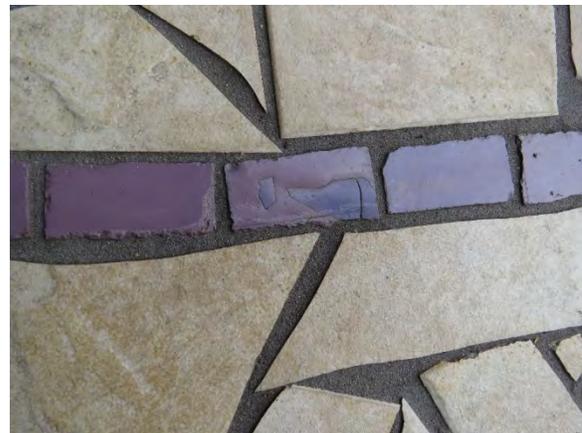
The only noted fills in a purple tile, which may be original to installation. The larger fill has a crack.

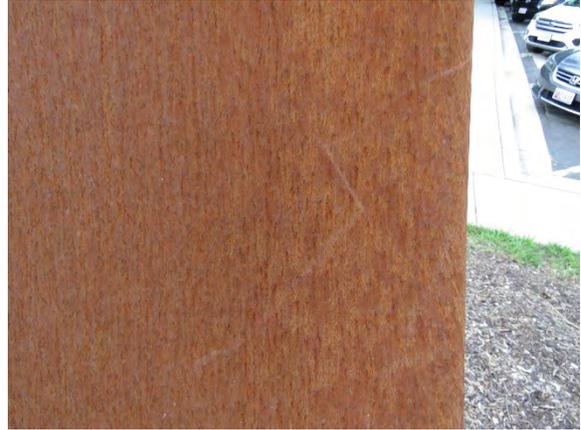
A zigzag scratch running through the stable corrosion layer on the side of the beam.

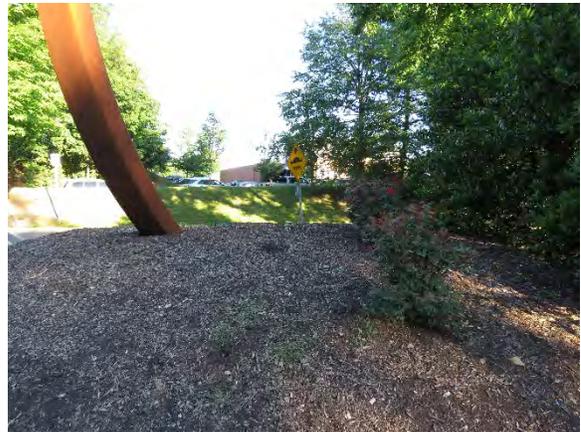
Mulch covering the mound and base of the sculpture.
