CITY OF ROCKVILLE

# KING FARM FARMSTEAD PROPERTY CONDITION ASSESSMENT

DEPARTMENT OF RECREATION AND PARKS

JULY 3, 2014

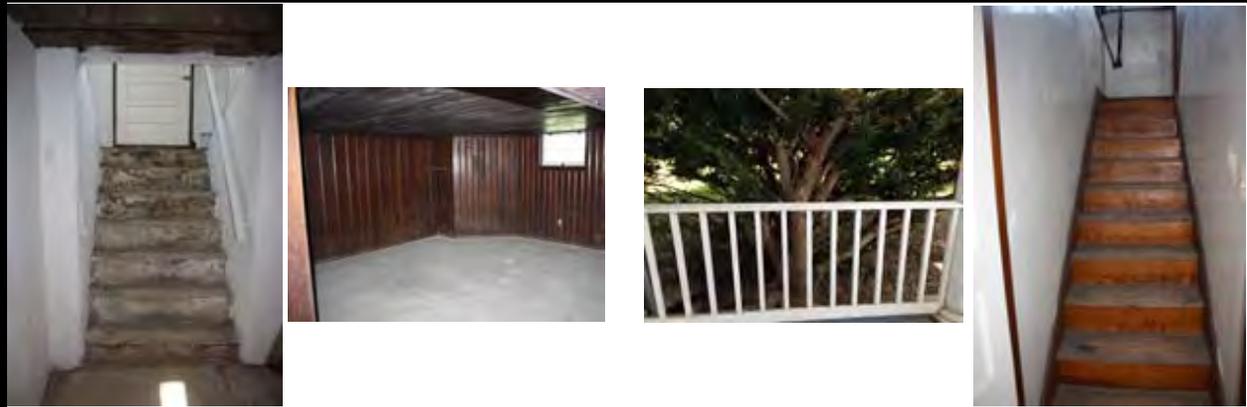
1. The railing @ the attic stair is not compliant.
2. Front porch railing too low.
3. Railings for the stair @ room 1 are too low.
4. There is no railing present in the secondary stairwell by room 5.

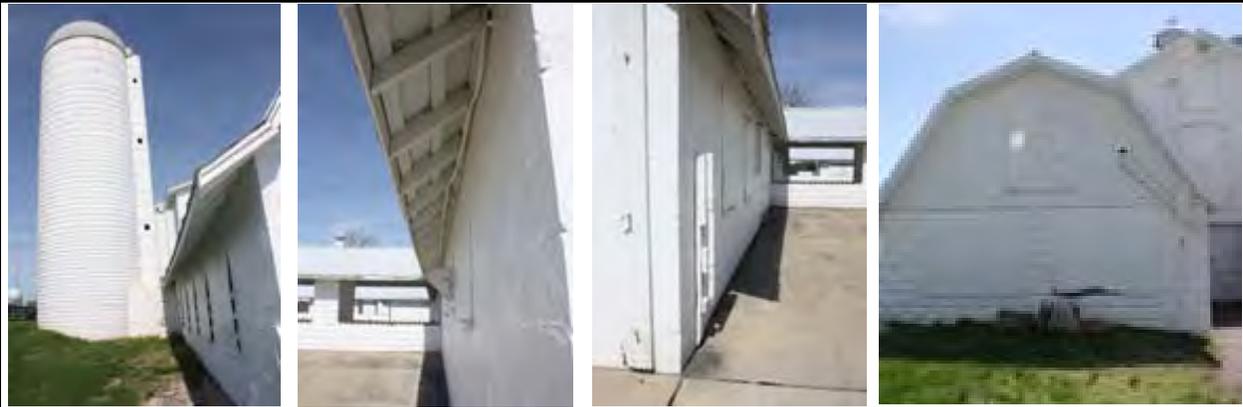
1. Miscellaneous appurtenances attached to siding @ elevation C.
2. Rust and peeling paint on silos.
3. Deteriorated conduit mounted beneath eaves @ elevation B. Wood siding beneath gambrel roofs show signs of minor flaking.
4. Sill rot @ windows on elevation A.

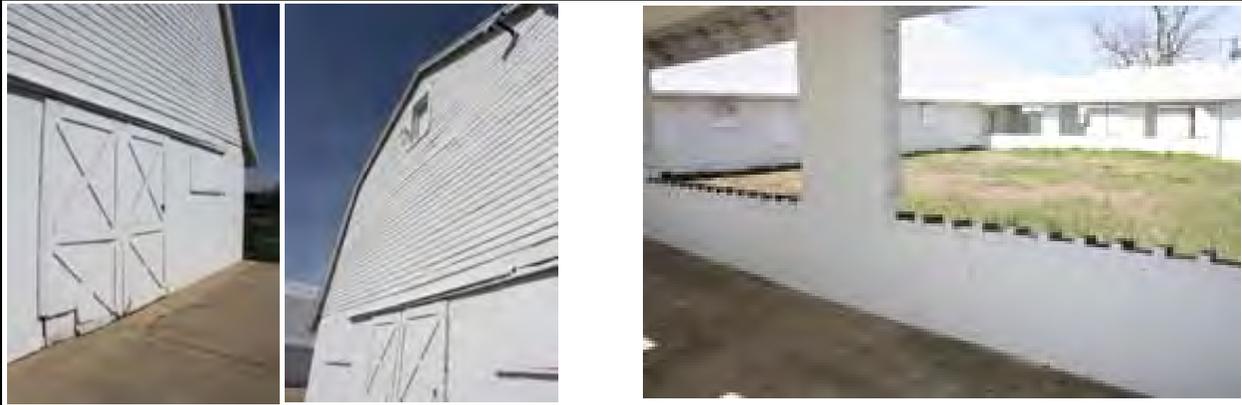
Exterior paint shows some signs of wear @ all elevations. Cracks show in CMU and siding.

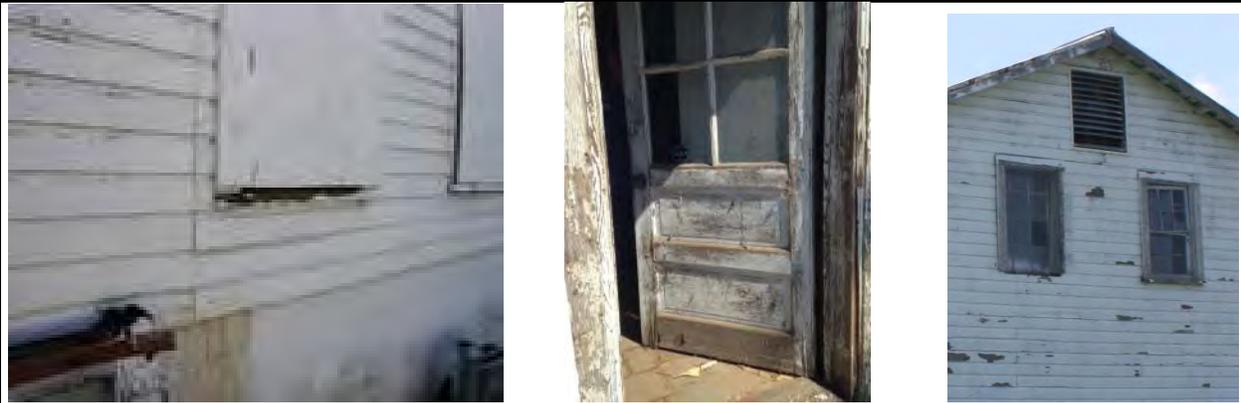
Sliding barn door in poor condition and rotted at the bottom; Front door @ room 1 deteriorated; Sill rot @ elevation B windows. Windows beneath gable @ elevation C in poor condition; No reasonable access into room 2.

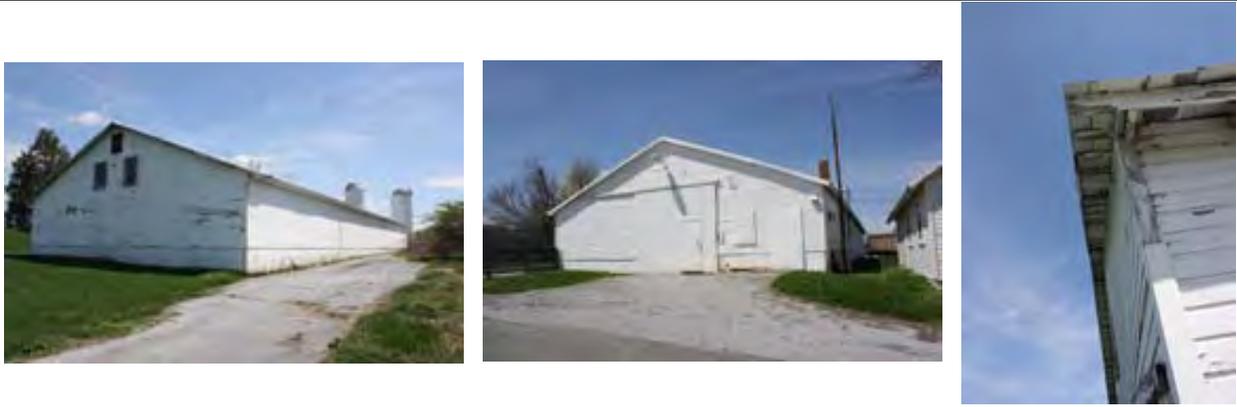
Exterior surfaces in poor condition.

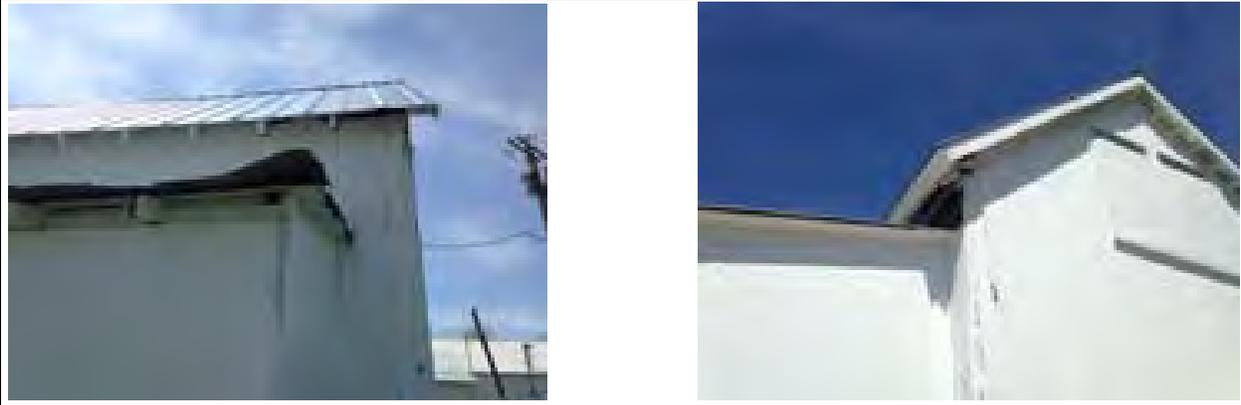
There is no proper gutter system present.

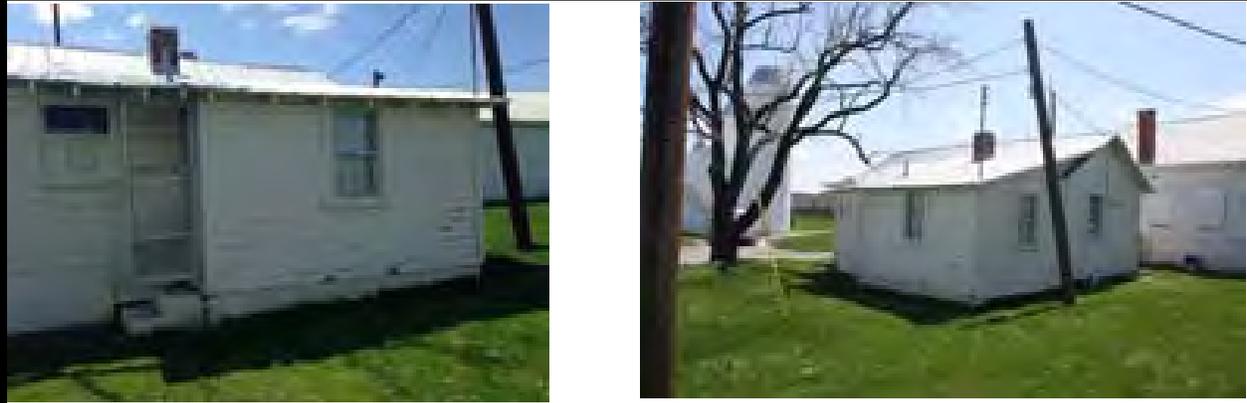
Minor damage to roof and eaves.

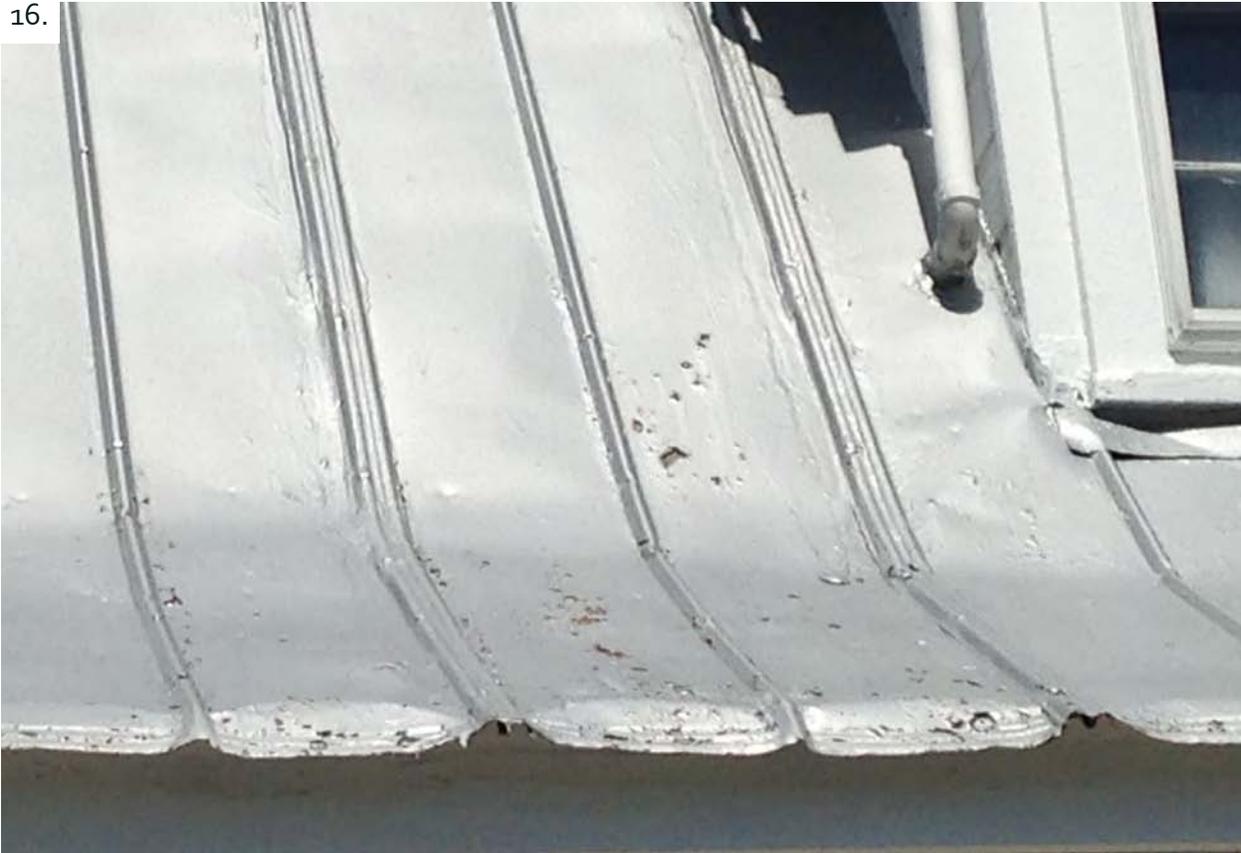
16. **Roof** Deteriorated edges and rust spots. Various pinholes throughout.

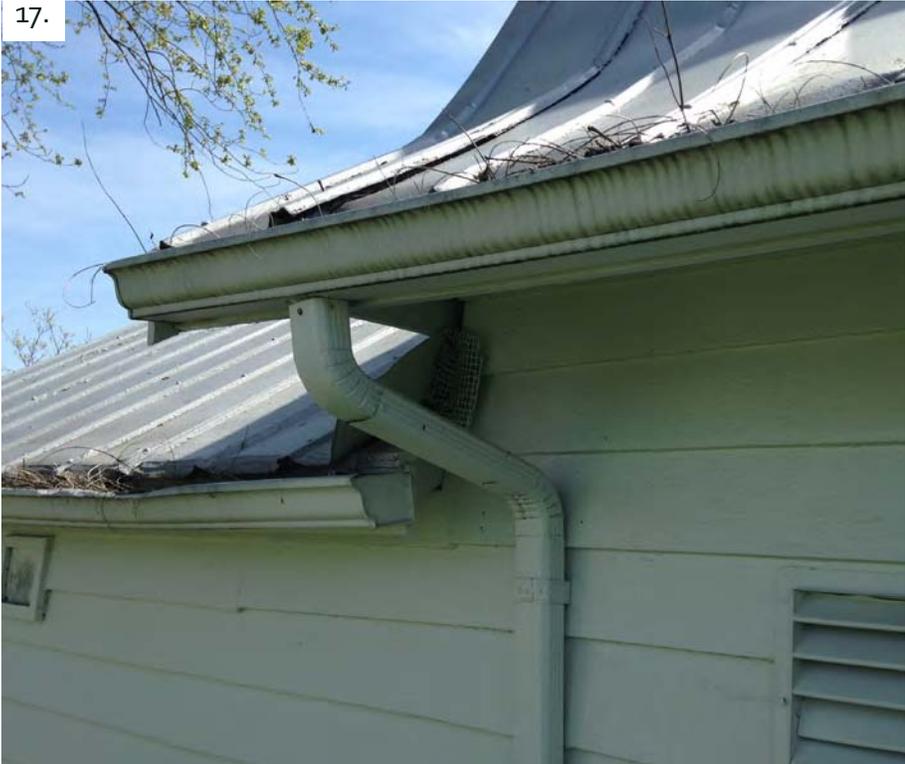
17. **Flared Eave** Gutters very full of debris, and showing signs of deterioration.

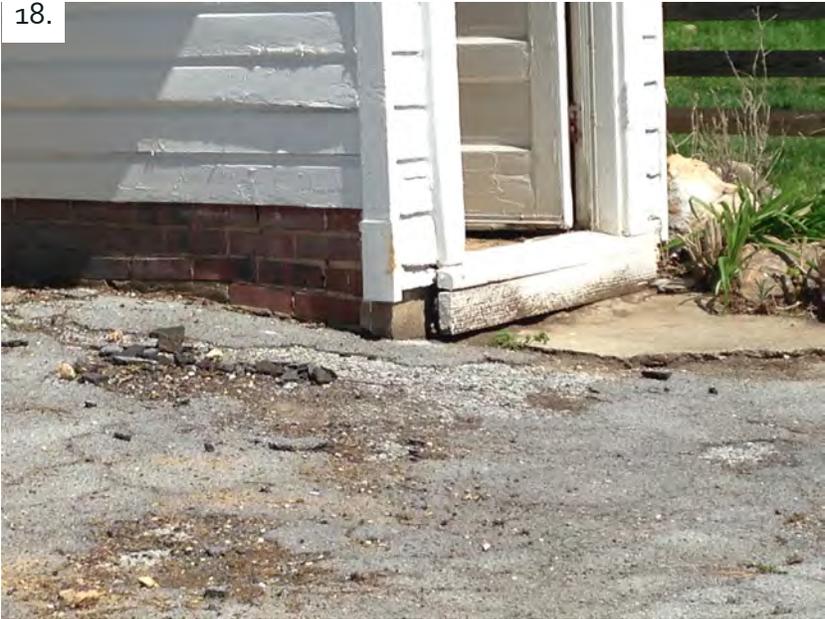
18. **Apartment Entrance** Stoop disconnected from foundation and deteriorated concrete pad.

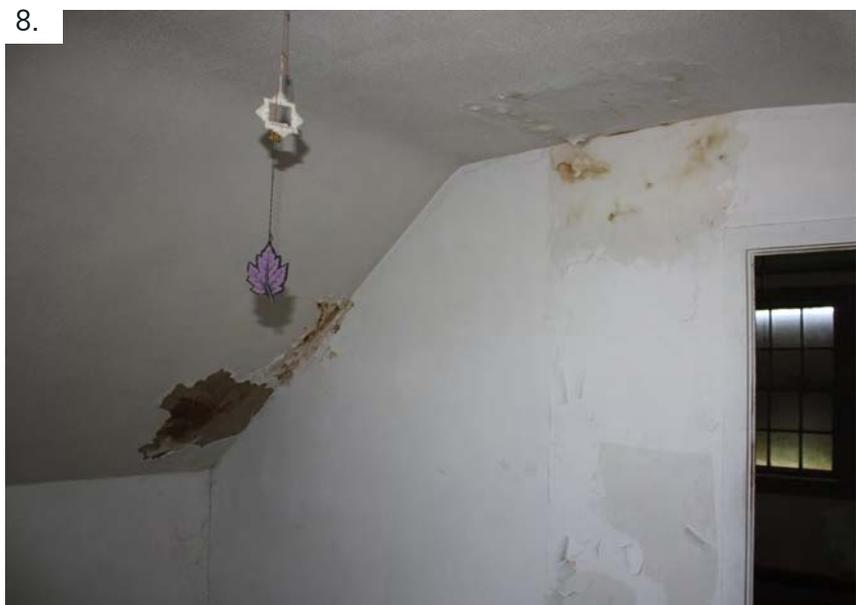
8. **Front Room** Significant signs of mold growth and water damage.

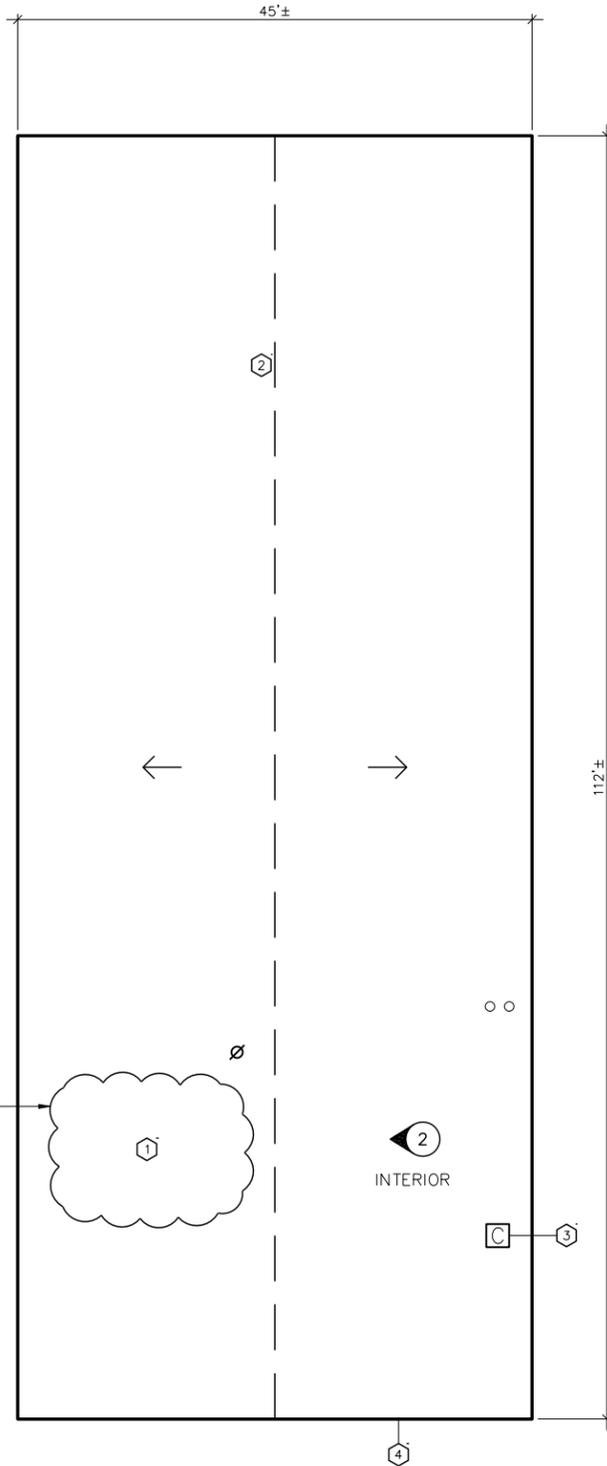
ROOF SAGGING 4 INTERIOR  
 2"x10" SUPPORT BEAMS  
 ARE BROKEN
