**CITY OF ROCKVILLE**

**KING FARM FARMSTEAD PROPERTY**

**CONDITION ASSESSMENT**

DEPARTMENT OF RECREATION AND PARKS  
JULY 3, 2014

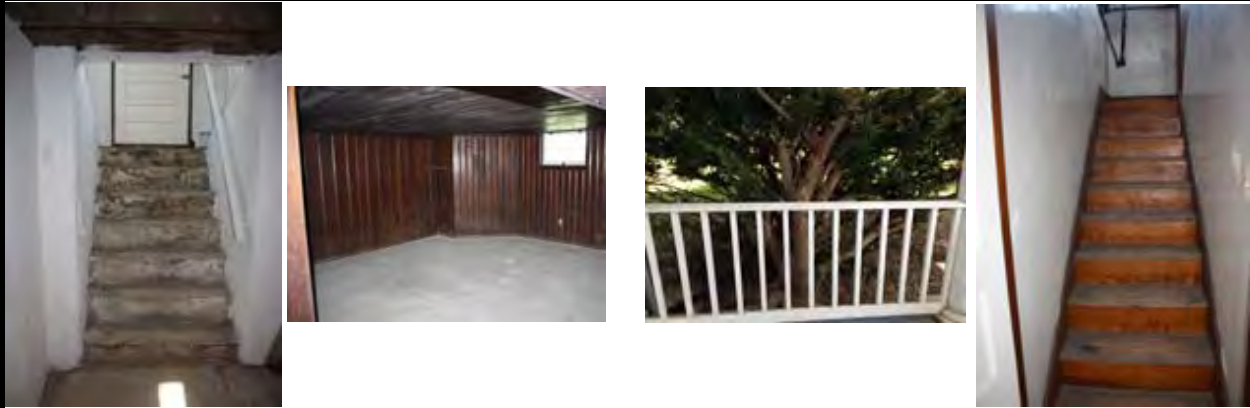
| King Farm Property Condition Assessment | |
|---|---|
| <p>1. No appropriate exit from the basement. Steps very steep. Ceiling heights too low in basement.</p> <p>2. Rear interior stairwell too narrow for public use.</p> <p>3. All doors @ second floor are too narrow.</p> | |

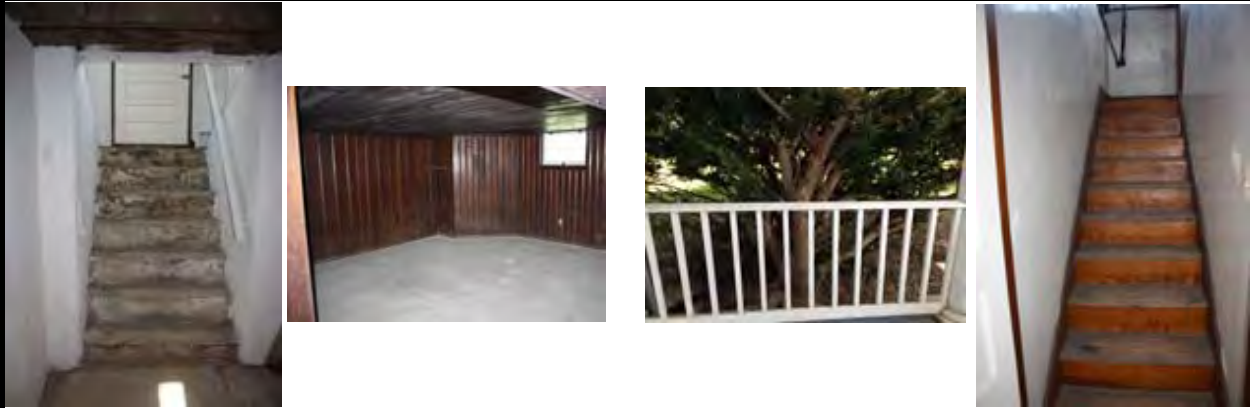
| King Farm Property Condition Assessment | |
|---|---|
| <ol style="list-style-type: none"> <li>1. The railing @ the attic stair is not compliant.</li> <li>2. Front porch railing too low.</li> <li>3. Railings for the stair @ room 1 are too low.</li> <li>4. There is no railing present in the secondary stairwell by room 5.</li> </ol> | |

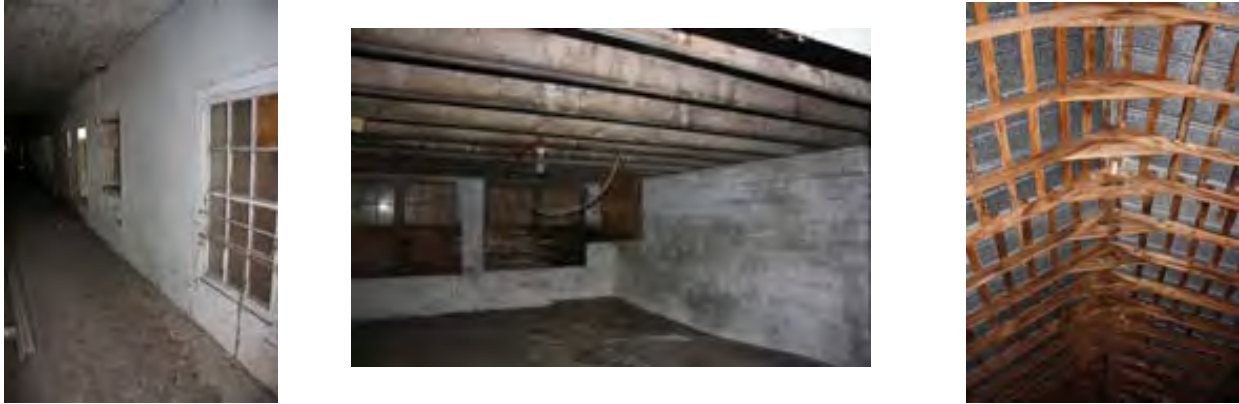
| King Farm Property Condition Assessment | |
|---|---|
| <p>Attic space is not insulated. Barn walls are not insulated.</p> | |

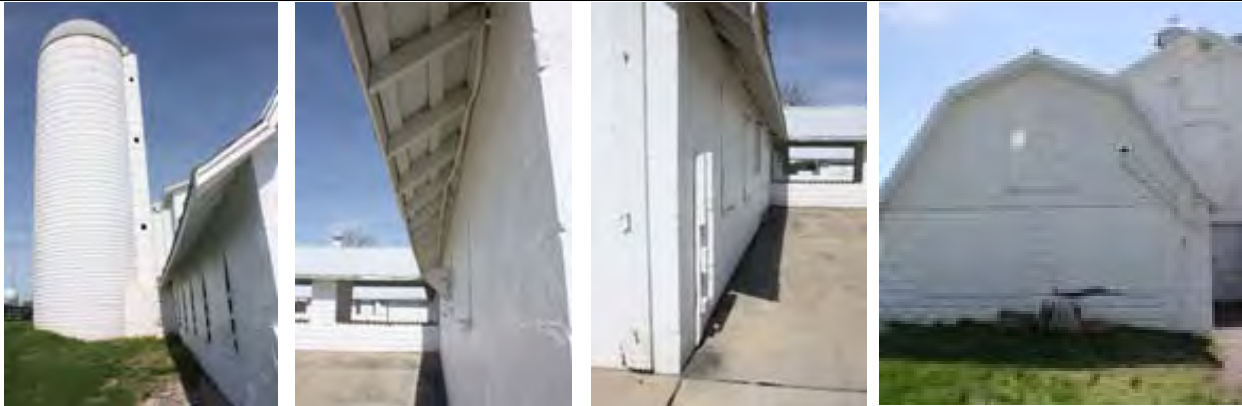
| King Farm Property Condition Assessment | |
|---|---|
| <ol style="list-style-type: none"> <li>1. Miscellaneous appurtenances attached to siding @ elevation C.</li> <li>2. Rust and peeling paint on silos.</li> <li>3. Deteriorated conduit mounted beneath eaves @ elevation B. Wood siding beneath gambrel roofs show signs of minor flaking.</li> <li>4. Sill rot @ windows on elevation A.</li> </ol> | |

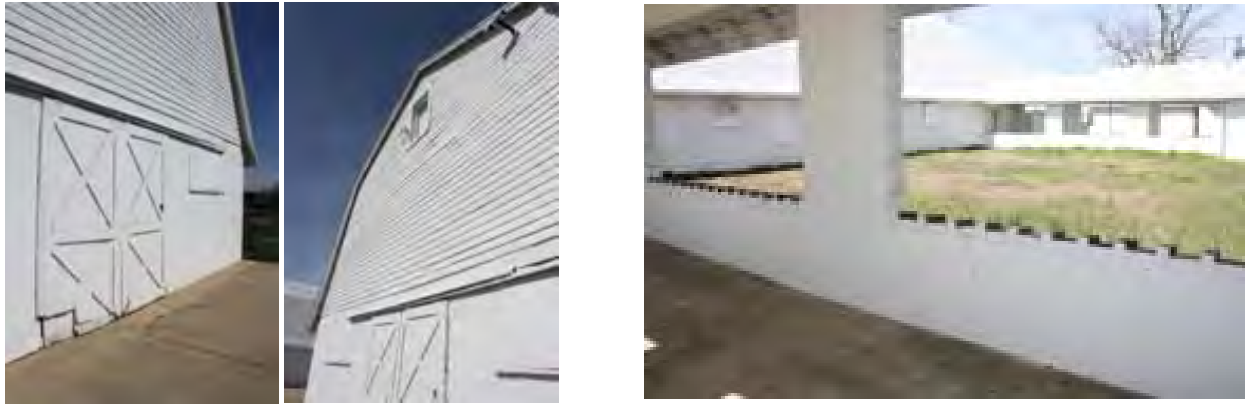
| King Farm Property Condition Assessment | |
|---|---|
| <p>Exterior paint shows some signs of wear @ all elevations. Cracks show in CMU and siding.</p> | |

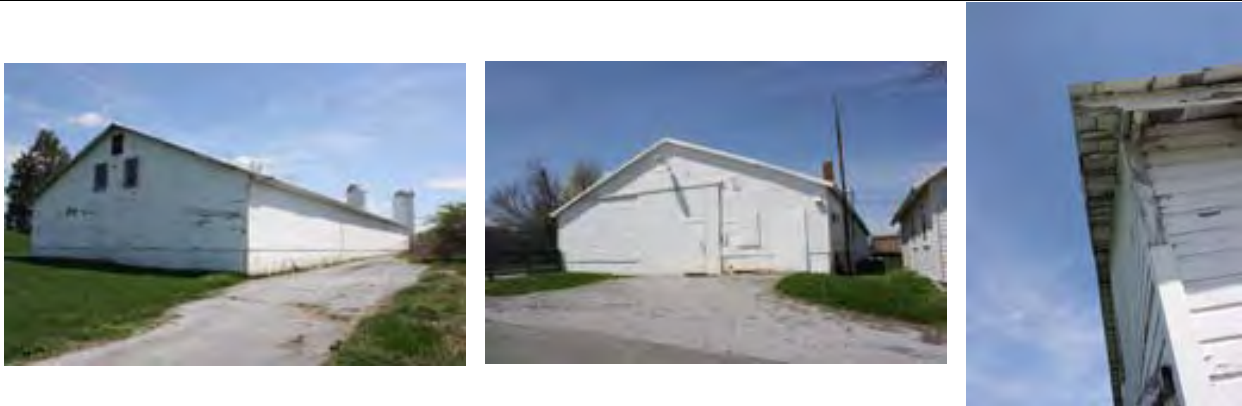
| King Farm Property Condition Assessment | |
|---|---|
| Exterior surfaces in poor condition. | |

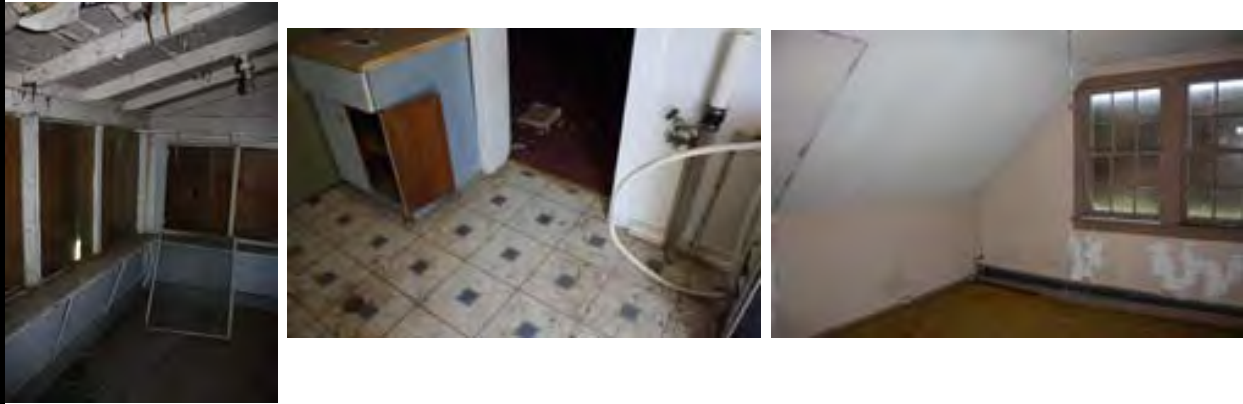
| King Farm Property Condition Assessment | |
|---|---|
| <p>1. Floors @ first and second level are soft and feel spongy. See 6-7.</p> <p>2. Second level is too low, causing the first floor ceiling height to be non-compliant.</p> <p>3. Floors in additions are in very poor condition from extensive moisture damage.</p> | |

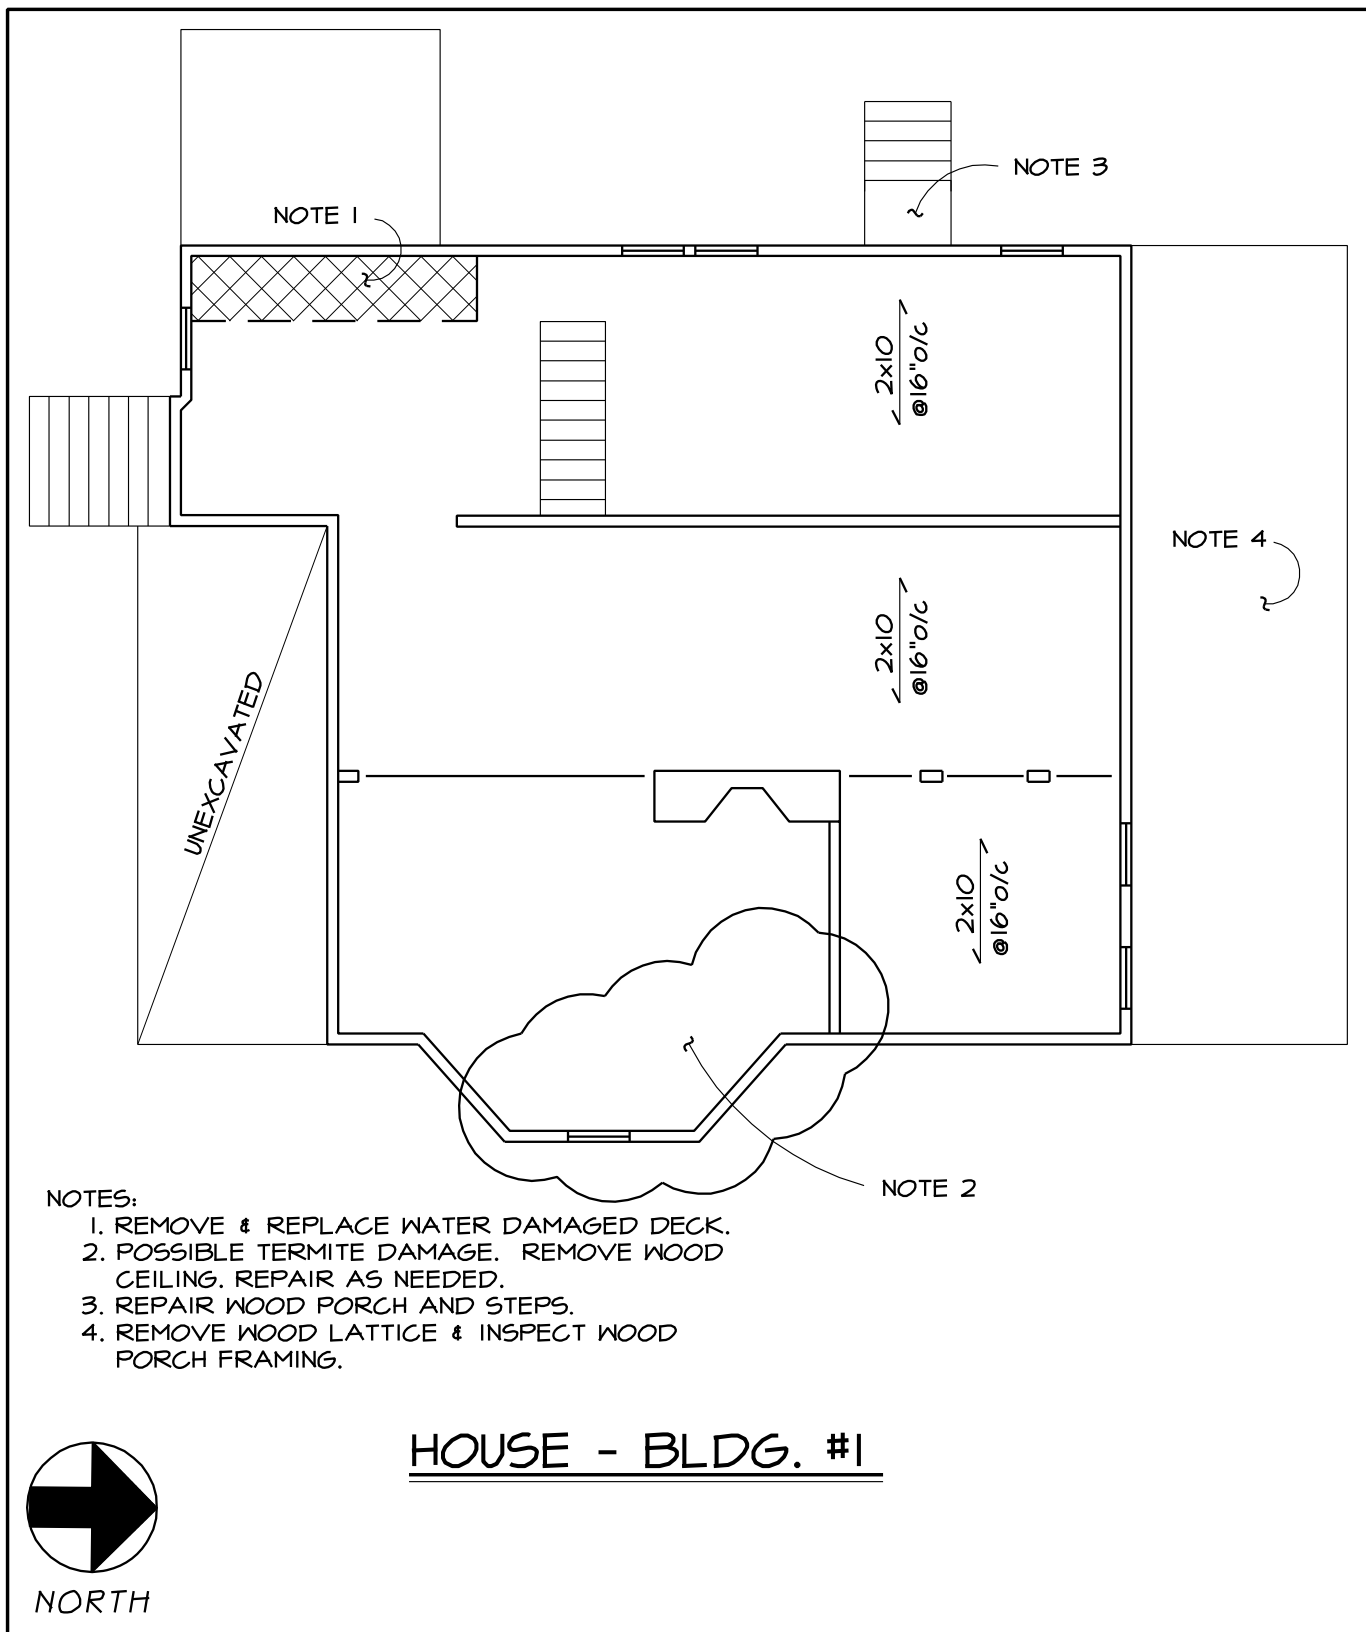
1. REMOVE & REPLACE WATER DAMAGED DECK.
2. POSSIBLE TERMITE DAMAGE. REMOVE WOOD CEILING. REPAIR AS NEEDED.
3. REPAIR WOOD PORCH AND STEPS.
4. REMOVE WOOD LATTICE & INSPECT WOOD PORCH FRAMING.

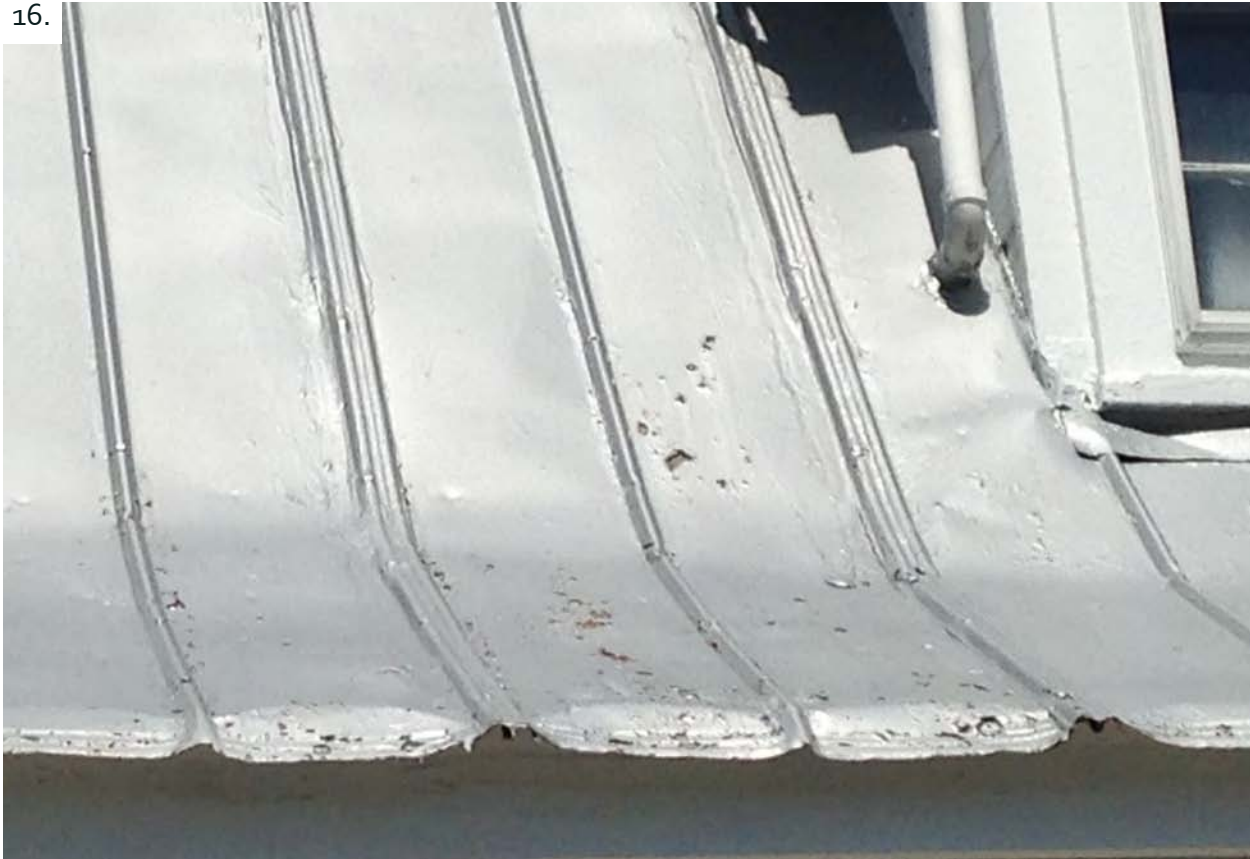
16. **Roof** Deteriorated edges and rust spots. Various pinholes throughout.

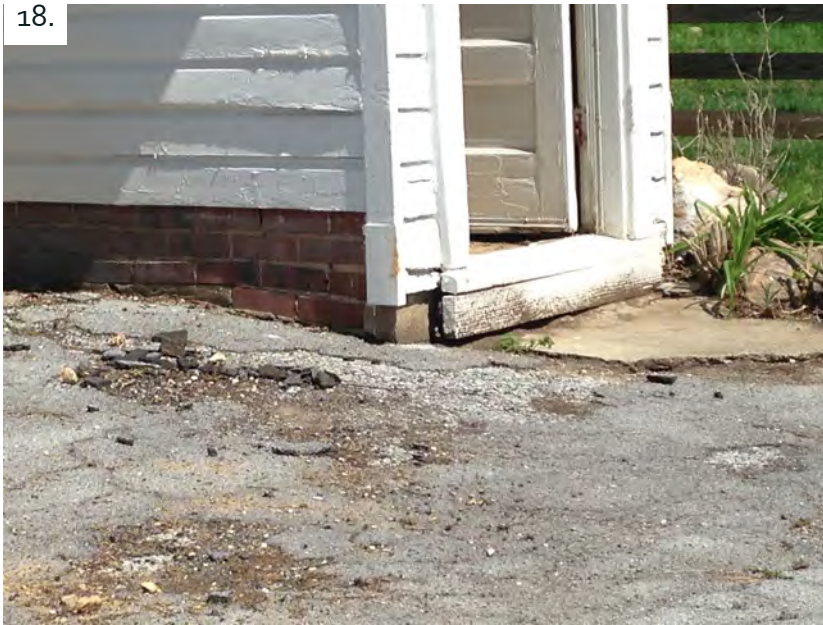
18. **Apartment Entrance** Stoop disconnected from foundation and deteriorated concrete pad.

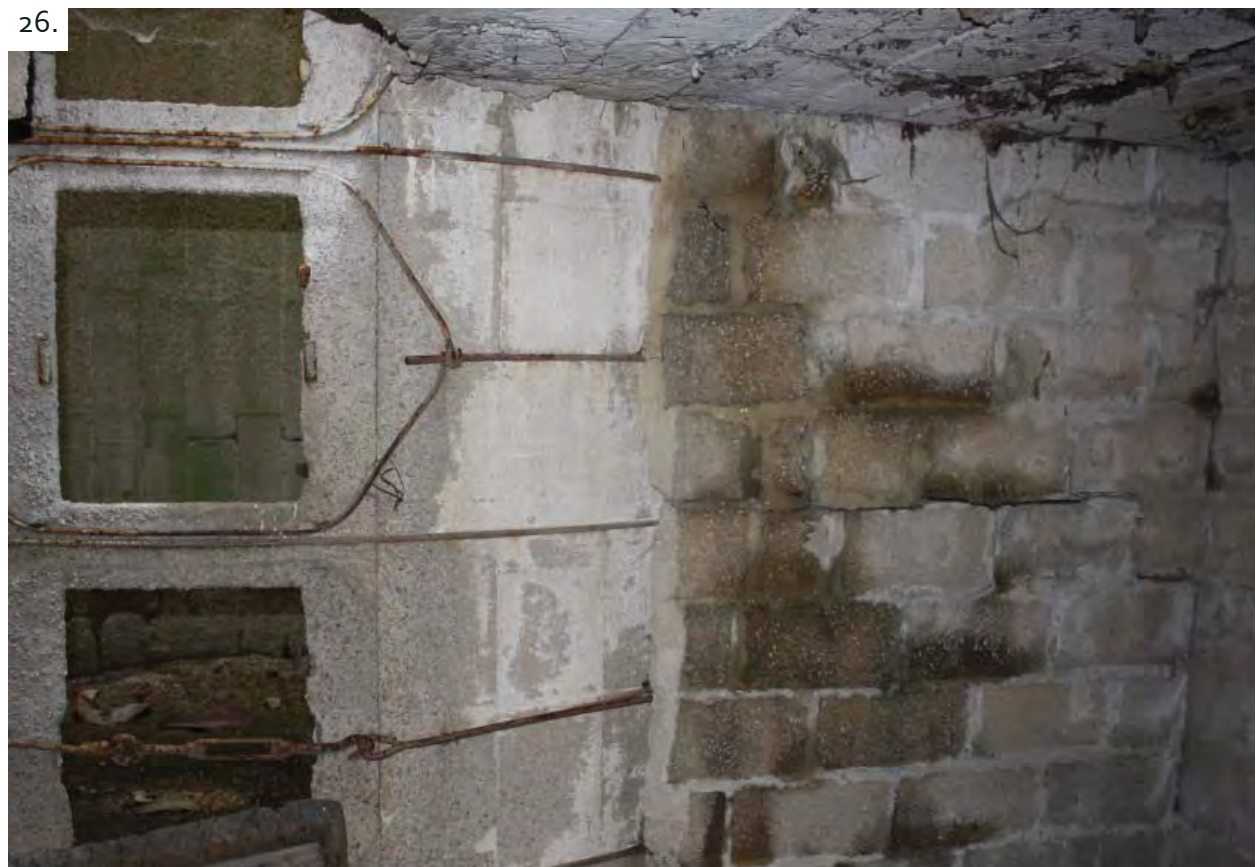
26. **Connector 3** Significantly deteriorated and showing many signs of water damage.
