**RedGate Park Clubhouse  
Condition Assessment Report  
City of Rockville**

**September 29, 2022**

**RedGate Park Clubhouse**  
**Condition Assessment Report**

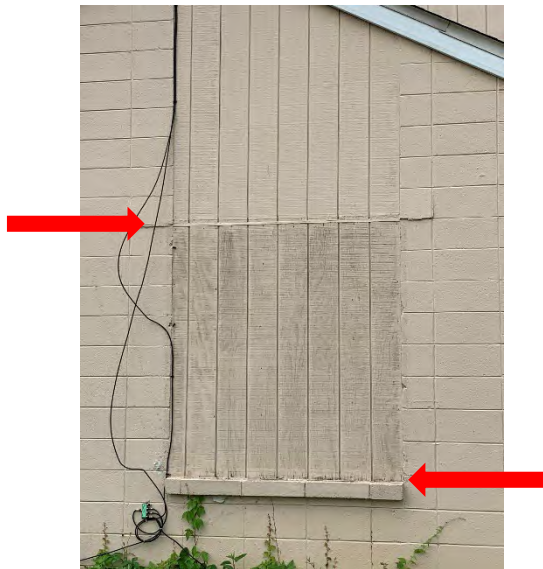
A closed-over window on the North wall of the later addition has the steel lintel showing signs of corrosion and is causing heaving in the adjacent CMU (see Figure 5). Due to the lack of flashing and conditioning, most wood wall materials have absorbed moisture at transitions and shows signs of moisture penetration (see Figure 6).

Figure 5: Exposed CMU and T-111 Wall Detail

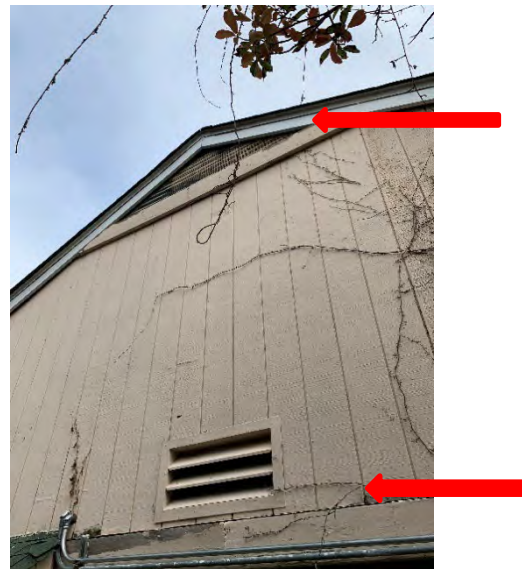
Figure 6: South Wall T-111

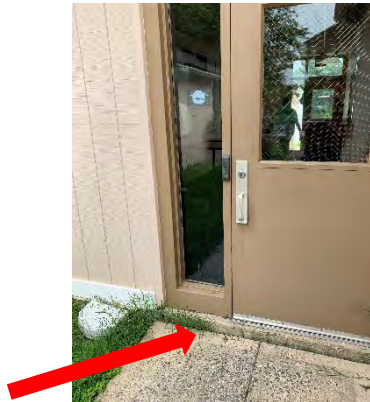
The south entrance to the building is a single non-insulated door with a side lite and transom that is positioned towards the right side of the connector between buildings. There is not roof overhang to protect from adverse weather. This door has a curb of 3-1/2". This entrance is not ADA compliant (see Figure 7) Access to this door, via a sloping sidewalk, is also not ADA compliant.

Figure 7: South Entrance

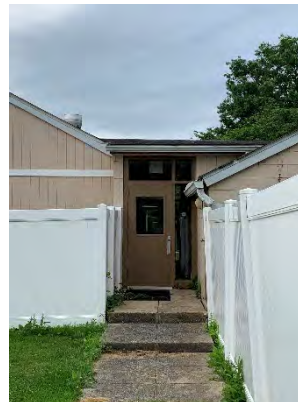
There is an additional exit door across from the main entrance. This door is similar to the main entrance but does not have a curb. Access to the entrance is not ADA compliant (see figure 8) due to the slope and steps.

Figure 8: North Entrance

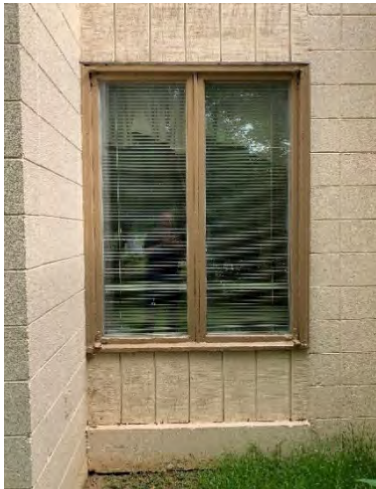
The majority of the painted wood windows are insulated, swing-out casement style, with a custom bay window of six (6) insulated fixed sash units in the east façade. All but one of the casement units were not operable as they are painted shut and the hardware gears are stripped. The windows in the original portion of the building are single-paned uninsulated glass. Some of their frames show degradation (see figure 9.). The aforementioned custom bay window units show signs of glazing sealant failure (internal haze in the air space), as well as having the majority of their wood sashes and frames showing decay, causing them to sag (see Figures 10 & 11).

**Figure 9: Original Single-Pane Casement Window**

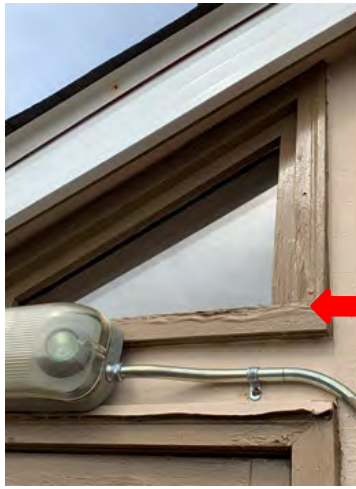
**Figure 10: East Bay Window Detail**

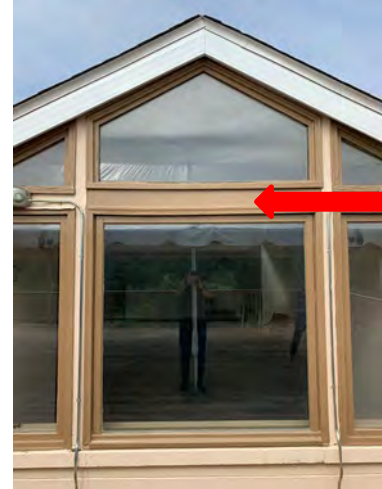
**Figure 11: Custom Fixed Bay Window**

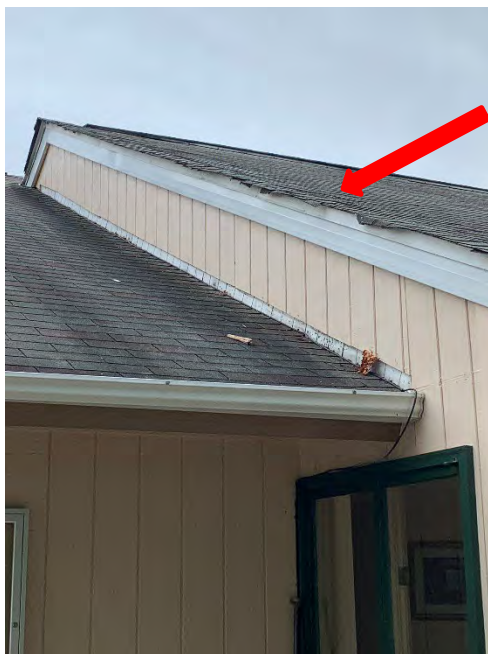
The gable and valley roof are clad with asphalt shingles. The roof is in poor condition with previous repairs visible. There is shingle loss near the roof's edges along with warping of the substrate underneath (see Figures 12 and 13). The roof, substrate, and fascia would have to be removed and replaced.

**Fig. 12: Roof End Conditions on West Roof**

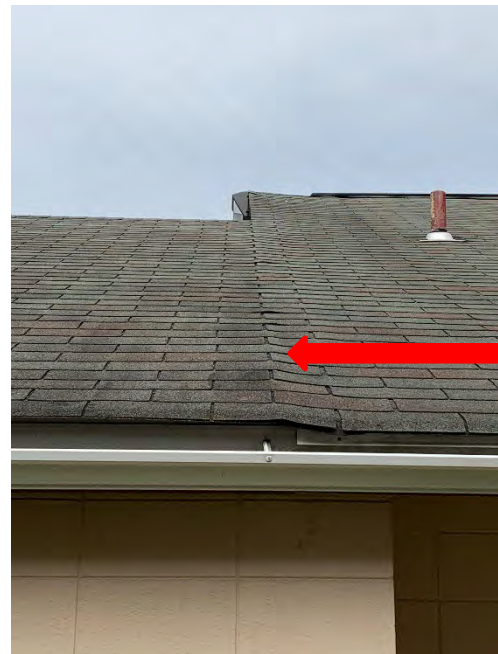
**Fig. 13: Warping of Roof Plane**

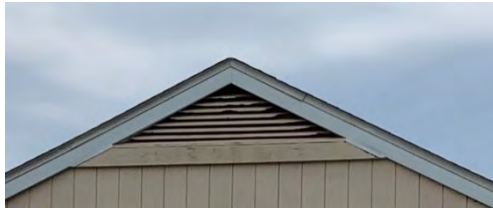
There are gable louvers on the north and south sides of the building. Due to weather exposure, both louvers and surrounding trim are showing signs of rot and require replacement.

**Fig. 14: Louver on North Side**

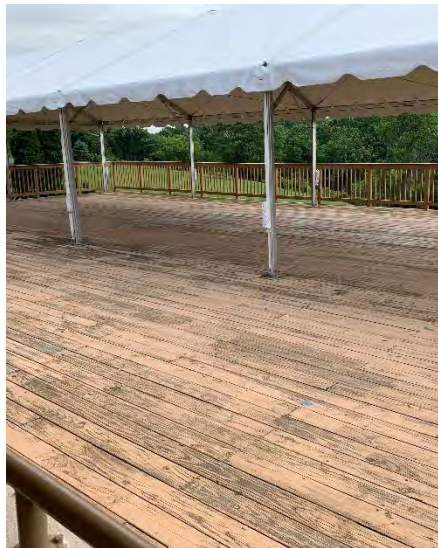
The wood deck appears to be in good condition, but the structure as documented in the original construction drawings does not consider the wind loading from the tented canopy that was added, nor the additional length of the structural members not originally shown. The stain is weathered and would need to be refinished. The attached canopy is in good condition and has no noticeable defects. Existing railing was cut off for installation of wood deck and partially remains today. Stair treads vary from 10 ½" – 10 ¾" in depth and are not to current code. The handrail doesn't extend beyond the last riser and is also not to current code.

**Fig. 15: Wood Deck and Canopy**

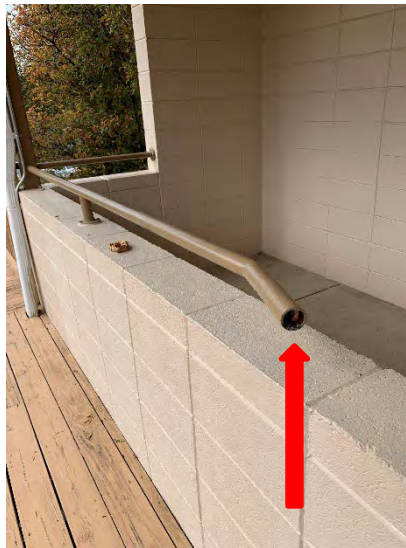
**Fig. 16: Existing Tube Railing**

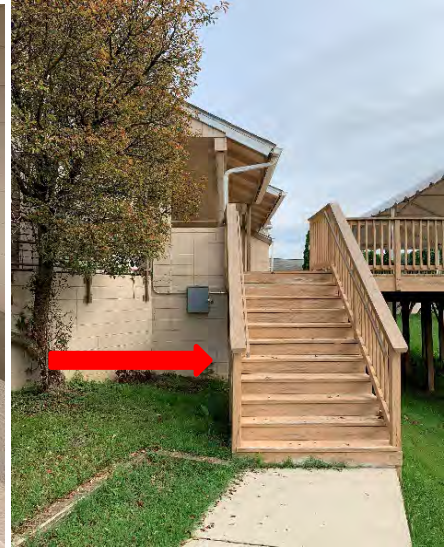
**Fig. 17: Deck Stairs**

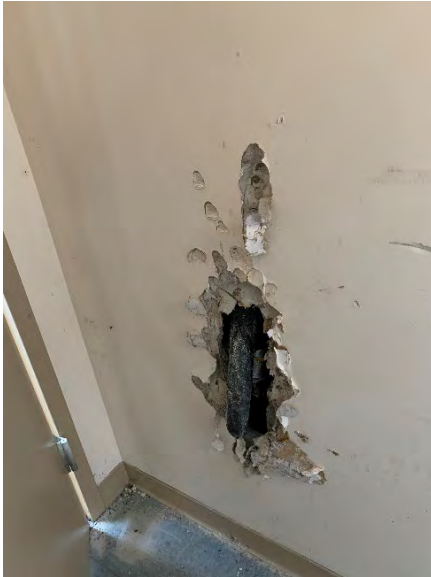
The interior wall cladding is primarily painted gypsum wall board with minimal areas of painted, exposed stack-bond CMU. Wooden slat wall used for display is against the wall of the the retail space. There are various holes located in the gypsum wall board. There is no insulation or moisture barriers on any of the exterior CMU walls. Exposed CMU is spalling with bubbled paint due to moisture exposure.

Fig. 22: Various Hole in GWB

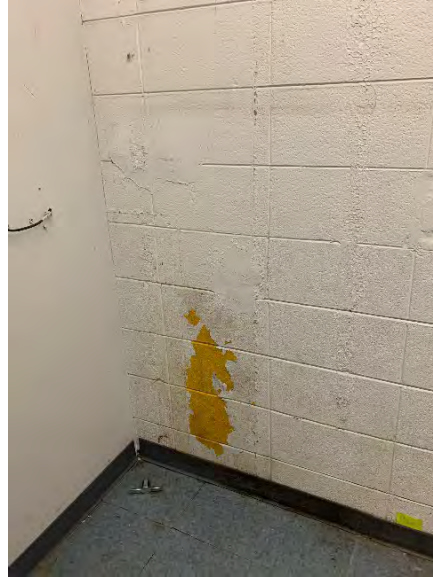
Fig. 23: CMU Conditions

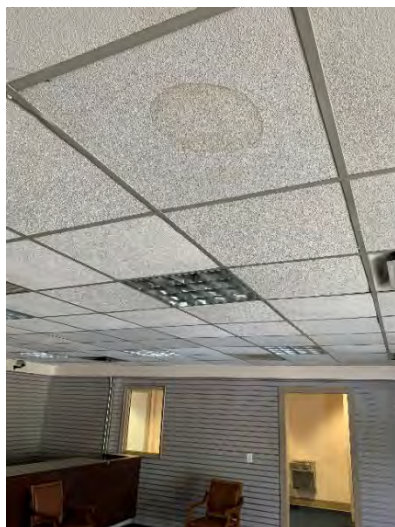
The ceiling cladding consists of 24"x24" lay-in ceiling panels with a 15/16" metal grid. A great deal of moisture has been absorbed by the ceiling tiles, causing them to sag; water stains are also present. The dining area has gypsum board ceiling with exposed, painted trusses; no acoustic materials are present. There are joint cracks and water damage within the adjacent gypsum board clad bulkheads.

Fig. 24: ACT Ceiling Tile with Water Stains

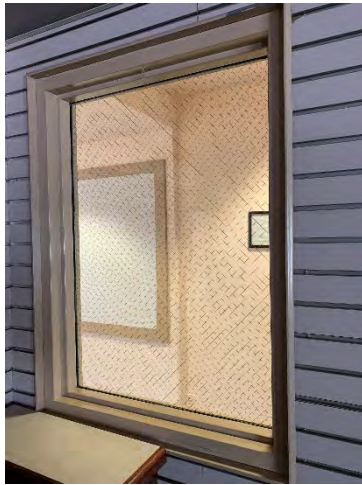
There are multiple interior windows within the walls of the building. All but one contains wire glass. The other window is covered up with painted gypsum board to match the surrounding wall. The wire glass is not code compliant (see Figures 26 and 27 below).

**Fig. 26: Wire Glass Interior Window**

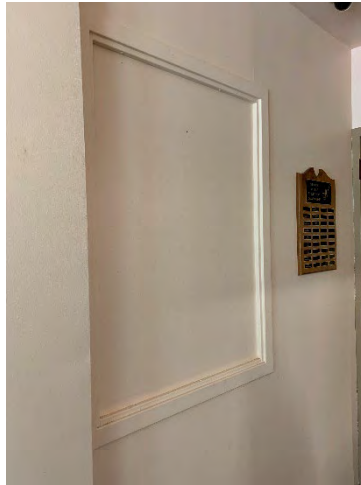
**Fig. 27: Covered Interior Window**

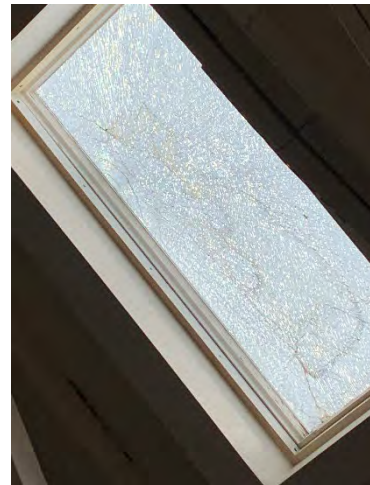
There are five (5) skylights in the dining area. All the skylights appear to be in good condition except for one (1). The glass of the third skylight from the north is shattered (see Figure 28 ).

**Fig. 28: Broken Skylight**

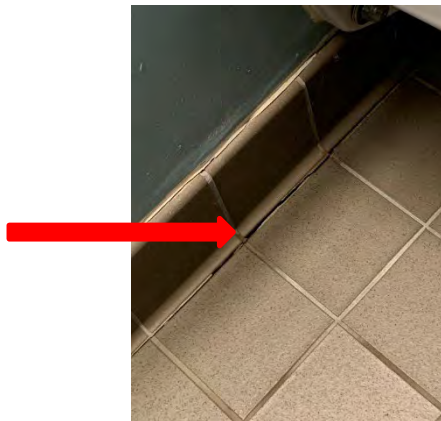
The toilet rooms wall finishes are painted gypsum board. Floor finishes are 6"x6" quarry tile and cove base. Floor tile in both toilet rooms is cracked near the back wall and where the building expansion transition begins. The floors do not align with the original construction. Plumbing fixtures and stall widths do not have enough clearance to be ADA compliant. The edge of sink to stall face doesn't accommodate a person in a wheelchair and someone trying to get into the stall behind them. The paper towel dispensers project too far into the path of travel.

**Fig. 29: Separation of Floor**

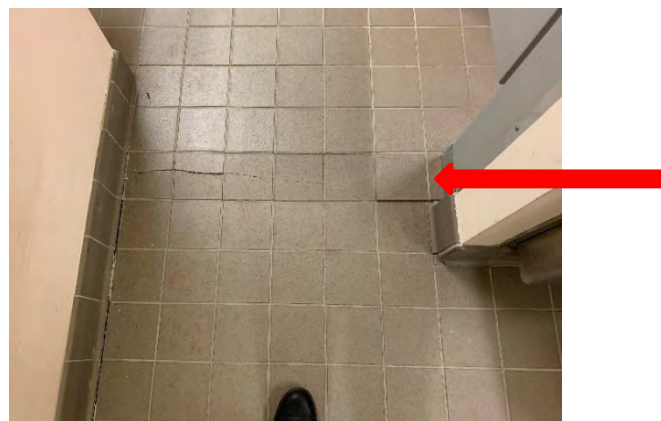
**Fig. 30: Change in Floor Elevation and Wall Finishes**

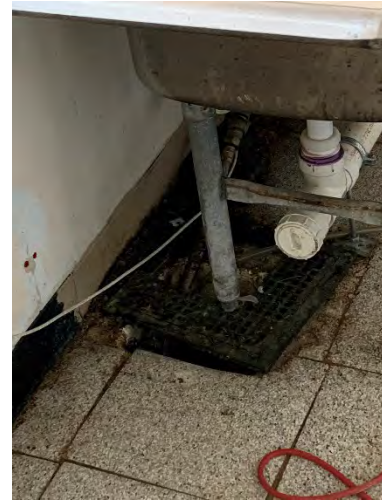
The snack bar equipment and casework is beyond its useful life. The finished walls are painted gypsum board with a vinyl wall base. The finished floor is 12"x12" textured VCT tile with level loop broadloom carpet in the dining area. Water damage and mold is evident under the sink.

Fig. 32: Under Sink Condition

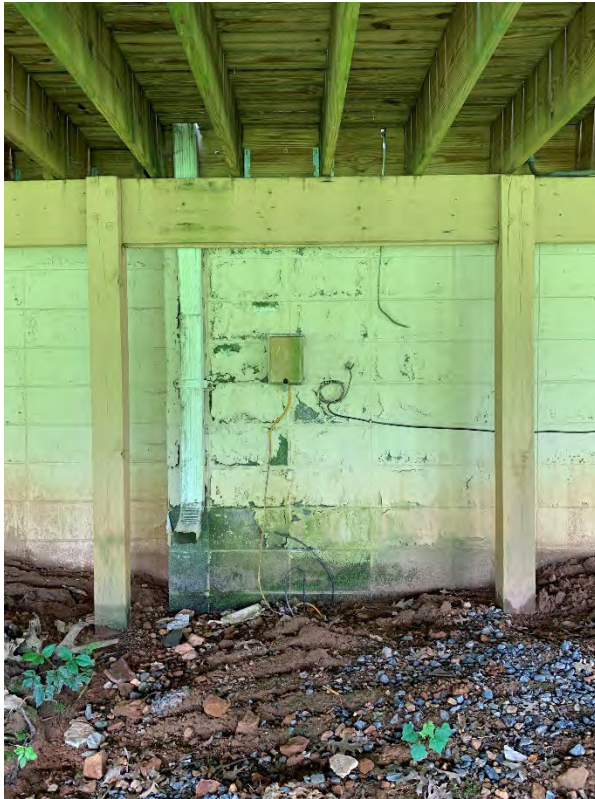
Most of the exterior walls were visible from the outside during the assessment. They are painted concrete masonry unit walls of mostly 6" or 8" thickness. A few locations appear to have modifications made with studs and wood panel to accommodate new openings or cover up old openings. From the outside, minor spalls were visible at a few locations. Under the deck, the masonry paint is peeling, and erosion of the surrounding grade was observed near a downspout (see Figure 33). Overall, the exterior faces of the CMU walls appear to be in acceptable condition; the T-111 siding shows degradation at material transition.

Figure 33: Masonry under Deck near Downspout

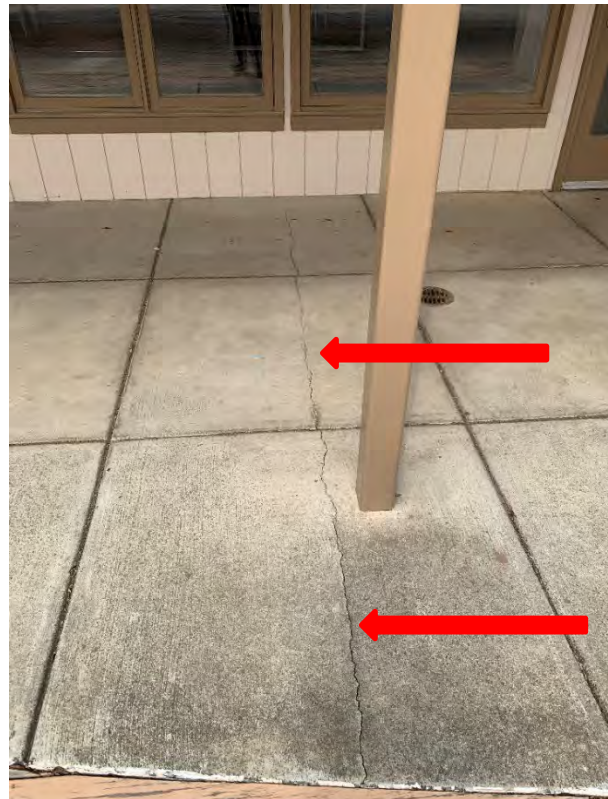
Figure 34: Crack at Terrace Slab

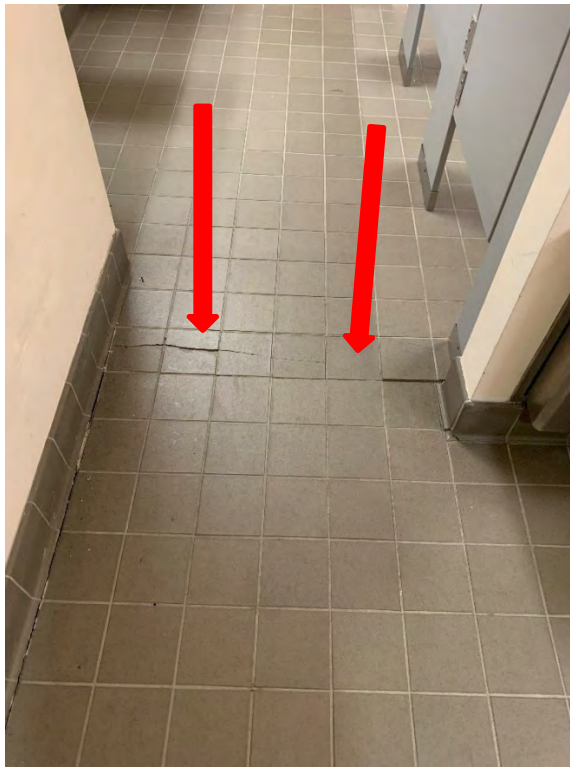
**Figure 35: Change in Floor Elevation at Women's Bathroom**

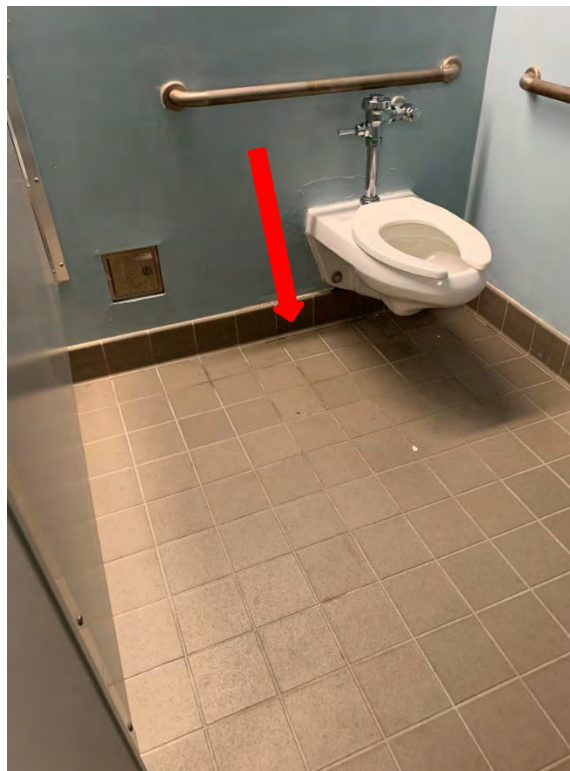
**Figure 36: Separation of Floor and Wall Finishes at Men's Bathroom**

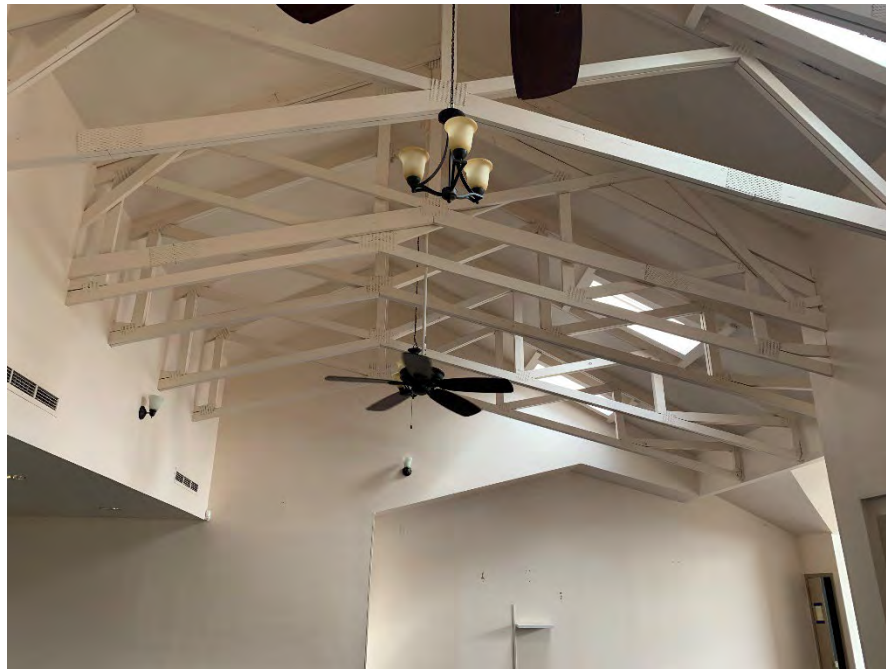
The roof framing was covered by ceiling or soffit in most areas. However, the wood trusses were visible in the dining room of the addition. The trusses appear to be in good condition (see Figure 37). One of the skylights was cracked while remaining in the frame, which may result in water damage to the surrounding structure. In the original building, there were a few small water stains on the ceiling in the retail area, which could be the result of a roof or utility leak.

Figure 37: Typical Condition of Roof Trusses at Addition

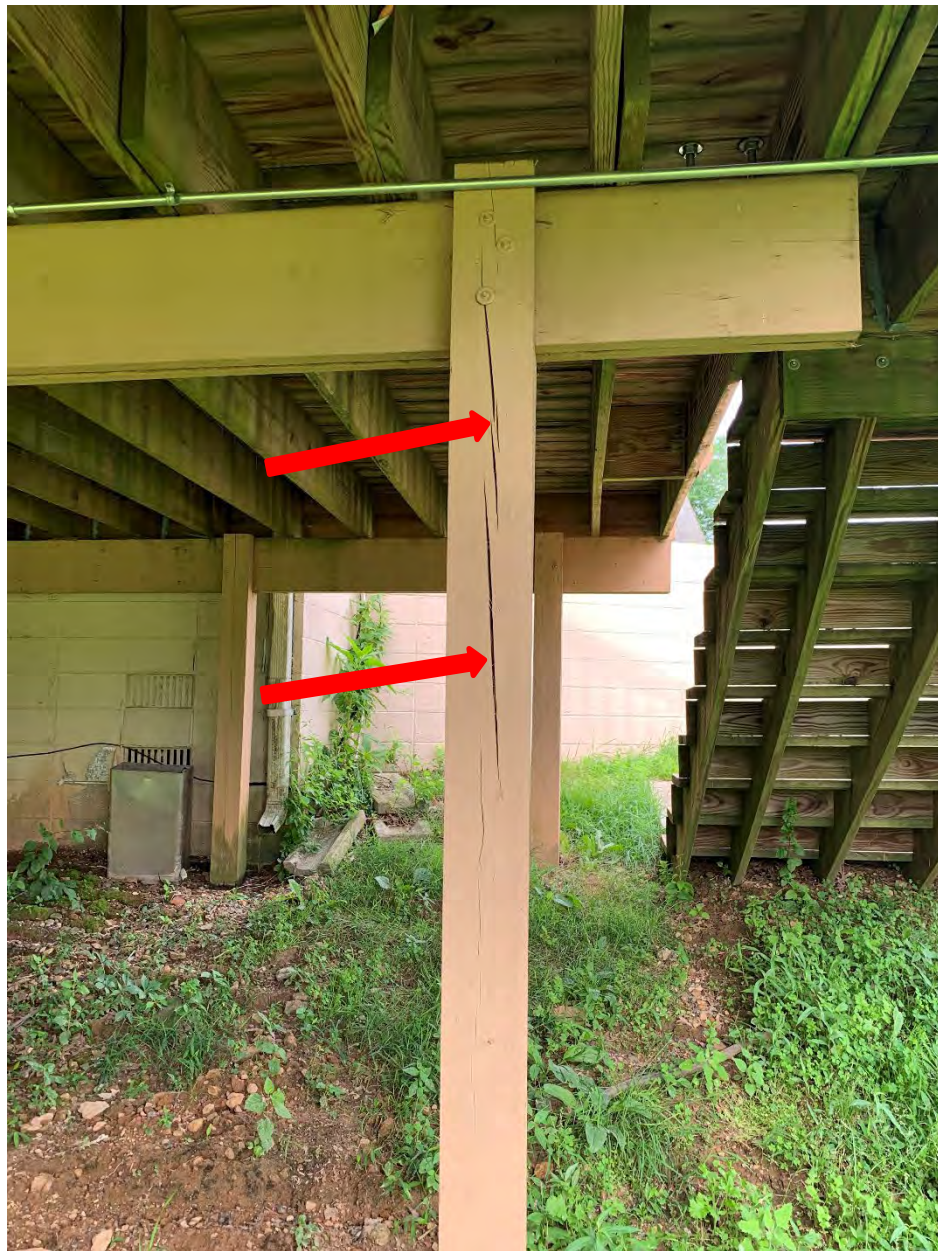
While observing the deck from the underside, it was apparent that many of the wood posts exhibited vertical checks (see Figure 38). A few checks appeared on both sides of the posts, which causes concern that the post is splitting. The record drawings state that the longest post should be 6 feet long. Most of the posts are over 6 feet long with the outermost posts being well over 6 feet, perhaps double. Since the structural capacity of a post decreases as length increases, it is crucial to stay within the intended design lengths.

**Figure 38: Vertical Checks at Deck Posts**

Based on the post length and tent issues described above, a structural analysis of the deck is recommended to confirm that the capacity is acceptable if it is going to remain in use.

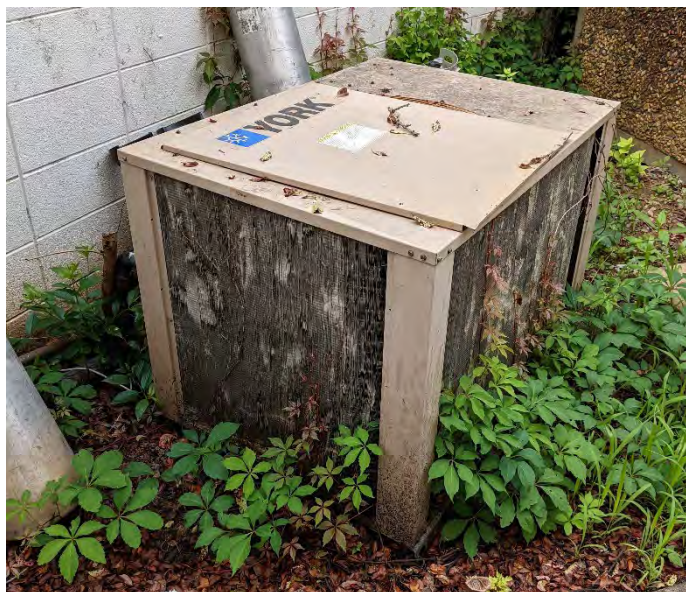
The split system serving the dining area of the building was not operational at the time of visit and appeared in poor condition. Based on nameplate data shown on the outdoor unit, this system is past its useful life at approximately 21 years old. There is significant damage to the fins on the outdoor unit and it is expected that the indoor unit motor will not function adequately based on its age and its lack of recent operation - which will deform ball bearings over time.

Figure 39: Dining Area Outdoor Unit

The split DX system serving the dining area is beyond its useful life and a replacement system will be necessary. With a new system, the existing ductwork and air devices are recommended to be replaced if any unit sizing changes occur to ensure that the area has adequate air distribution. Similarly, the duct layout should be reviewed and adjusted as required for better distribution. Because the existing kitchen hood does not incorporate any make-up air, a new make-up air system will be required by code to serve this space if the hood will remain.

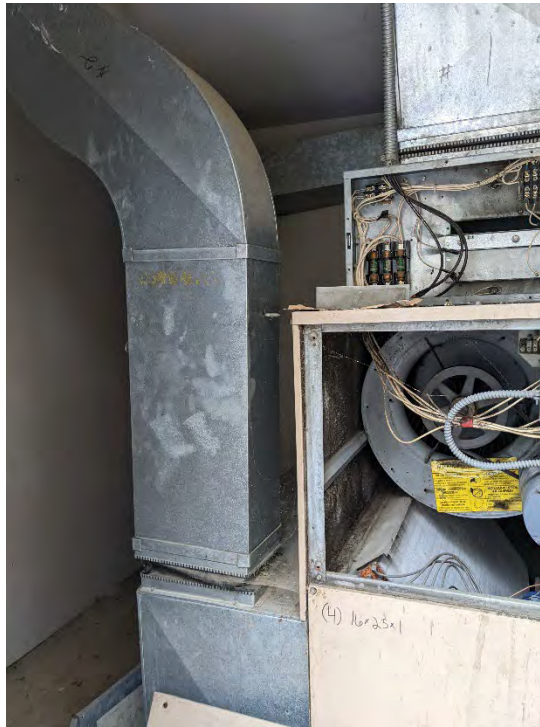
The ductwork serving the dining area was only observable within the mechanical room, and the ductwork in this location appeared in fair condition. The air devices mounted within the dining area were also in fair condition. There is an air cleaner mounted in the ceiling of the dining area, but it was unclear from the site survey whether it was operational – it appeared in poor condition.

**Figure 40: Dining Area Indoor Unit and Ductwork**

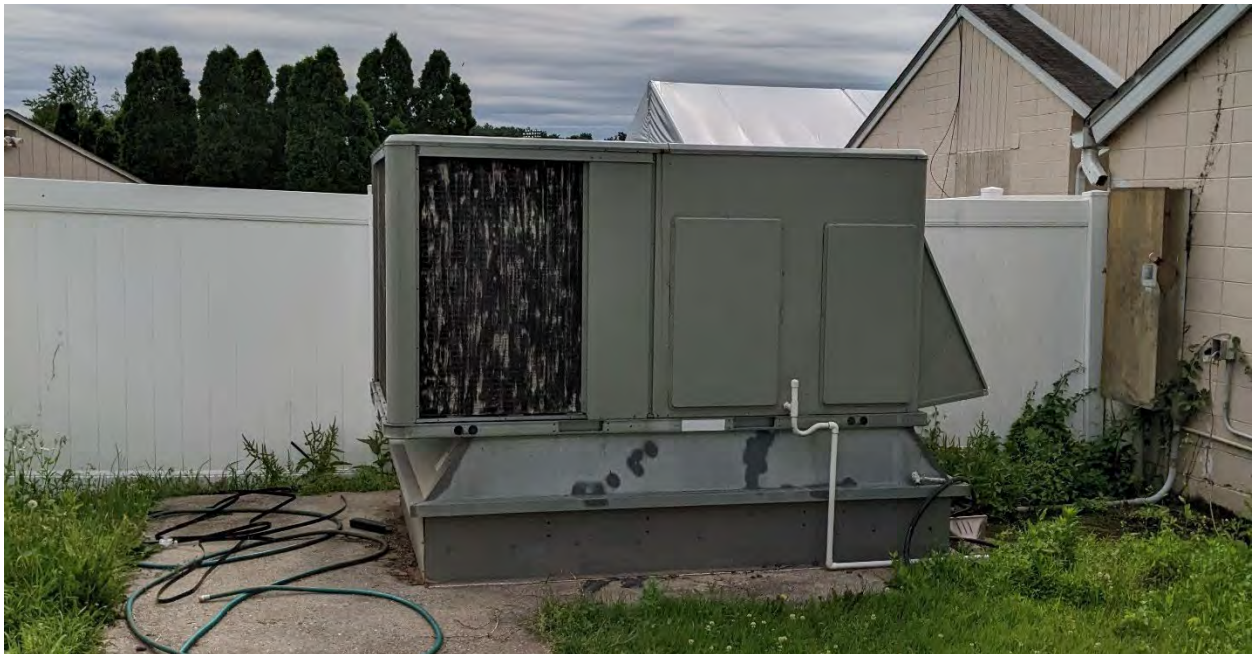
The packaged RTU system serving the remainder of the building is approximately ten years old and appears in adequate condition. The ductwork in this area was not visible, but the air devices appear in good condition.

Figure 42: Packaged RTU

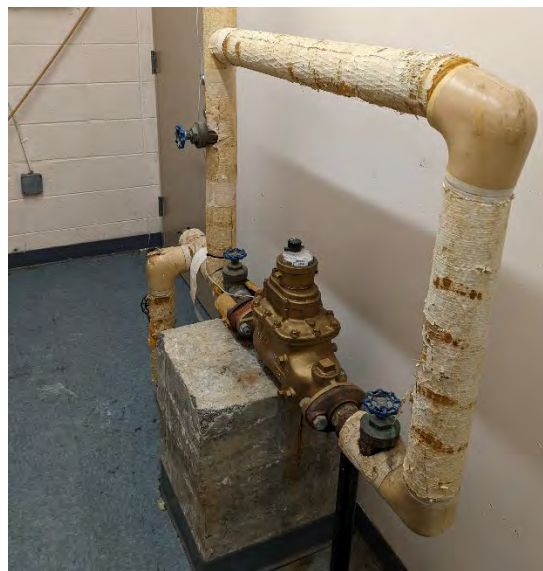
The existing plumbing system serves the toilet rooms located in the southwest corner of the building and the plumbing fixtures within the snack bar area of the dining room. Additionally, there is a mop sink and electric water cooler located near the toilet rooms. The domestic hot water system is served by a single electric storage water heater located in a closet adjacent to the toilet rooms which is fifteen years old, but appears in good condition. The Women's toilet room contains four (4) water closets and three (3) lavatories while the Men's toilet room contains three (3) water closets, two (2) urinals, and three (3) lavatories. The snack bar contains a hand sink and a three-compartment sink, the latter of which drains to a floor mounted grease interceptor. There was no backflow preventer located on the domestic water system, and where visible, the domestic water insulation appeared in poor condition.

**Figure 49: Domestic Water Insulation**

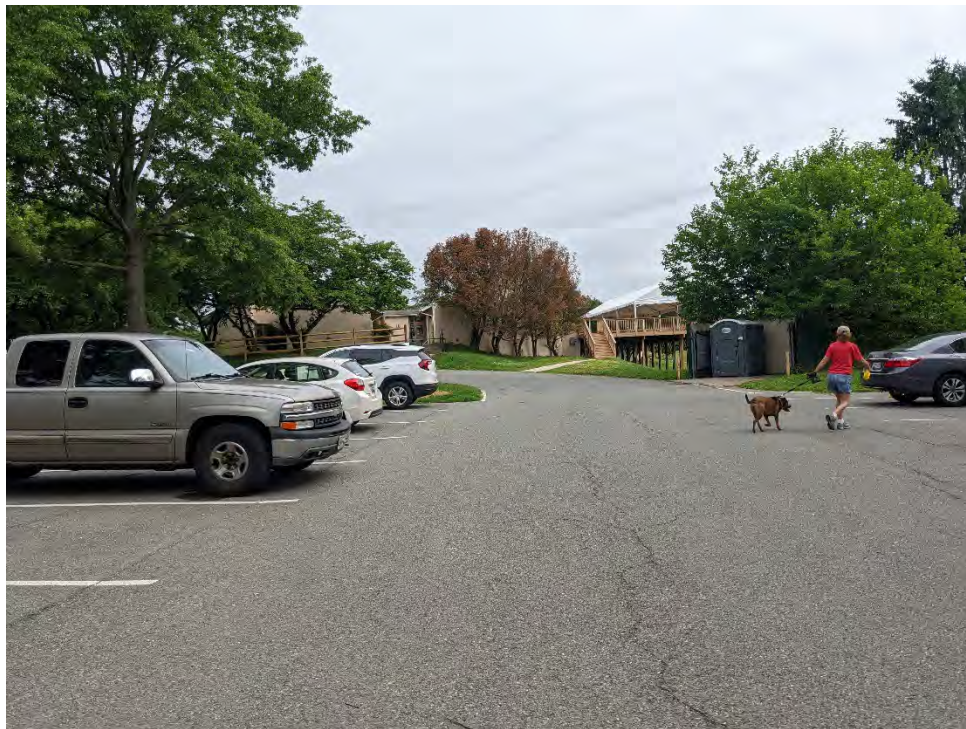
The existing parking lot is located to the south of the building and contains approximately 148 parking spaces, none of which are ADA accessible. The asphalt within the parking lot is in good condition with little to no alligator cracking or signs of failure. The slopes range from just under 1% to 5% within the parking lot. The drop-off loop adjacent to the building is as steep as 7%. Curb and gutter are not present, but the lot is divided by a 50 to 15 foot wide grass and wooded median. Trees are present throughout the lot.

**Figure 51: Minor Pavement Cracks within Parking Lot**

For future use, the existing pavement section within the parking lot should be milled and overlaid to extend its useful life while the pavement section with the driveway entrance should be replaced in full. We recommend studies to confirm the entrance along Avery Road meets current City, County and MDOT SHA requirements including but not limited to sight distance analysis and traffic signal analysis.

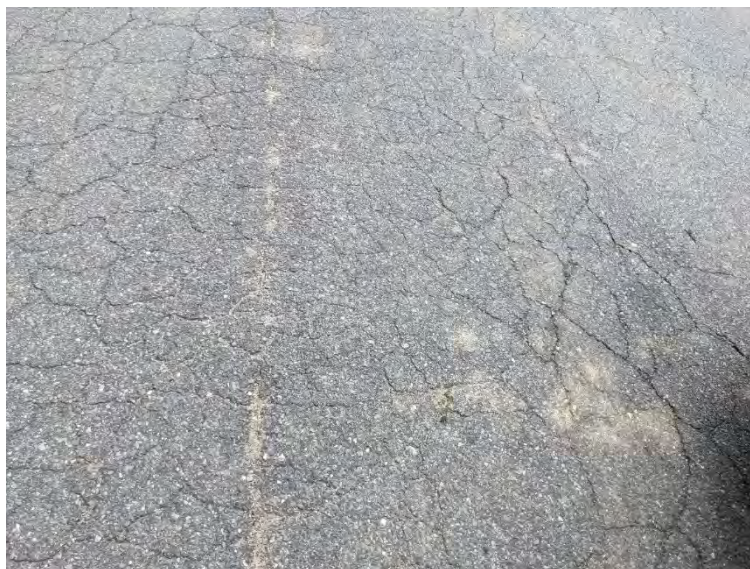
The pavement within driveway entrance from Avery Road contains large portions of alligator cracking and several portions show increased signs of failure.

**Figure 52: Alligator Cracks within Entrance Road**

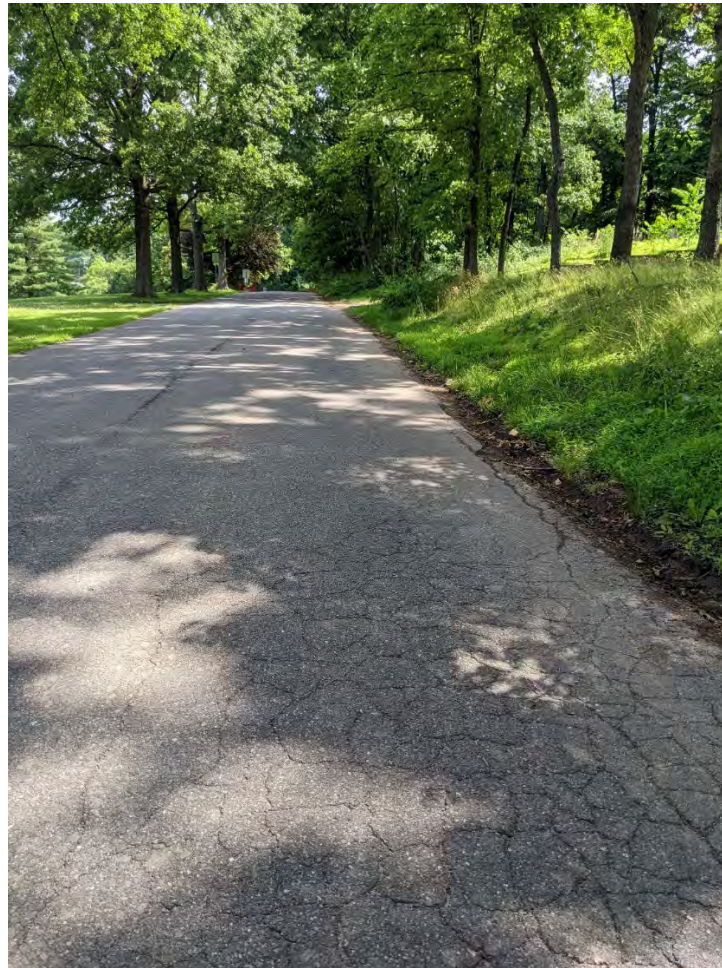
**Figure 53: Alligator Cracking within Entrance Road**

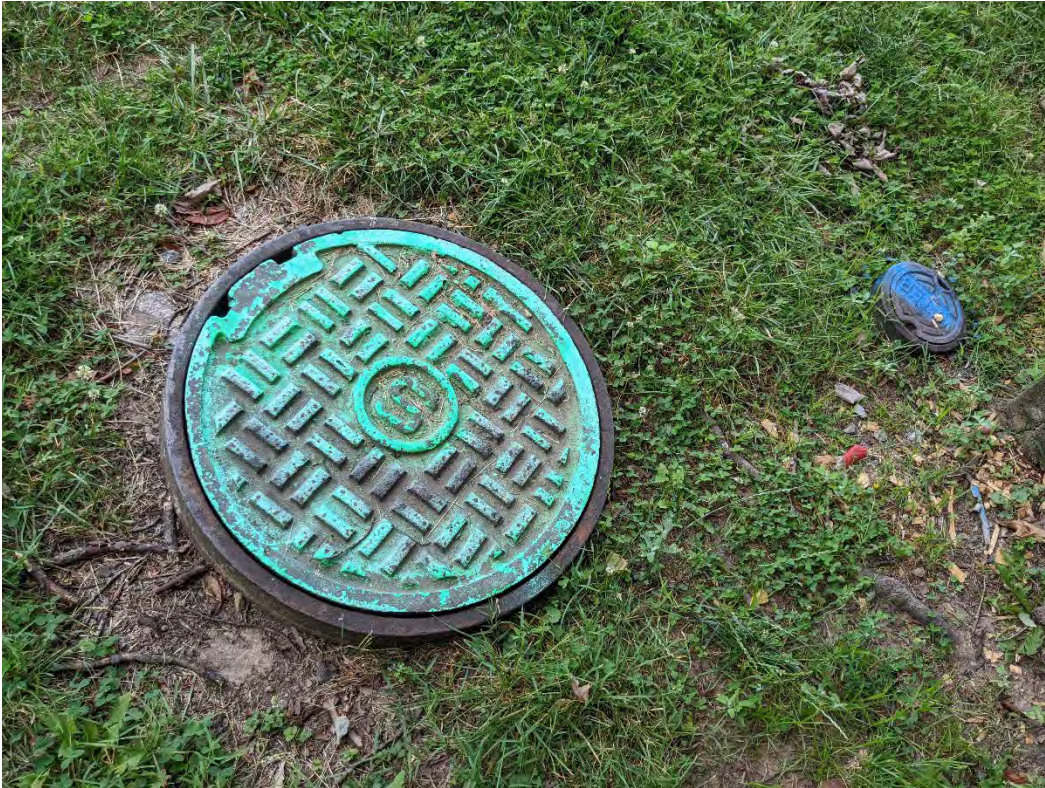
Currently the water service to the building is provided by an existing 8-inch water line extending from Taft Court. The condition of the water line is unknown. Several valves and a fire hydrant near the parking lot were located during the site visit and did not show signs of leakage or failure.

**Figure 34 : Water Valve and Sanitary Sewer Manhole West of the Building**

The existing water and sewer services for the building should be inspected prior to the redevelopment of the building to ensure proper functioning. Video camera inspection is recommended for the sanitary sewer system. City-required separation must be maintained between the water and sanitary sewer systems.
