**CABIN JOHN CREEK  
WATERSHED ASSESSMENT AND  
MANAGEMENT  
RECOMMENDATIONS**

**FINAL REPORT**

**ENVIRONMENTAL MANAGEMENT DIVISION  
DEPARTMENT OF PUBLIC WORKS  
CITY OF ROCKVILLE, MARYLAND**

**Approved July 18, 2011**

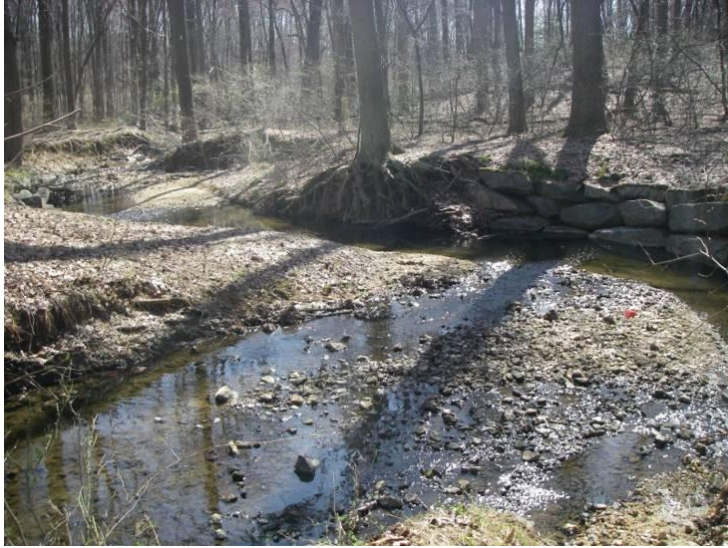
FIGURE 14: RIP-RAP ARMORING (REACH BOG-004)

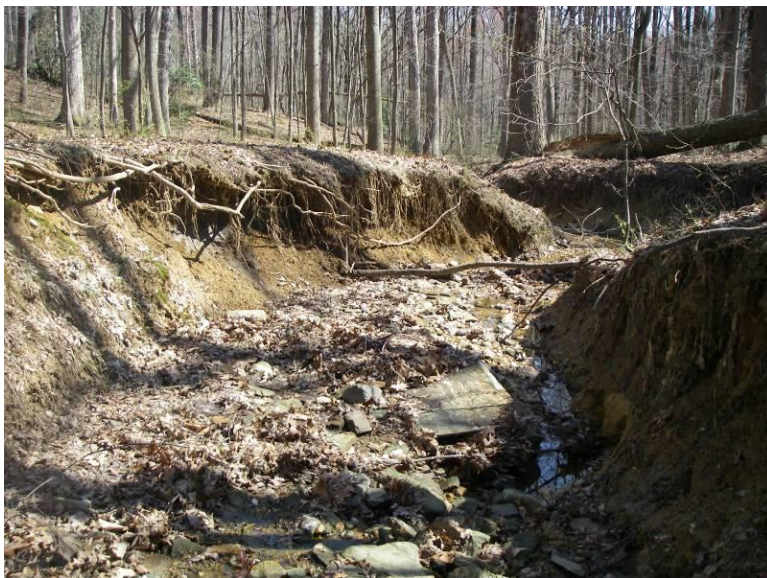
Tributaries draining to the mainstem reaches are generally stable with the exception of Reach 005 which is experiencing severe erosion and active headcutting along the entire reach. Low flow, shallow depth and poor habitat make the tributary reaches unsuitable as fish habitat.

FIGURE 15: SEVERE BANK EROSION (REACH BOG-005)

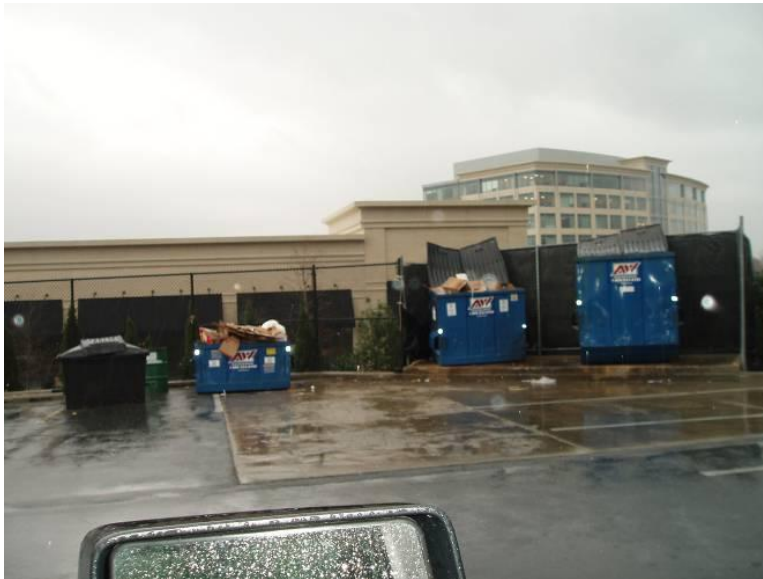
Another hotspot site, the Seven Locks Maintenance Yard for the Highway Services Division of the Montgomery County Department of Transportation, also drains to both Bogley Branch and Lower Cabin John sub-watersheds. Its HSI assessment is included under the Lower Cabin John section. The maintenance yard was a confirmed hotspot for leaking vehicles, overflowing dumpsters and poor parking lot condition.

FIGURE 18: OVERFLOWING DUMPSTERS (H-102)

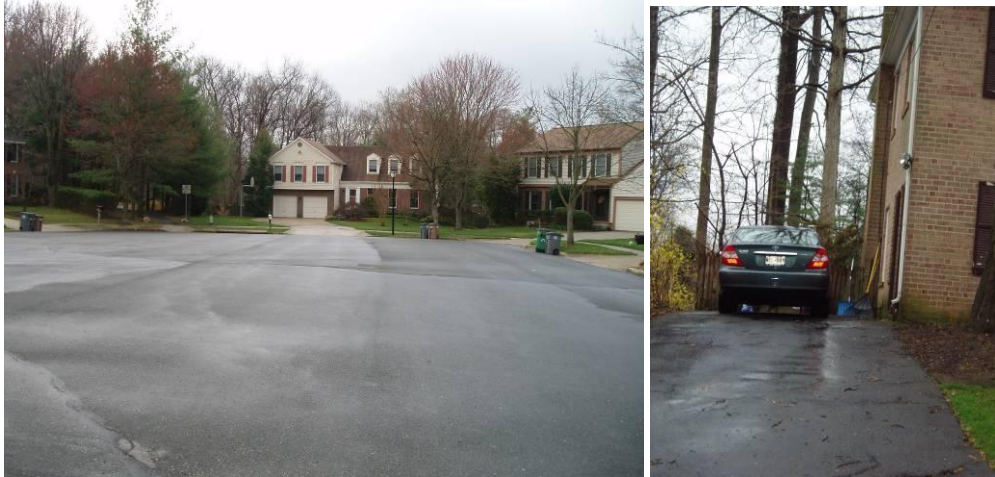
FIGURE 19: EXCESSIVELY WIDE CUL-DE-SAC (N-101); DOWNSPOUT INDIRECTLY CONNECTED TO THE STORM DRAIN (N-102)

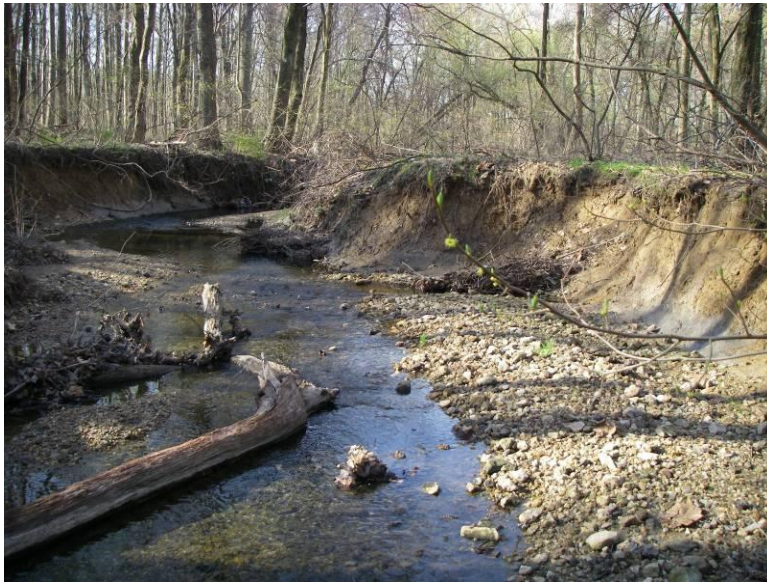
The mainstem reaches for the Dawson Farm Creek sub-watershed can generally be characterized as incising with erosion occurring along the outsides of meanders. Gravel and sand point bars are common throughout the mainstem with areas of bedrock and exposed clay substrate. Eroded sediment is filling in available pools. Many of the reaches in this sub-watershed are constrained by existing infrastructure. There are large areas of channel straightening and stabilization, specifically along Reach 003, paralleling Wootton Parkway.

FIGURE 22: INCISED CHANNEL WITH GRAVEL POINT BARS (REACH DFC-002)

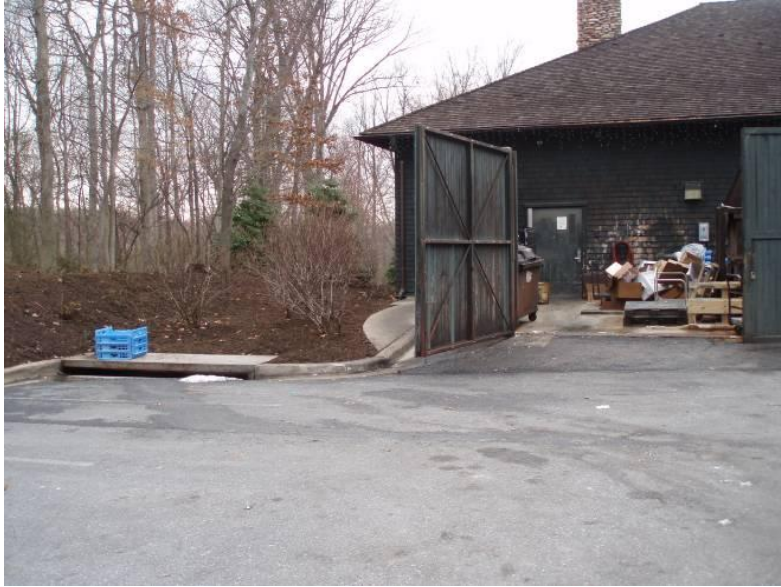
FIGURE 25: EVIDENCE OF WASHWATER DUMPING INTO STORMDRAIN SYSTEM (H-308)

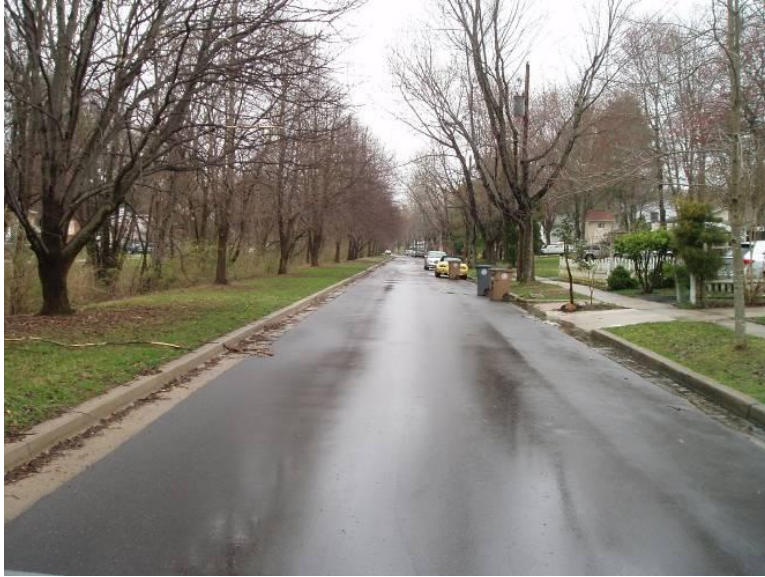
FIGURE 26: TYPICAL NEIGHBORHOOD CONDITIONS (N-129)

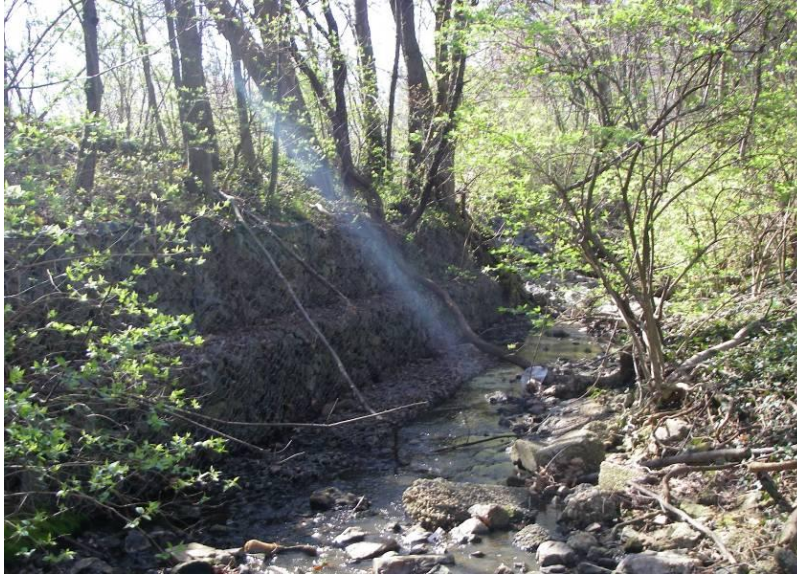
FIGURE 29: STREAMBANK ARMORING (REACH EST-001)

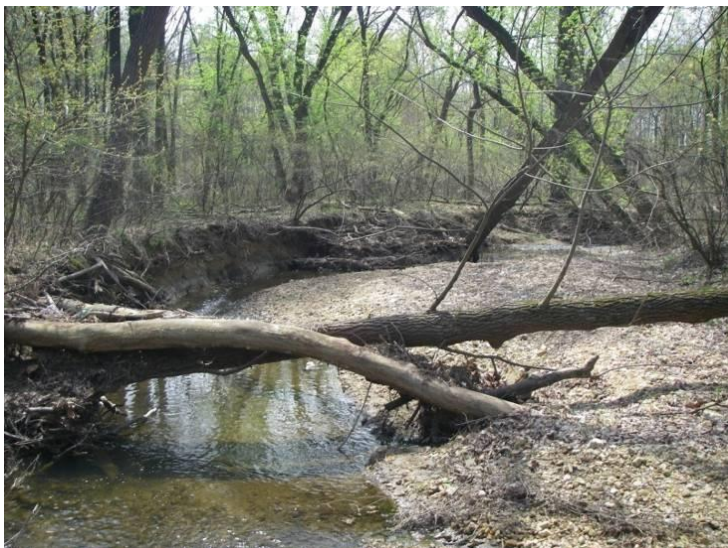
The mainstem reaches of the sub-watershed are moderately eroded and actively widening. There are areas of severe erosion along several outer meanders with sediment deposition in the form of gravel and sand bars on inner meanders. In addition to this natural erosion, human impacts on Reach 001 are severe. A person was encountered during the field work using a shovel to cut off existing meanders thus straightening the channel. This disturbance has occurred along approximately 700 feet of the reach. (City staff were not able to find this person after the report of his illegal activities.) Habitat for the mainstem reaches are in the low-suboptimal to high-marginal range with areas of heavy algae. Riffles and pools are the dominant habitat.

FIGURE 34: GRAVEL POINT BAR AND WIDENING CHANNEL (REACH LCJ-001)

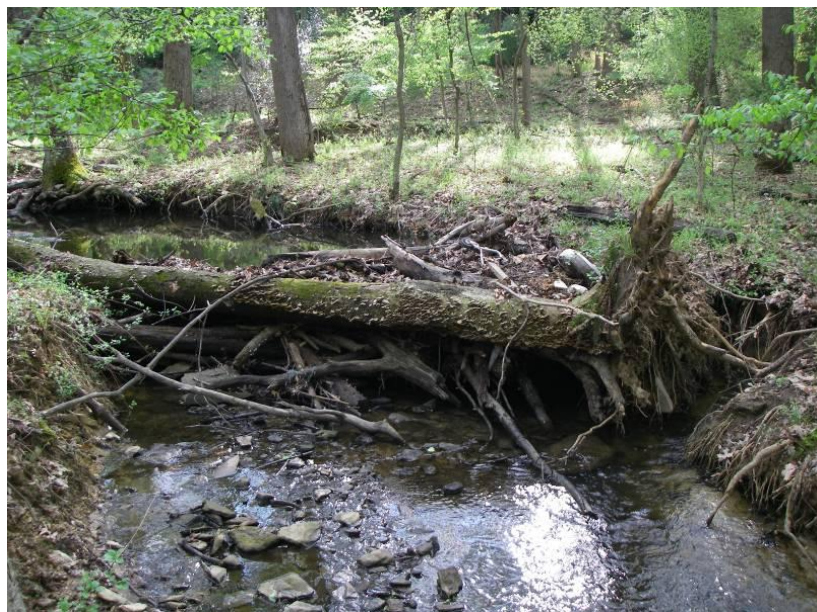
FIGURE 39: DEBRIS JAM CONTRIBUTING TO EROSION (REACH OFC-015)

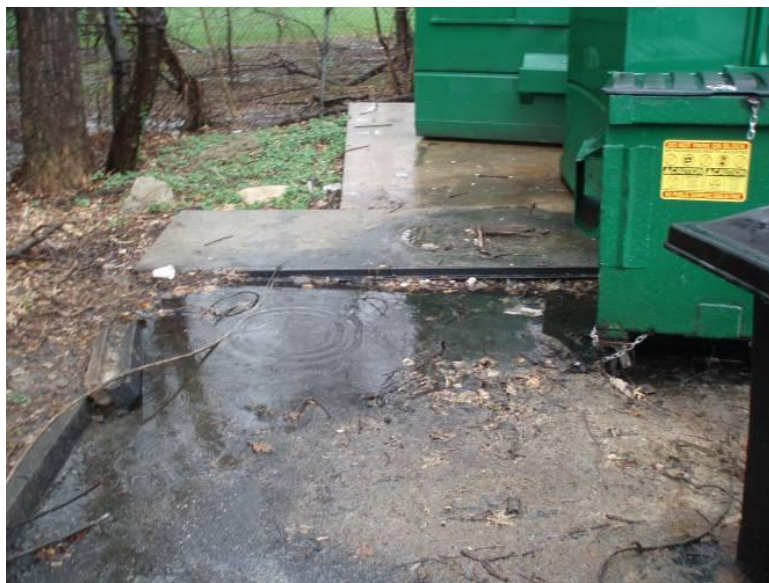
FIGURE 42: OVERFLOWING GREASE TRAP (H-302).

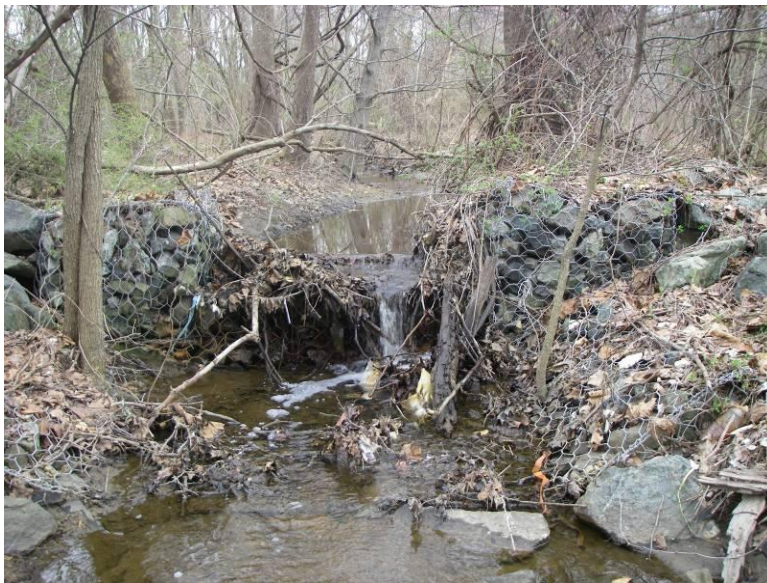
FIGURE 45: IN-STREAM GABION WEIR (REACH SLT-005)

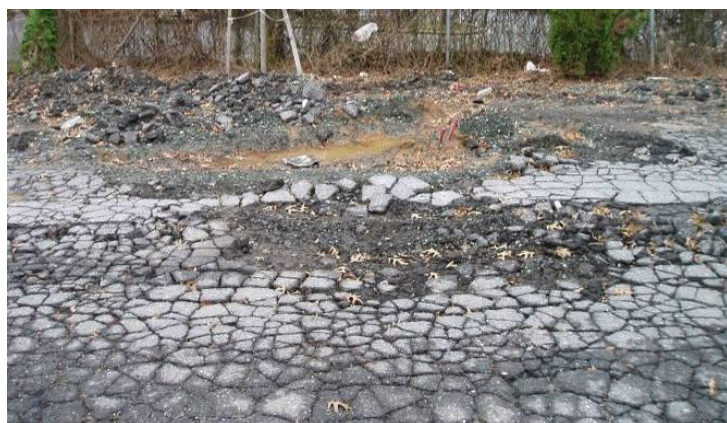
FIGURE 48: PARKING LOT IN NEED OF REPLACEMENT (H-101).

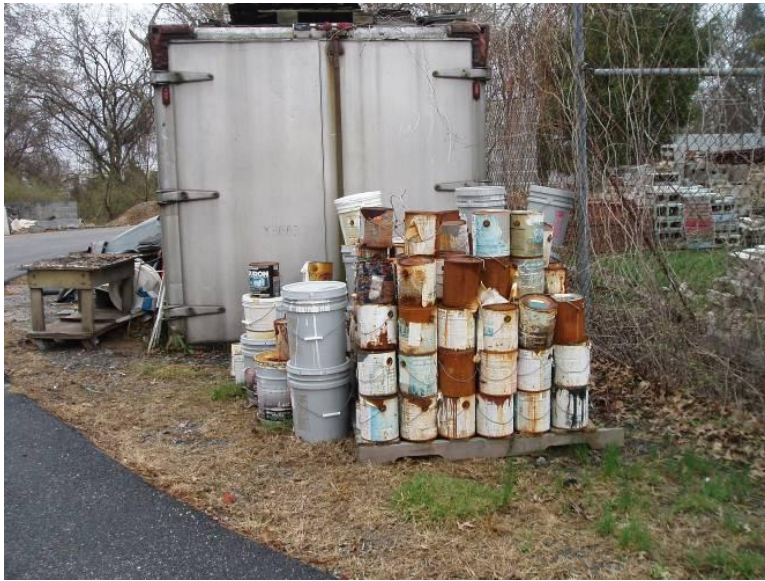
FIGURE 49: IMPROPERLY STORED OUTDOOR MATERIALS (H-103)

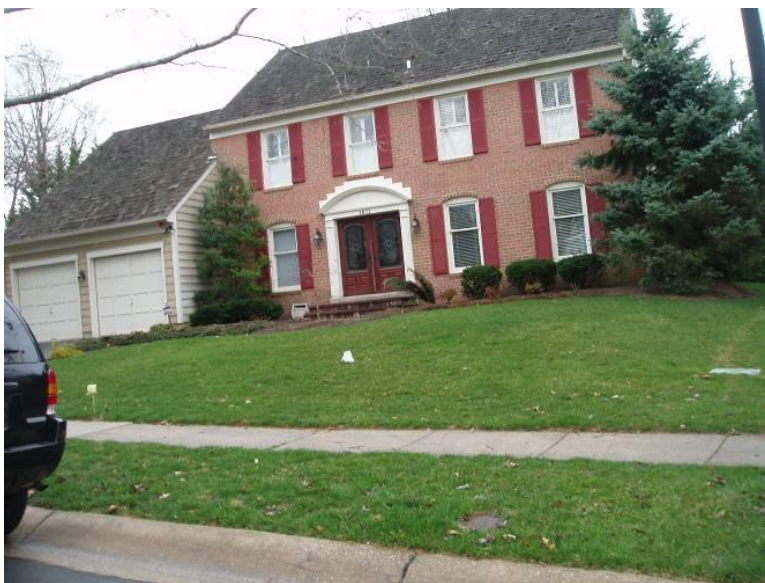
FIGURE 50: POTENTIAL HIGH MAINTENANCE LAWN (N-105)

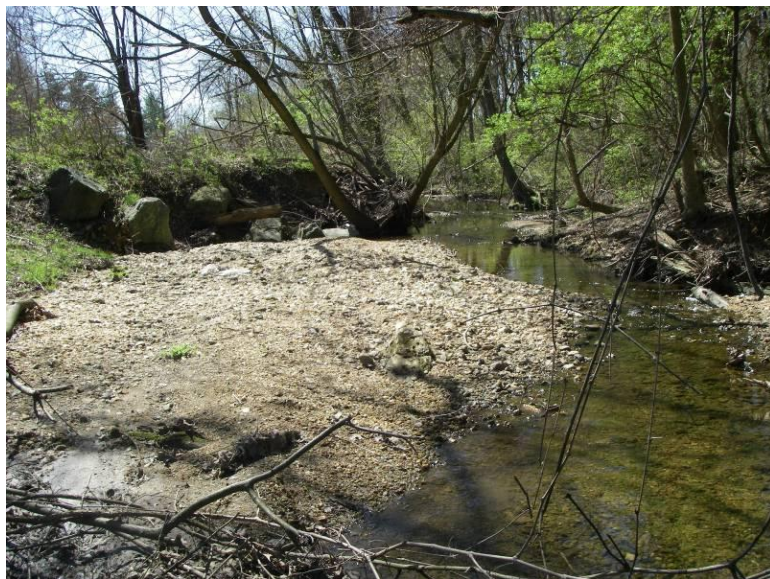
FIGURE 53: OVERWIDENED CHANNEL, WITH GRAVEL DEPOSITION (REACH UCJ-005)
