Safe Streets for All
**VISION ZERO
INTERSECTION
SAFETY AUDITS**

City of Rockville, Maryland

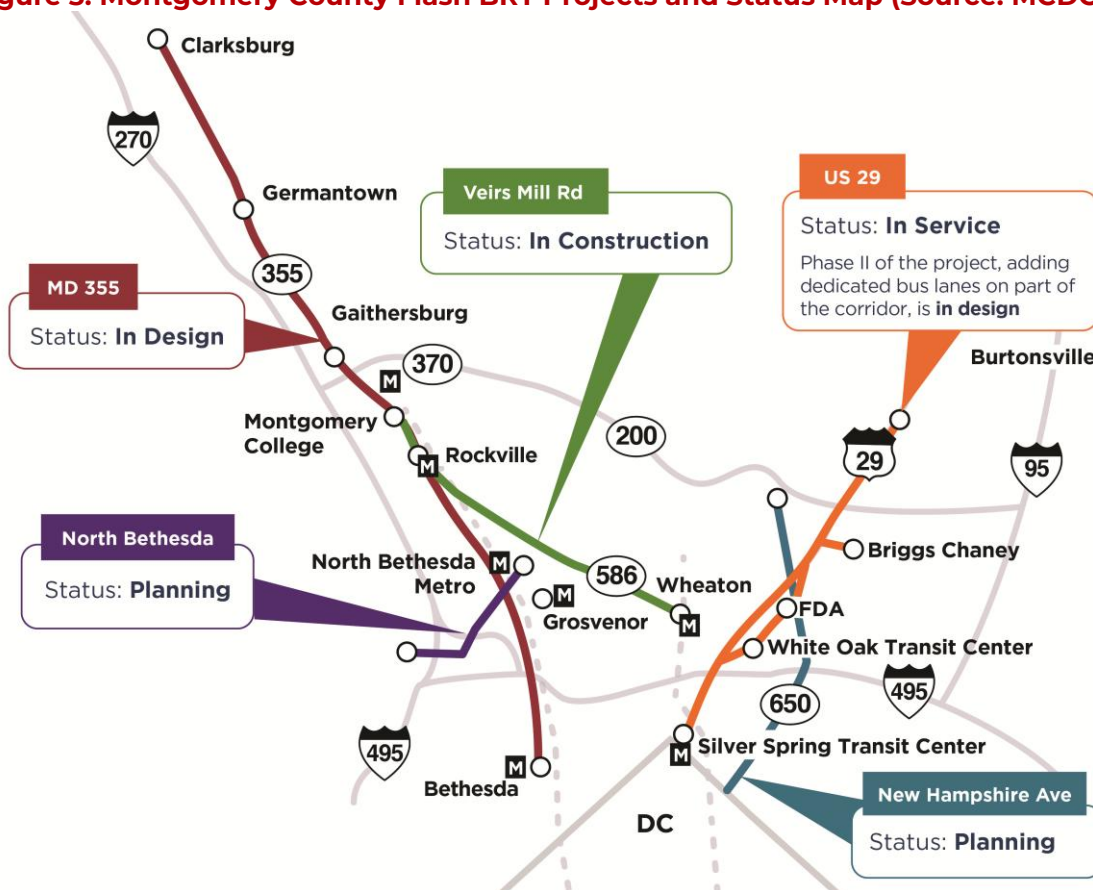
The project scope and schedule also limited the range of concepts evaluated at each intersection. The recommendations focus on practical short- and long-term treatments that address the priority safety issues identified in each intersection chapter.

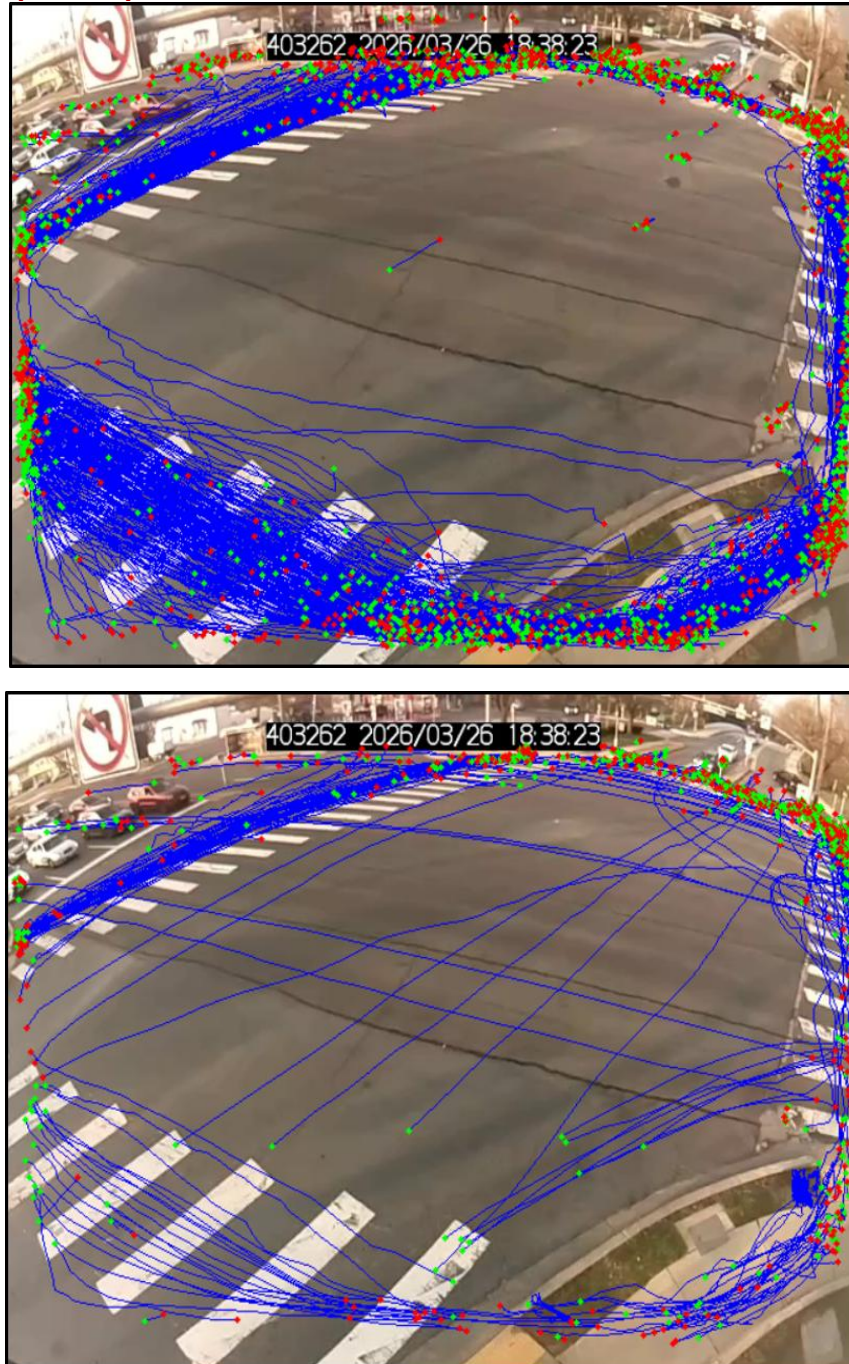
Near-miss severity is summarized using Post-Encroachment Time (PET), which quantifies the time between two users occupying the same conflict area. The analysis documents the number of observed conflicts by user type (vehicle-vehicle, vehicle-pedestrian, and vehicle-bicycle), the distribution of conflicts by PET range, and the movements most frequently associated with conflicts. Near-miss events were observed at every study intersection, and each intersection included observed activity by people walking and people biking. These findings help identify elevated-risk conditions and recurring interaction patterns that can be addressed proactively, particularly where reported crashes alone may not fully describe the safety risk for vulnerable roadway users. **Appendix C** contains the **Near-Miss Data**.

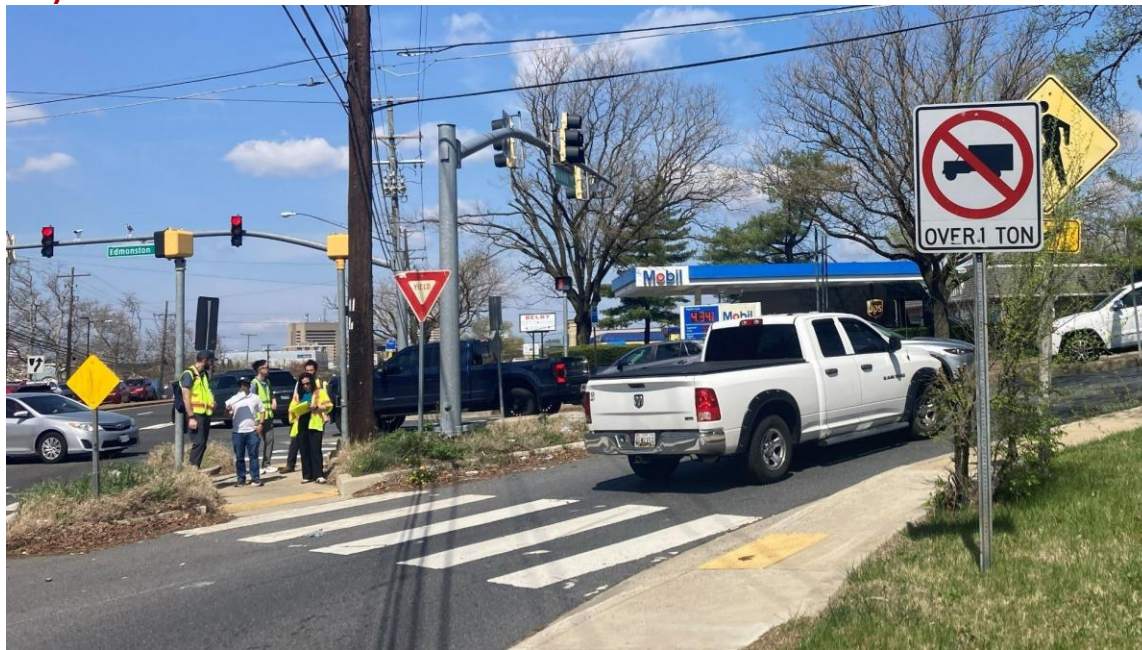
Site visit observations typically document:

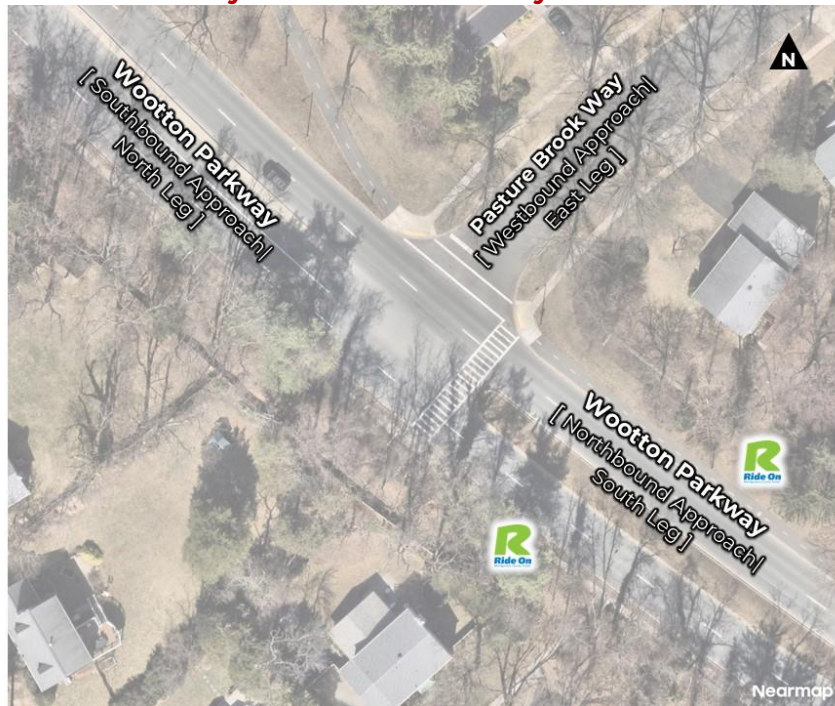
Figure 6. #1 – Wootton Parkway & Pasture Brook Way Intersection

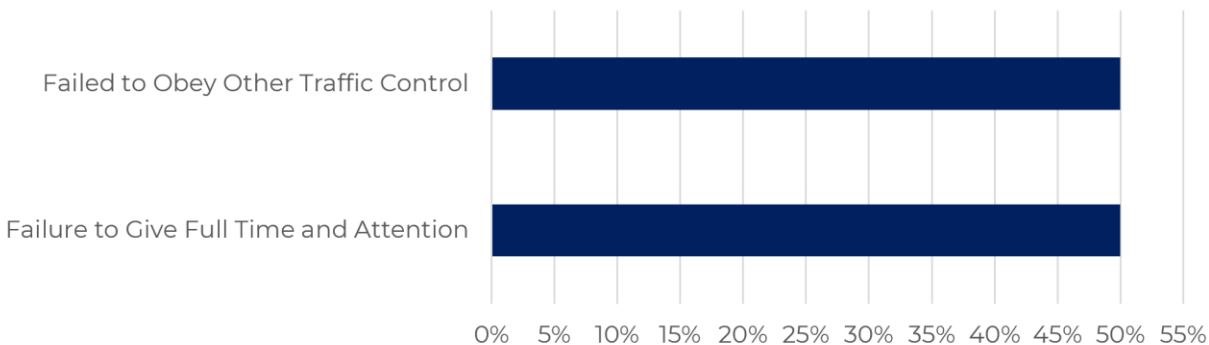
NEAR-MISS VIDEO ANALYSIS

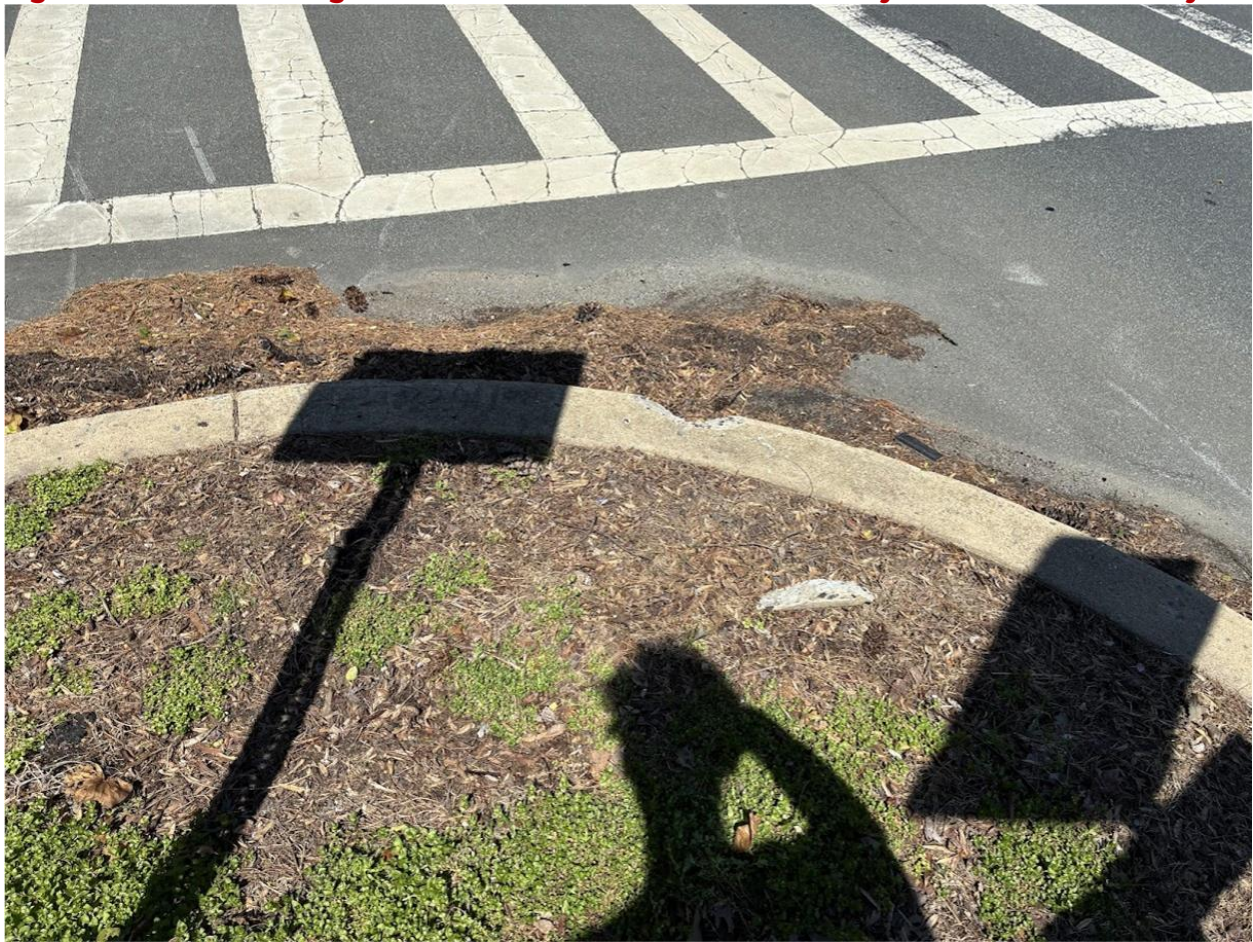
Figure 9: Outdated Pedestrian Crossing Sign at Intersection #1 – Wootton Parkway & Pasture Brook Way

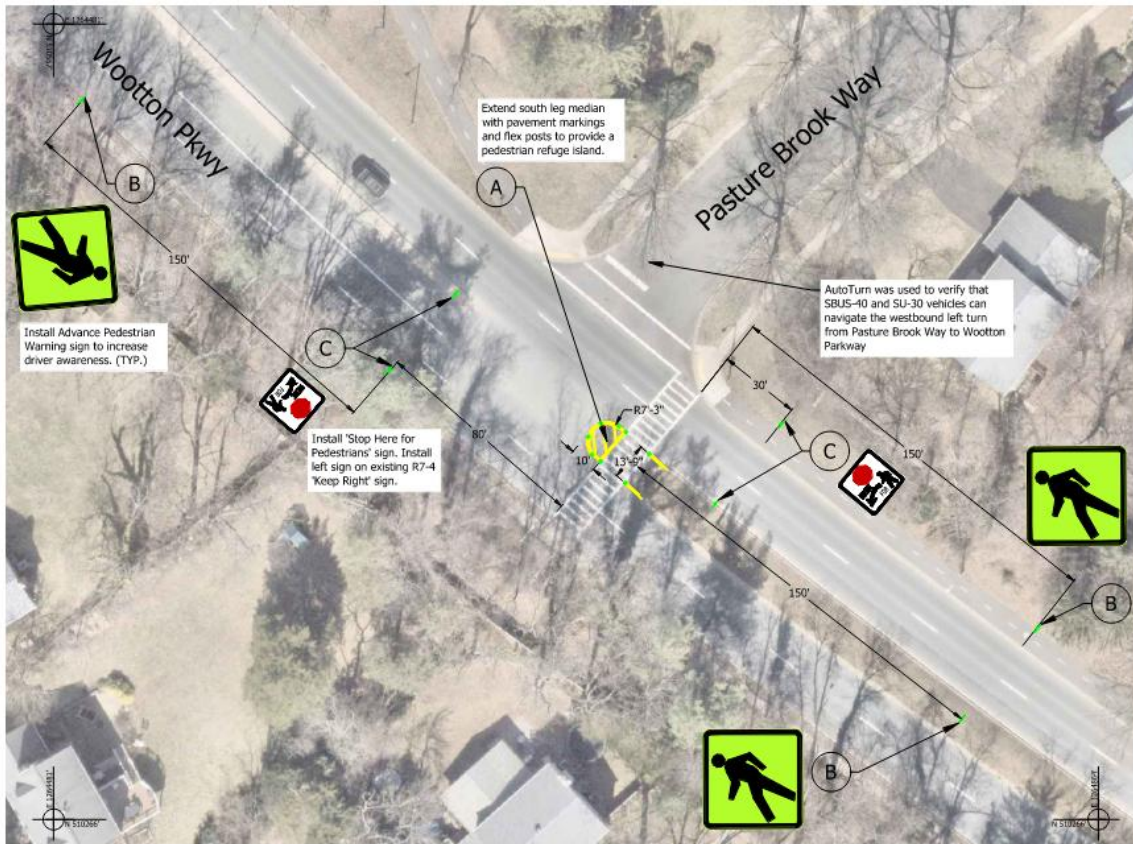
Figure 11. Short-Term Recommendations for Intersection #1 – Wootton Parkway & Pasture Brook Way

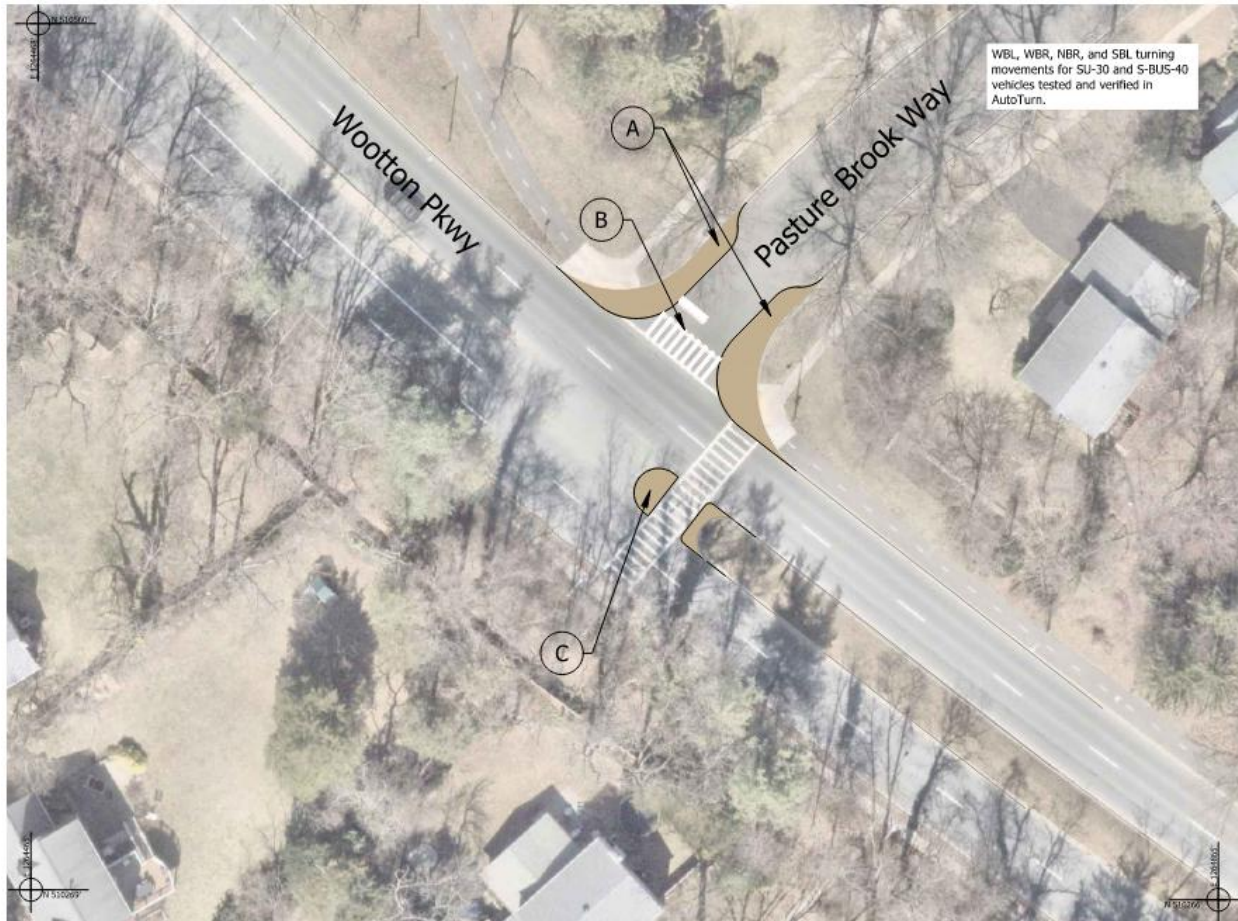
Figure 12. Long-Term Recommendations for Intersection #1 – Wootton Parkway & Pasture Brook Way

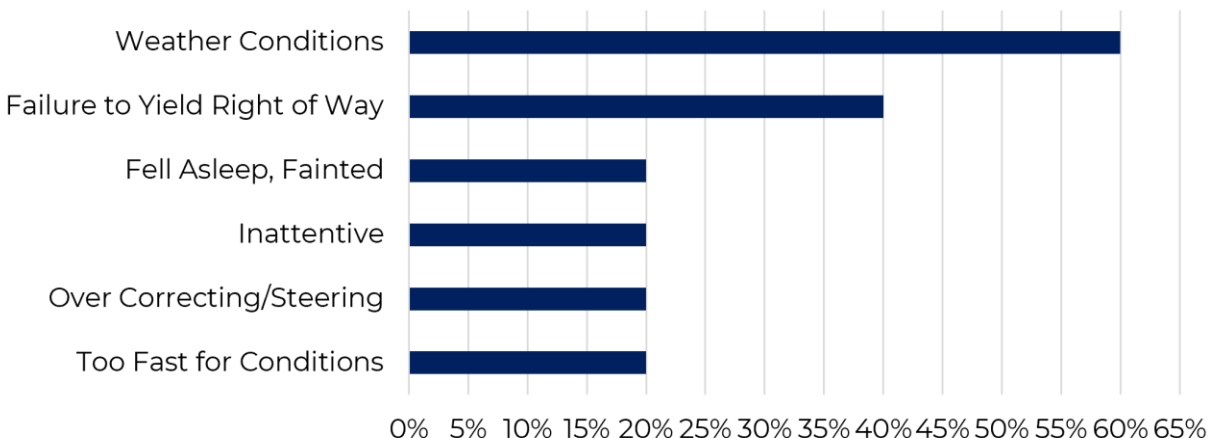
NEAR-MISS VIDEO ANALYSIS

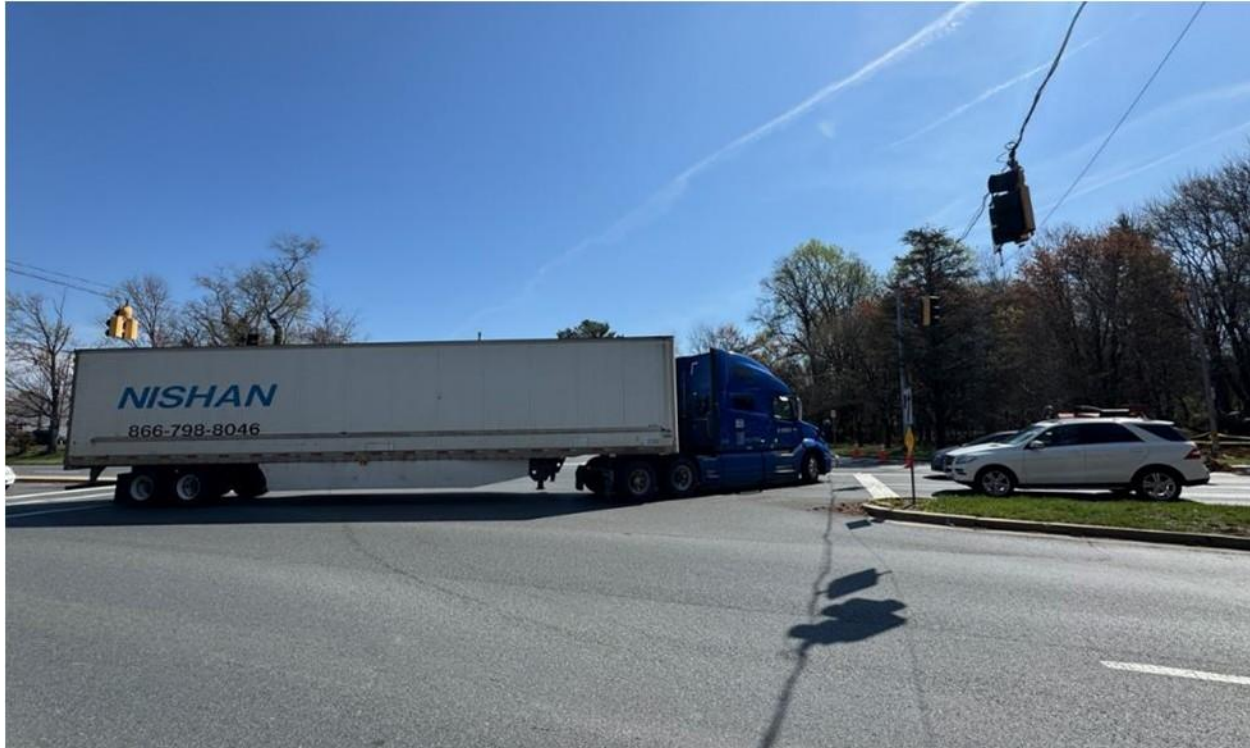
Figure 16. Truck making right turn from Wootton Parkway onto W. Edmonston Drive at Intersection #2 - Wootton Parkway & W. Edmonston Drive

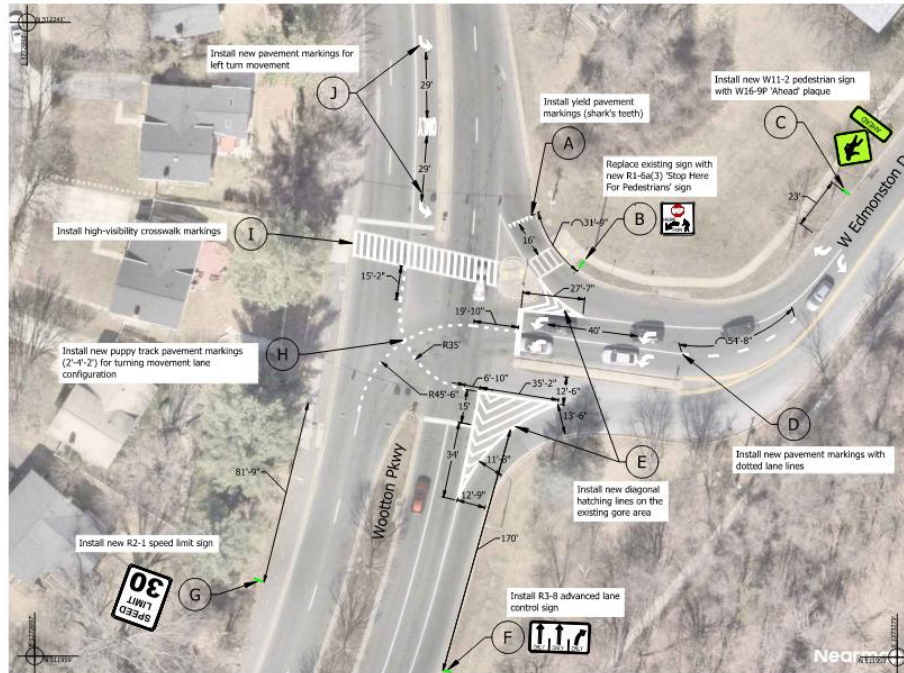
Figure 18. Short-Term Recommendations for Intersection #2 - Wootton Parkway & W. Edmonston Drive

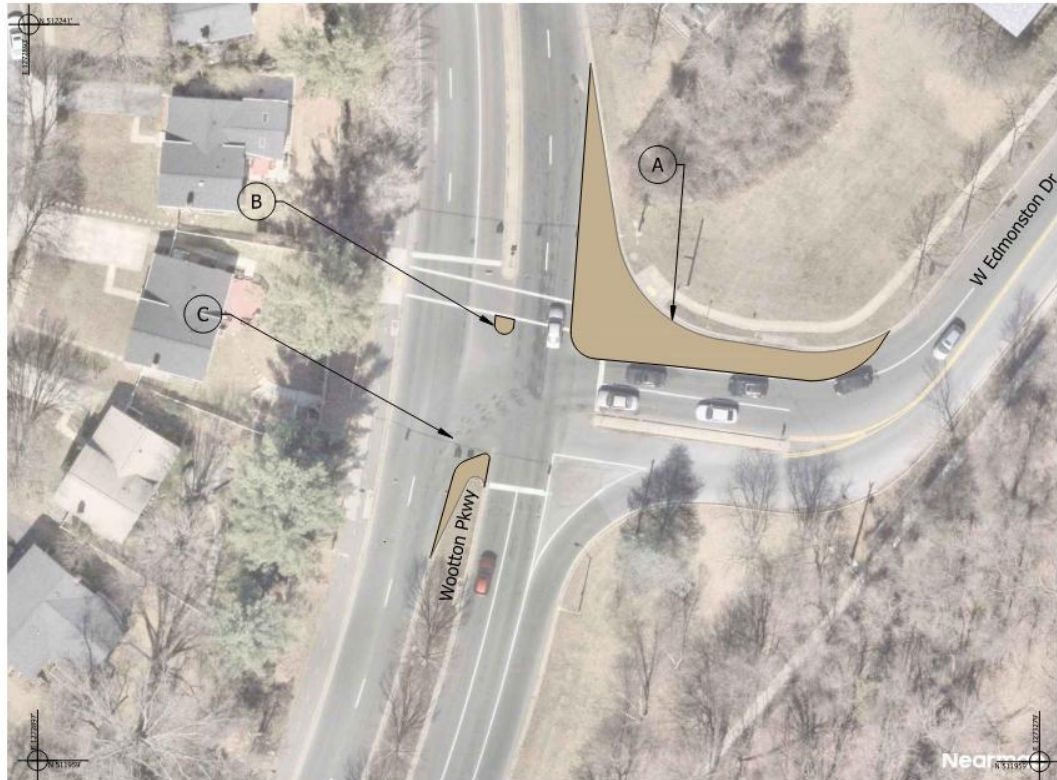
Figure 19. Long-Term Recommendations for Intersection #2 - Wootton Parkway & W. Edmonston Drive

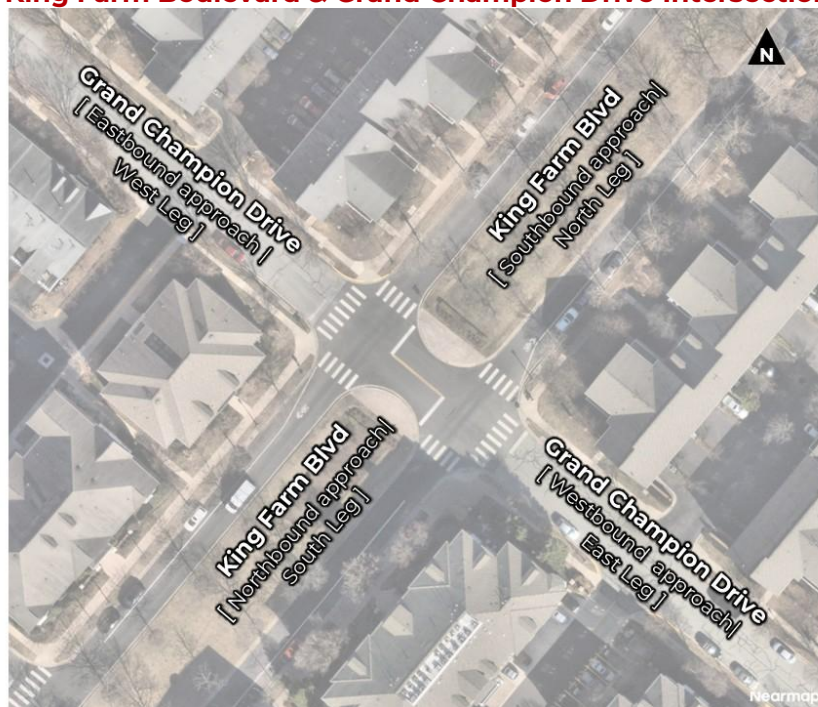
Figure 20. #3 – King Farm Boulevard & Grand Champion Drive Intersection

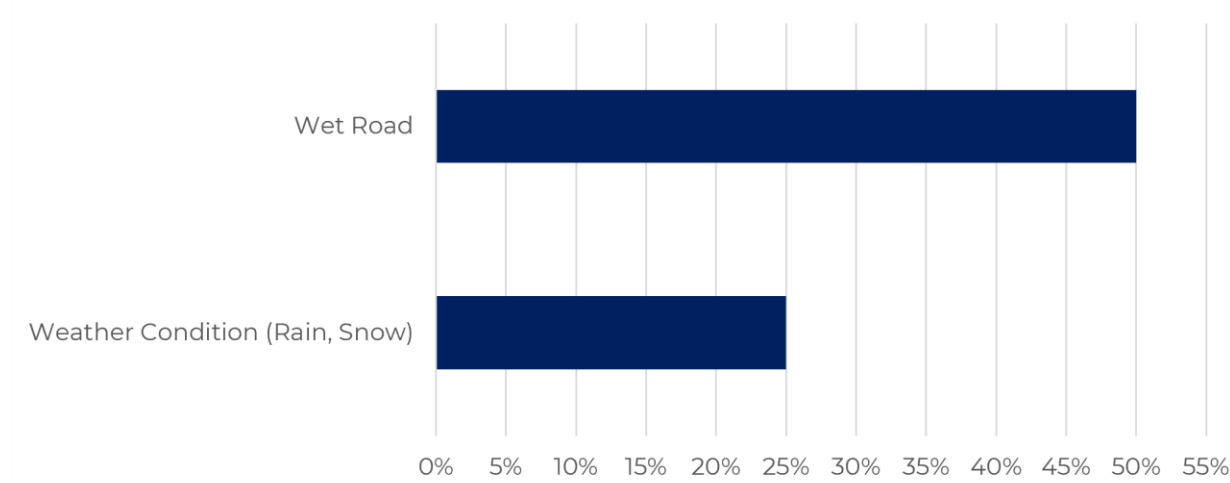
NEAR-MISS VIDEO ANALYSIS

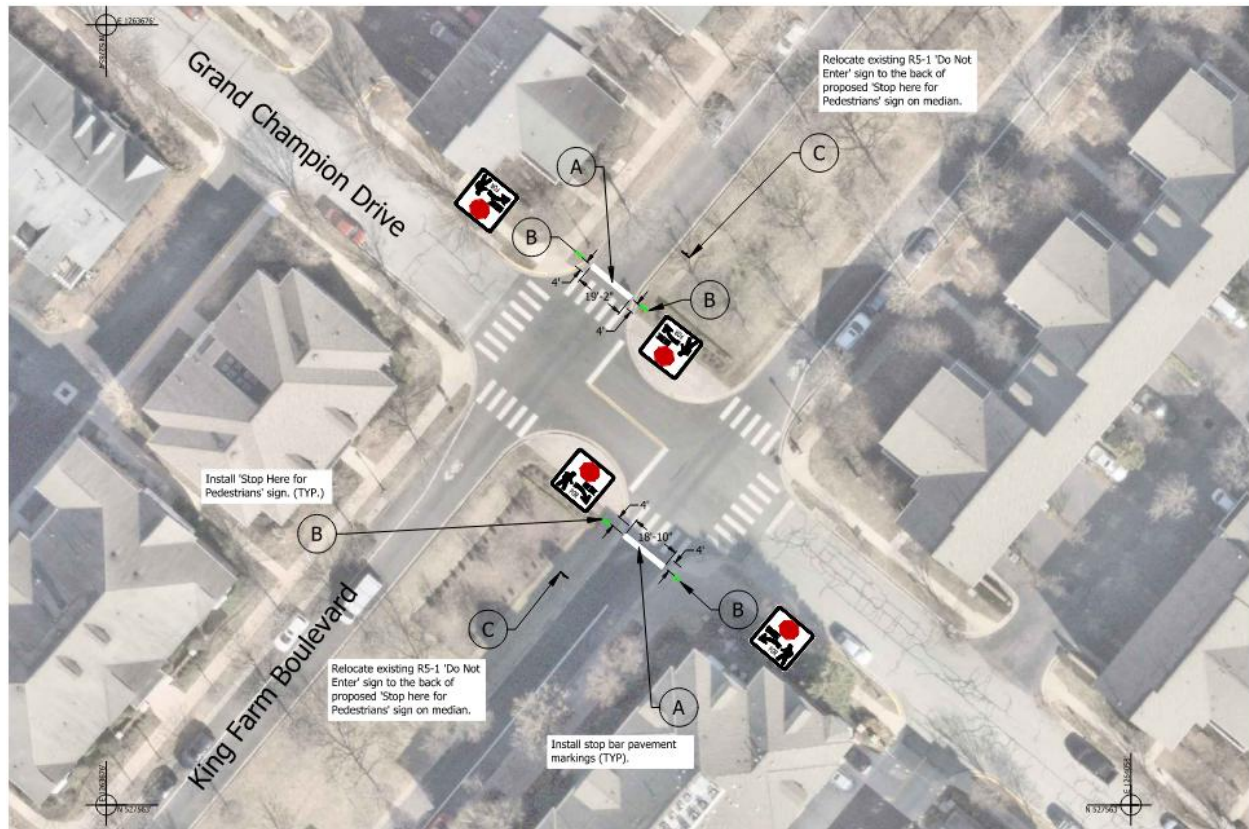
Figure 25. Short-Term Recommendations for Intersection #3 – King Farm Boulevard & Grand Champion Drive

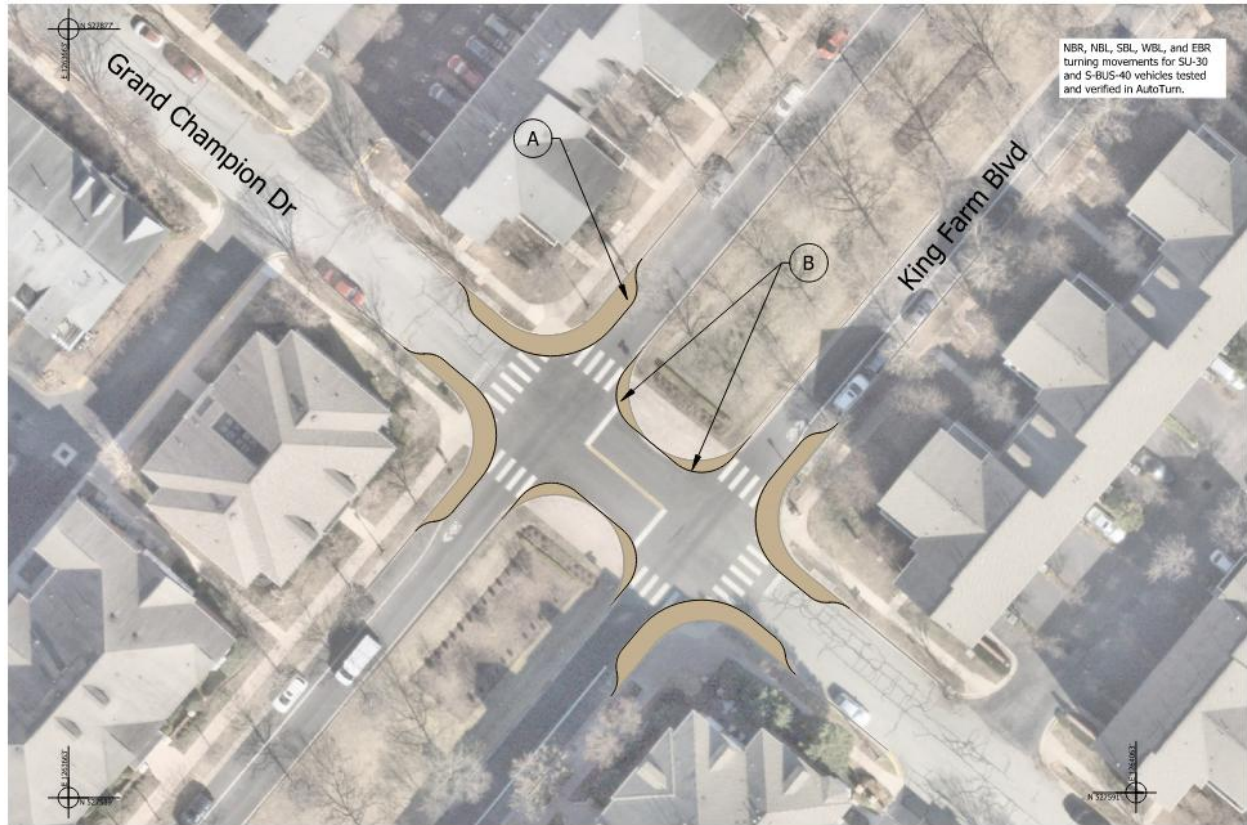
Figure 26. Long-Term Recommendations for Intersection #3 – King Farm Boulevard & Grand Champion Drive

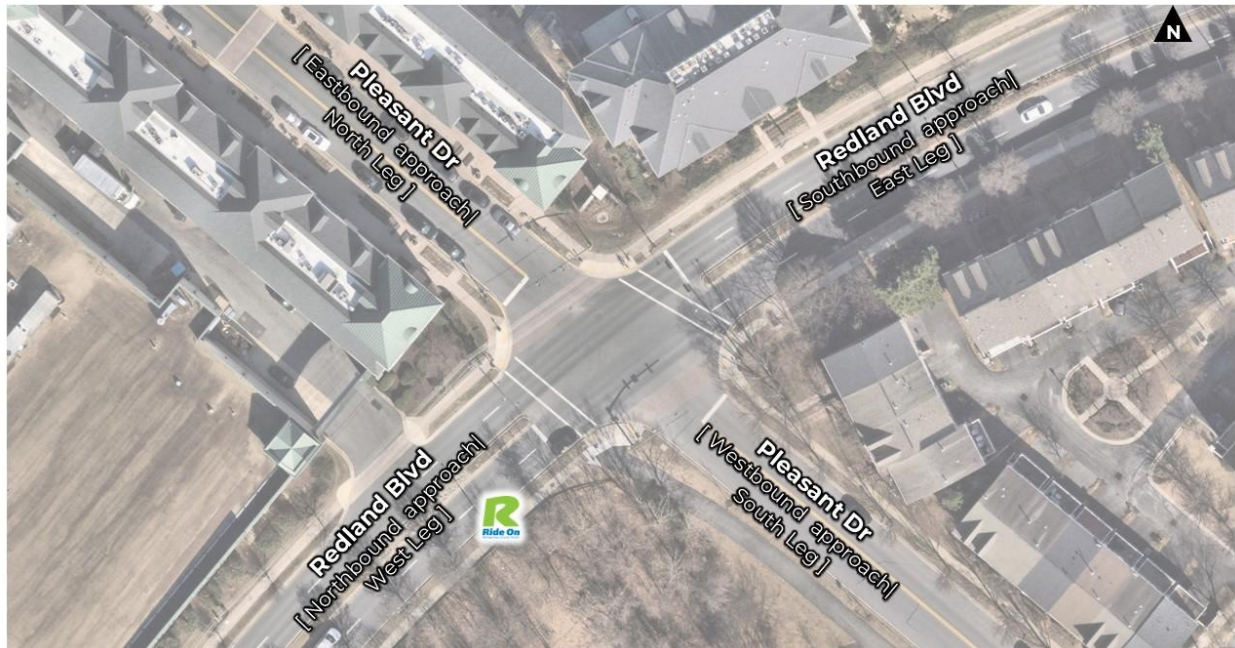
Figure 27. #4 – Redland Boulevard & Pleasant Drive Intersection

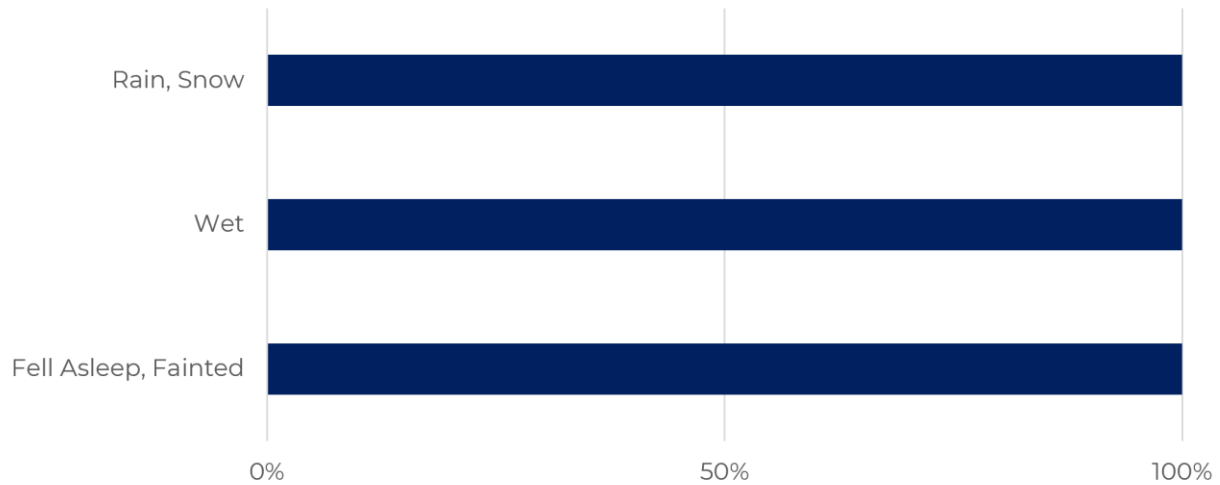
NEAR-MISS VIDEO ANALYSIS

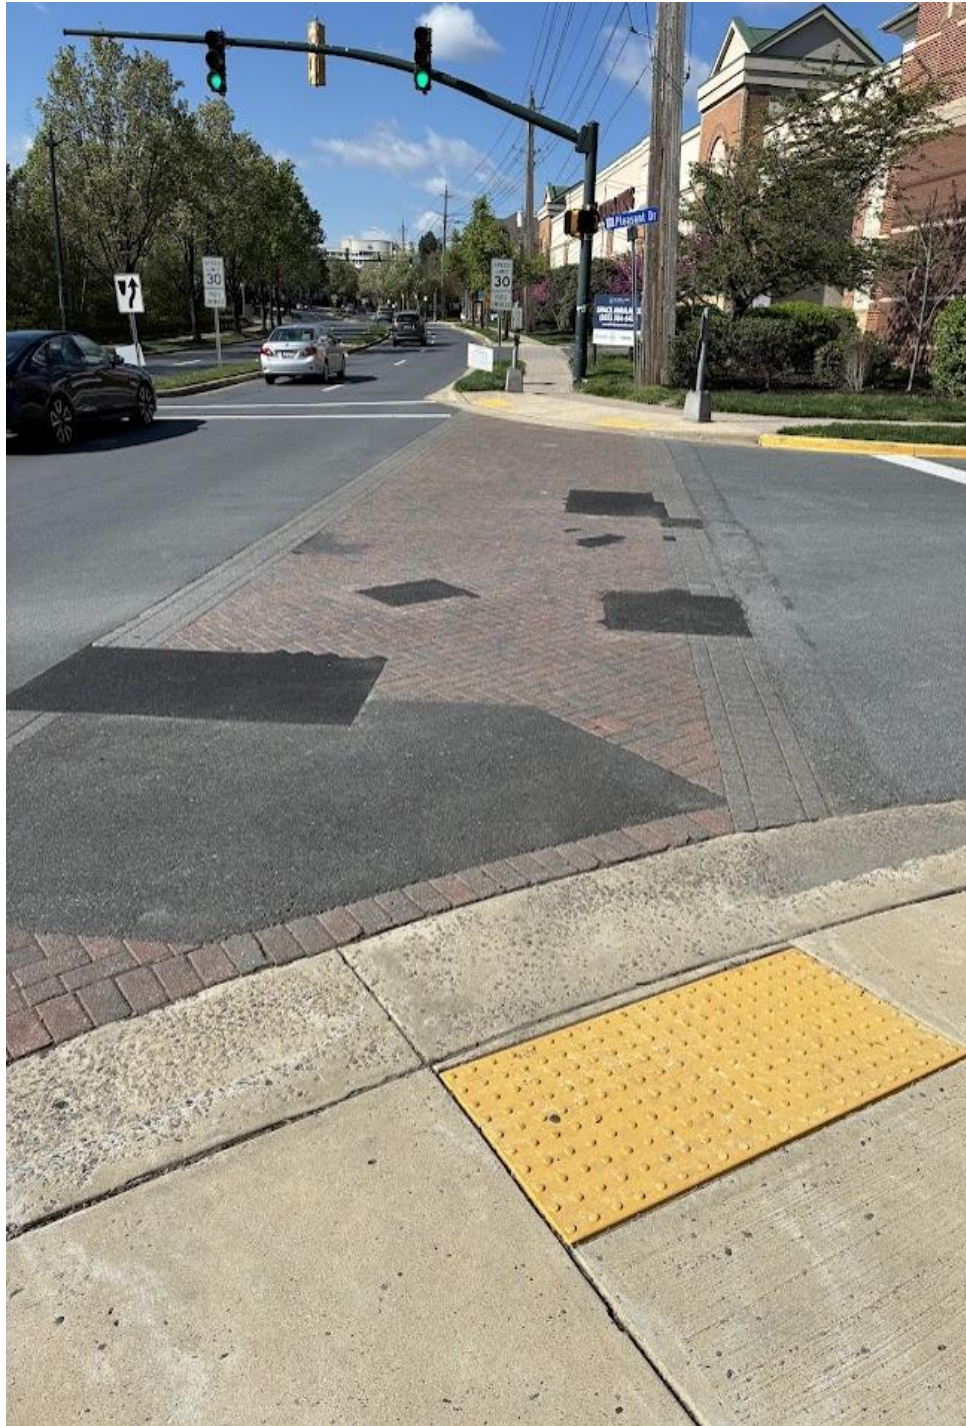
Figure 30. Narrow sidewalks along Redland Boulevard at Intersection #4 – Redland Boulevard & Pleasant Drive

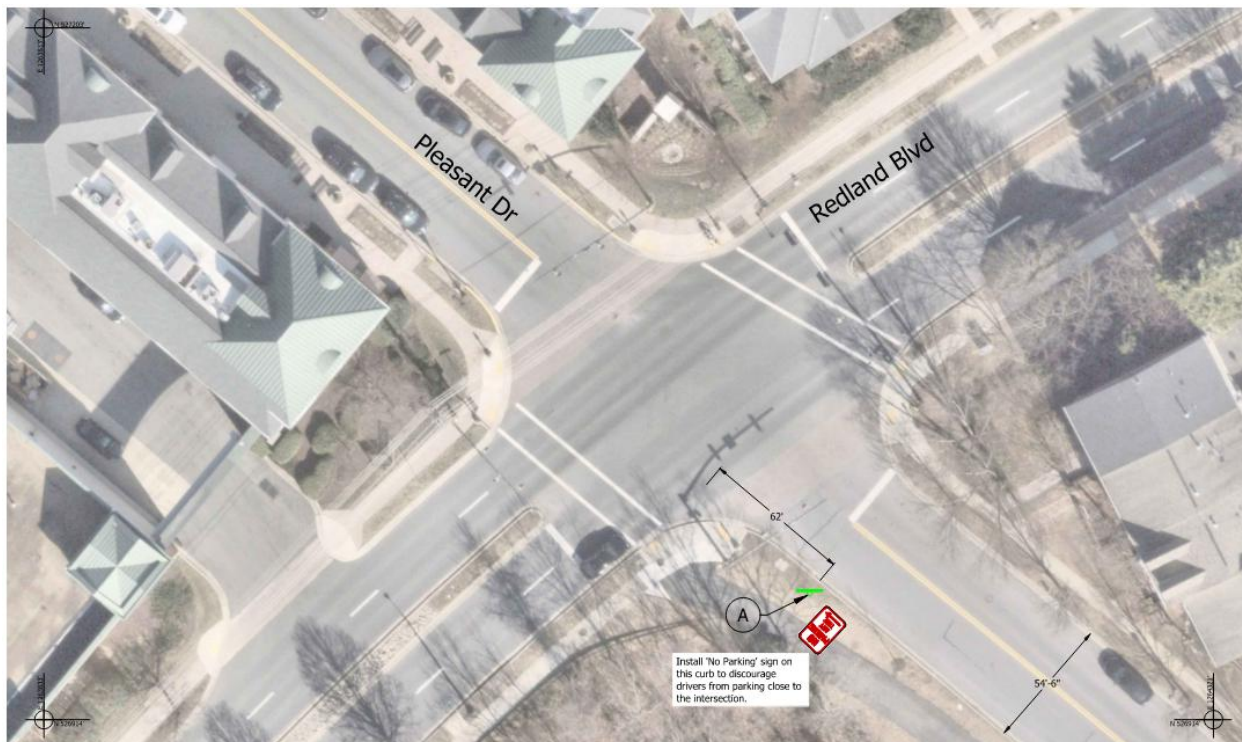
Figure 32. Short-Term Recommendations for Intersection #4 – Redland Boulevard & Pleasant Drive

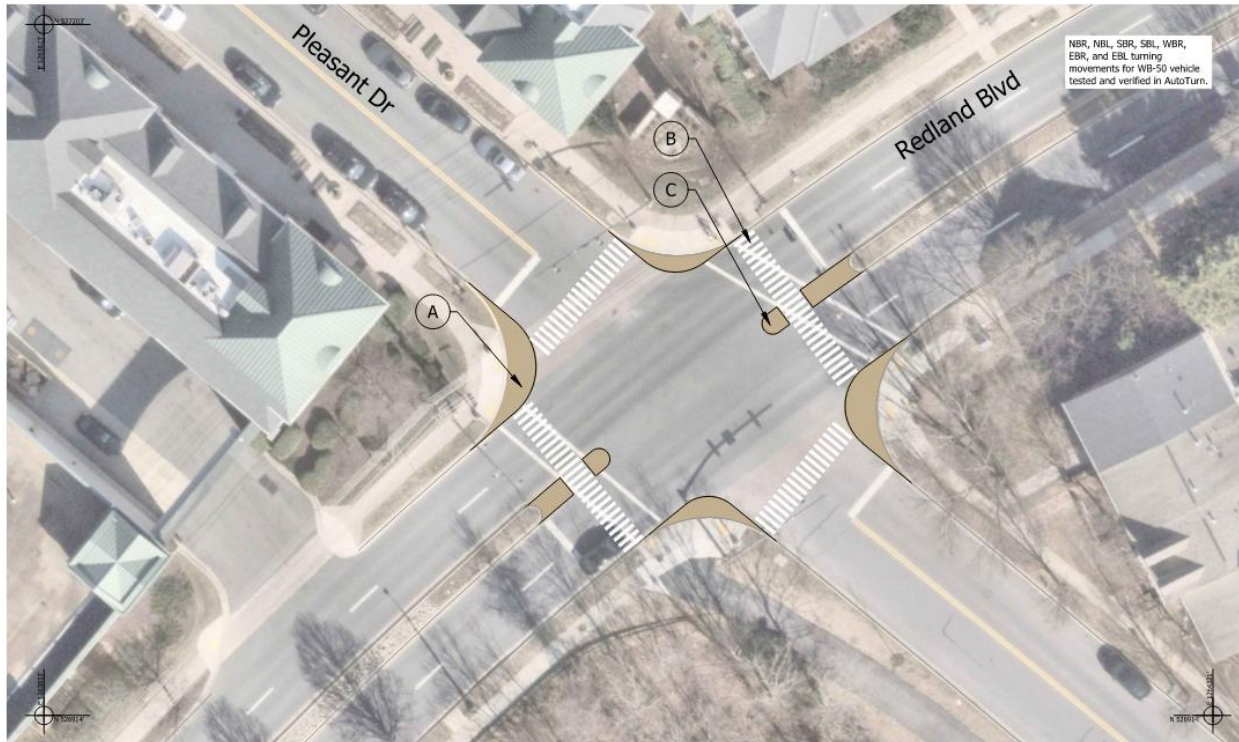
Figure 33. Long-Term Recommendations for Intersection #4 – Redland Boulevard & Pleasant Drive

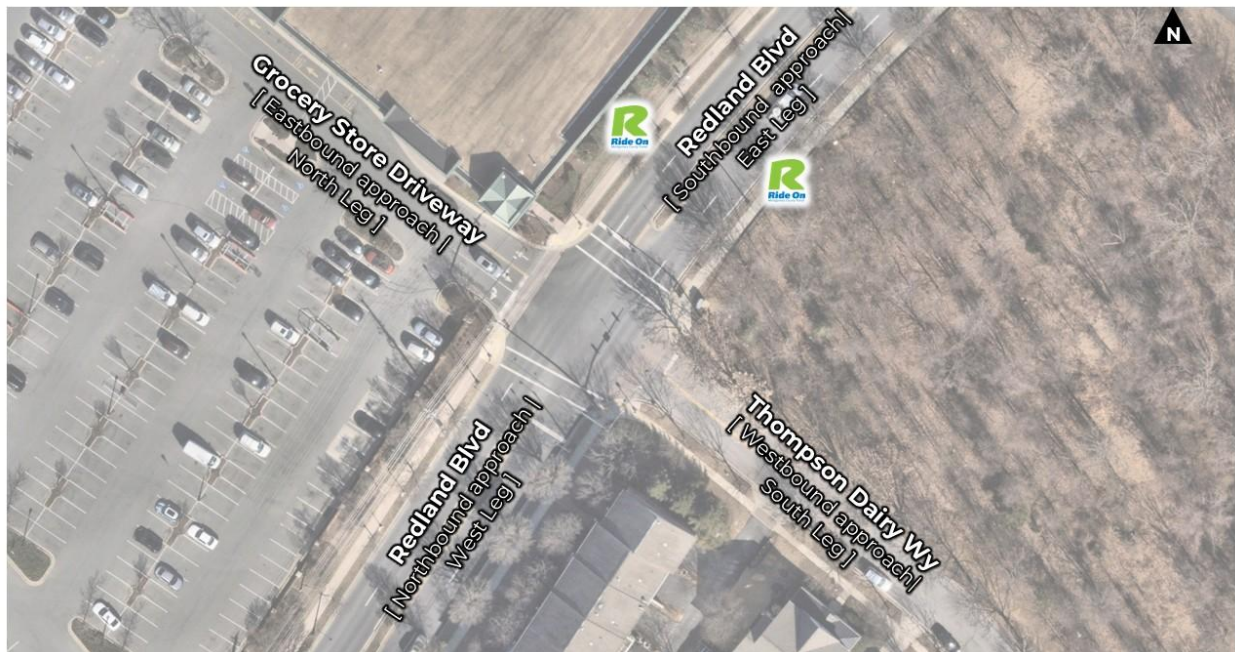
Figure 34. #5 – Redland Boulevard & Thompson Dairy Way Intersection

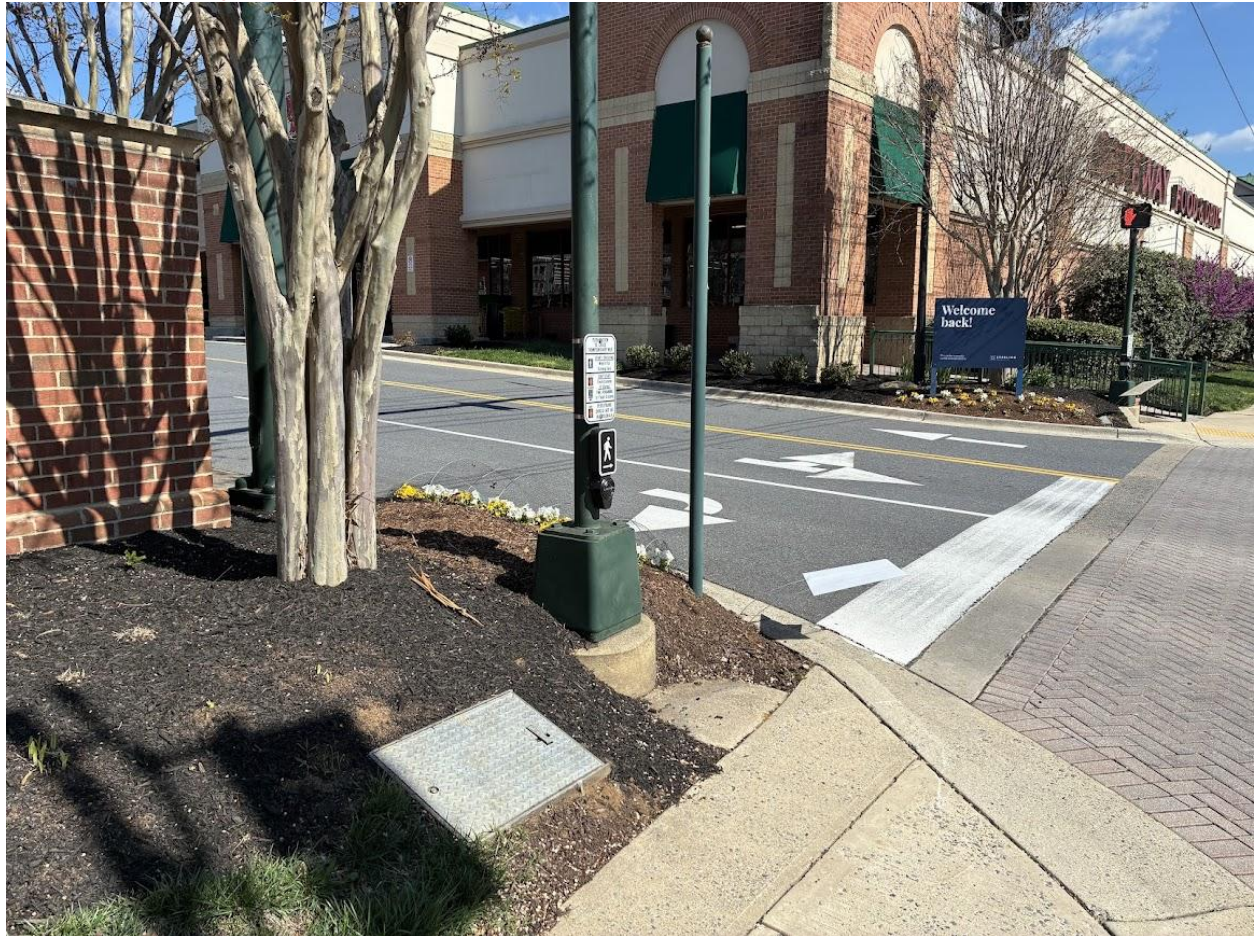
Figure 36. Sidewalk is missing on the westbound approach at Intersection #5 – Redland Boulevard & Thompson Dairy Way

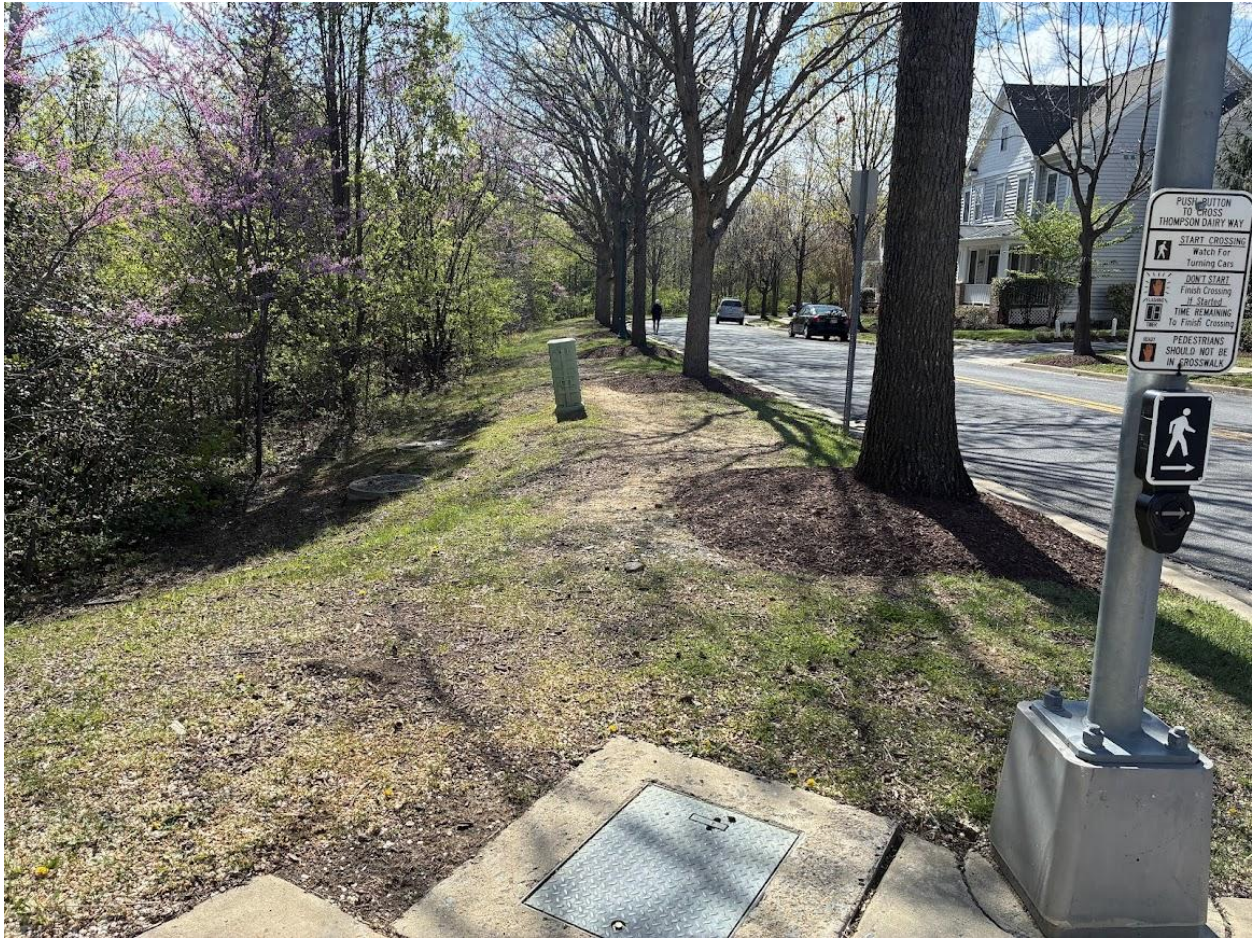
Figure 37. Lack of ADA-Compliant access on the northwest corner at Intersection #5 – Redland Boulevard & Thompson Dairy Way

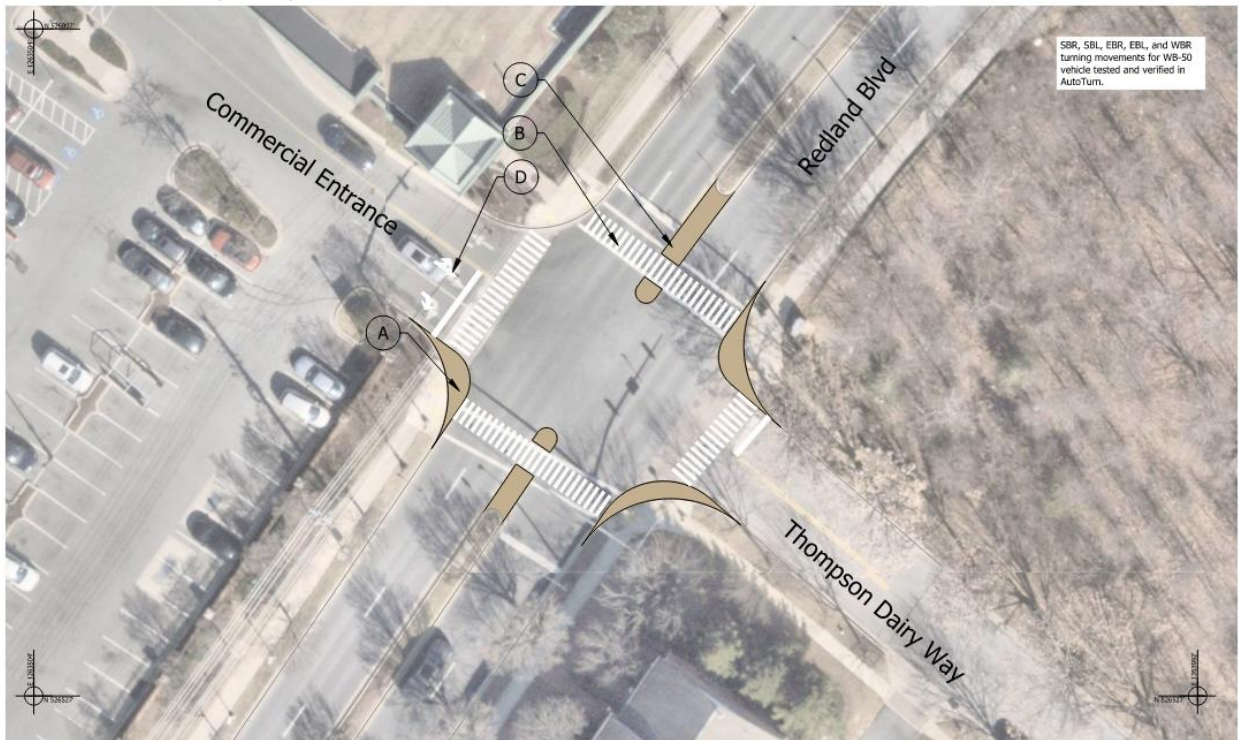
Figure 38. Long-Term Recommendations for Intersection #5 – Redland Boulevard & Thompson Dairy Way

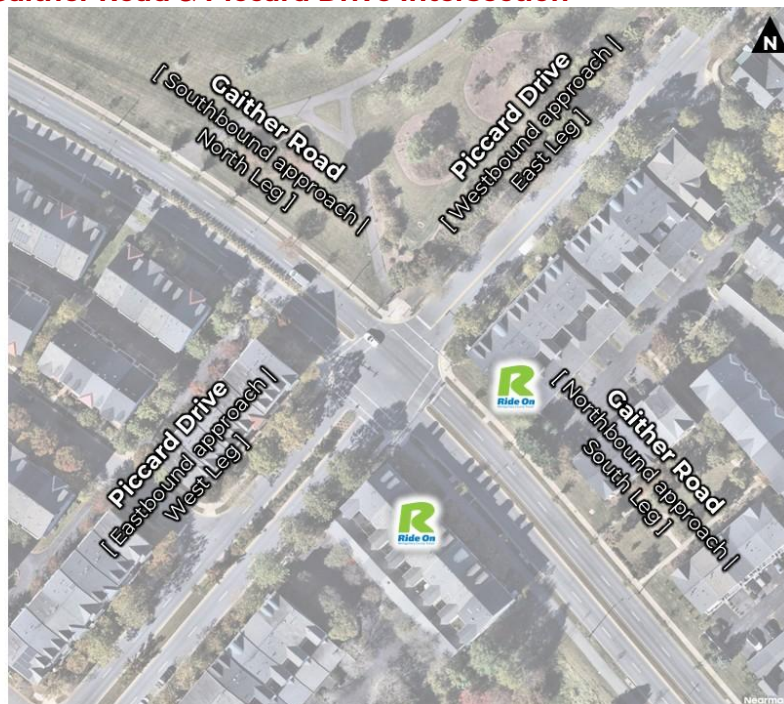
Figure 39. #6 – Gaither Road & Piccard Drive Intersection
