Safe Streets for All
**VISION ZERO
INTERSECTION
SAFETY AUDITS**

City of Rockville, Maryland

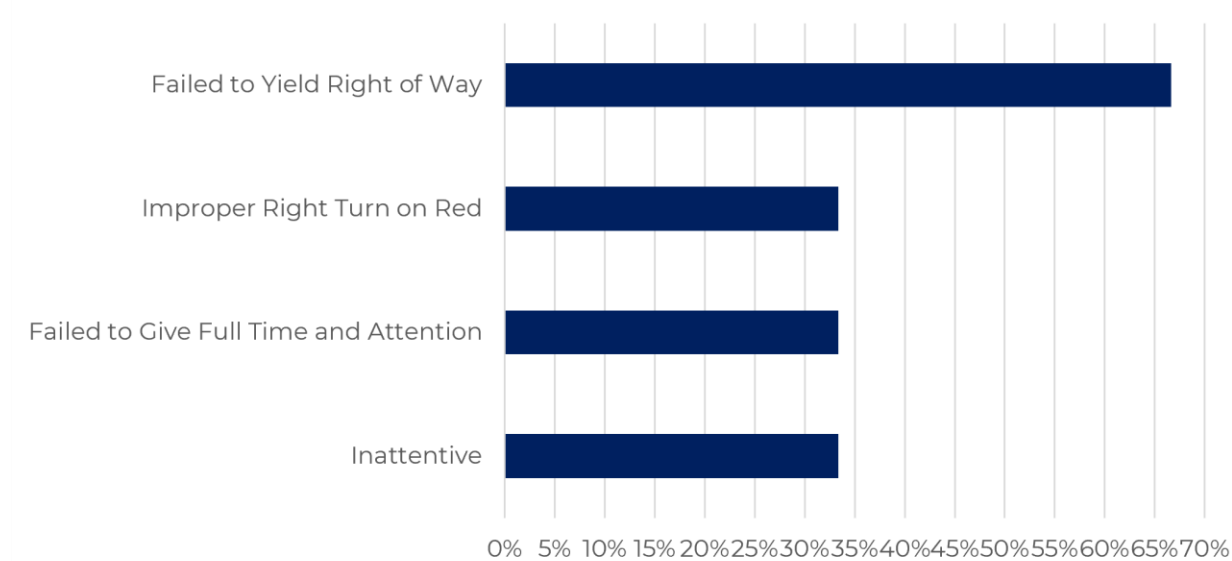
NEAR-MISS VIDEO ANALYSIS

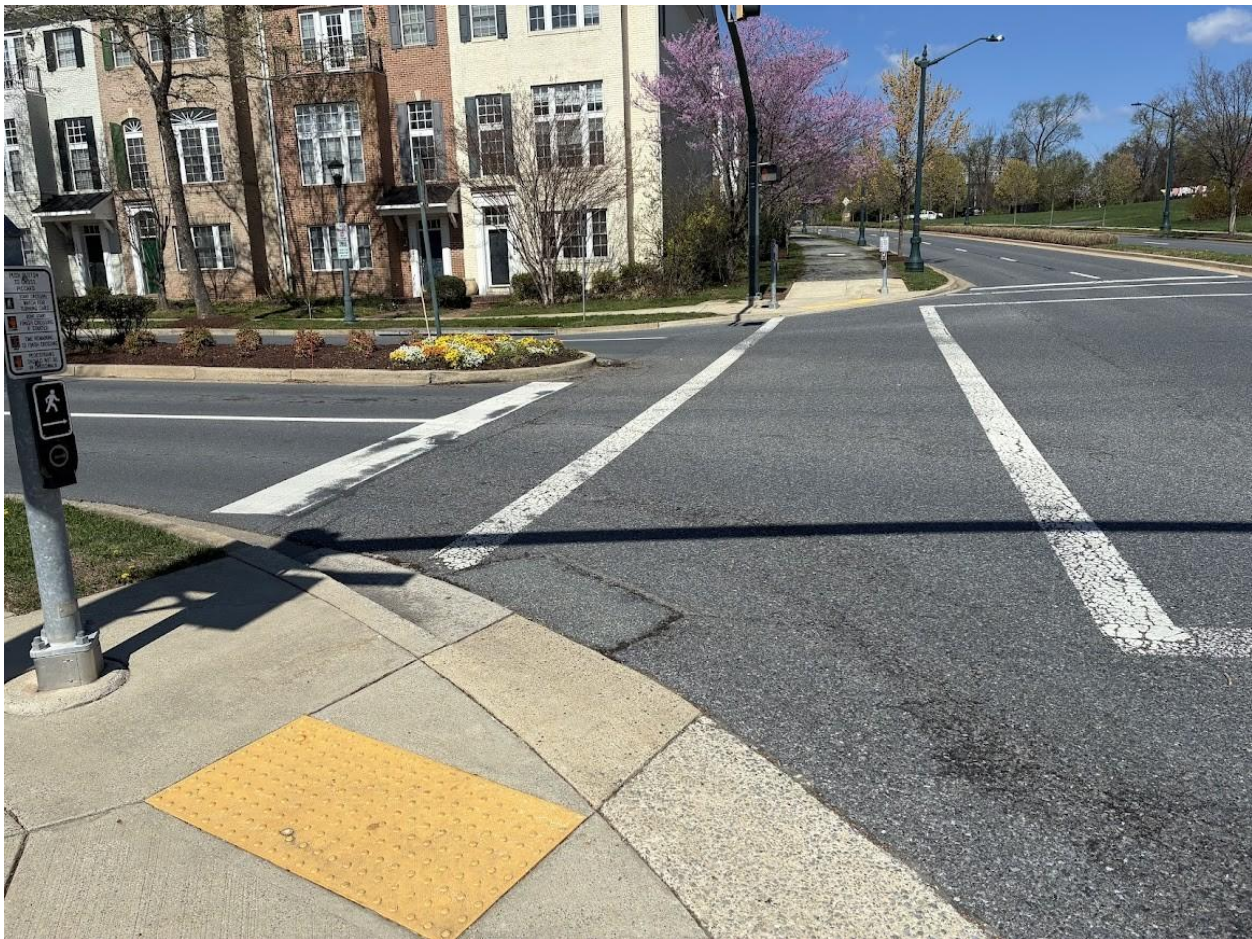
Figure 42. Cars on Piccard Drive parked close to Intersection #6 – Gaither Road & Piccard Drive

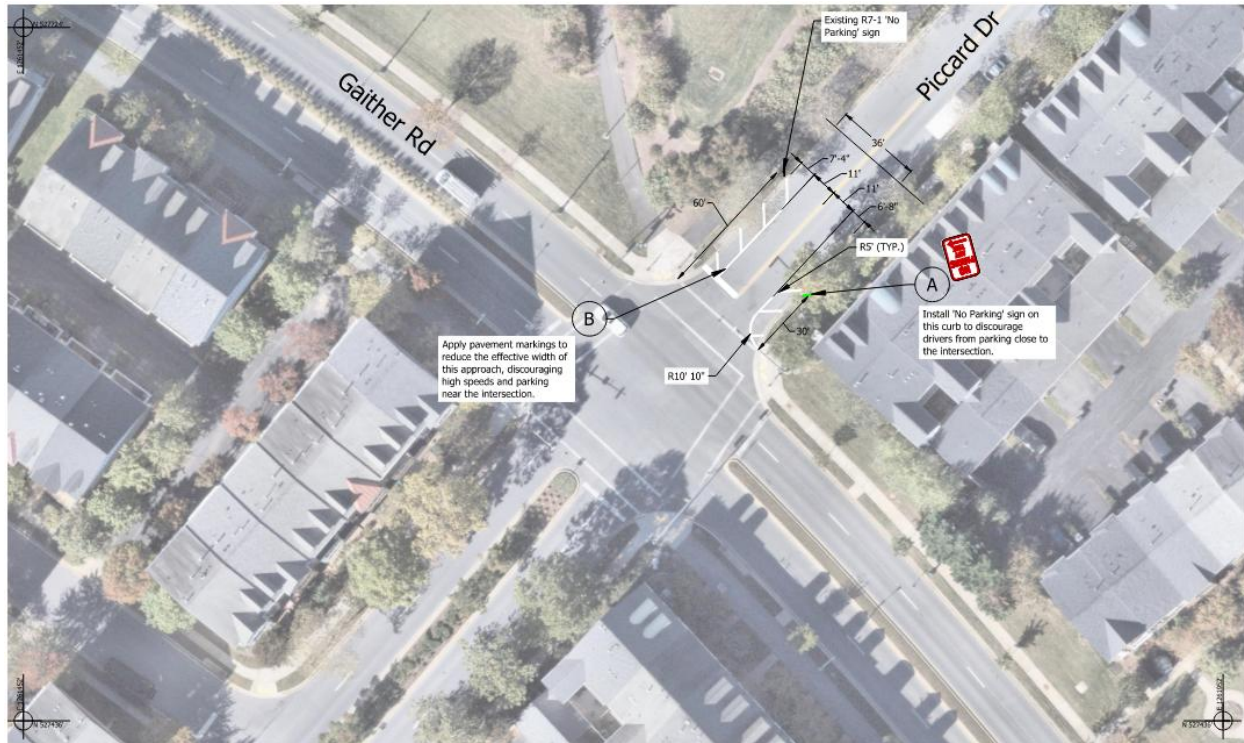
Figure 43. Short-term Recommendations at Intersection #6 – Gaither Road & Piccard Drive

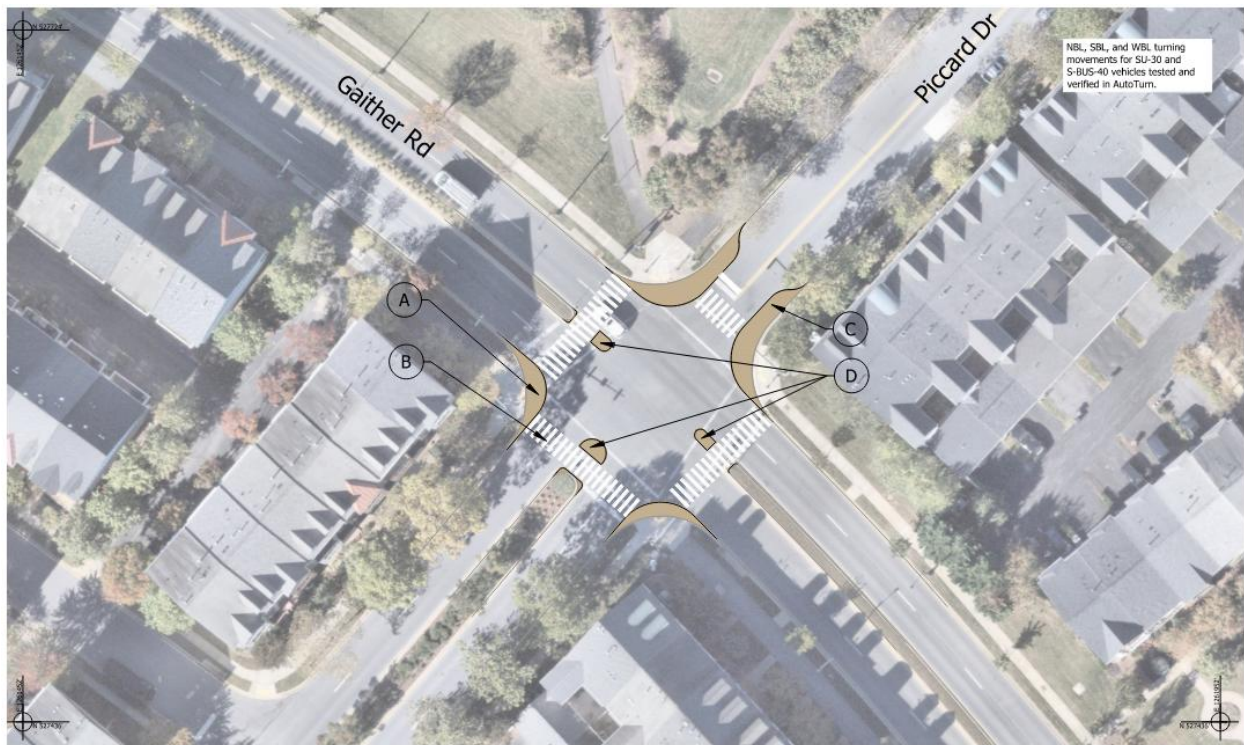
Figure 44. Long-term Recommendations at Intersection #6 – Gaither Road & Piccard Drive

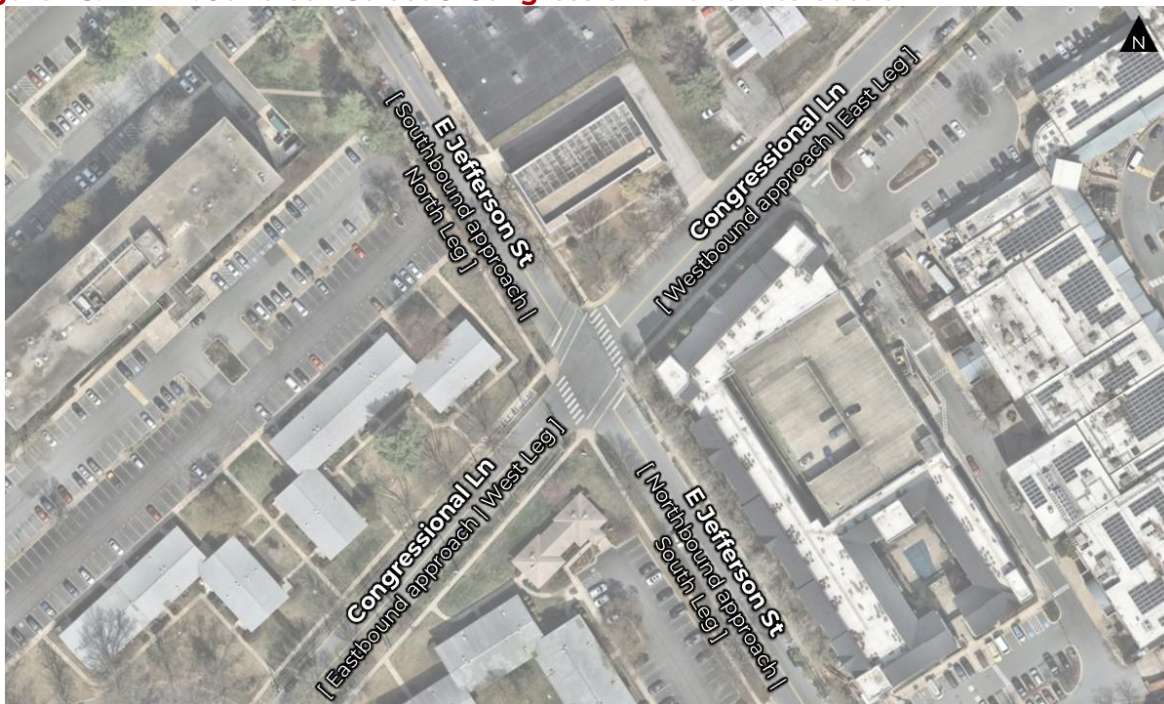
Figure 45. #7 – E. Jefferson Street & Congressional Lane Intersection

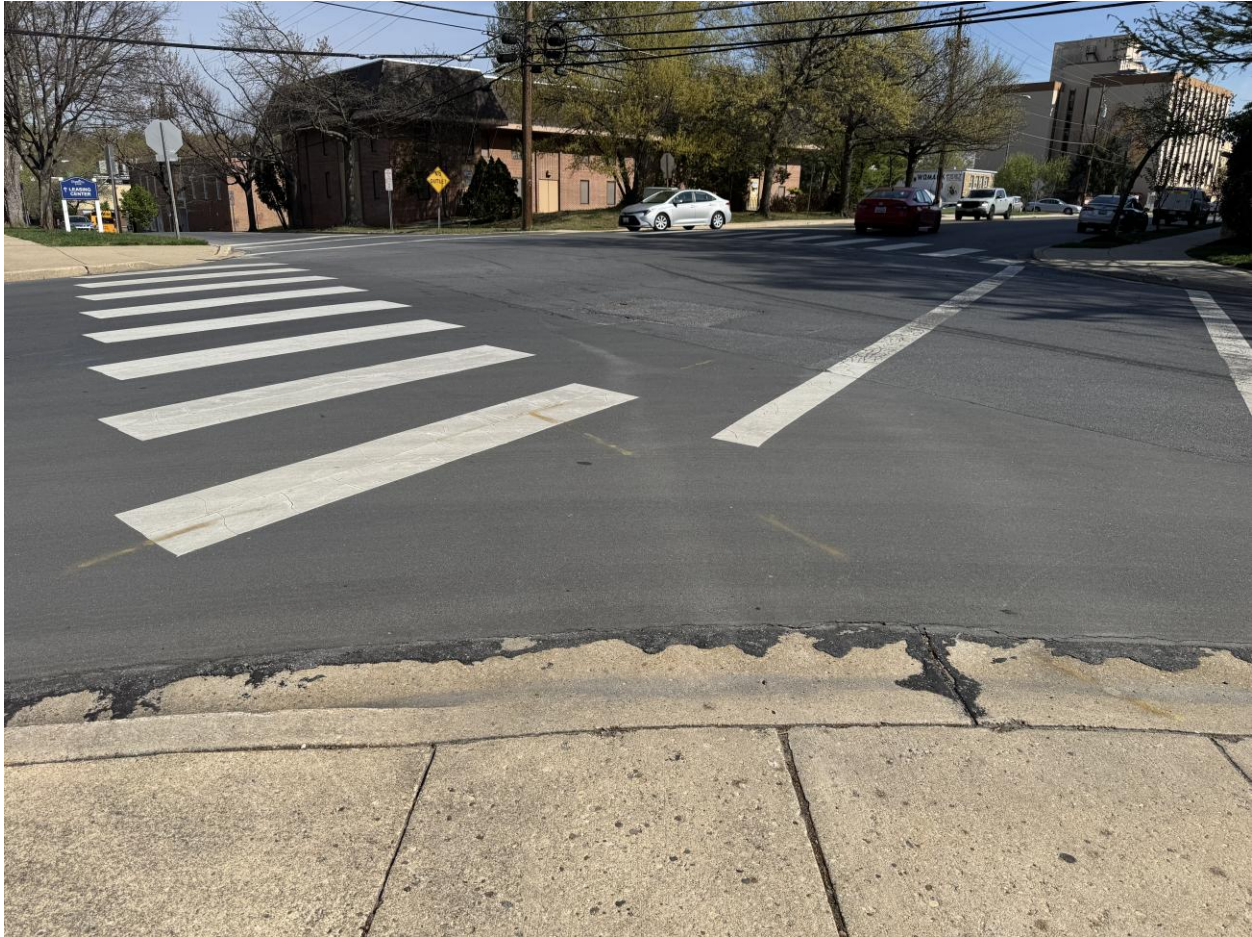
Figure 47. Bicycle route without any bicycle lane or symbol marking along Congressional Lane at Intersection #7 – E. Jefferson Street & Congressional Lane

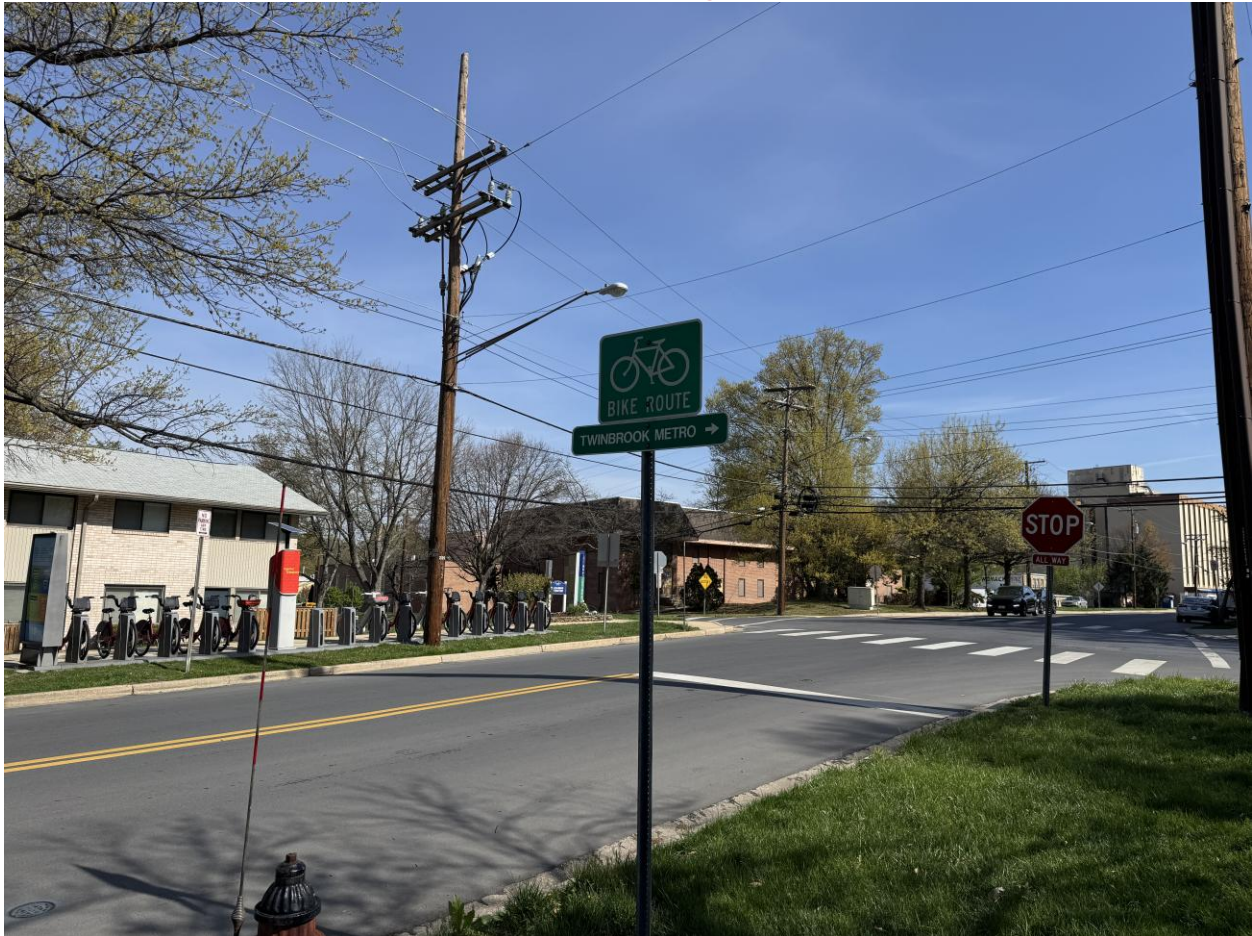
Figure 48. Bus stop at the southeast corner of the intersection is missing ADA-compliant amenities, bus pad, and parking regulation signage at Intersection #7 – E. Jefferson Street & Congressional Lane

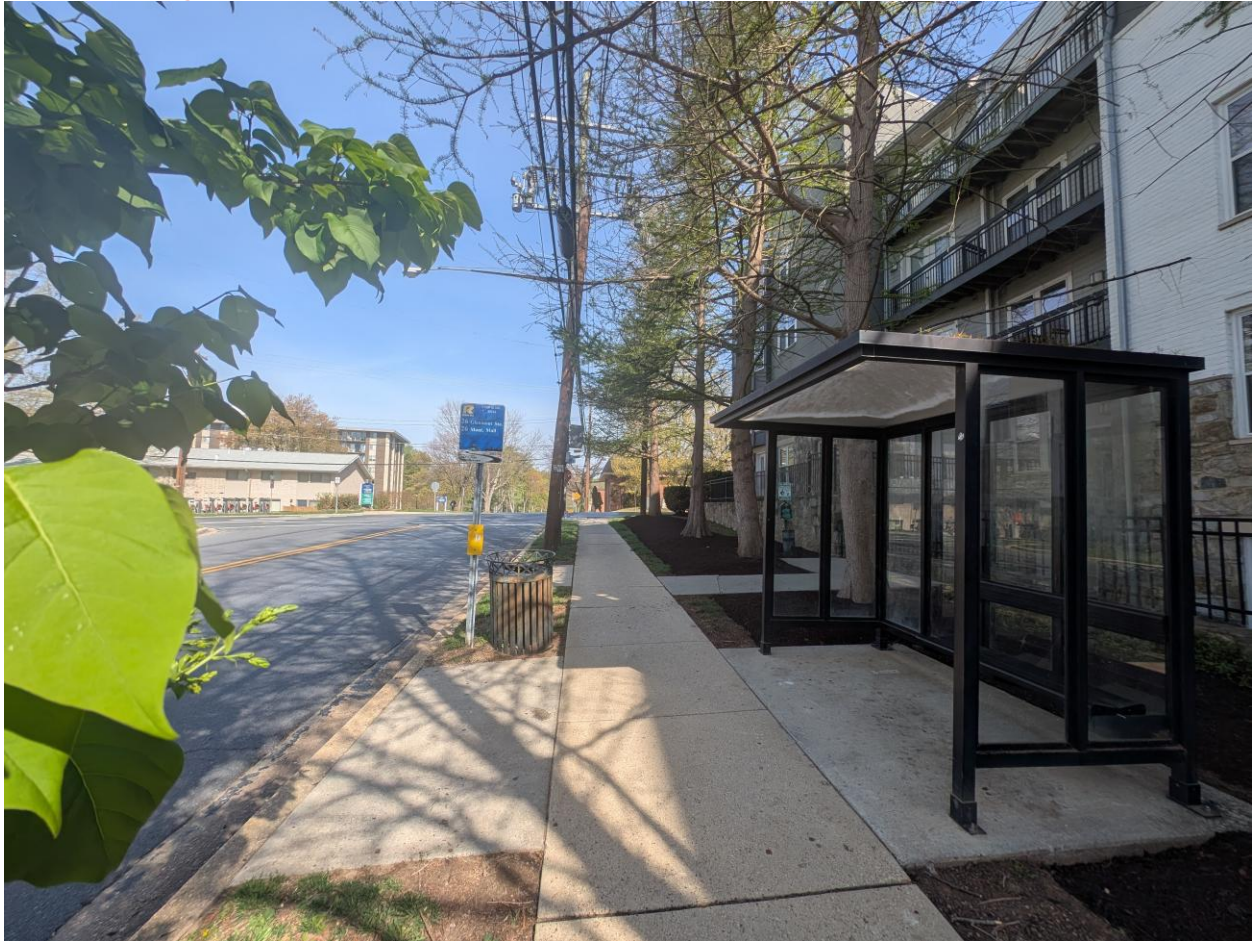
IDENTIFIED SAFETY ISSUES

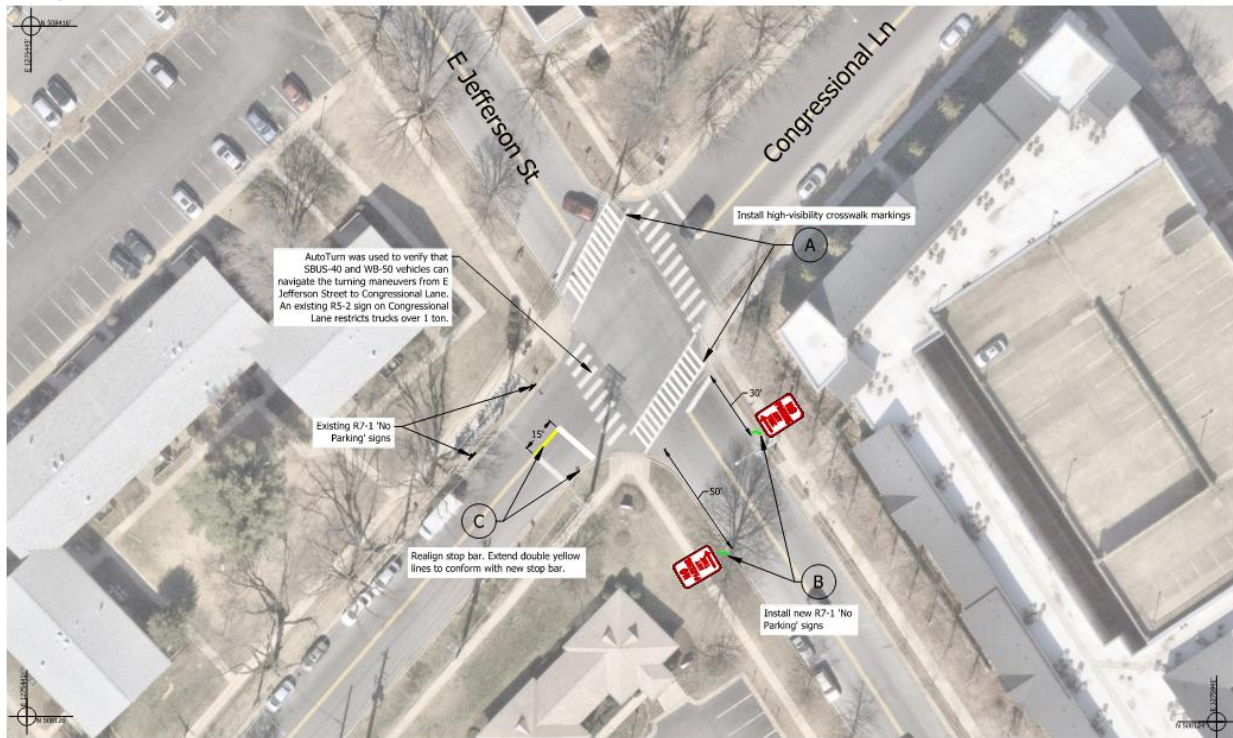
Figure 49. Short-Term Recommendations for Intersection #7 – E. Jefferson Street & Congressional Lane

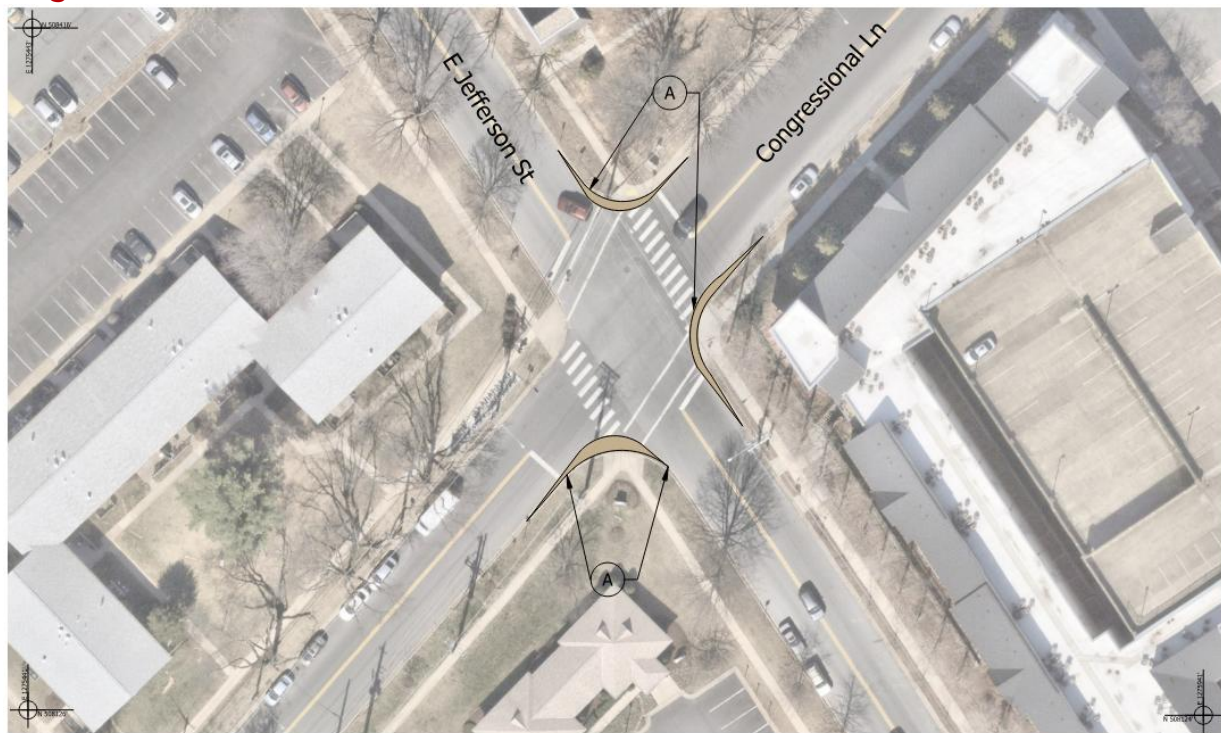
Figure 50. Long-Term Recommendations for Intersection #7 – E. Jefferson Street & Congressional Lane

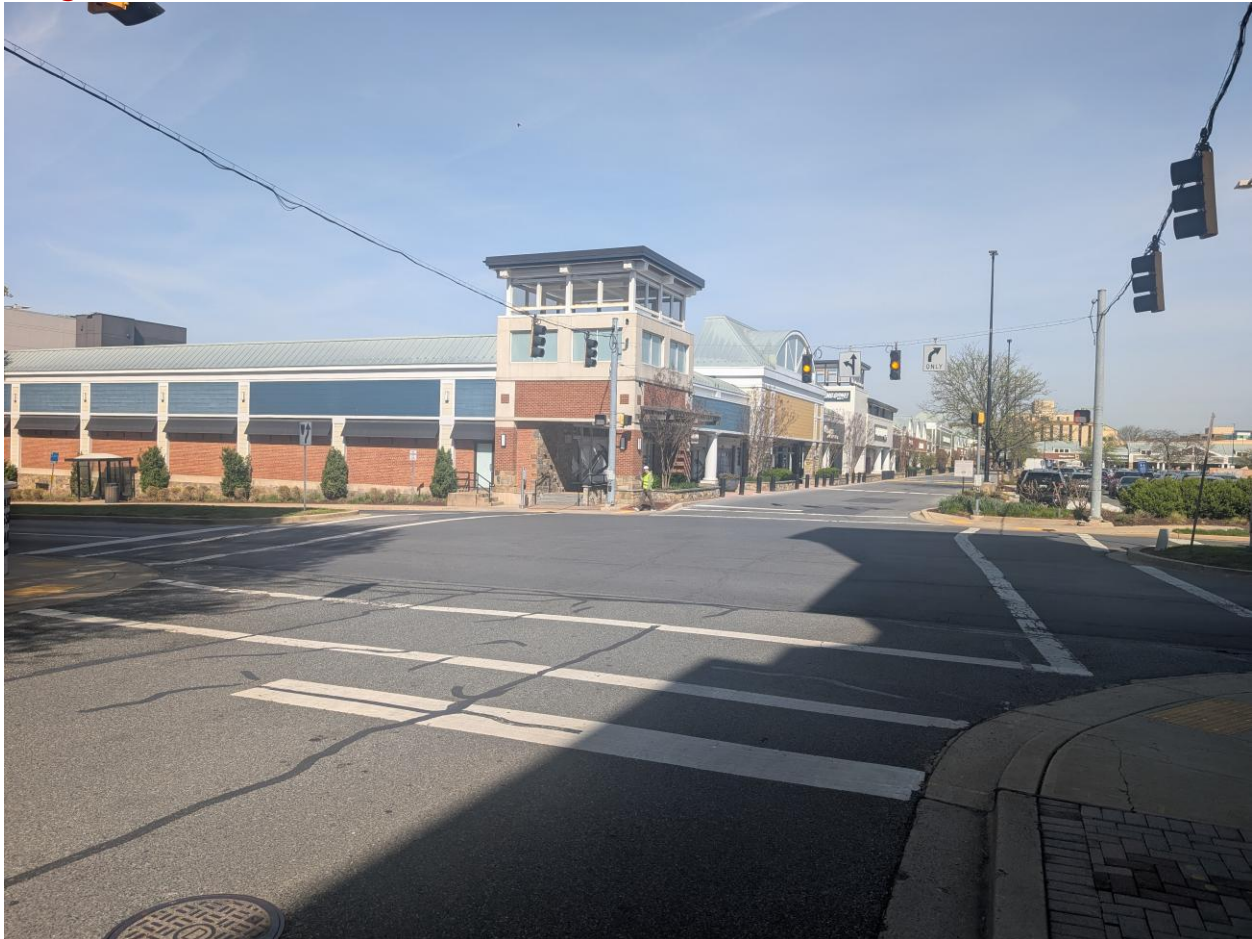
Figure 54. Figure 55: Existing crosswalk crossing Halpine Road at Intersection #8 - Halpine Road and Congressional Plaza

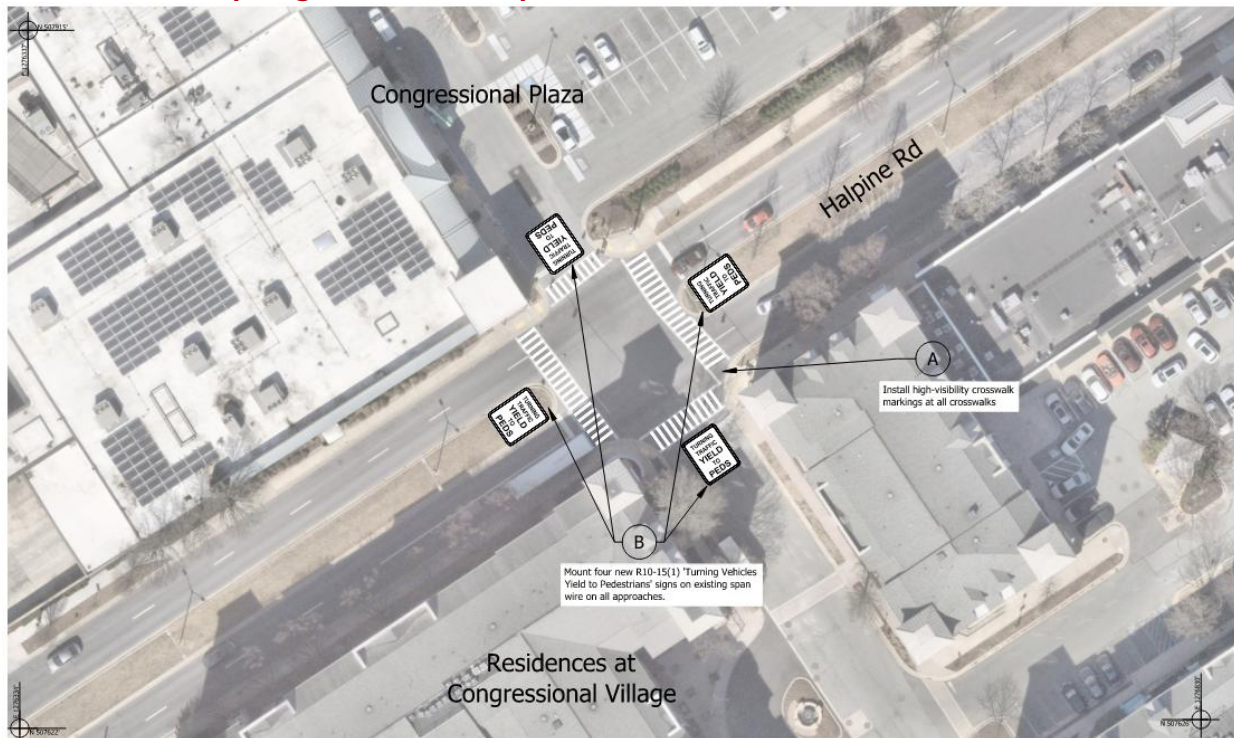
Figure 55. Short-Term Recommendations for Intersection #8 – Halpine Road & Shopping Center Entrance (Congressional Plaza)

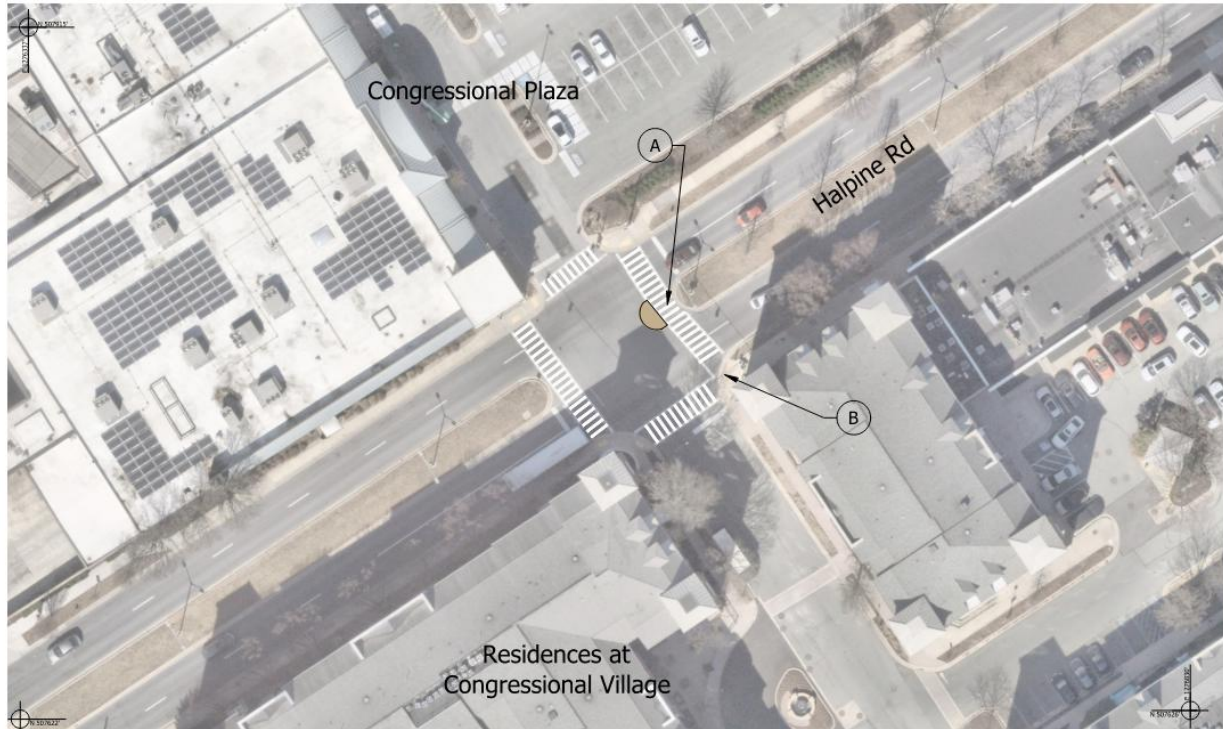
Figure 56. Long-Term Recommendations for Intersection #8 – Halpine Road & Shopping Center Entrance (Congressional Plaza)

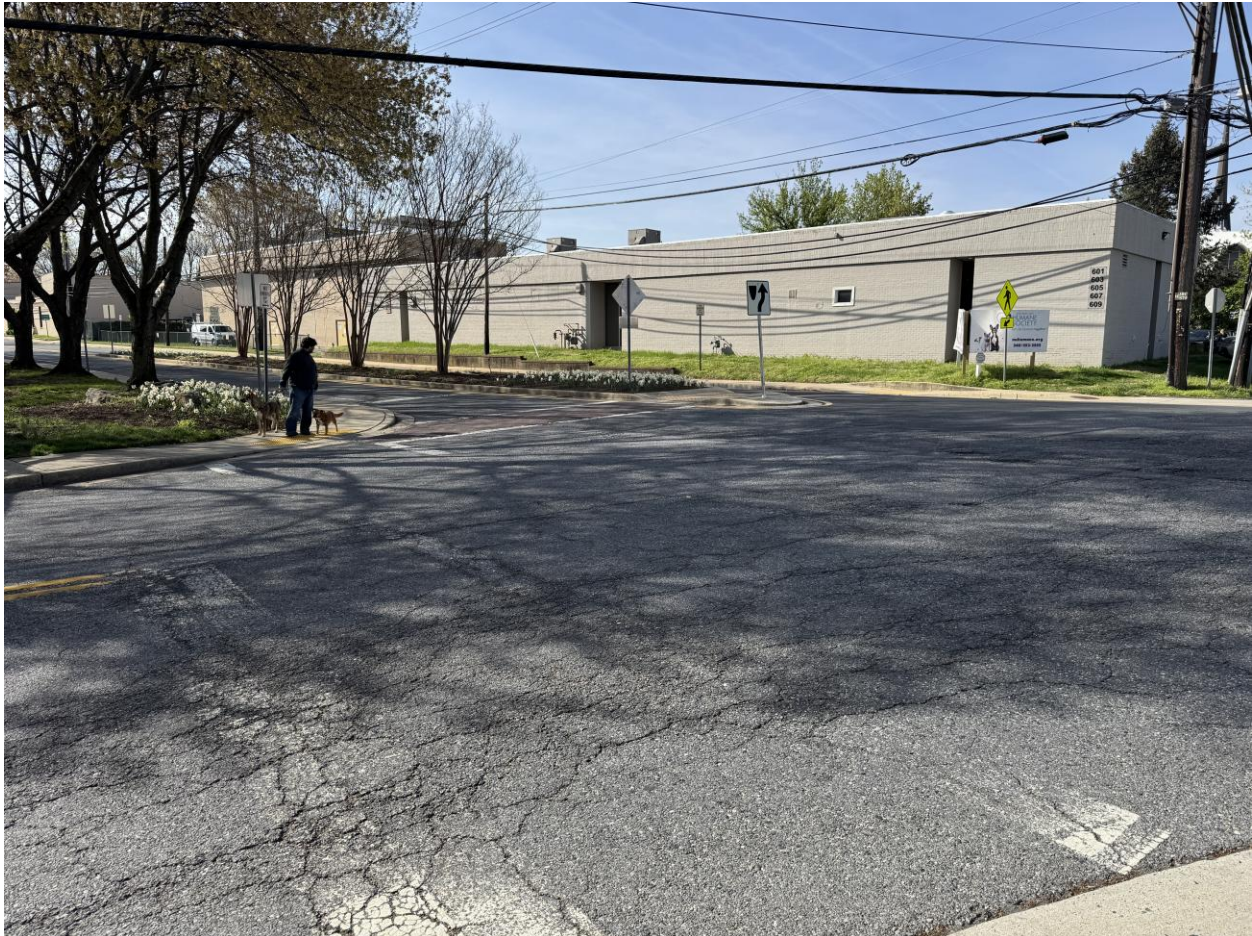
Figure 59. A bus making a right turn to S. Stonestreet Avenue from Baltimore Road at Intersection #9 – Baltimore Road & S. Stonestreet Avenue

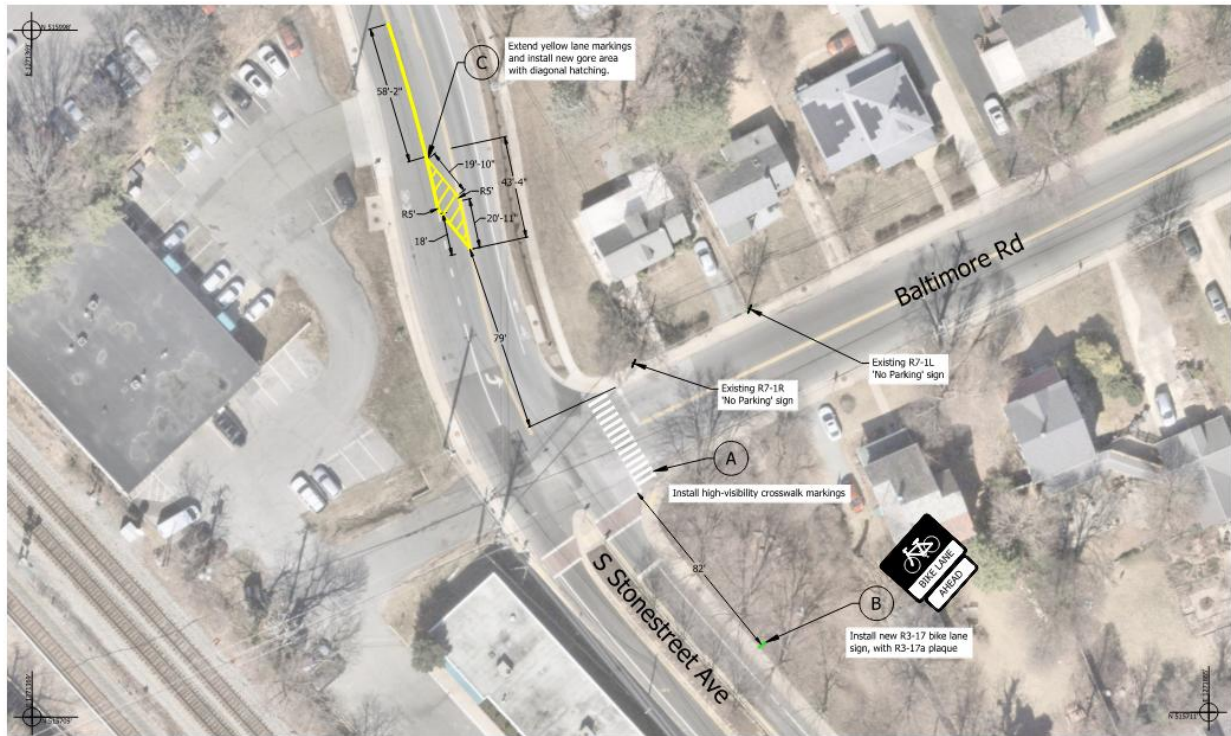
Figure 61. Short-Term Recommendations for Intersection #9 – Baltimore Road & S. Stonestreet Avenue

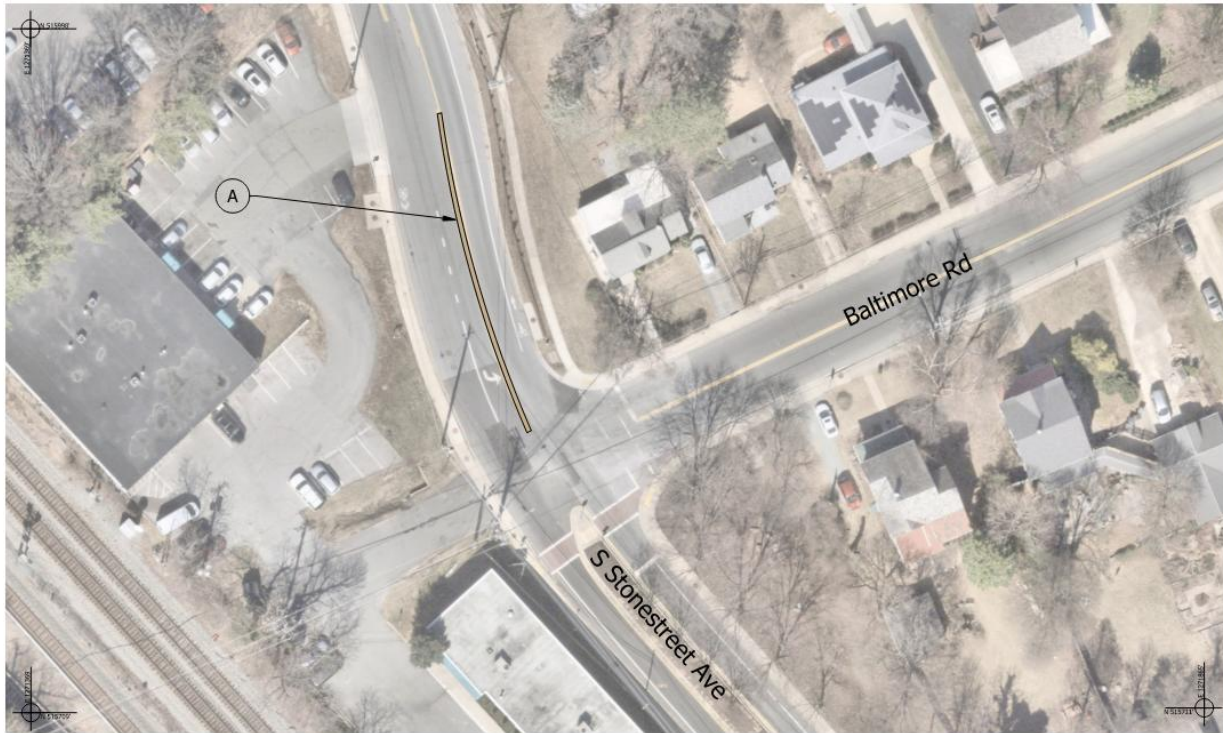
Figure 62. Long-Term Recommendations for Intersection #9 – Baltimore Road & S. Stonestreet Avenue

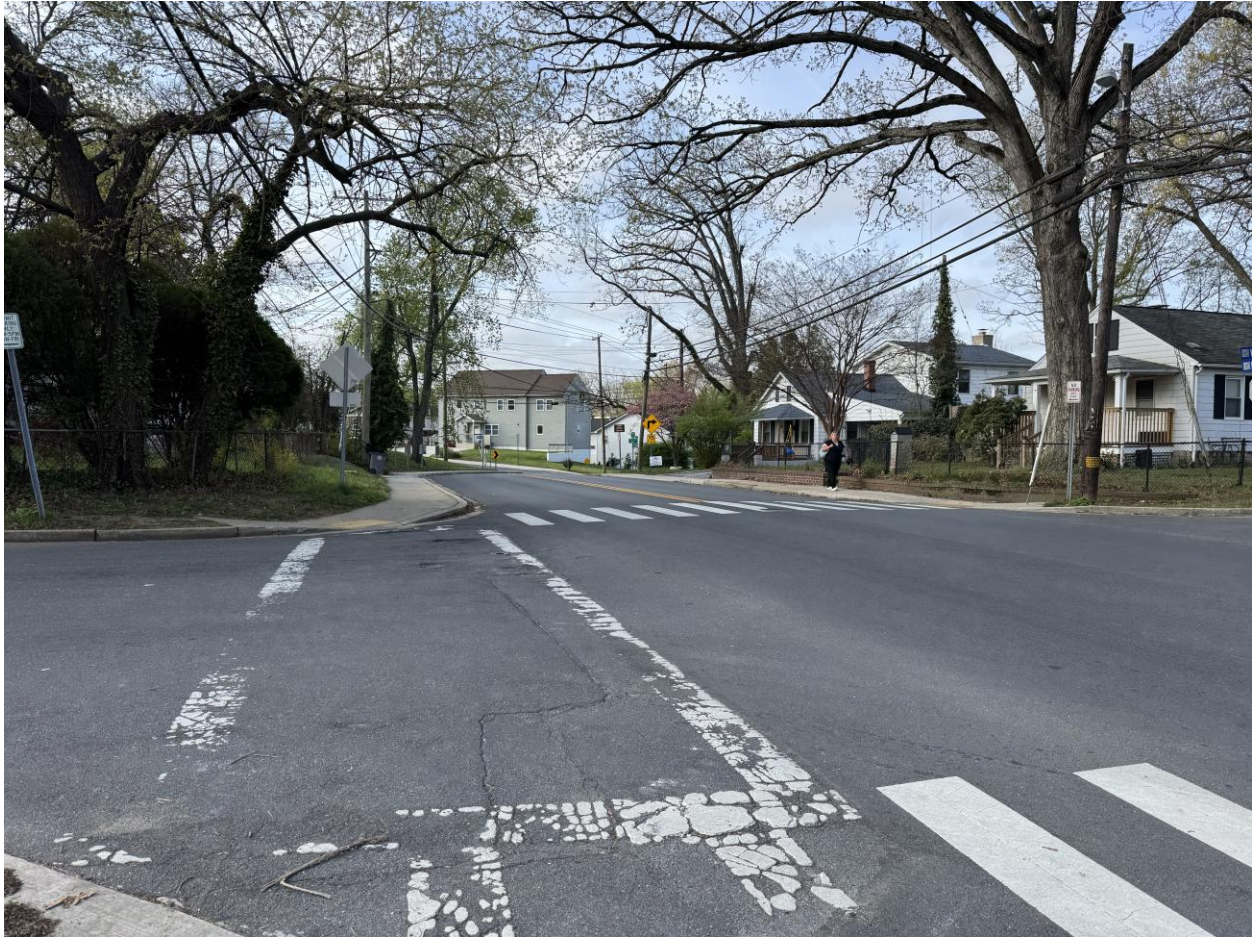
Figure 65. A pedestrian using an unmarked crosswalk across Woodland Road at Intersection #10 – Woodland Road & N. Horners Lane

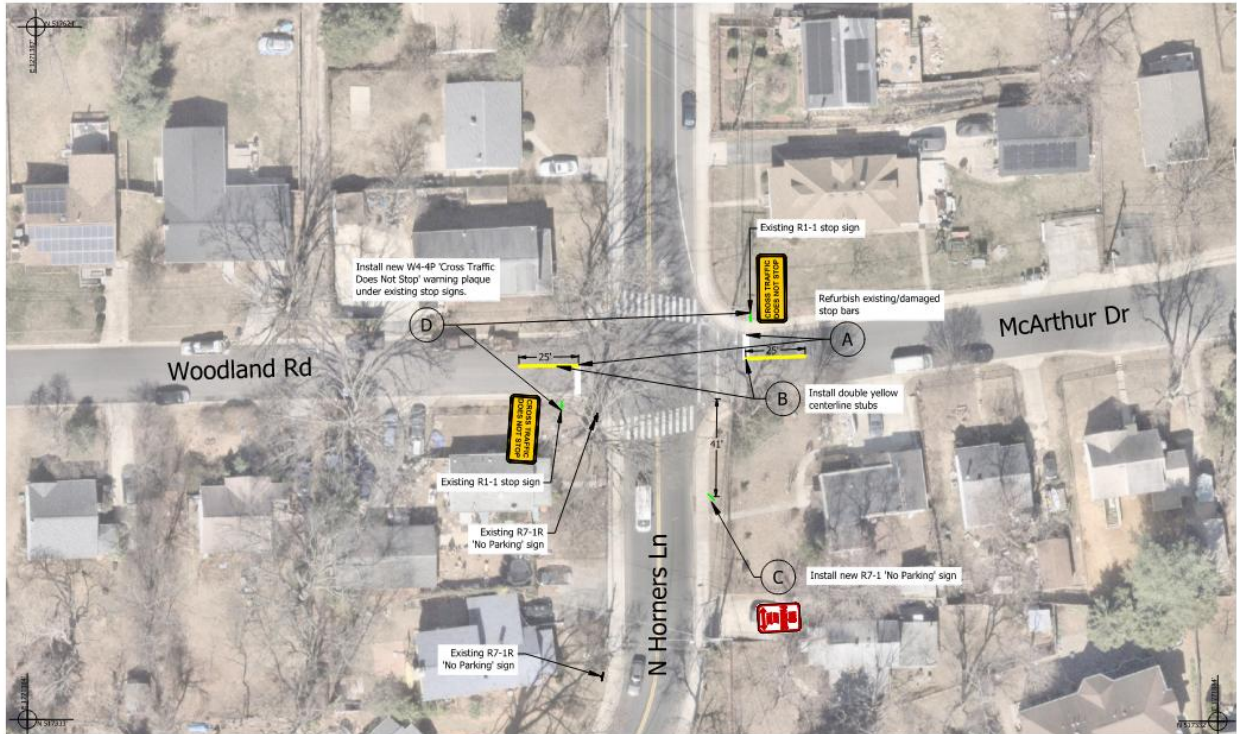
Figure 67. Short-Term Recommendations for Intersection #10 – Woodland Road & N. Horners Lane

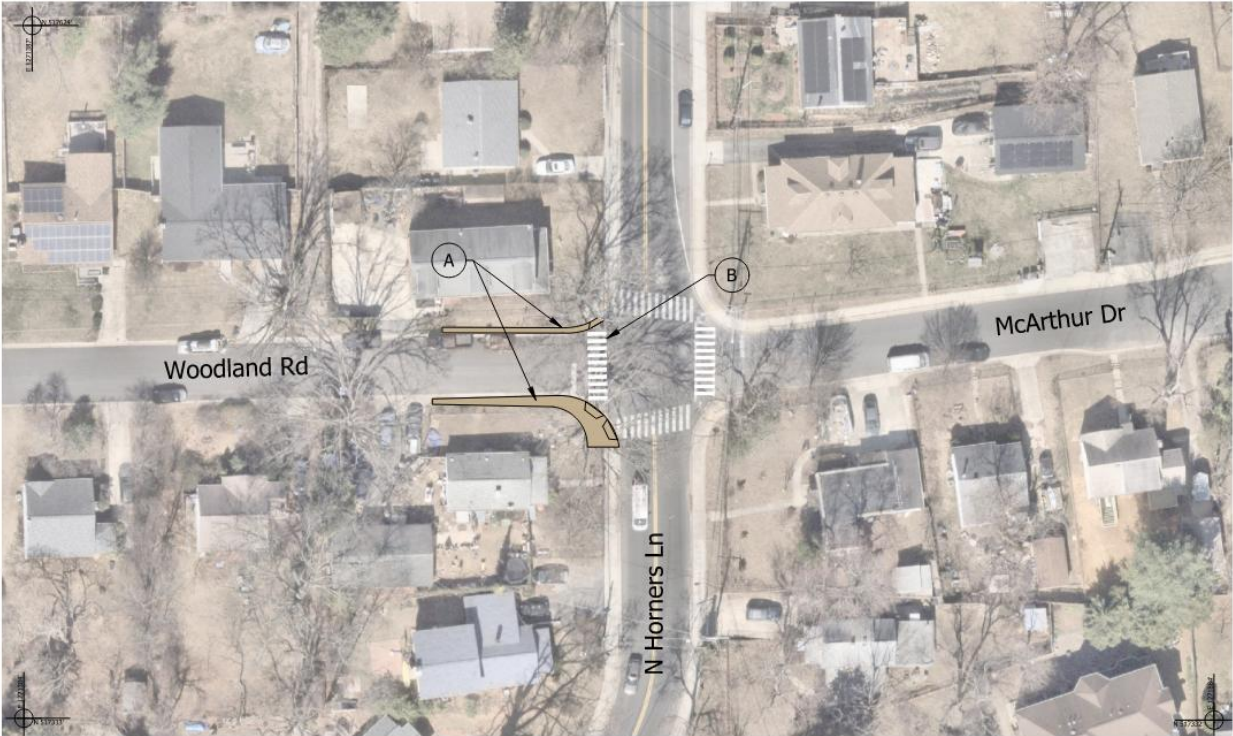
Figure 68. Long-Term Recommendations for Intersection #10 – Woodland Road & N. Horners Lane

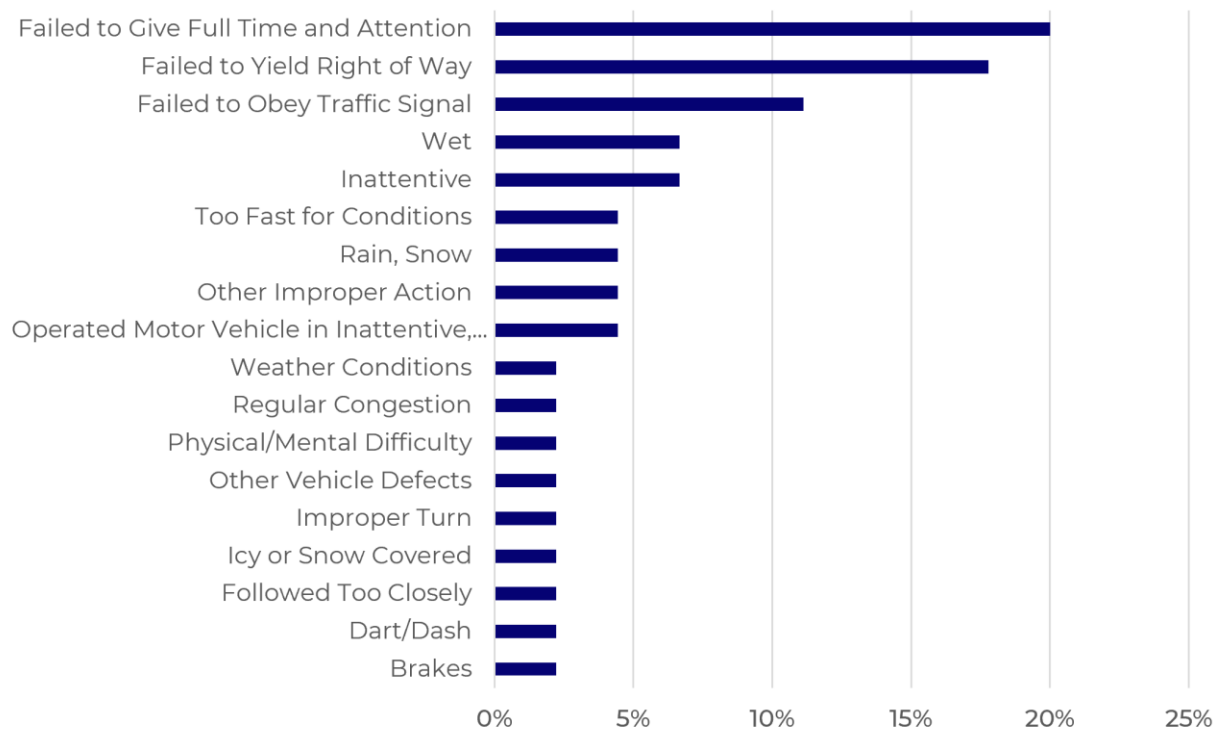
NEAR-MISS VIDEO ANALYSIS

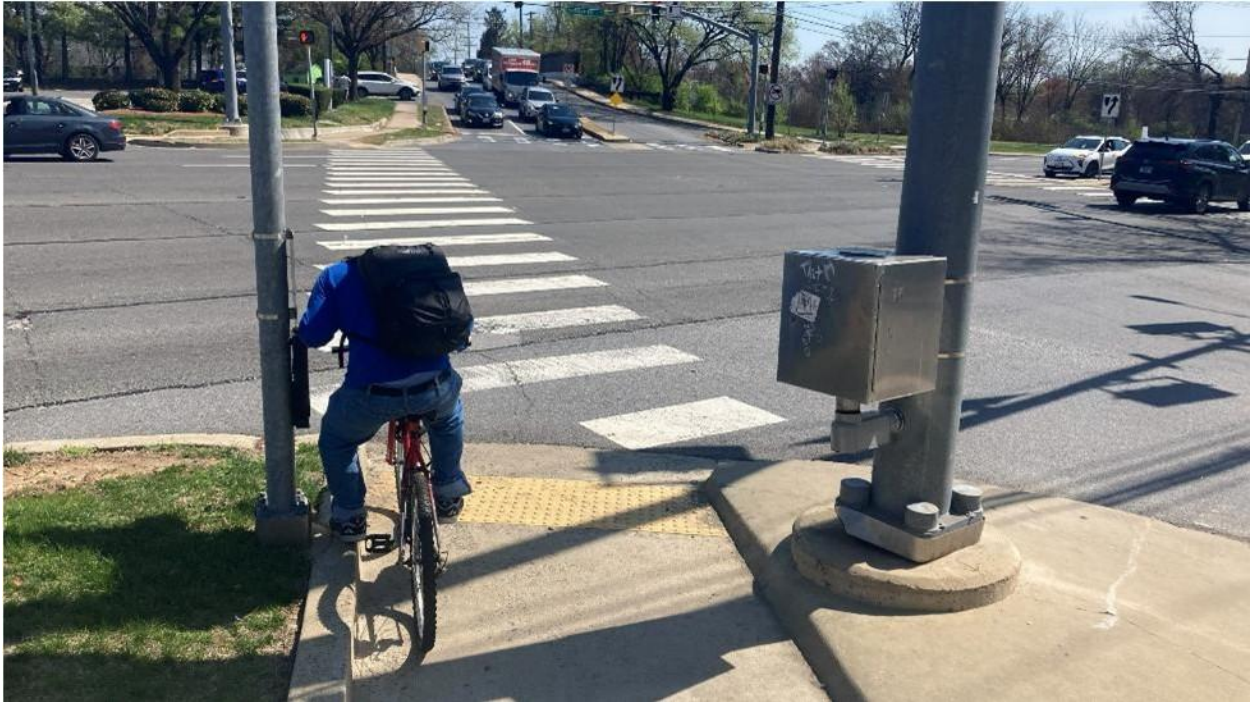
Figure 72. Channelizing Island on the Southeast Corner of Intersection #11 - Rockville Pike (MD 355) & Edmonston Drive

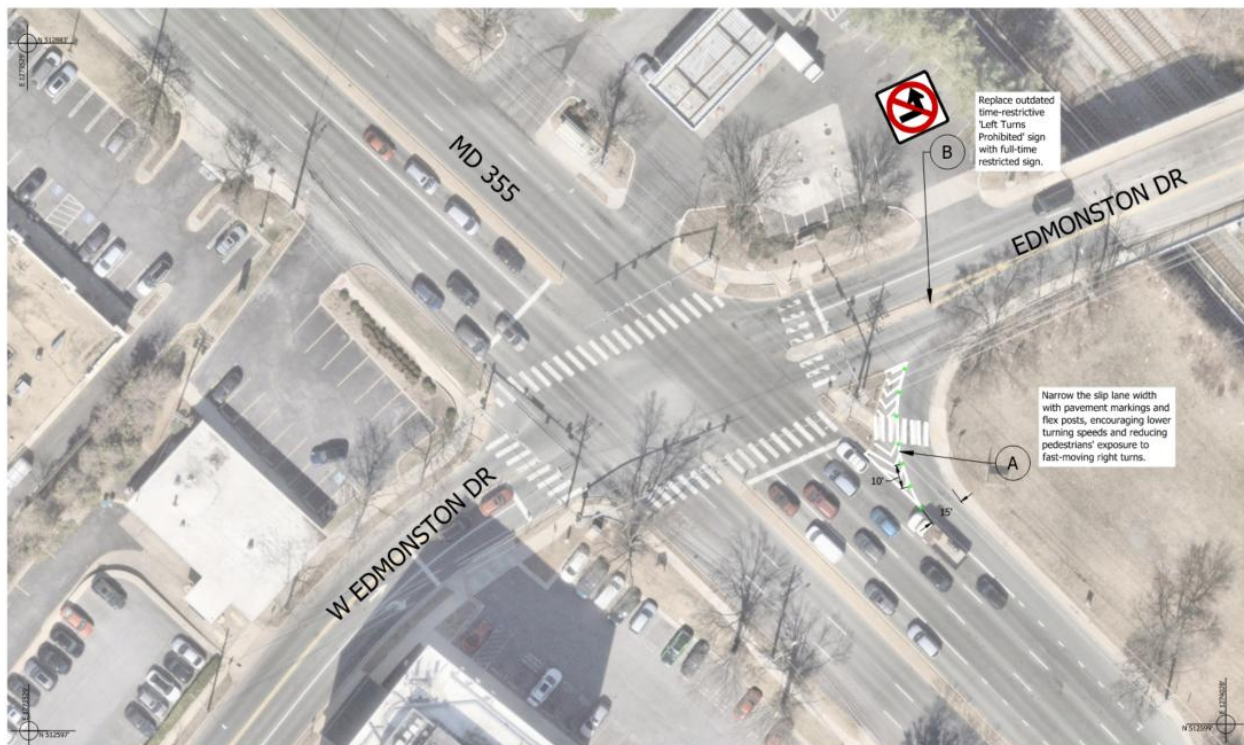
Figure 74. Short-Term Recommendations for Intersection #11 - Rockville Pike (MD 355) & Edmonston Drive

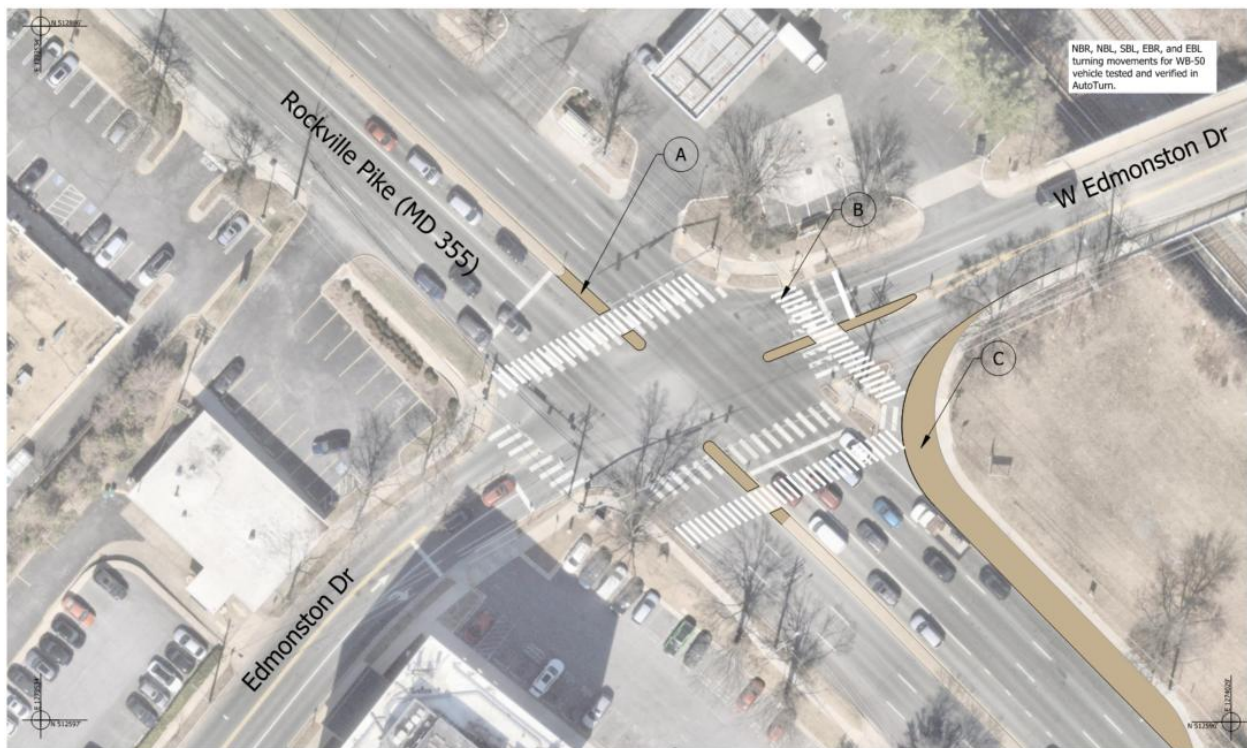
Figure 75. Long-Term Recommendations for Intersection #11 - Rockville Pike (MD 355) & Edmonston Drive
