Safe Streets for All
**VISION ZERO
INTERSECTION
SAFETY AUDITS**

City of Rockville, Maryland

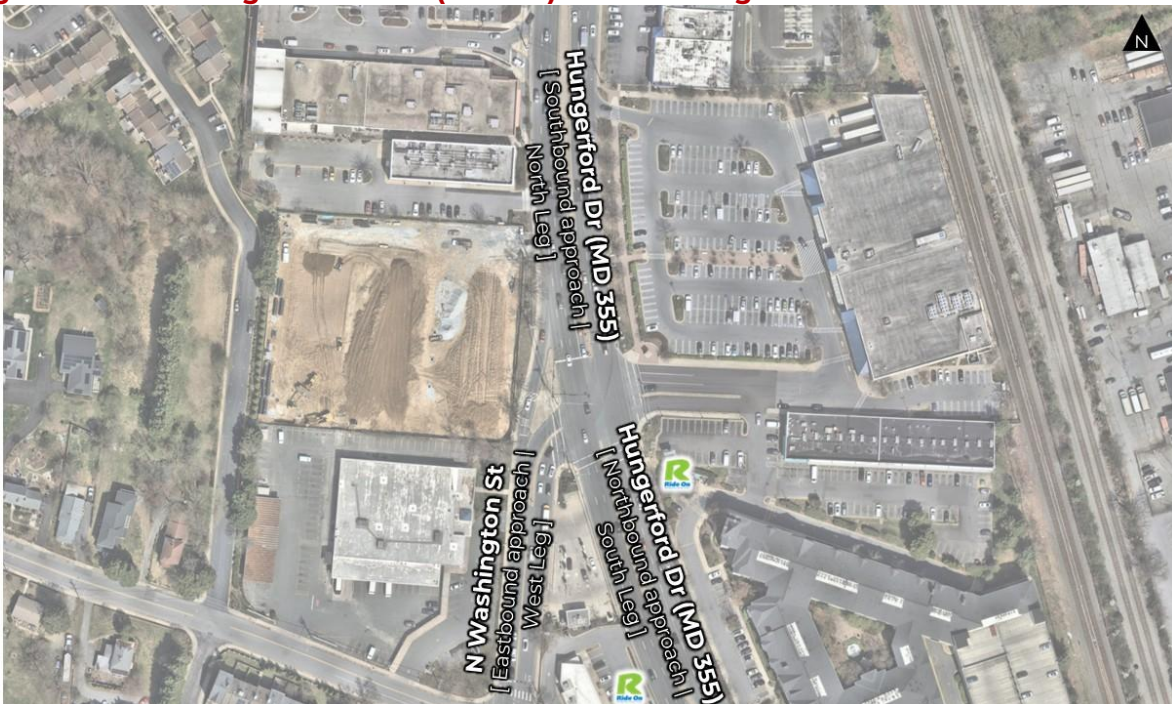
Figure 76. #12 - Hungerford Drive (MD 355) & N. Washington Street Intersection

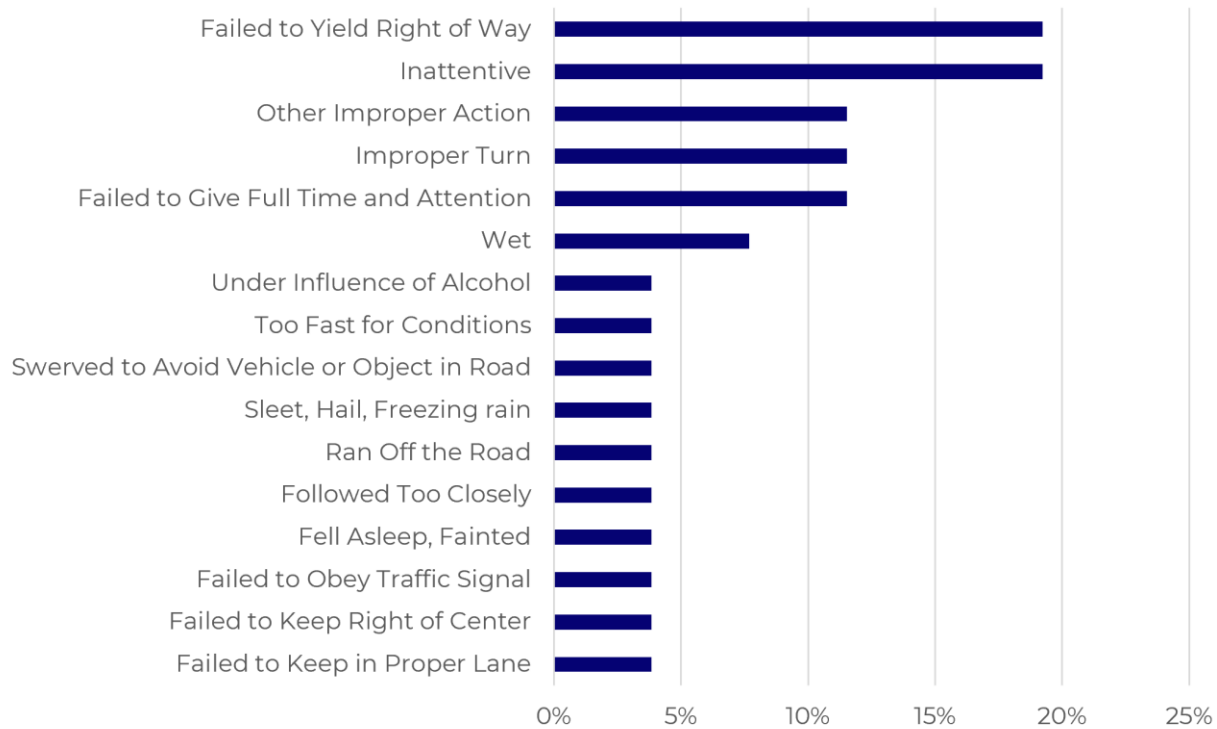
NEAR-MISS VIDEO ANALYSIS

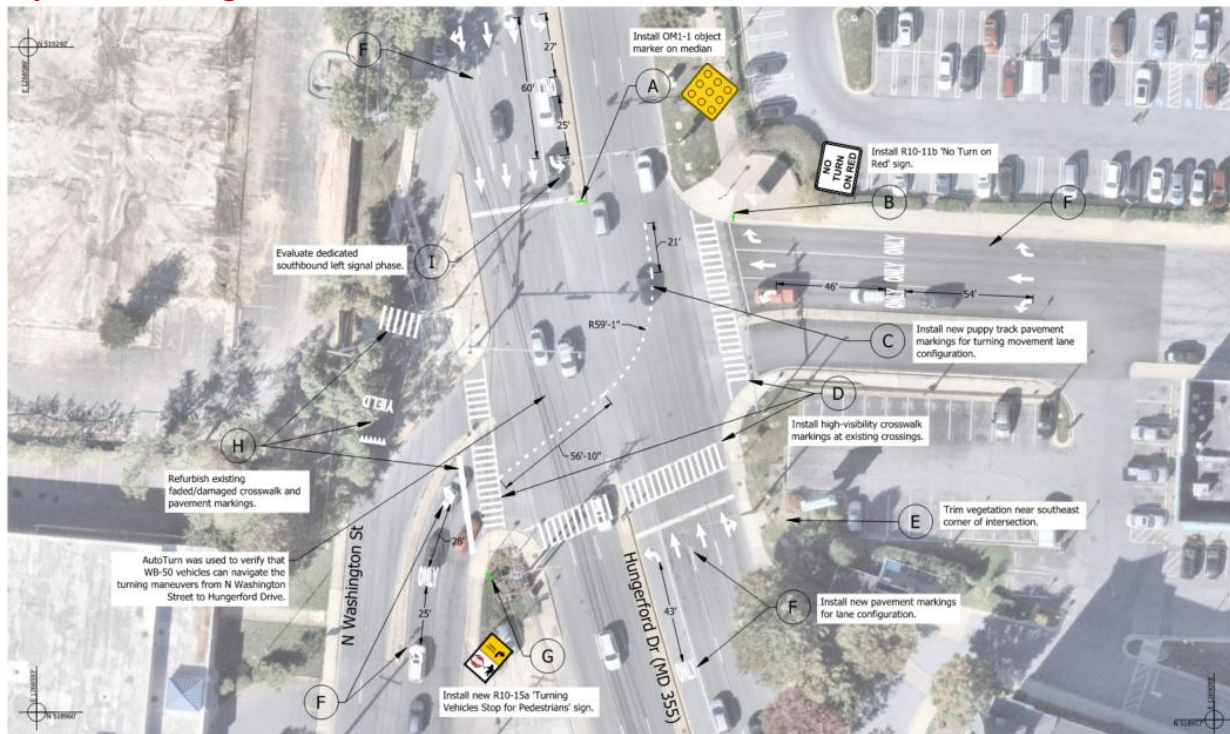
Figure 81. Short-Term Recommendations for Intersection #12 - Hungerford Drive (MD 355) & N. Washington Street

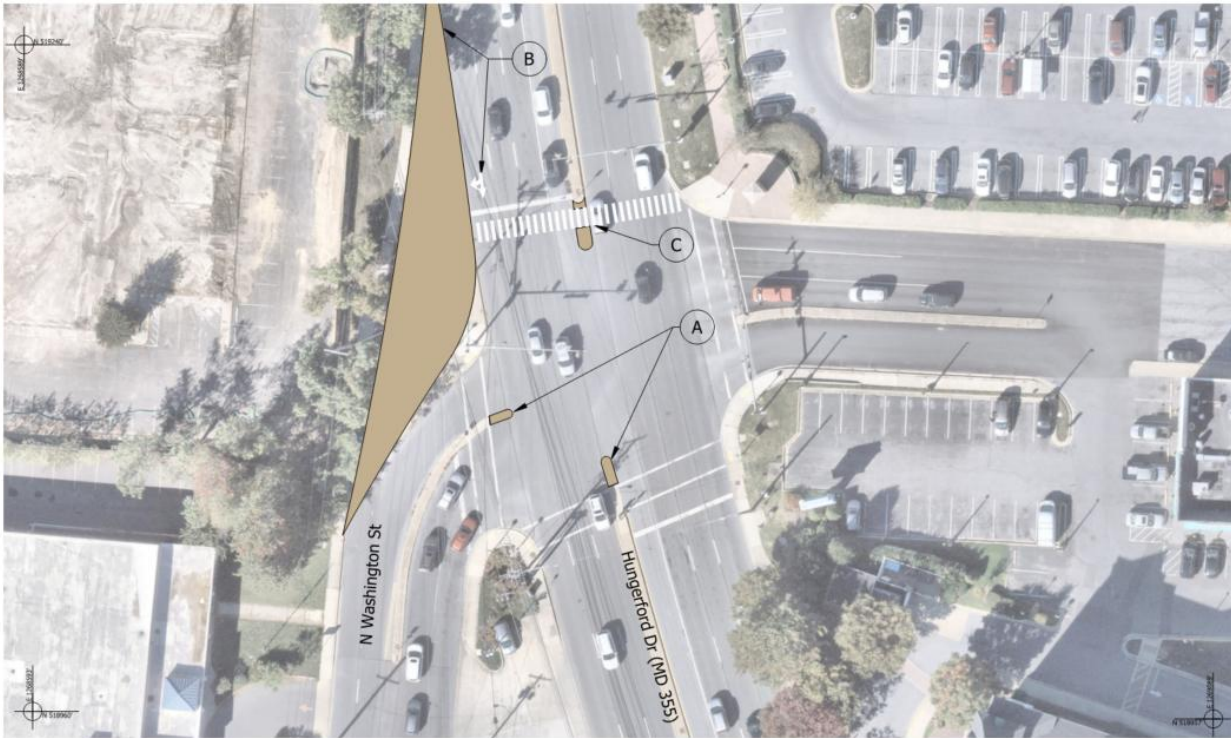
Figure 82. Long-Term Recommendations for Intersection #12 - Hungerford Drive (MD 355) & N. Washington Street

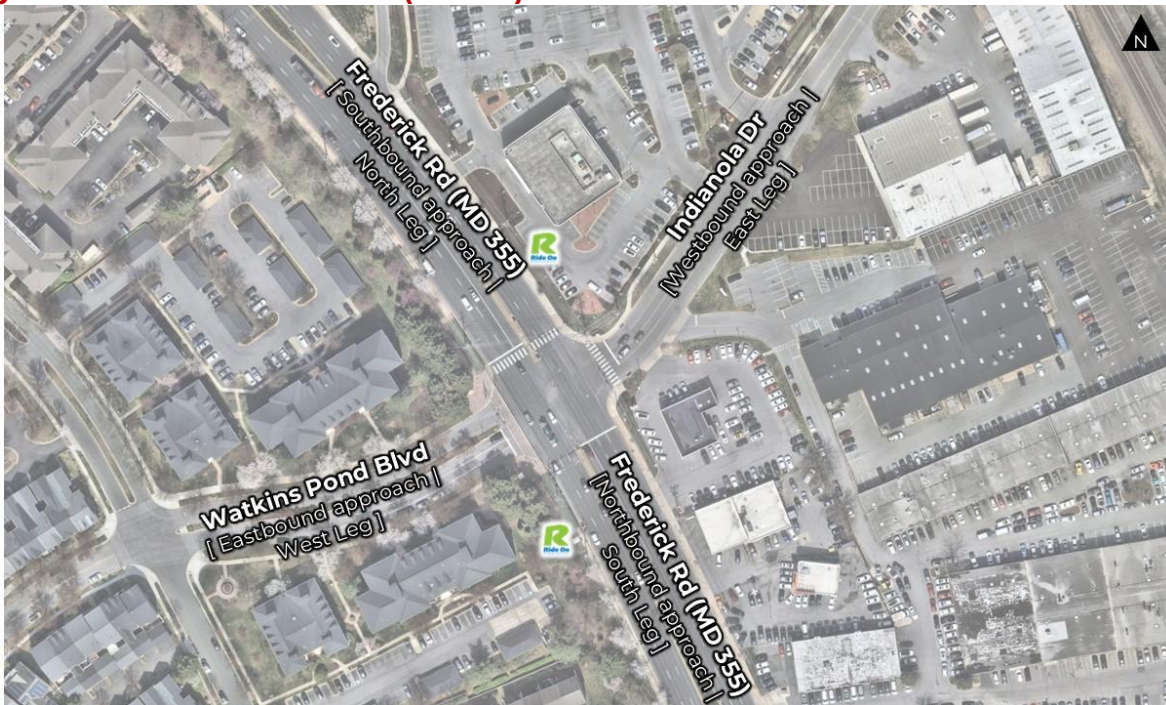
Figure 83. #13 - Frederick Road (MD 355) & Watkins Pond Boulevard Intersection

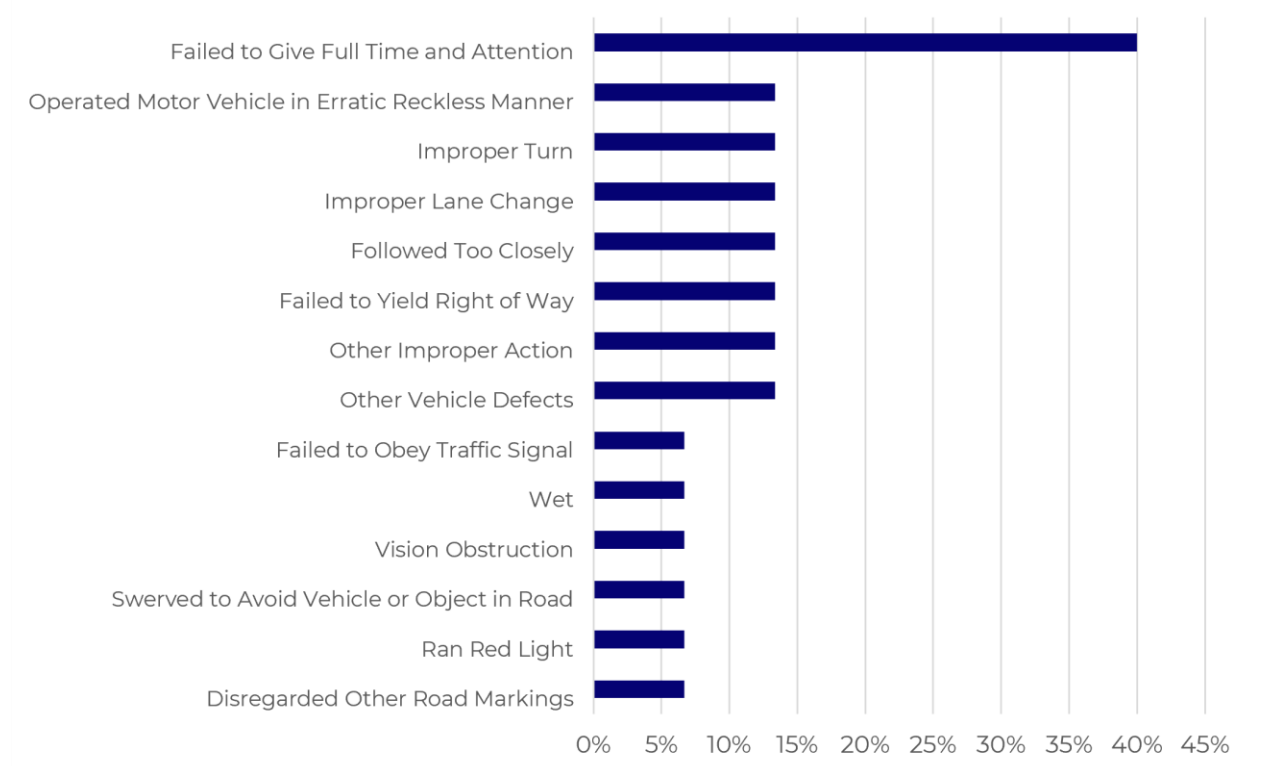
NEAR-MISS VIDEO ANALYSIS

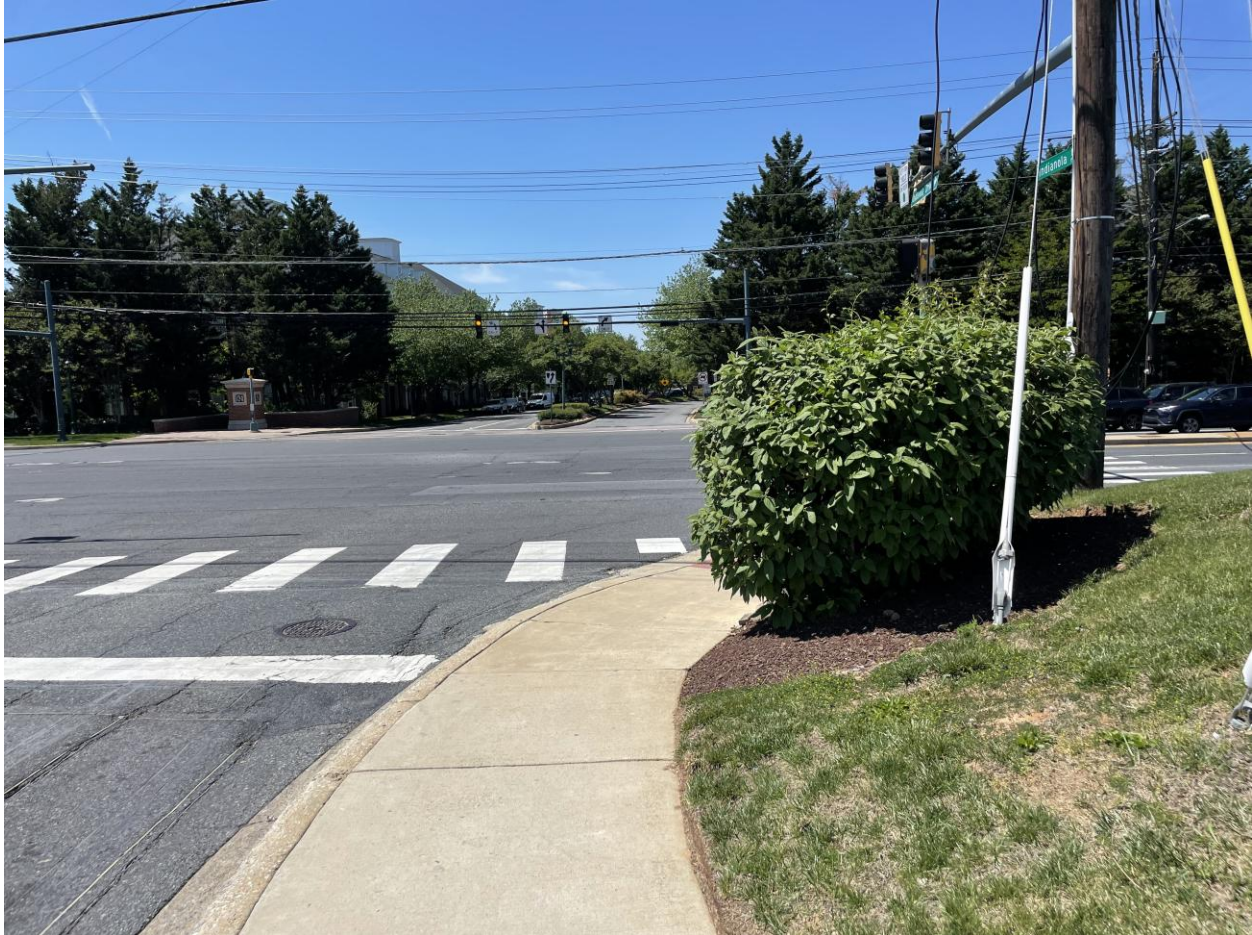
Figure 86. Deteriorated crosswalk pavement markings and detectable warning surfaces #13 - Frederick Road (MD 355) & Watkins Pond Boulevard

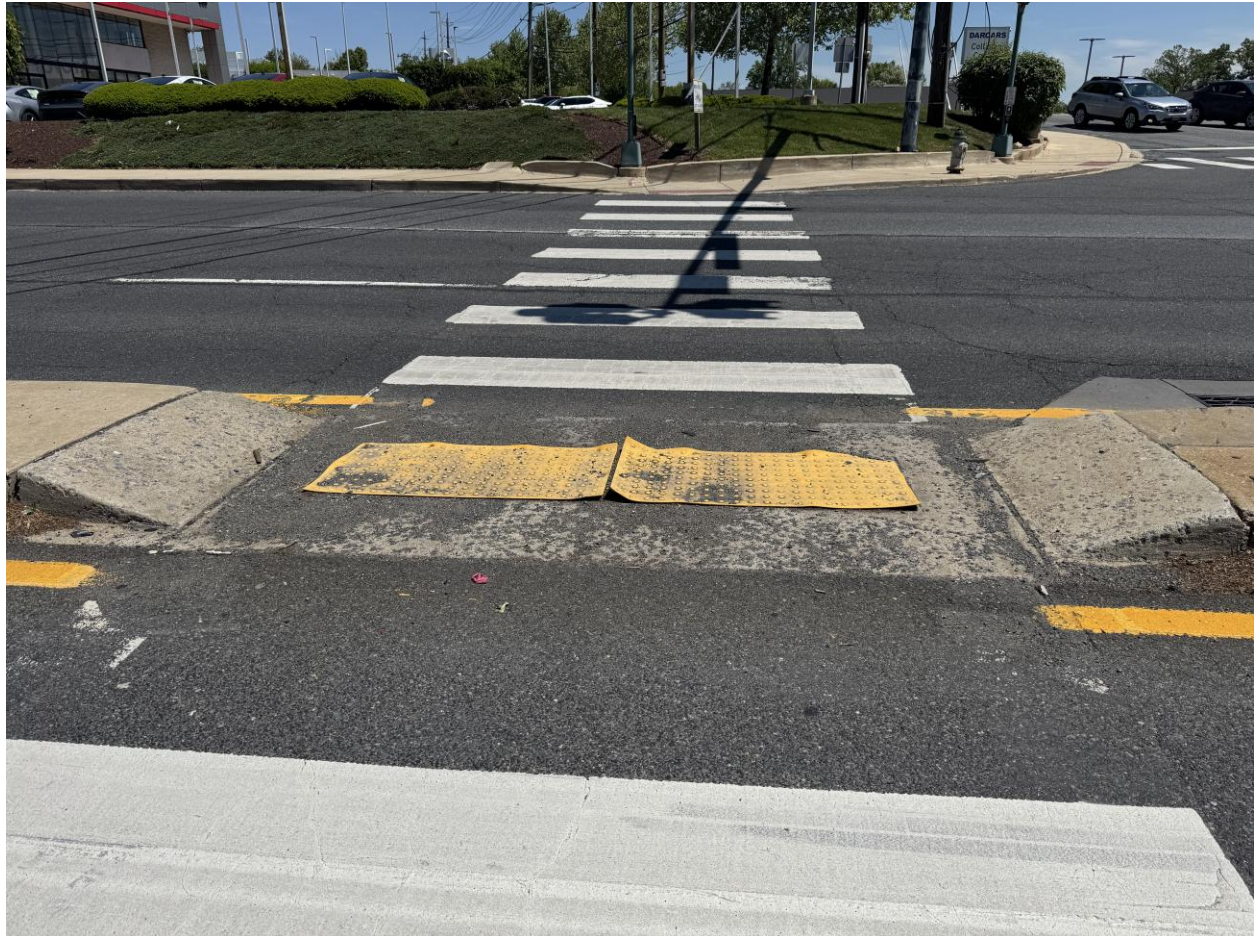
Figure 87. Damaged curb ramps and brick crosswalk on east leg #13 - Frederick Road (MD 355) & Watkins Pond Boulevard

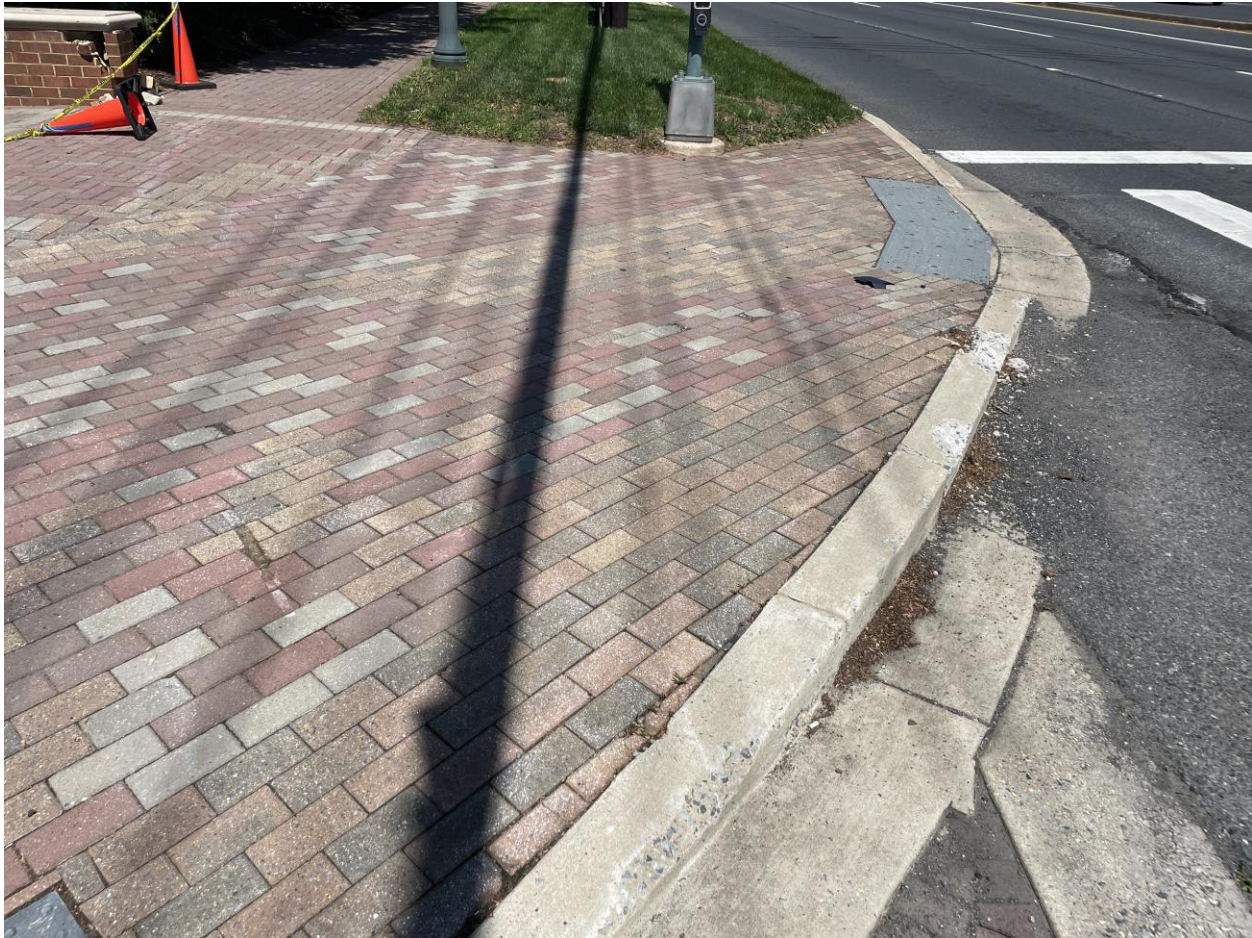
IDENTIFIED SAFETY ISSUES

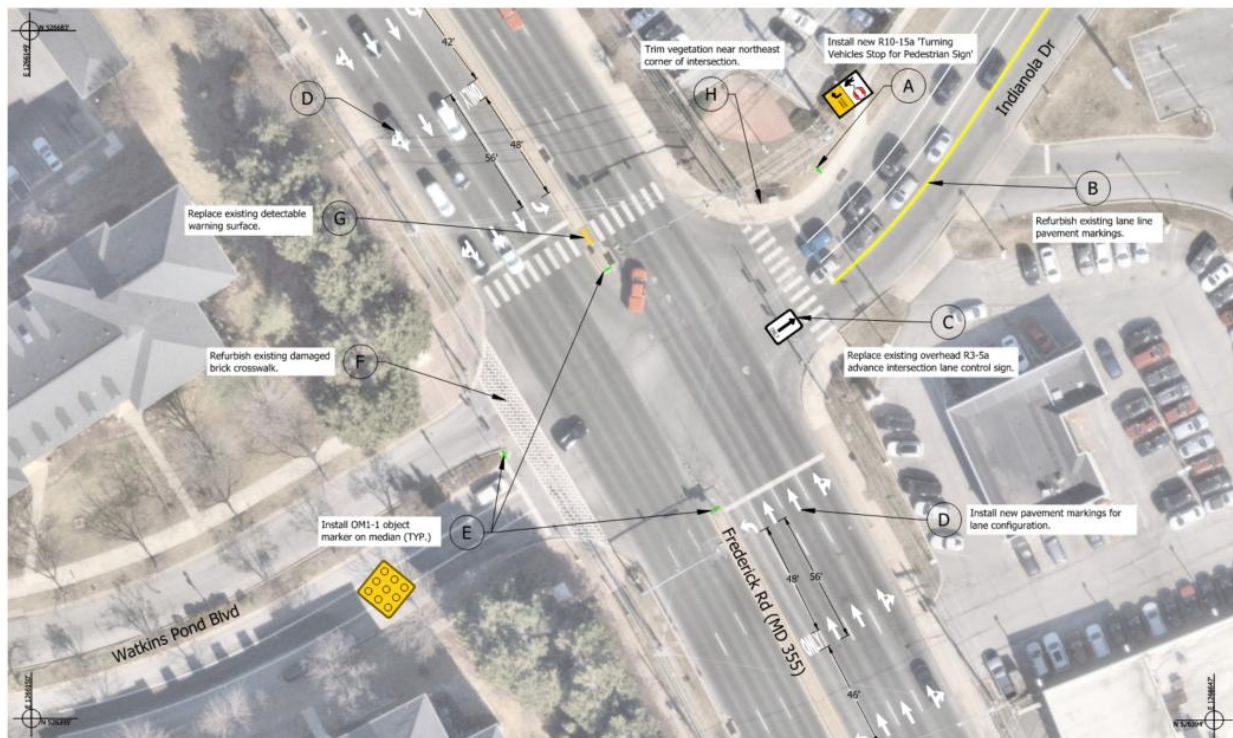
Figure 88. Short-Term Recommendations for Intersection #13 - Frederick Road (MD 355) & Watkins Pond Boulevard

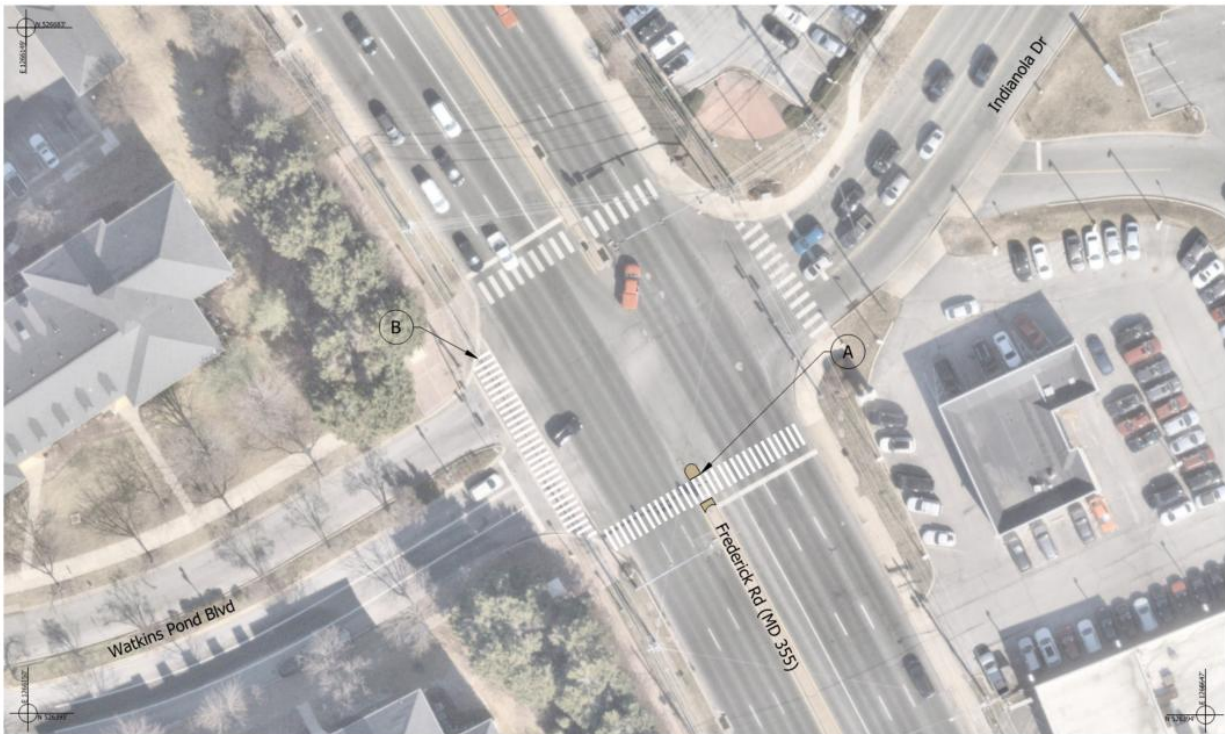
Figure 89. Long-Term Recommendations for Intersection #13 - Frederick Road (MD 355) & Watkins Pond Boulevard

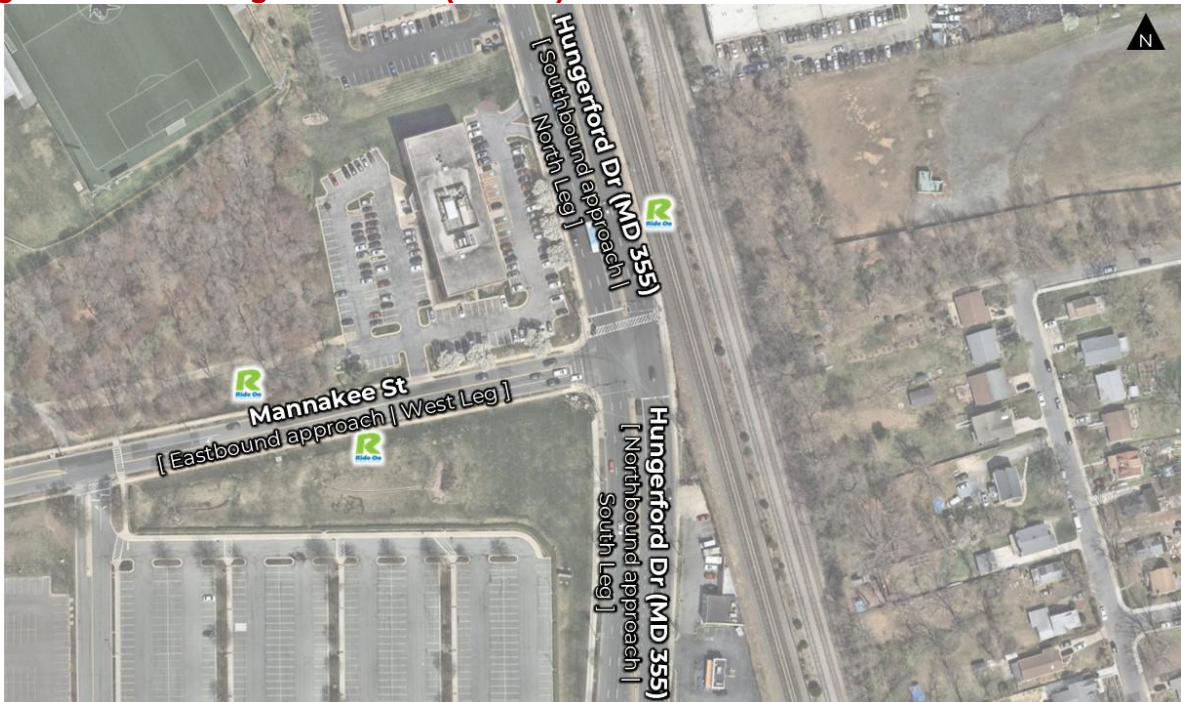
Figure 90. #14 - Hungerford Drive (MD 355) & Mannakee Street Intersection

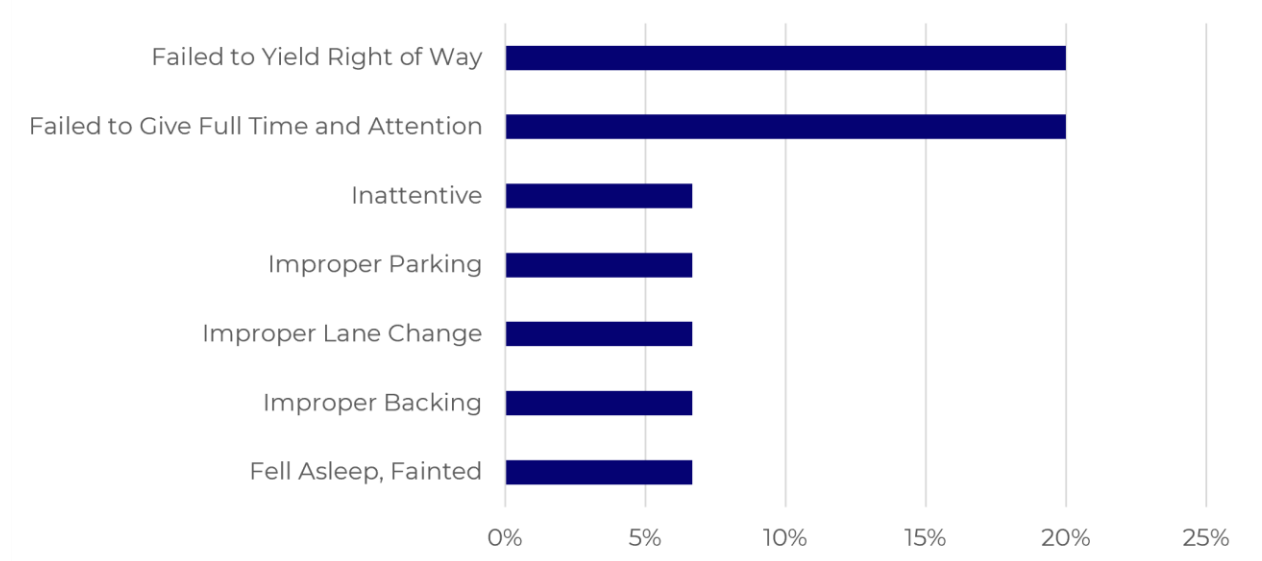
NEAR-MISS VIDEO ANALYSIS

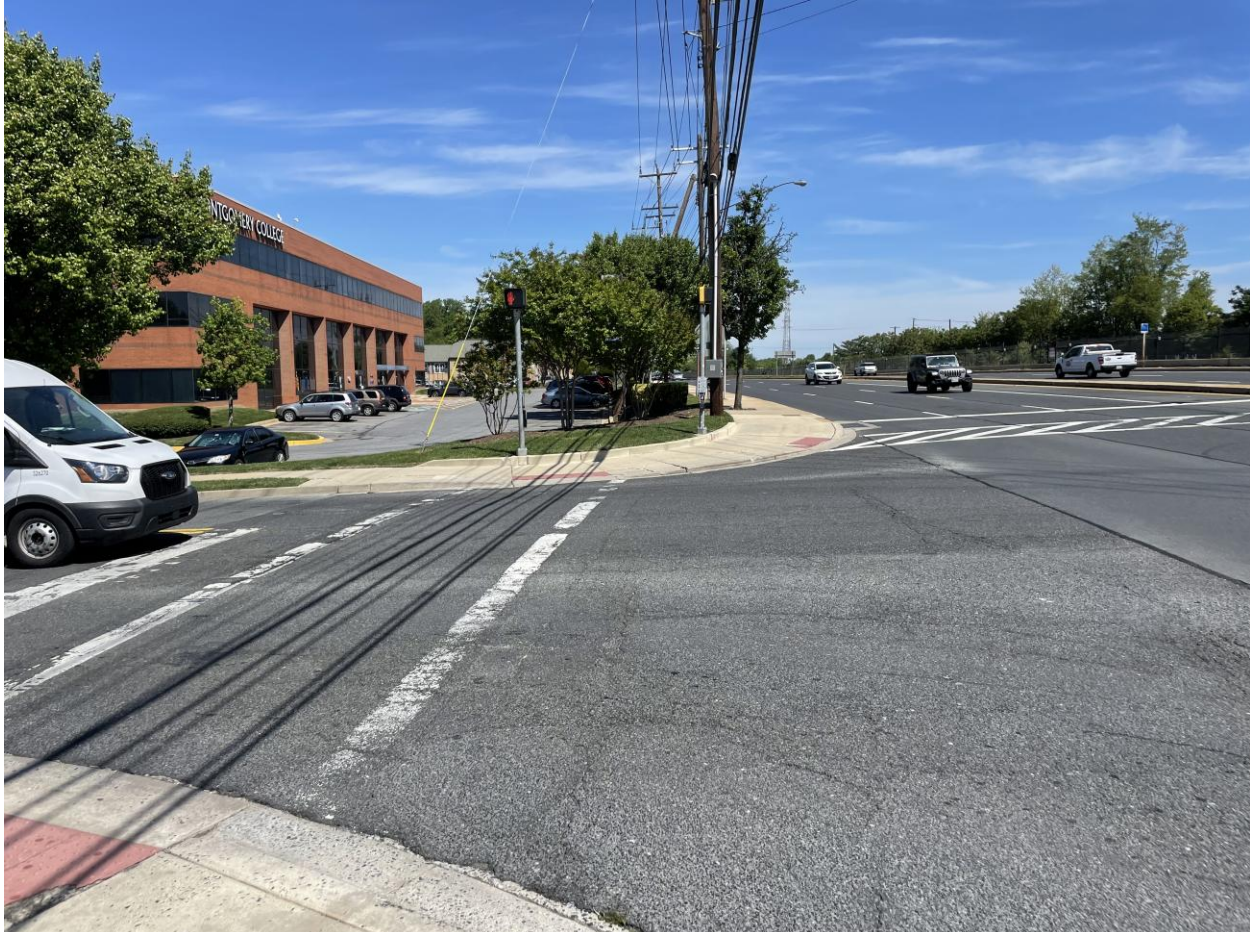
Figure 93. Long pedestrian crosswalk on north leg with deteriorated pavement marking #14 - Hungerford Drive (MD 355) & Mannakee Street

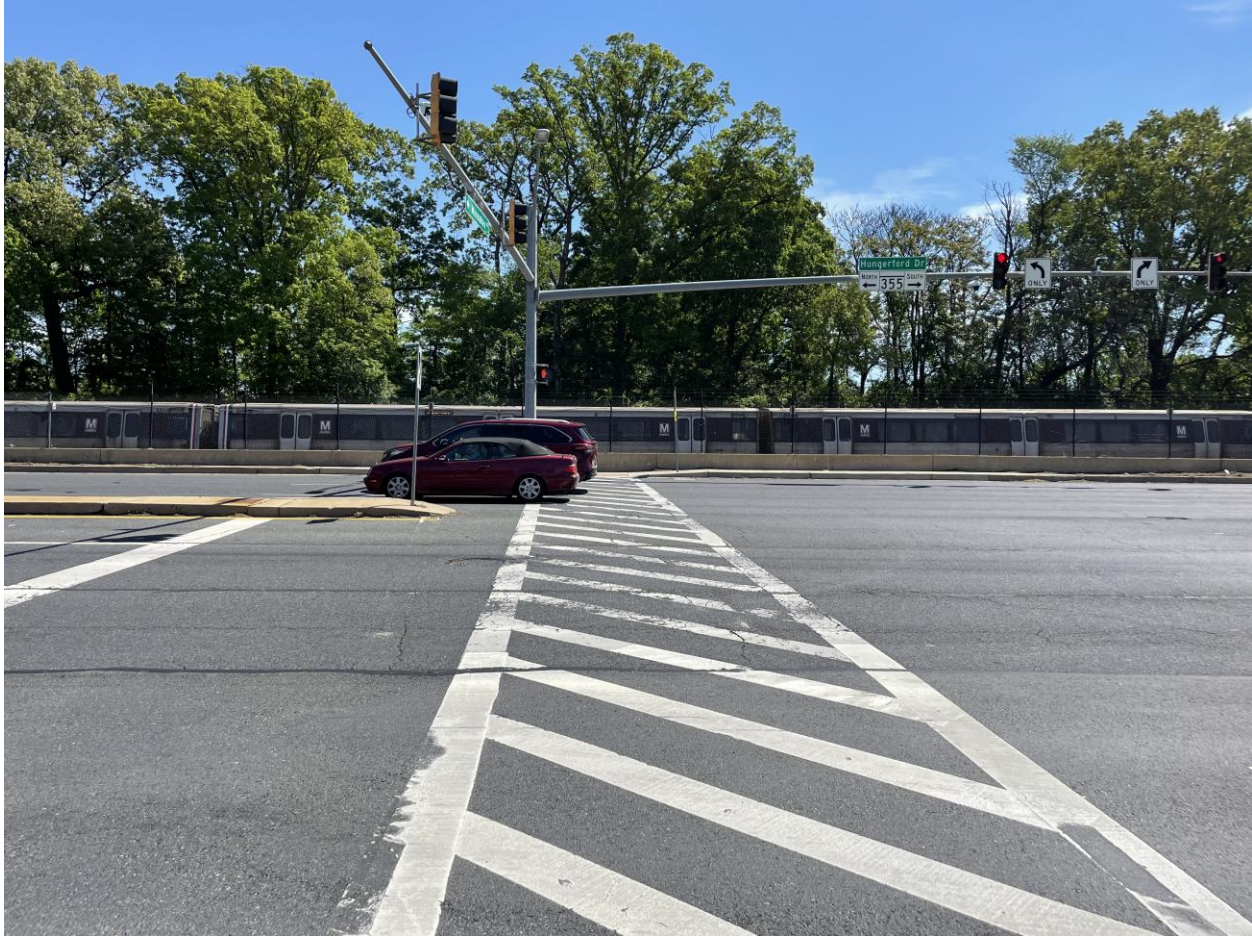
Figure 94. Low visibility of west leg pedestrian crosswalk from southbound approach and several near misses between northbound left-turn-vehicles and pedestrians on west leg crosswalk #14 - Hungerford Drive (MD 355) & Mannakee Street

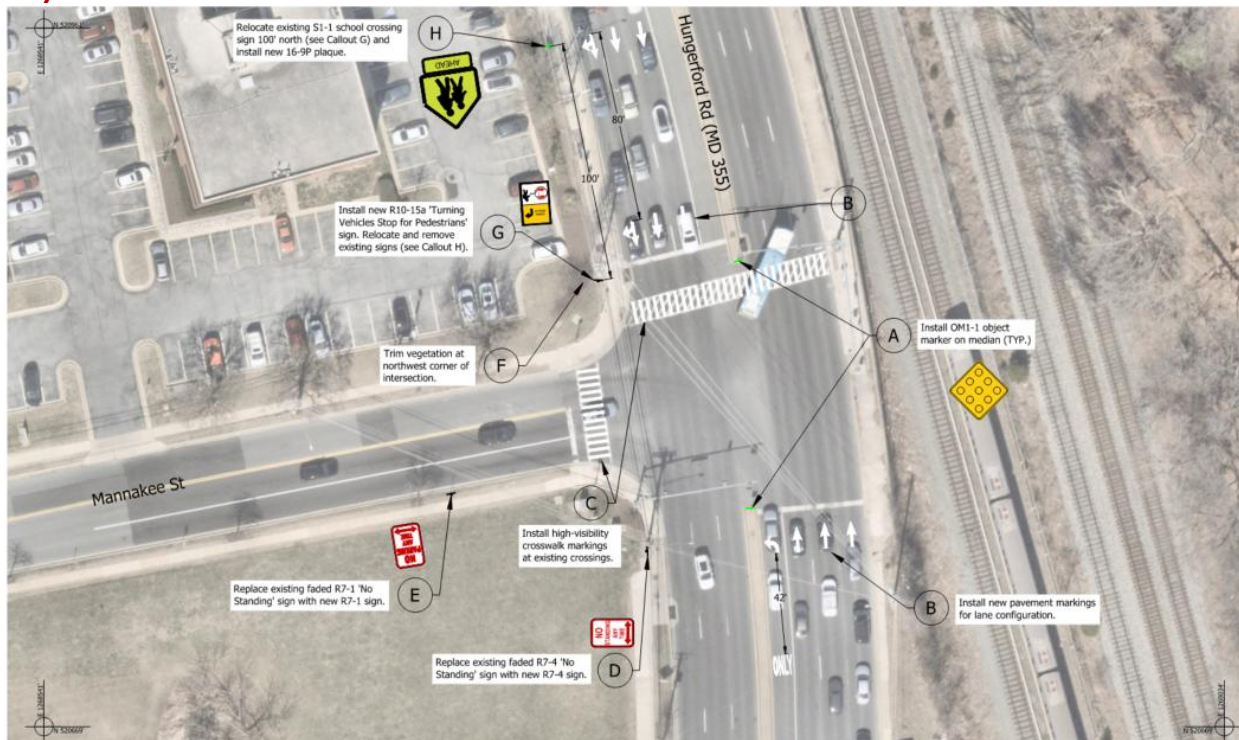
Figure 95. Short-Term Recommendations for Intersection #14 - Hungerford Drive (MD 355) & Mannakee Street

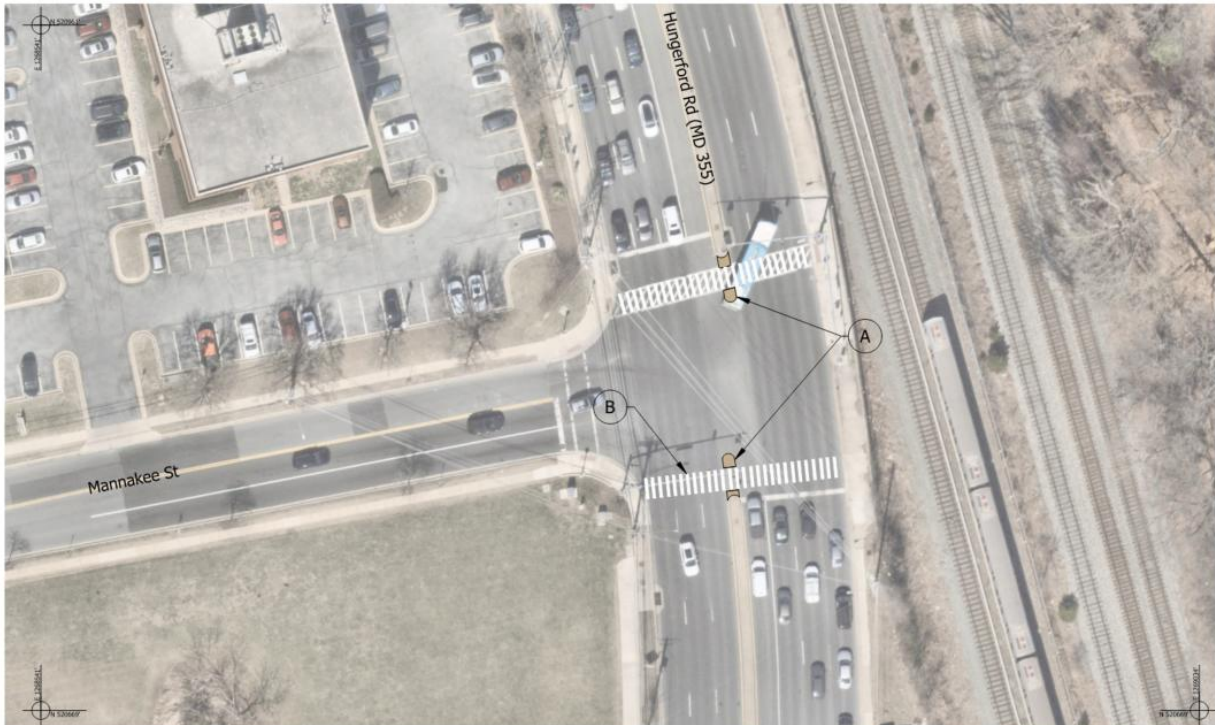
Figure 96. Long-Term Recommendations for Intersection #14 - Hungerford Drive (MD 355) & Mannakee Street

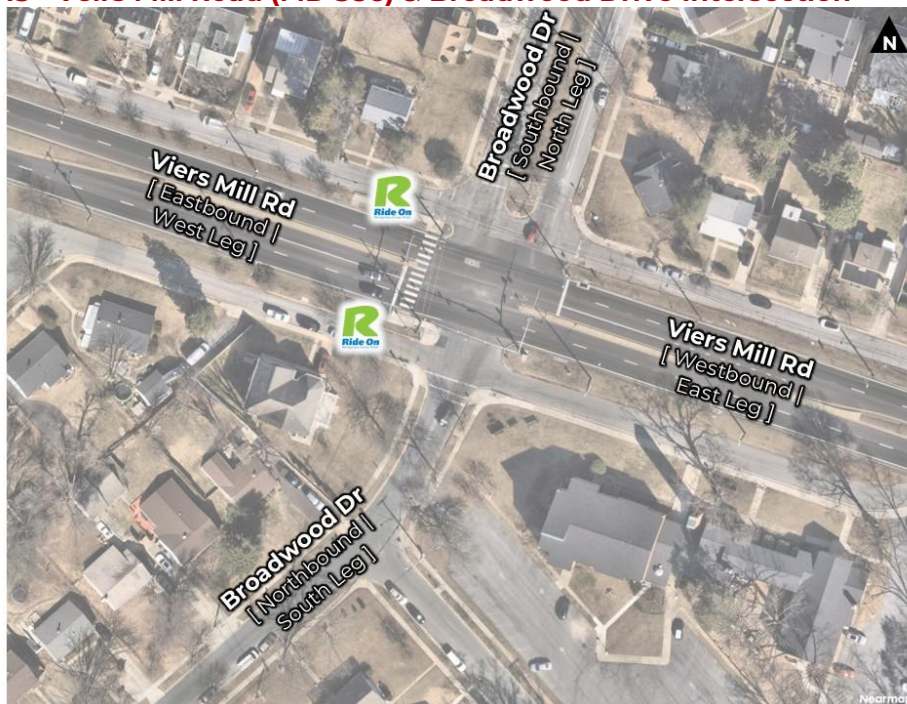
Figure 97. #15 - Veirs Mill Road (MD 586) & Broadwood Drive Intersection

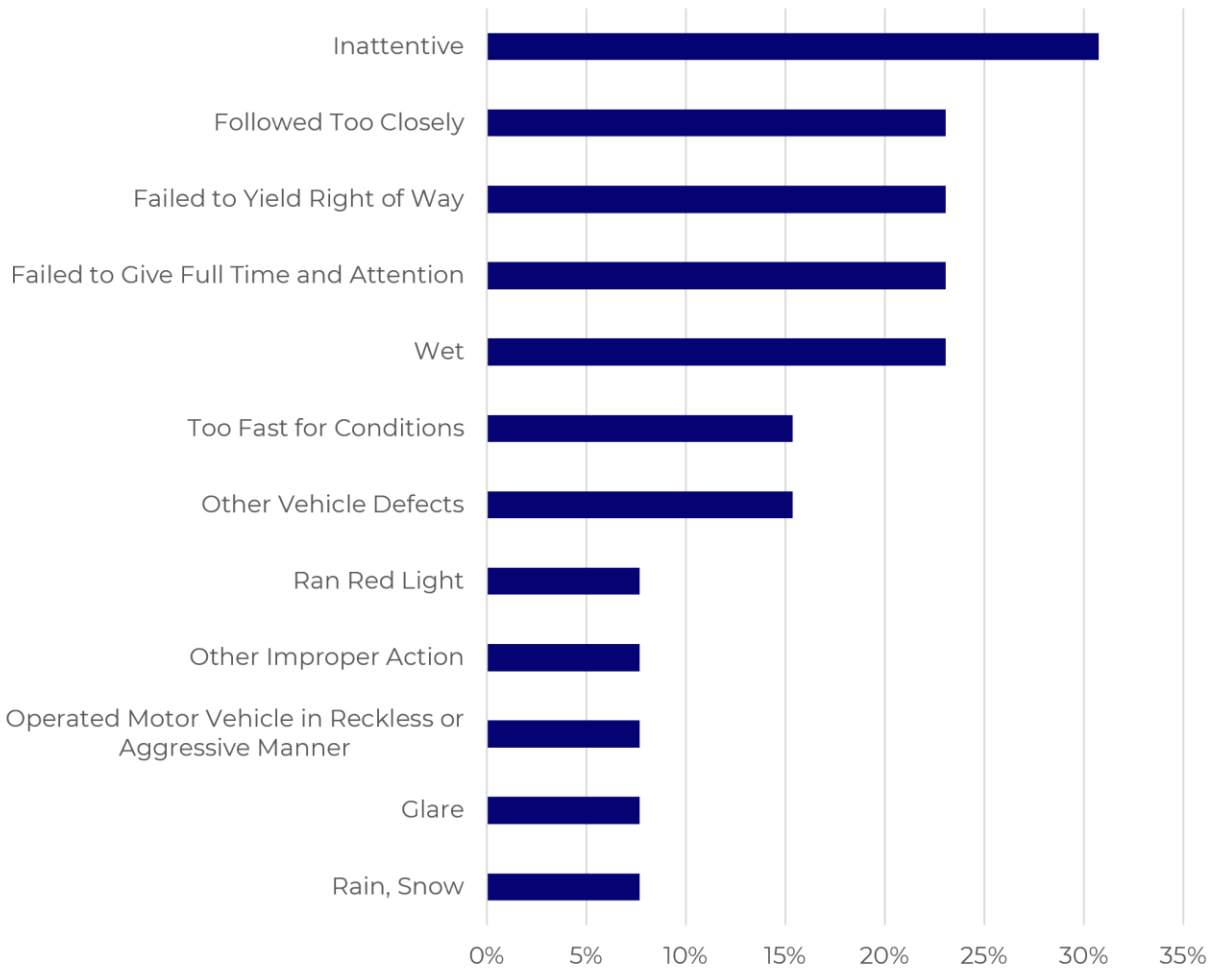
NEAR-MISS VIDEO ANALYSIS

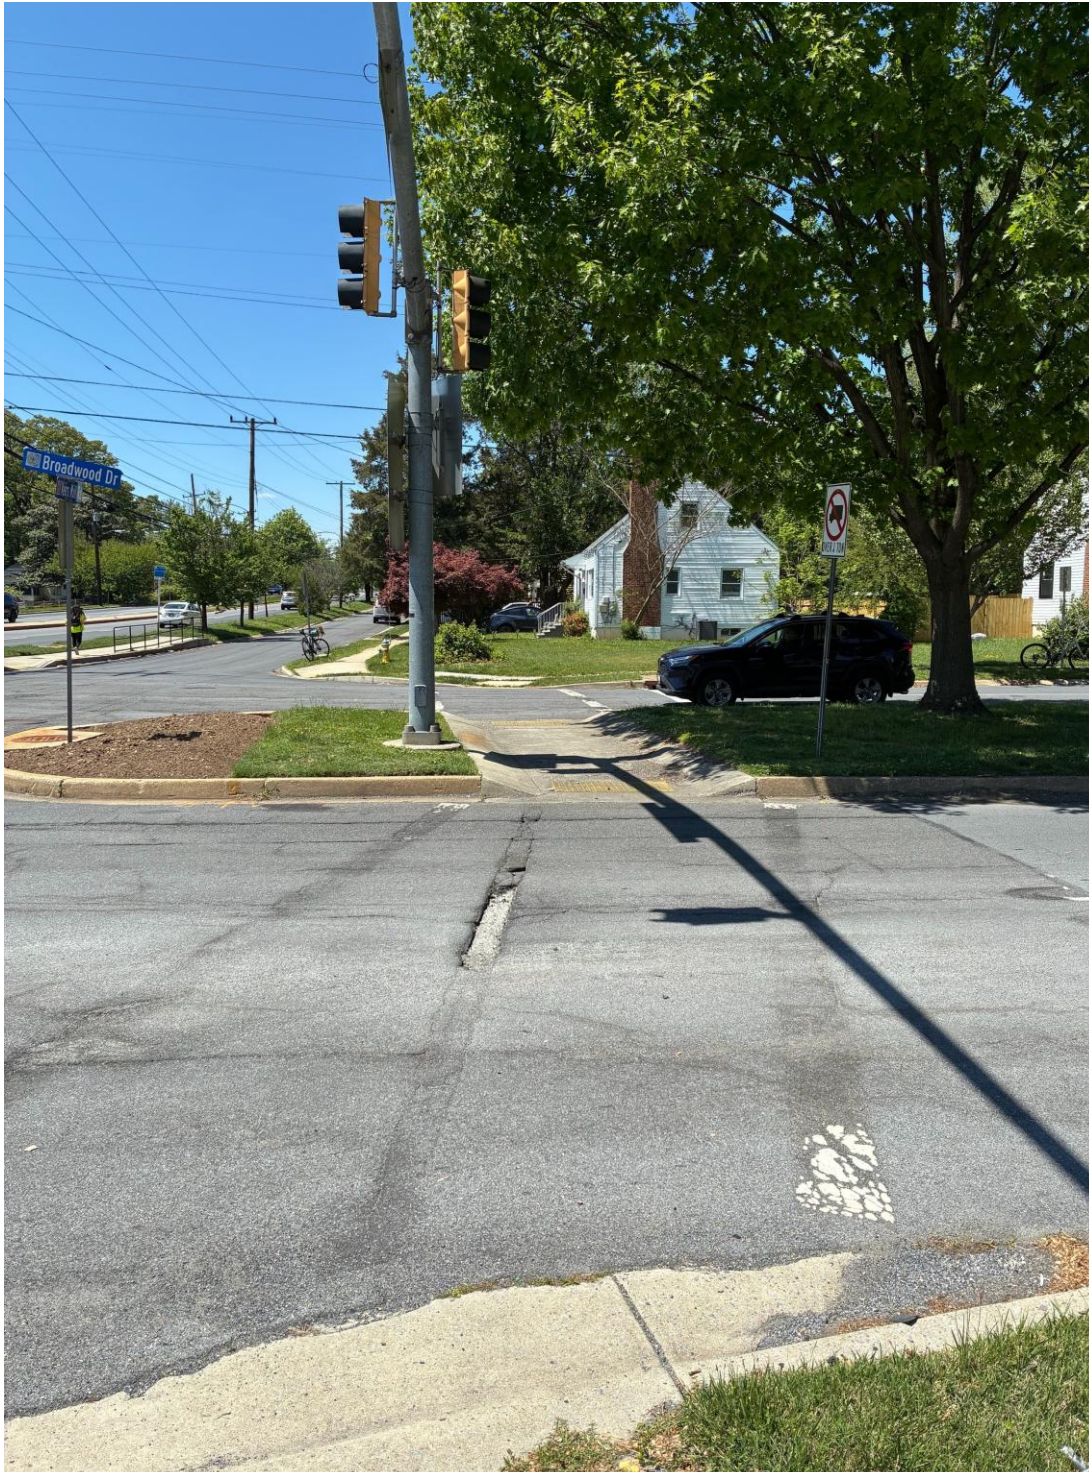
Figure 100. Obstructed signal head at Intersection #15 - Veirs Mill Road (MD 586) & Broadwood Drive

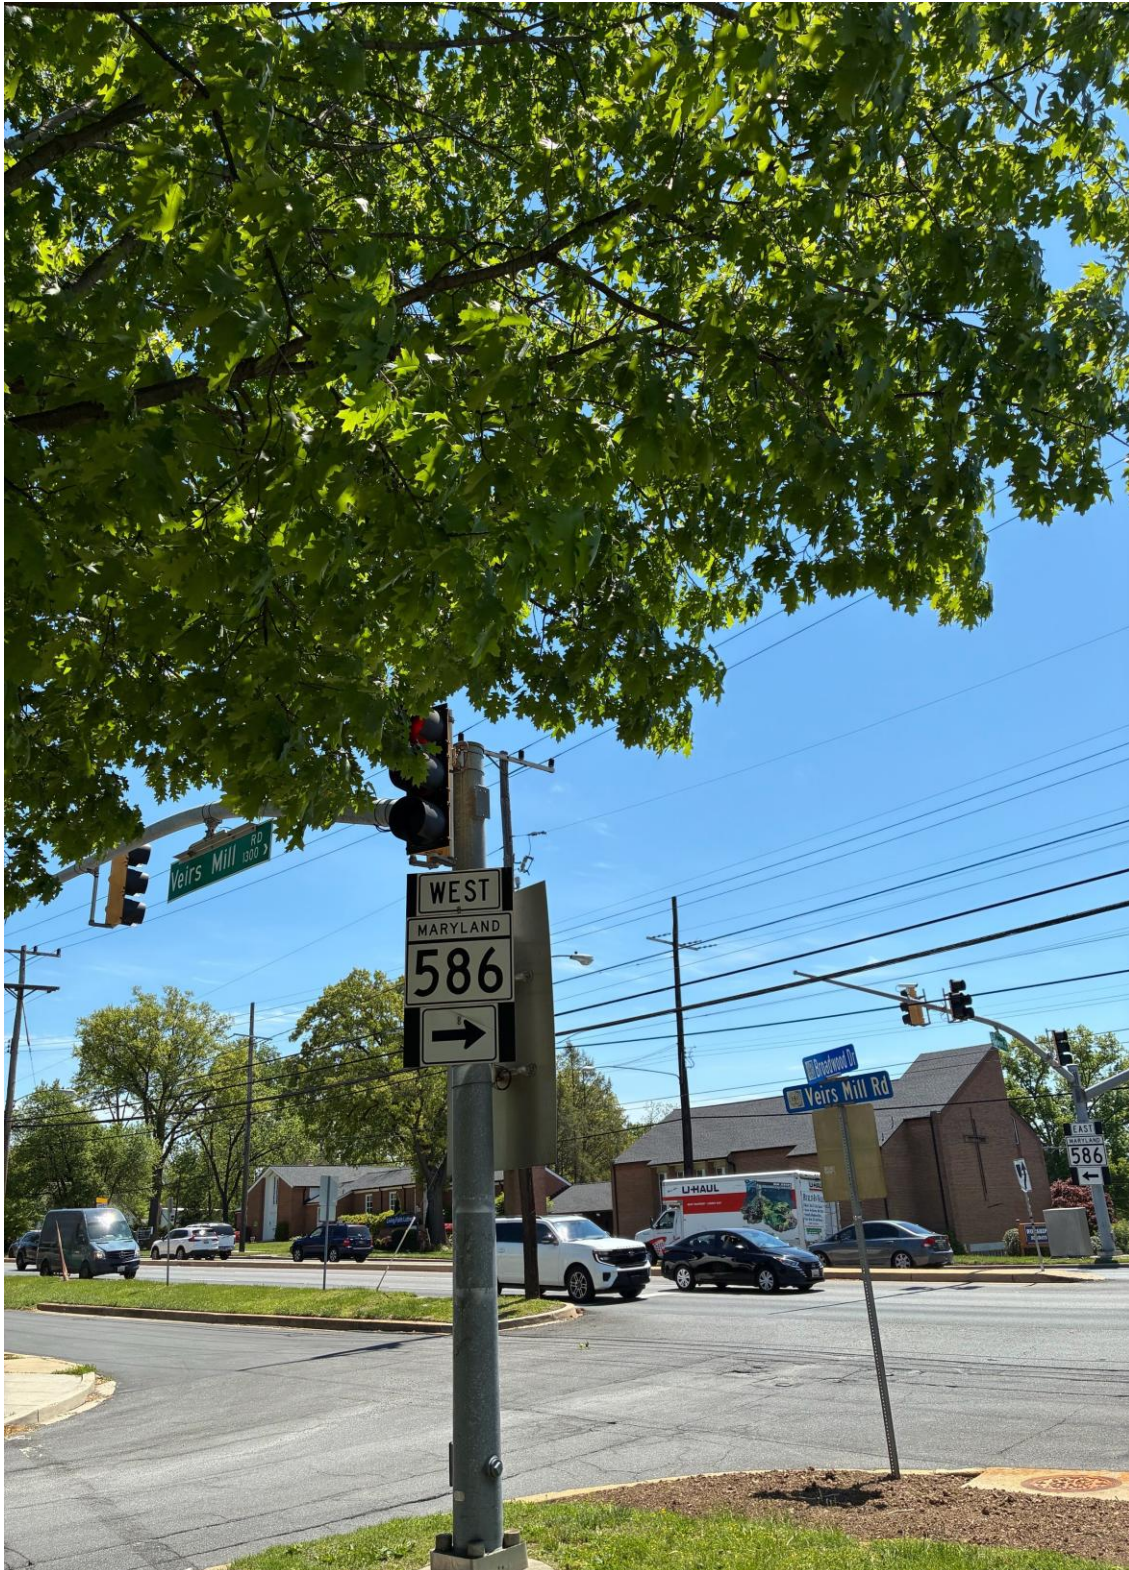
Figure 101. Missing crosswalk on frontage road at Intersection #15 - Veirs Mill Road (MD 586) & Broadwood Drive
