Safe Streets for All
**VISION ZERO
INTERSECTION
SAFETY AUDITS**

City of Rockville, Maryland

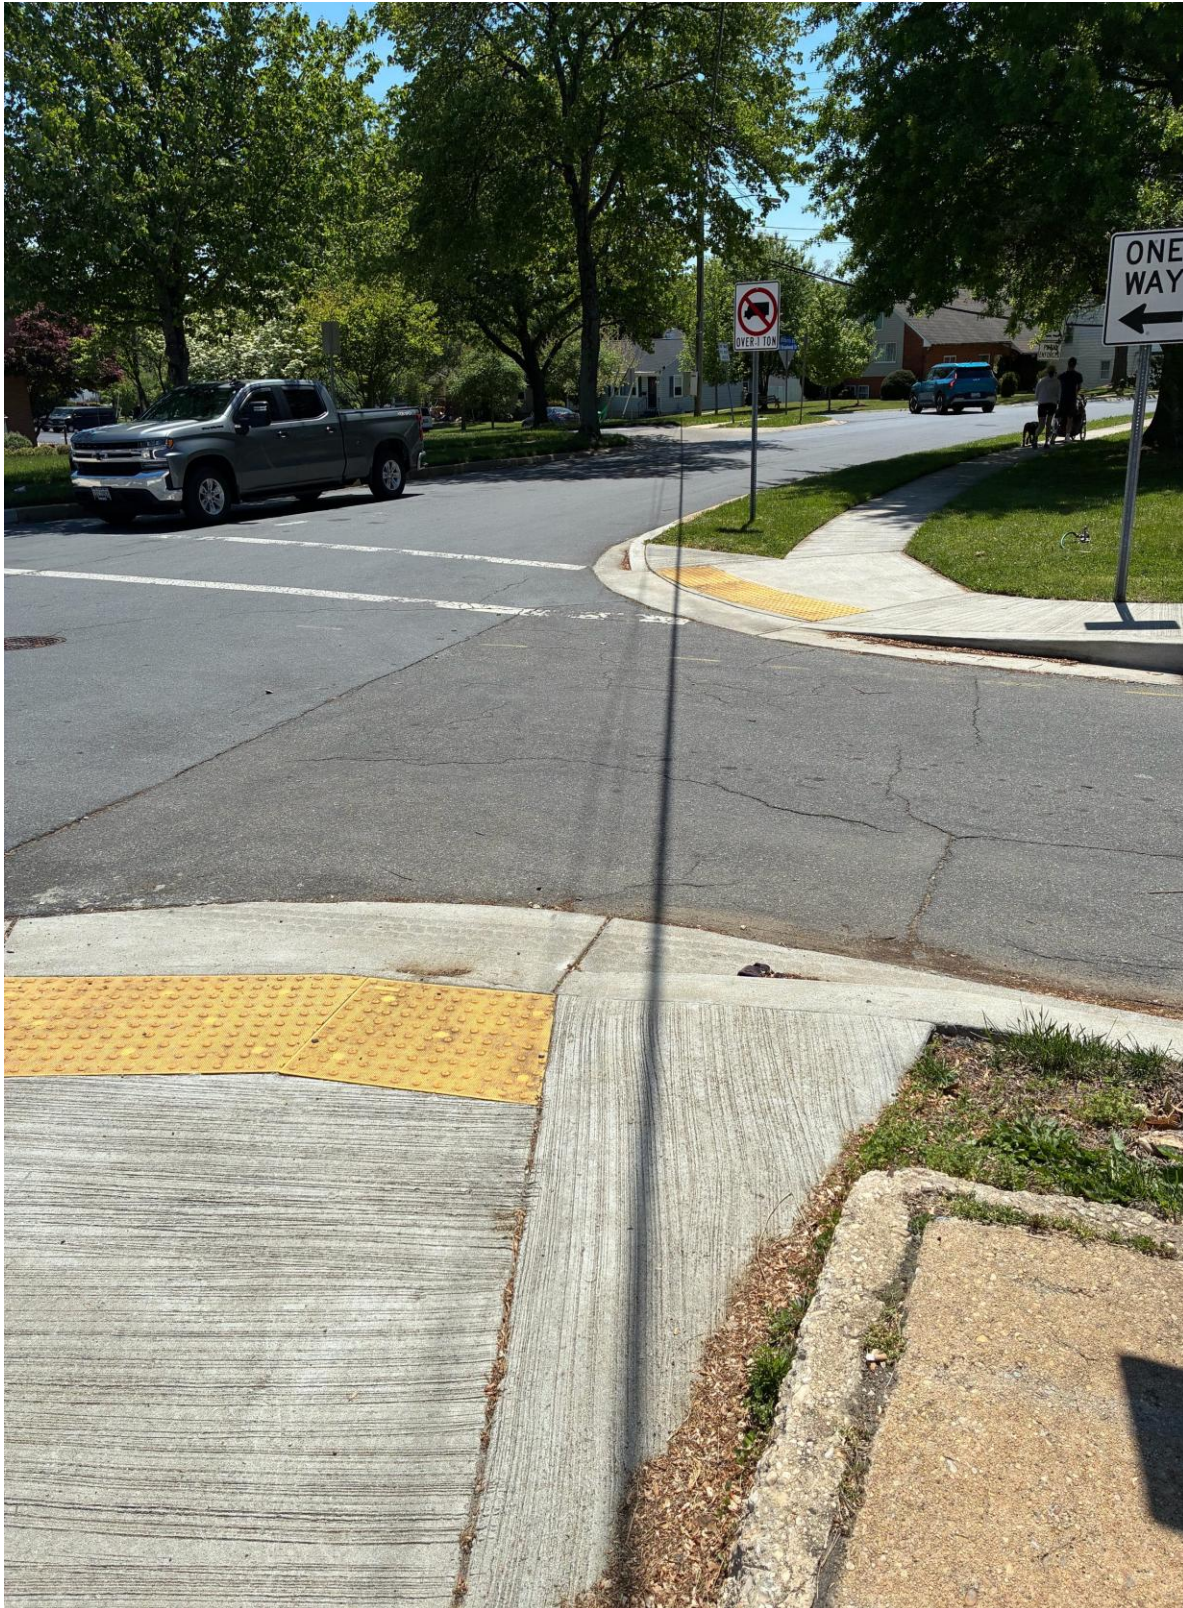
IDENTIFIED SAFETY ISSUES

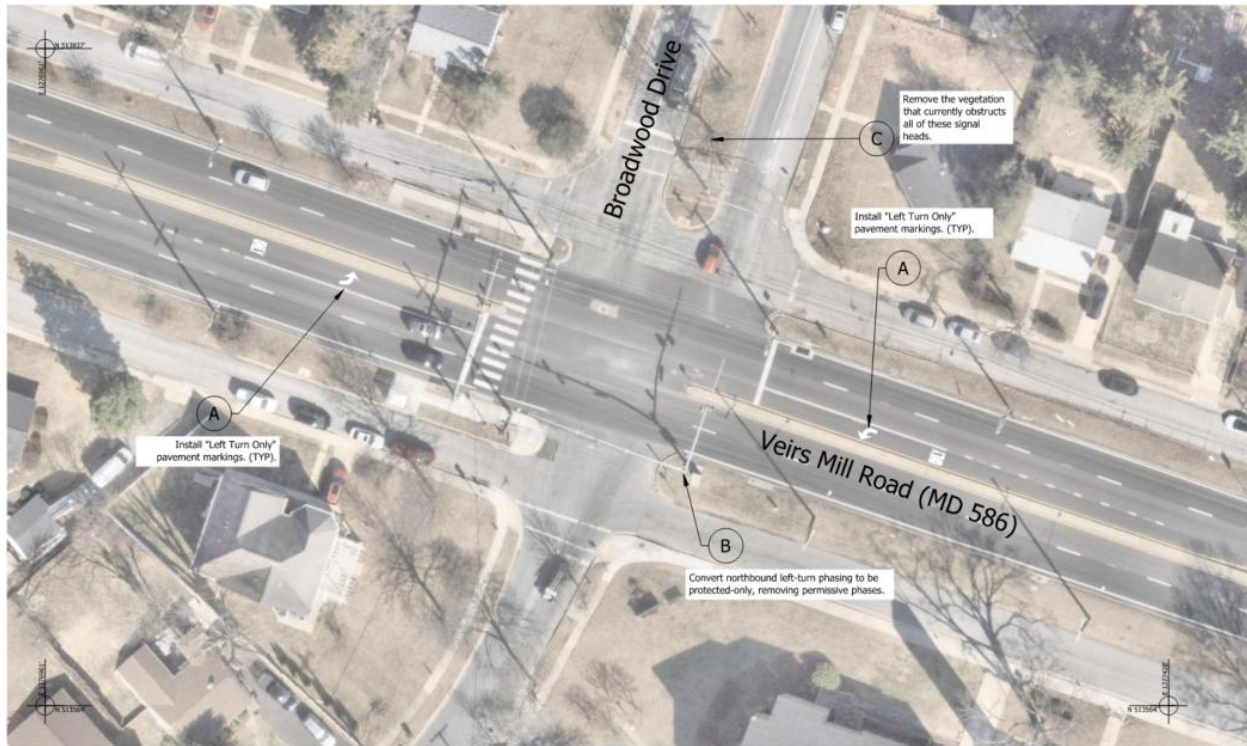
Figure 102. Short-Term Recommendations for Intersection #15 - Veirs Mill Road (MD 586) & Broadwood Drive

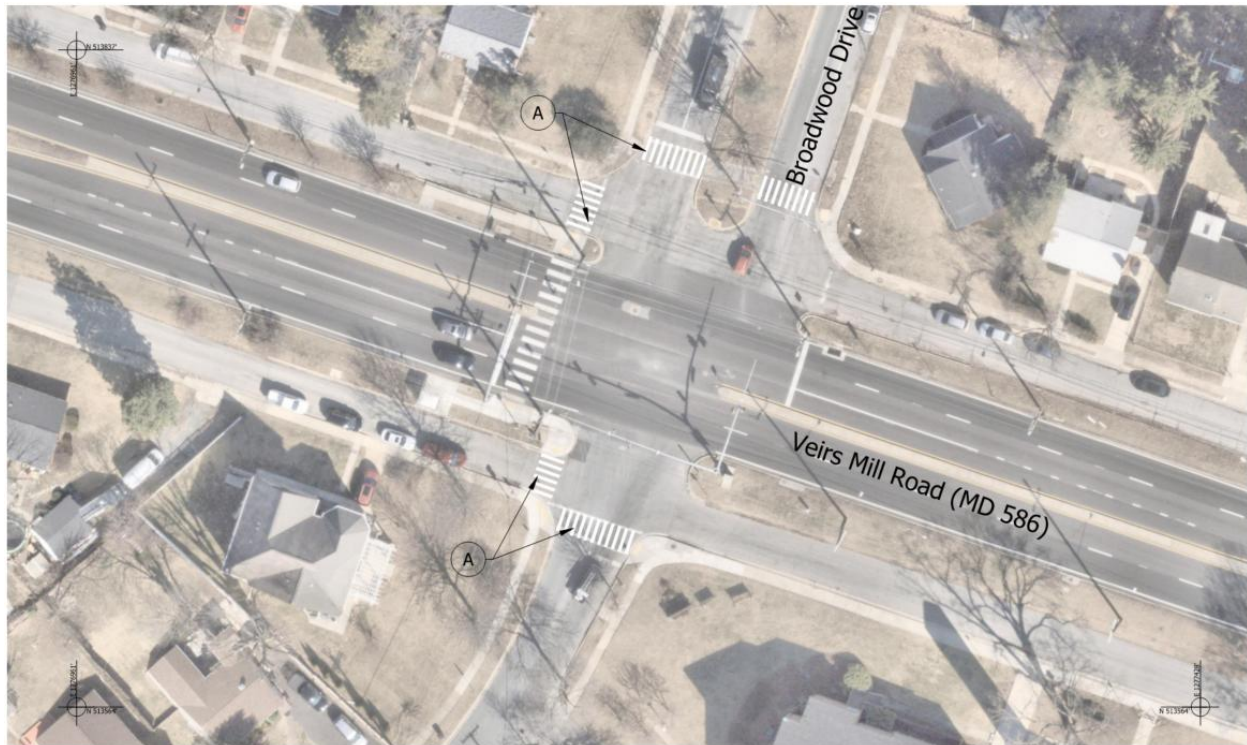
Figure 103. Long-Term Recommendations for Intersection #15 - Veirs Mill Road (MD 586) & Broadwood Drive

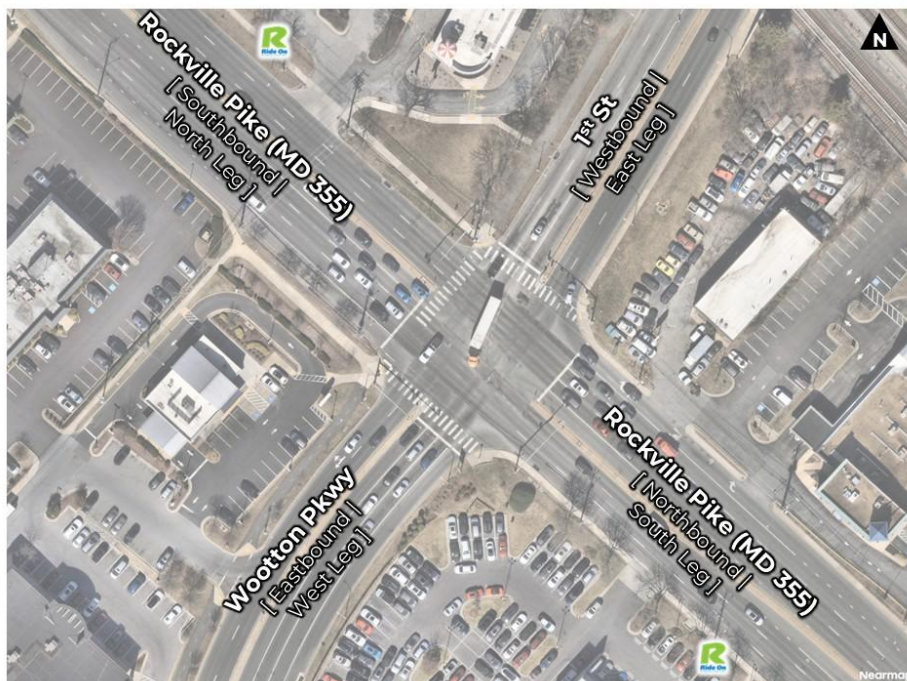
Figure 104. #16 - Rockville Pike (MD 355) & First Street/Wootton Parkway Intersection

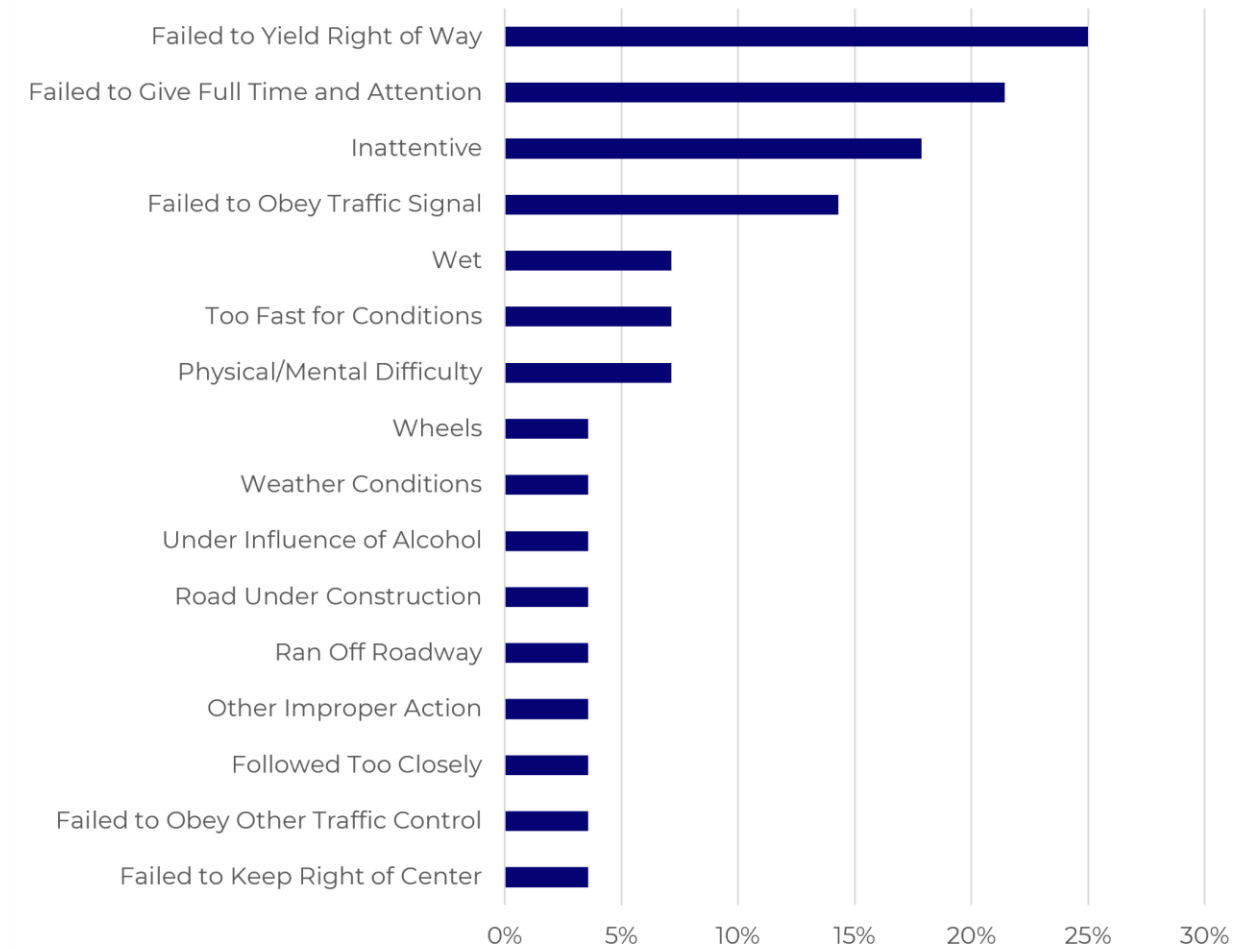
NEAR-MISS VIDEO ANALYSIS

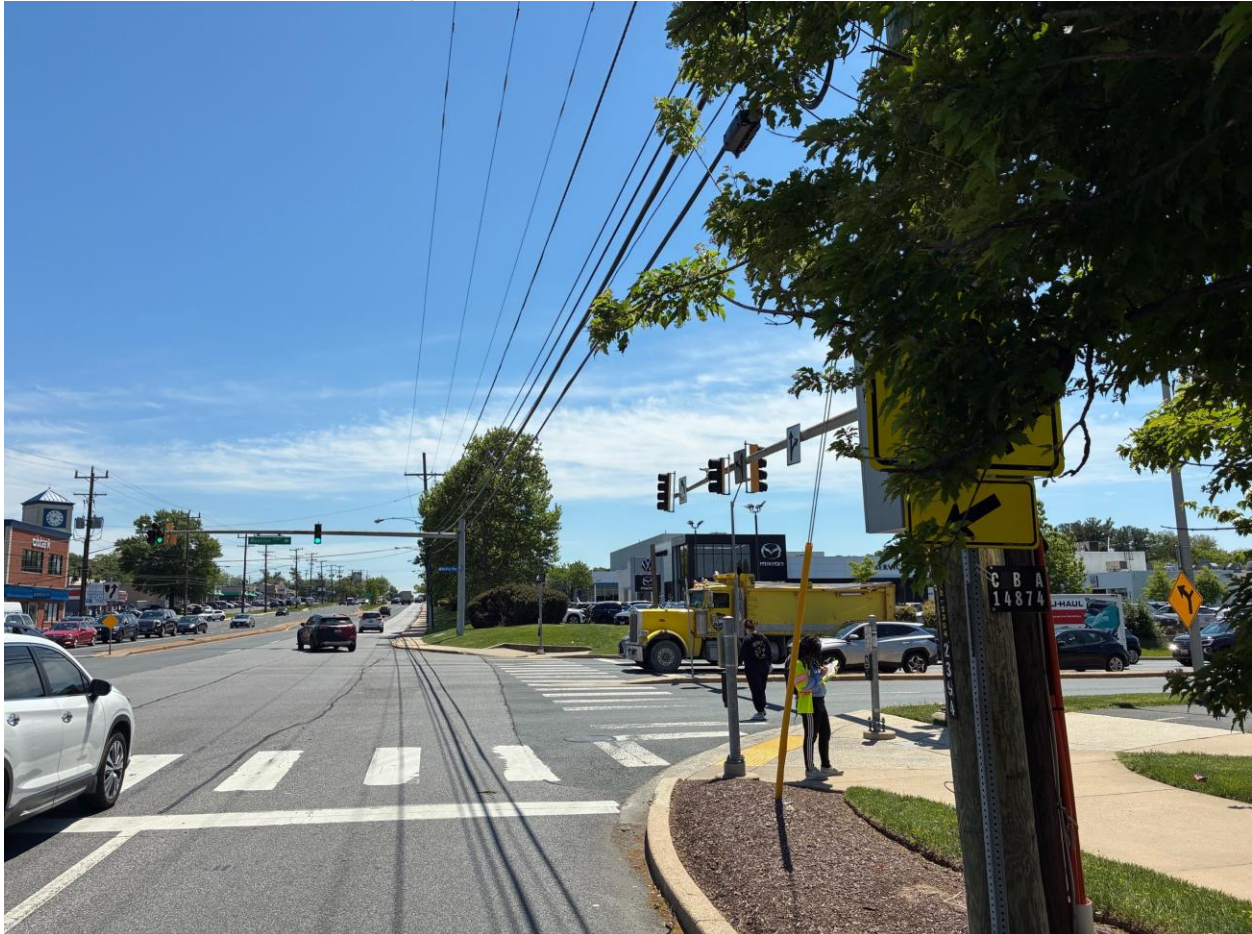
Figure 107. Bicycle signs at Intersection #16 - Rockville Pike (MD 355) & First Street/Wootton Parkway

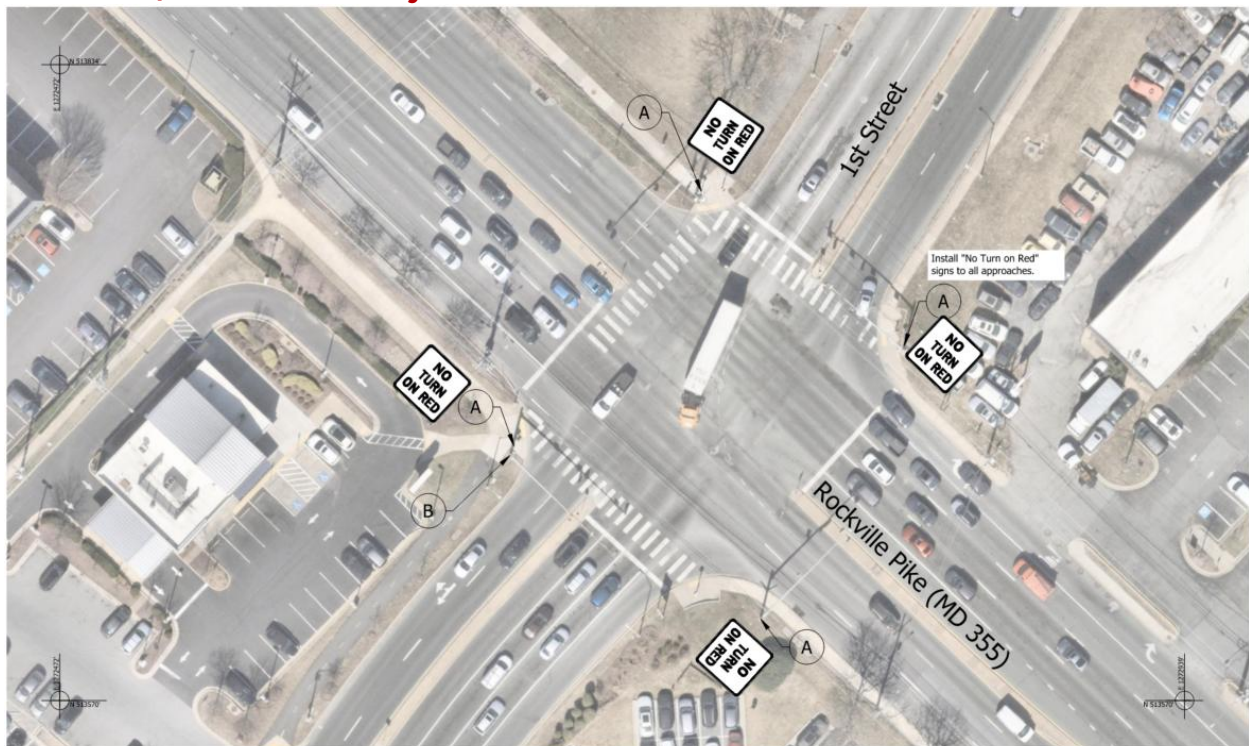
Figure 108. Short-Term Recommendations for Intersection #16 - Rockville Pike (MD 355) & First Street/Wootton Parkway

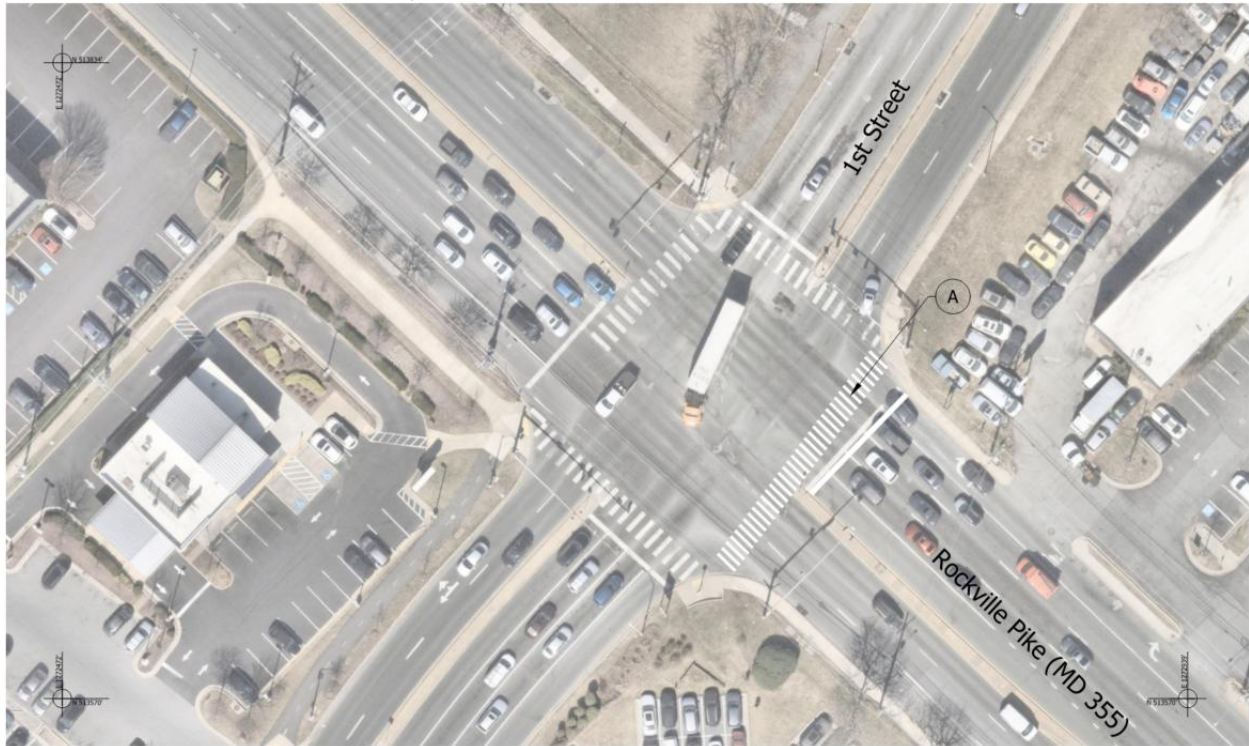
Figure 109. Long-Term Recommendations for Intersection #16 - Rockville Pike (MD 355) & First Street/Wootton Parkway

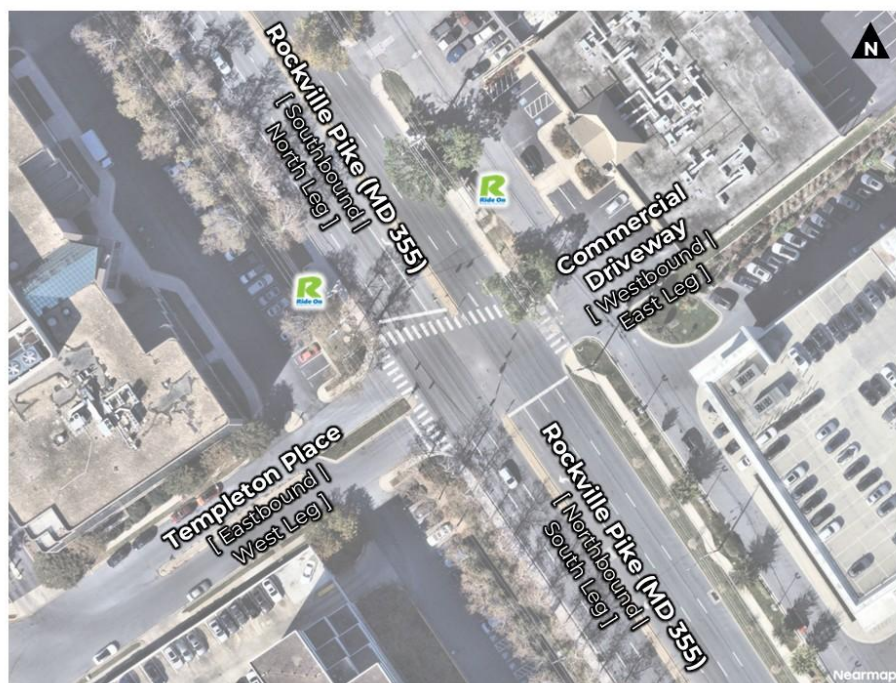
Figure 110. #17 - Rockville Pike (MD 355) & Templeton Place Intersection

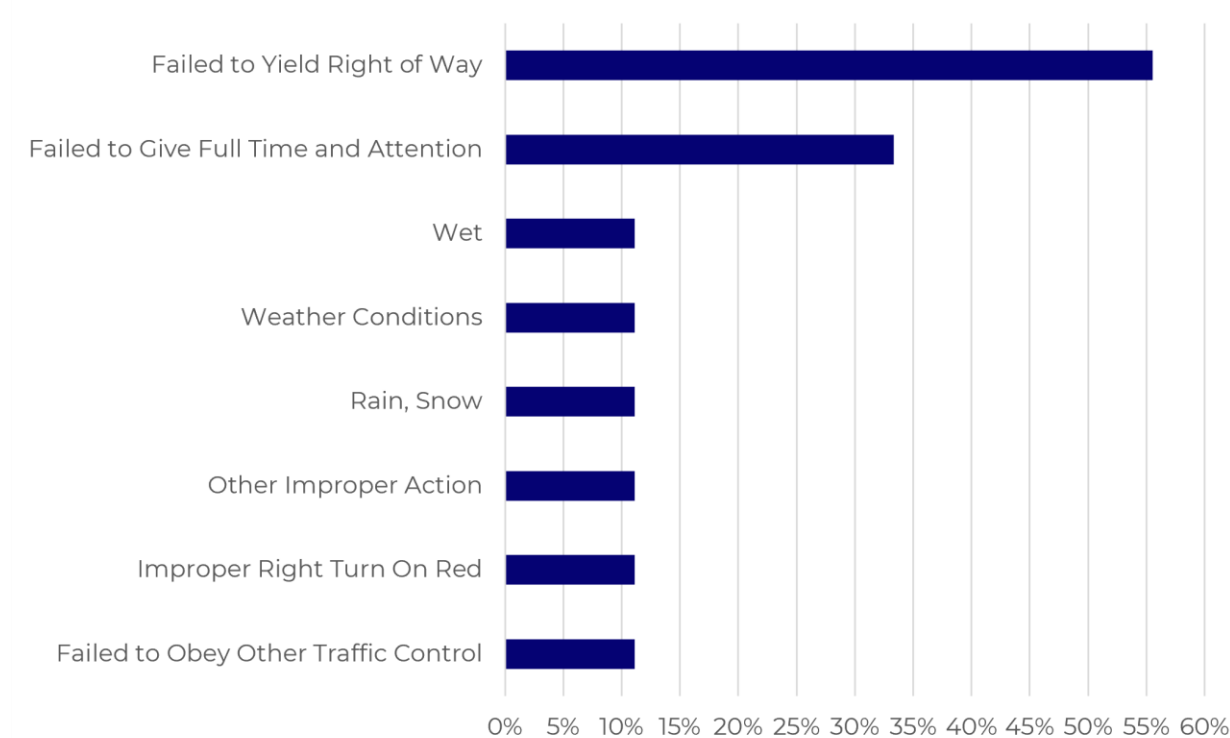
NEAR-MISS VIDEO ANALYSIS

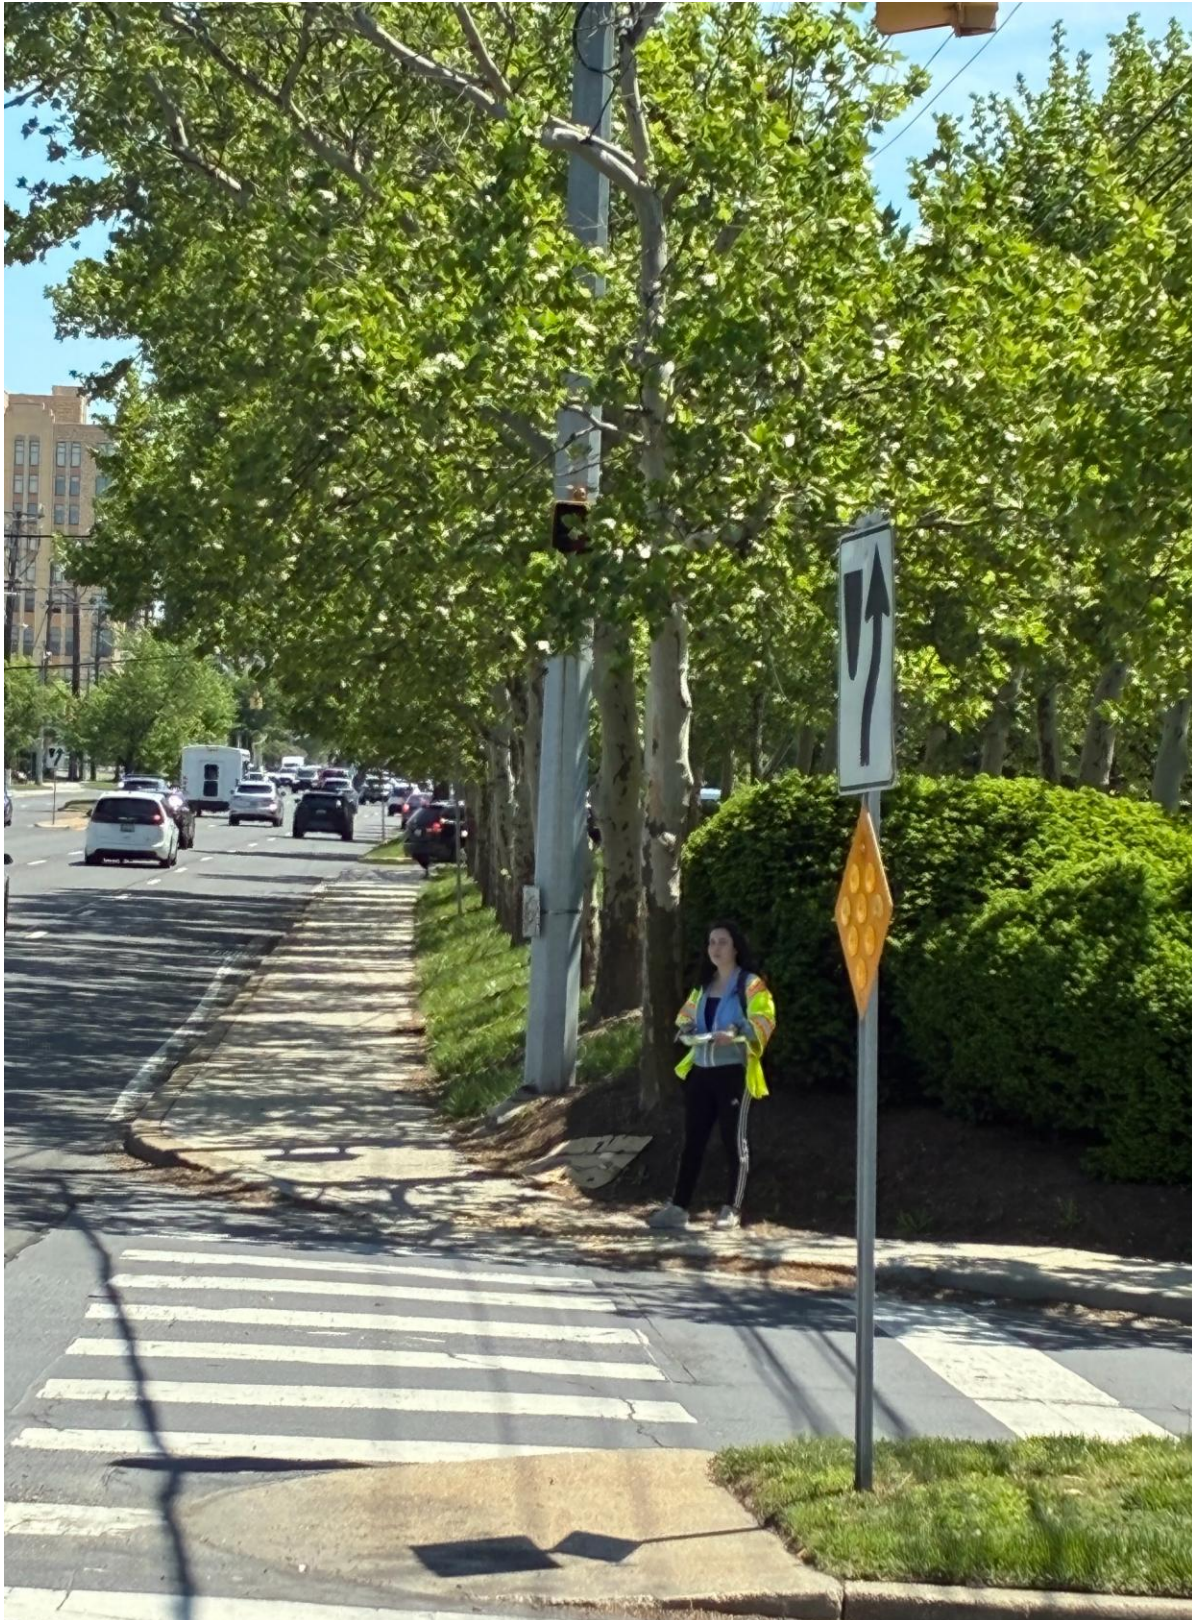
Figure 113. Missing pedestrian signal heads on the westbound approach at Intersection #17 - Rockville Pike (MD 355) & Templeton Place

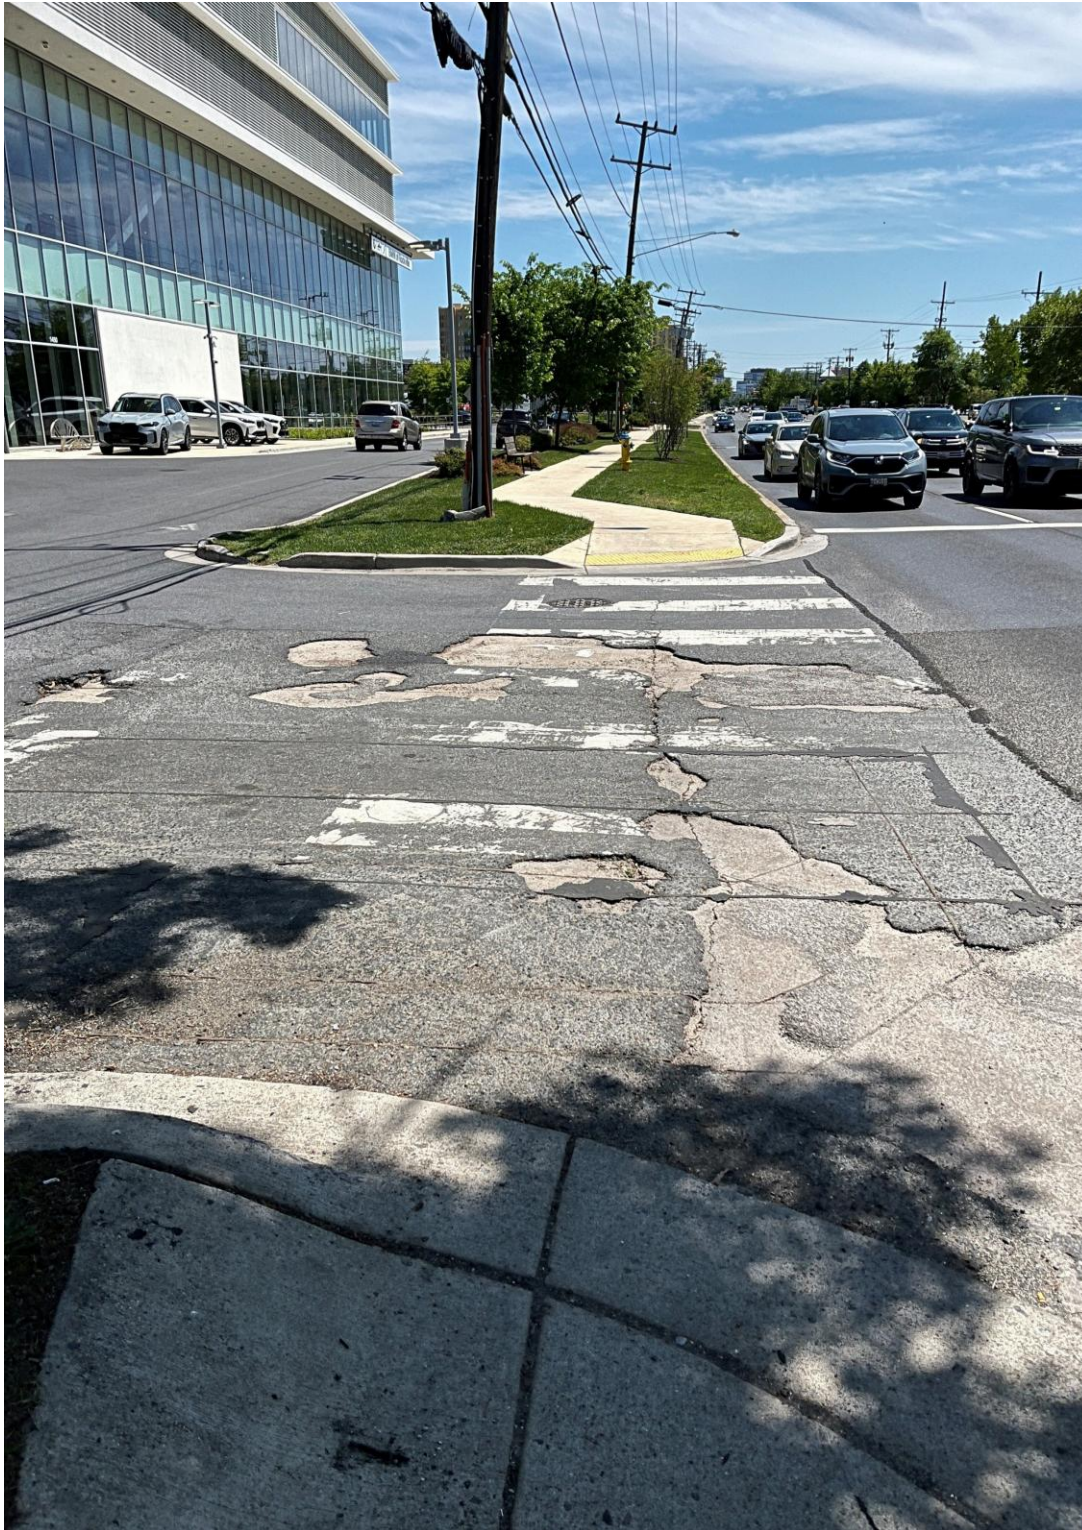
IDENTIFIED SAFETY ISSUES

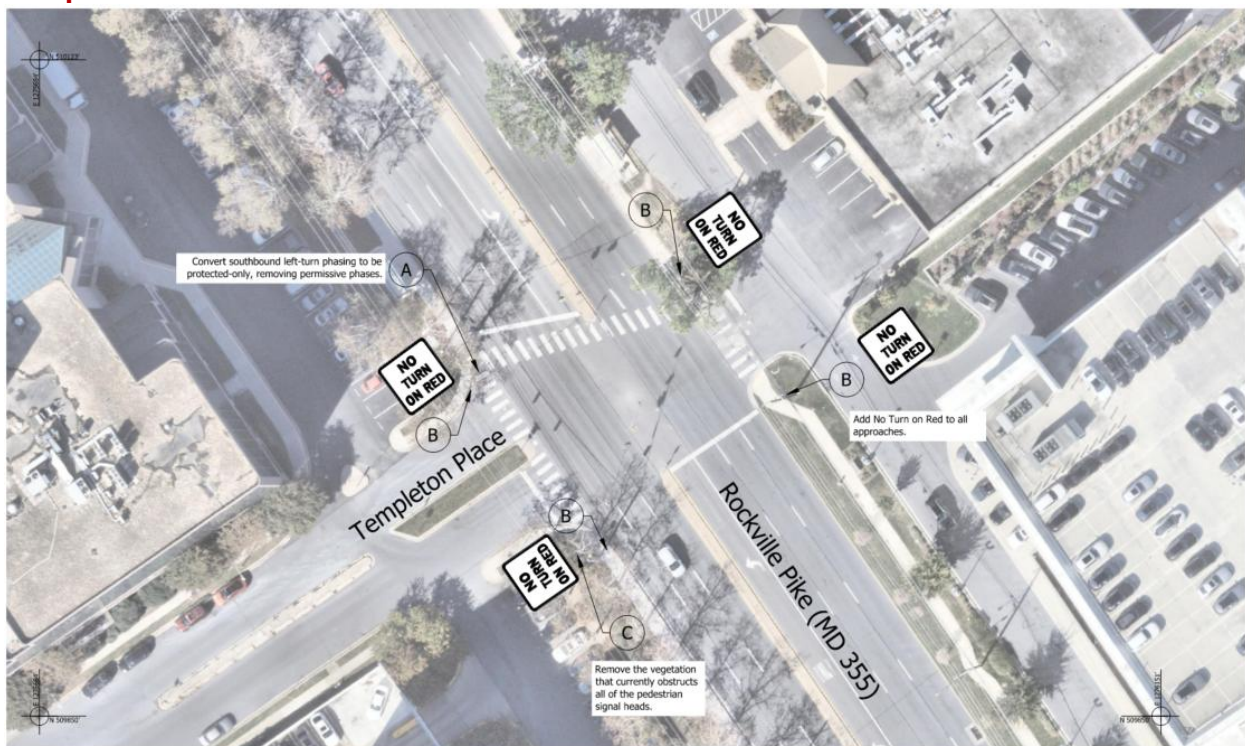
Figure 114. Short-Term Recommendations for Intersection #17 - Rockville Pike (MD 355) & Templeton Place

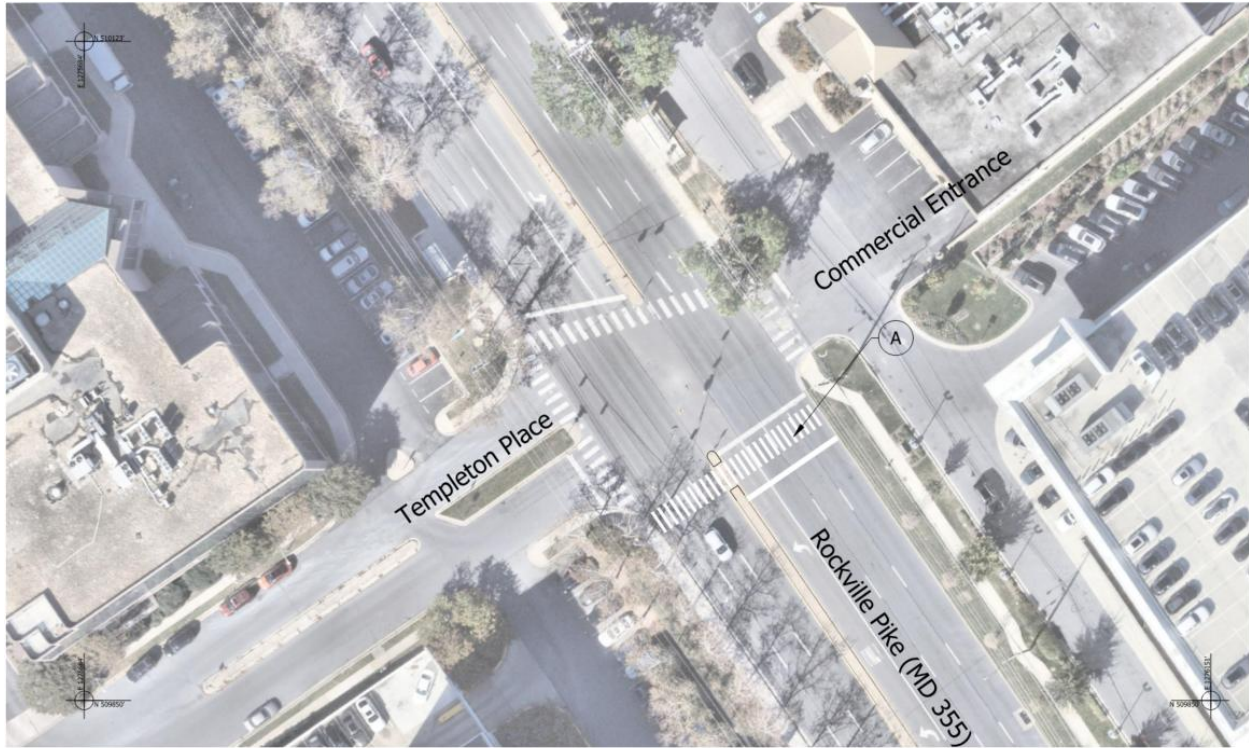
Figure 115. Long-Term Recommendations for Intersection #17 - Rockville Pike (MD 355) & Templeton Place

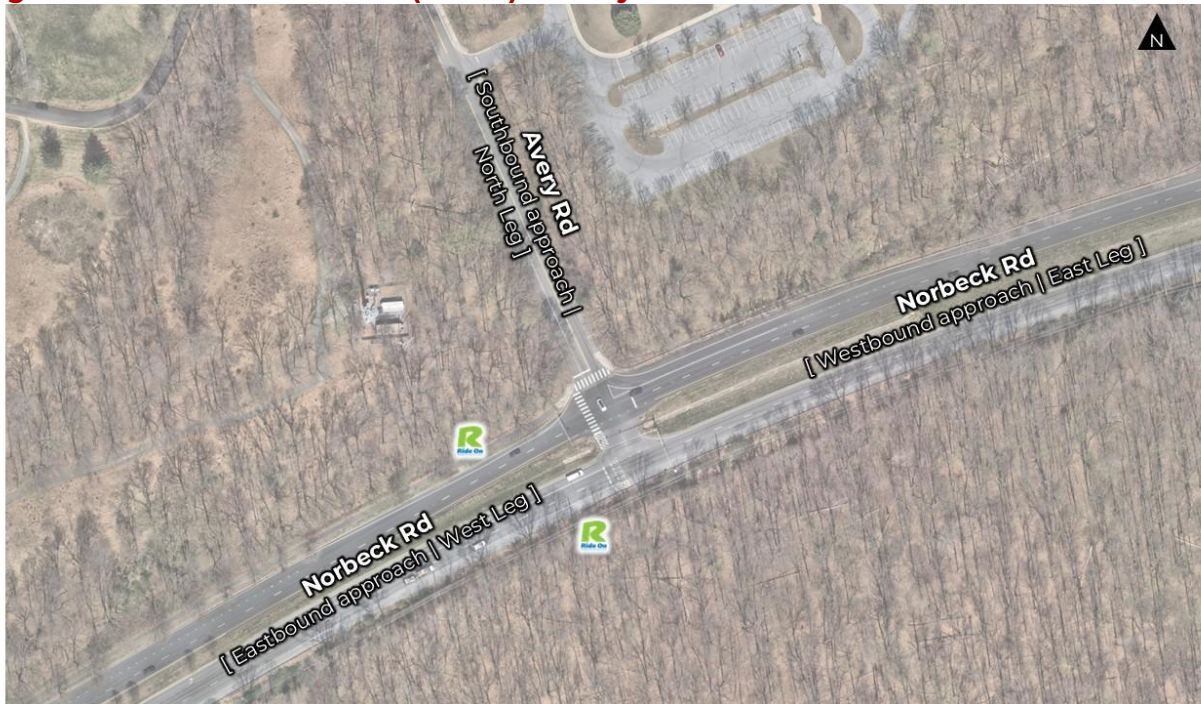
Figure 116. #18 - Norbeck Road (MD 28) & Avery Road Intersection

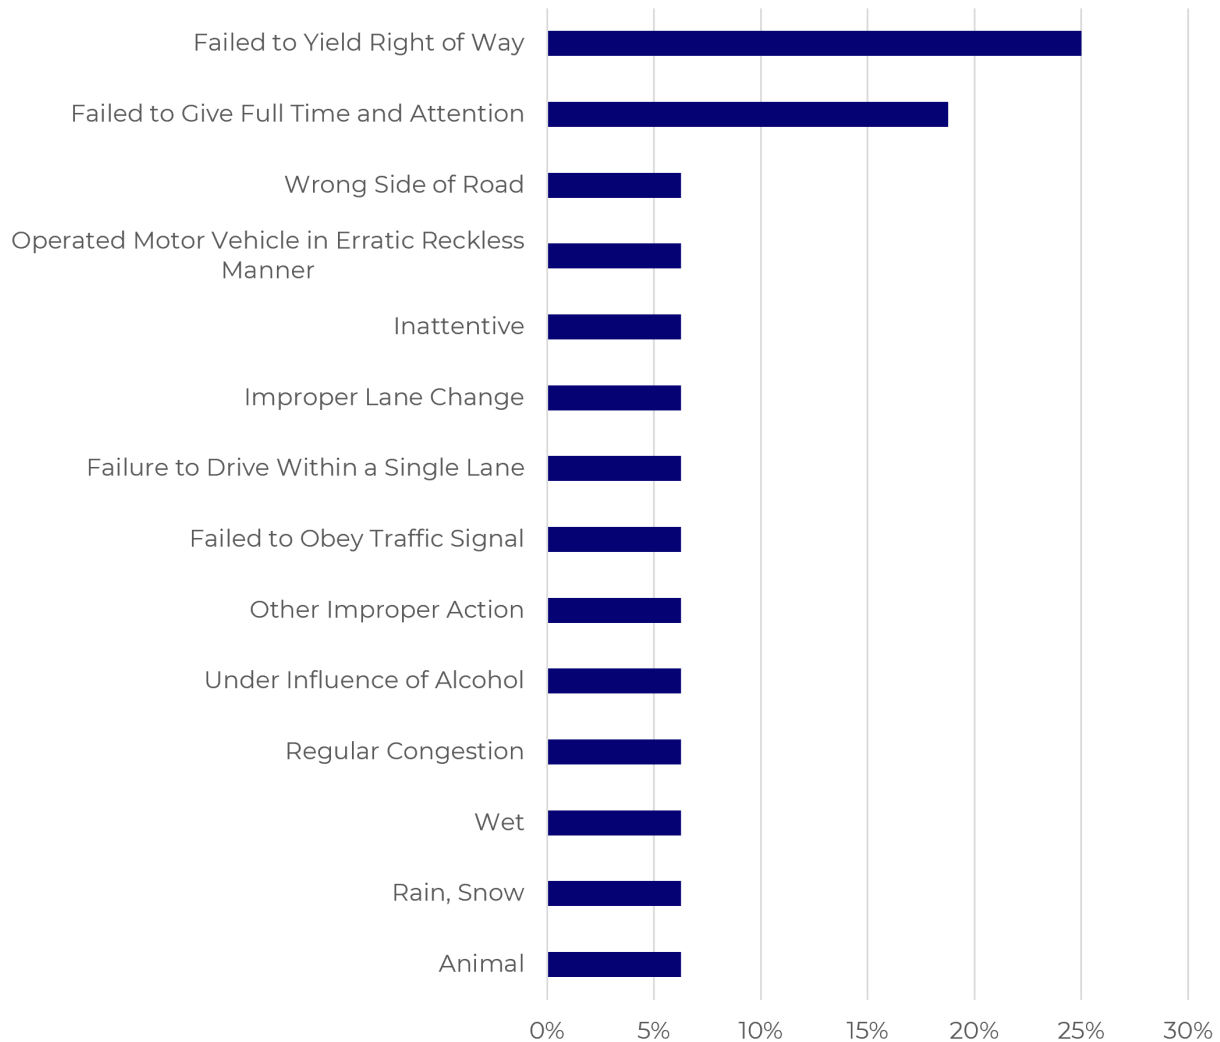
NEAR-MISS VIDEO ANALYSIS

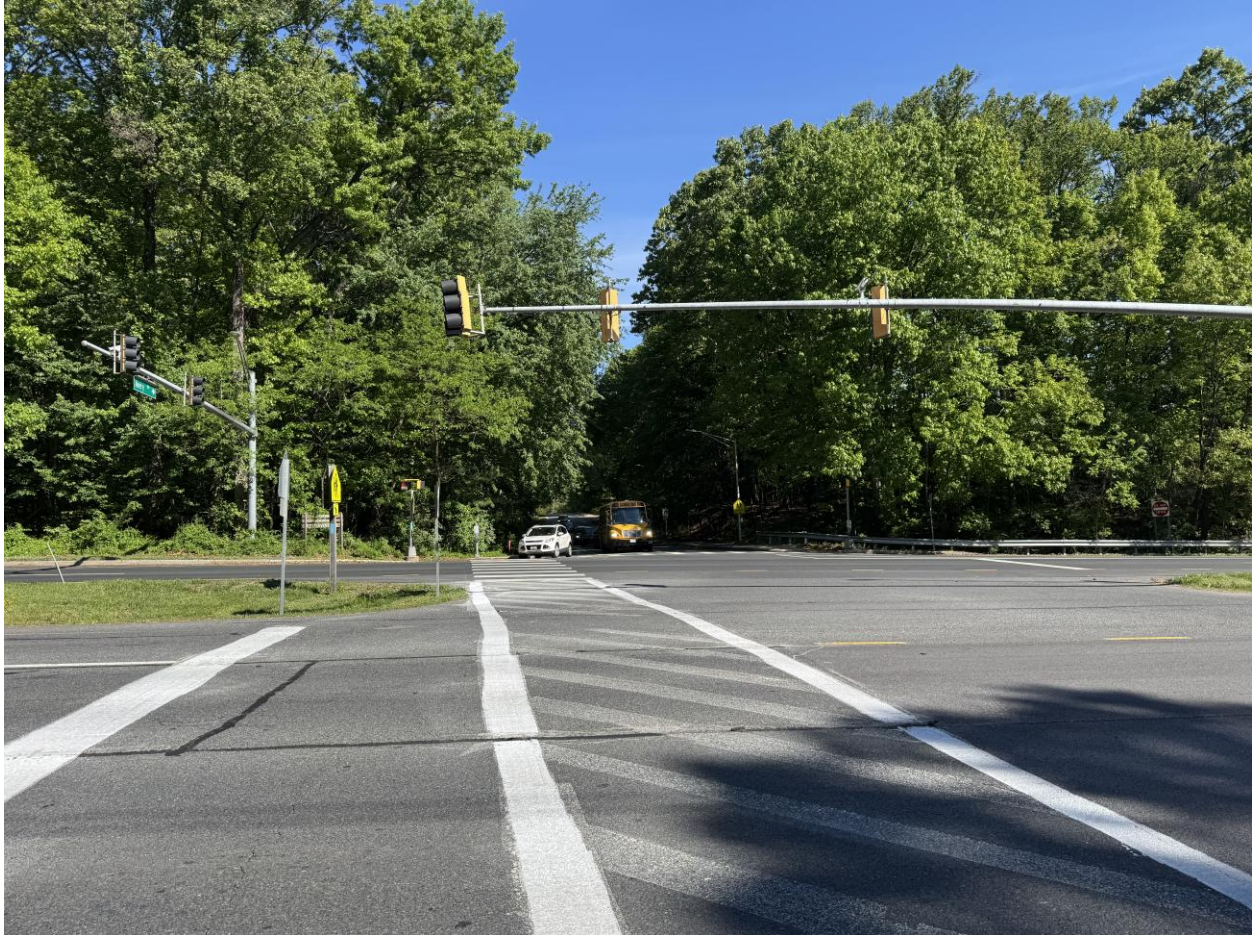
Figure 119. Vehicles turning on a permissive left turn from eastbound Norbeck to northbound Avery. Three head on left turn crashes and 138 near misses occurred in this movement. #18 - Norbeck Road (MD 28) & Avery Road

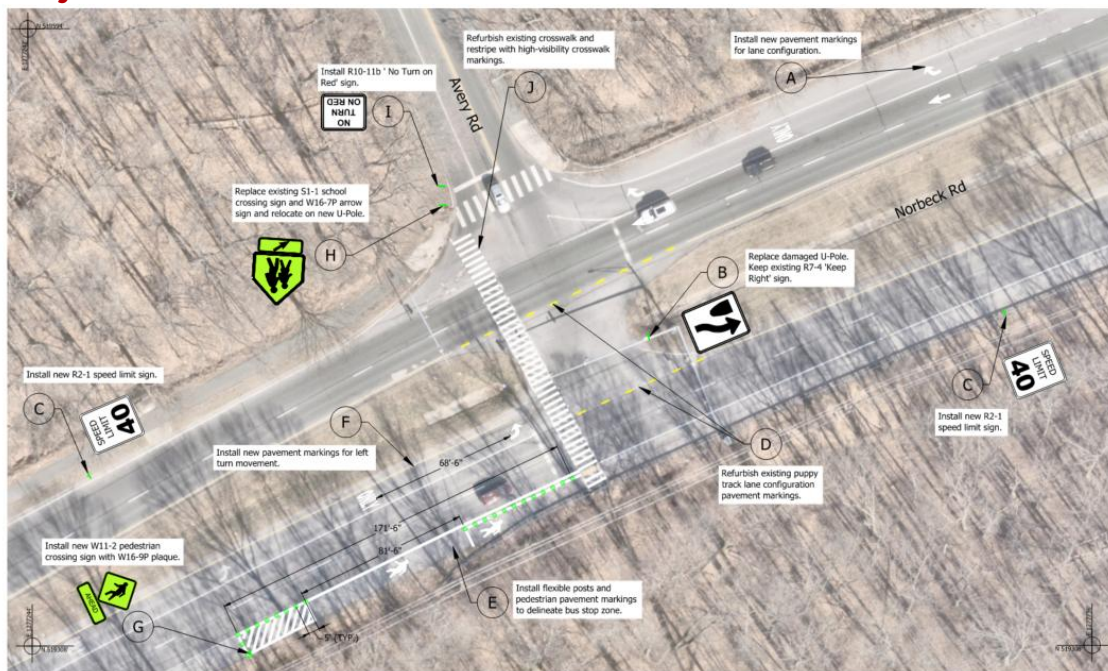
Figure 121. Short-Term Recommendations for Intersection #18 - Norbeck Road (MD 28) & Avery Road

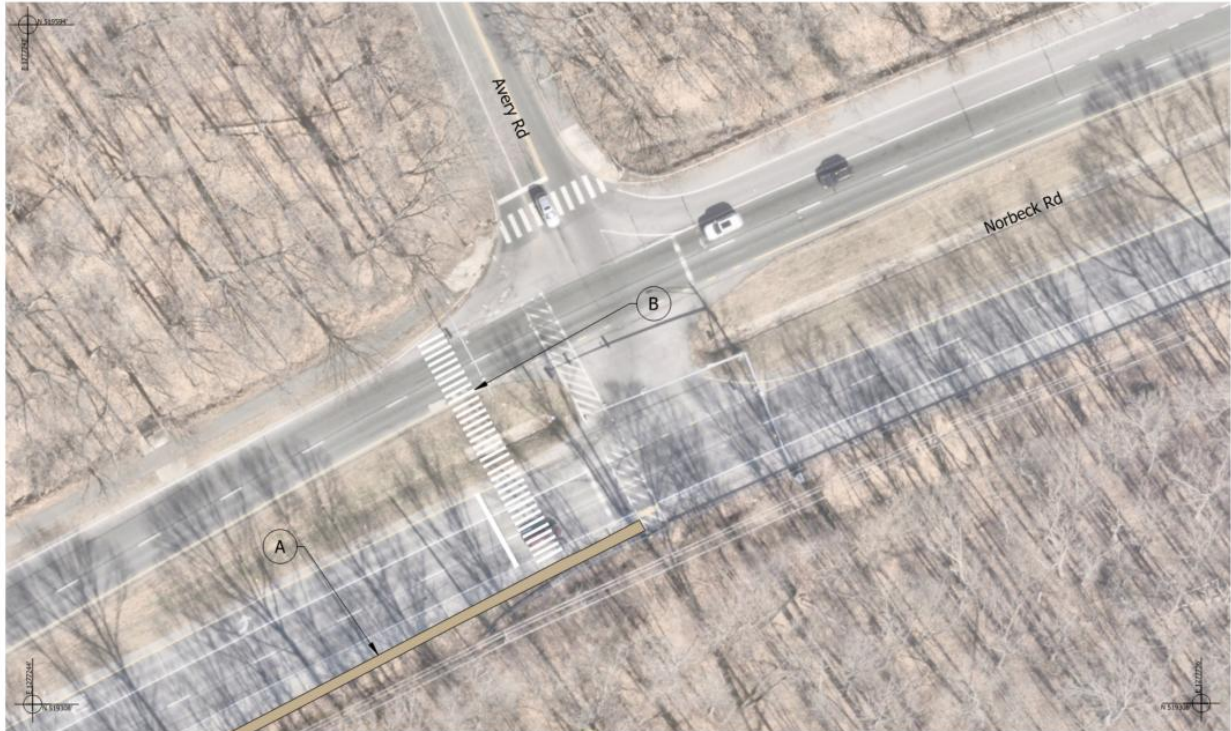
Figure 122. Long-Term Recommendations for Intersection #18 - Norbeck Road (MD 28) & Avery Road

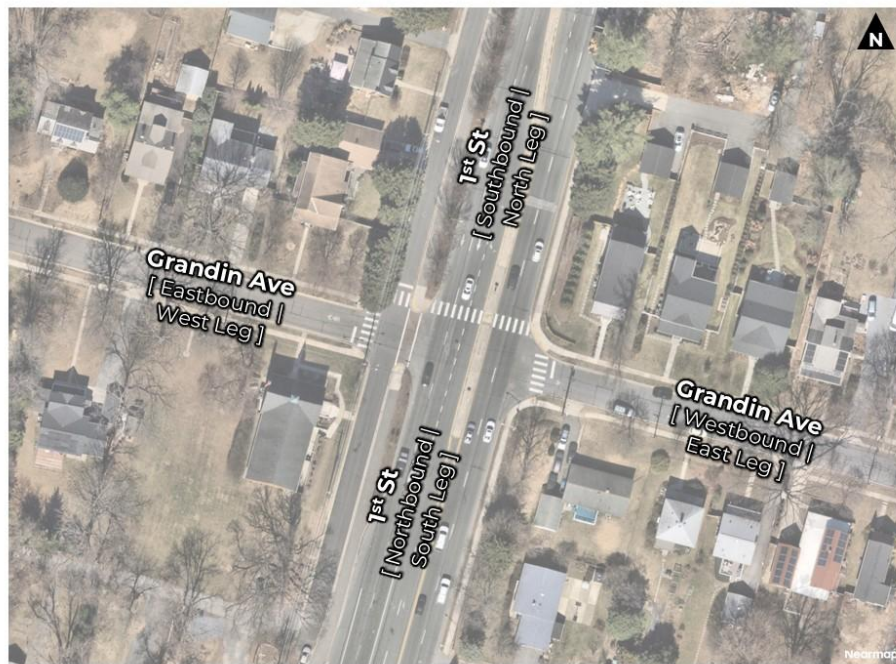
Figure 123. #19 - First Street (MD 28) & Grandin Avenue Intersection

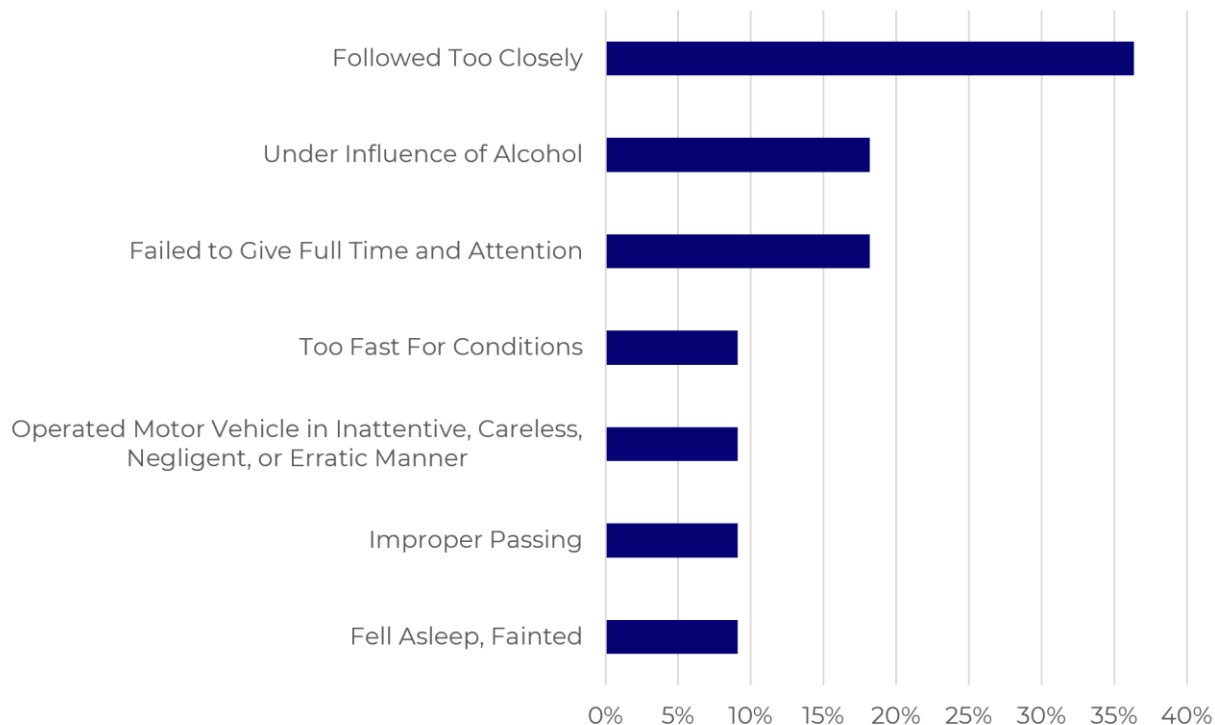
NEAR-MISS VIDEO ANALYSIS
