Safe Streets for All
**VISION ZERO
INTERSECTION
SAFETY AUDITS**

City of Rockville, Maryland

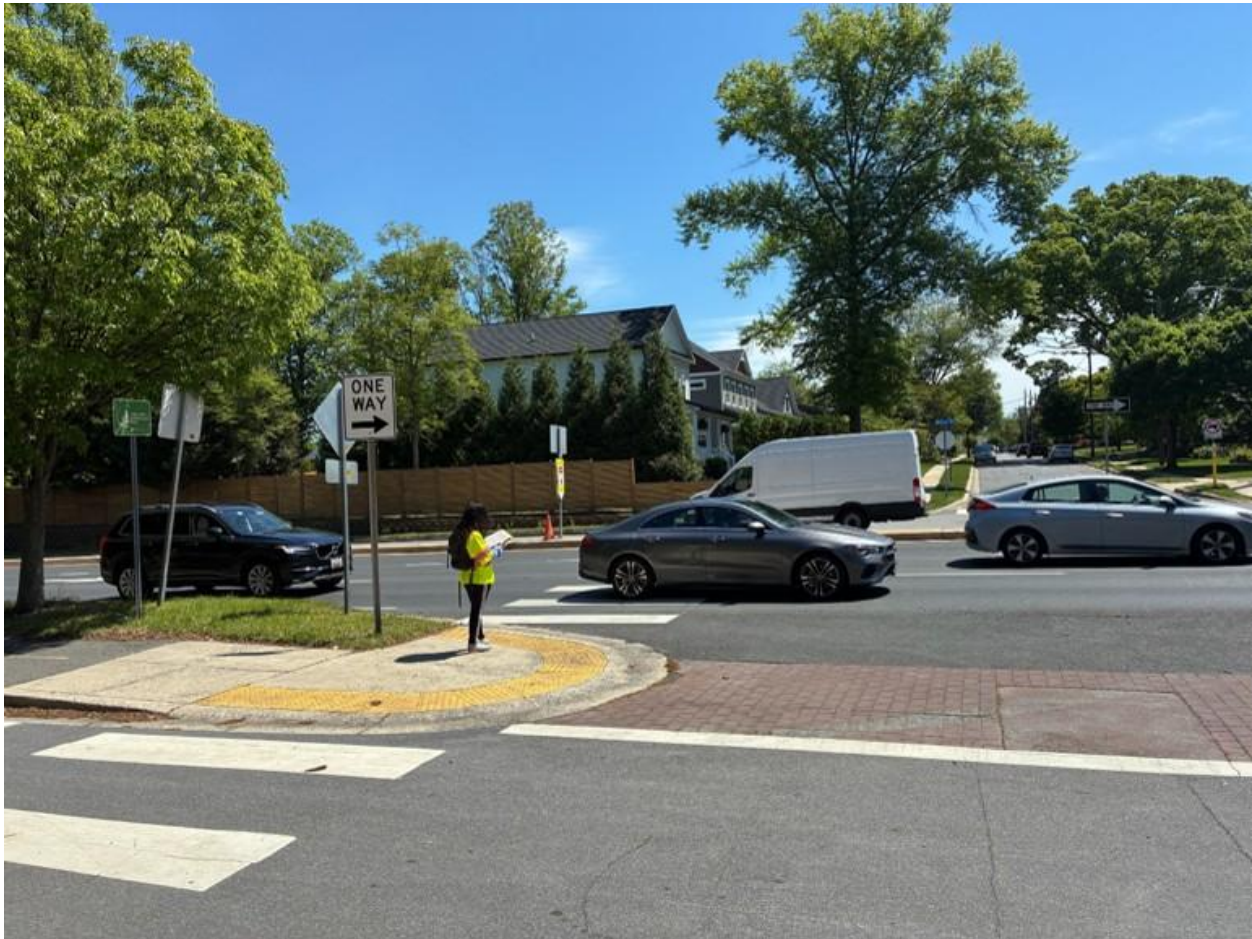
Figure 126. No crosswalks on Grandin Avenue at Intersection #19 - First Street (MD 28) & Grandin Avenue

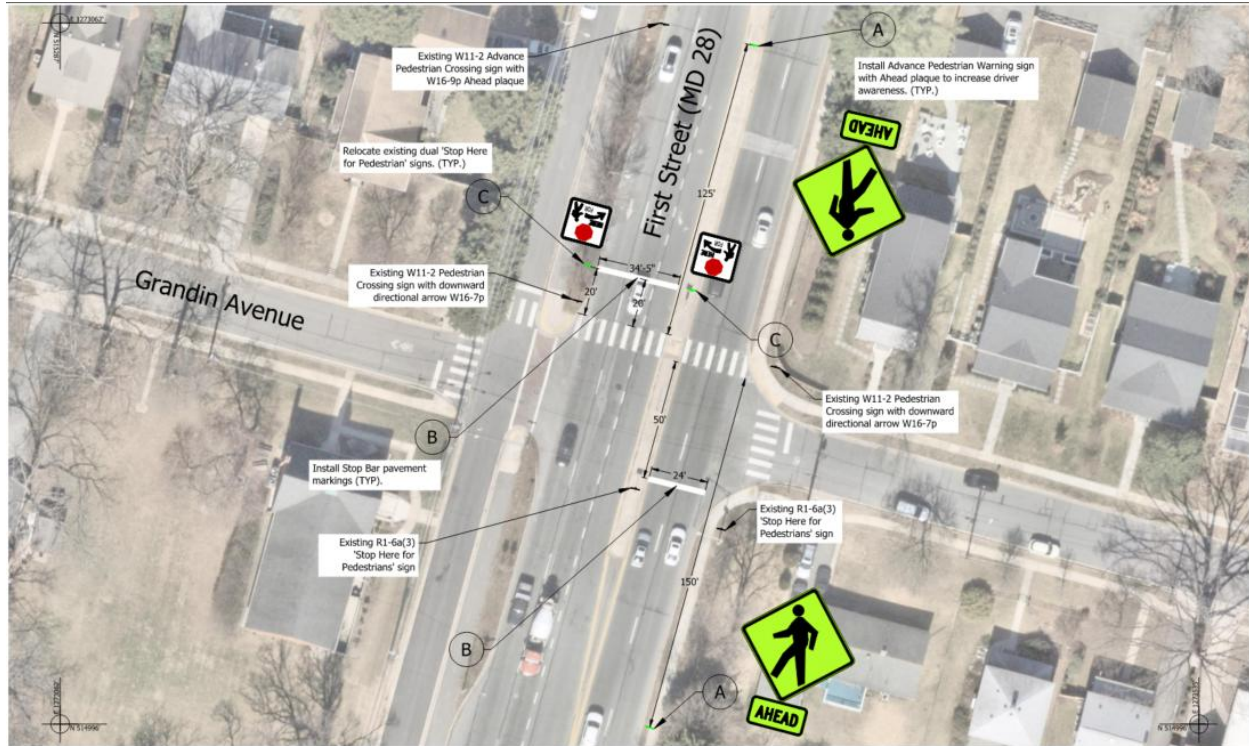
Figure 127. Short-Term Recommendations for Intersection #19 - First Street (MD 28) & Grandin Avenue

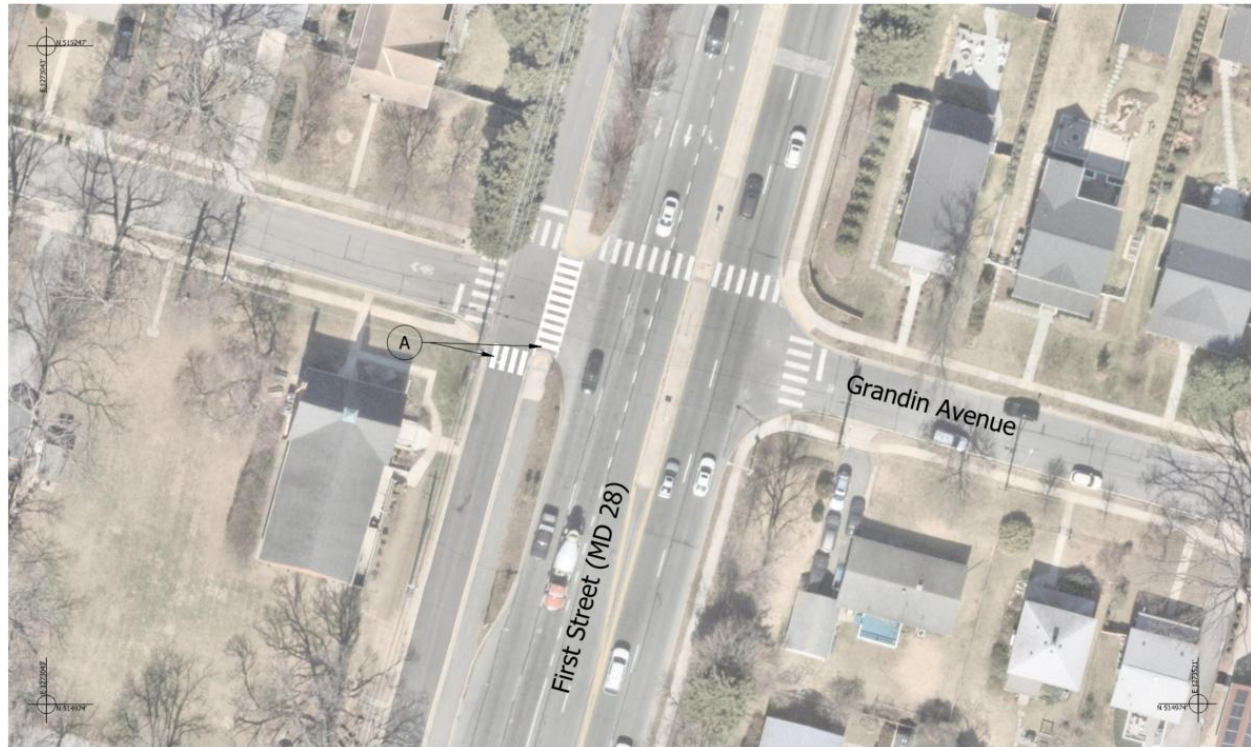
Figure 128. Long-Term Recommendations for Intersection #19 - First Street (MD 28) & Grandin Avenue

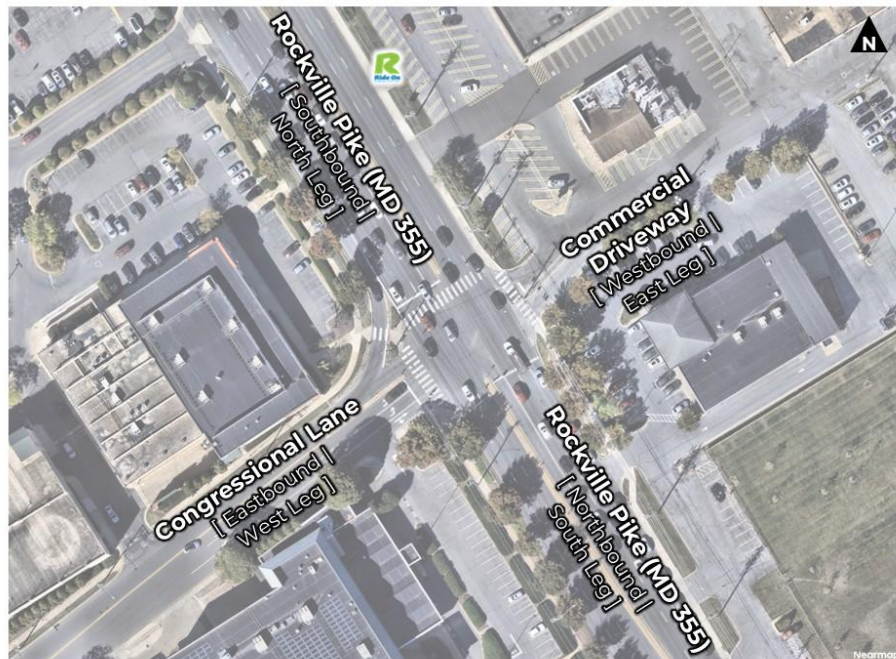
Figure 129. #20 - Rockville Pike (MD 355) & Congressional Lane Intersection

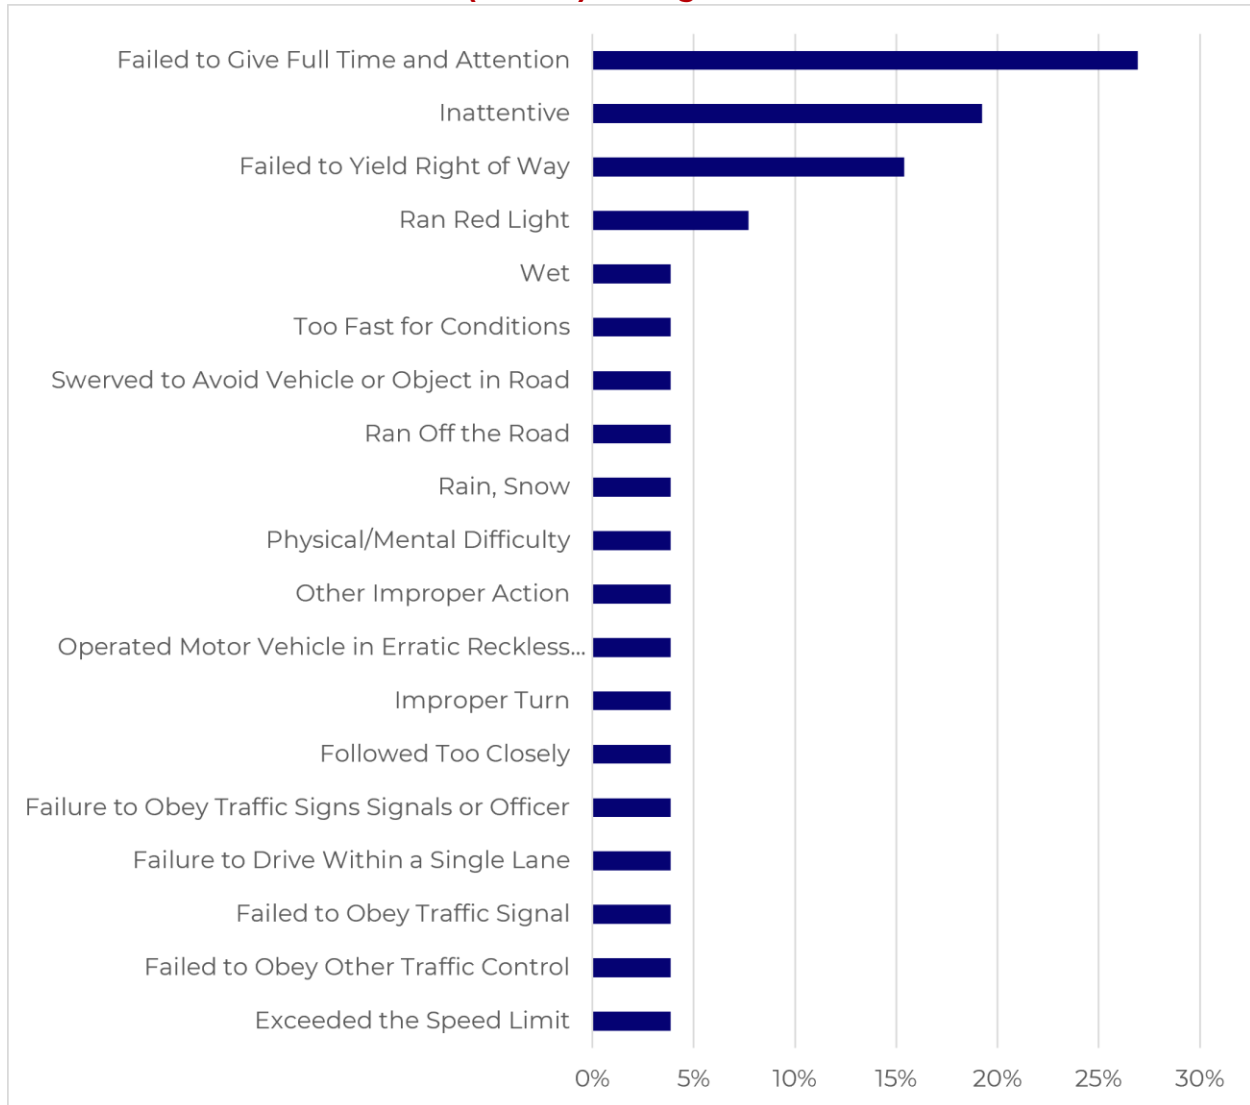
NEAR-MISS VIDEO ANALYSIS

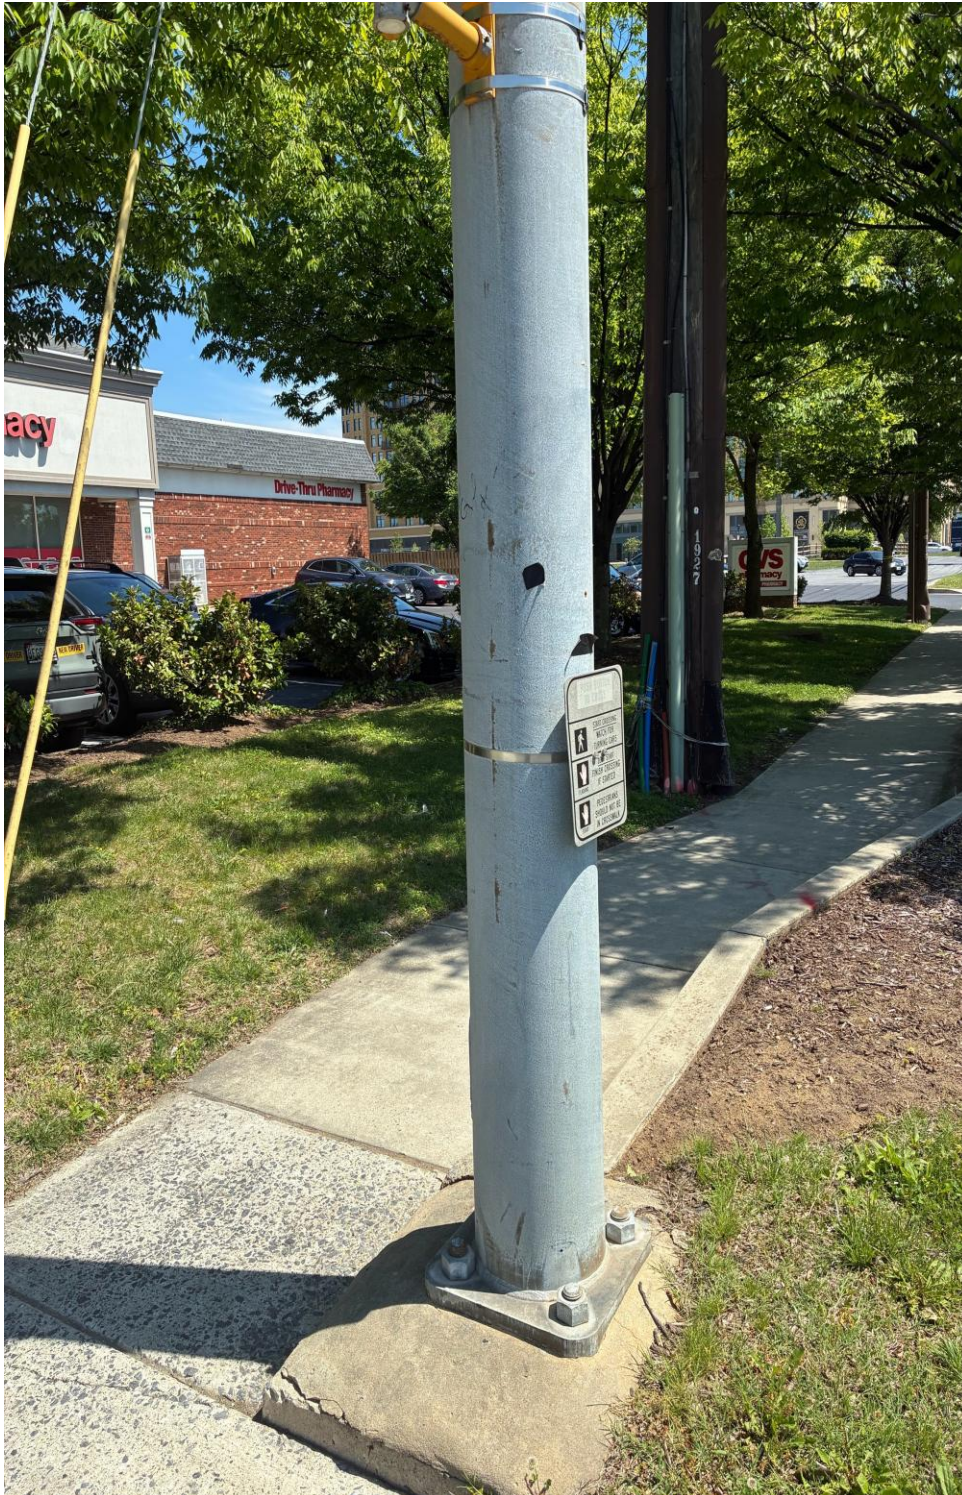
Figure 132. Missing ADA-compliant curb ramps at Intersection #20 - Rockville Pike (MD 355) & Congressional Lane

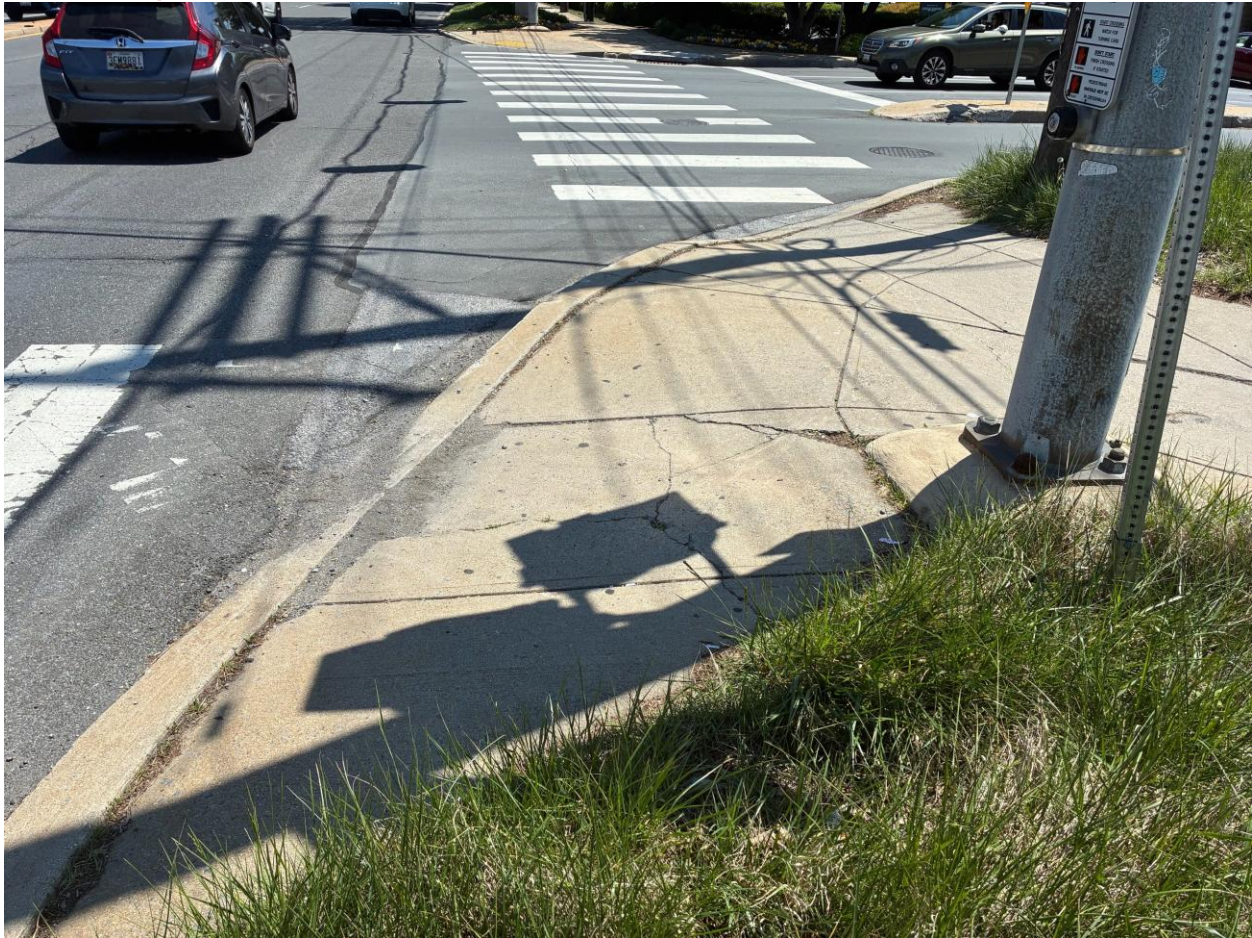
Figure 133. Slip lane at Intersection #20 - Rockville Pike (MD 355) & Congressional Lane

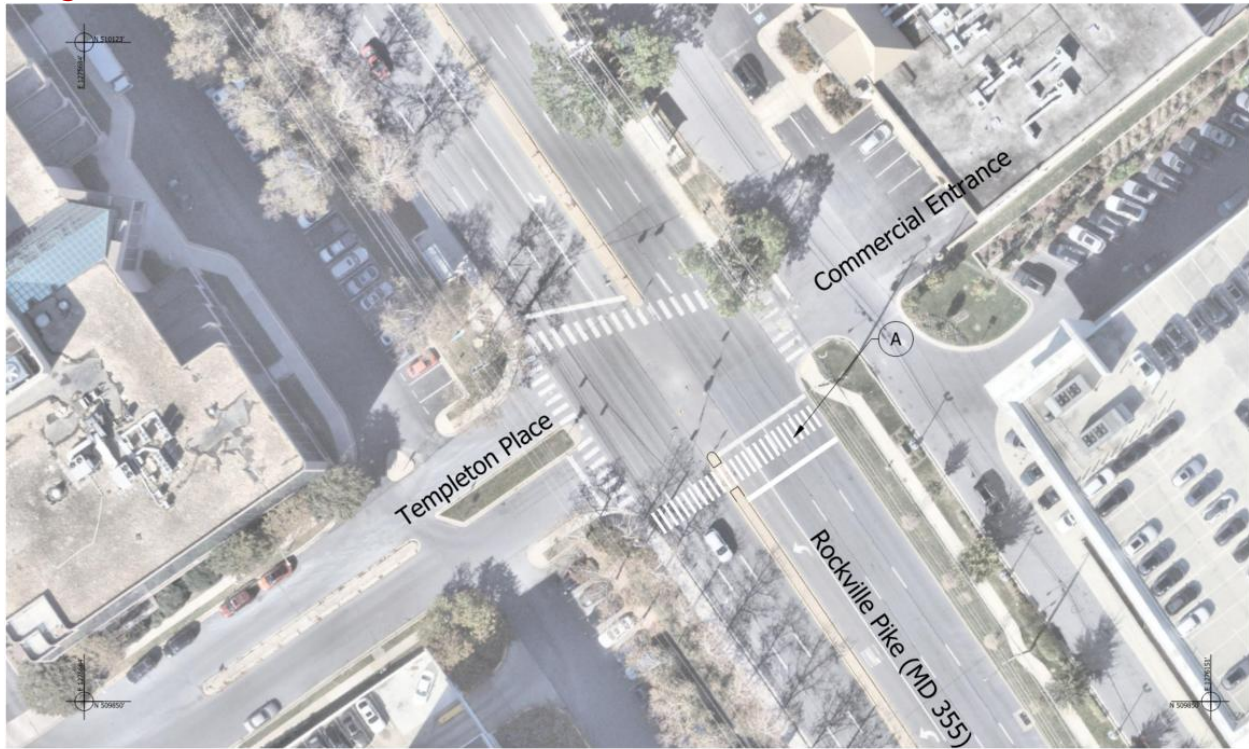
Figure 134. Long-Term Recommendations for Intersection #20 - Rockville Pike (MD 355) & Congressional Lane

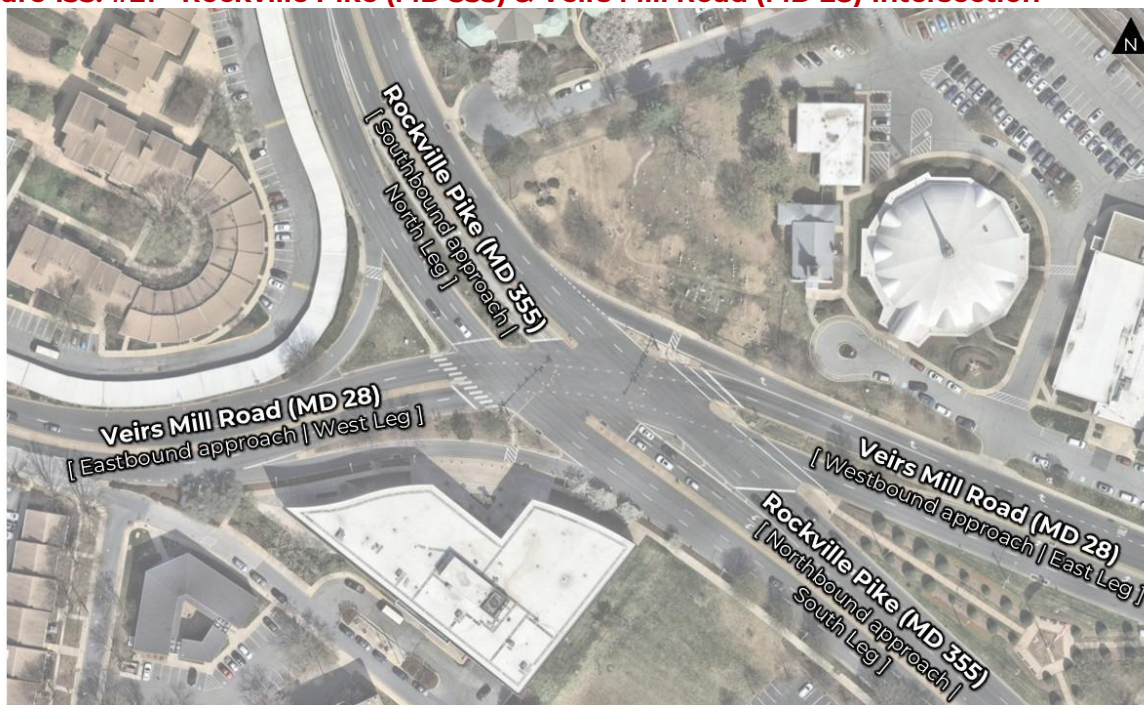
Figure 135. #21 - Rockville Pike (MD 355) & Veirs Mill Road (MD 28) Intersection

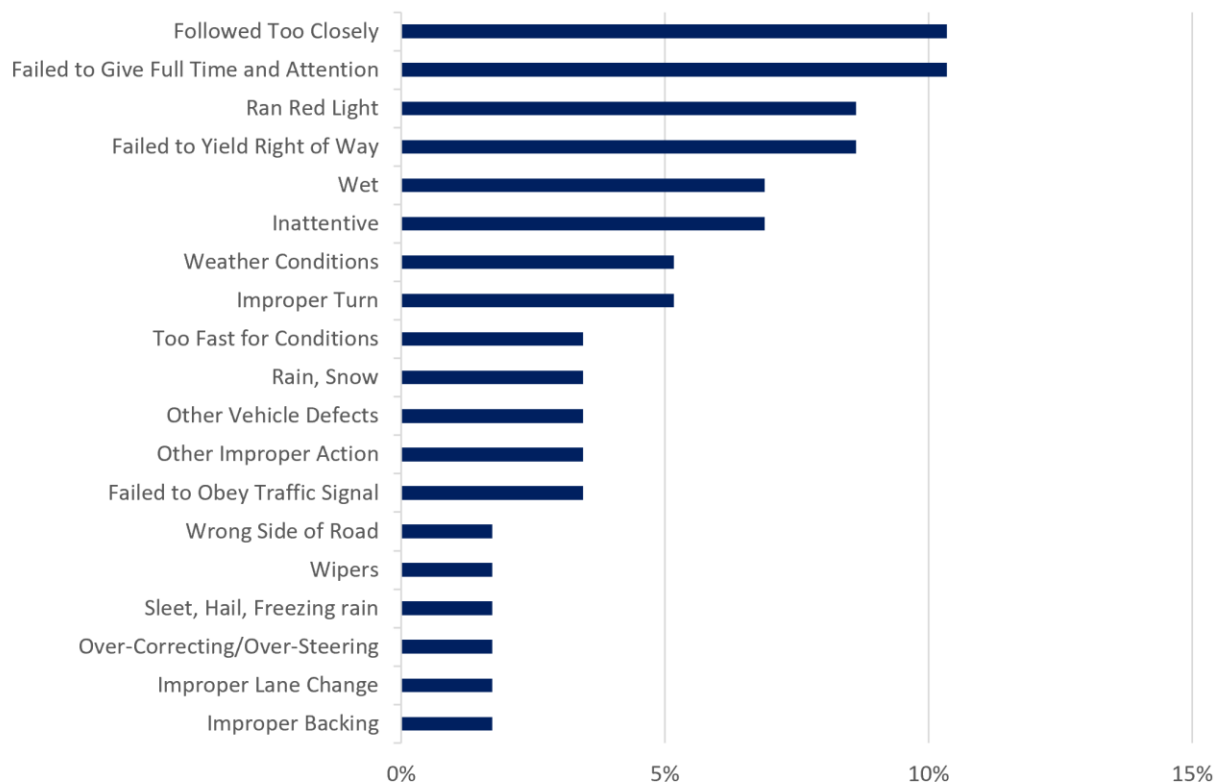
NEAR-MISS VIDEO ANALYSIS

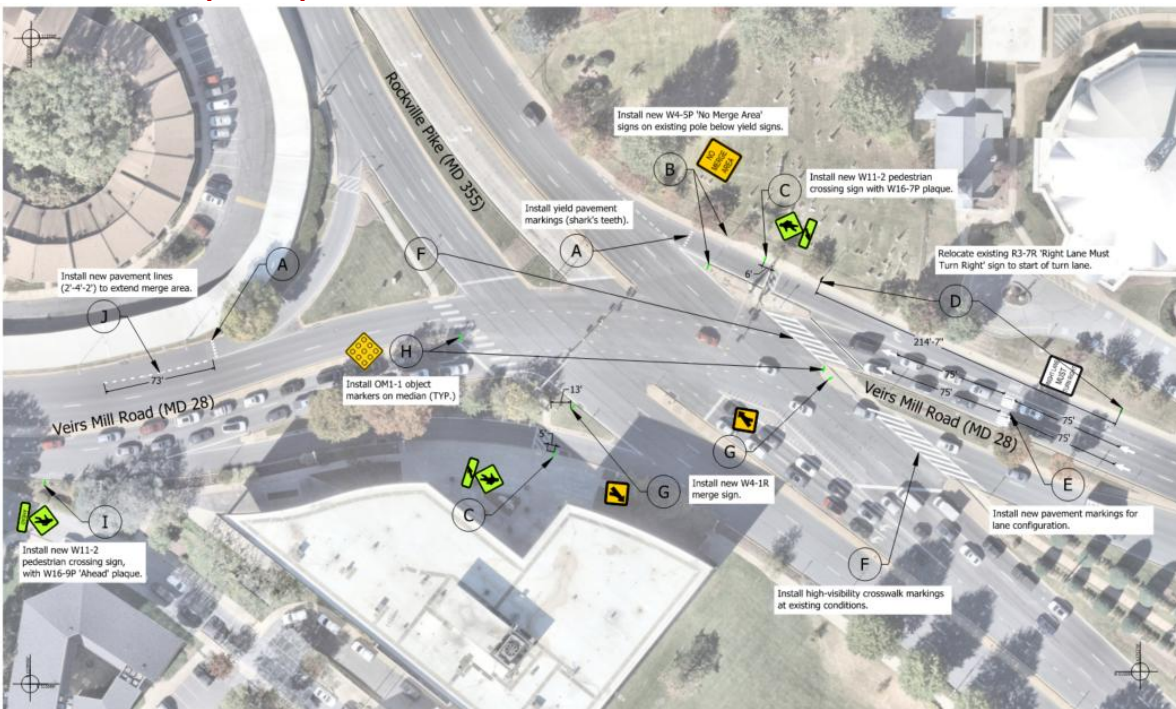
Figure 140. Short-Term Recommendations for Intersection #21 - Rockville Pike (MD 355) & Veirs Mill Road (MD 28)

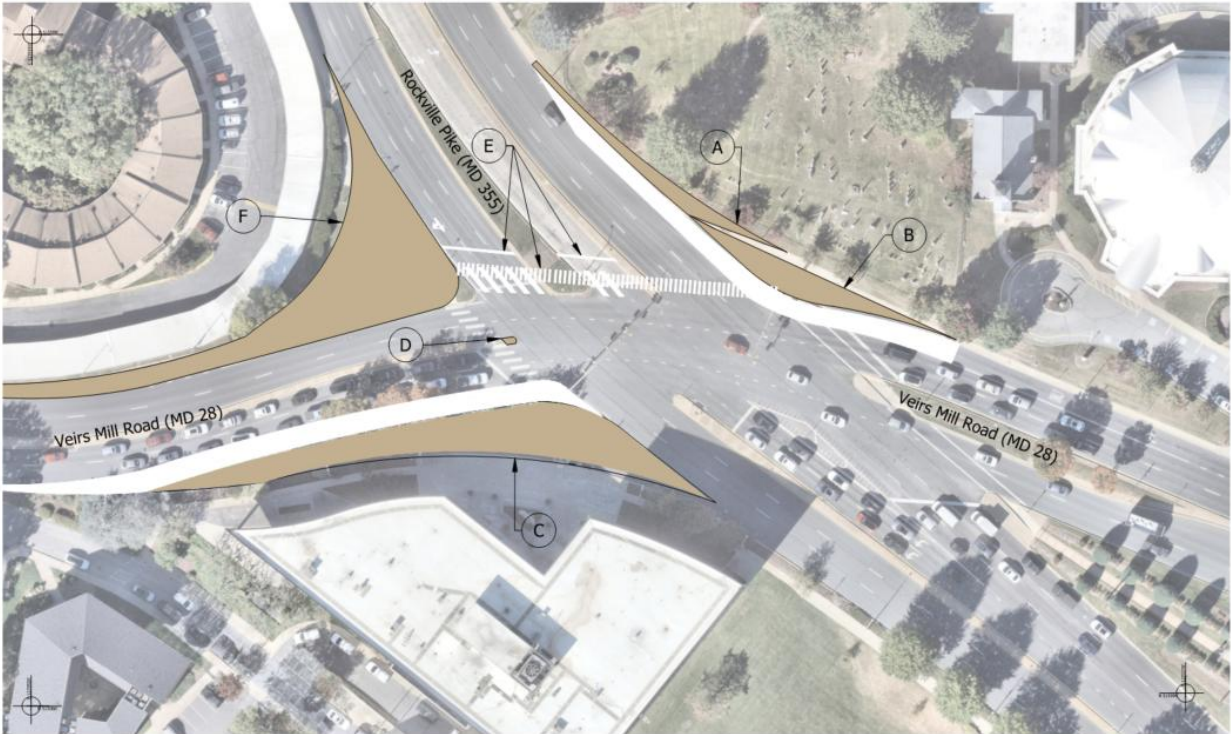
Figure 141. Long-Term Recommendations for Intersection #21 - Rockville Pike (MD 355) & Veirs Mill Road (MD 28)

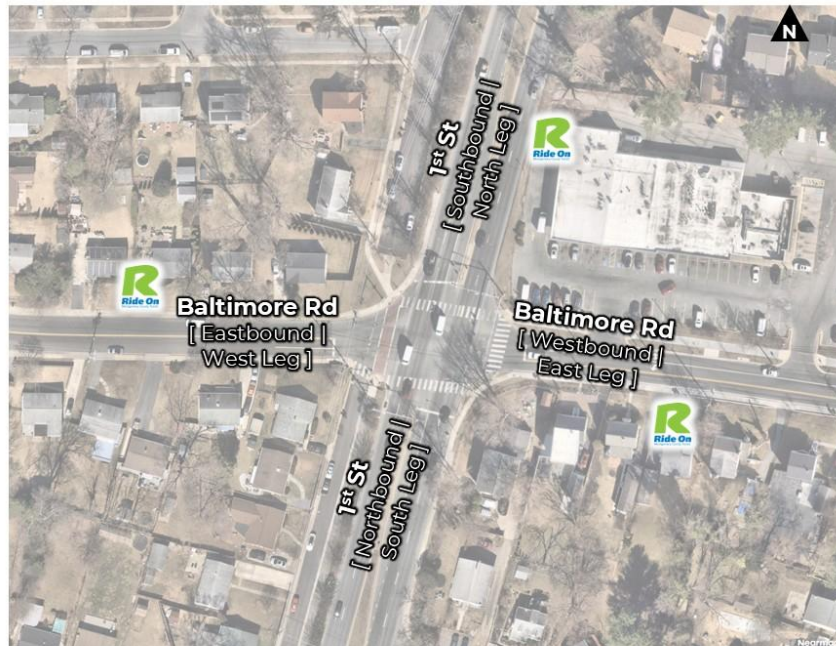
Figure 142. #22 - First Street (MD 28) & Baltimore Road Intersection

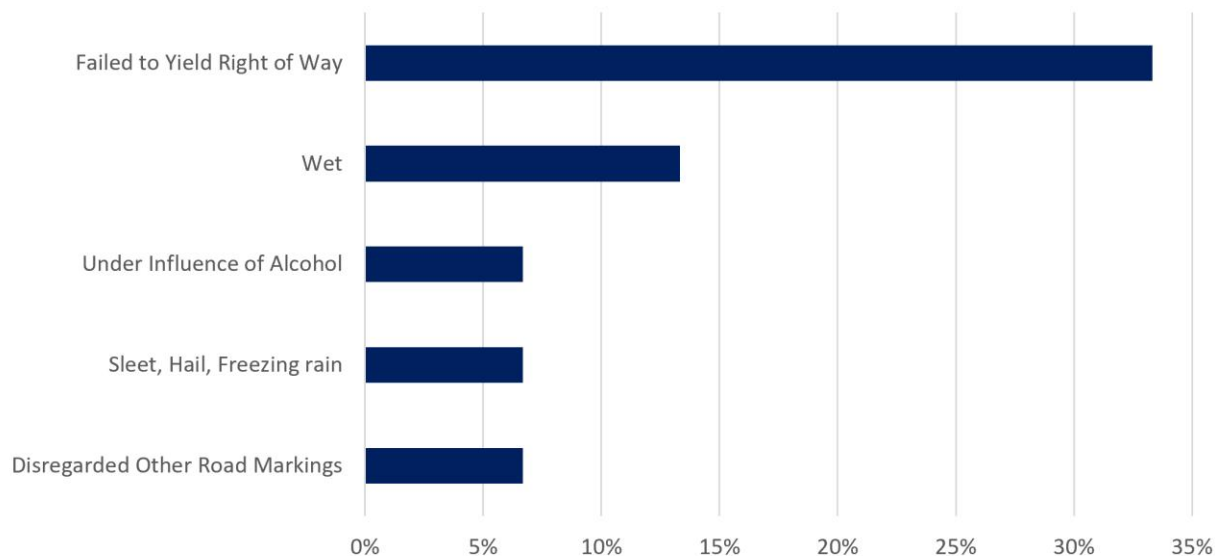
NEAR-MISS VIDEO ANALYSIS

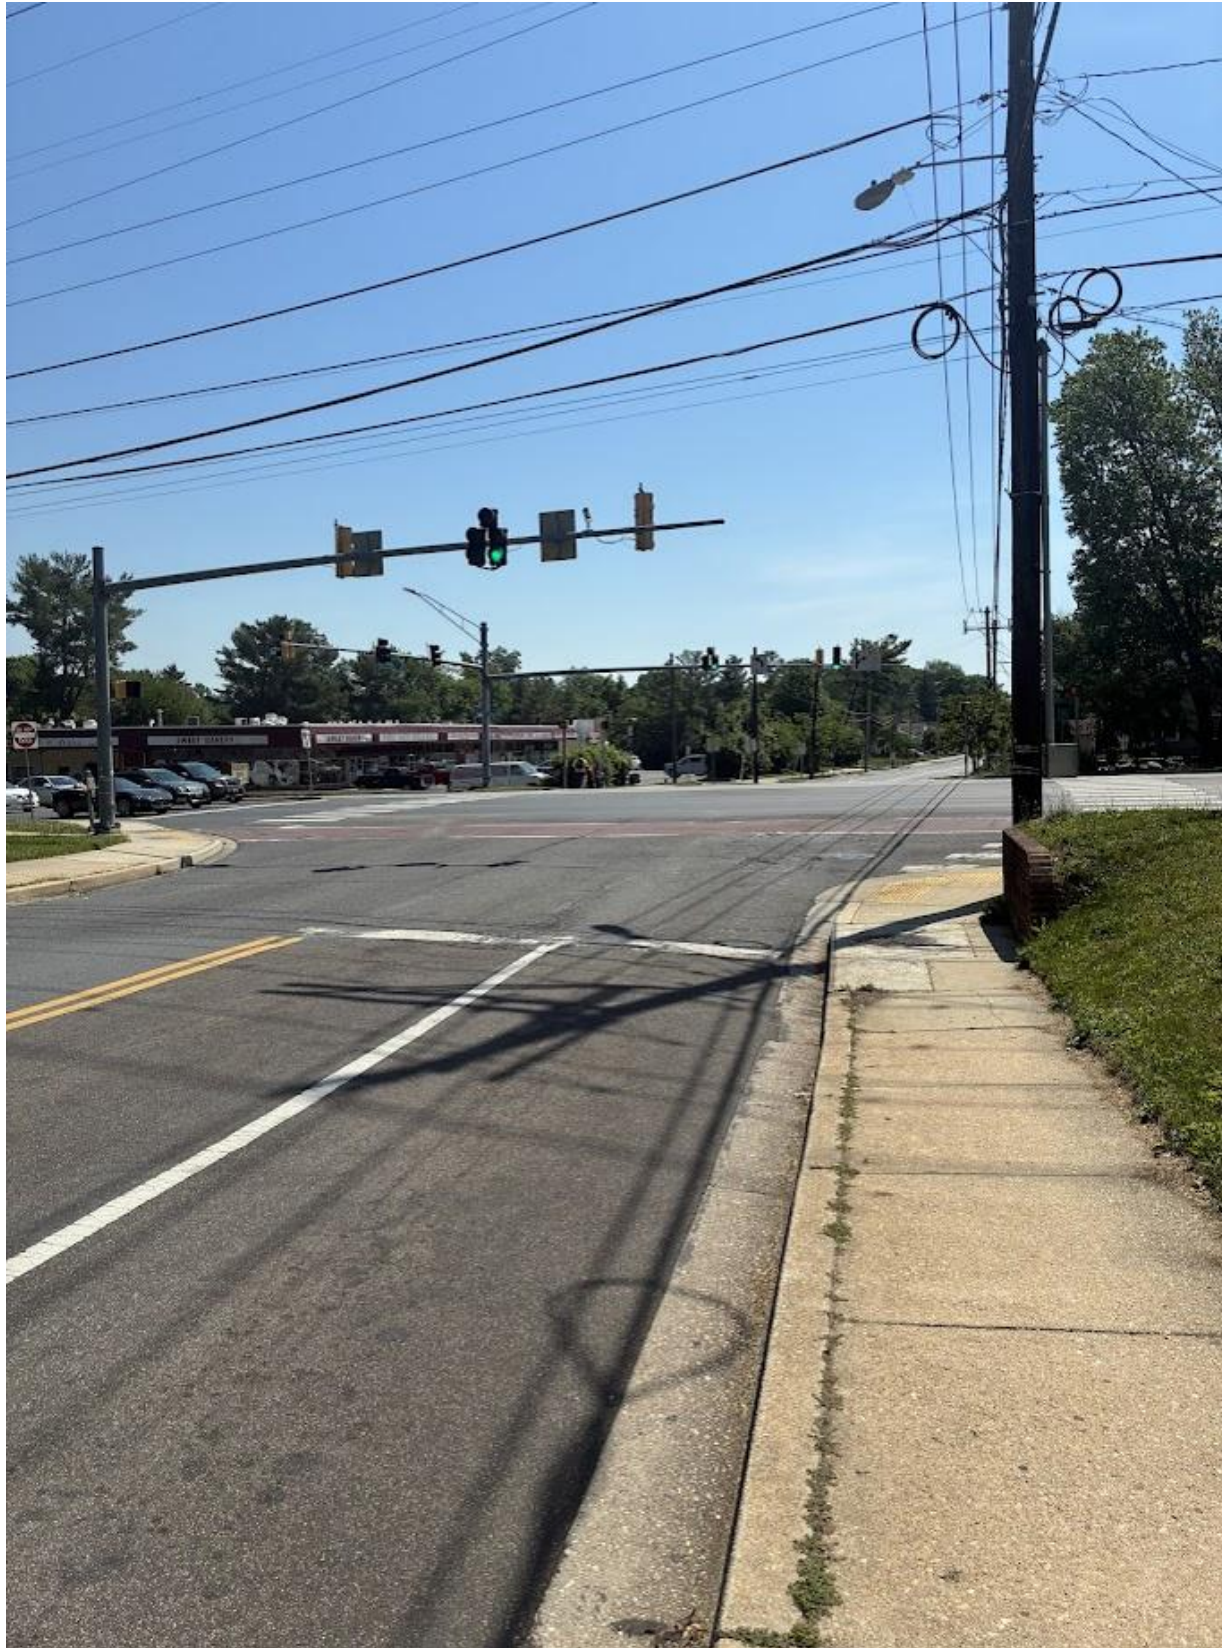
Figure 145. Wide curb radius at Intersection #22 - First Street (MD 28) & Baltimore Road

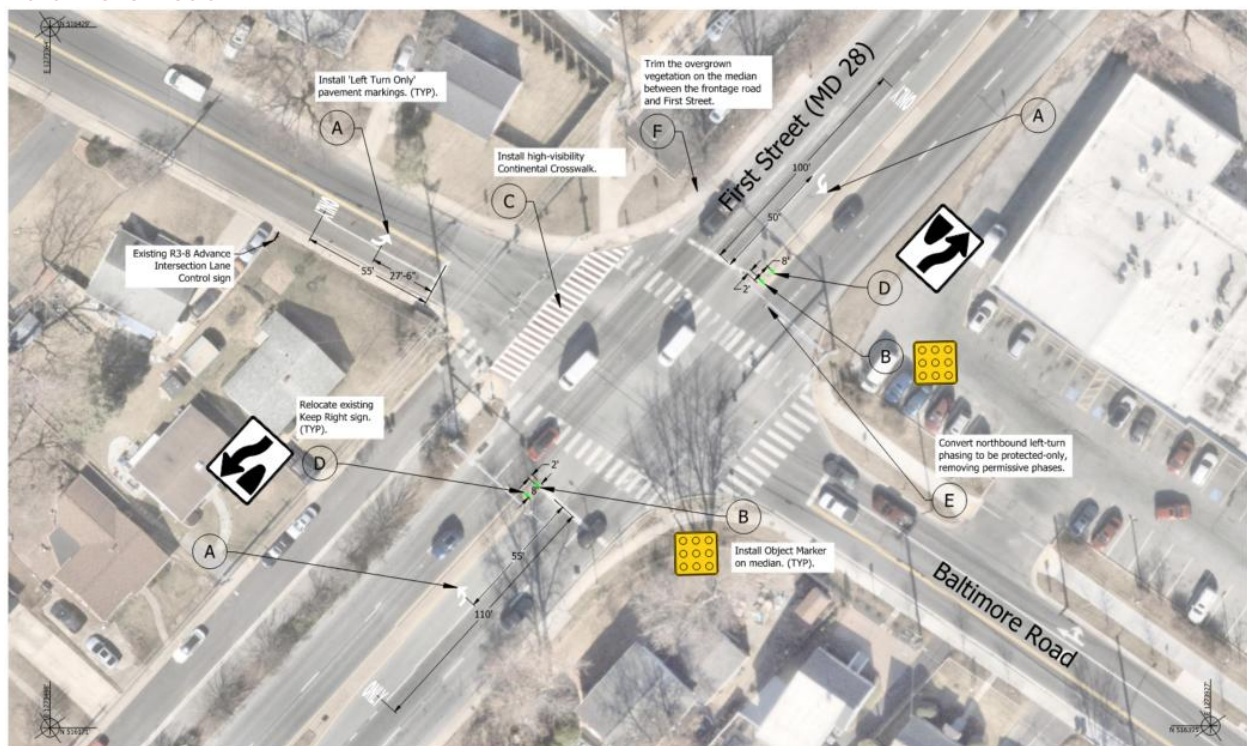
Figure 146. Short-Term Recommendations for Intersection #22 - First Street (MD 28) & Baltimore Road

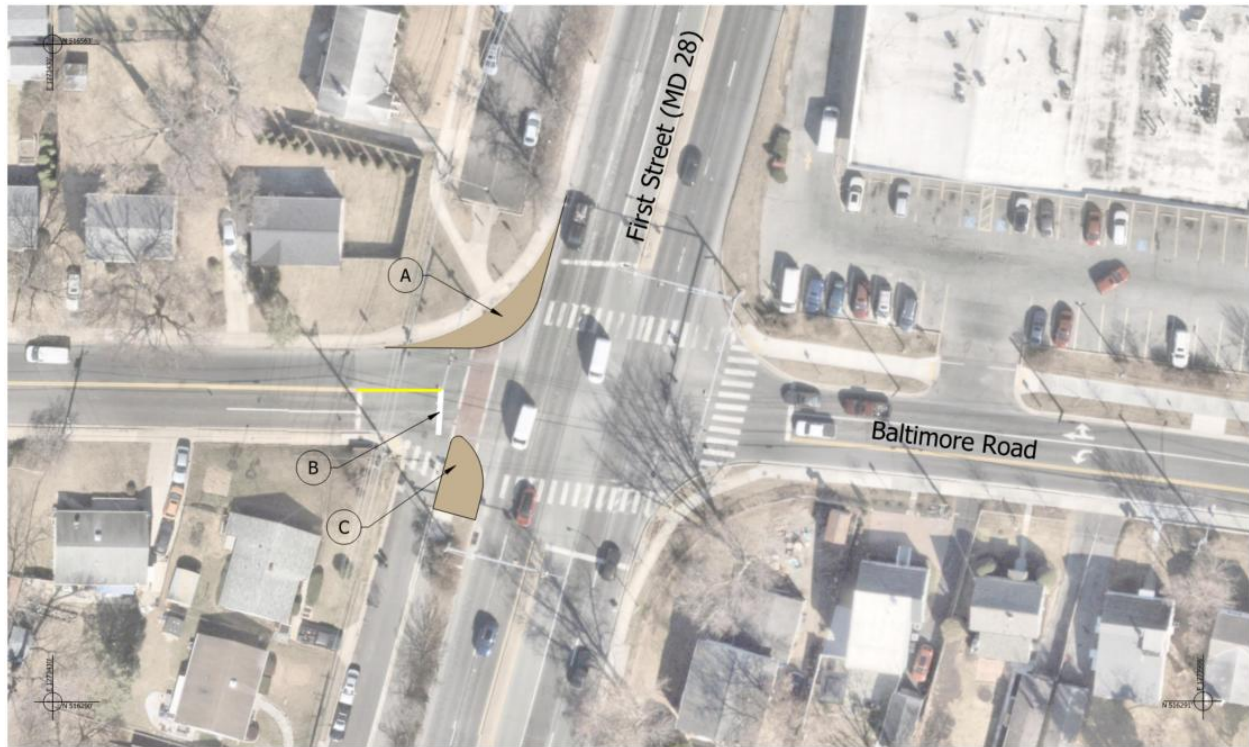
Figure 147. Long-Term Recommendations for Intersection #22 - First Street (MD 28) & Baltimore Road

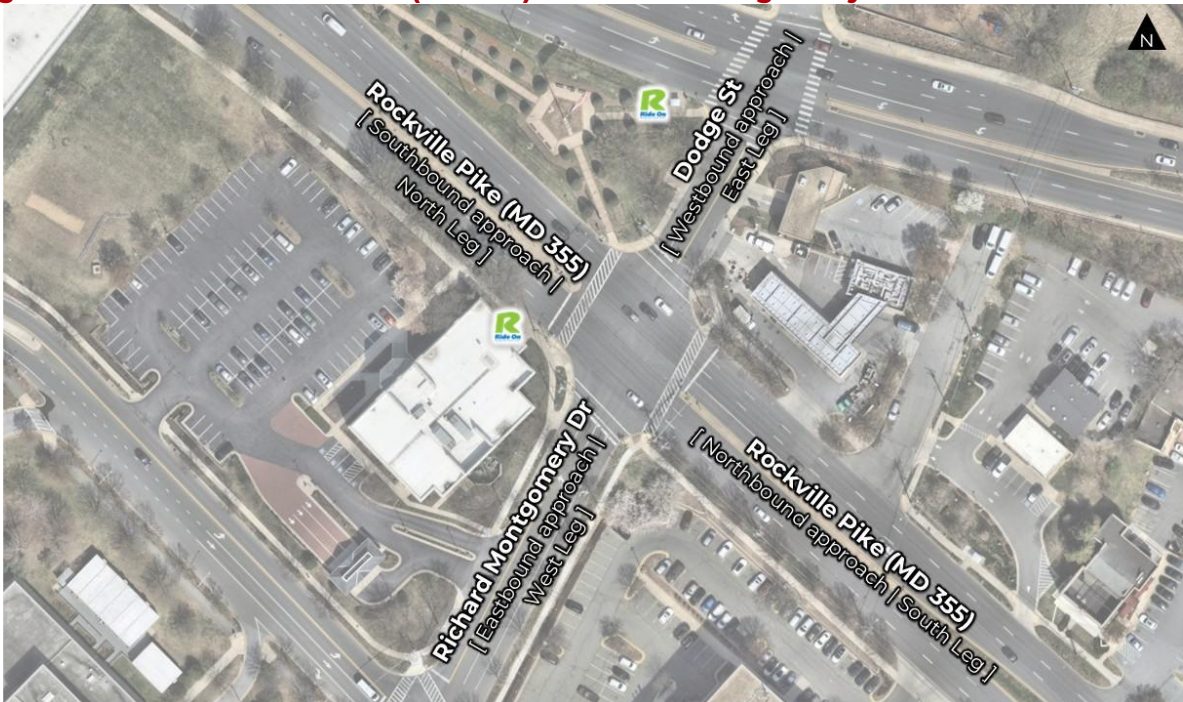
Figure 148. #23 - Rockville Pike (MD 355) & Richard Montgomery Street Intersection

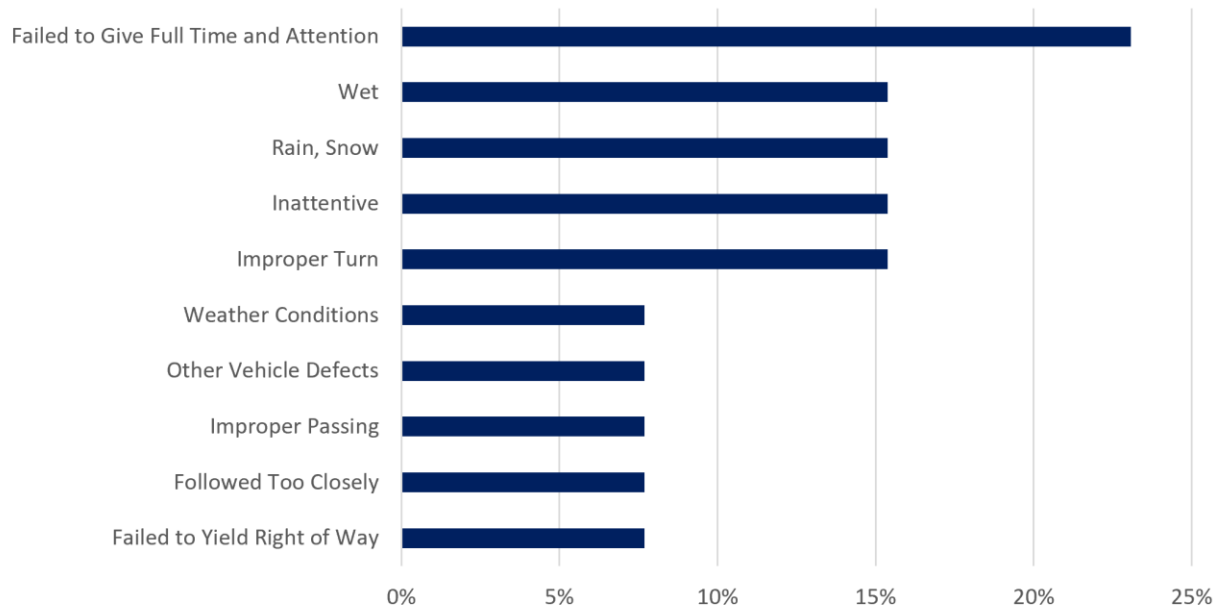
NEAR-MISS VIDEO ANALYSIS

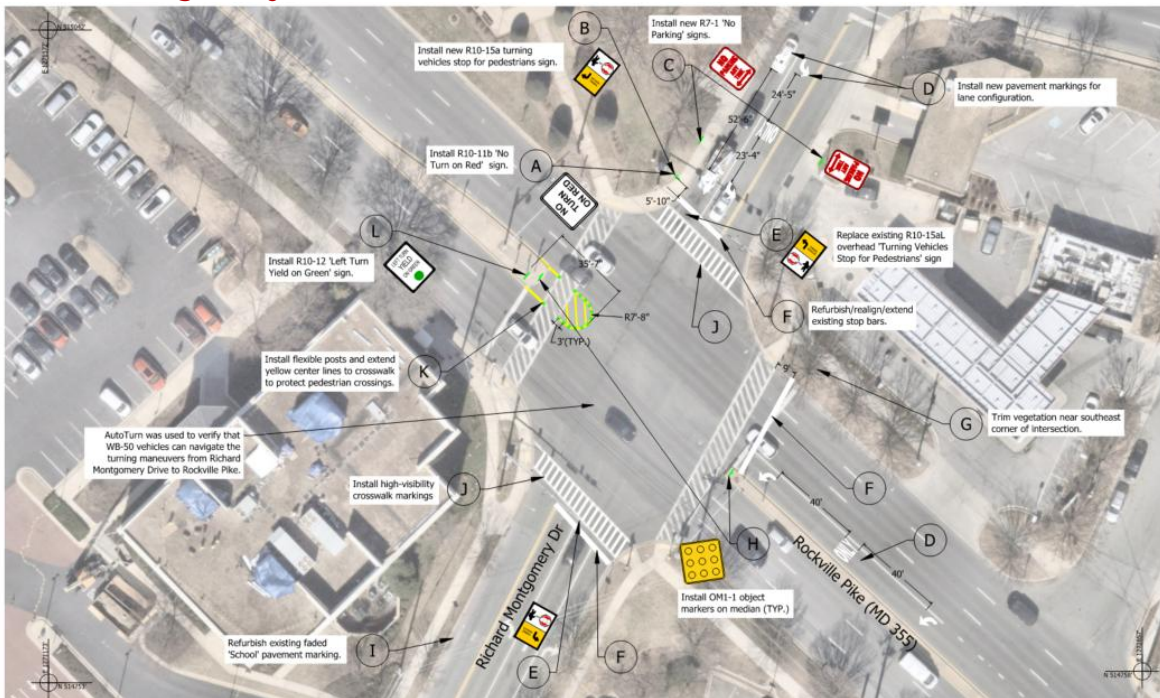
Figure 153. Short-Term Recommendations for Intersection #23 - Rockville Pike (MD 355) & Richard Montgomery Street

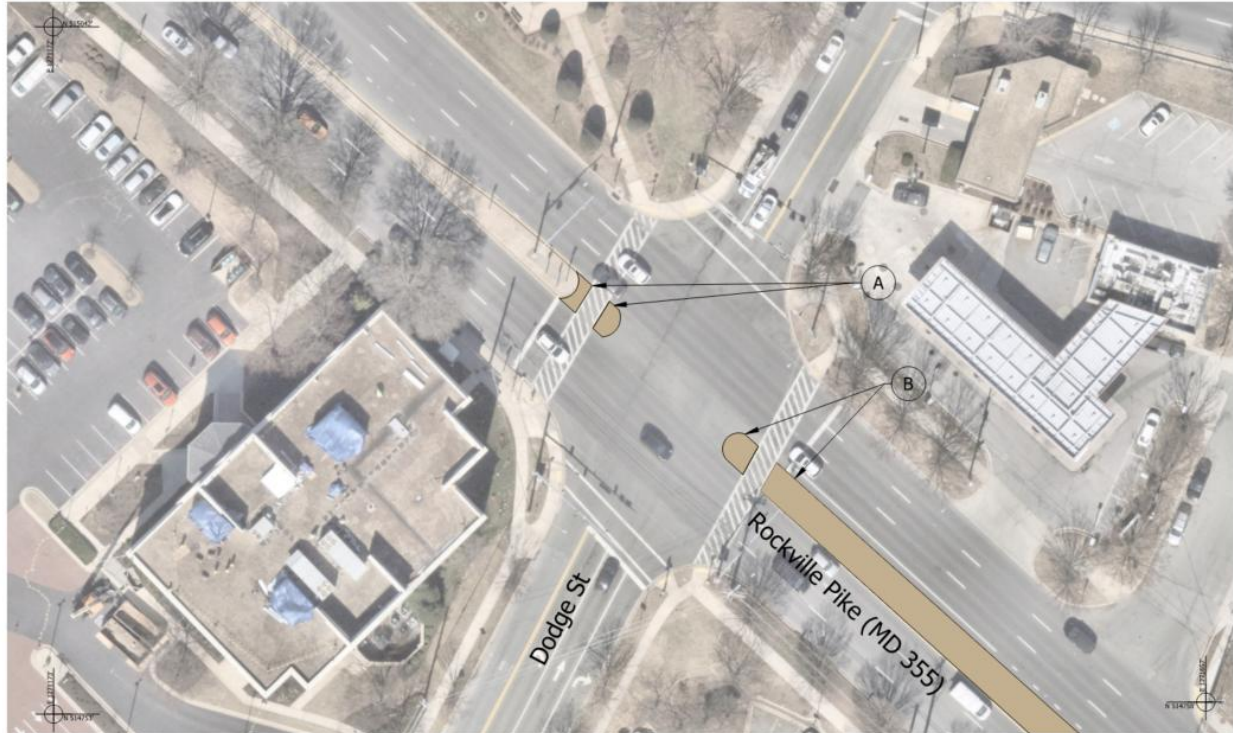
Figure 154. Long-Term Recommendations for Intersection #23 - Rockville Pike (MD 355) & Richard Montgomery Street

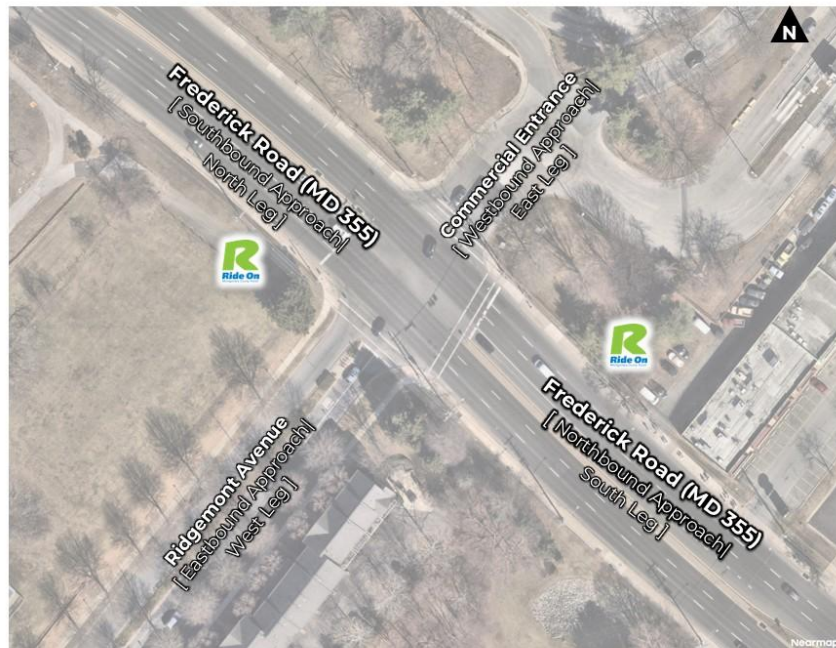
Figure 155. #24 - Frederick Road (MD 355) & Ridgemont Avenue Intersection

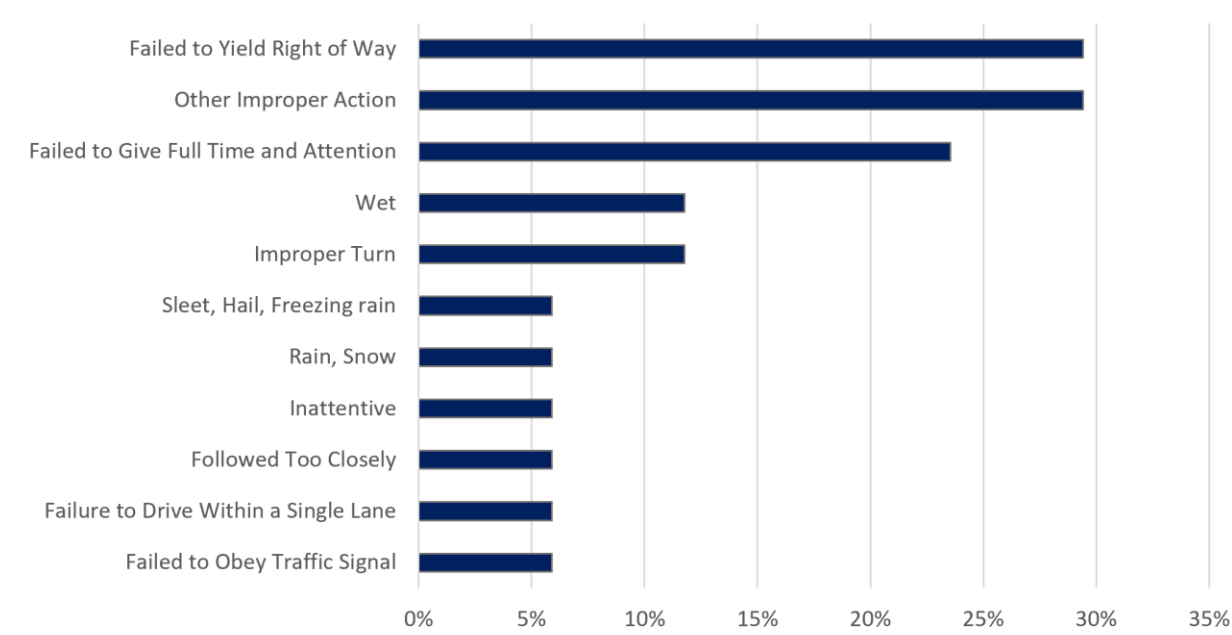
NEAR-MISS VIDEO ANALYSIS
