Safe Streets for All
**VISION ZERO
INTERSECTION
SAFETY AUDITS**

City of Rockville, Maryland

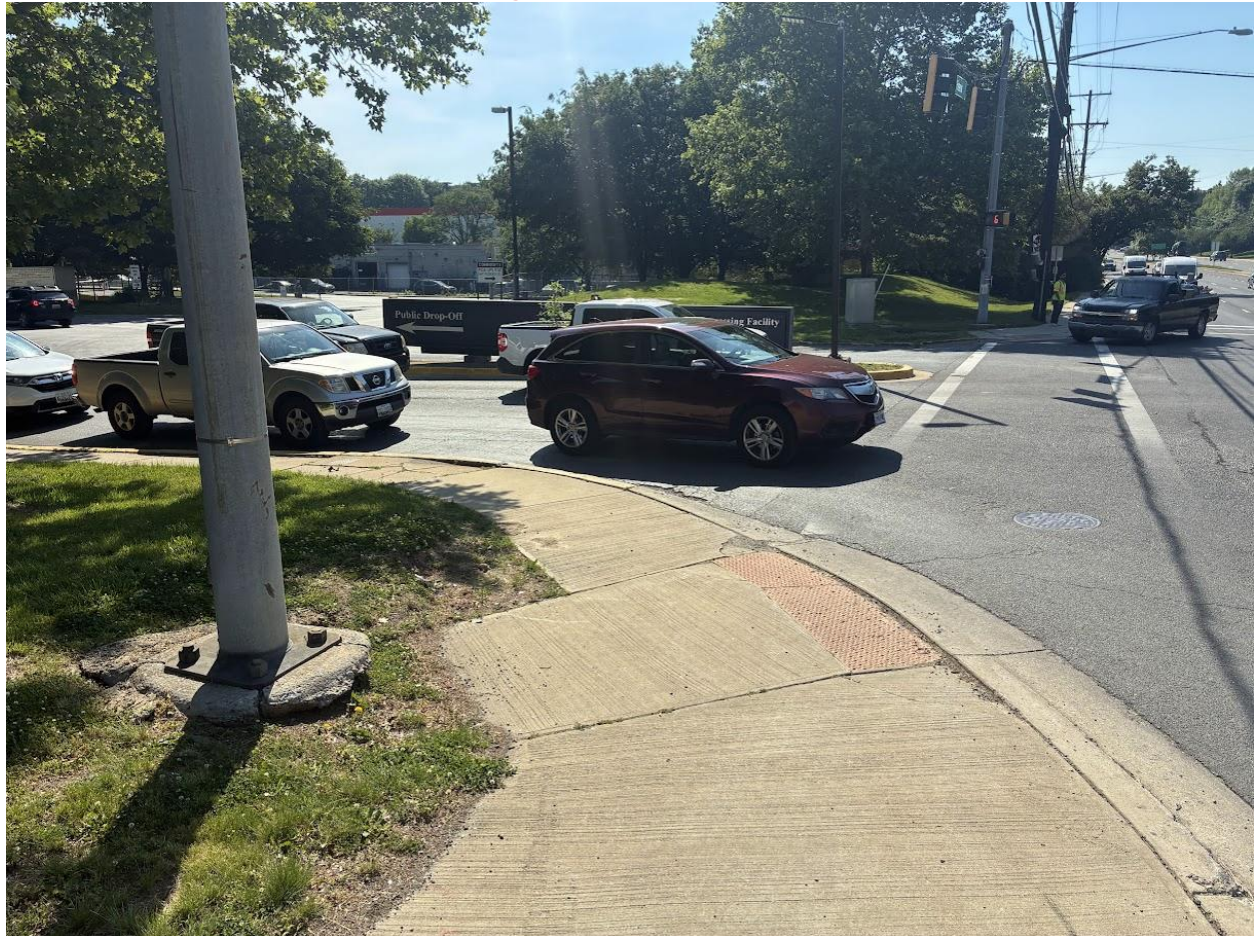
Figure 158. Missing crosswalk on the southbound approach at Intersection #24 - Frederick Road (MD 355) & Ridgemont Avenue

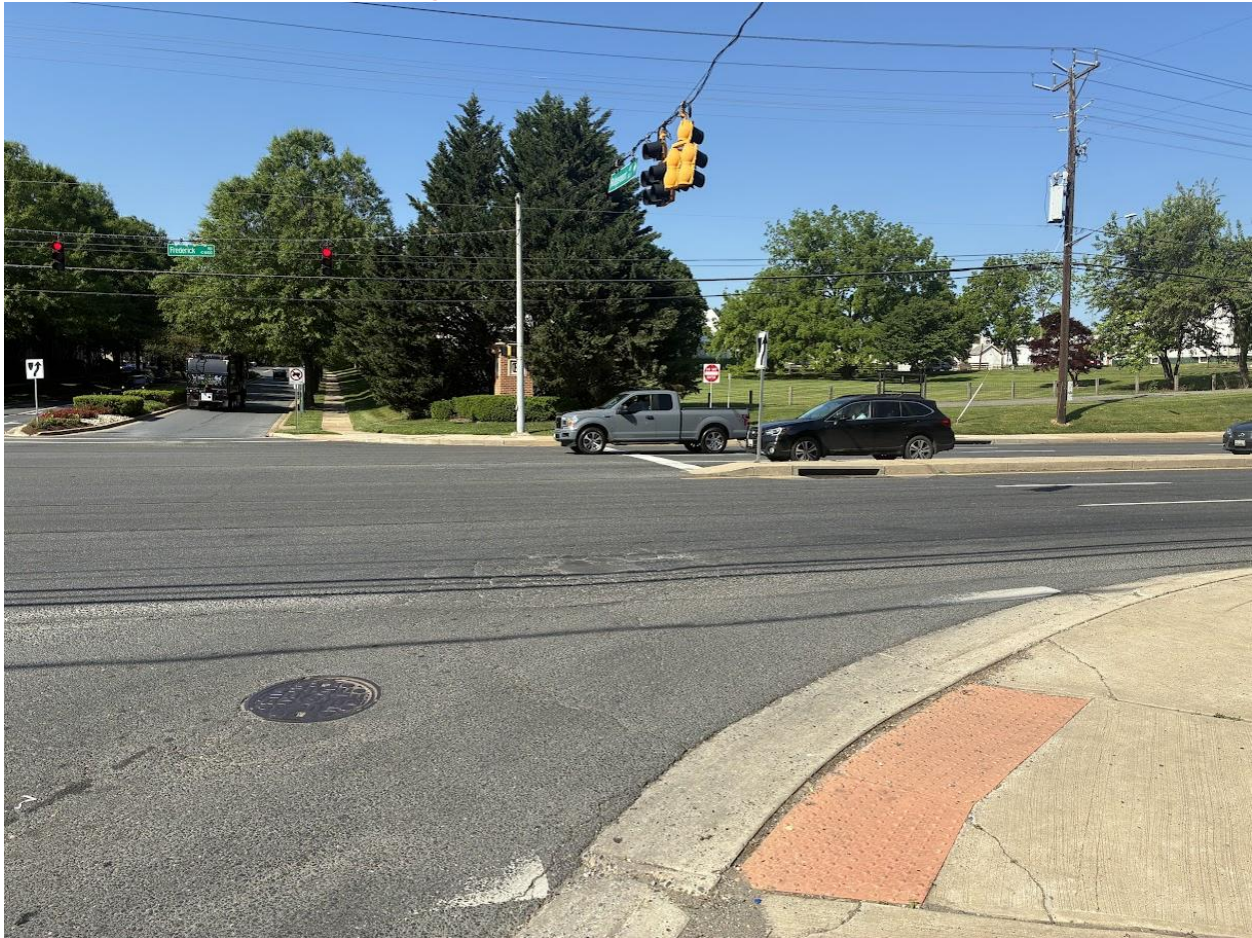
IDENTIFIED SAFETY ISSUES

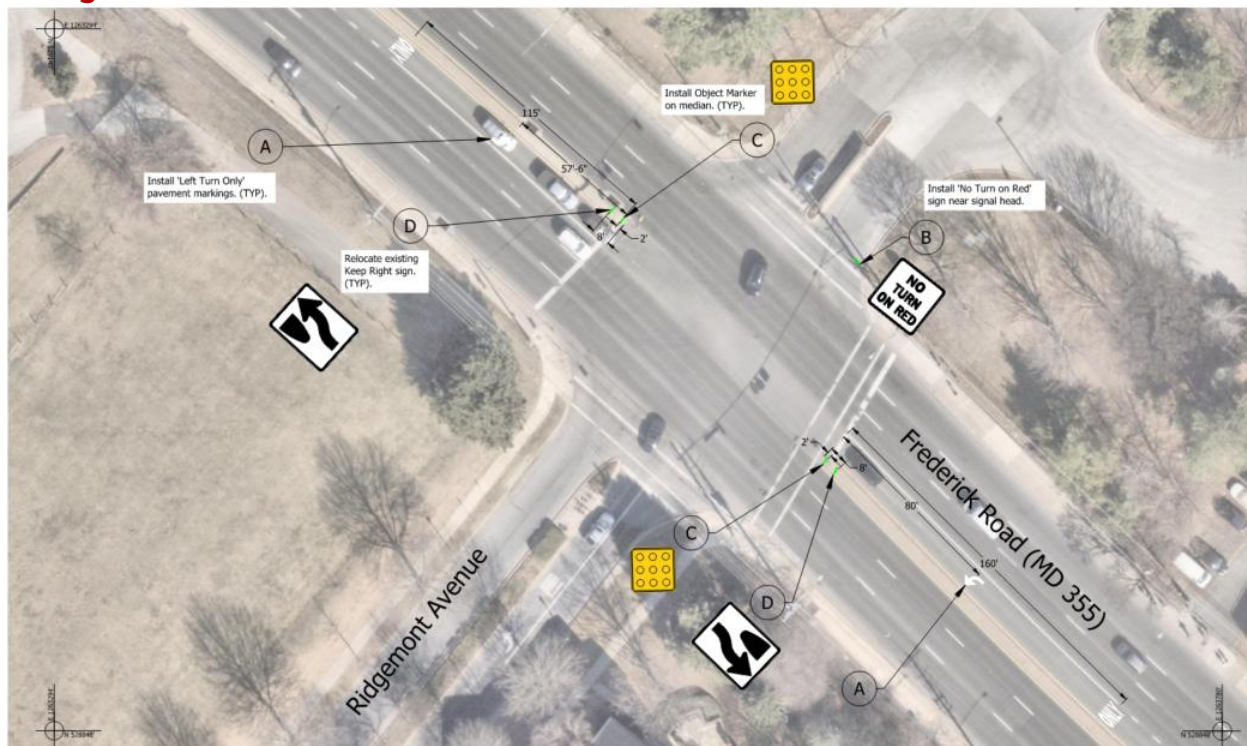
Figure 159. Short-Term Recommendations for Intersection #24 - Frederick Road (MD 355) & Ridgmont Avenue

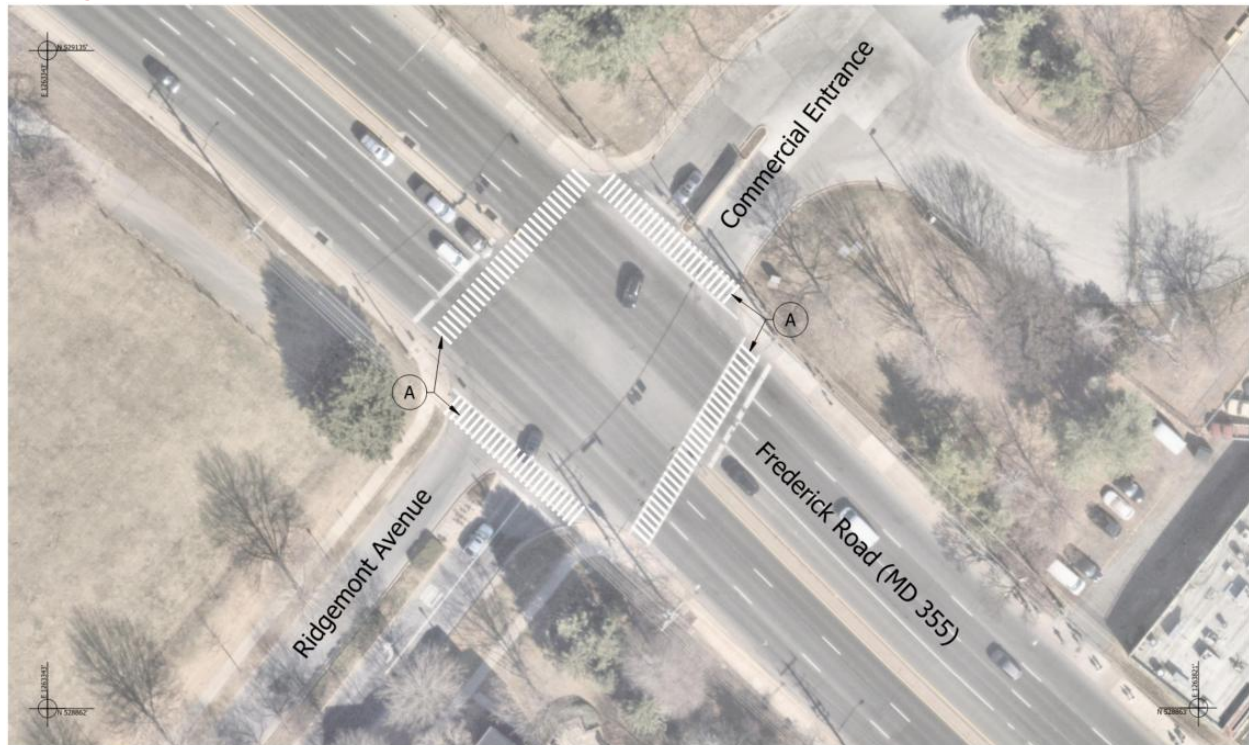
Figure 160. Long-Term Recommendations for Intersection #24 - Frederick Road (MD 355) & Ridgemont Avenue

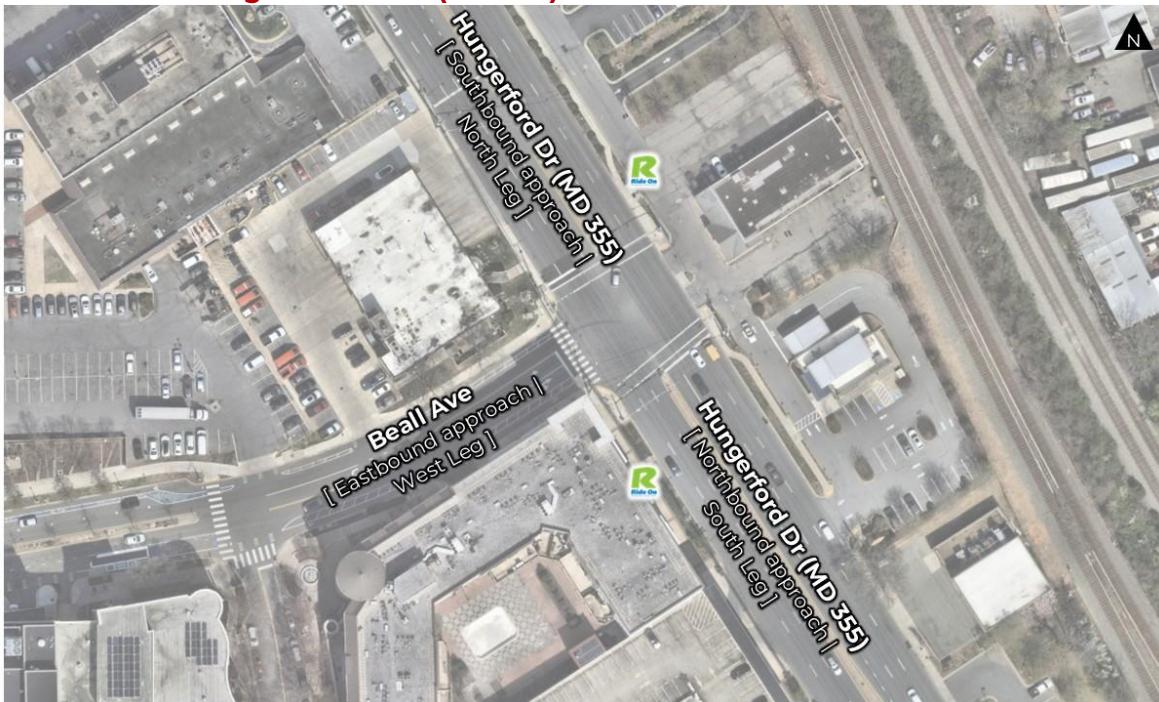
Figure 161. #25 - Hungerford Drive (MD 355) & Beall Avenue Intersection

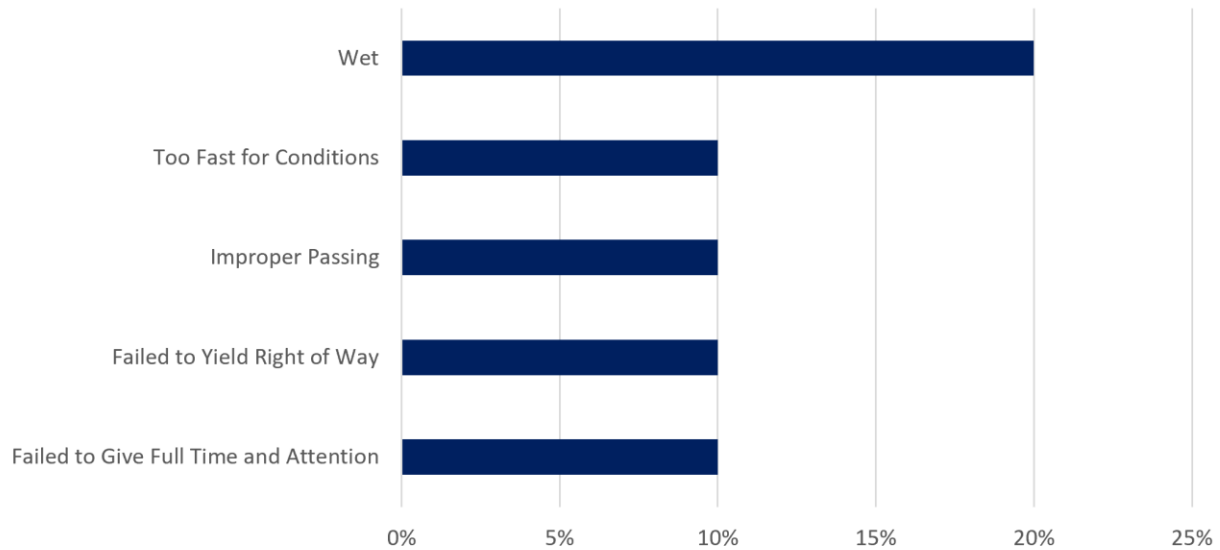
NEAR-MISS VIDEO ANALYSIS

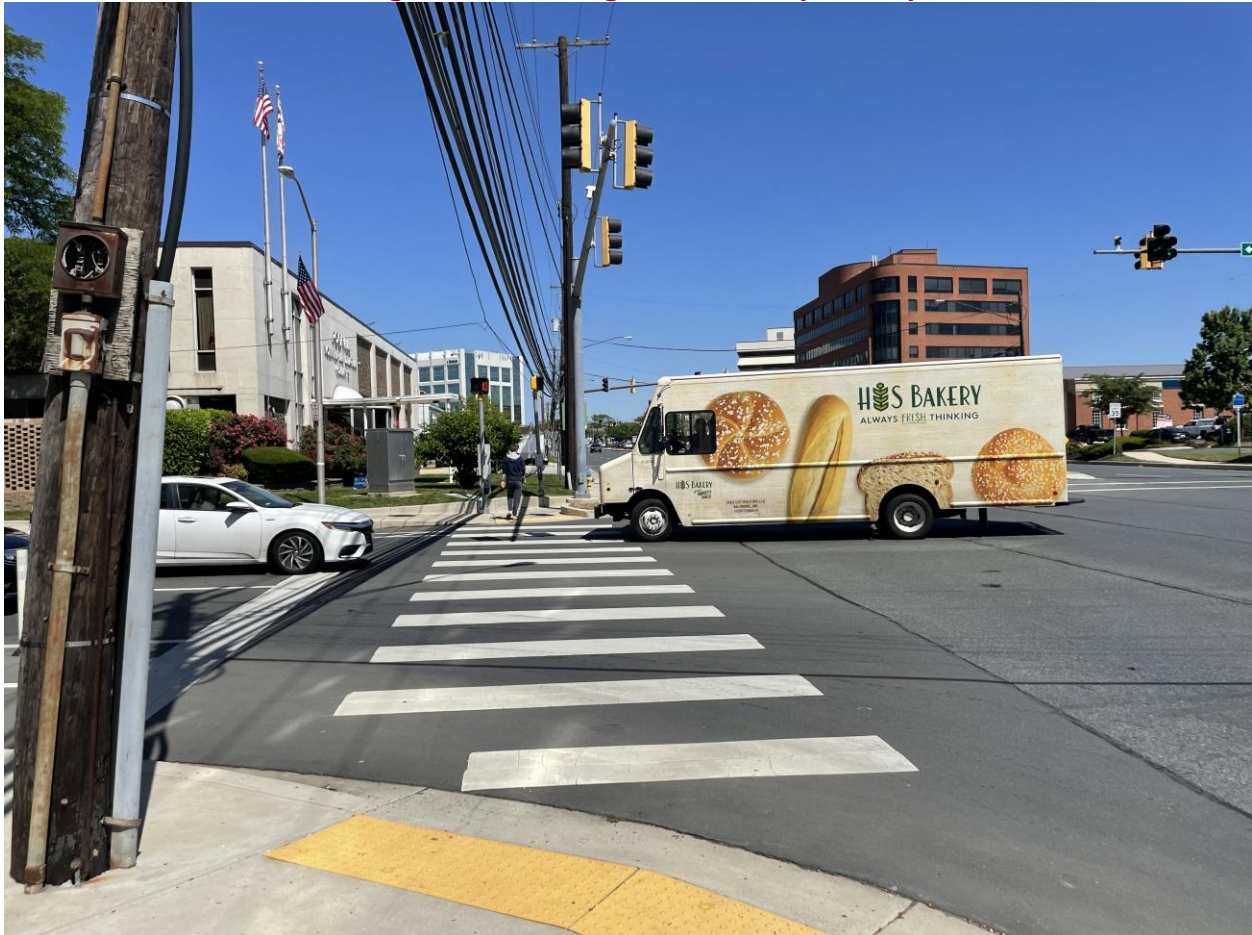
Figure 164. Long pedestrian crosswalks on the north and south legs with left-turn vehicles and deteriorated pavement markings lacking high visibility design #25 - Hungerford Drive (MD 355) & Beall Avenue

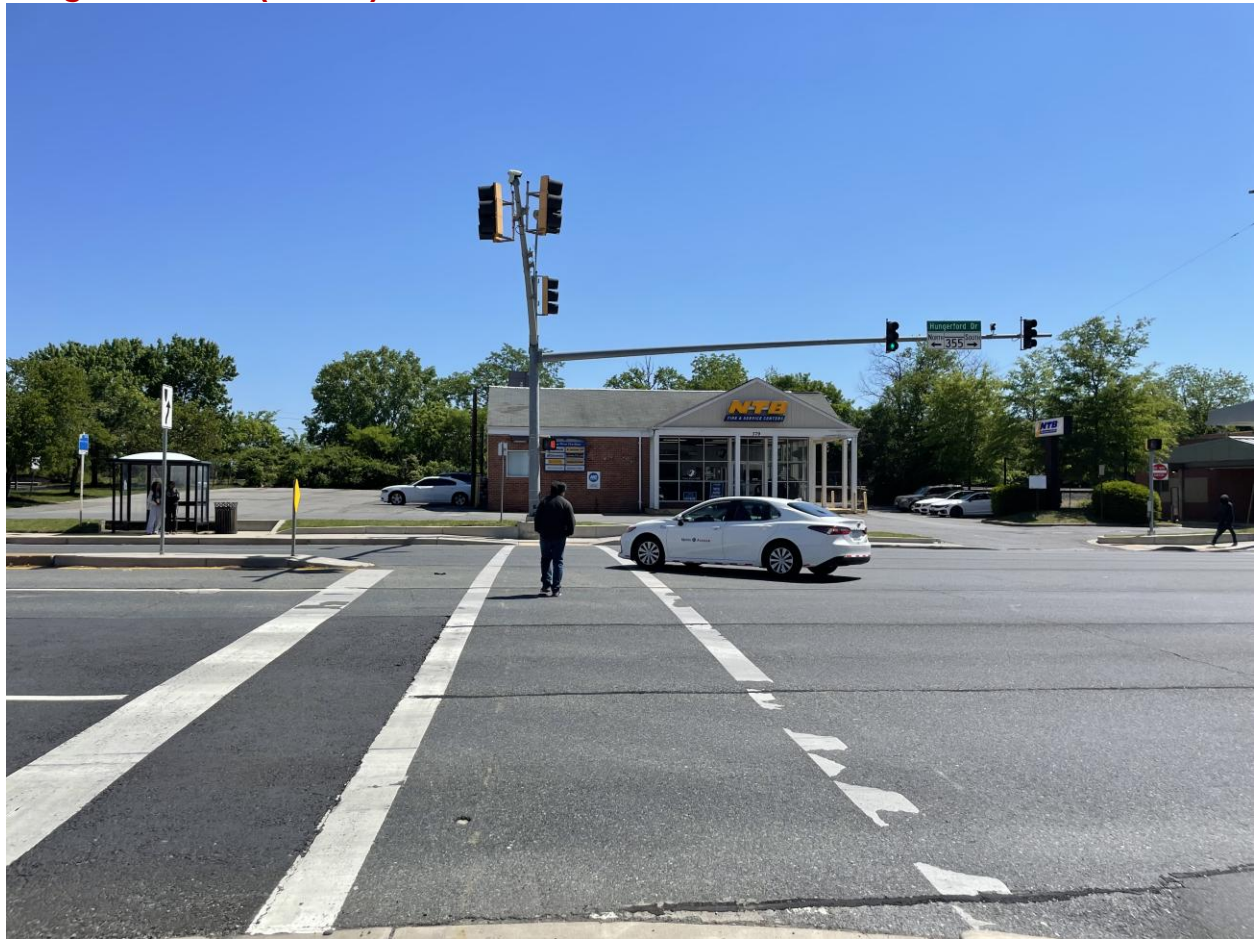
Figure 165. Unmarked pedestrian crosswalk over driveways on east leg #25 - Hungerford Drive (MD 355) & Beall Avenue

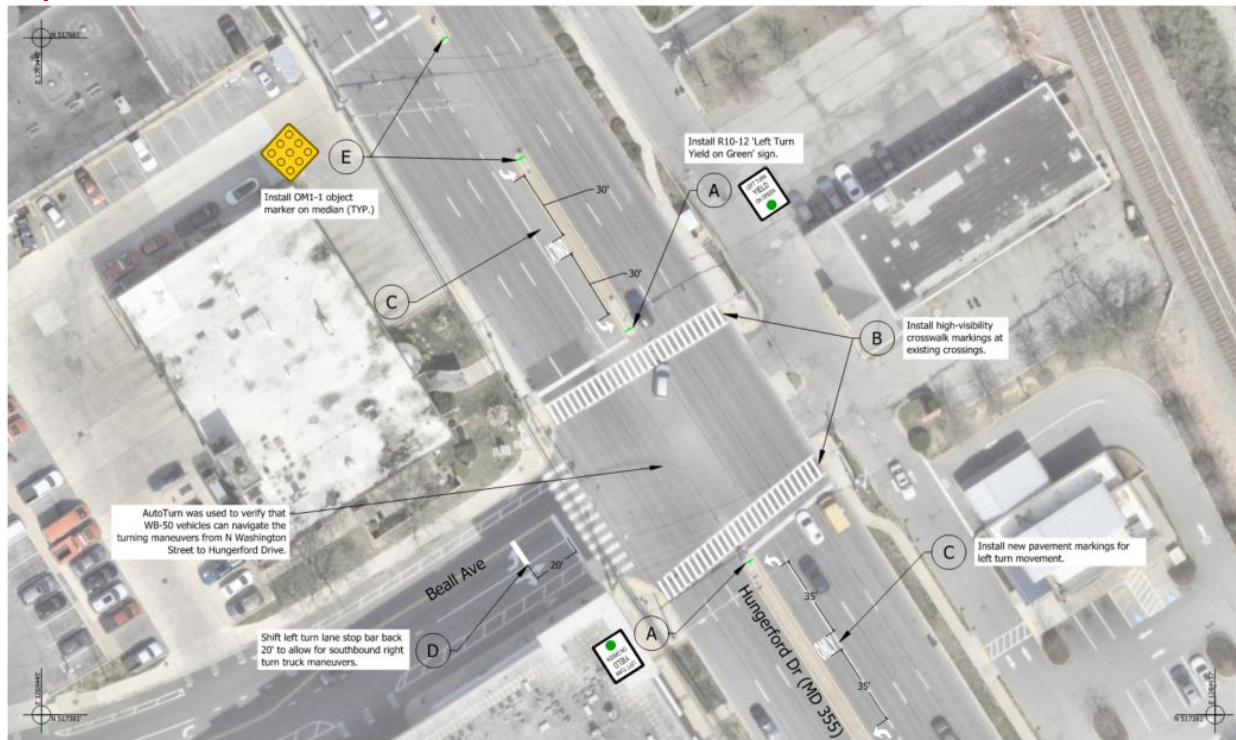
Figure 166. Short-Term Recommendations for Intersection #25 - Hungerford Drive (MD 355) & Beall Avenue

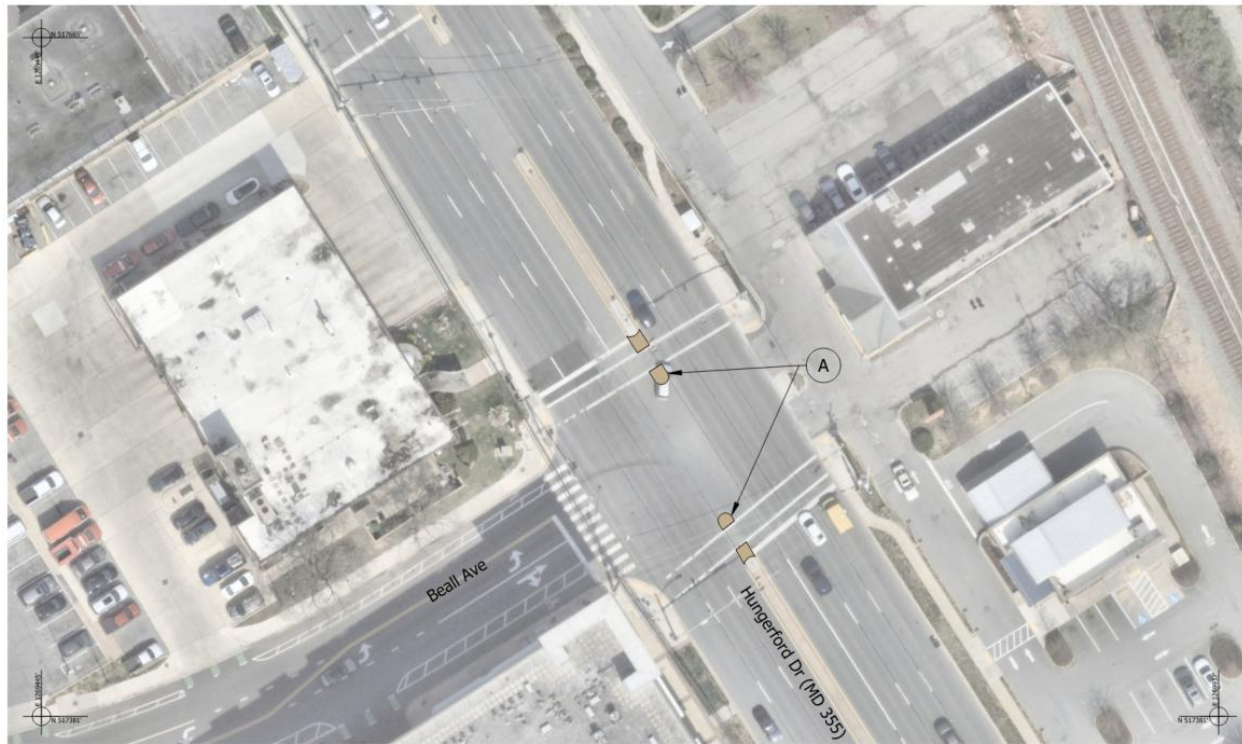
Figure 167. Long-Term Recommendations for Intersection #25 - Hungerford Drive (MD 355) & Beall Avenue

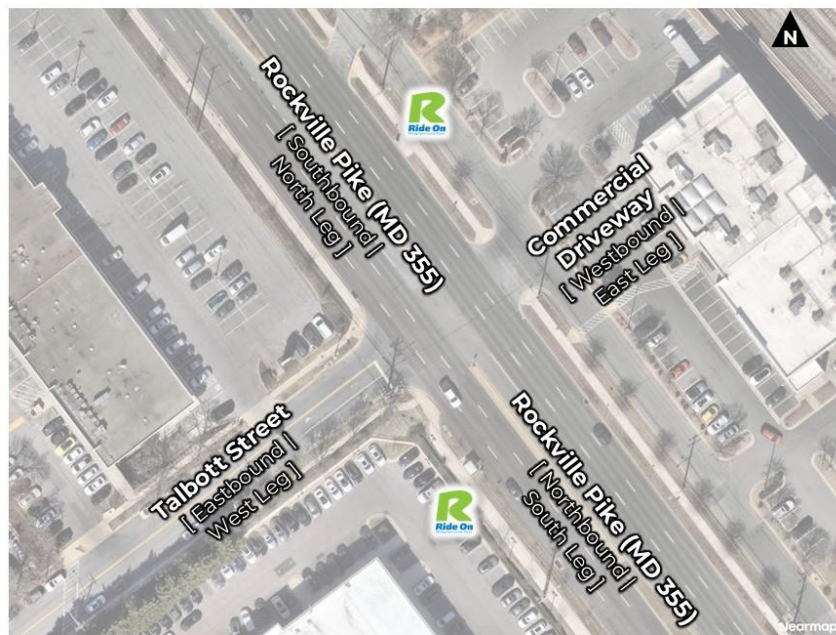
Figure 168. #26 - Rockville Pike (MD 355) & Talbott Street Intersection

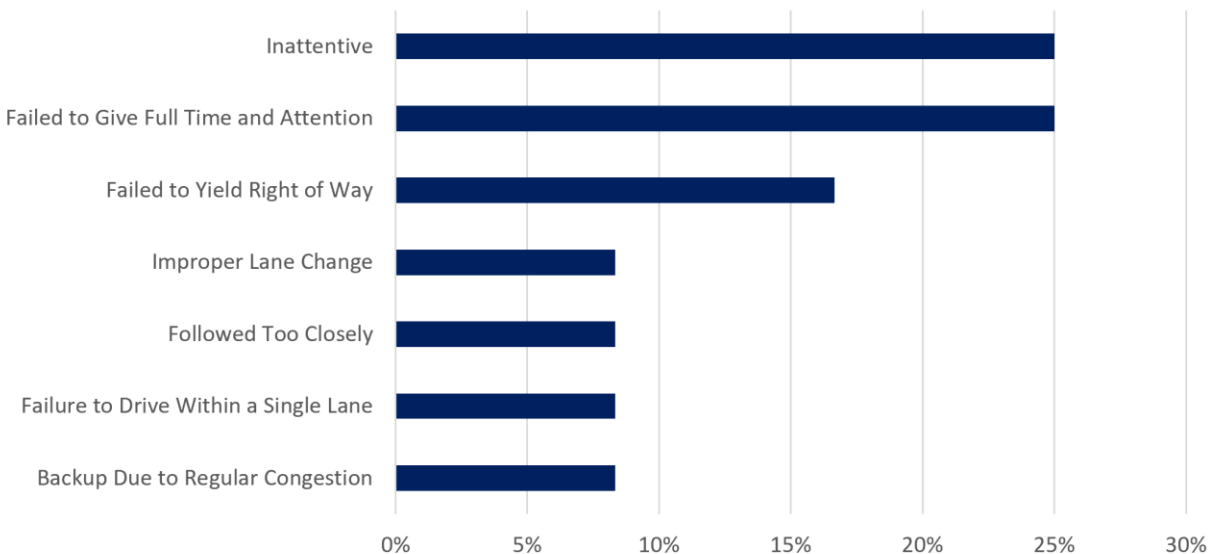
NEAR-MISS VIDEO ANALYSIS

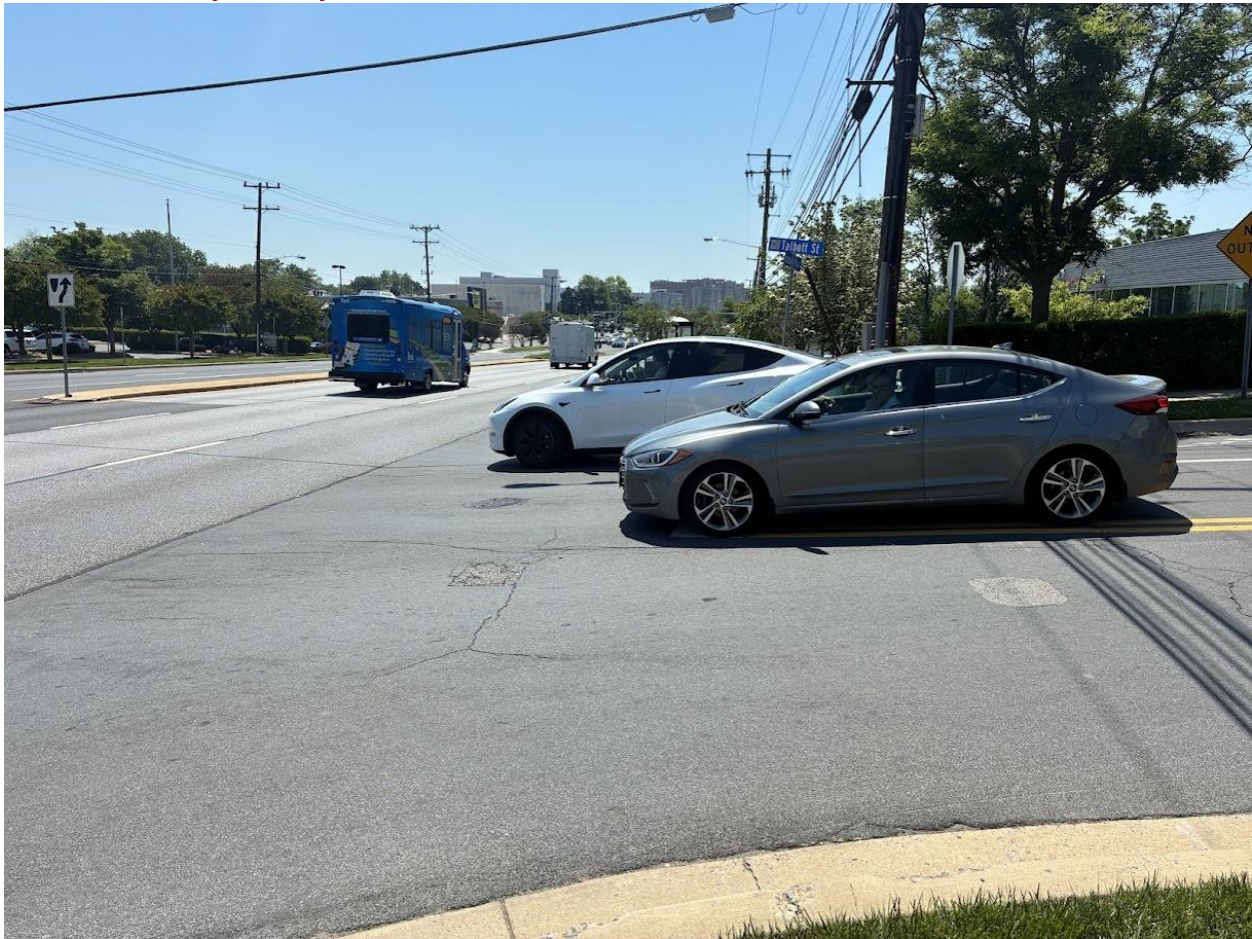
Figure 171. Drivers using the median as a 'refuge' at Intersection #26 - Rockville Pike (MD 355) & Talbott Street

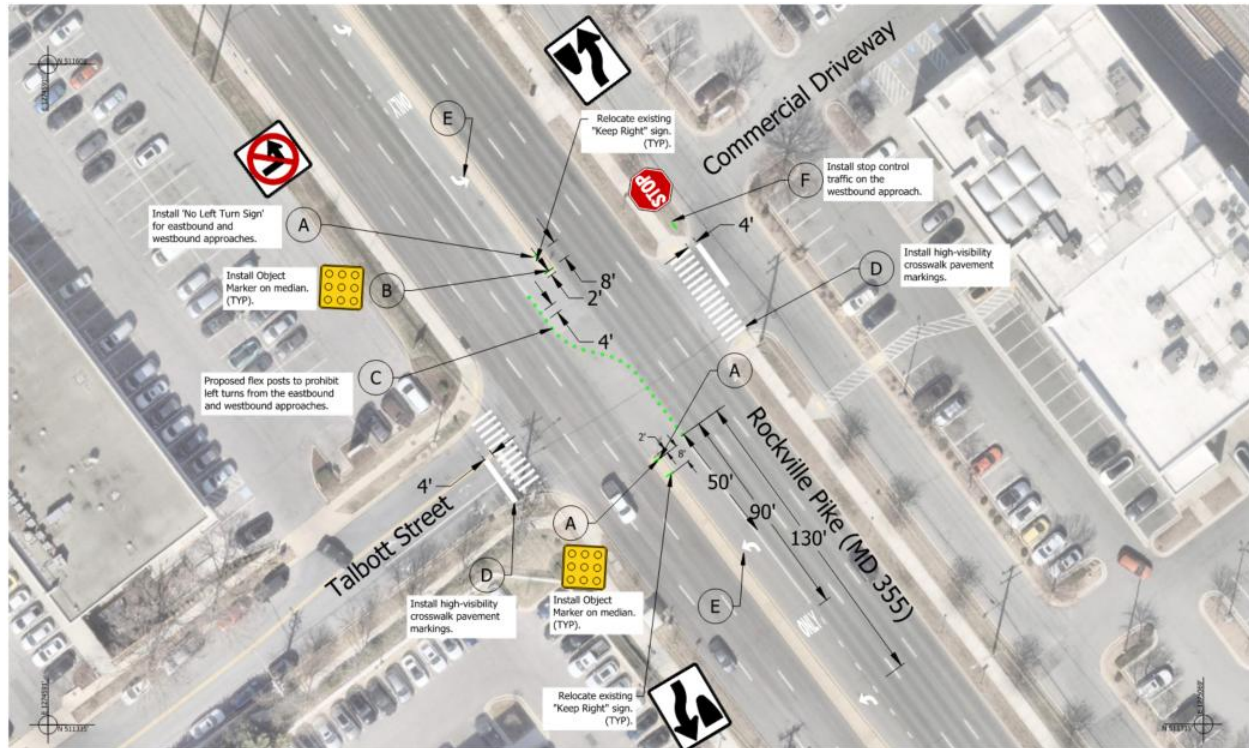
Figure 172. Short-Term Recommendations for Intersection #26 - Rockville Pike (MD 355) & Talbott Street

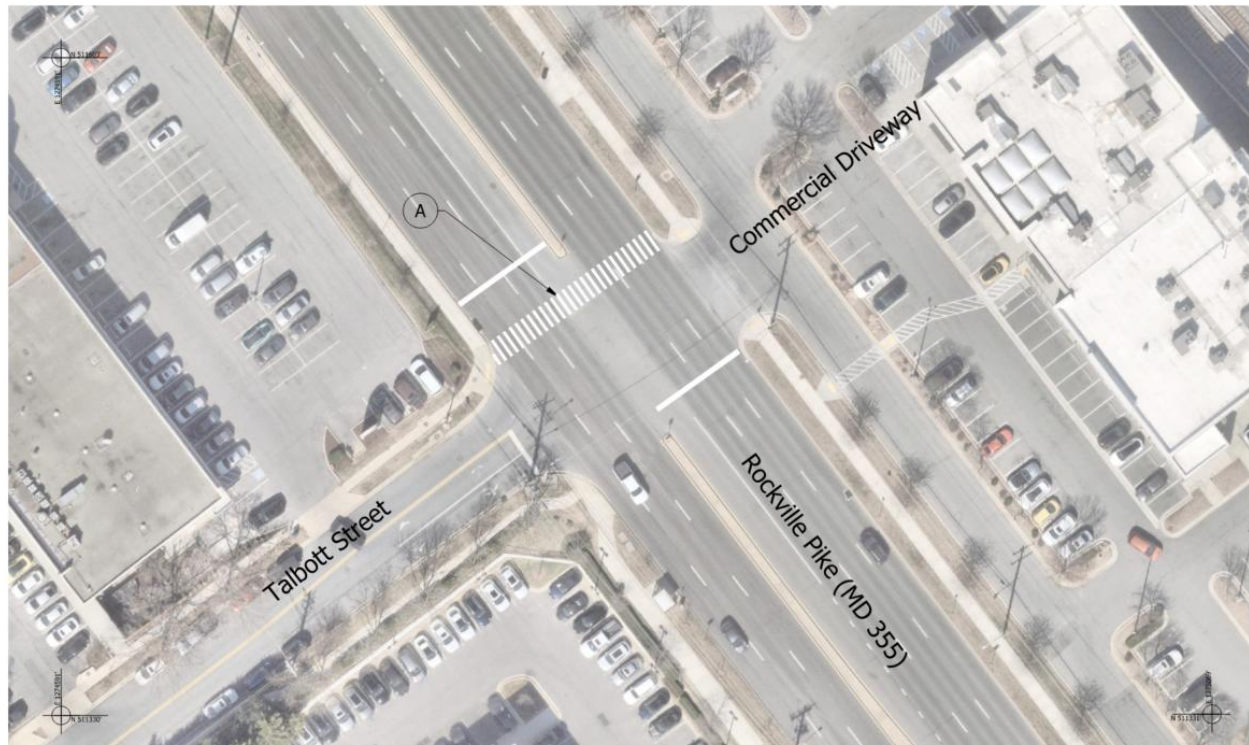
Figure 173. Long-Term Recommendations for Intersection #26 - Rockville Pike (MD 355) & Talbott Street

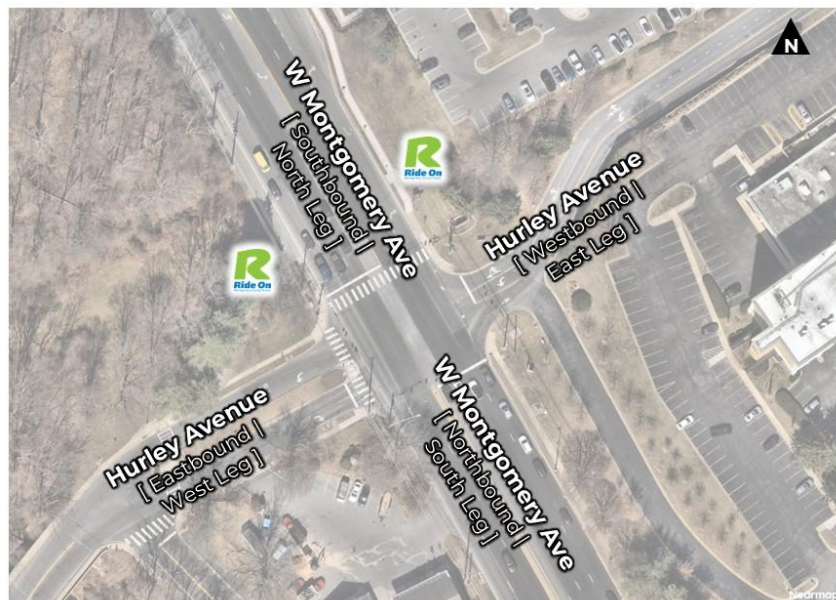
Figure 174. #27 - West Montgomery Avenue (MD 28) & Hurley Avenue Intersection

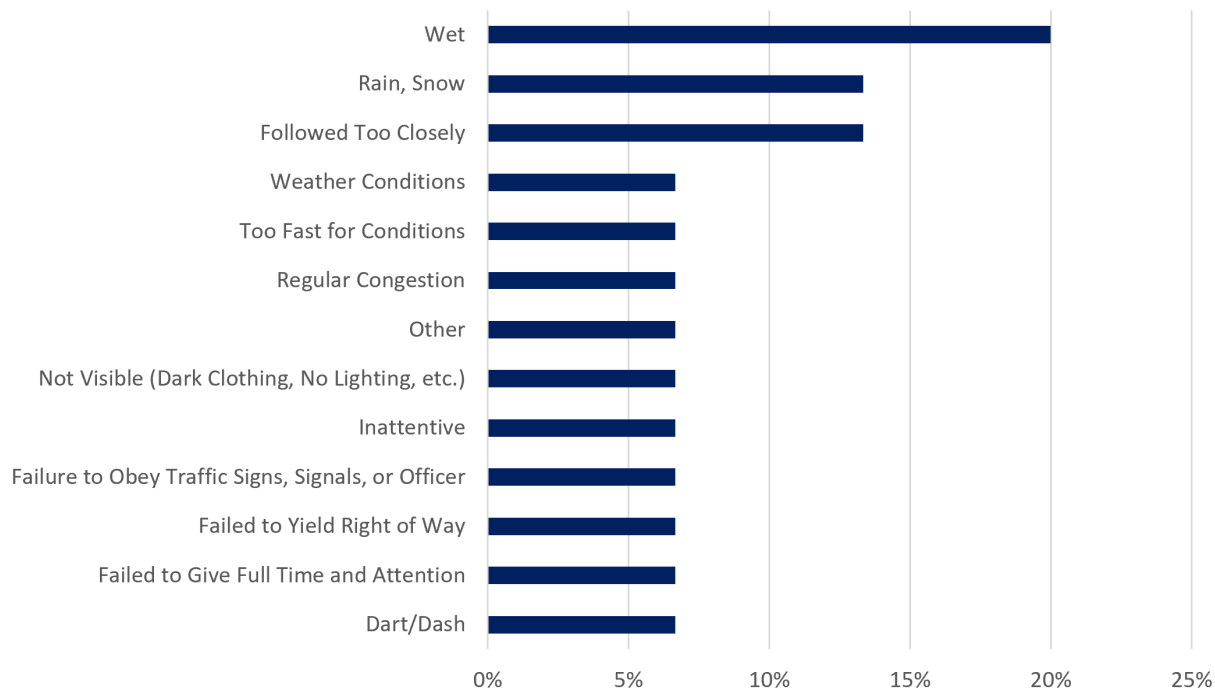
NEAR-MISS VIDEO ANALYSIS

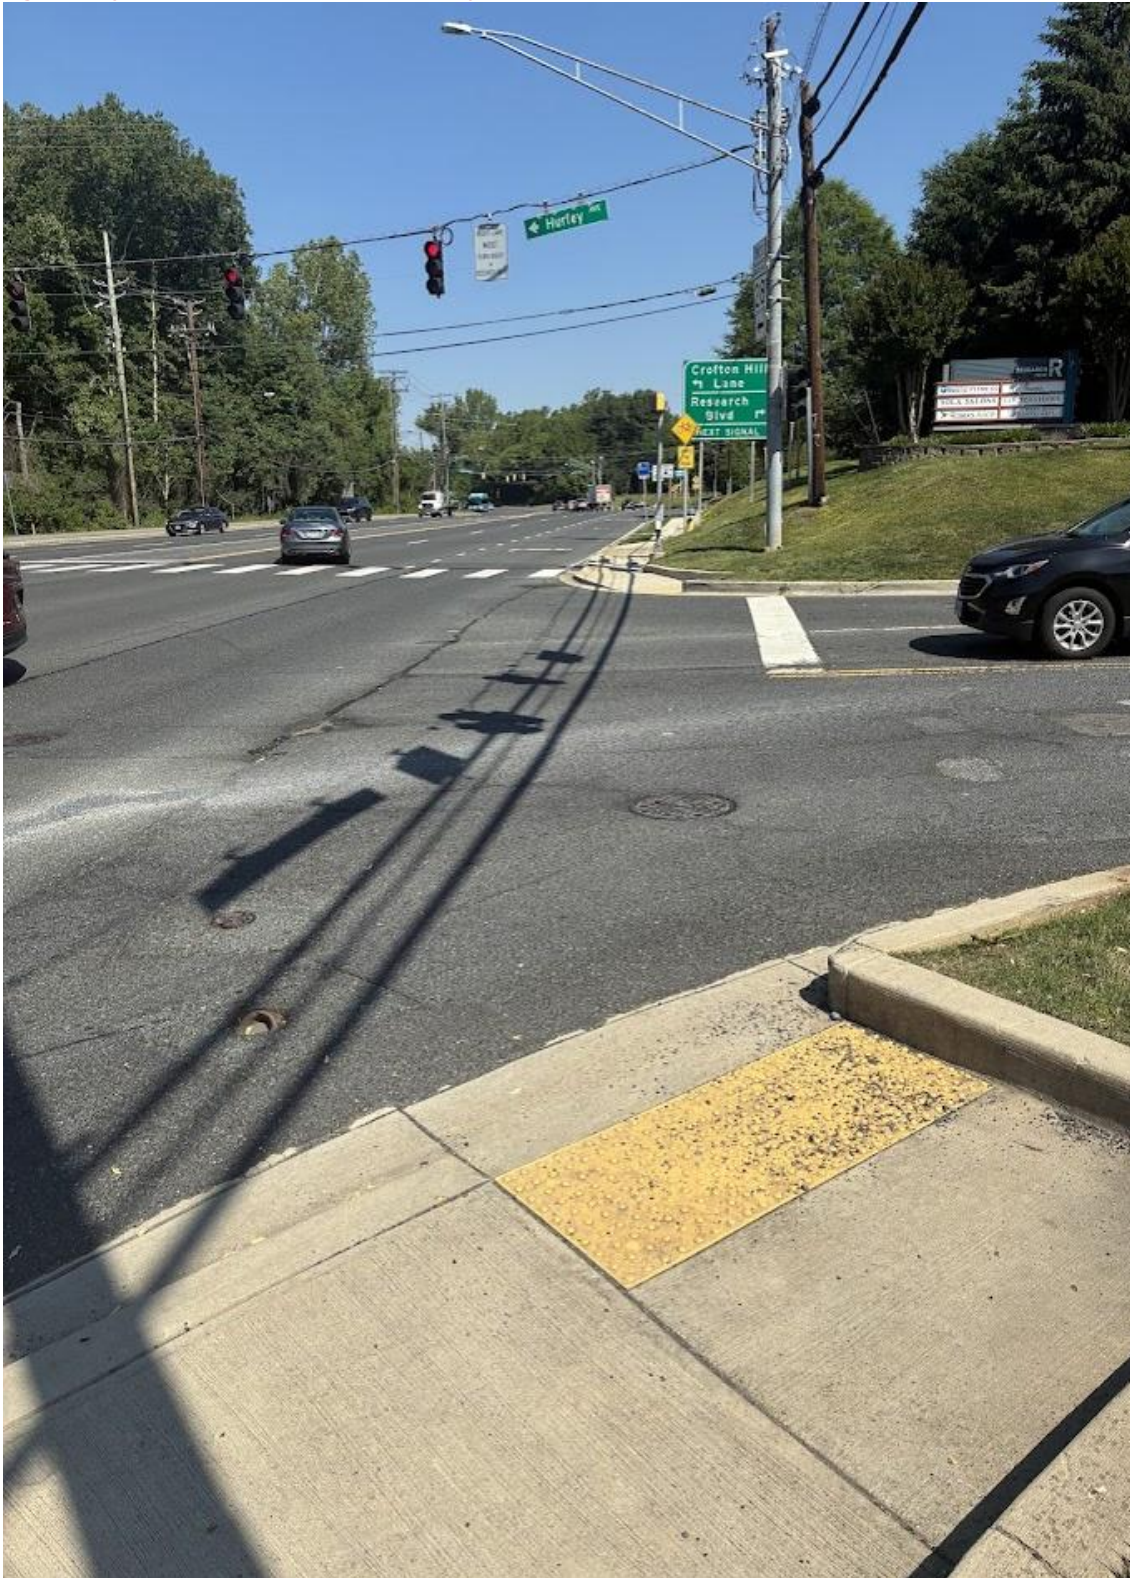
IDENTIFIED SAFETY ISSUES

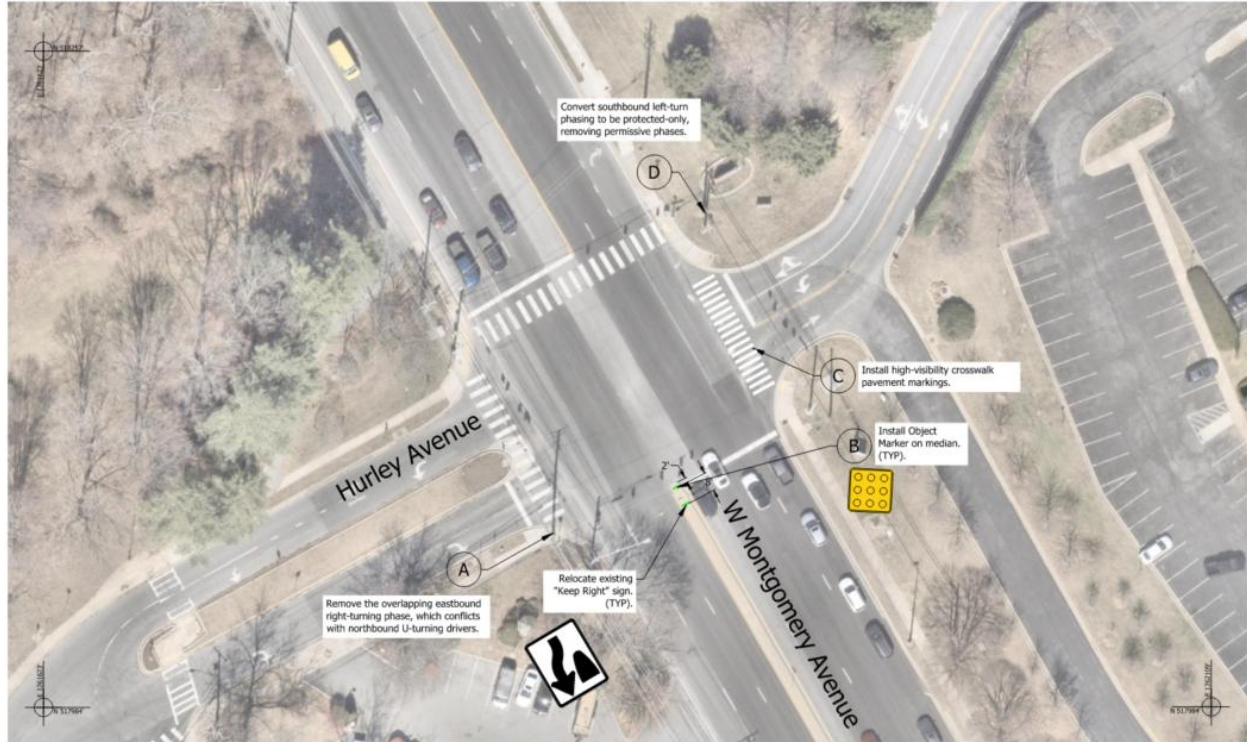
Figure 177. Short-Term Recommendations for Intersection #27 - West Montgomery Avenue (MD 28) & Hurley Avenue

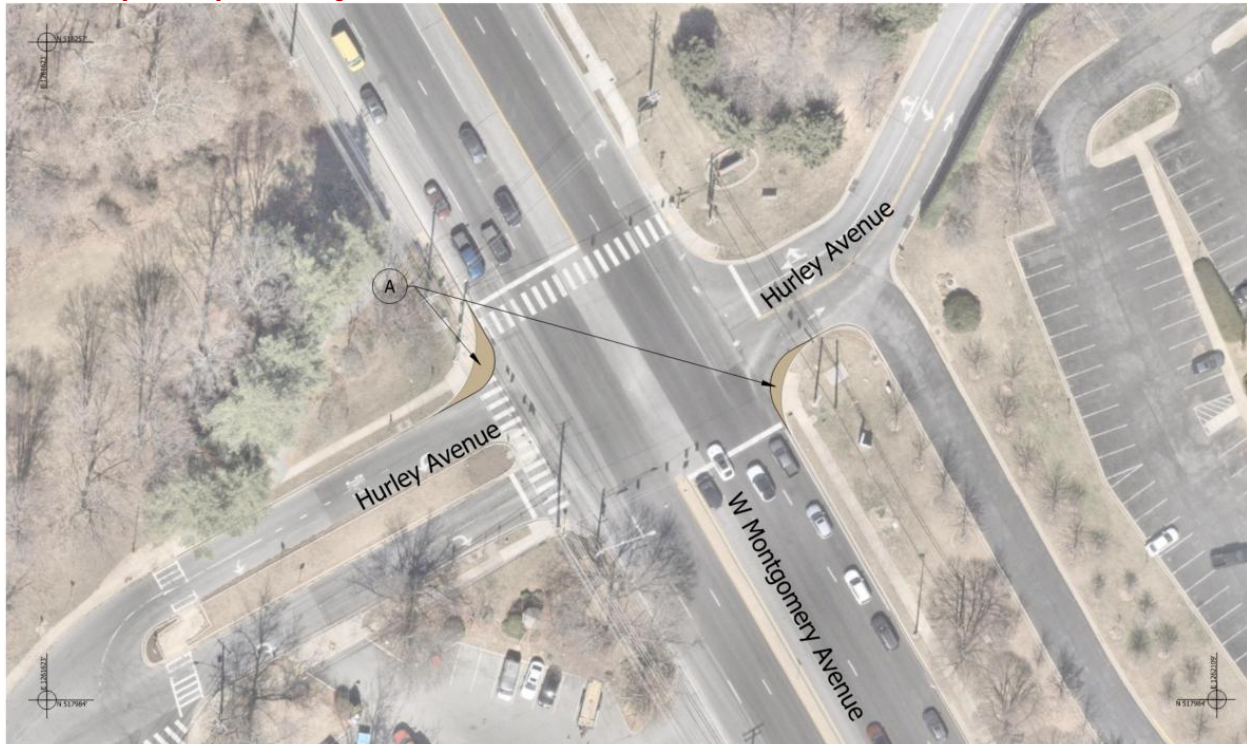
Figure 178. Long-Term Recommendations for Intersection #27 - West Montgomery Avenue (MD 28) & Hurley Avenue

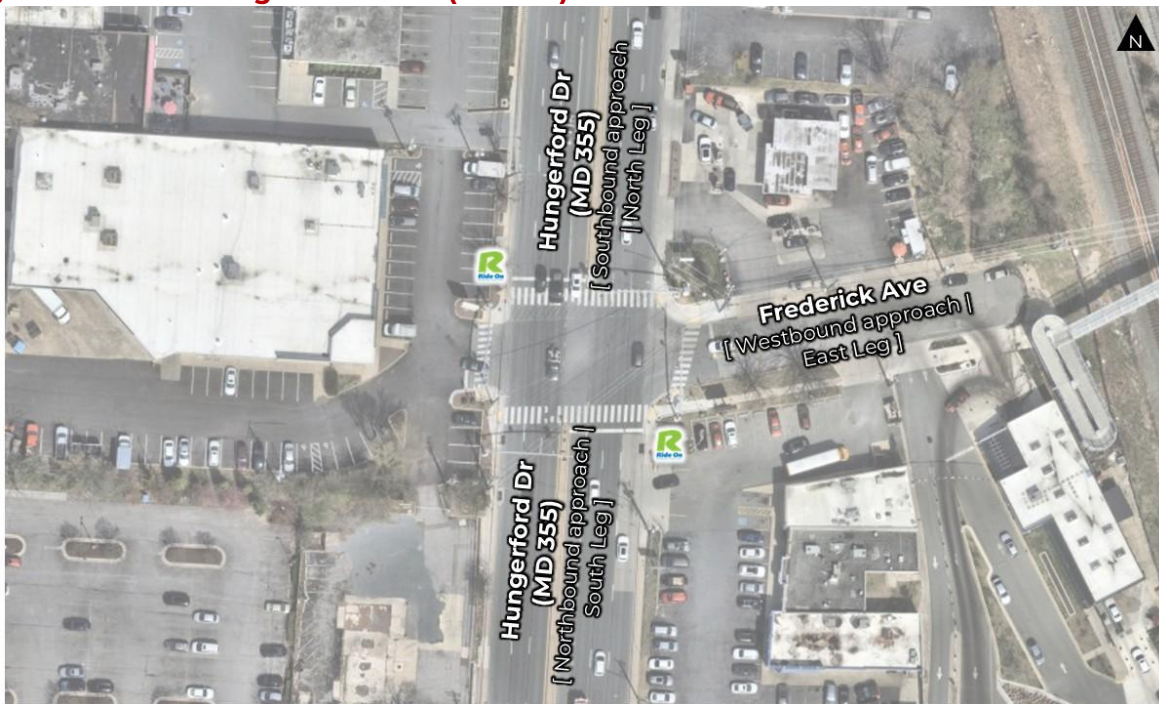
Figure 179. #28 - Hungerford Drive (MD 355) & Frederick Avenue Intersection

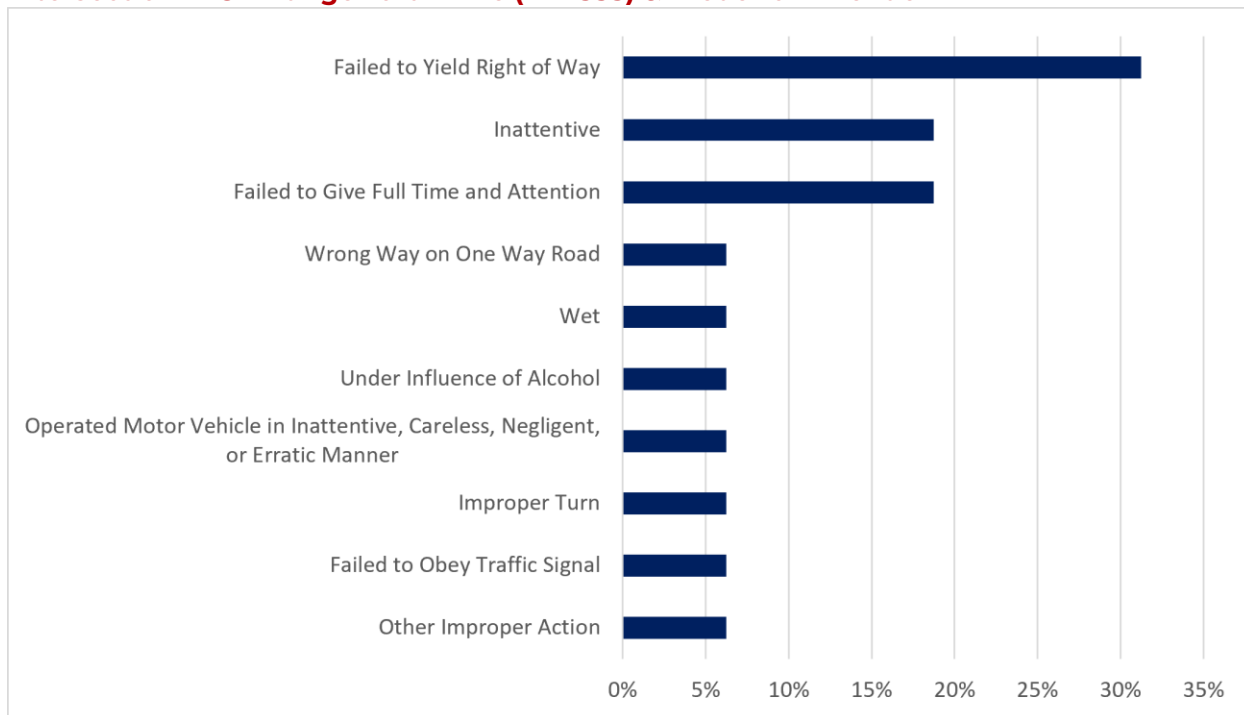
NEAR-MISS VIDEO ANALYSIS

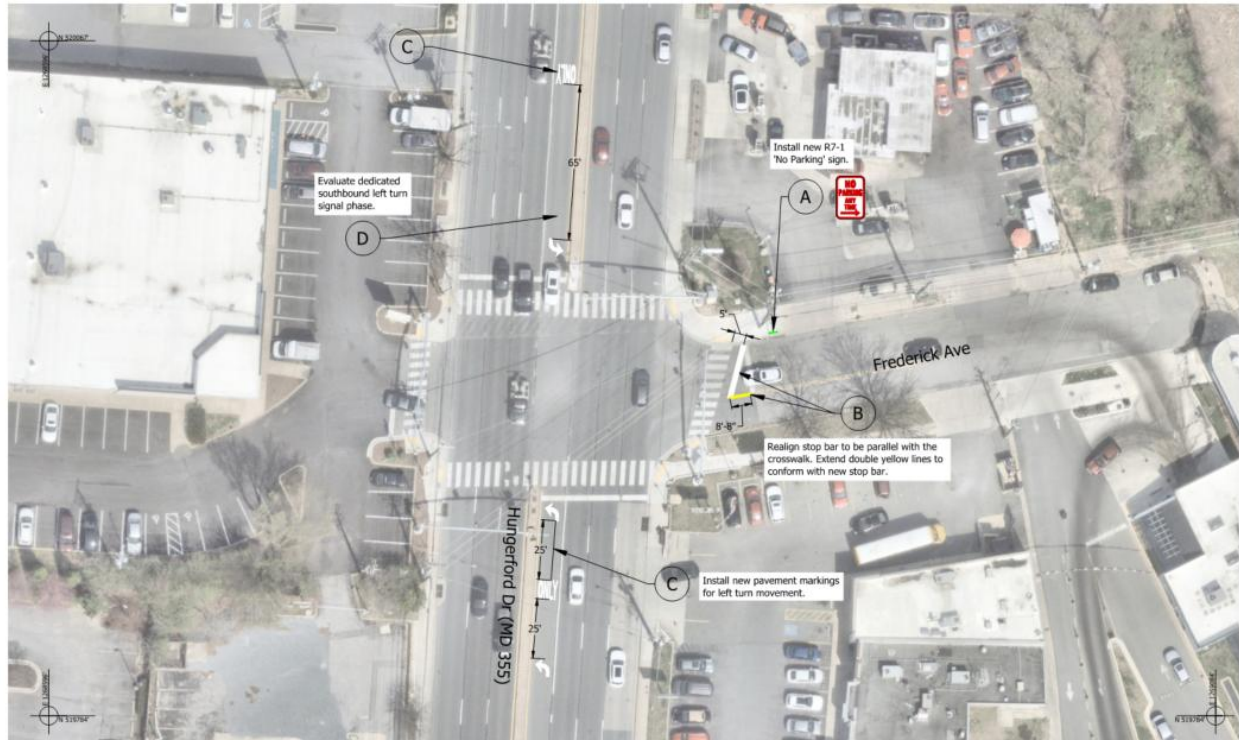
Figure 184. Short-Term Recommendations for Intersection #28 - Hungerford Drive (MD 355) & Frederick Avenue

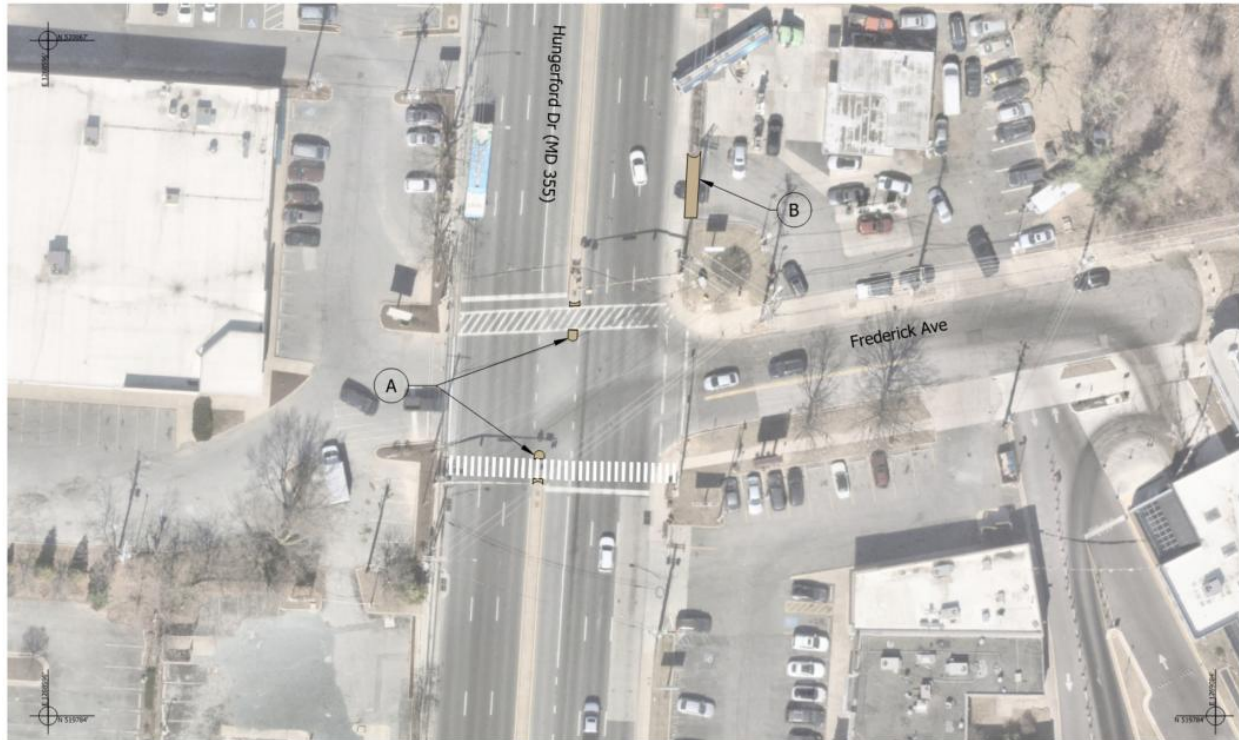
Figure 185. Long-Term Recommendations for Intersection #28 - Hungerford Drive (MD 355) & Frederick Avenue
