Safe Streets for All
**VISION ZERO
INTERSECTION
SAFETY AUDITS**

City of Rockville, Maryland

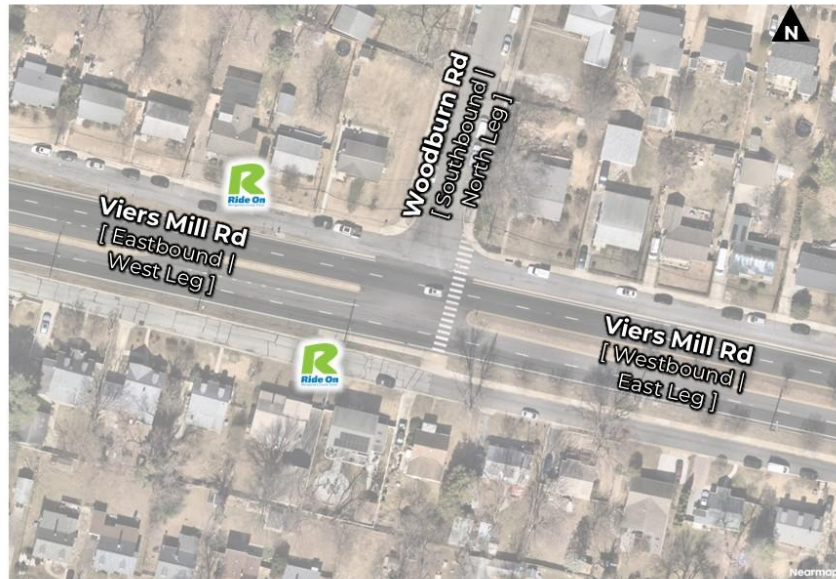
Figure 186. #29 - Veirs Mill Road (MD 586) & Woodburn Road Intersection

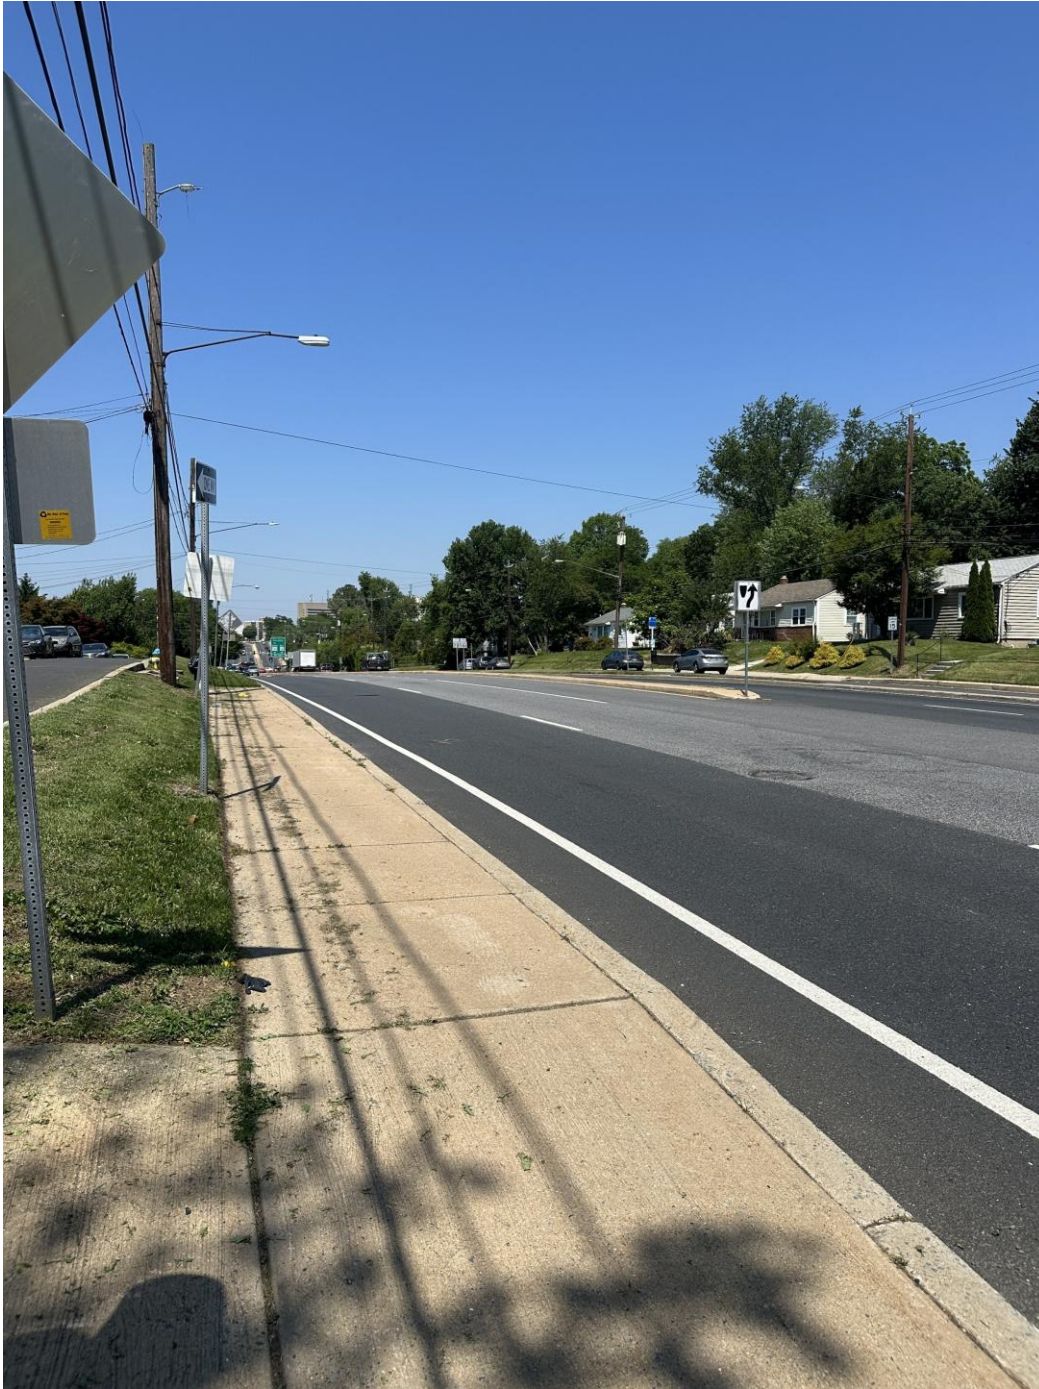
IDENTIFIED SAFETY ISSUES

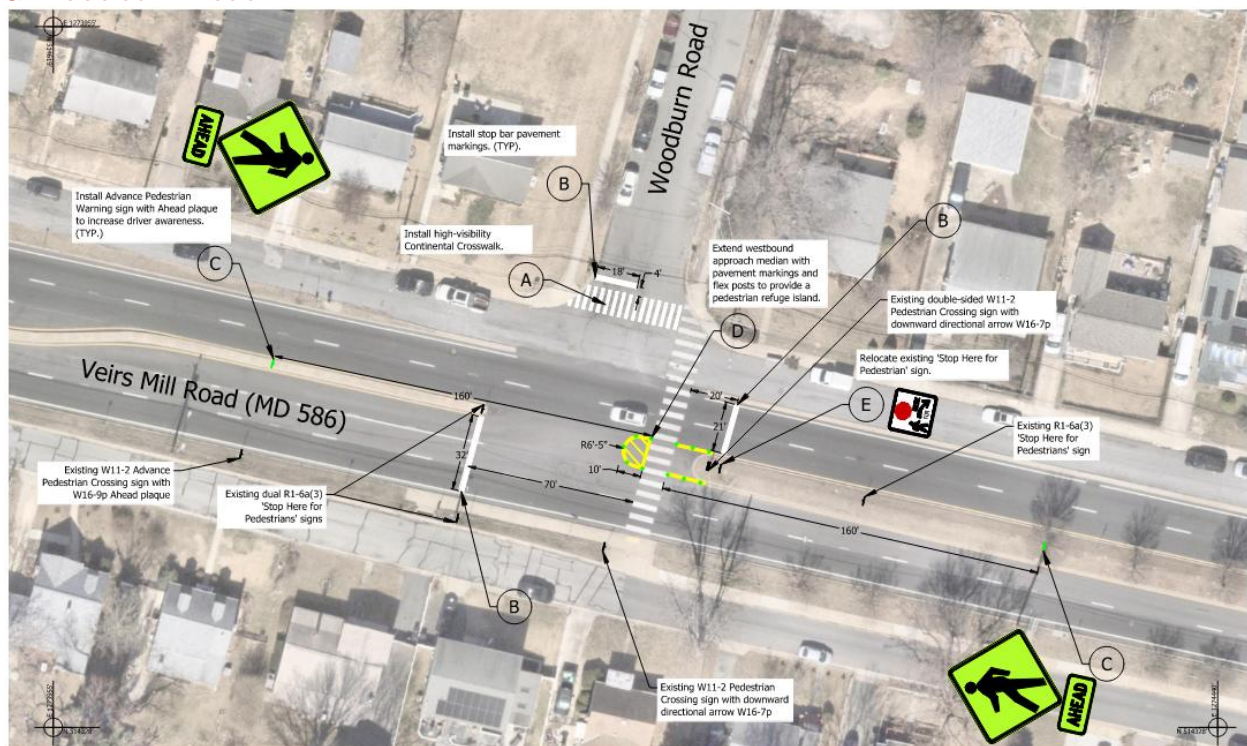
Figure 188. Short-Term Recommendations for Intersection #29 - Veirs Mill Road (MD 586) & Woodburn Road

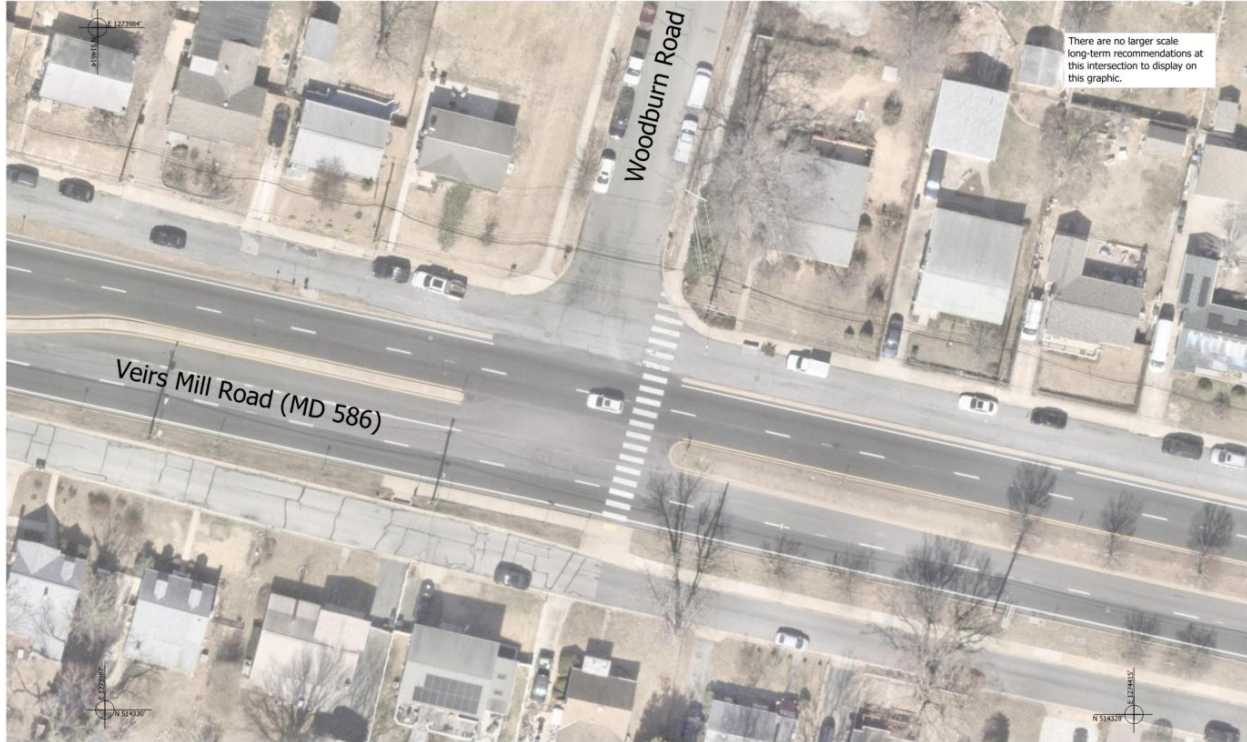
Table 228. Long-Term Recommendations for Intersection #29 - Veirs Mill Road (MD 586) & Woodburn Road

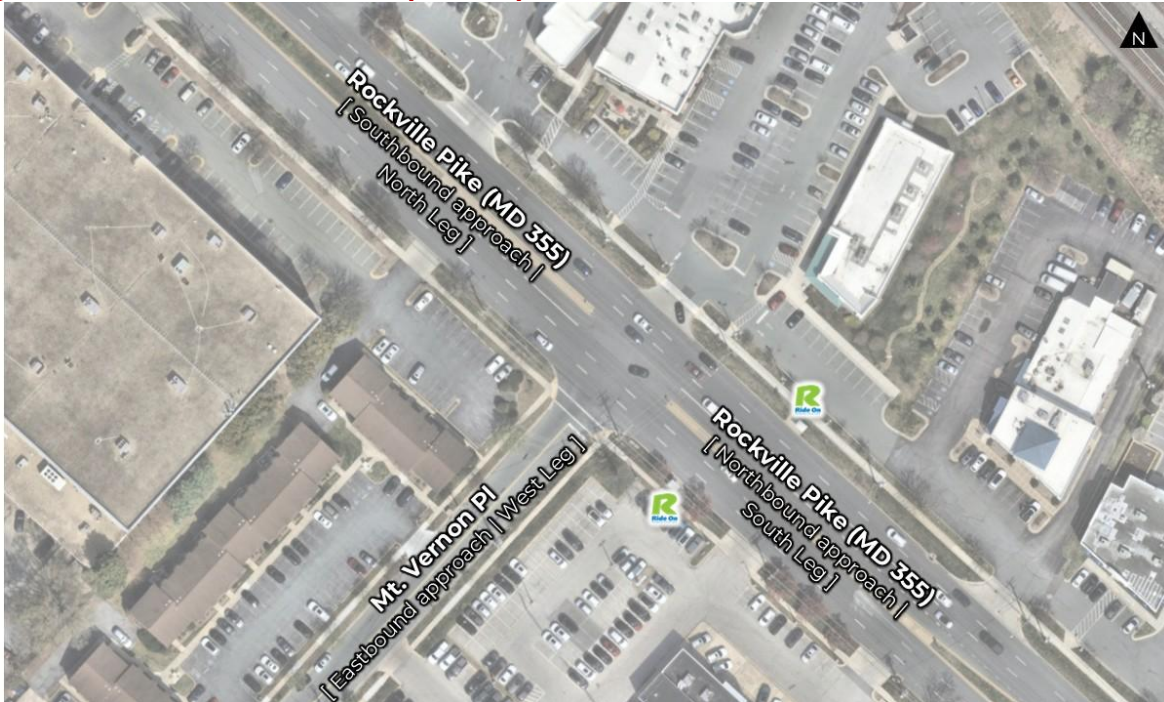
Figure 190. #30 - Rockville Pike (MD 355) & Mt. Vernon Place Intersection

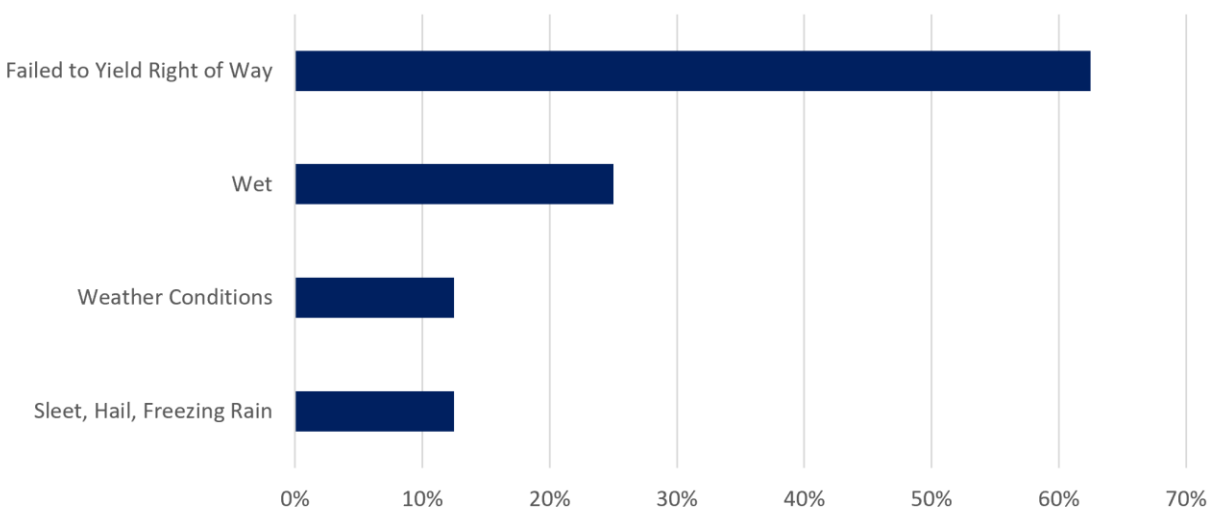
NEAR-MISS VIDEO ANALYSIS

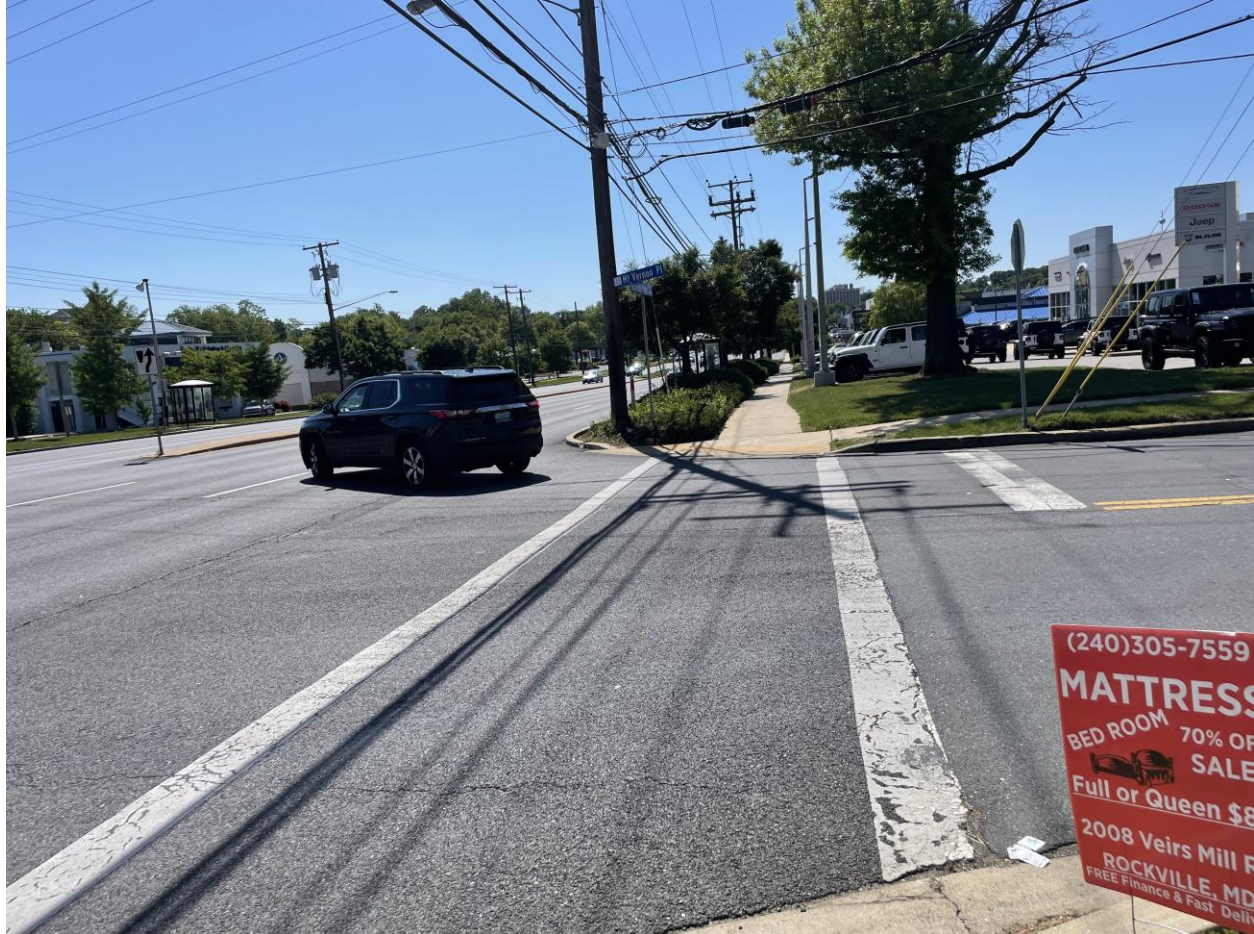
Figure 193. Permitted left turn from Mt. Vernon Place across four lanes of southbound Rockville Pike at intersection #30 - Rockville Pike (MD 355) & Mt. Vernon Place

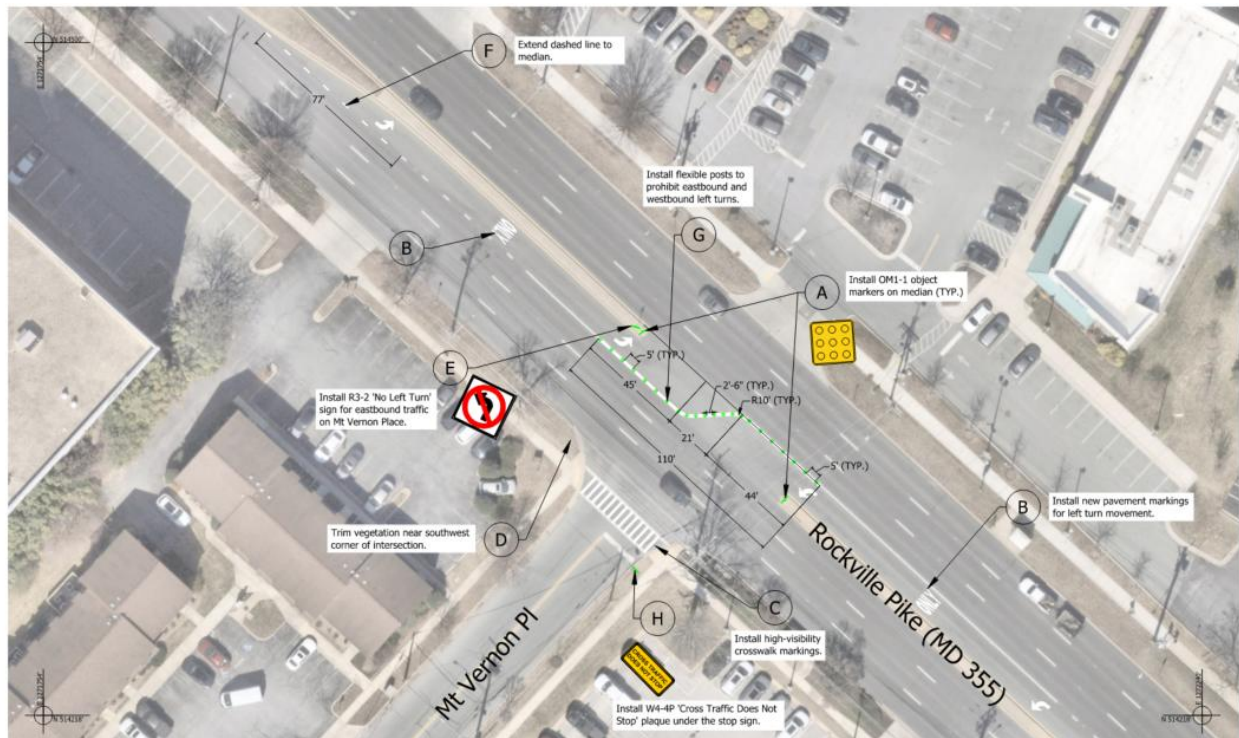
Figure 194. Short-Term Recommendations for Intersection #30 - Rockville Pike (MD 355) & Mt. Vernon Place

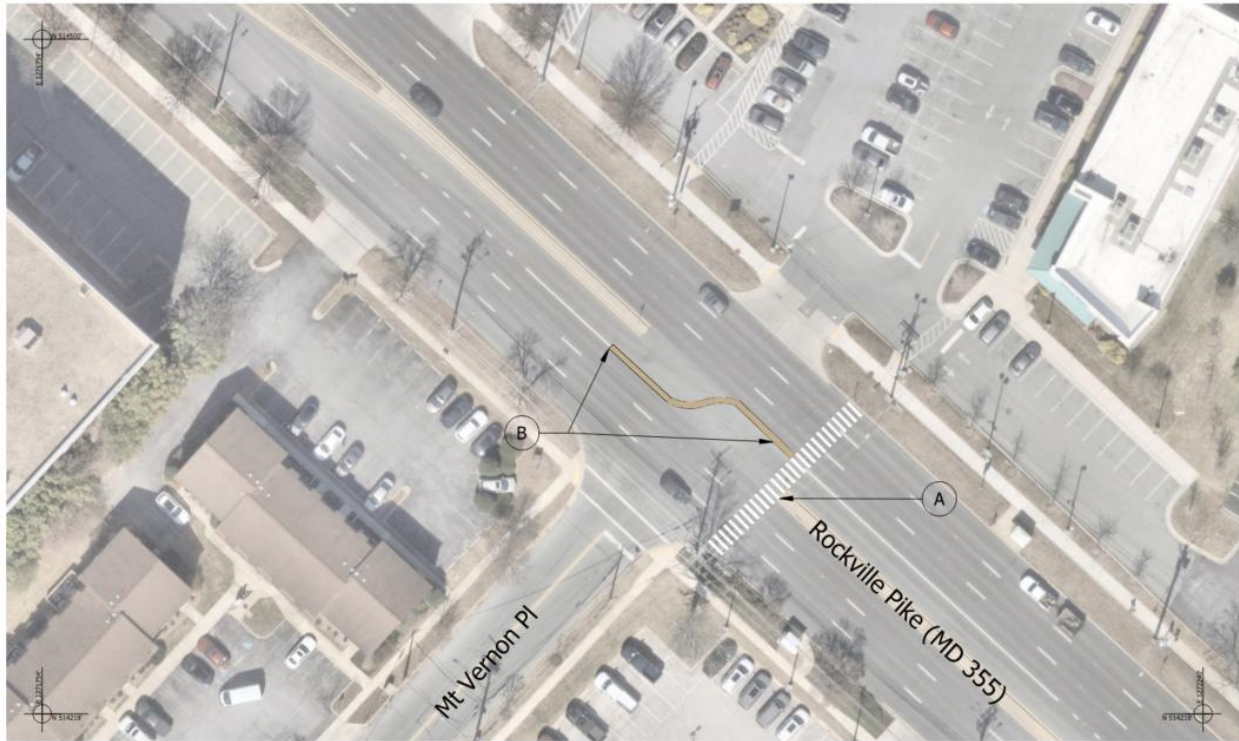
Figure 195. Long-Term Recommendations for Intersection #30 - Rockville Pike (MD 355) & Mt. Vernon Place
