Maryland Historical Trust Maryland Inventory of Historic Properties Form

historic Rollins Park Shell; Congressional Service Shell

street and number 1807 Rockville Pike not for publication

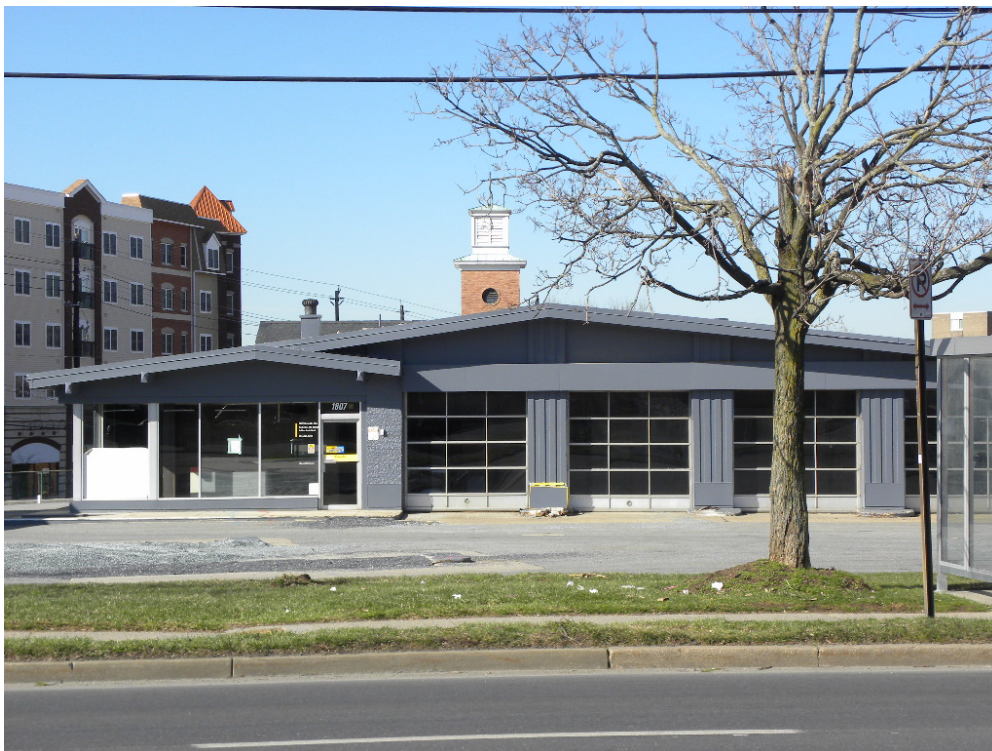
East elevation. Visible behind the station is the tower of the Rockville Volunteer Fire Department. (Photos except as noted: Steven A. Karr, March 2010)

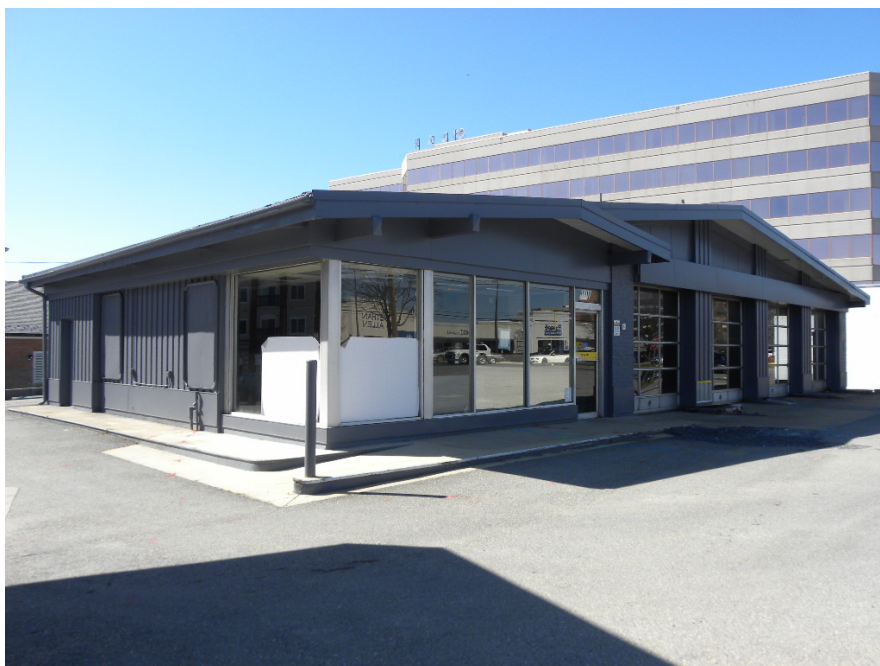
View from northeast

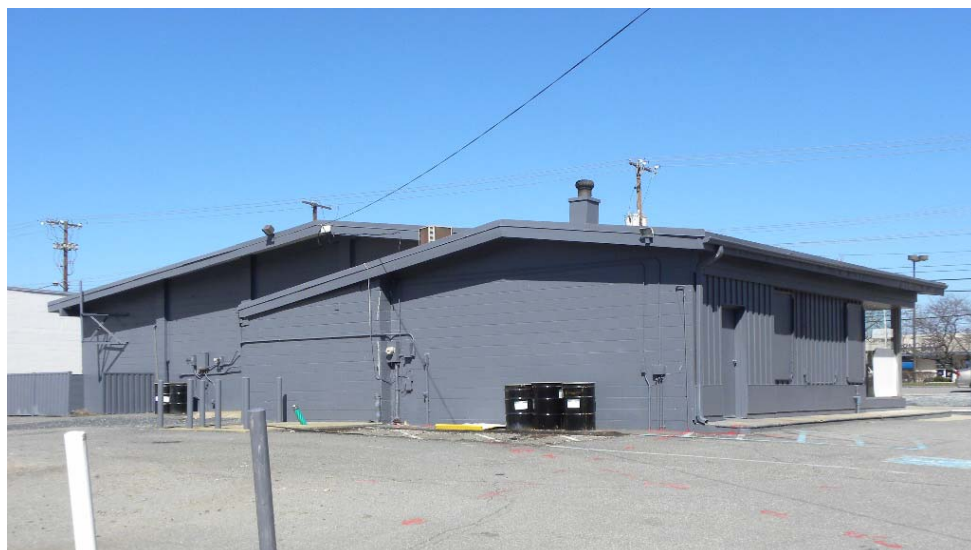
View from southwest

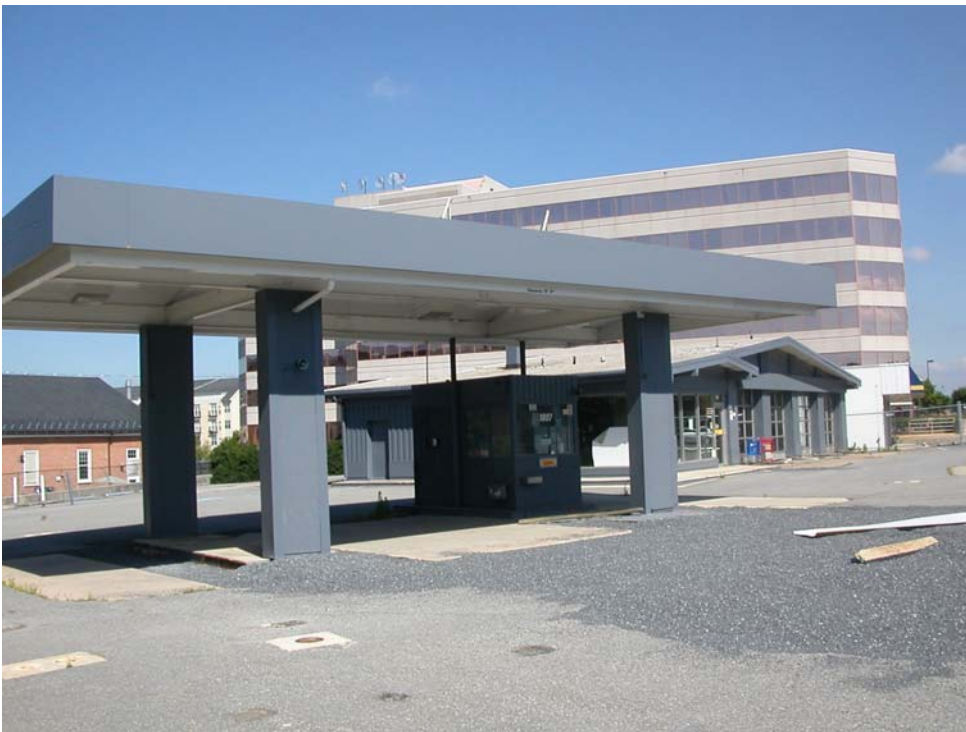
View of canopy from northeast
(Photo: Rosemary Prola, June 2010)

Southwest of the station building is a large, flat-roofed canopy supported by large piers of concrete block. Under the canopy is a cashier kiosk and space for four gasoline pumps that have already been removed. Additional gasoline pumps once stood on concrete pads on the east side of the building near Rockville Pike and a storage shed was located at the southwest corner of the building.¹ Both pumps and shed are gone.

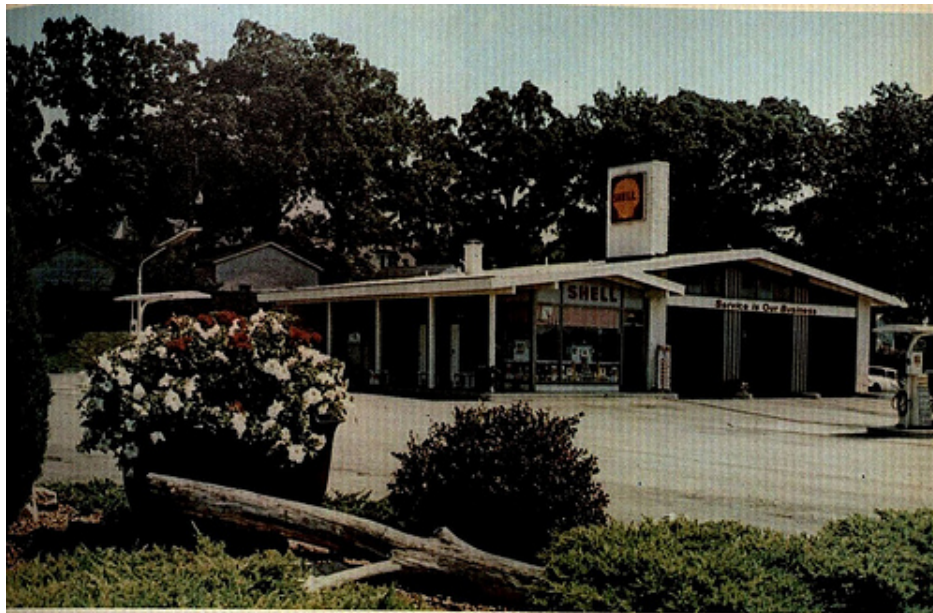
Above: “Shell Ranch-style station, 1969” Photo of a prototypical ranch-style station (not the subject property) copied from the September 1969 issue of the *National Petroleum News* by Mark Potter. Downloaded from flickr.com 24 June 2010
http://www.flickr.com/photos/mark_potter_2000/3342084311/in/pool-1149631@N22

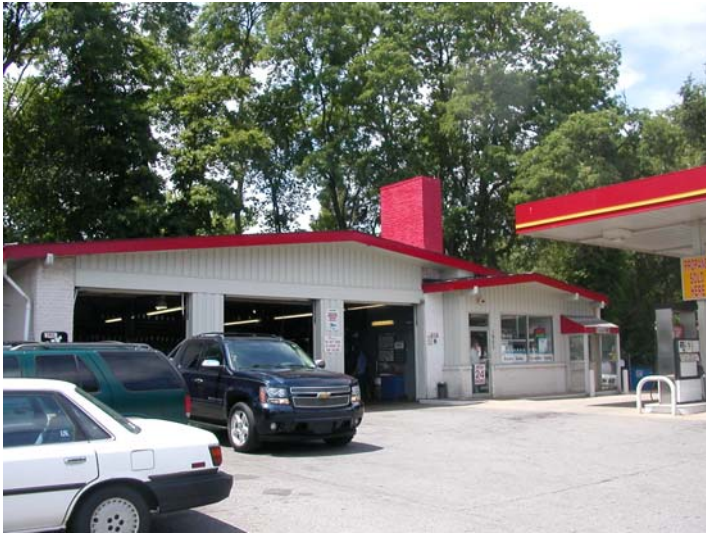
Former Shell station at 1907 Rockville Pike (Photo: Rosemary Prola, 30 June 2010).

Twinbrook neighborhood was remodeled in the new ranch style.¹⁸ The station still stands, although it is now part of the Getty chain. The Veirs Mill Road station is very similar to the subject property, and includes a key feature of the ranch style missing from the Rockville Pike station: the “chimney stack” sign.
