7. Description

This is a 1 ½-story plus basement, two-bay dwelling, constructed in 1937. The house is clad in stucco, and displays characteristic features of the bungalow form, including a low-pitched, side-gable roof with overhanging eaves, full-width porch, and central dormer. The house has a setback of approximately 50 feet from Anderson Avenue. The neighborhood contains houses of many different styles, most of which were constructed in the twentieth century.

J. Leonard Beall House, 536 Anderson Avenue
1949 Klingle Atlas (Rev.1953)

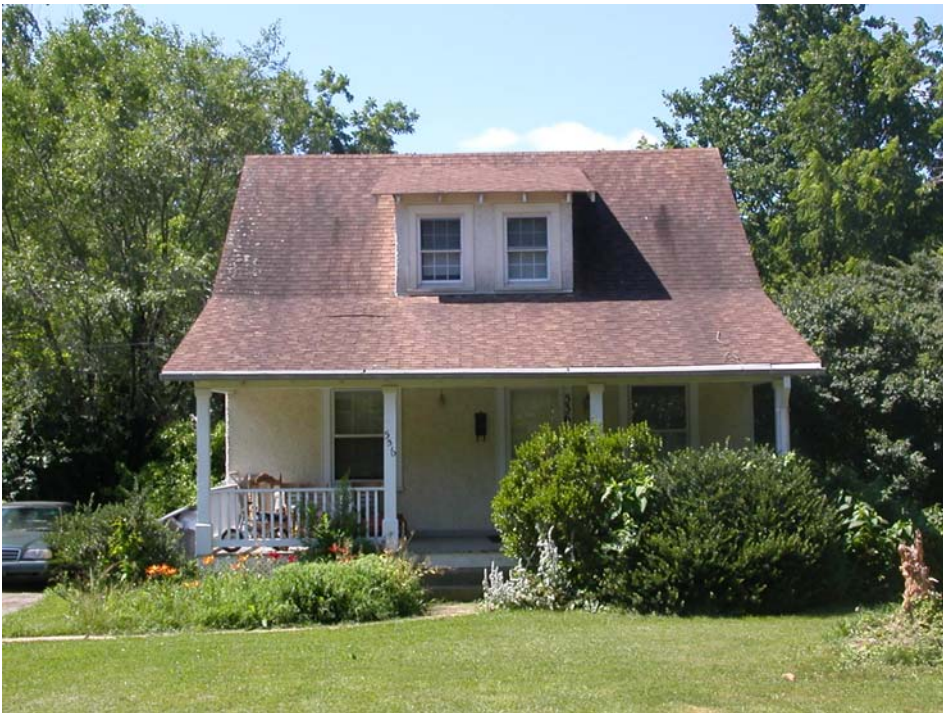
North elevation

Clad in stucco finished in the pebble-dash method, the house has a low-pitched side-gable roof. The front slope of the roof extends to cover the full-width porch on the façade. The porch appears to have its original square chamfered wood posts, railing, and deck. The roof has exposed rafter ends on the front and rear elevations. A brick chimney pierces the southern slope of the roof. On the rear (south) elevation, there is a one-bay bump out covered by a shed roof with exposed rafter tails. The bump out stands on brick piers and is clad in horizontal wood siding. Steps under the bump out lead to the basement entry.

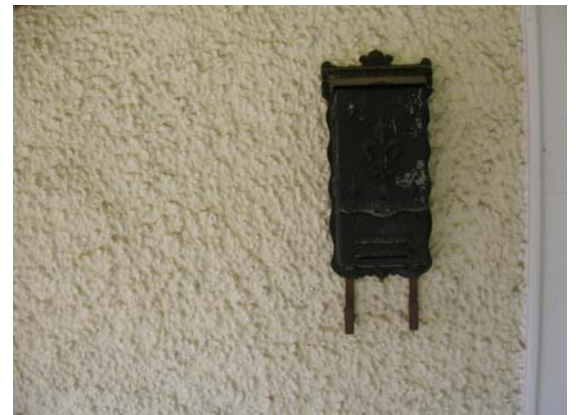
Detail of façade showing pebble-dash finish

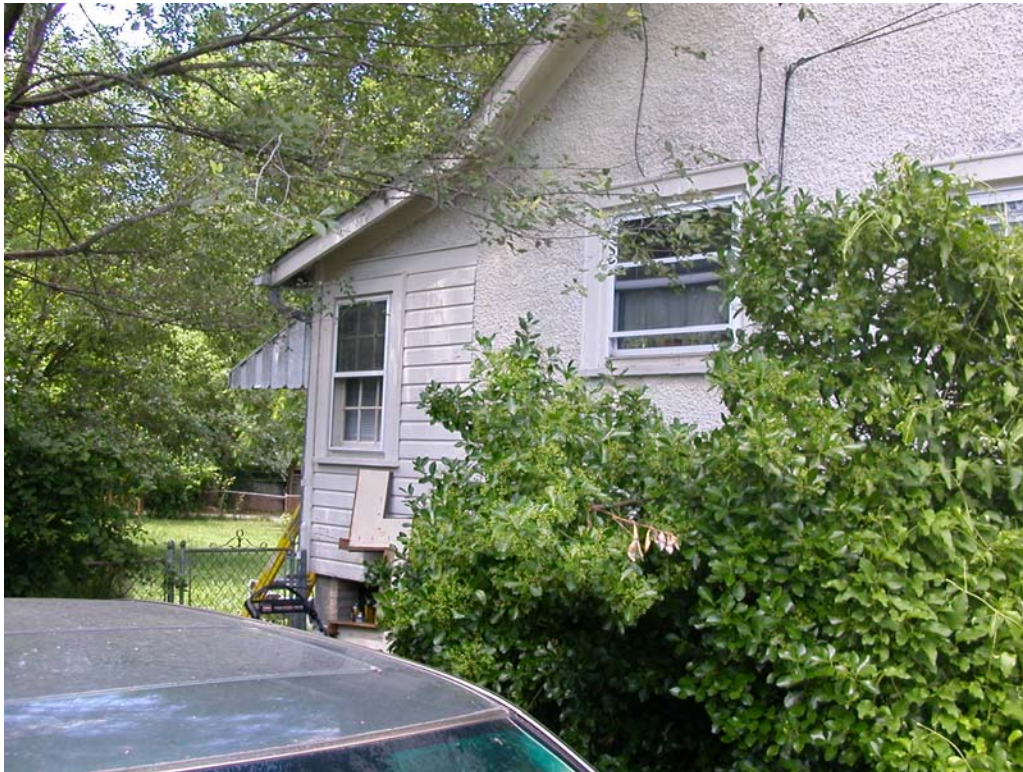
**Detail of west elevation showing
rear bump out**

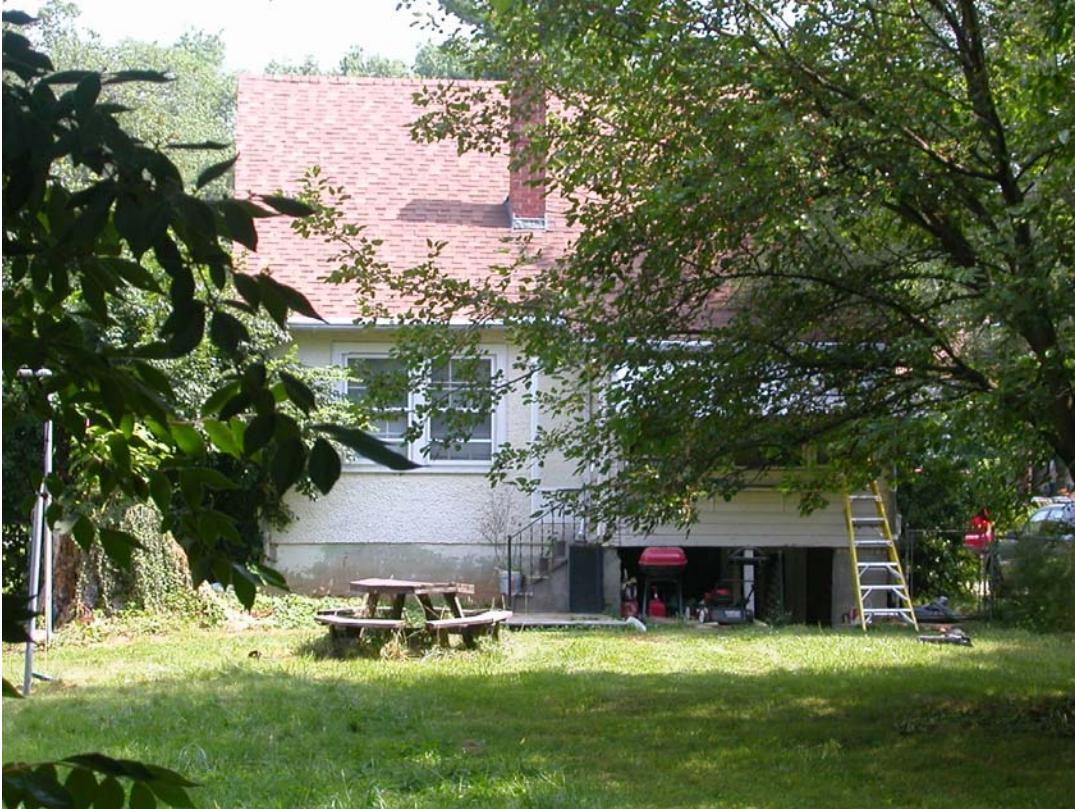
**View of south elevation from
alley**

The dwelling windows are mainly 6/6 wood sashes and 6/6 vinyl replacement sashes, with original wood sashes on the first floor of the façade and the west elevation, and on the east and south elevation of the rear bump out. Both the wood and vinyl windows retain original wood trim and are covered with vinyl storm windows. The front entry door is a modern replacement. The central dormer has a shed roof with exposed rafter tails and contains a pair of 6/6 vinyl sashes. There are vertical wood ventilators in each gable pediment and metal casements in the basement.

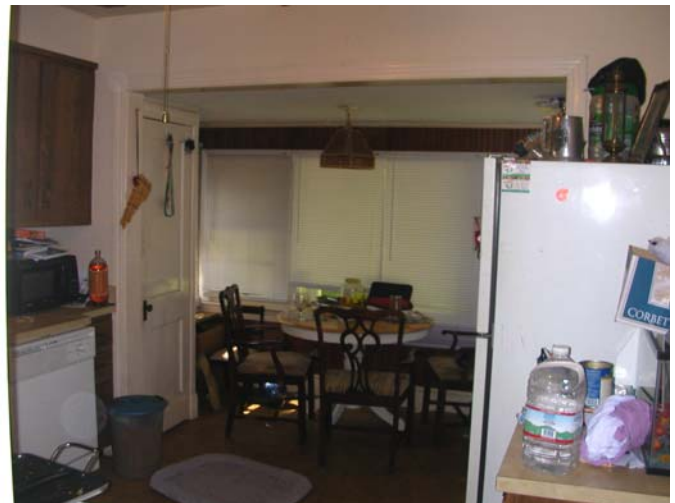
The interior has a compact plan. Like all bungalow designs, it manages to create a significant amount of living space out of modest square footage. The front door opens directly into the living room. An arched opening in the corner of the south wall leads to the original dining room, presently used as a bedroom. Through a doorway in the east wall of the living room is a short hallway. Off of this hallway are a bedroom, bath, kitchen with breakfast nook bump out (pictured right), and stairway leading the second level.

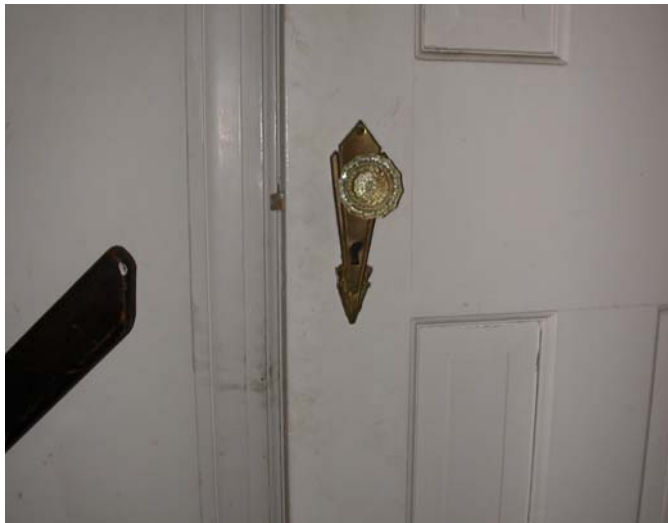
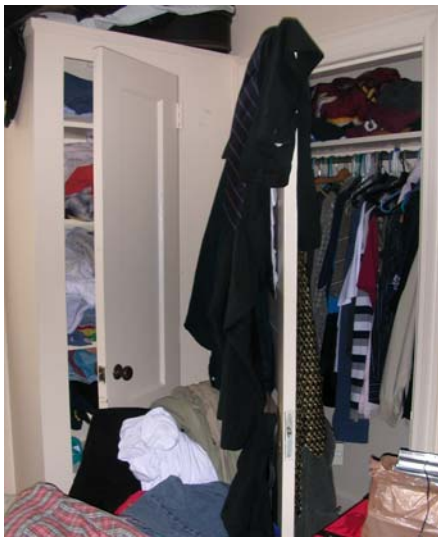
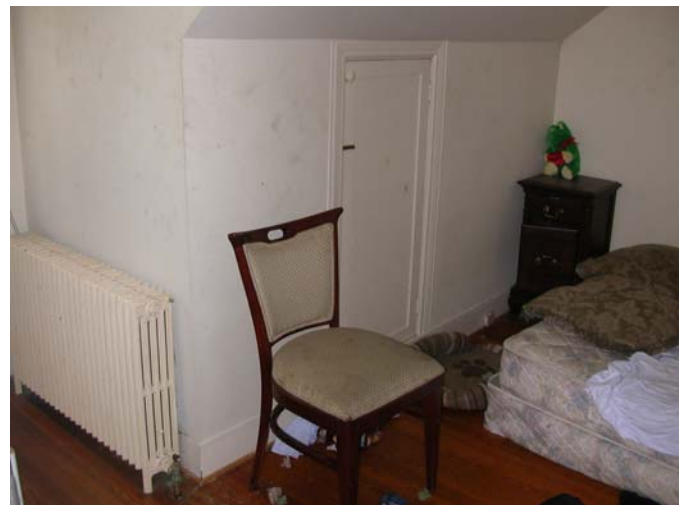
the top of the stairs opens into a shallow closet that extends half the width of the house. A bedroom is located off of the open space. The interior of the house retains many original features including hardwood floors on the first and second levels; five-panel wood interior doors, some with original Art Deco-influenced hardware; wall tile, tub, shower rod, and vanity cabinet (with replacement top) in the bath; a built-in storage cabinet in the first-floor bedroom, linen closet in the hallway, and broom closet in the kitchen; and built-in storage under the eaves on the second floor.

Interior details. Clockwise from top left: original door hardware; arched opening to dining room; under-eave storage; cabinet and closet in first-floor bedroom.

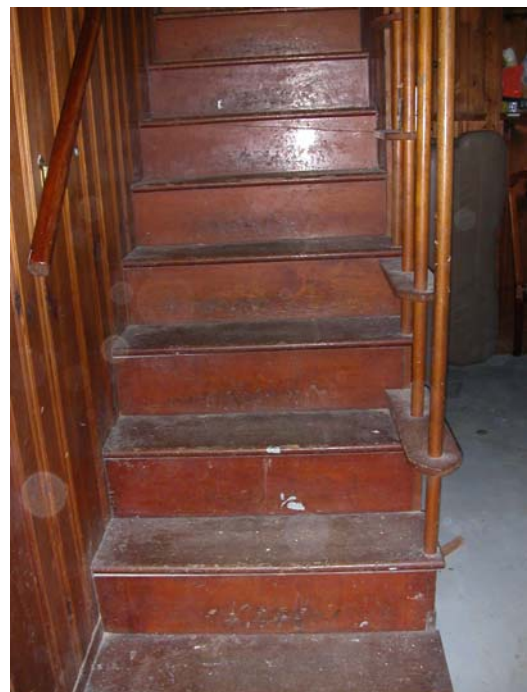
The basement is accessed by enclosed stairs located on the left side of the arched opening on the first level. The basement is divided into two main spaces: a small bedroom and “recreation room” with tongue-and-groove-pine paneled walls and painted linoleum floor in the north half; and an unfinished utility room in the south half. The paneling and stair rail design indicate that the space was likely finished in the 1940s or 1950s. A door in the rear of the utility room leads to the outside.

Basement. Views of recreation room (left) and step-to-ceiling stair railing.
