## STAFF RECOMMENDATION

**TO:** Historic District Commission

**SUBJECT:** Evaluation of Significance of 801 Hungerford Drive

**DESCRIPTION:** Subdivision 0201 Parcel # P368

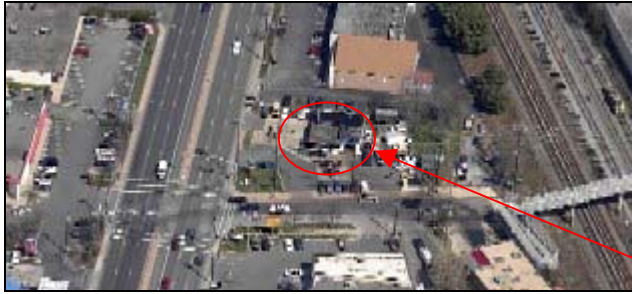
Subject property

The building at 801 Hungerford Drive is a cement block gas station/ auto repair commercial facility constructed in 1963 and sited between a six-lane section of Hungerford Drive and the tracks of the MetroRail and MARC. The west and south elevations face the roadways. Frederick Road dead-ends immediately at the end of the subject lot. At the end of Frederick is the access ramp to the pedestrian bridge over the Metro and MARC tracks that connect to Stone Street and the Lincoln Park neighborhood.

The one-story building is located on a corner lot and has a square footprint. The massing consists of a square set into a L-shaped corner attached to the north and east sides of the square. The L-shape rectangular sections contain repair service bays for the garage. The station is set toward the back corner of the lot, providing paved frontage. Two landscape islands, one on the corner and the other fronting Hungerford Drive, are the exception to the pavement.

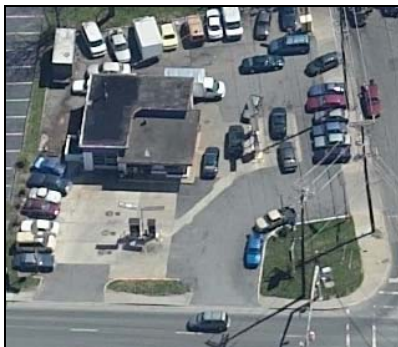
801 Hungerford Drive, corner of Hungerford and Frederick, Hungerford is located at bottom of image

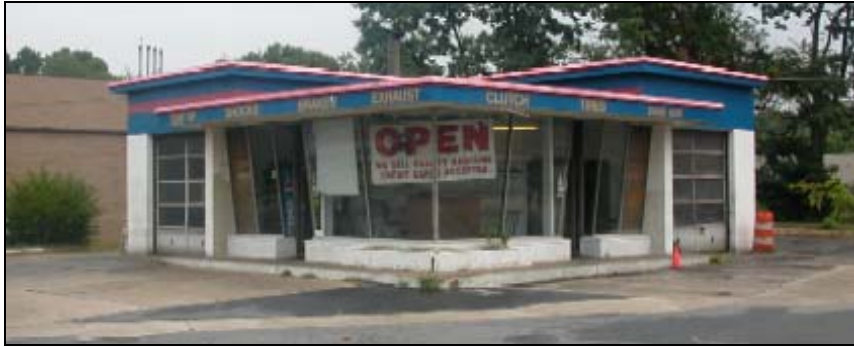
The square customer lobby has west and south elevations consisting of large plate glass windows that are canted forward at the top about 15 degrees. Recessed entrances are located in the center of the elevation with large angled, single-sheet glass sidewalls. The windows reach from the projecting cornice down to a one-foot high poured concrete foundation wall. Each of the two elevations contains four window panels, with the recessed entry dividing them into groups of two. The panels that are closest to the garage repair bays are not single panes – they are

jalousies. These could be replacement windows to provide additional circulation. The jalousies windows are broken and plywood sheets now cover the openings.

801 Hungerford, west (facing Hungerford Drive) and south elevations.

Exterior alterations to the property appear to be limited to replacement of the solid pane windows on the ends adjacent to the garage bays with jalousie windows, which have been broken and are boarded from behind.

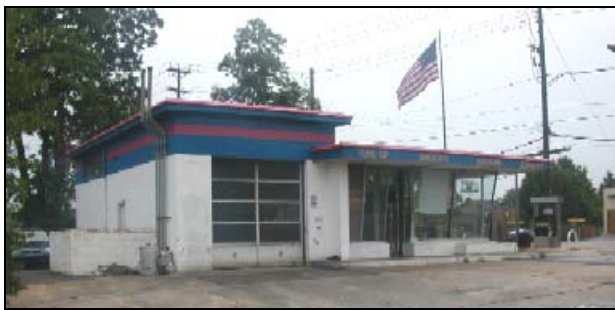
801 Hungerford Drive, west repair bay

The repair bays are marked by single bay aluminum overhead garage doors divided into paired horizontal lights with two bottom aluminum panels. The rear elevations of the repair bays contain two, 6-light vent windows set side-by-side near the top of the wall. The north elevation has a corner cement block half wall abutting the wall and fronting a side door.

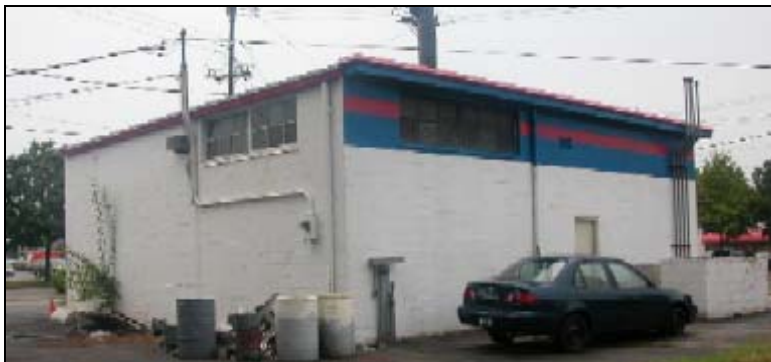
801 Hungerford, Rear (north and east) elevations.

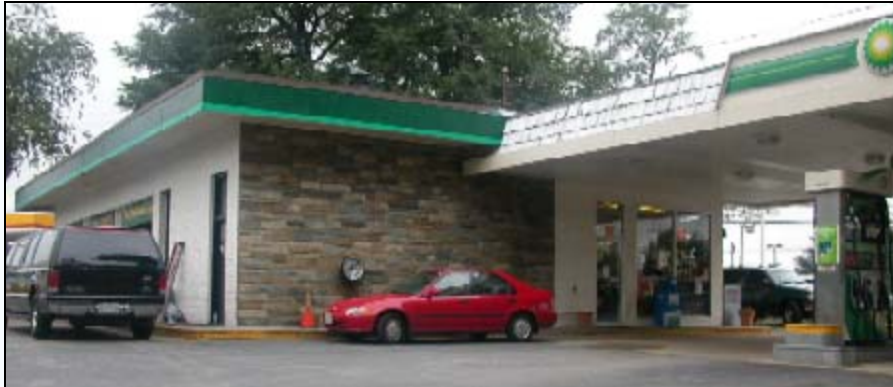
A gas station at 1910 Rockville Pike dates from 1966 and could be categorized as Neoelectic with its stone facing and cedar shake shingled mansard roof.<sup>6</sup>

Both the Veirs Mill and Rockville Pike stations differ from the 801 Hungerford Station in that their architecture has more in common with popular residential architecture of the time as opposed to being distinctly a part of "Car Culture".

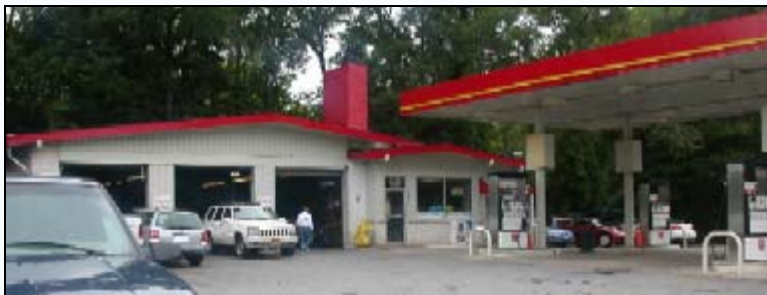
1907 Veirs Mill Road

This is 1968 station is constructed of brick and has vertical aluminum panels. The double shallow gable front and the tall wide brick chimneystack are reminiscent of a modern ranch house from the 1960s and 70s. Jackle and Sculli's *The Gas Station in America* refers to a very similar station as "The results of 'face-lifting' and 'top-hatting': an oblong box modified in the Shell's 'ranch' style".<sup>7</sup>

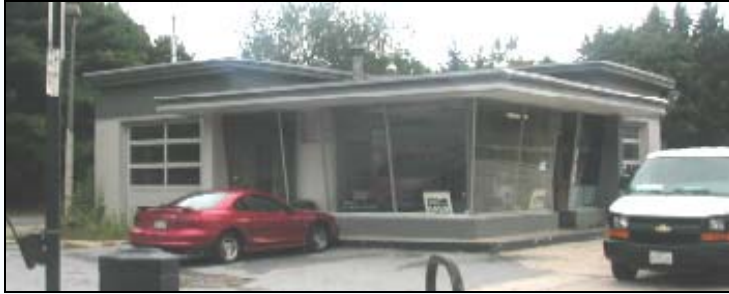
21615 Laytonsville Road,  
Laytonsville

A gas station in the Montgomery County crossroads of Laytonsville is owned by G. D. Armstrong, who also owned the station at 801 Hungerford from 1997 until recently. Although the building is almost an exact duplicate of the 801 Hungerford station, it was built two years later in 1965 and was always owned by G.D. Armstrong. Mr. Charles Owen, long time resident of Laytonsville and current Mayor, said that he remembered this station as a Phillips 66 station and thought it had been there since the late 1950s or early 60s.

In addition to the similarity of the slanting or canted display windows, the service garage doors have the identical two-tier horizontal panes with bottom panels. The similarities with the Laytonsville and Hungerford Drive stations extend to the buildings' massing. The 1950s buildings depicted in the ConocoPhillips archives clearly have one principal façade – they don't seem to be located on a corner lot. The Laytonsville and Hungerford Drive stations are located on corner lots. The corner lot prototype appears to be the same building, except for the two-bay service garage being split, with one bay being attached to the far sides of the square customer service area with the big slanted windows.

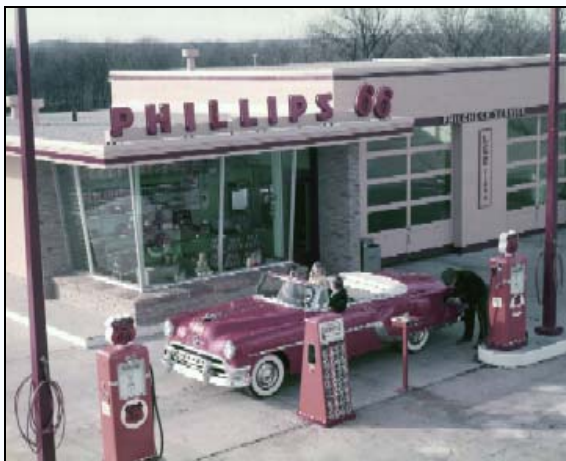
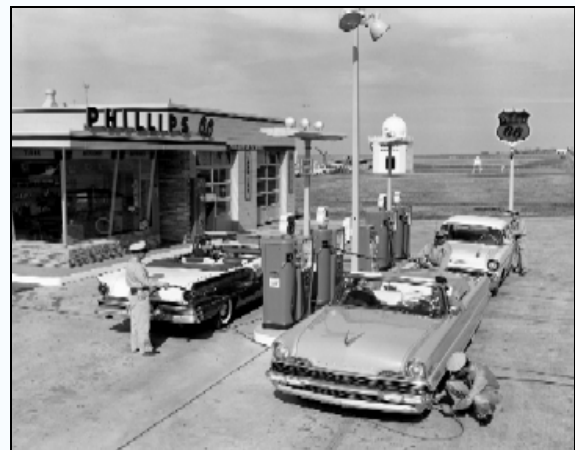
An archivist for the ConocoPhillips Corporation was consulted about the 801 Hungerford Drive station. Judging from a current photograph of the station, Archivist Jenny Brown stated that she believes the station type was used in the 1960s but the style looks more like a 1950s station. She sent the following photos illustrating the use of the floor to ceiling slanted glass windows.

Bartlett, Oklahoma, 1953

Oklahoma City, Oklahoma, Will Rogers  
Airport, 1956

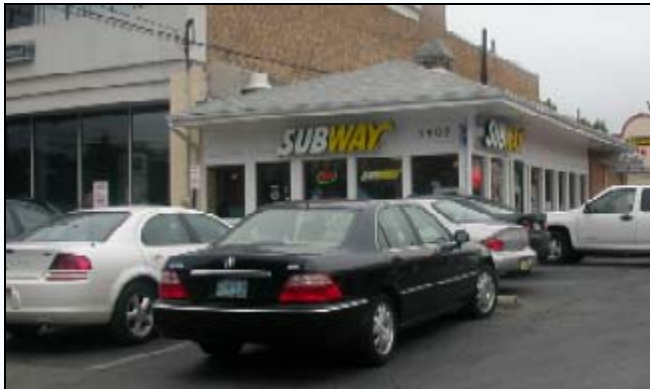
1402 Rockville Pike, former Dixie Donuts

The “Rockville Historic Buildings Catalog” identifies only one building associated with the roadside architecture along Rockville Pike -- a different type of a structure that also dates from the 1960s. Dixie Cream Donuts was constructed in 1965 – a rectangular 1-story building with large display windows, a pyramid roof and a small Colonial Revival style cupola vent with a pyramid roof. The building currently houses a Subway franchise.

The building fronts a small parking area of an access road along the pike and is surrounded by other commercial real estate.
