Today's Discussion

Restoring Croydon Creek / Calvin Park

Enhance approximately 4,000 linear feet of the Croydon Creek and Calvin Park Tributaries to Rock Creek

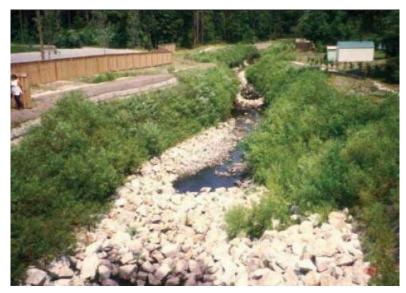
Priority 4 - Harden Channel in Place

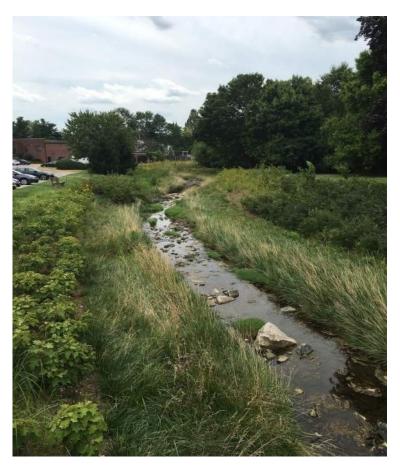
Natural Channel Design - Priority 2/3

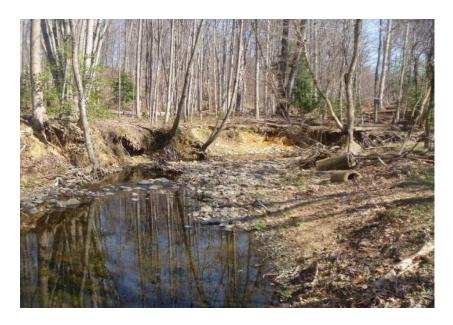
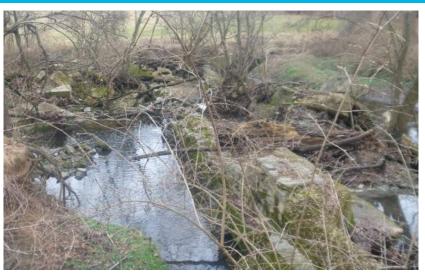
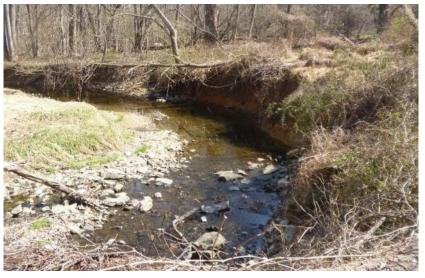
Croydon Creek

- Existing dam—over-widened channel, debris jam and rubble
- Steep eroding stream banks
- No floodplain access
- Tight meander bends

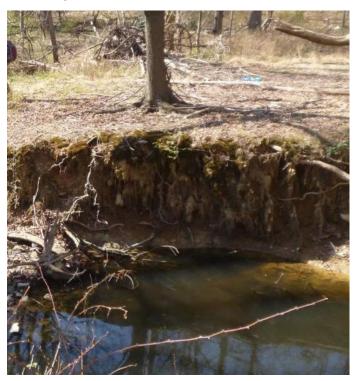
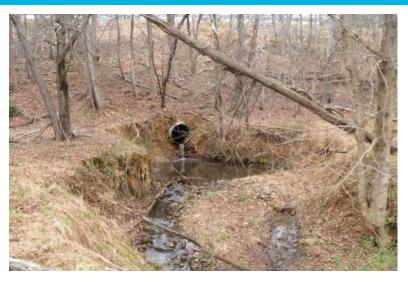
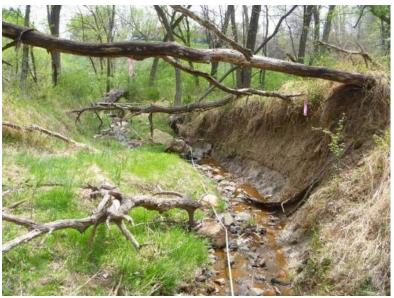
SHA Tributary

- Gully channel
- Erosion at culvert pipe
- Steep eroding stream banks
- No floodplain access

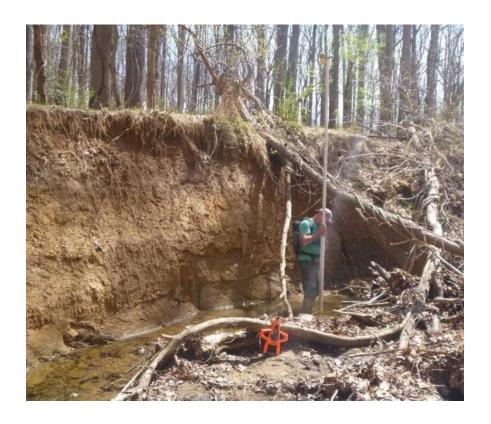
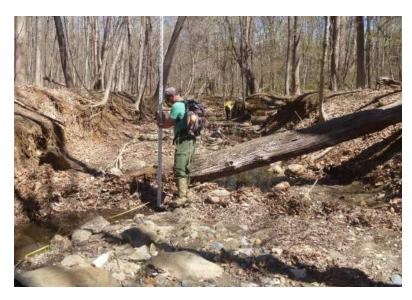
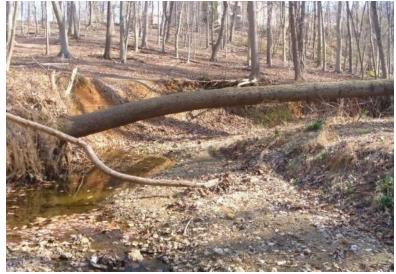
Calvin Tributary

- Steep eroding stream banks
- Over-enlarged channel
- No floodplain access

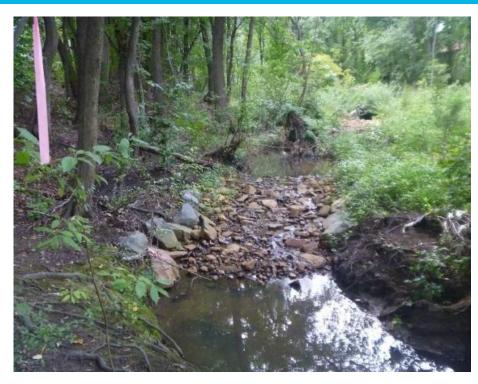
Constructed Riffles

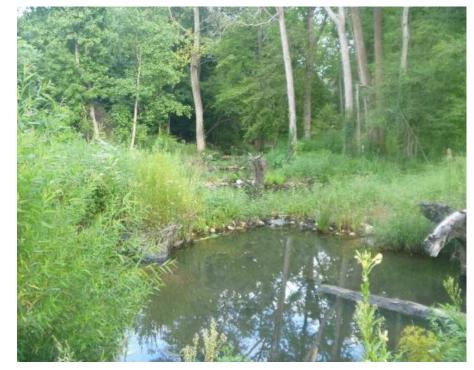
Regenerative Storm Conveyance (RSC)

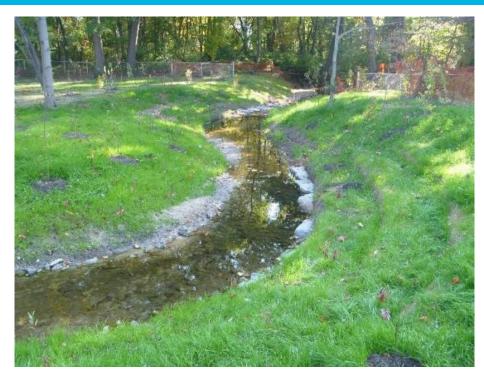
Bank stabilization/vegetation

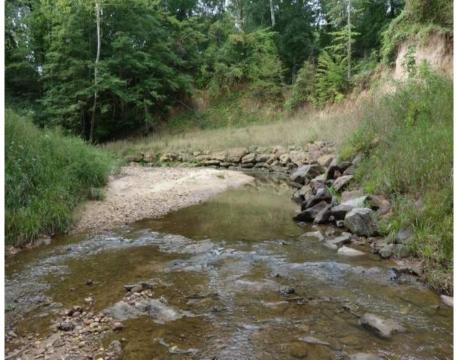
Boulder Revetment

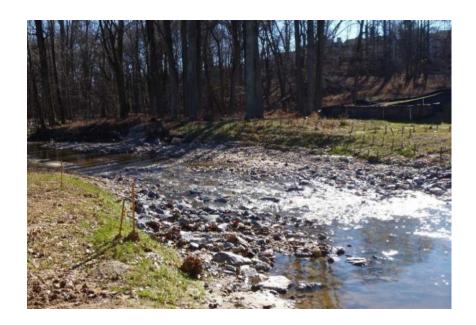
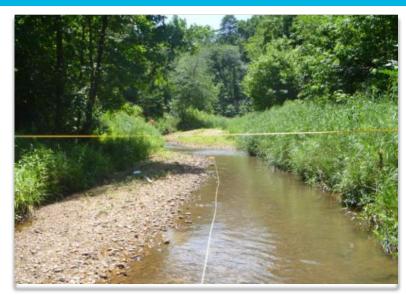
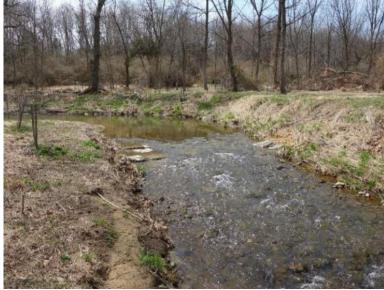
Croydon Creek Tributary

- Removal of dam and re-establish natural channel
- Install riffle grade controls
- Protect and establish vegetation

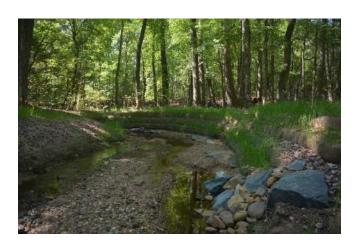
Croydon Creek Tributary

Tie into previous restoration reach

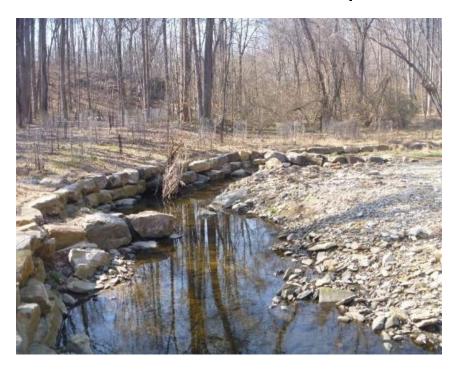
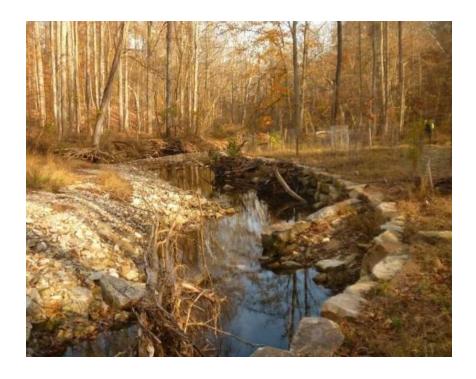
SHA Tributary

Regenerative Storm Conveyance (RSC)

- Riffle steps and pools slow down stream flow
- Reduce bank erosion
- Provide floodplain connection

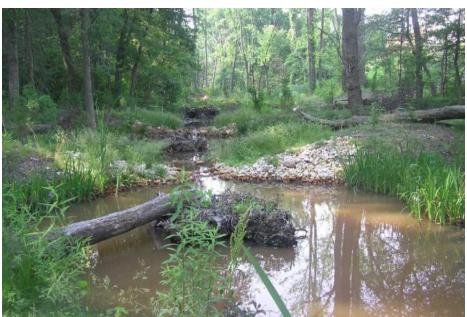
SHA Tributary

Create vernal pools next to stream: Temporarily wet areas provide habitat for frogs and other amphibians

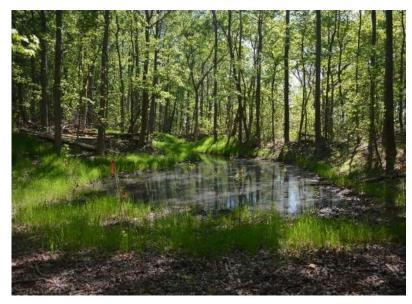
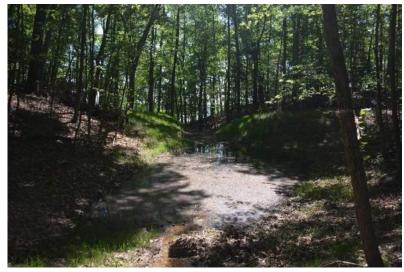
Calvin Tributary

- Install riffle weirs
- Requires minimal grading and disturbance
- Minimizes tree loss
- Wrapped soil lifts
- Tie-in to cemetery property

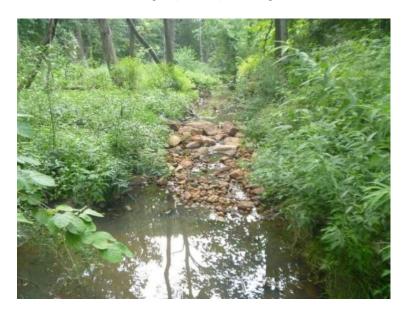
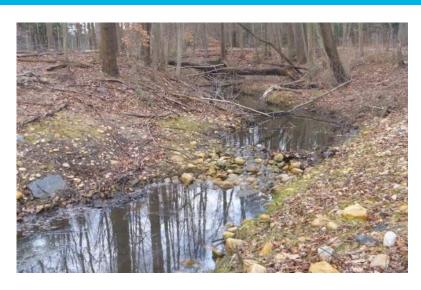
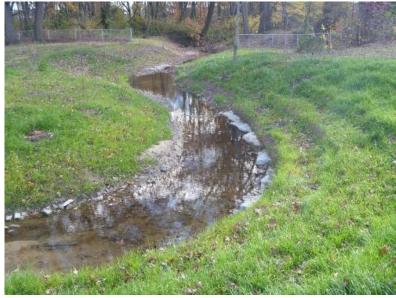
Calvin Tributary

Create vernal pools in old sections of channel:
