CROYDON CREEK / CALVIN PARK TRIBUTARY  
STREAM RESTORATION  
AERIAL EXHIBIT

JUNE 2018

CROYDON CREEK / CALVIN PARK TRIBUTARY  
STREAM RESTORATION

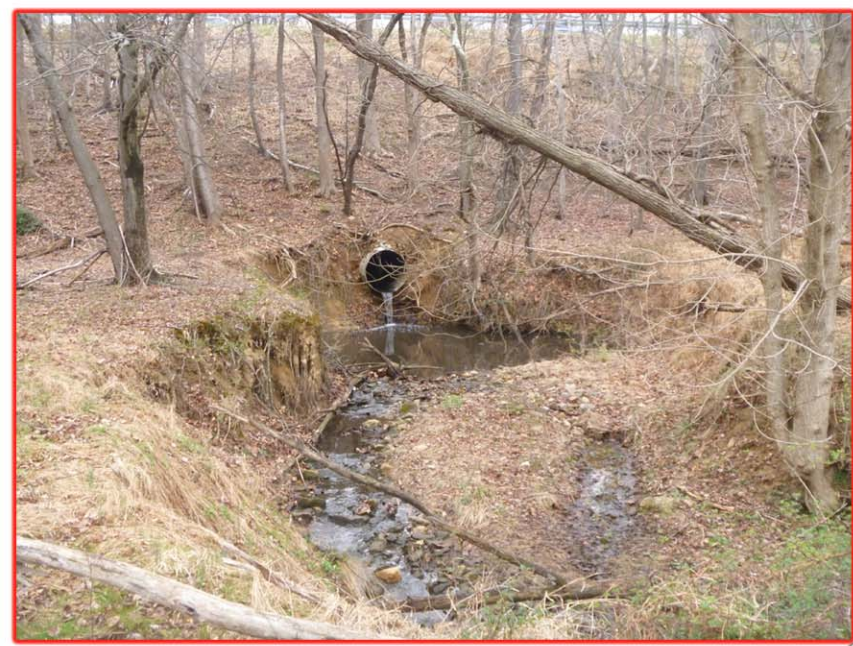
EXISTING OUTFALL & EROSION

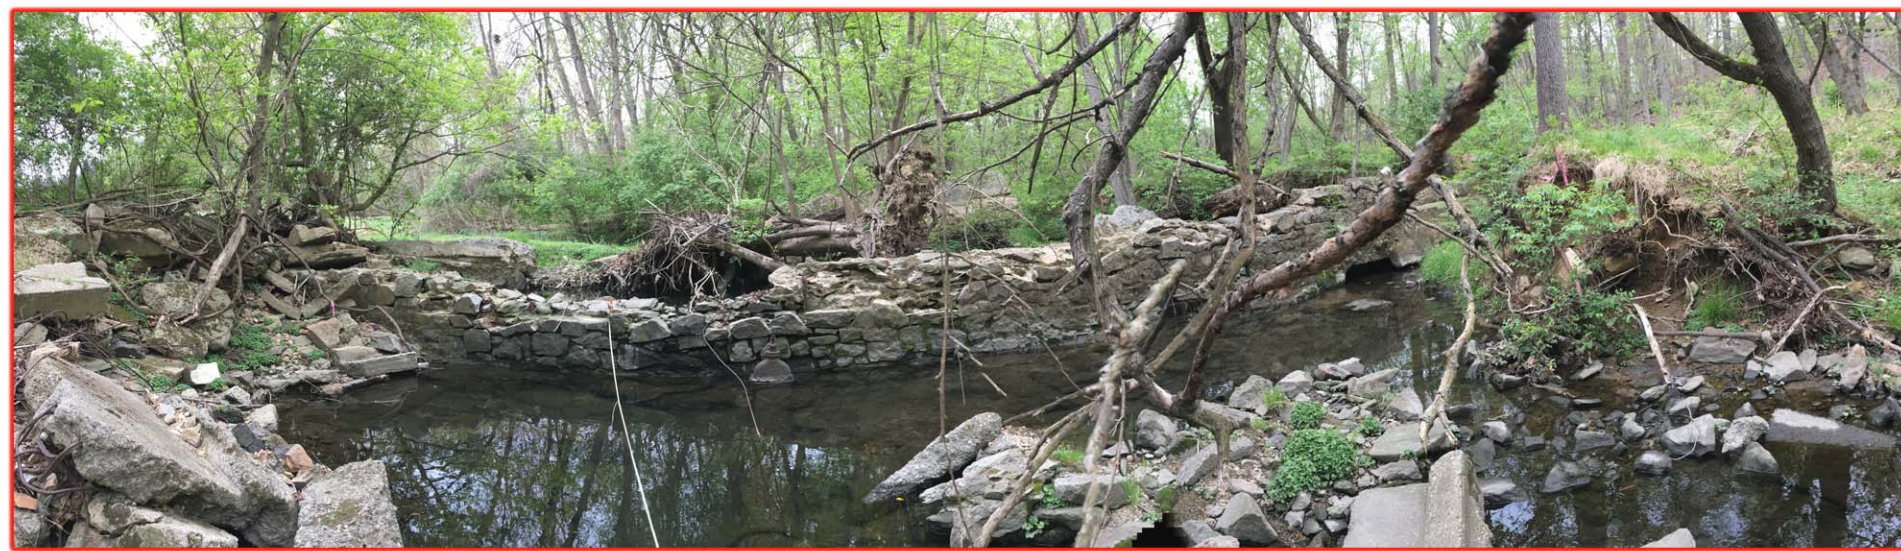
EXISTING DAM & INSTREAM RUBBLE TO BE REMOVED

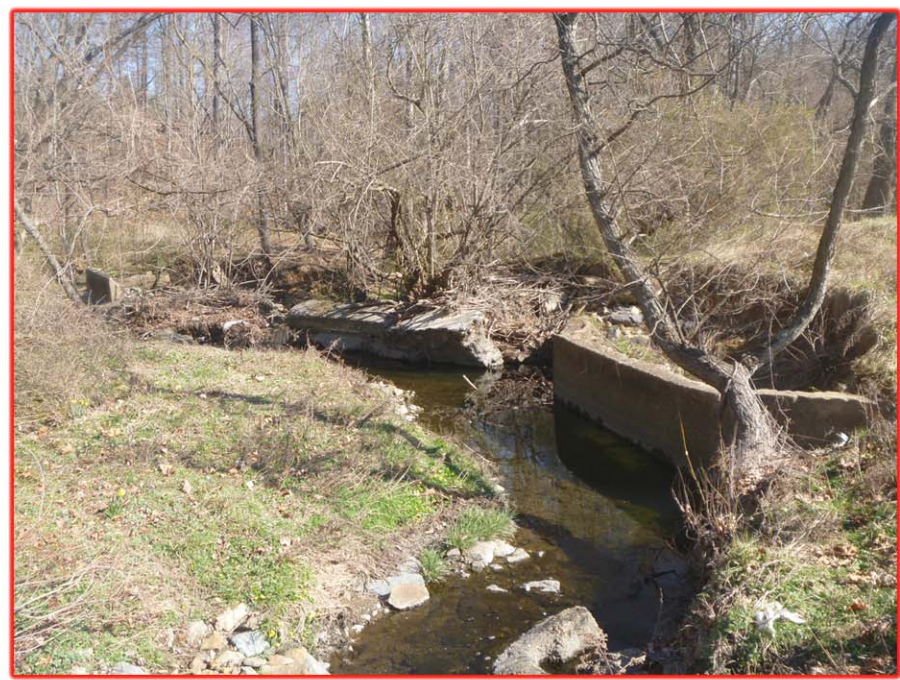
ERODED MEANDER BEND & CONCRETE RUBBLE TO BE REMOVED

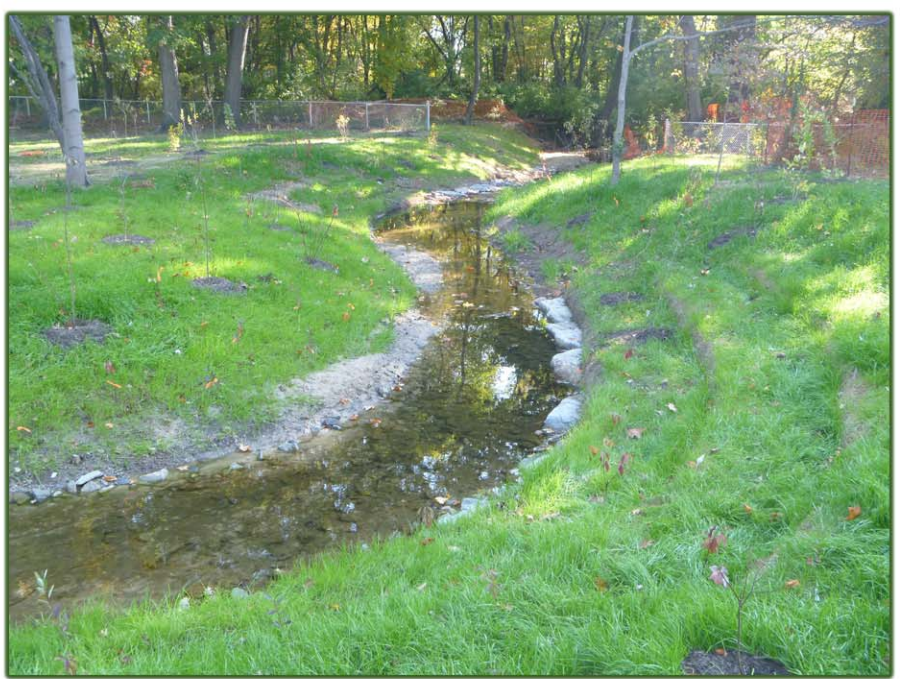
WRAPPED SOIL LIFTS EXAMPLE

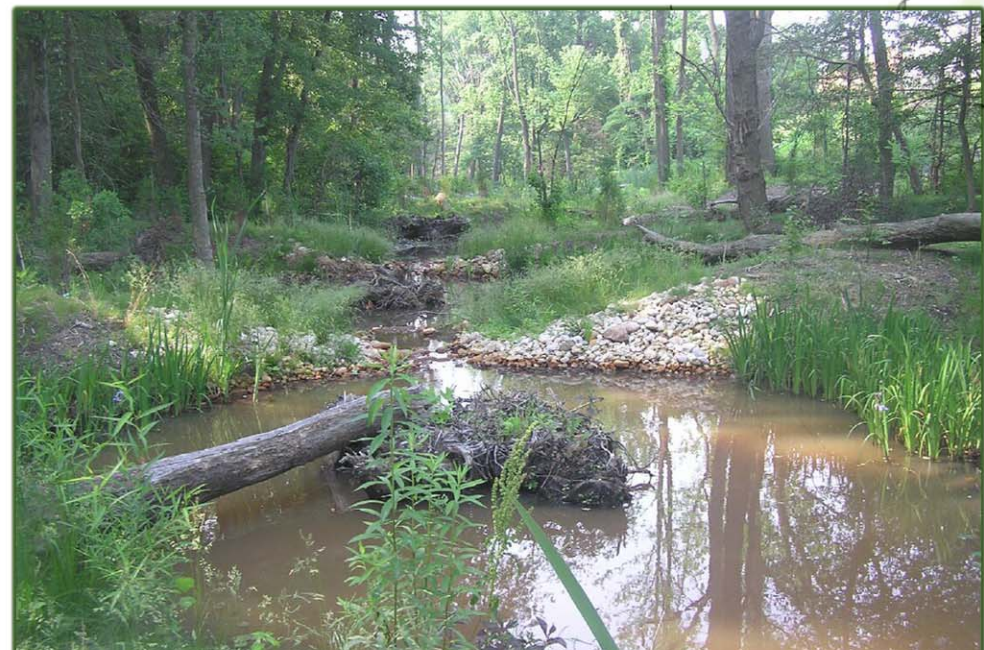
REGENERATIVE STORM CONVEYANCE (RSC)-EXAMPLE

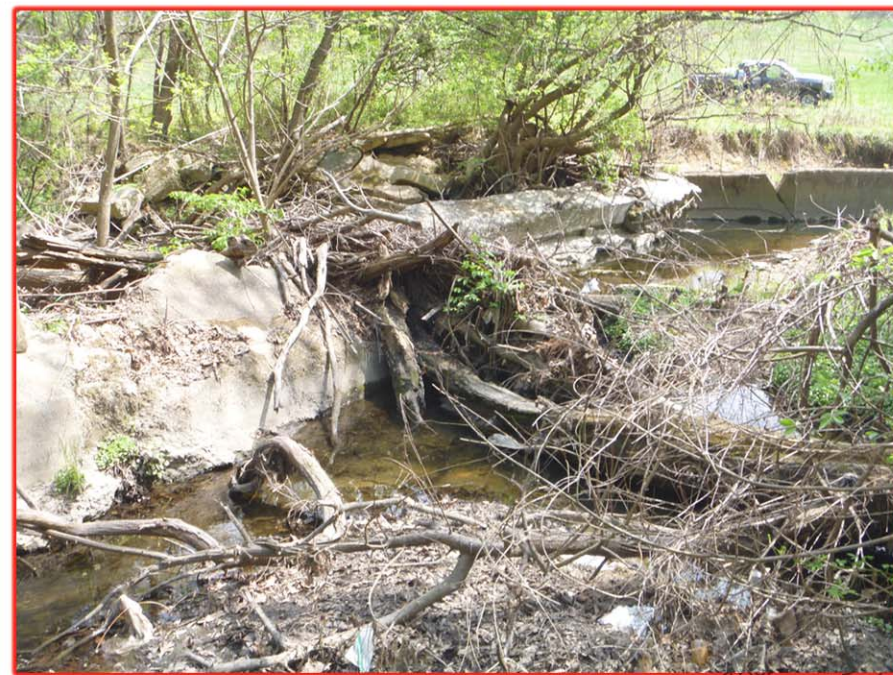
INSTREAM RUBBLE TO BE REMOVED

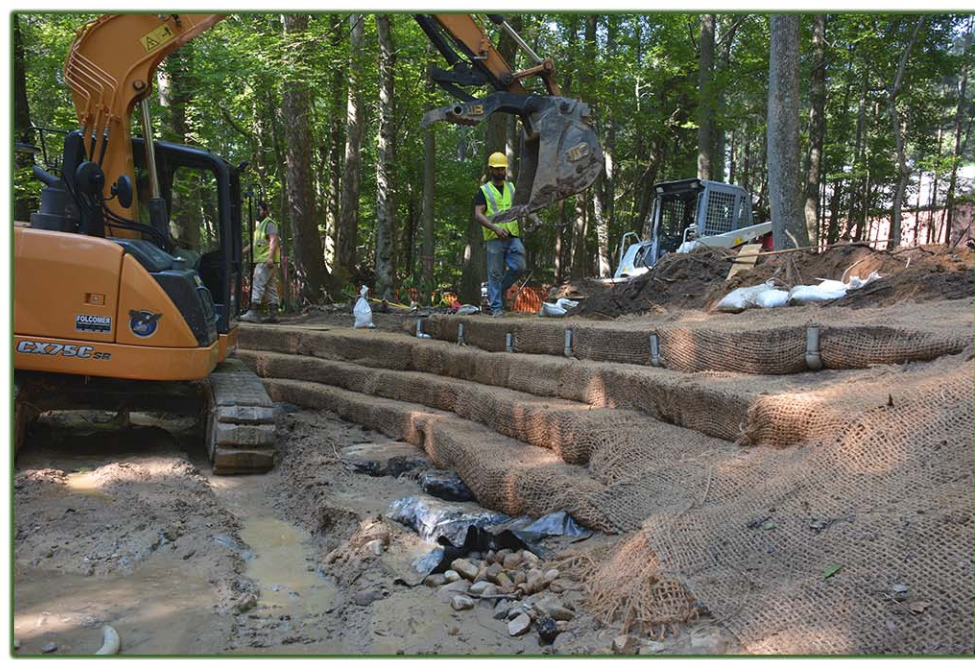
WRAPPED SOIL LIFTS CONSTRUCTION EXAMPLE

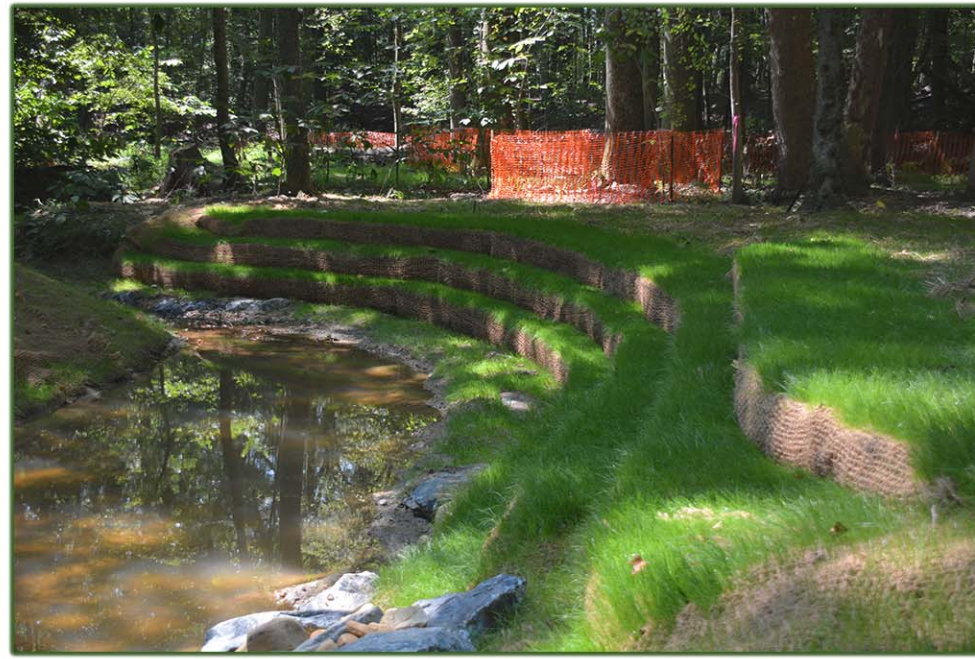
WRAPPED SOIL LIFTS EXAMPLE

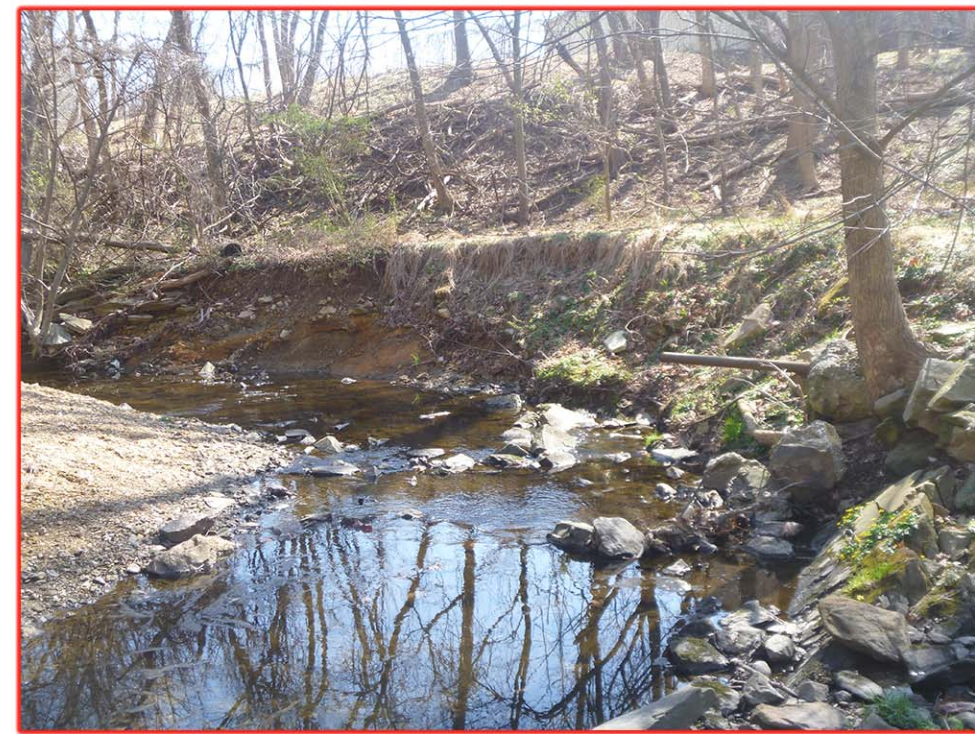
ERODING MEANDER BEND

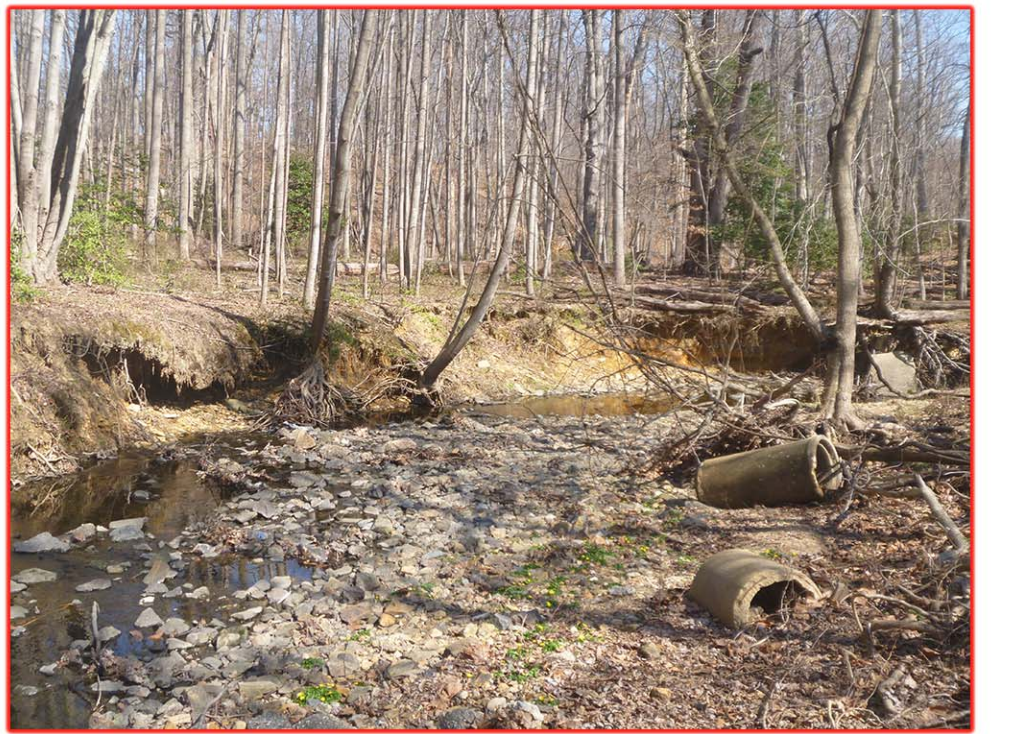
ERODING MEANDER BEND WITH UNDERCUT BANKS

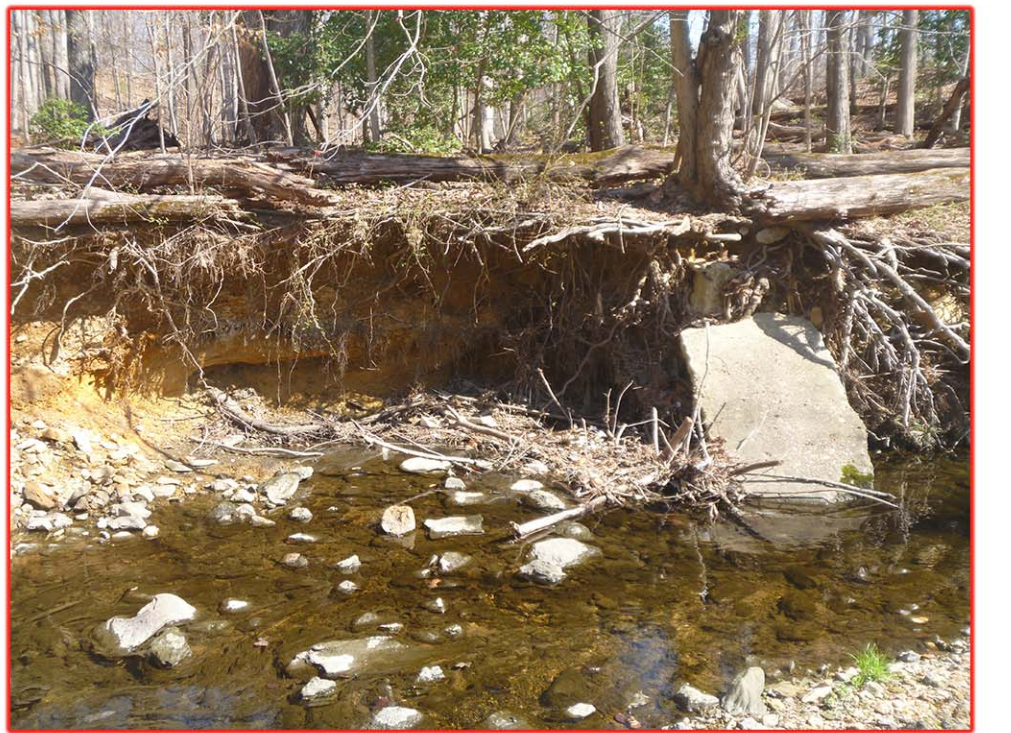
UNDERCUT BANK

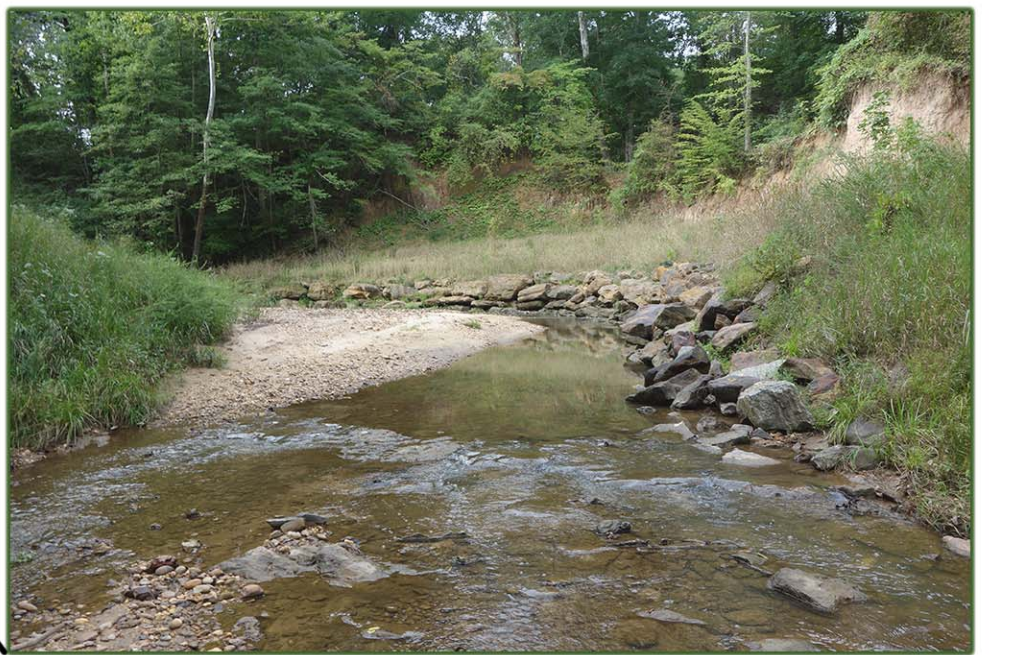
BOULDER REVETMENT EXAMPLE

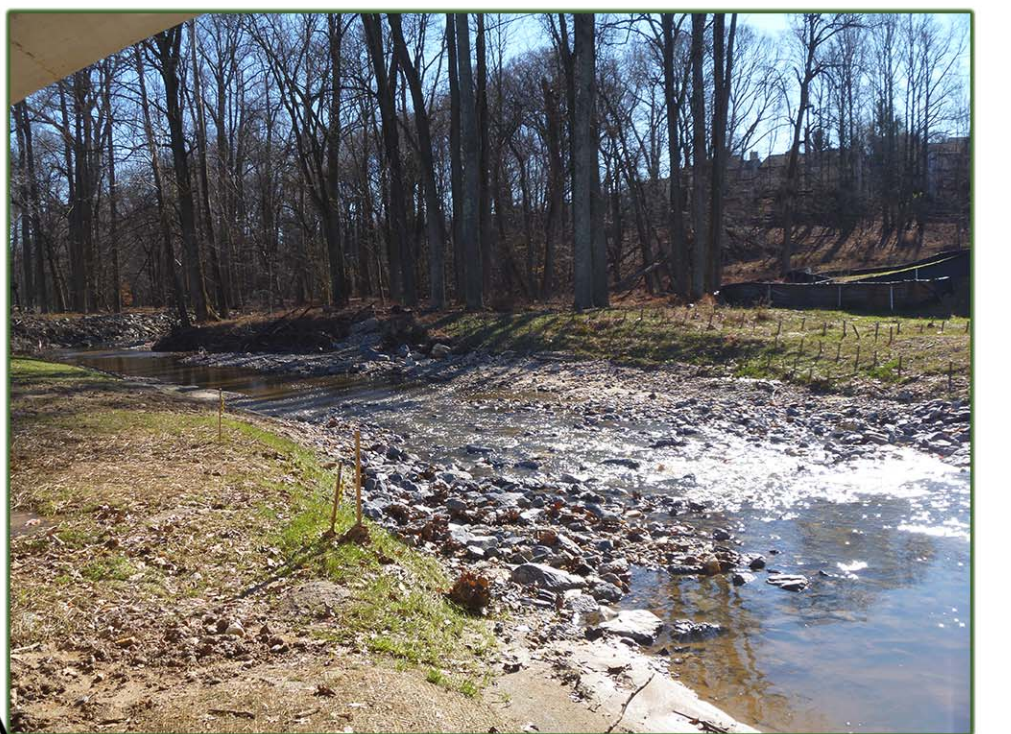
RIFFLE GRADE CONTROL EXAMPLE

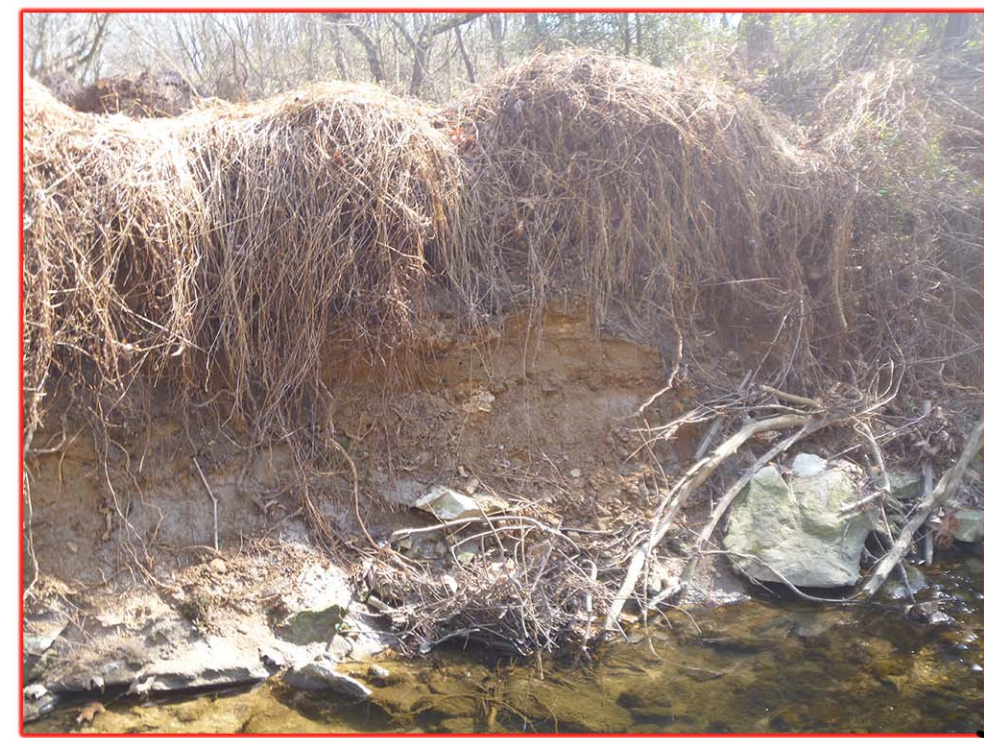
BANK EROSION

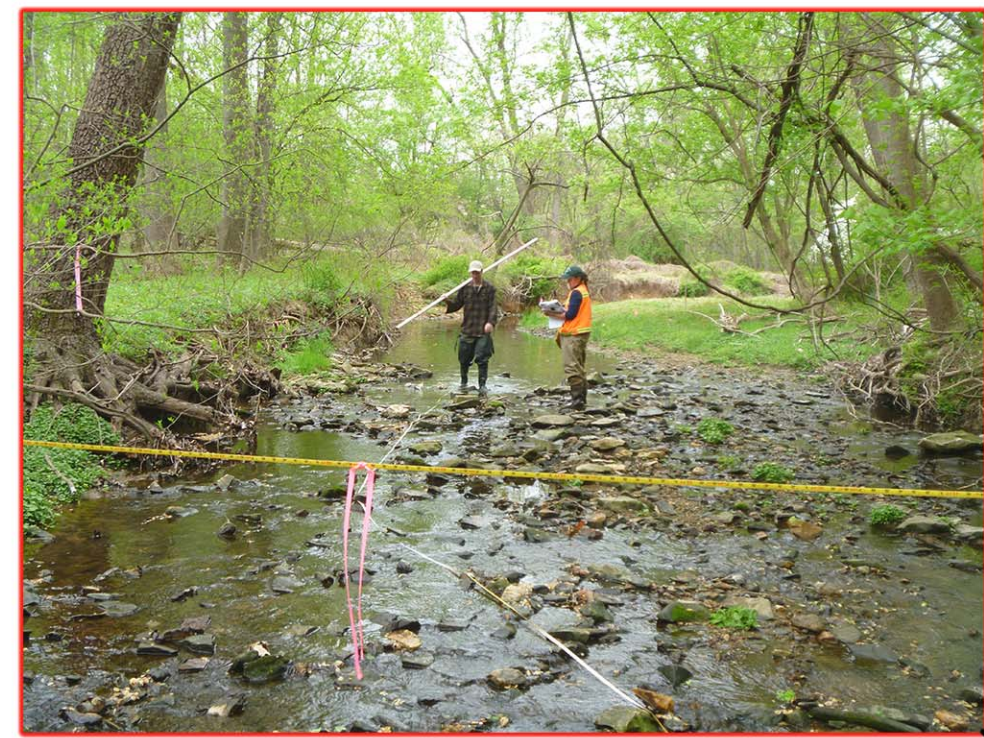
OVERWIDENED CHANNEL

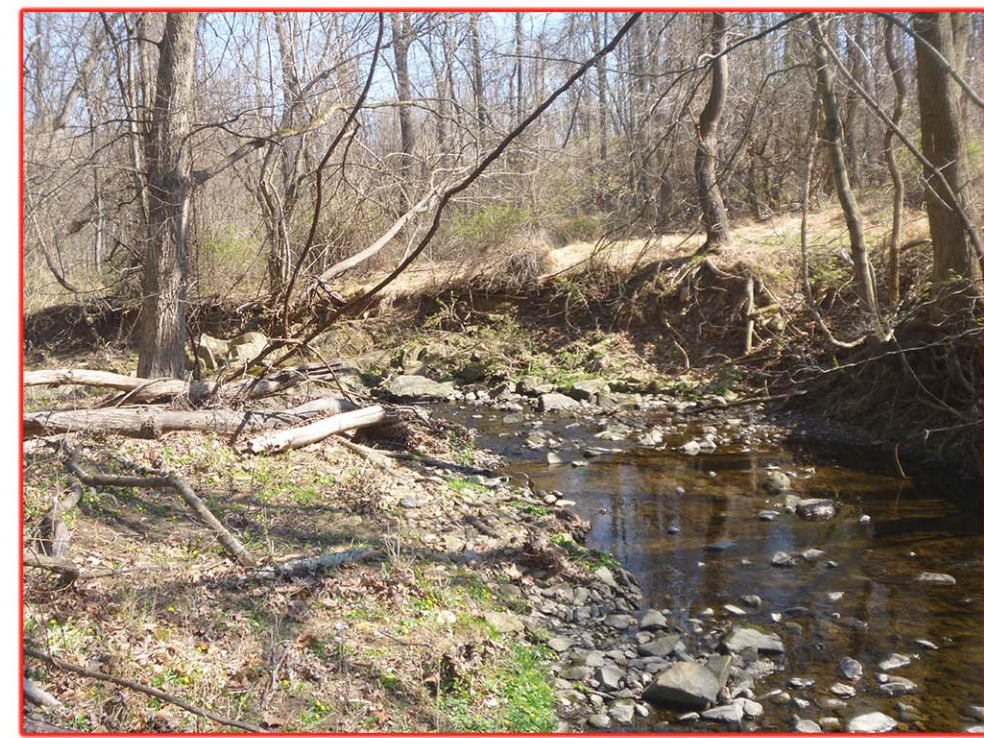
ERODING MEANDER BEND

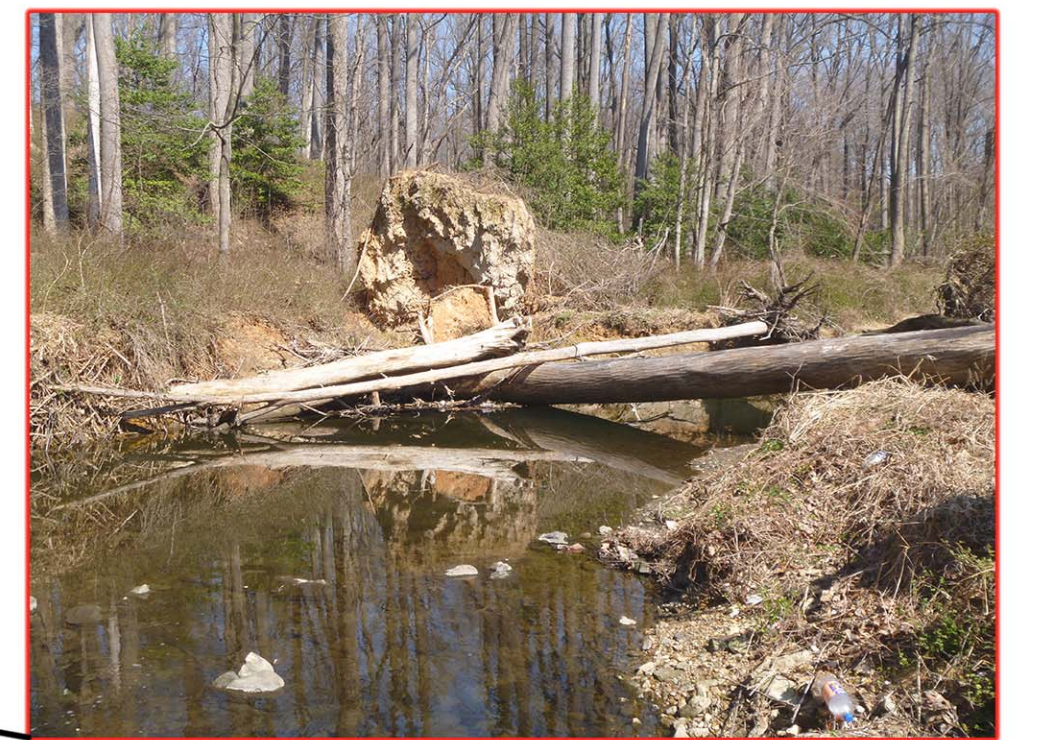
MEANDER BEND EROSION & FELLED TREES

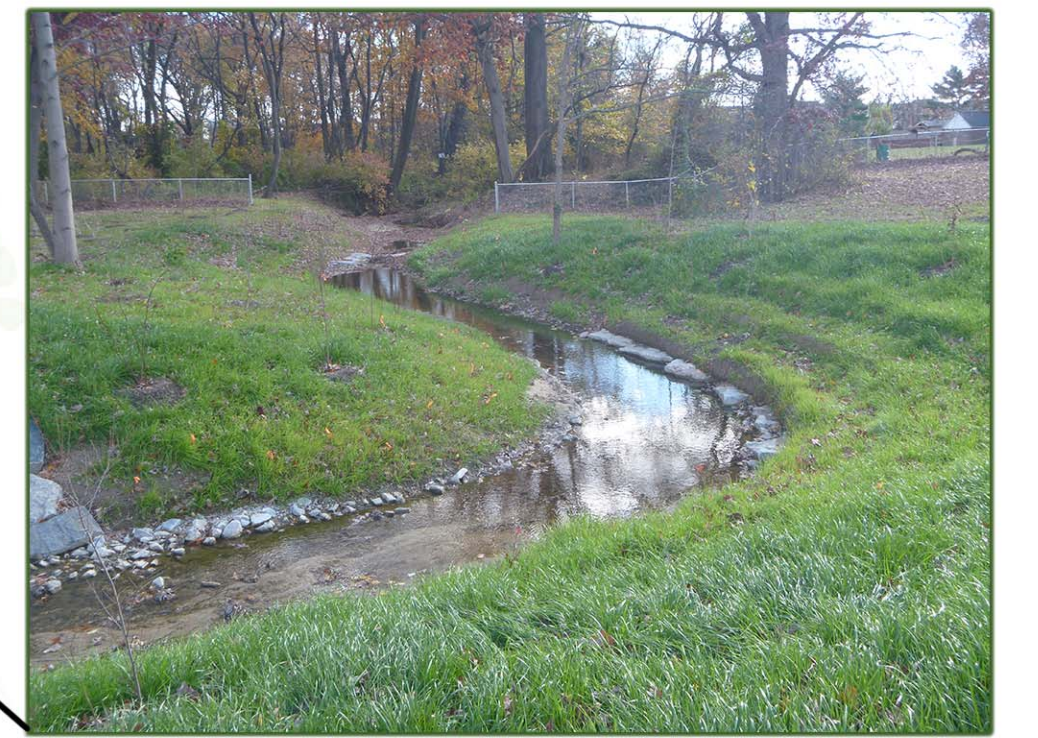
WRAPPED SOIL LIFTS EXAMPLE

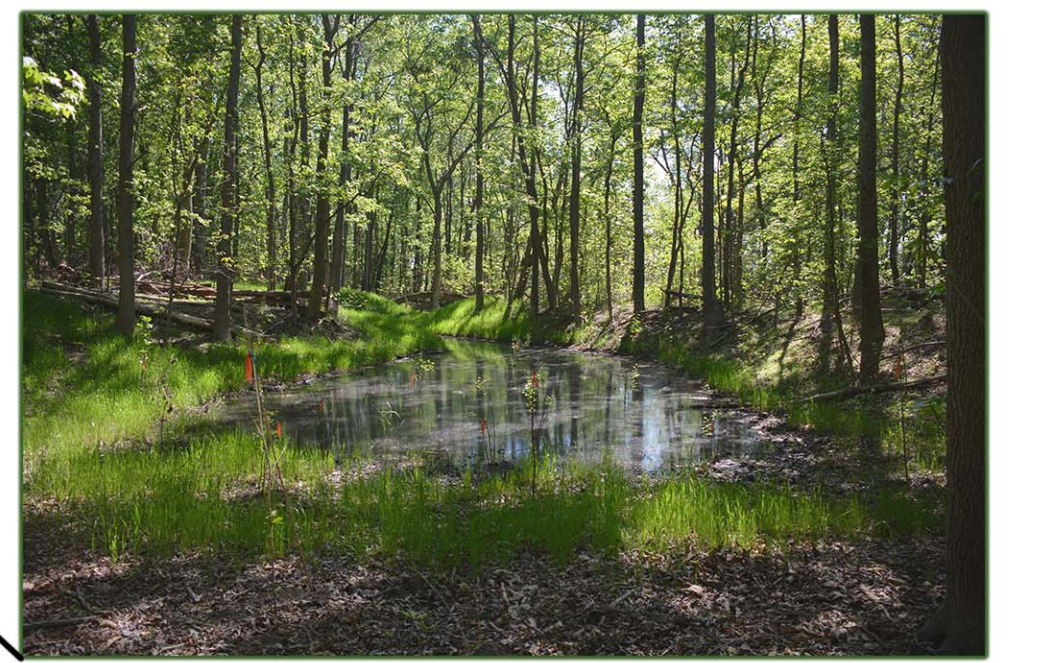
VERNAL POOL EXAMPLE

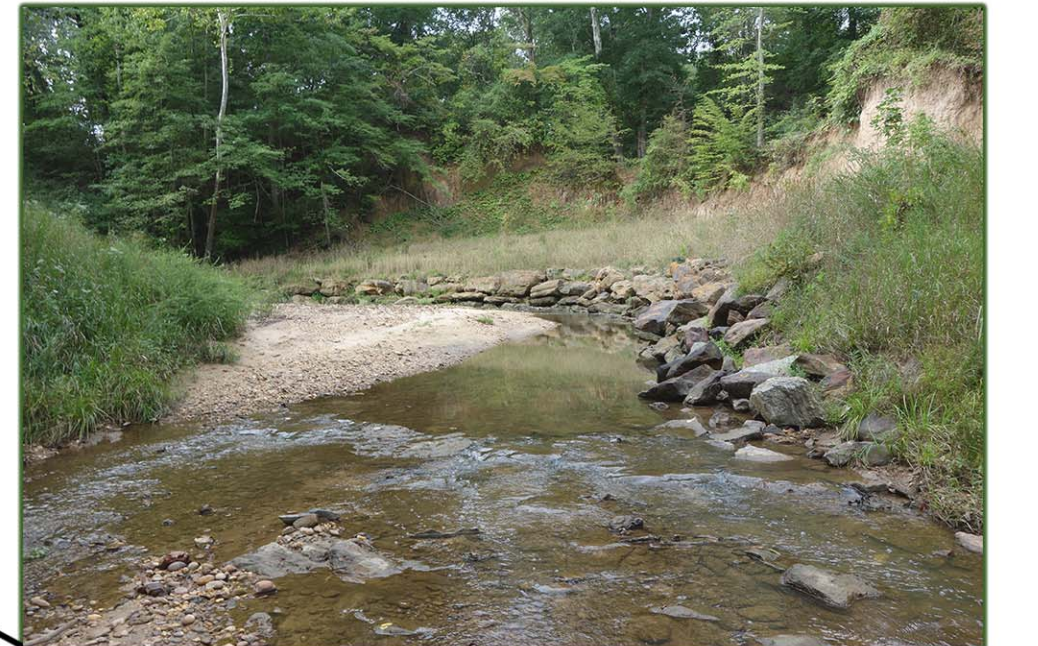
BOULDER REVETMENT EXAMPLE

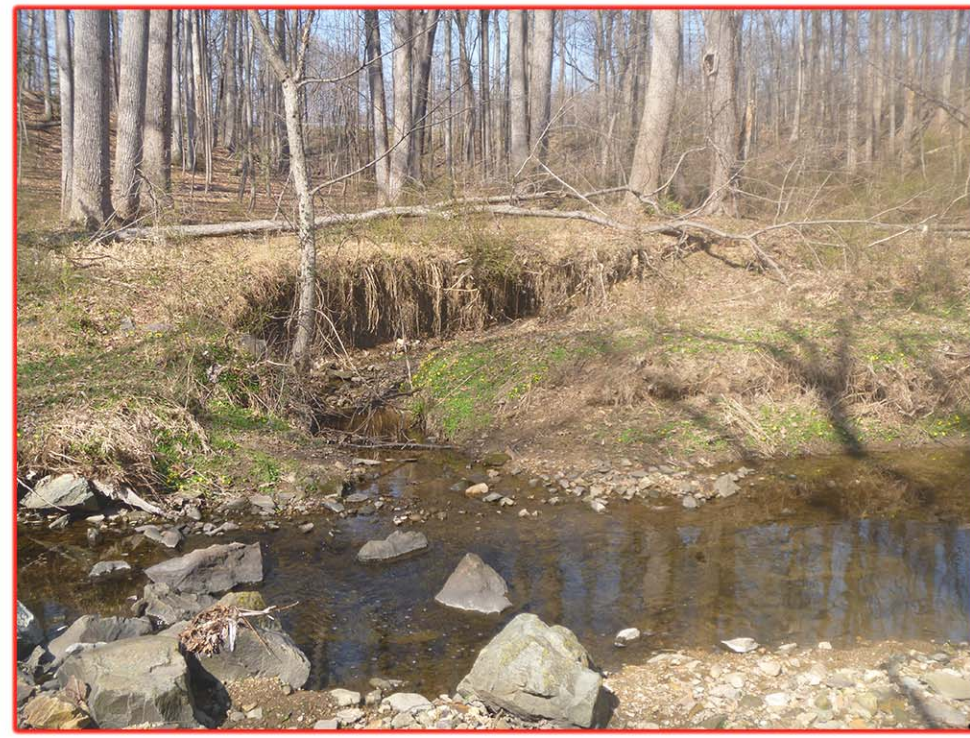
CONFLUENCE WITH SMALL TRIBUTARY

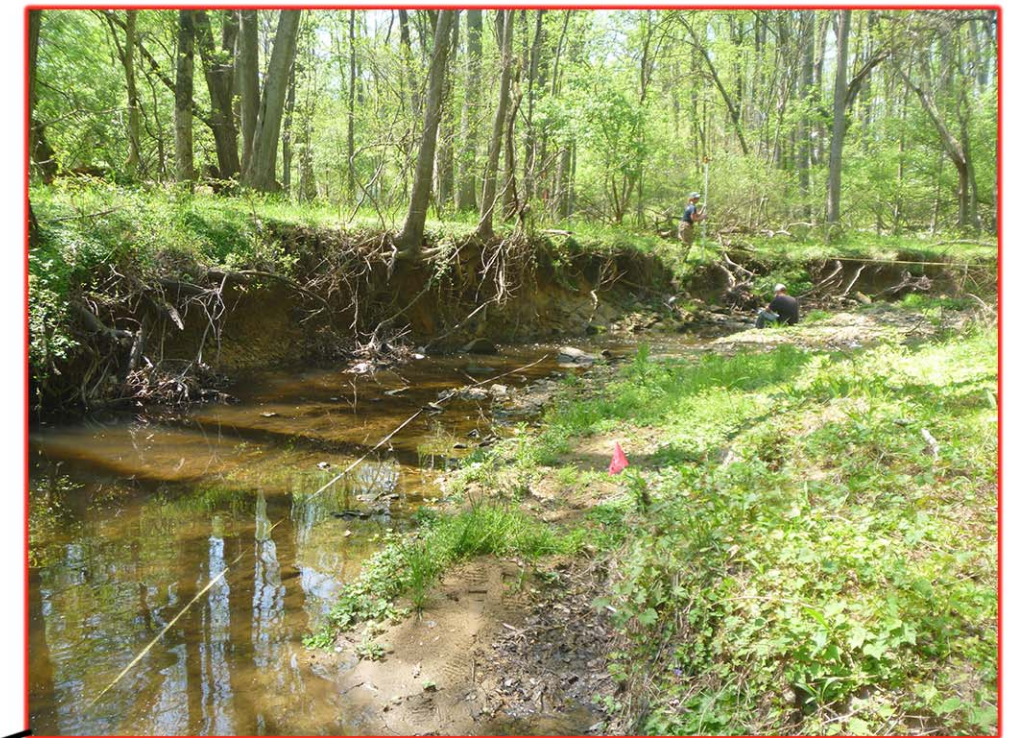
ERODING MEANDER BEND

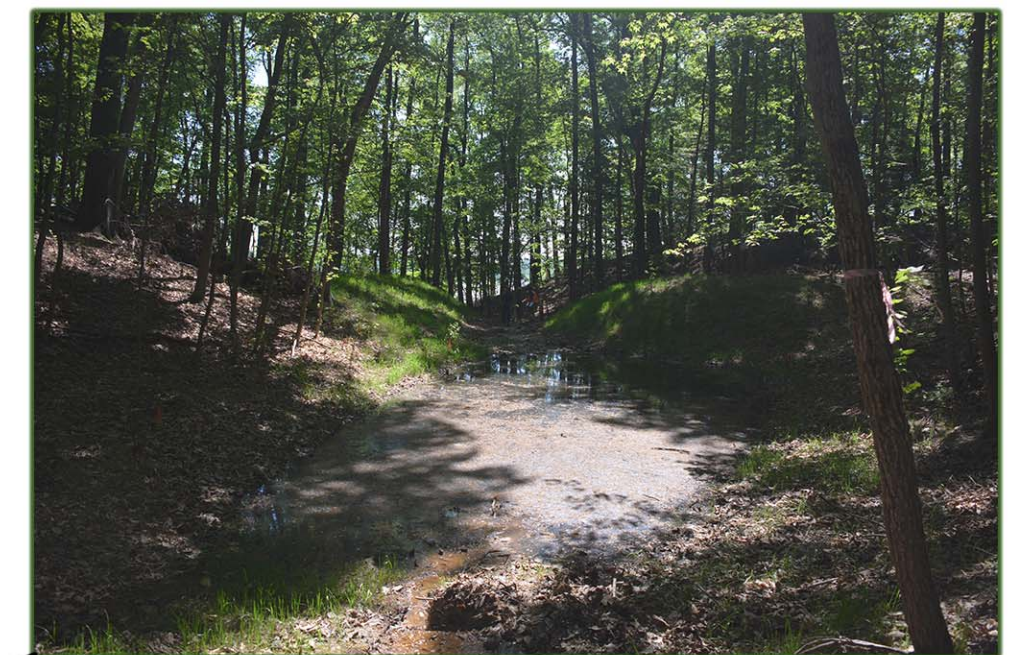
VERNAL POOL EXAMPLE

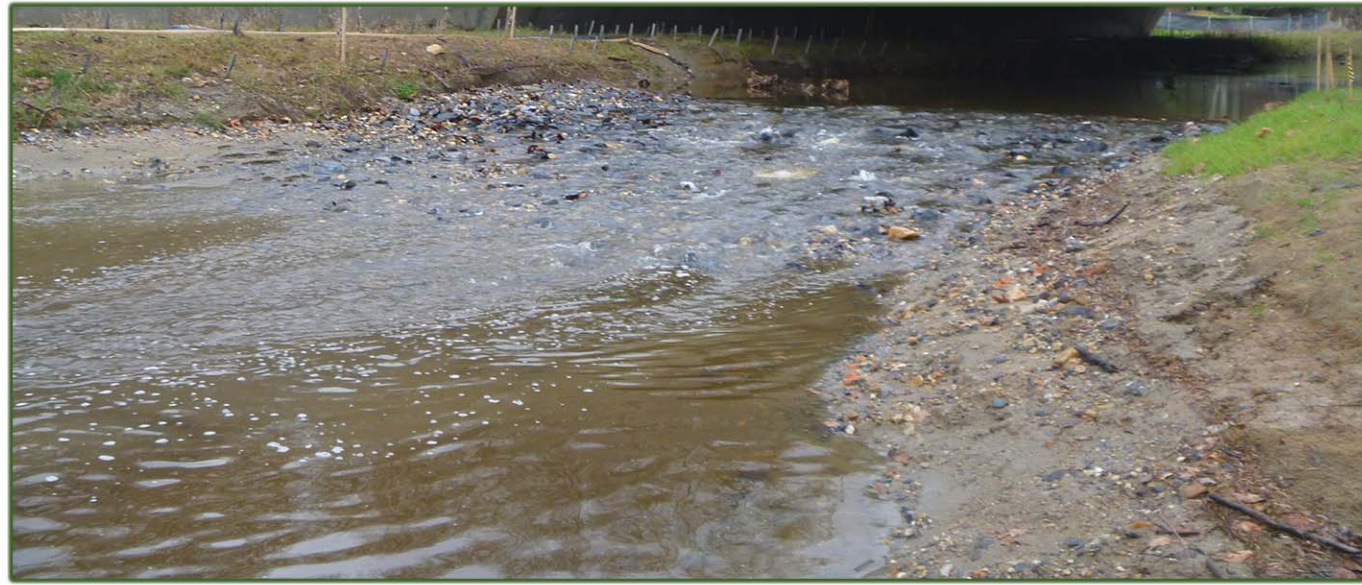
RIFFLE GRADE CONTROL EXAMPLE

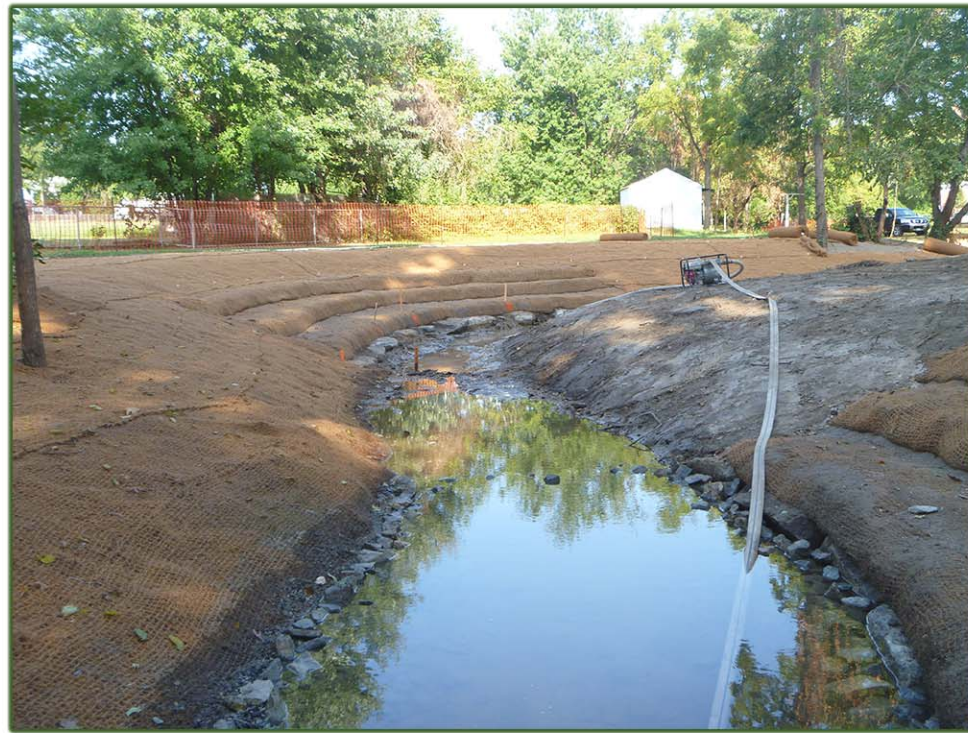
WRAPPED SOIL LIFT CONSTRUCTION EXAMPLE & PUMP DIVERSION

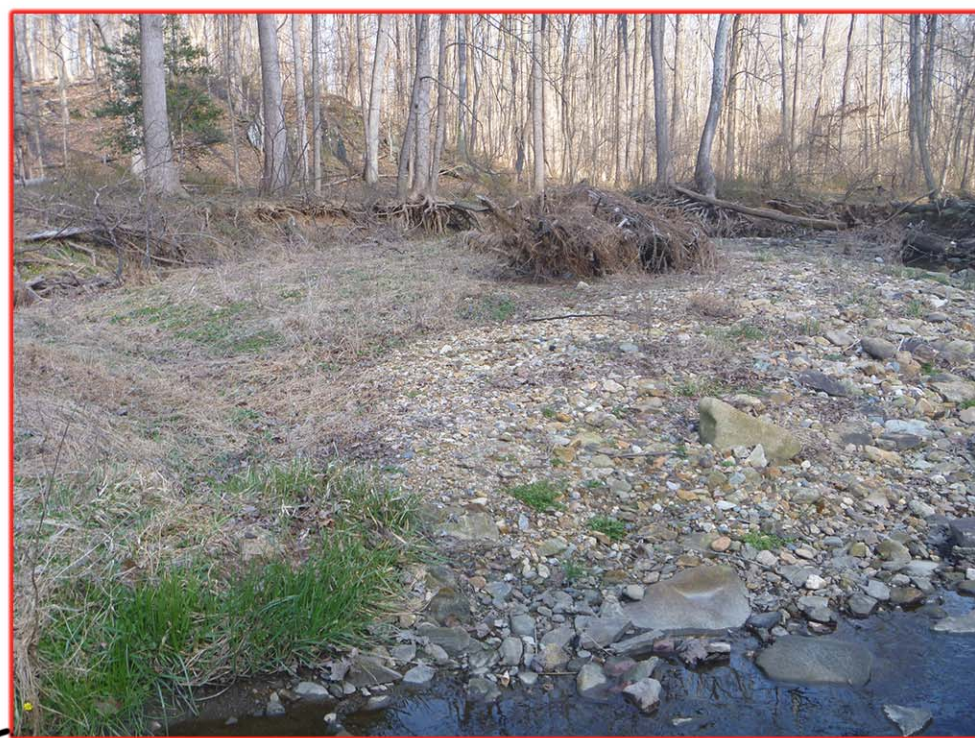
ABANDONED MEANDER BEND & OVERWIDENED CHANNEL

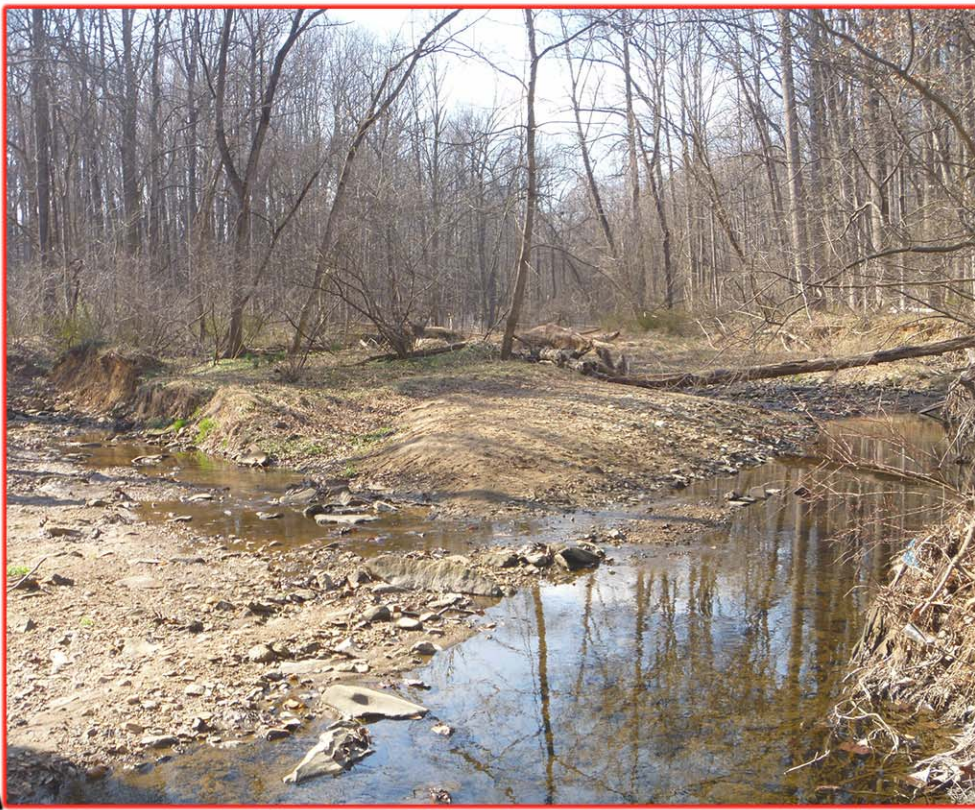
CONFLUENCE OF CROYDON CREEK & CALVIN TRIBUTARY

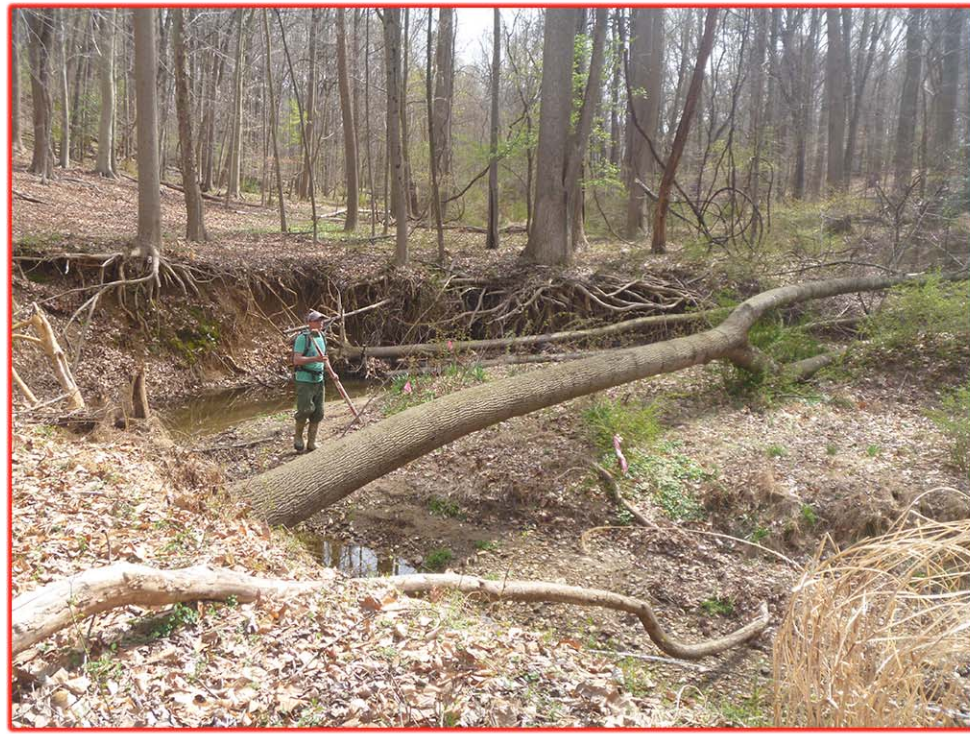
ERODED MEANDER BEND WITH FELLED TREES

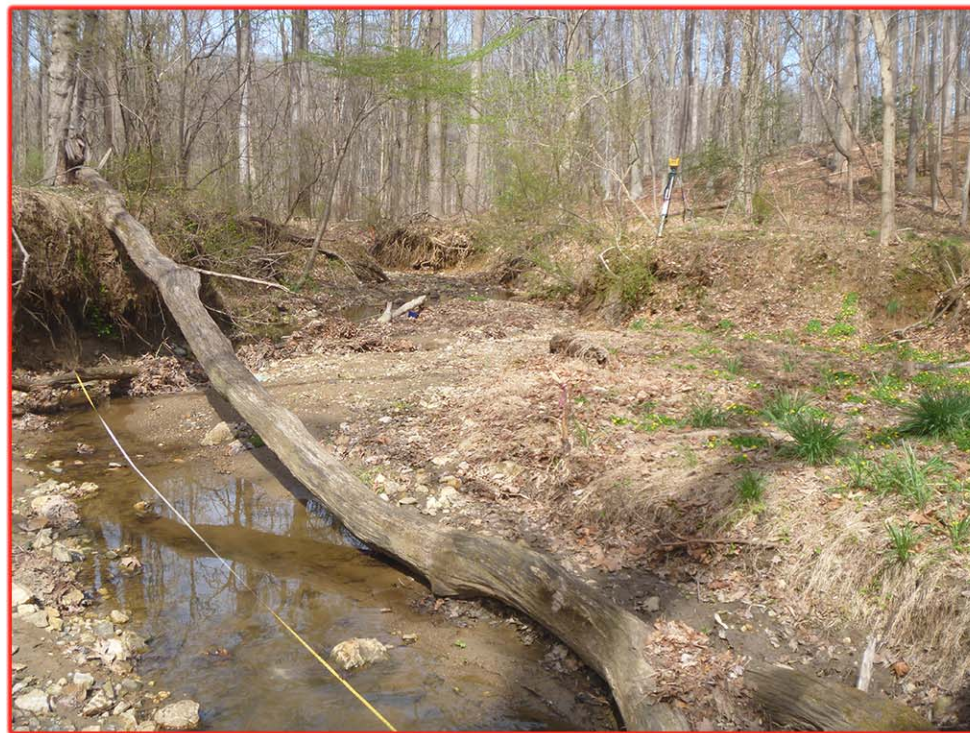
OVER-WIDENED CHANNEL WITH ERODED BANKS

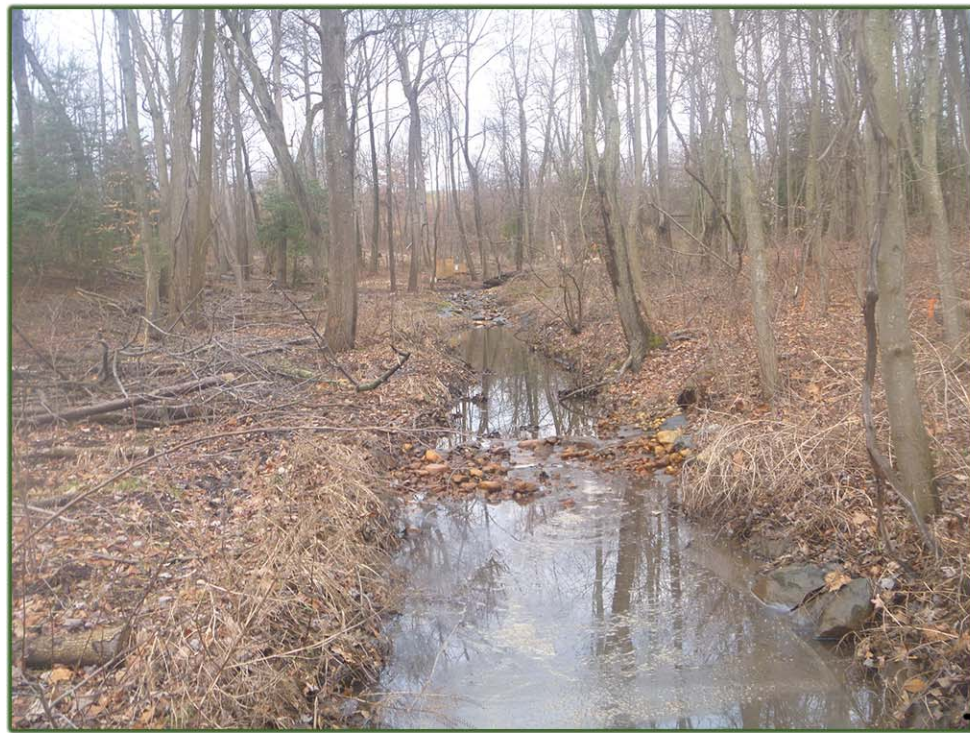
RIFFLE WEIR EXAMPLE

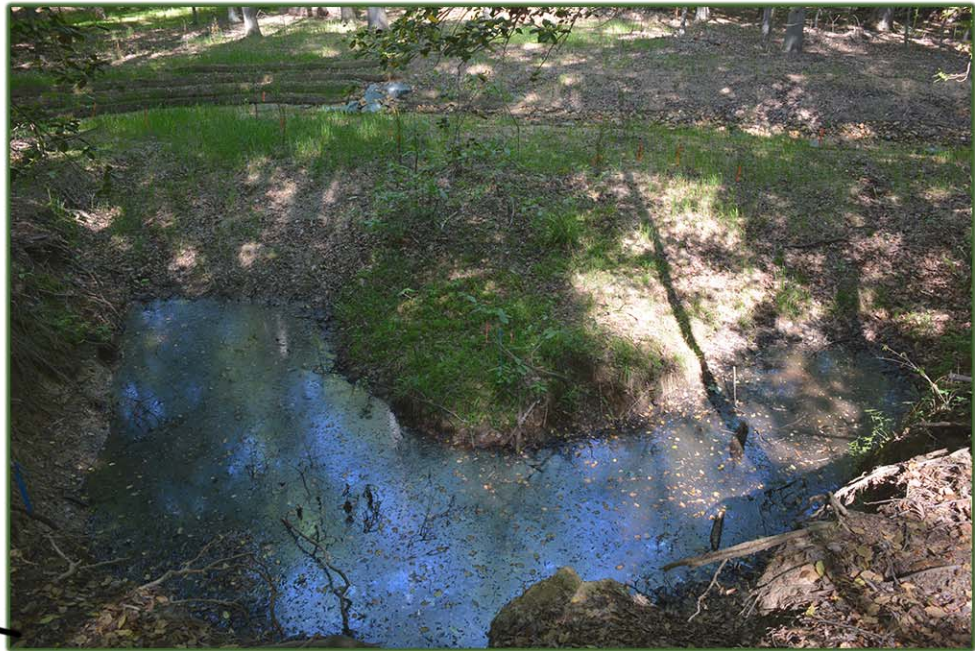
VERNAL POOL IN FORMER TORTUOUS MEANDER BEND EXAMPLE

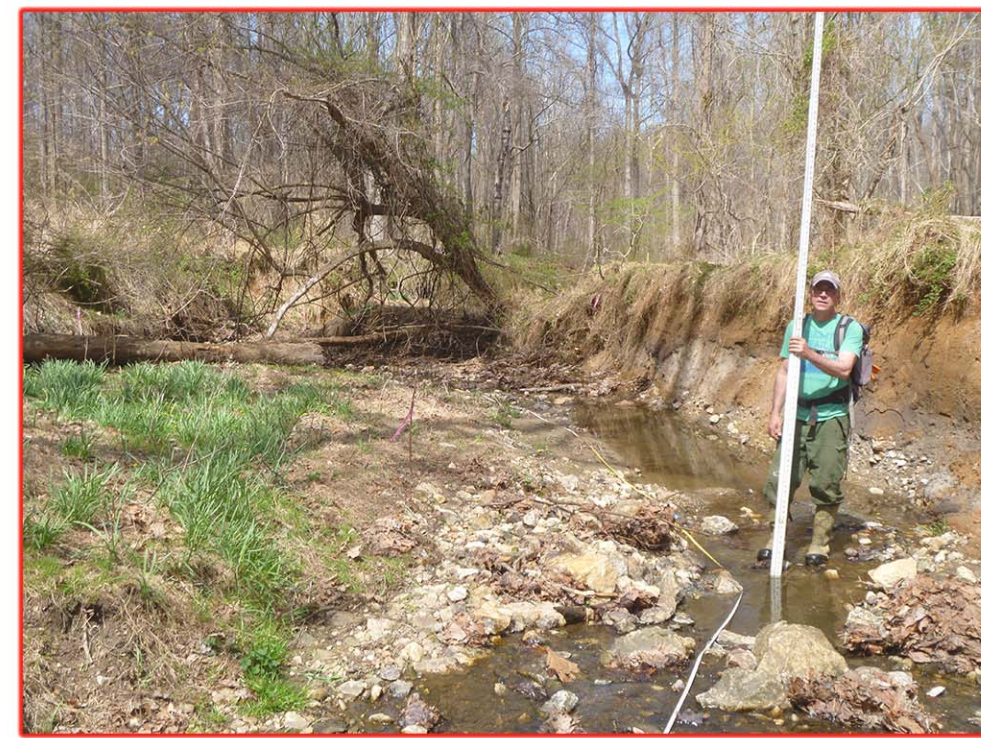
ERODING BANK
