CROYDON CREEK / CALVIN PARK TRIBUTARY  
STREAM RESTORATION  
AERIAL EXHIBIT

JUNE 2018

CROYDON CREEK / CALVIN PARK TRIBUTARY  
STREAM RESTORATION

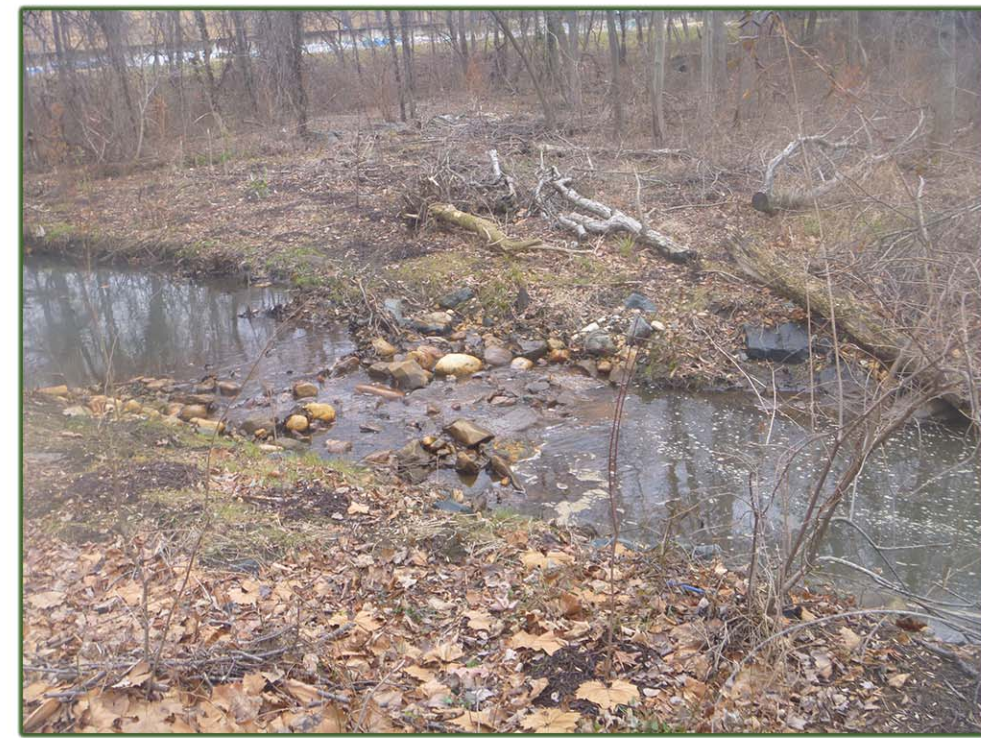
RIFFLE WEIR EXAMPLE 1

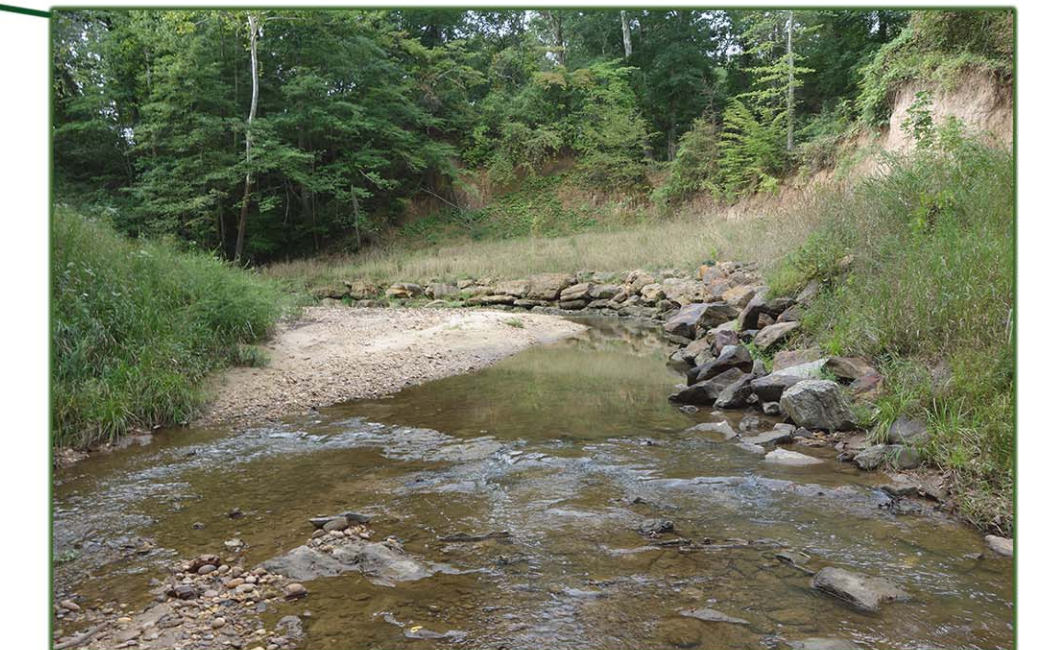
BOULDER REVETMENT EXAMPLE

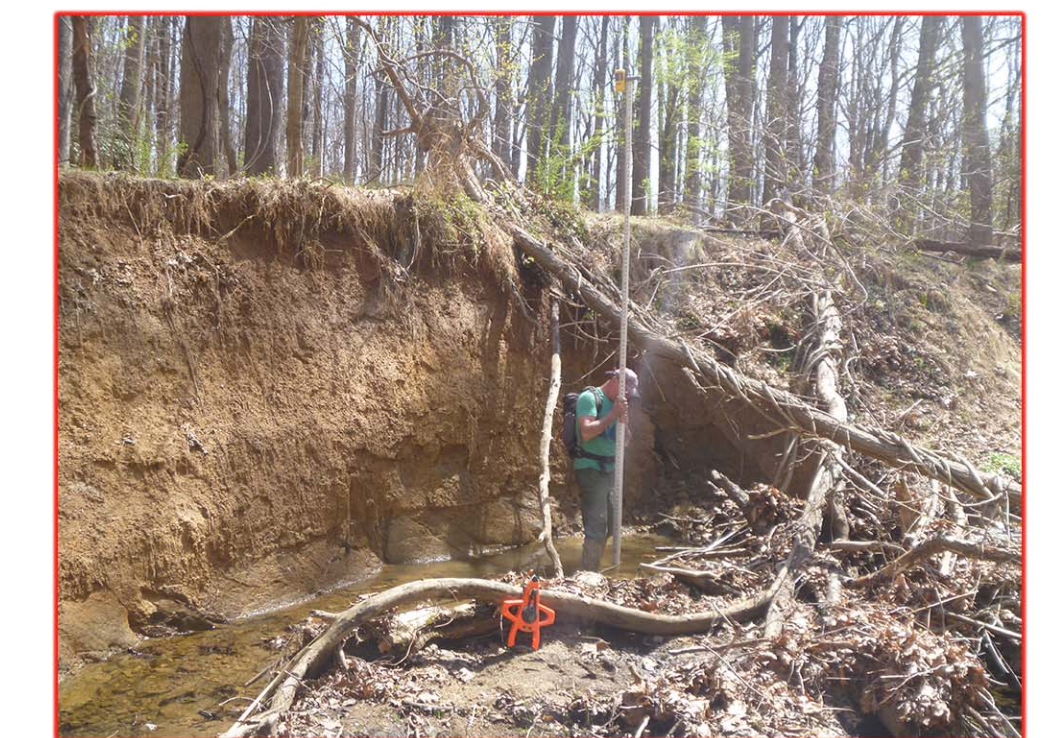
10-FT ERODING BANK

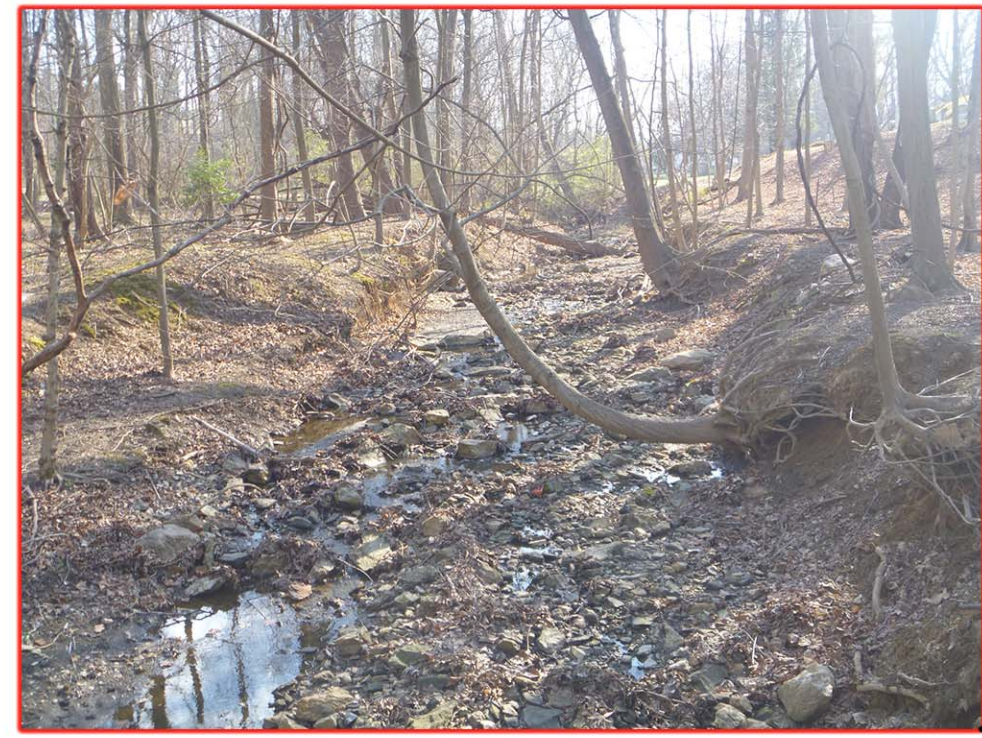
INCISED CHANNEL WITH ERODING BANKS

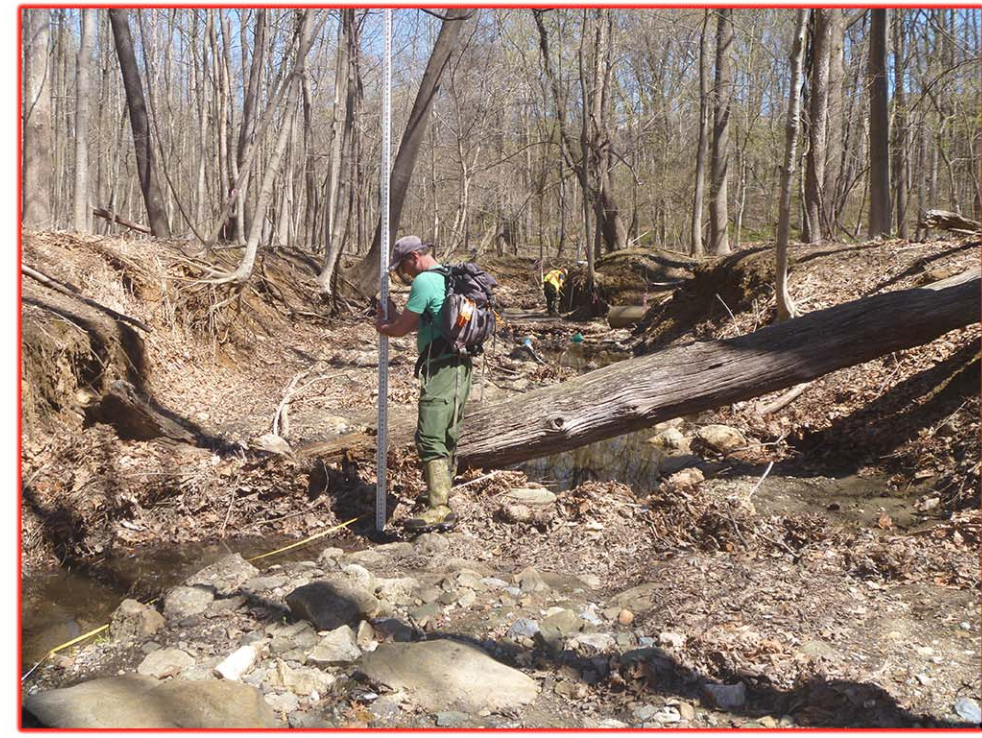
OVERWIDENED & INCISED CHANNEL

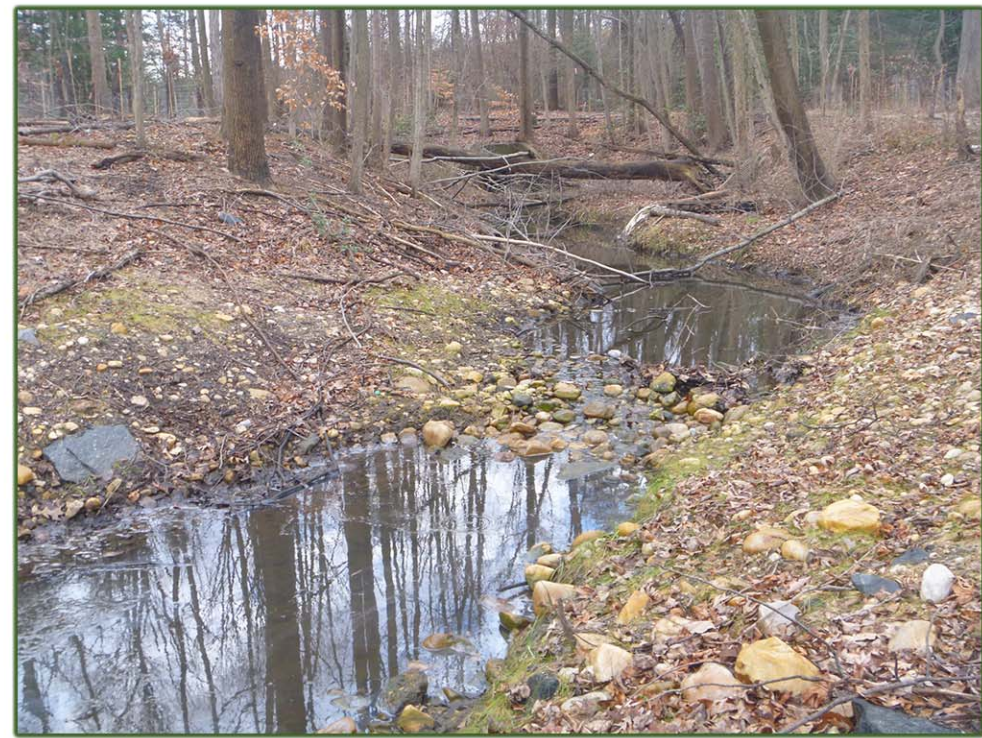
RIFFLE WEIR EXAMPLE 2

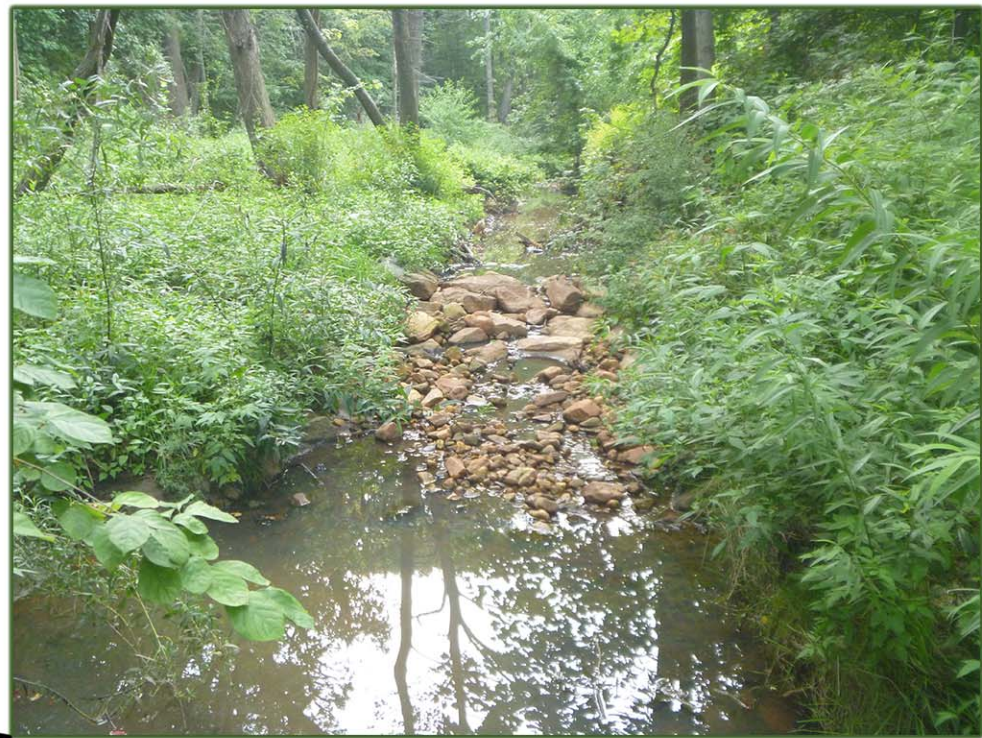
RIFFLE WEIR EXAMPLE 1

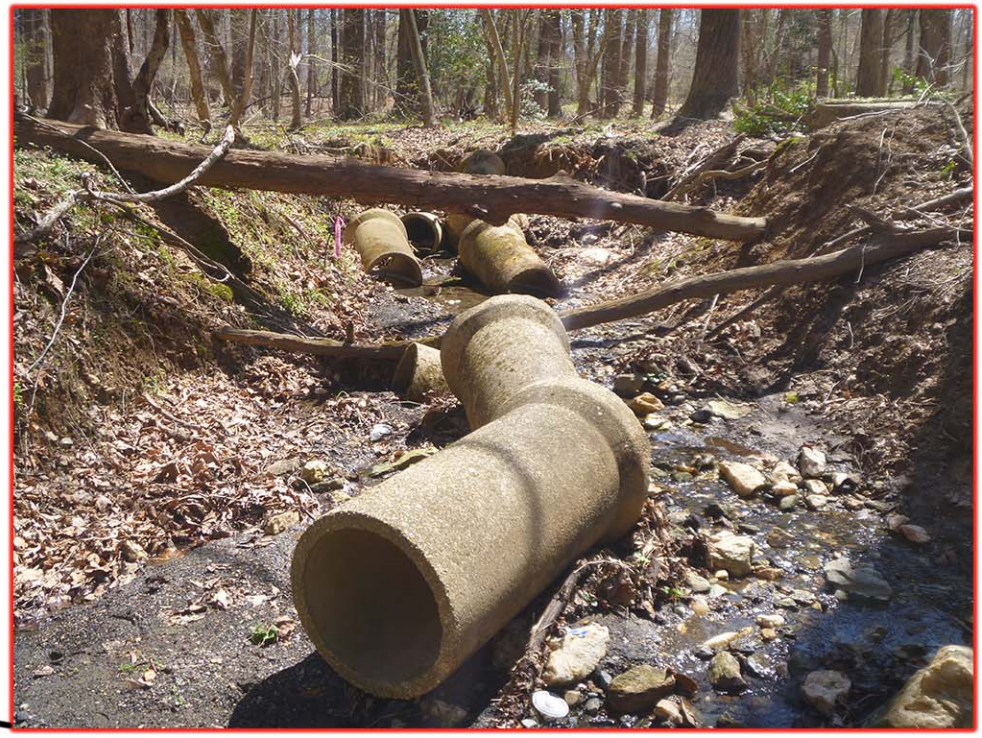
BROKEN STORMDRAIN OUTFALL
