# CHAPMAN AVENUE AND TWINBROOK PARKWAY INTERSECTION IMPROVEMENT REPORT

Twinbrook Safe Routes to School and Transit Access Feasibility Studies  
City of Rockville Contract No. BCS 2017-01H

December 2024

INTERSECTION IMPROVEMENT PLANS  
CHAPMAN AVE-TWINBROOK PKWY INTERSECTION

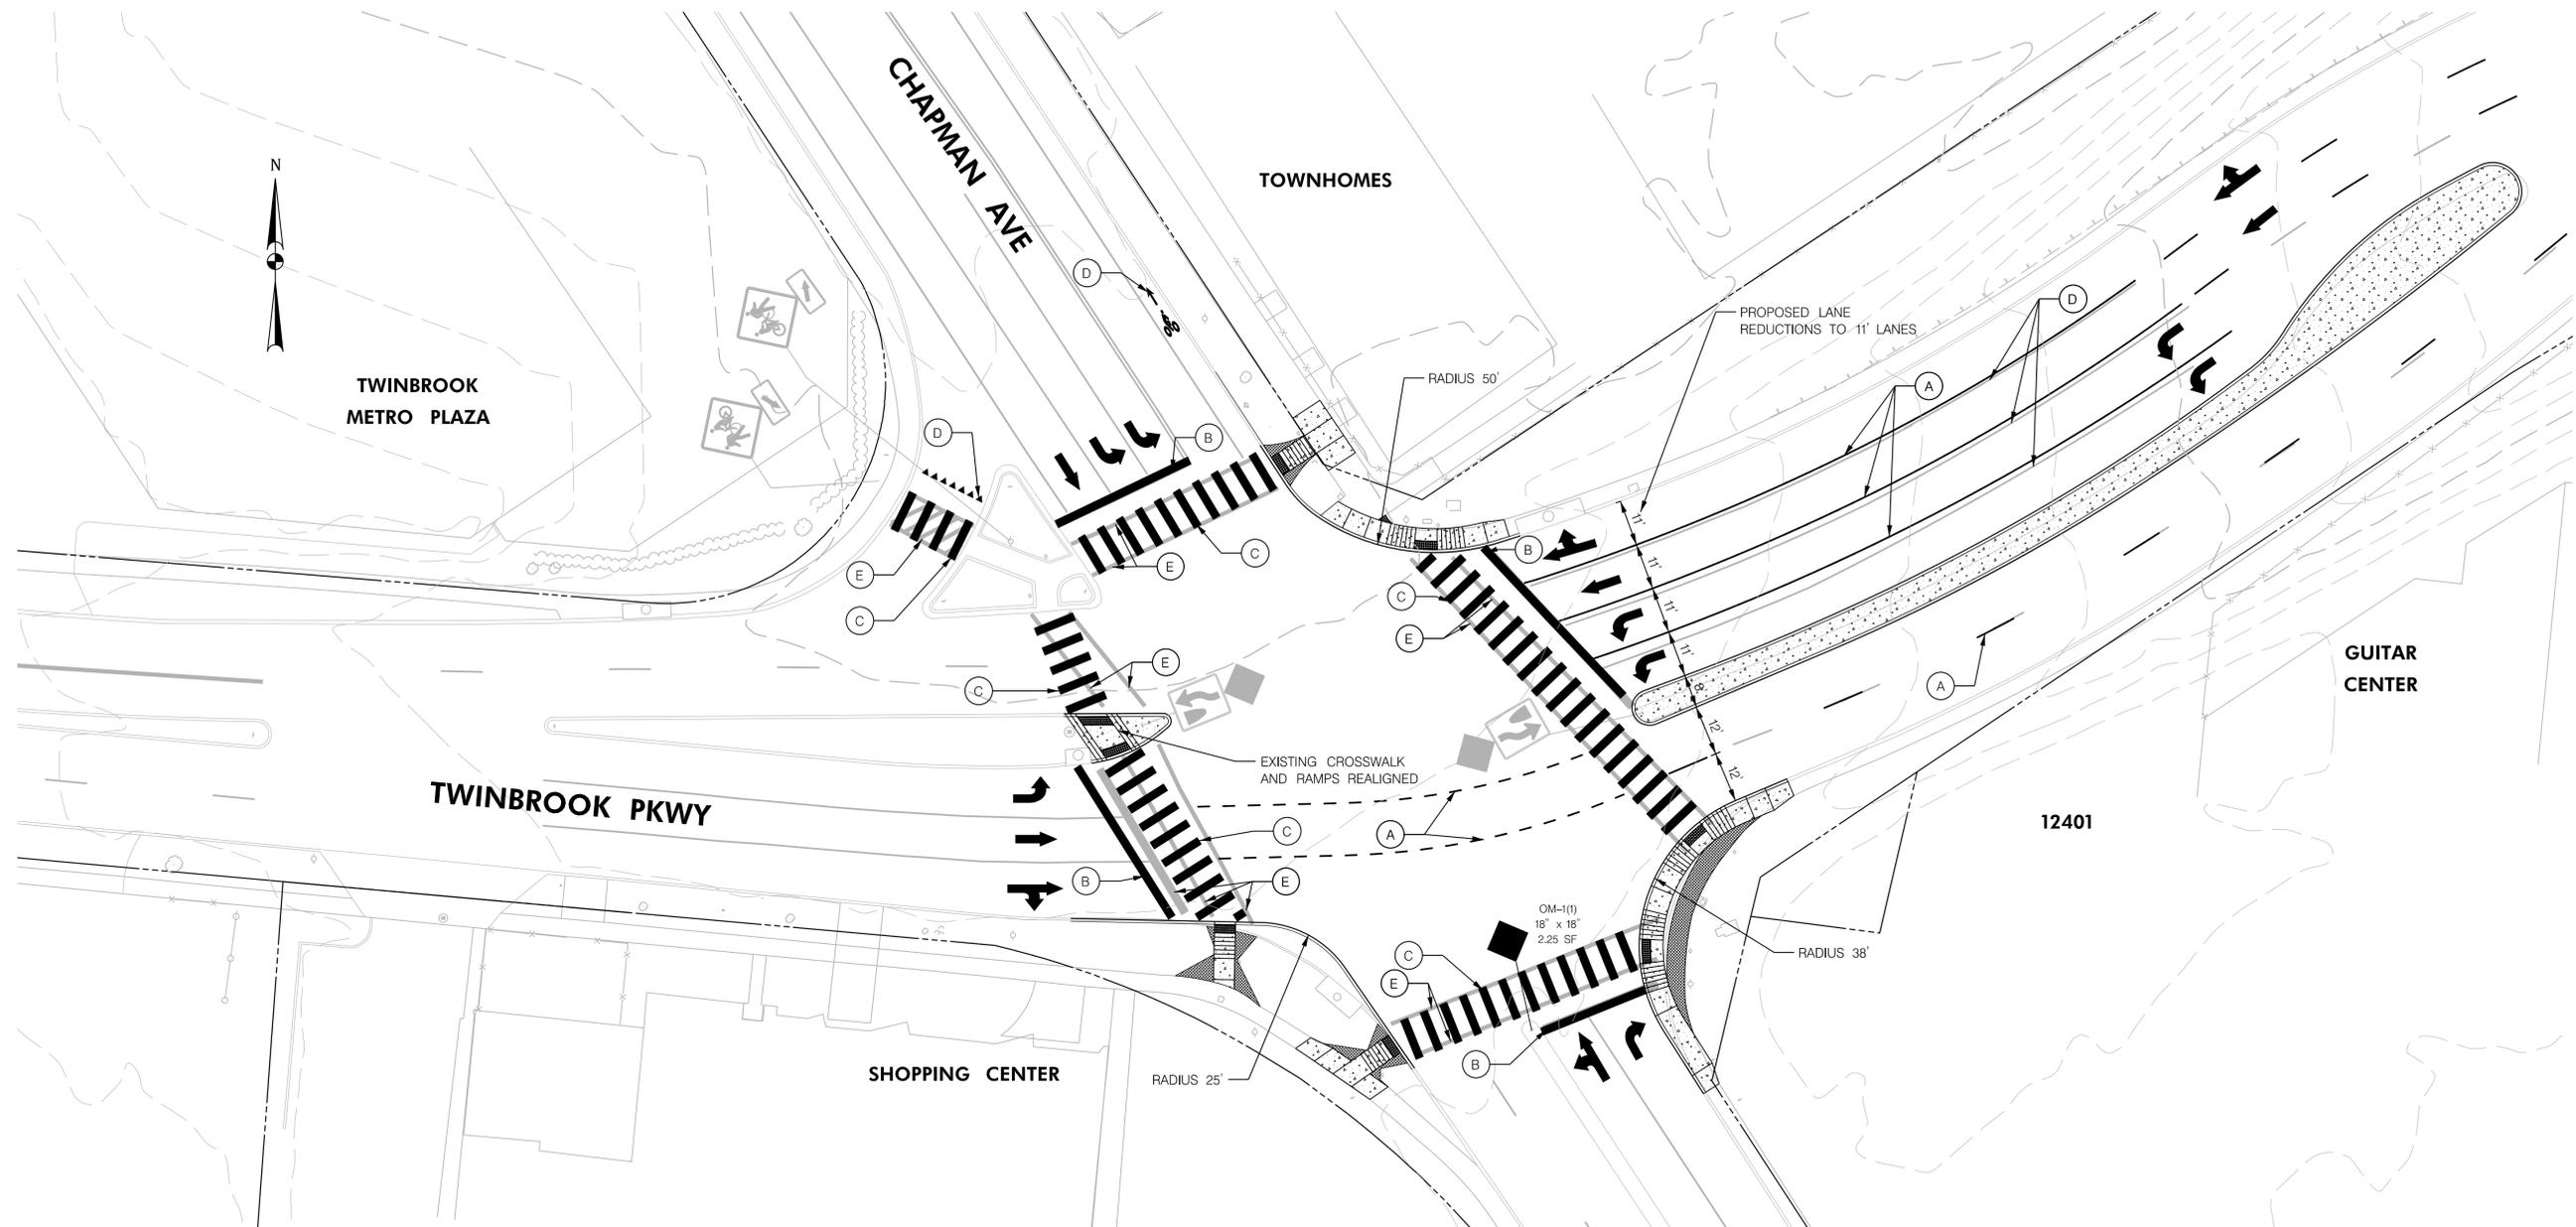
The project team recommends decreasing curb radii to the recommended 25-feet. Smaller curb radii encourage motorists to decrease their speed to make turns. The southeast quadrant's radius cannot be reduced to the preferred 25-feet as it would negatively impact turning movements of the design vehicles.

The project team also recommends converting the crosswalks at this intersection to continental style crosswalks. This would improve pedestrian visibility throughout the intersection.

An additional object marker sign is also recommended for the concrete median south of the intersection. The object marker sign should be placed below the existing keep right sign.

Lane width reduction is also recommended for westbound vehicles on Twinbrook Parkway.

The project team proposes moving forward with several intersection improvement techniques for Chapman Avenue and Twinbrook Parkway. The curb radii for this intersection should be reduced to 25-feet for all quadrants except for the southeast quadrant where it can be reduced to 38-feet.

The project team also proposes the addition of an obstacle marker sign for the south approach median. All crosswalks should be upgraded to continental style crosswalks.

The westbound lanes on Twinbrook Parkway should be reduced to 11-feet. These upgrades should improve pedestrian safety across the Chapman Avenue and Twinbrook Parkway intersection.

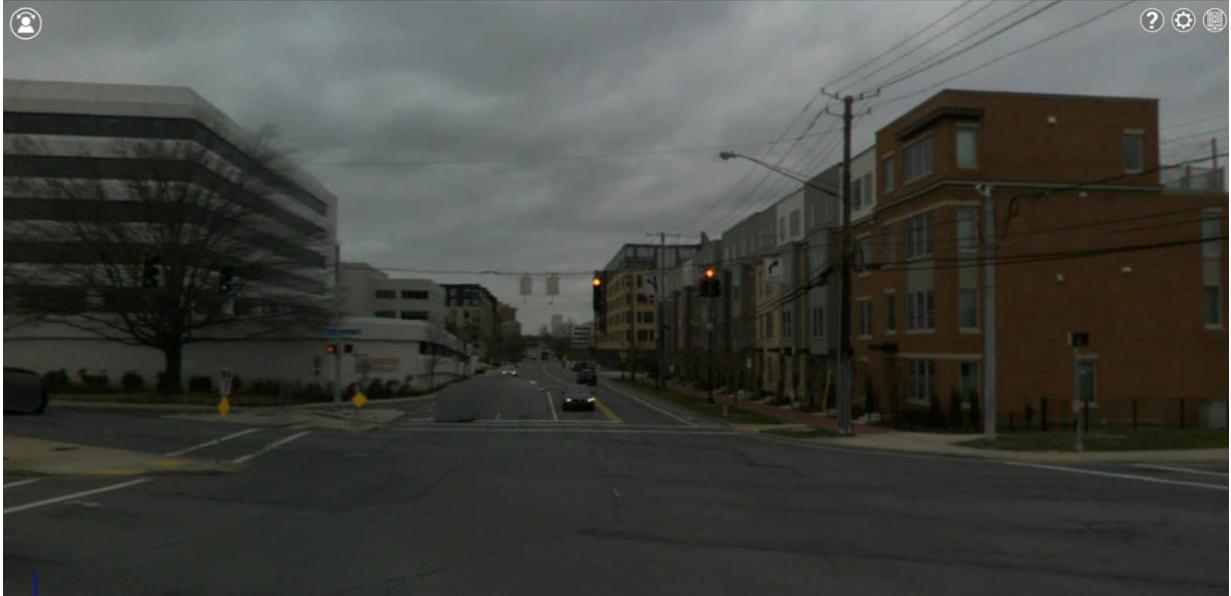
Ardennes Avenue and Halsey Road Intersection – Looking North

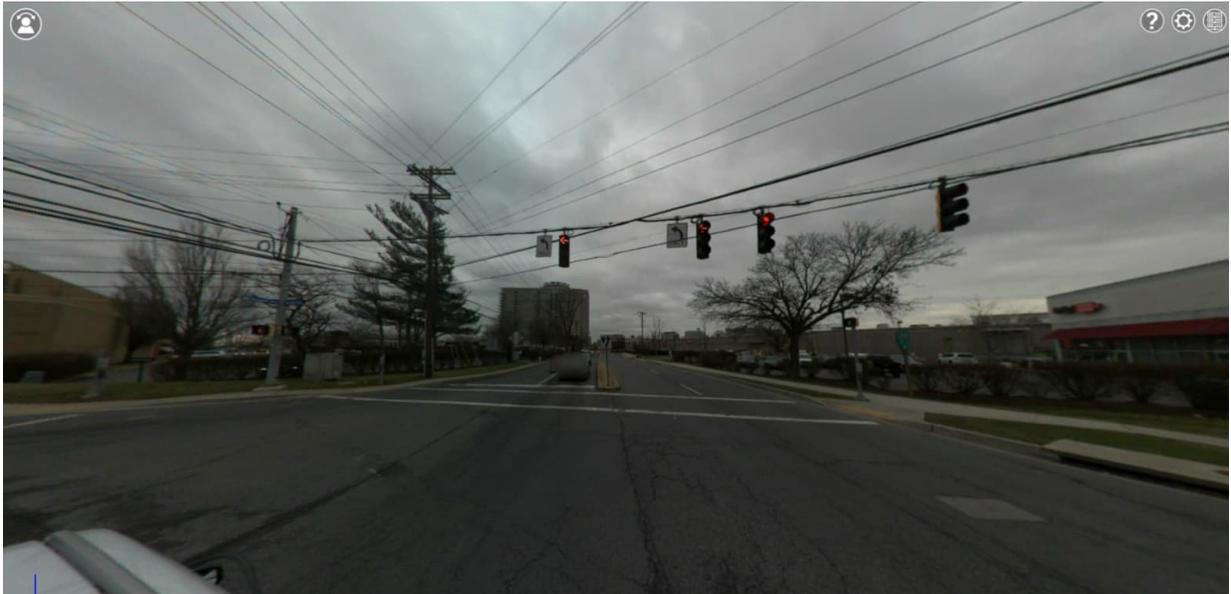
Ardennes Avenue and Halsey Road Intersection – Looking South

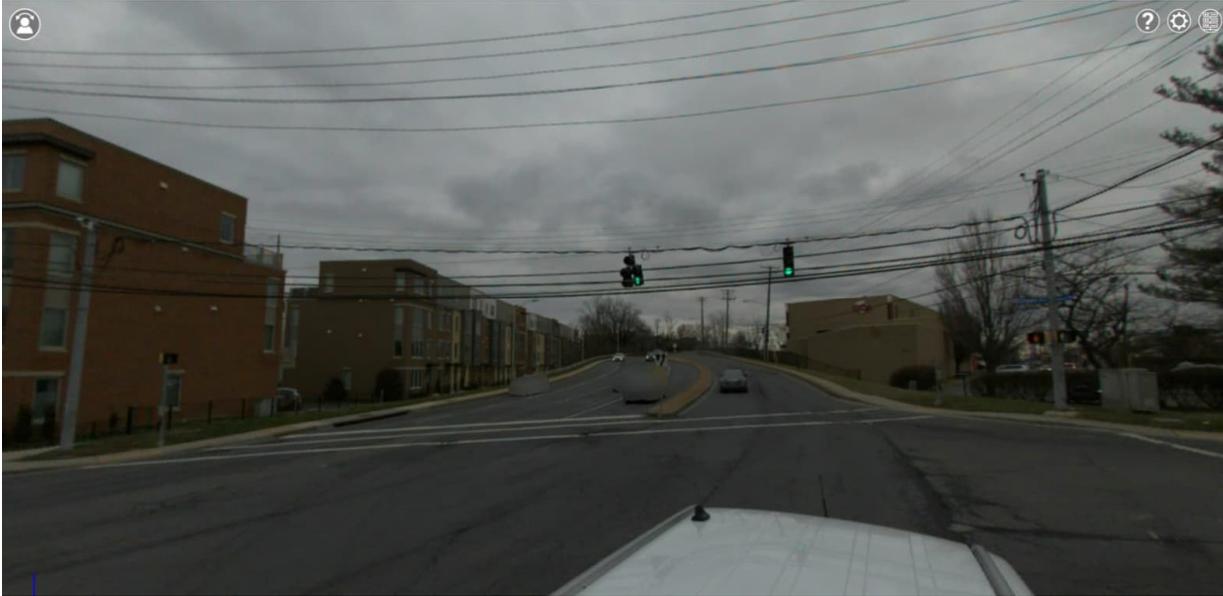
Ardennes Avenue and Halsey Road Intersection – Looking East

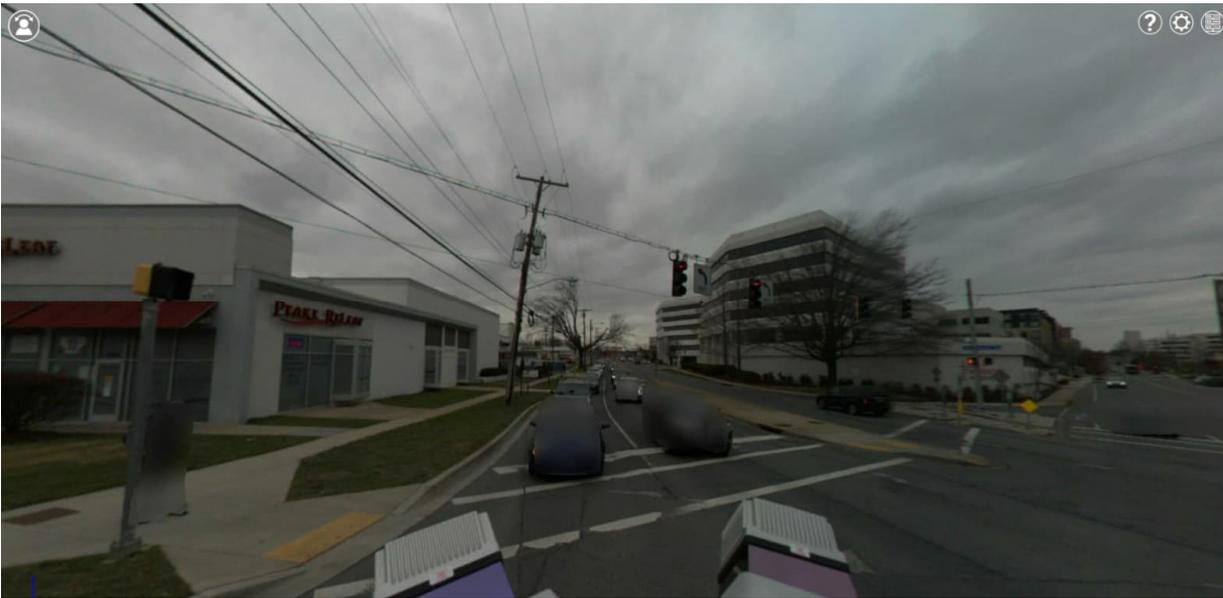
Ardennes Avenue and Halsey Road Intersection – Looking West
