Lewis Avenue Bicycle and Pedestrian Improvements

Existing Conditions Memorandum

Prepared for:
City of Rockville

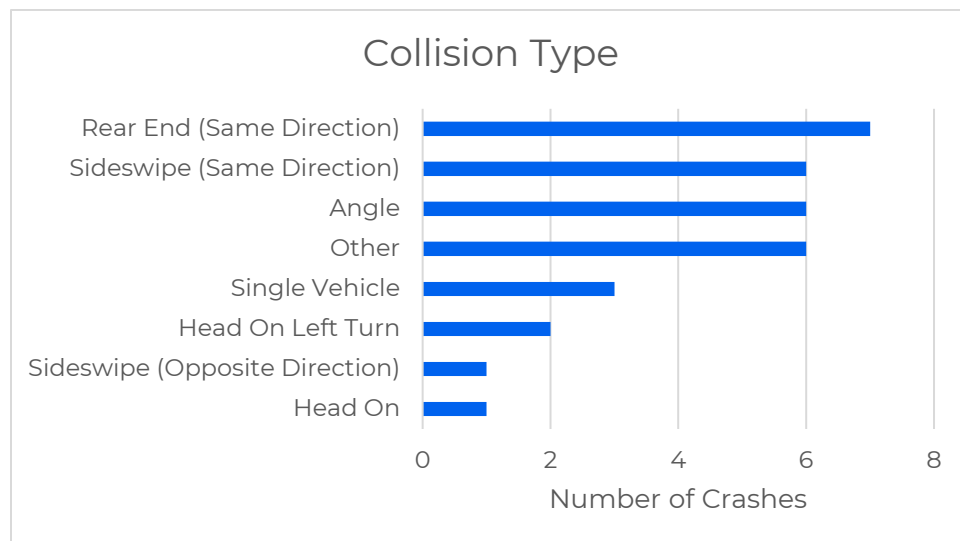
Figure 2. Collision types for corridor crashes from April 2021 through March 2026

Over the study corridor, the predominant crash types were rear-end crashes, same-direction sideswipes, and angle crashes, as shown in Figure 2.

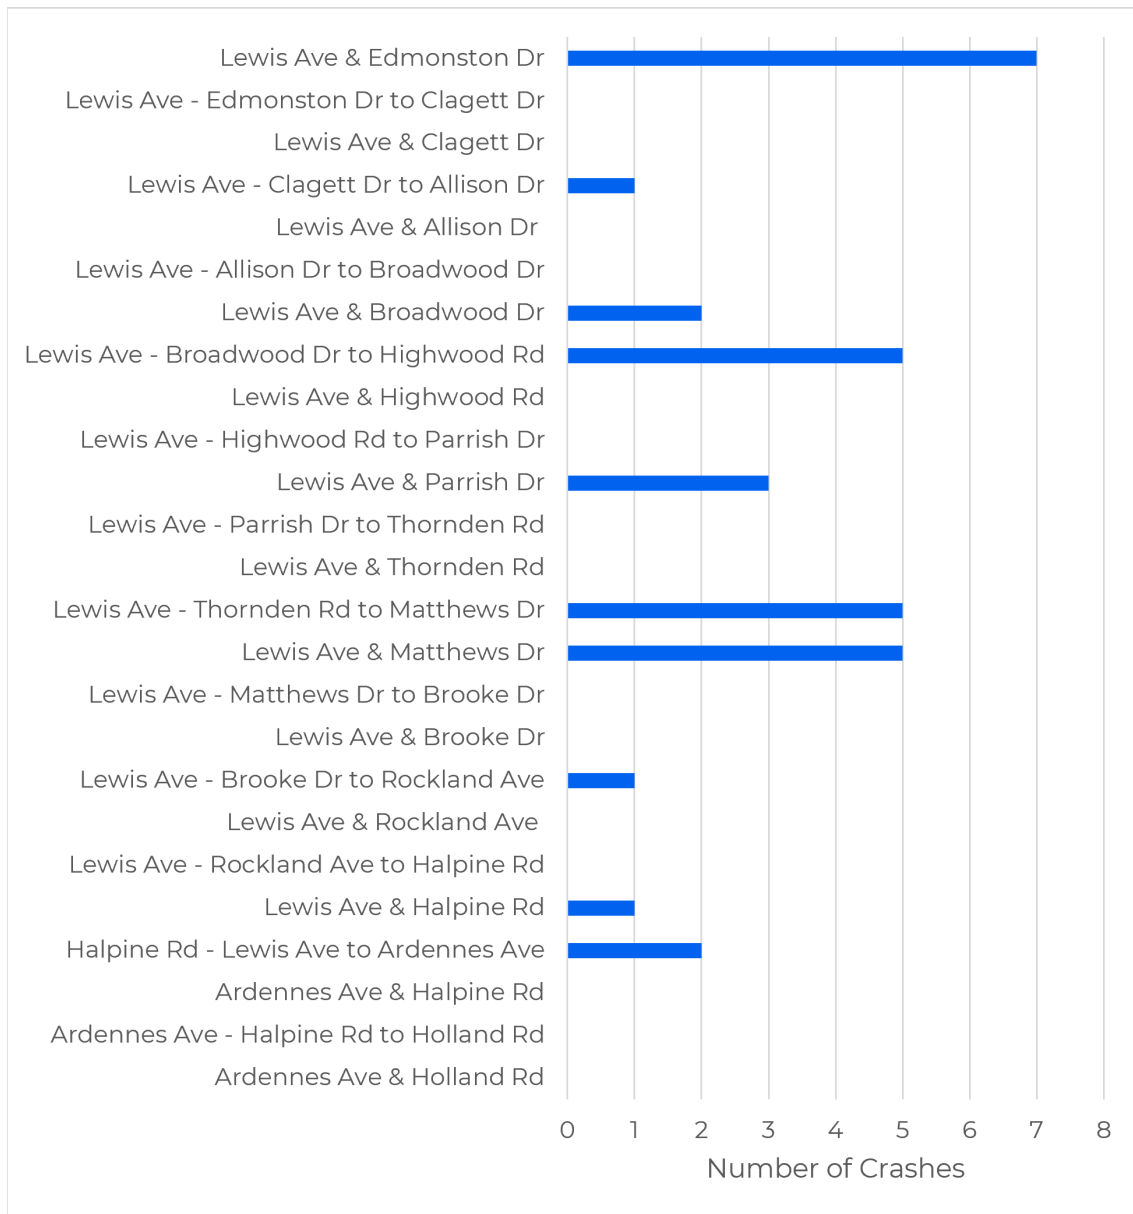
Figure 7. Corridor crashes by segment or intersection

Figure 7 displays crashes by segment and intersection along the study corridor to highlight locations with higher crash frequencies. Locations are arranged beginning at the northernmost intersection and progressing south along Lewis Avenue to Halpine Road, then east along Halpine Road, and finally north along Ardennes Avenue. Additional information on crash patterns is provided in the following sections for locations with five or more reported crashes.

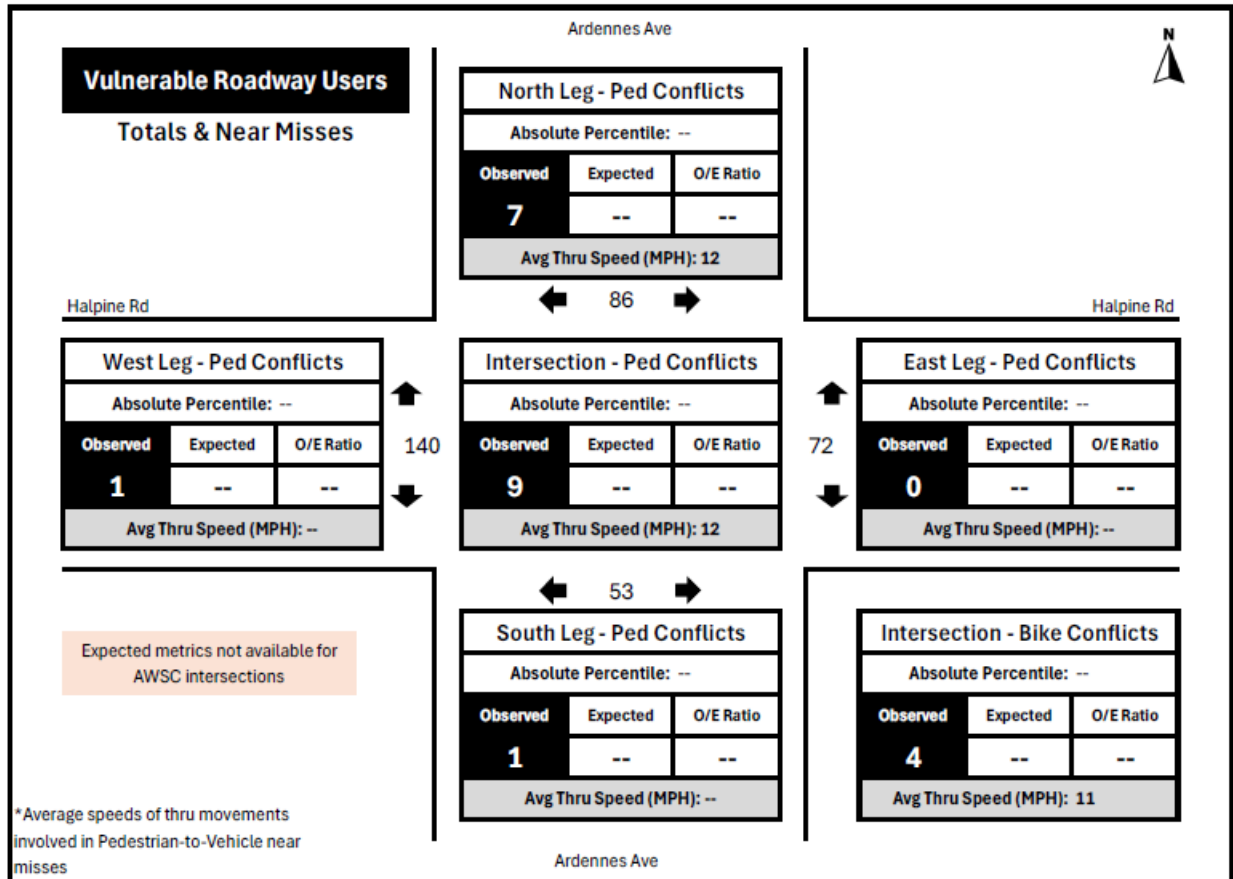
Figure 11. Near-miss data summary for bicyclists and pedestrians at Ardennes Avenue and Halpine Road

Near-miss data for this four-way stop-controlled intersection is broken down by vehicle-to-pedestrian and vehicle-bicycle conflicts.

Zero vehicle-vehicle conflicts were observed at this intersection.

11-12 MPH and there were higher post encroachment times, meaning roadway users did not come very close to colliding.

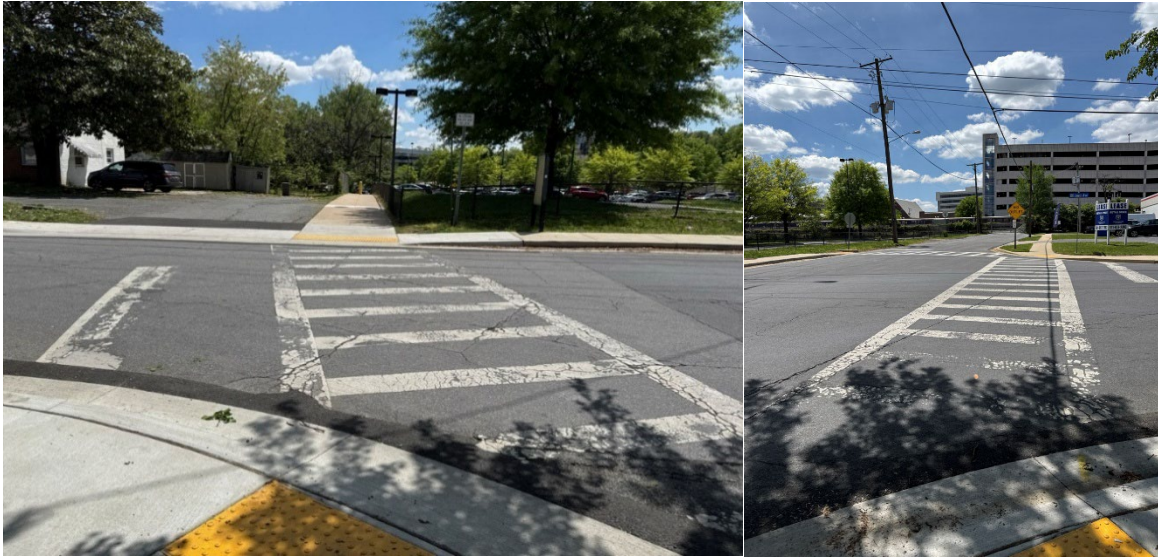
Figure 12. Pedestrian facilities and shared use path at the Lewis Avenue and Halpine Road intersection (left, looking south) and crosswalk connection to mixed-use development (right, looking west)

Curb Ramps	<ul style="list-style-type: none"> Curb ramps with directional warning surface at all marked crosswalks Curb ramp openings aligned with the curb line
Bike Facilities	<ul style="list-style-type: none"> Shared Use Path in the south leg of the intersection Lewis Avenue is a Signed Shared Roadway The east leg of Halpine Road is part of a Signed Shared Roadway
Transit Facilities	<ul style="list-style-type: none"> No bus stops, although Halpine Avenue is a Ride On Route Metro connection south of the intersection

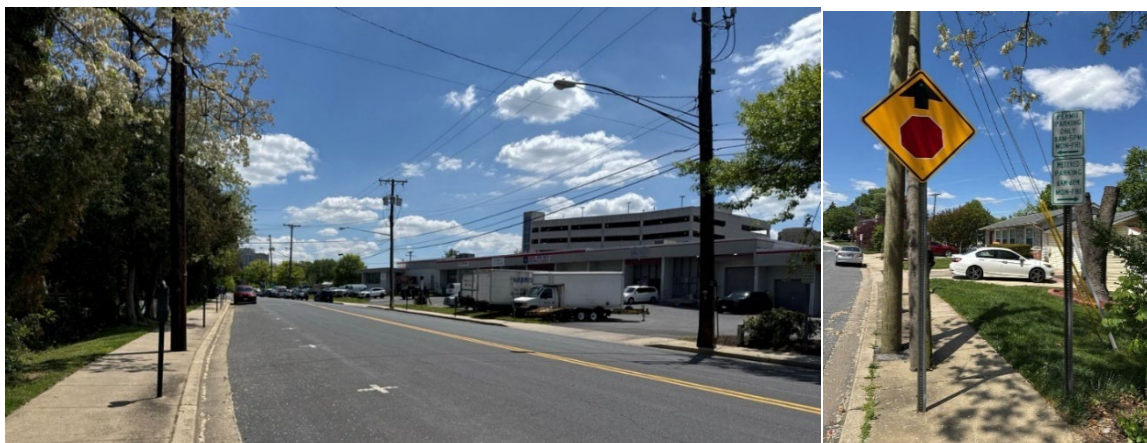
Figure 14. Metered parking spaces on Lewis Avenue between Halpine Road and Rockland Avenue (left, looking south) and signs (right, looking north)

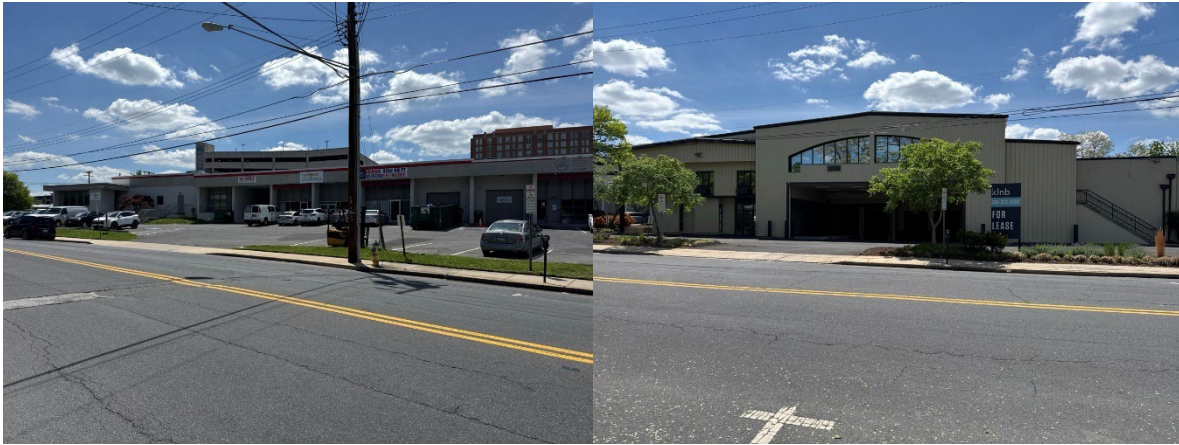
Figure 15. Mixed-use developments along Lewis Avenue between Halpine Road and Rockland Avenue (looking west)

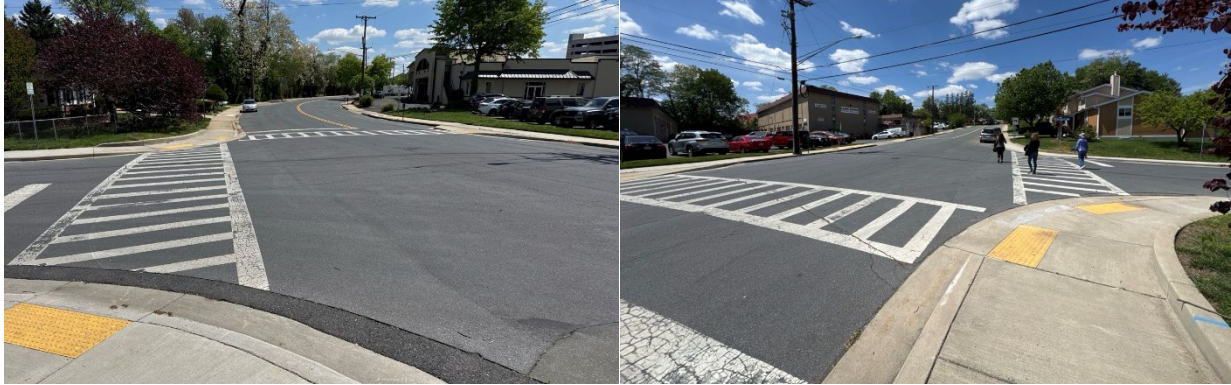
Figure 16. Lewis Avenue and Rockland Avenue intersection (left, looking south; right, looking north)

Intersection Feature	Description
Traffic Control Devices	<ul style="list-style-type: none"> All-way stop-controlled intersection T-intersection with two-lane approaches and no dedicated turn lanes. A driveway is present on the east side of the intersection and is represented as the eastbound approach in Figure 16
Land-Use	<ul style="list-style-type: none"> Mixed-use development containing office uses and industrial developments on the west side Single-family residential uses on the east side
Crosswalks	<ul style="list-style-type: none"> Marked crosswalks with perpendicular bar markings on the south and east legs
Curb Ramps	<ul style="list-style-type: none"> Curb ramps with directional warning surface at all marked crosswalks Curb ramp openings aligned with the curb line
Bike Facilities	<ul style="list-style-type: none"> Lewis Avenue is a Signed Shared Roadway
Transit Facilities	<ul style="list-style-type: none"> No transit facilities

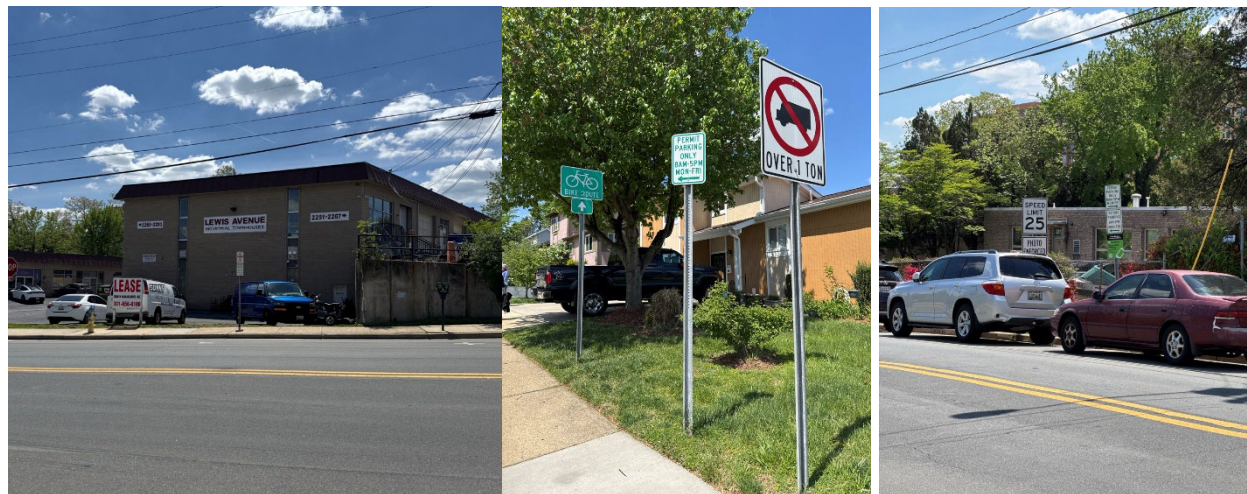
Figure 18. Industrial land use and signs along Lewis Avenue between Rockland Avenue and Brooke Drive (left, looking west; middle, looking north; right, looking south)

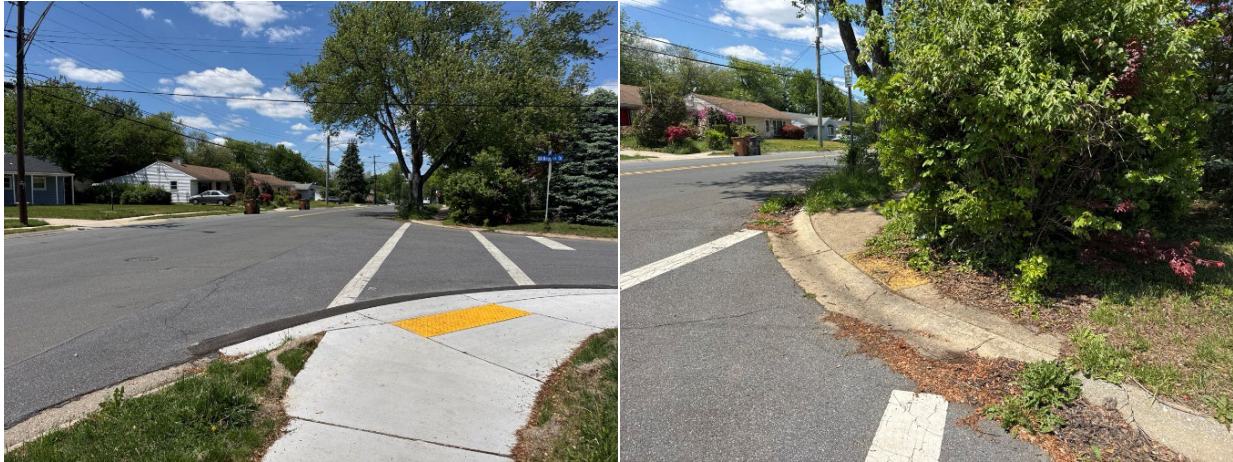
Figure 19. Lewis Avenue and Brooke Drive intersection with overgrown vegetation (looking north)

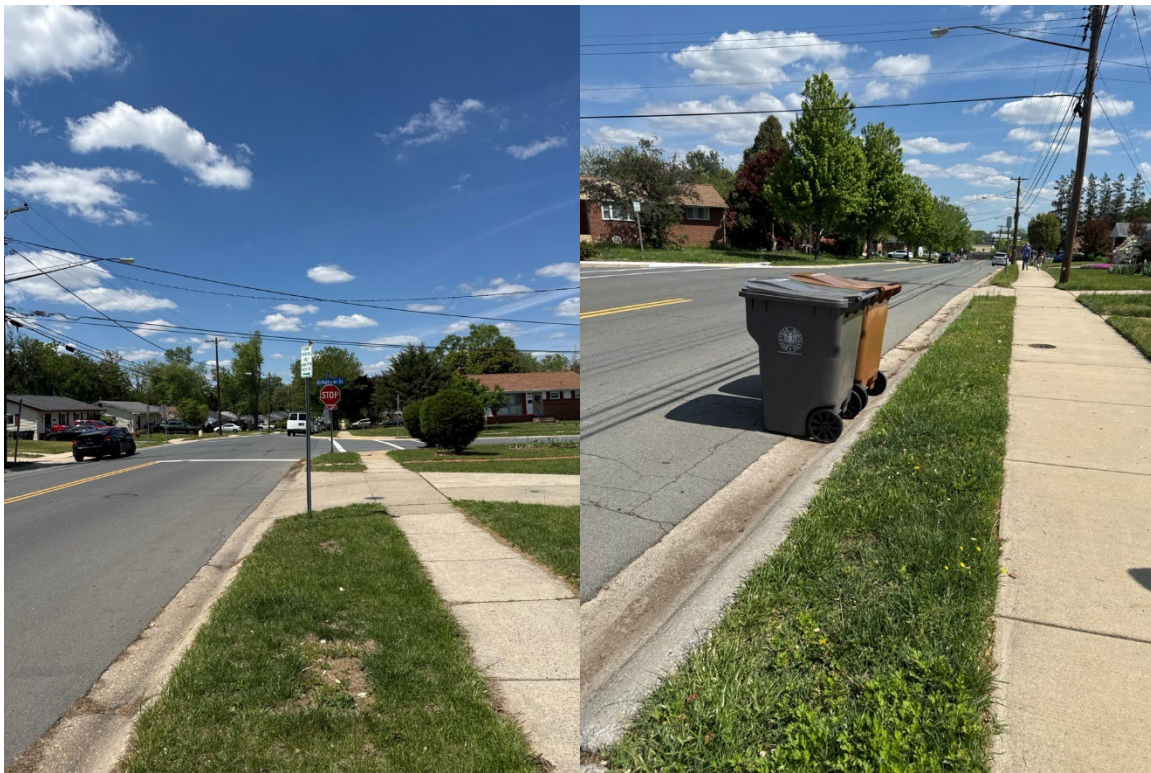
Figure 21. Lewis Avenue between Brooke Drive and Matthews Drive (left, looking north; right, looking south)

Segment Feature	Description
Traffic Control Devices	<ul style="list-style-type: none"> One travel lane in each direction separated by a marked centerline 25 mph posted speed limit Southbound Bike Route (D11-1) sign just south of the Matthews Road intersection
Land-Use	<ul style="list-style-type: none"> Single-family residential uses Frequent driveways, potential conflicts
Sidewalks	<ul style="list-style-type: none"> Continuous sidewalks on both sides of Lewis Avenue No accessibility issues associated with landscaping, streetscape features, or utility poles
Bike facilities	<ul style="list-style-type: none"> Signed Shared Roadway
Parking	<ul style="list-style-type: none"> Northbound and southbound permit parking (8:00 AM to 5:00 PM, Monday through Friday) Low parking utilization, with less than 5% occupancy
Transit	<ul style="list-style-type: none"> Not part of a transit route

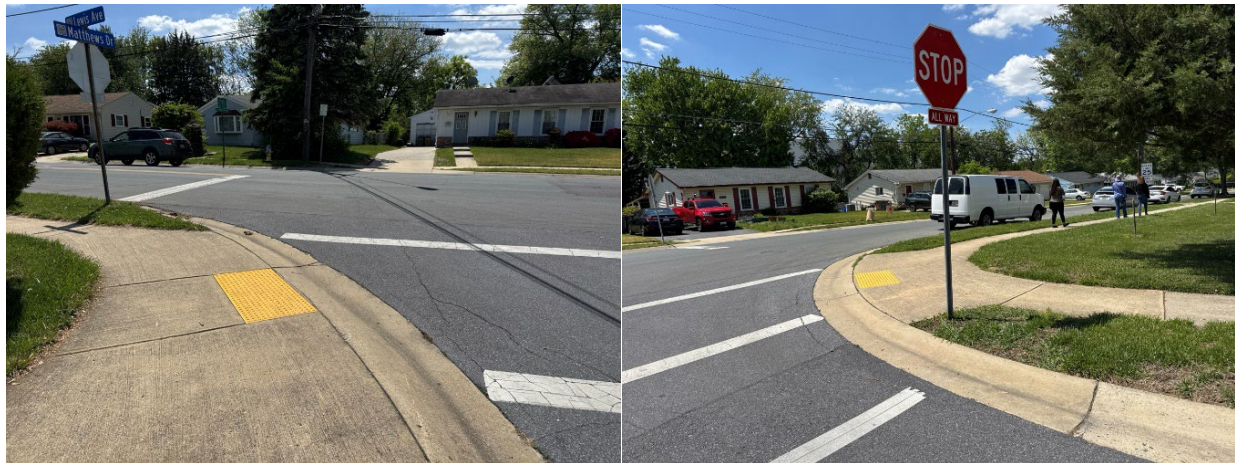
Figure 22. Lewis Avenue and Matthews Drive intersection (left, looking south; right, looking north)

Intersection Feature	Description
Traffic Control Devices	<ul style="list-style-type: none"> All-way stop-controlled intersection T-intersection with two-lane approaches and no dedicated turn lanes. A driveway is present on the east side of the intersection and is represented as the eastbound approach in Figure 22 Sight distance concerns and reports of drivers failing to stop
Land-Use	<ul style="list-style-type: none"> Single-family residential uses
Crosswalks	<ul style="list-style-type: none"> Marked crosswalk with transverse markings on the east leg
Curb Ramps	<ul style="list-style-type: none"> Curb ramps with directional warning surface at the marked crosswalk Curb ramp openings aligned with the curb line
Bike Facilities	<ul style="list-style-type: none"> Lewis Avenue is a Signed Shared Roadway
Transit Facilities	<ul style="list-style-type: none"> No transit facilities

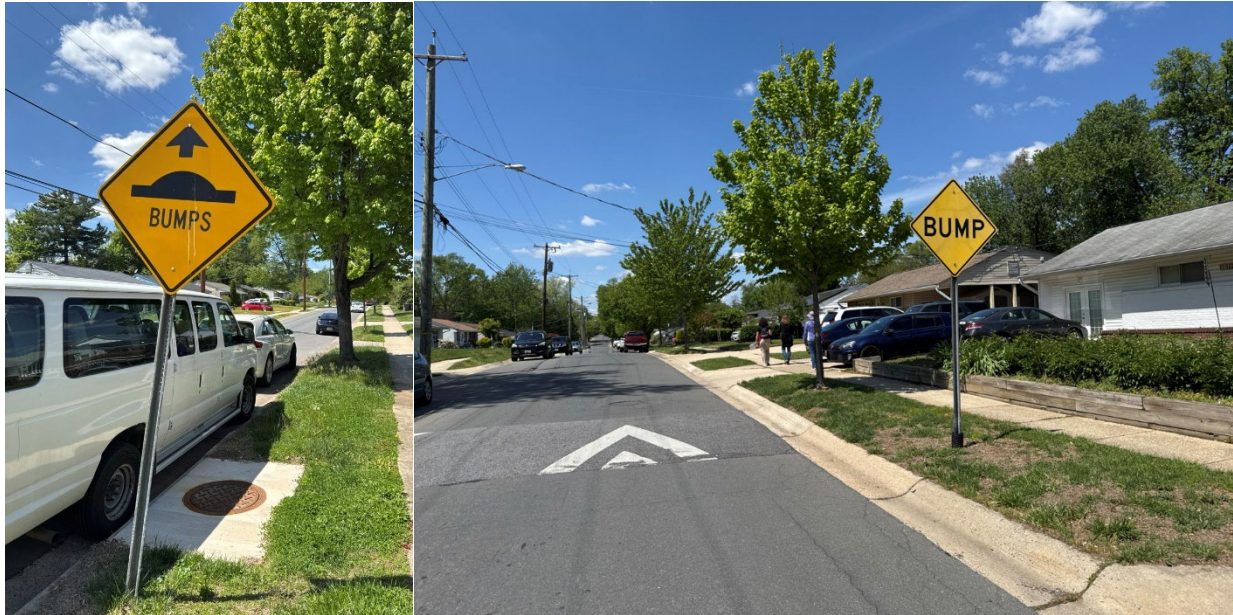
Figure 24. Signs and speed hump on Lewis Avenue between Matthews Drive and Thornden Road (looking north)

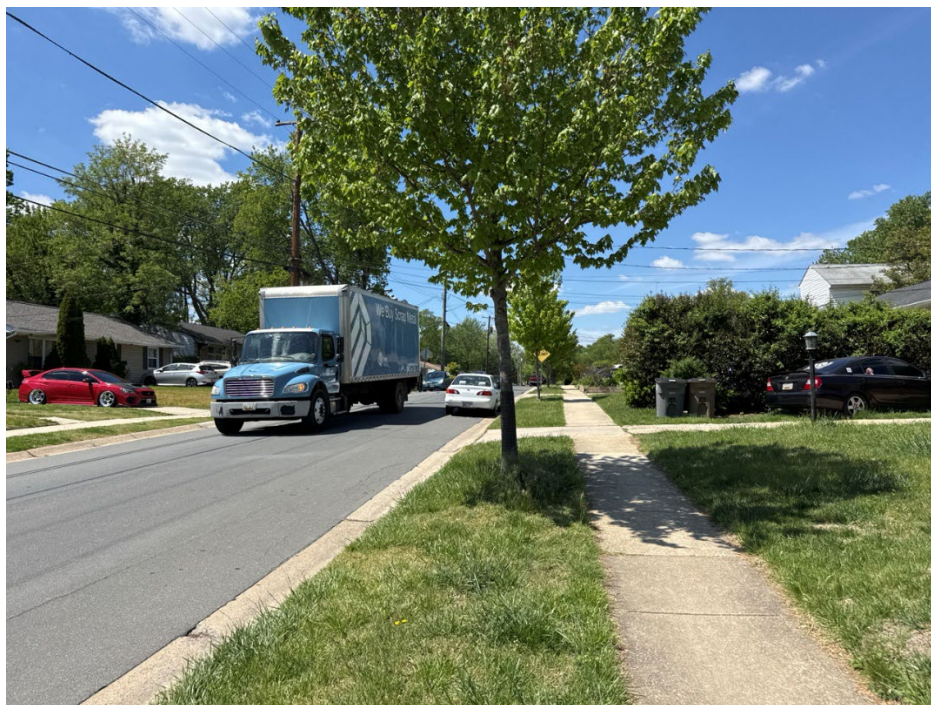
Figure 25. Heavy vehicle presence on Lewis Avenue between Matthews Drive and Thornden Road (looking north)

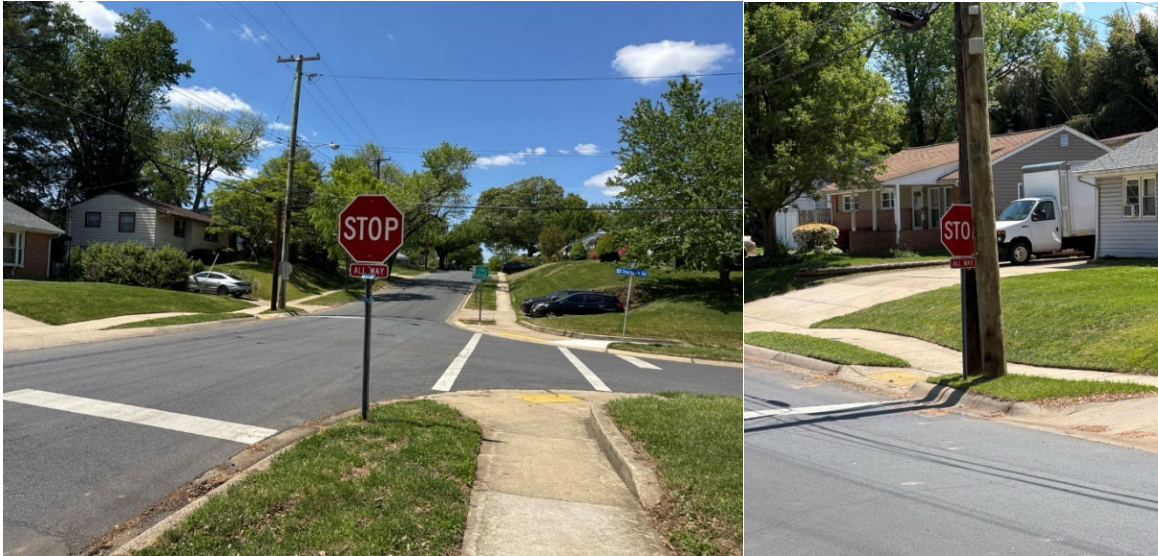
Figure 26. Lewis Avenue and Thornden Road intersection (left: looking north; right: looking south)

Intersection Feature	Description
Traffic Control Devices	<ul style="list-style-type: none"> All-way stop-controlled intersection T-intersection with two-lane approaches and no dedicated turn lanes. A driveway is present on the east side of the intersection and is represented as the eastbound approach in Figure 26 Sight distance concerns and reports of drivers failing to stop Bike Route (D11-1) sign on Lewis Avenue (northeast corner of the intersection)
Land-Use	<ul style="list-style-type: none"> Single-family residential uses
Crosswalks	<ul style="list-style-type: none"> Marked crosswalk with transverse markings on the east leg
Curb Ramps	<ul style="list-style-type: none"> Curb ramps with directional warning surface at the marked crosswalk Curb ramp openings aligned with the curb line
Bike Facilities	<ul style="list-style-type: none"> Lewis Avenue is a Signed Shared Roadway
Transit Facilities	<ul style="list-style-type: none"> No transit facilities

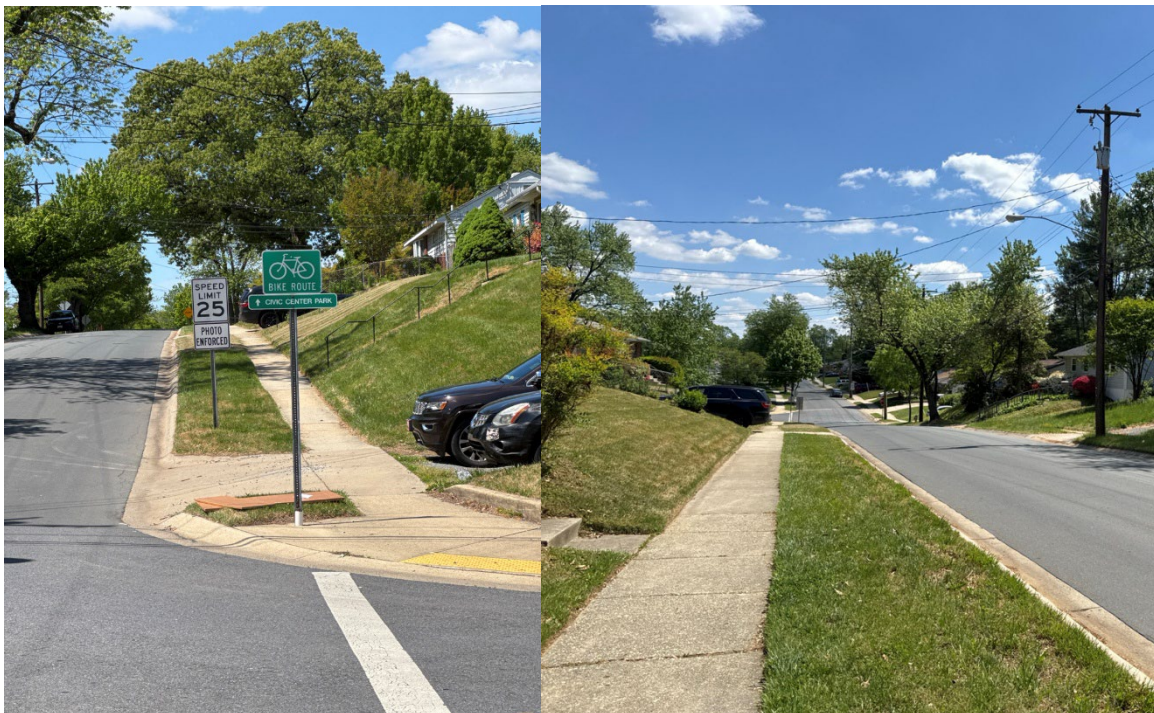
Figure 28. Lewis Avenue between Thornden Road and Parrish Drive (left, looking north; right, looking south)

Segment Feature	Description
Traffic Control Devices	<ul style="list-style-type: none"> • One travel lane in each direction, no marked centerline • 25 mph posted speed limit • Residents noted that vehicles frequently travel at high speeds in this area, particularly southbound traffic traveling downhill from Parrish Drive toward Thornden Road. The resident also mentioned that drivers often fail to stop at the STOP sign at Thornden Road. Several children live in the area, raising additional safety concerns. Rolling grades and downhill conditions contribute to speeding concerns. • Northbound Speed Limit (R2-1) sign with Photo Enforced (R10-19aP) plaque near Thornden Road • Northbound Bike Route (D11-1) sign near Thornden Road
Land-Use	<ul style="list-style-type: none"> • Single-family residential uses. Frequent driveways, potential conflicts
Sidewalks	<ul style="list-style-type: none"> • Continuous sidewalks on both sides of Lewis Avenue • No accessibility issues associated with landscaping, streetscape features, or utility poles

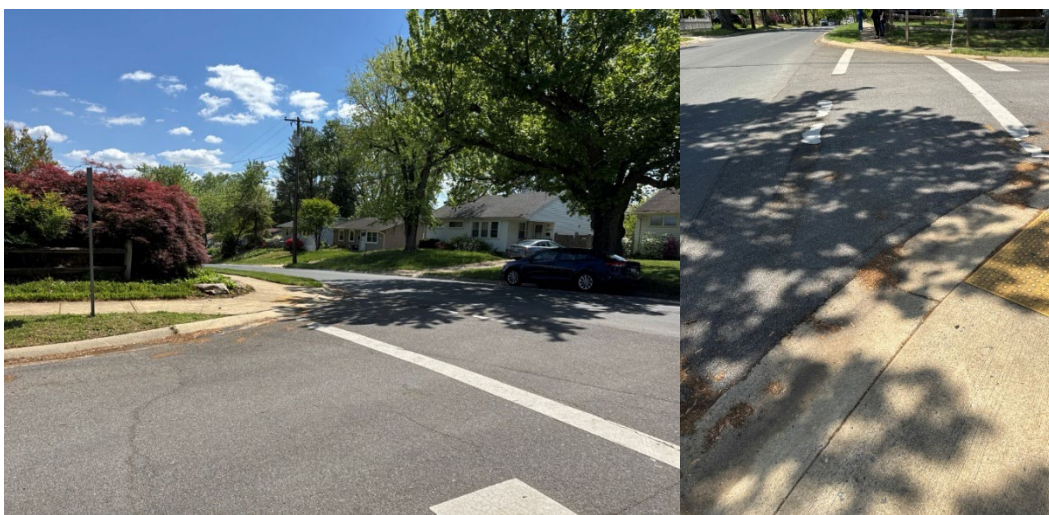
Figure 29. Lewis Avenue and Parrish Drive intersection (left: looking south; right: looking north)

Intersection Feature	Description
Traffic Control Devices	<ul style="list-style-type: none"> Two-way stop-controlled intersection T-intersection with two-lane approaches and no dedicated turn lanes. A driveway is present on the east side of the intersection and is represented as the eastbound approach in Figure 29 Limited sight distance
Land-Use	<ul style="list-style-type: none"> Single-family residential uses
Crosswalks	<ul style="list-style-type: none"> Marked crosswalk with transverse markings on the east leg Existing crosswalk pavement markings exhibit fading and wear
Curb Ramps	<ul style="list-style-type: none"> Curb ramps with directional warning surface at the marked crosswalk Curb ramp openings aligned with the curb line
Bike Facilities	<ul style="list-style-type: none"> Lewis Avenue is a Signed Shared Roadway
Transit Facilities	<ul style="list-style-type: none"> No transit facilities

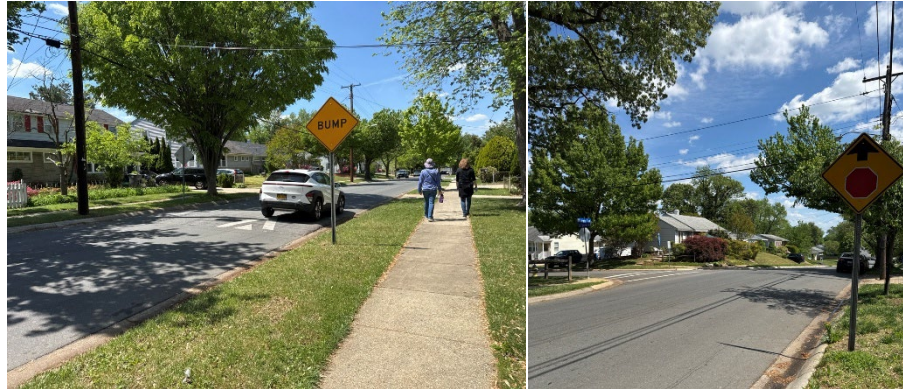
Figure 31. Lewis Avenue between Parrish Drive and Highwood Road (left: looking north; right: looking south)

Segment Feature	Description
Traffic Control Devices	<ul style="list-style-type: none"> • One travel lane in each direction, no marked centerline • 25 mph posted speed limit. • The southbound STOP AHEAD (W3-1) sign in advance of the Thornden Road intersection may create confusion for drivers because it is located within the influence area of the Parrish Drive intersection, where the southbound approach operates under free-flow conditions (uncontrolled). • Speed hump present • The northbound and southbound BUMP (W8-1) signs are not appropriately used. The BUMP sign should be installed in advance of a sharp rise in the roadway profile. The SPEED HUMP (W17-1) sign should instead be used in advance of a vertical roadway deflection intended to reduce vehicle speeds, which is the road feature present along this segment of Lewis Avenue.
Land-Use	<ul style="list-style-type: none"> • Single-family residential uses. Frequent driveways, potential conflicts

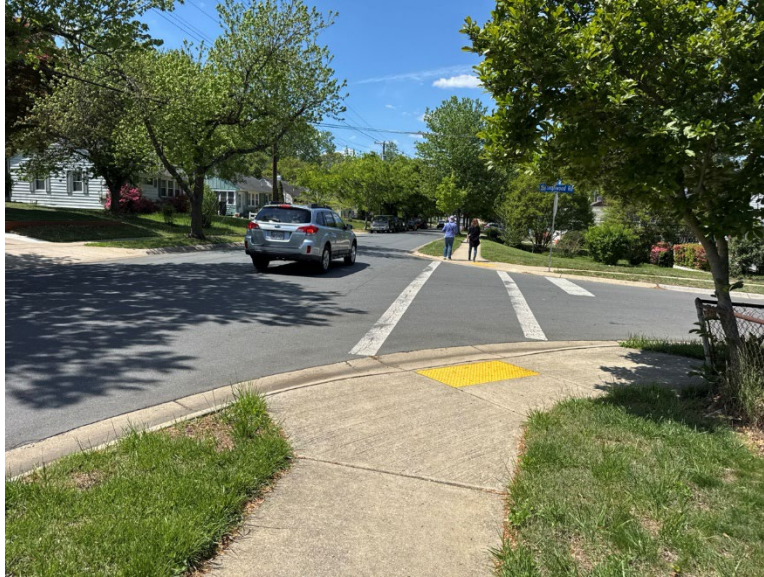
Figure 32. Lewis Avenue and Highwood Road intersection (looking north)

Intersection Feature	Description
Traffic Control Devices	<ul style="list-style-type: none"> Two-way stop-controlled intersection T-intersection with two-lane approaches and no dedicated turn lanes. A driveway is present on the east side of the intersection and is represented as the eastbound approach in Figure 32
Land-Use	<ul style="list-style-type: none"> Single-family residential uses
Crosswalks	<ul style="list-style-type: none"> Marked crosswalk with transverse markings on the east leg
Curb Ramps	<ul style="list-style-type: none"> Curb ramps with directional warning surface at the marked crosswalk Curb ramp openings aligned with the curb line
Bike Facilities	<ul style="list-style-type: none"> Lewis Avenue is a Signed Shared Roadway
Transit Facilities	<ul style="list-style-type: none"> No transit facilities

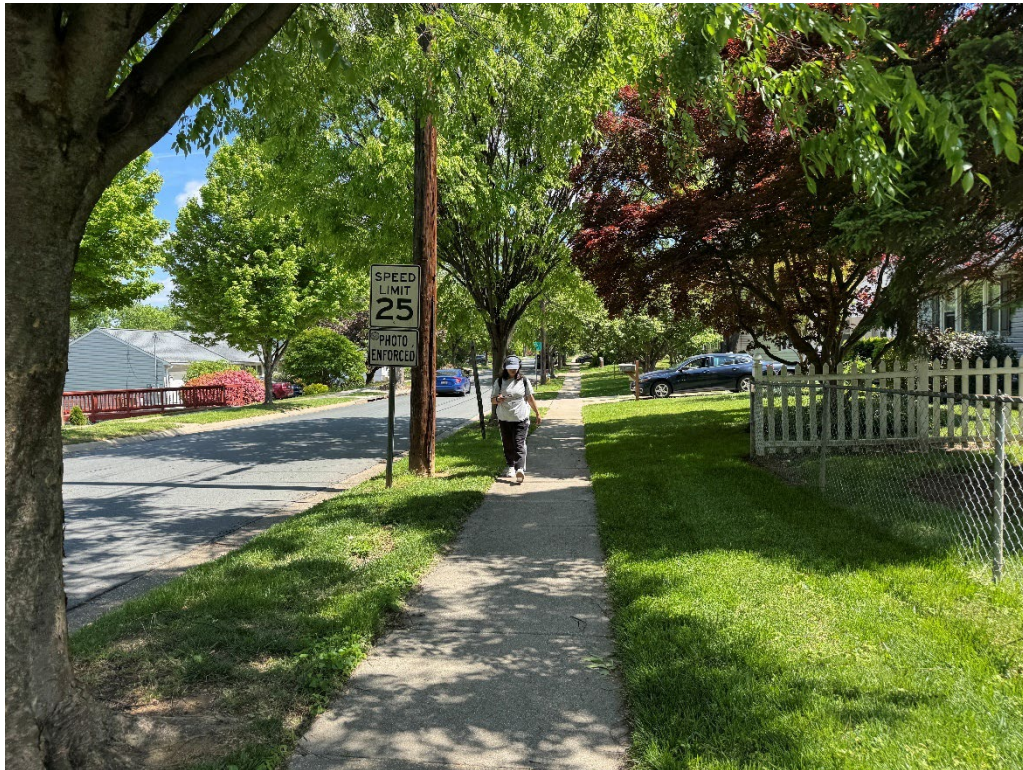
Figure 34. Lewis Avenue between Highwood Road and Broadwood Drive (looking south)

Segment Feature	Description
Traffic Control Devices	<ul style="list-style-type: none"> One travel lane in each direction, no marked centerline 25 mph posted speed limit. Southbound Speed Limit (R2-1) sign with Photo Enforced (R10-19aP) plaque just south of the Broadwood Drive intersection
Land-Use	<ul style="list-style-type: none"> Single-family residential uses Frequent driveways, potential conflicts
Sidewalks	<ul style="list-style-type: none"> Continuous sidewalks on both sides of Lewis Avenue No accessibility issues associated with landscaping, streetscape features, or utility poles
Bike facilities	<ul style="list-style-type: none"> Signed Shared Roadway
Parking	<ul style="list-style-type: none"> Northbound and southbound on-street parking (no posted signs) Approximately 30% parking occupancy
Transit	<ul style="list-style-type: none"> Not part of a transit route

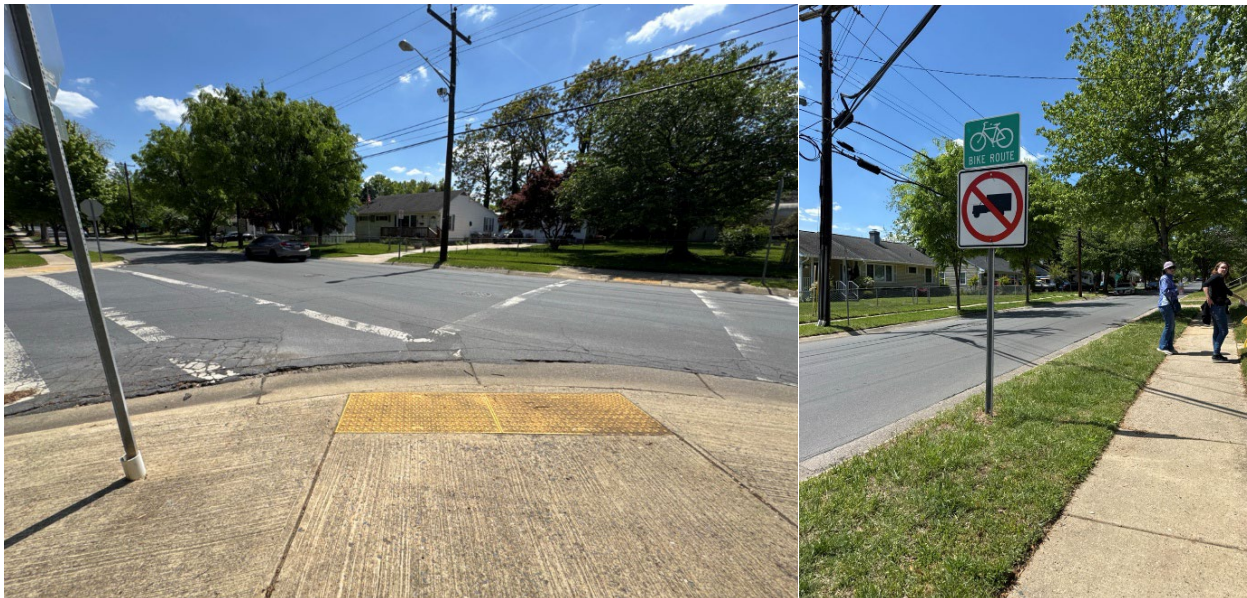
Figure 35. Lewis Avenue and Broadwood Drive intersection (left: looking south; right: looking north)

Intersection Feature	Description
Traffic Control Devices	<ul style="list-style-type: none"> All-way stop-controlled intersection T-intersection with two-lane approaches and no dedicated turn lanes. A driveway is present on the east side of the intersection and is represented as the eastbound approach in Figure 35 Bike Route (D11-1) sign on Lewis Avenue (northeast corner of the intersection) No Trucks (R5-2) sign on Lewis Avenue (northeast corner of the intersection)
Land-Use	<ul style="list-style-type: none"> Single-family residential uses
Crosswalks	<ul style="list-style-type: none"> Marked crosswalks with transverse markings on the north and east legs Existing crosswalk and stop line pavement markings exhibit fading and wear
Curb Ramps	<ul style="list-style-type: none"> Curb ramps with directional warning surface at the marked crosswalk Curb ramp openings aligned with the curb line
Bike Facilities	<ul style="list-style-type: none"> Lewis Avenue is a Signed Shared Roadway

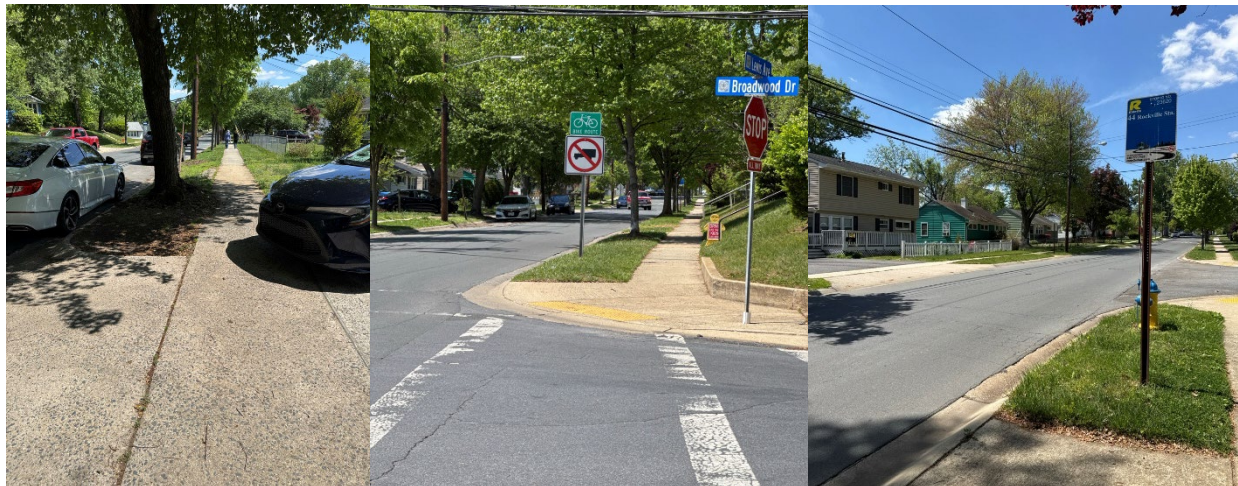
Figure 37. Lewis Avenue between Broadwood Drive and Allison Drive (left: looking south; middle and right: looking north)

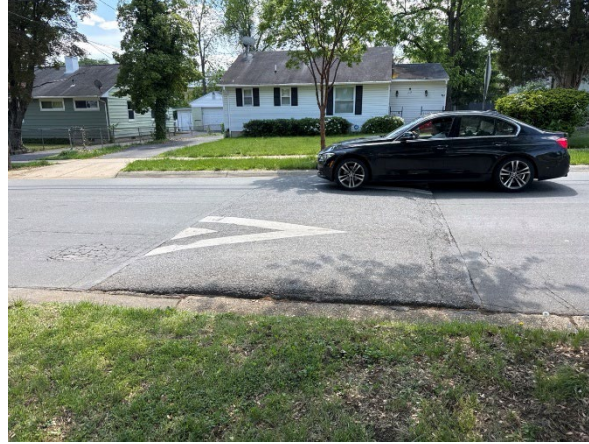
Figure 40: Speed hump on Lewis Avenue between Allison Drive and Clagett Drive

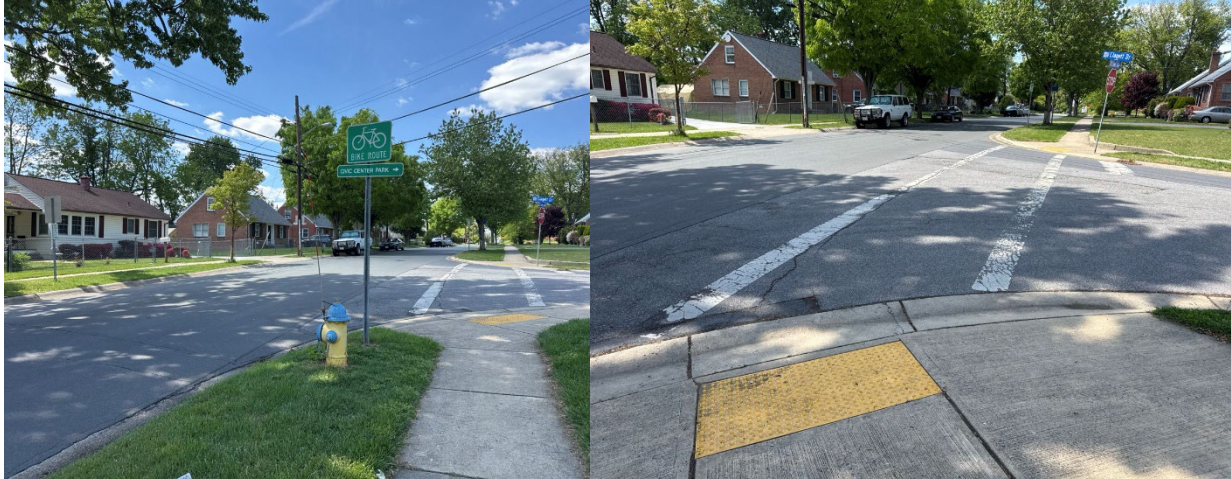
Figure 41. Lewis Avenue and Clagett Drive intersection (looking north)

Intersection Feature	Description
Traffic Control Devices	<ul style="list-style-type: none"> • Two-way stop-controlled intersection • T-intersection with two-lane approaches and no dedicated turn lanes. A driveway is present on the east side of the intersection and is represented as the eastbound approach in Figure 41 • Bike Route (D11-1) signs on both approaches of Lewis Avenue • Bike Route (D11-1) sign on Clagett Drive
Land-Use	<ul style="list-style-type: none"> • Single-family residential uses
Crosswalks	<ul style="list-style-type: none"> • Marked crosswalks with transverse markings on the east leg • Existing crosswalk and stop line pavement markings exhibit fading and wear
Curb Ramps	<ul style="list-style-type: none"> • Curb ramps with directional warning surface at the marked crosswalk • Curb ramp openings aligned with the curb line
Bike Facilities	<ul style="list-style-type: none"> • Lewis Avenue is a Signed Shared Roadway • Clagett Drive is a Signed Shared Roadway

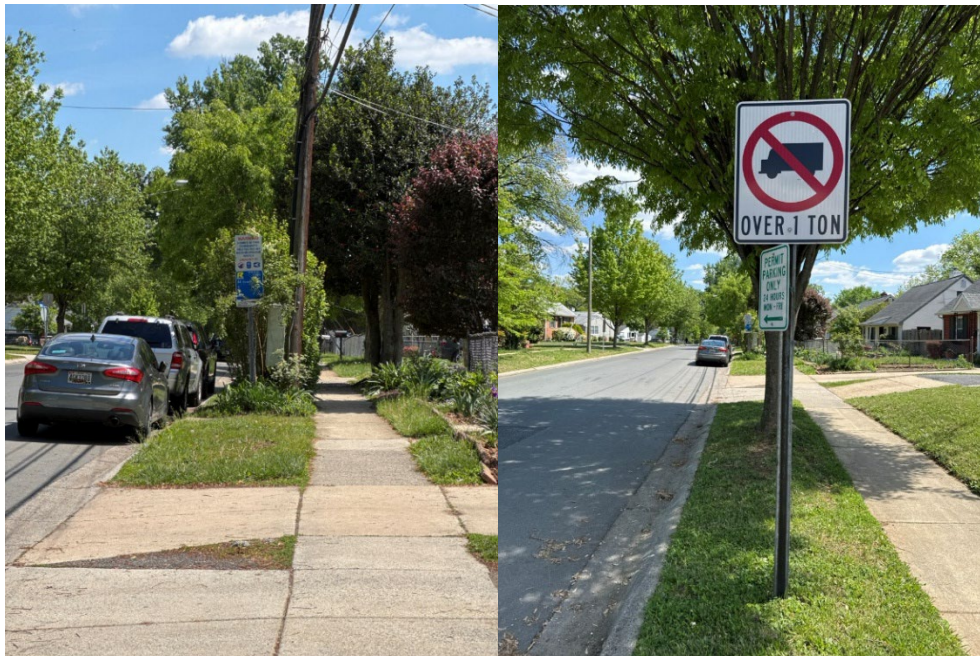
Figure 43. Bus stop and signs along Lewis Avenue between Clagett Drive and Edmonston Drive (left: looking north; right: looking south)

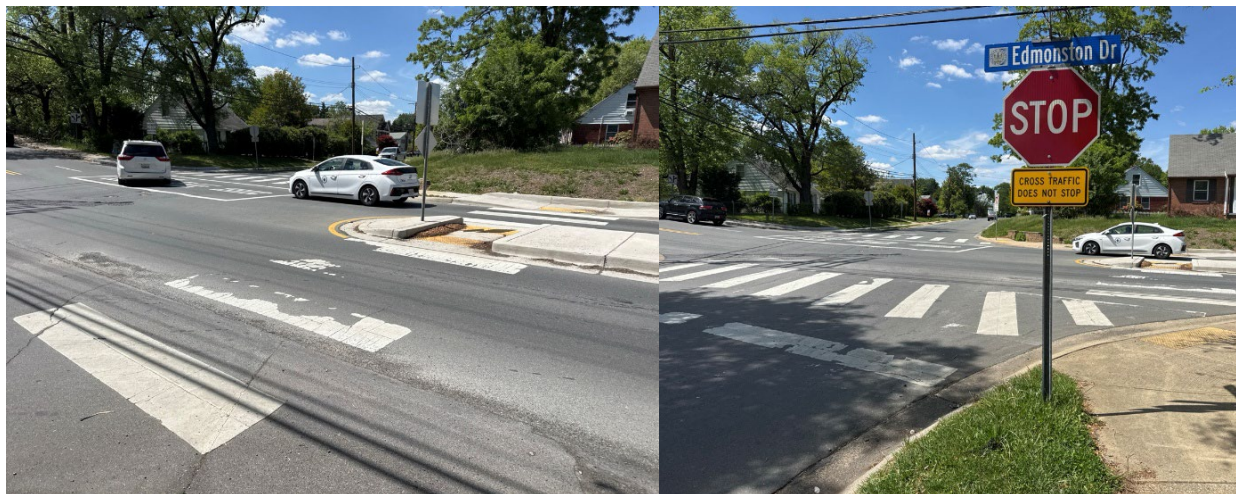
Figure 44. Lewis Avenue and Edmonston Drive intersection (looking north)

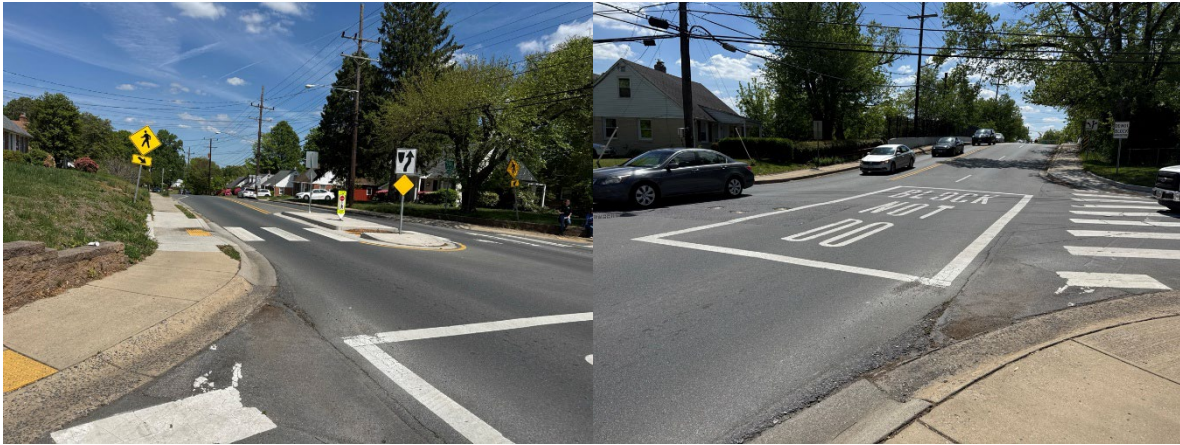
Figure 45. Lewis Avenue and Edmonston Drive intersection (left: looking east; right: looking west)

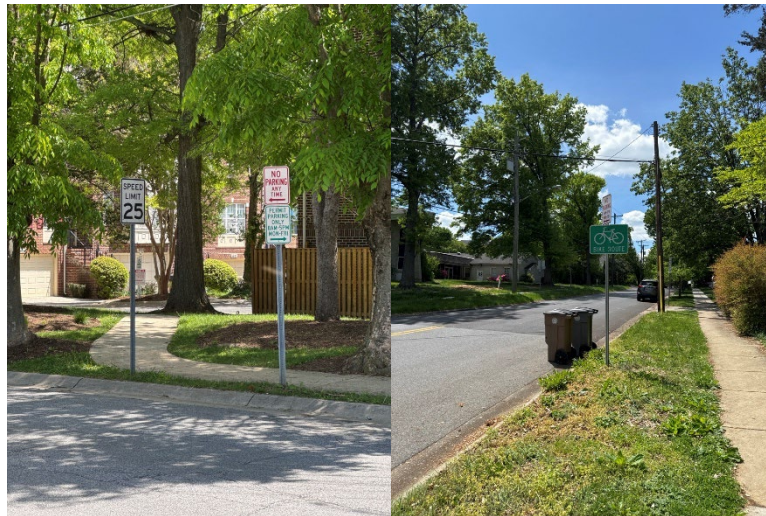
Figure 47: Halpine Road between Lewis Avenue and Ardennes Avenue (left: looking east; right: looking west)

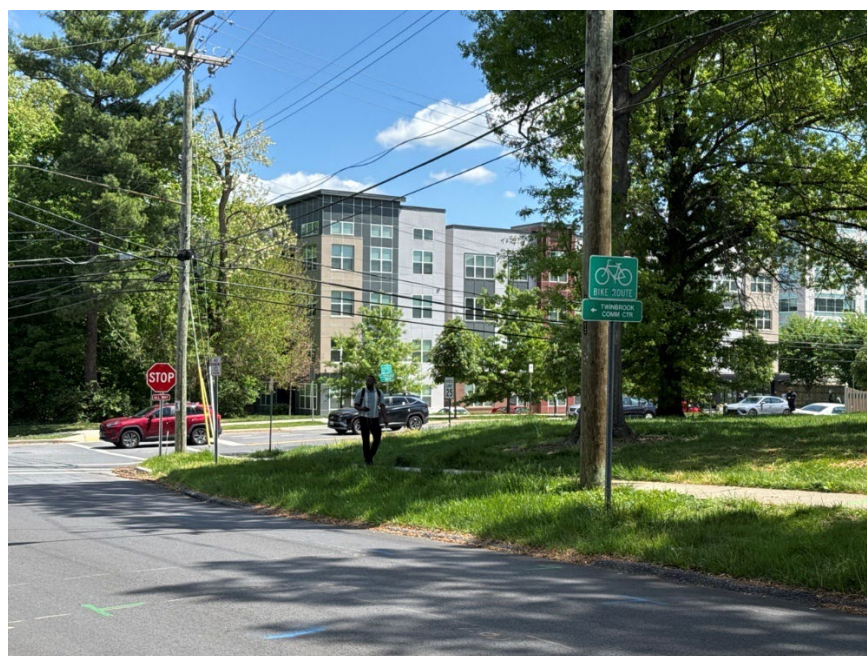
Figure 48: Halpine Road approaching Ardennes Avenue (looking east)

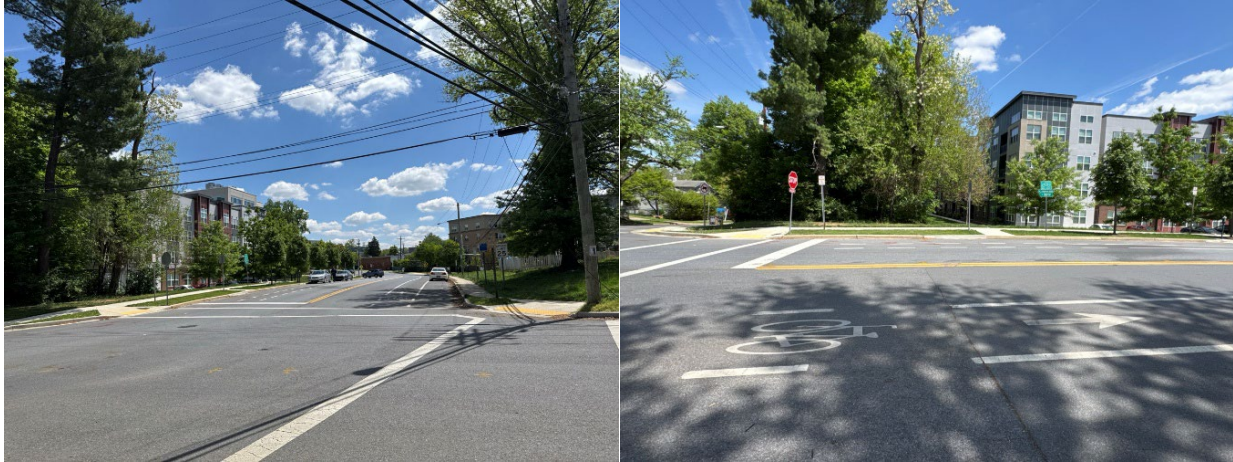
Figure 49. South leg of the Ardennes Avenue and Halpine Road (left: looking south; right, looking east)
