Lewis Avenue Bicycle and Pedestrian Improvements

Existing Conditions Memorandum

Prepared for:
City of Rockville

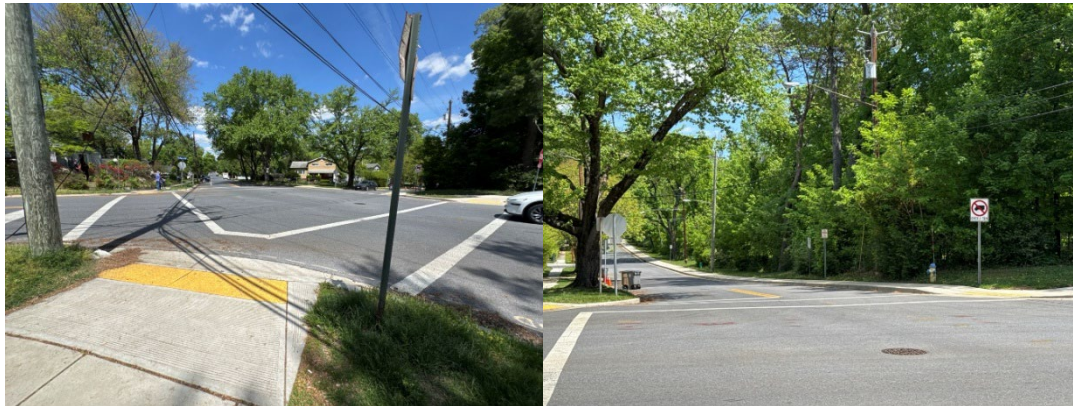
Figure 51. Ardennes Avenue and Halpine Road intersection (left: looking north; right: looking east)

Bike Facilities	<ul style="list-style-type: none"> • Bike lanes on both sides of the road in the south leg of Ardennes Avenue • The north leg of Ardennes Avenue is part of a Signed Shared Roadway • The west leg of Halpine Road is part of a Signed Shared Roadway
Transit Facilities	<ul style="list-style-type: none"> • Ardennes Avenue is a Ride On Route, with bus stops located on both sides of the road • No bus stops on Halpine Road, although the west leg is part of a Ride On Route

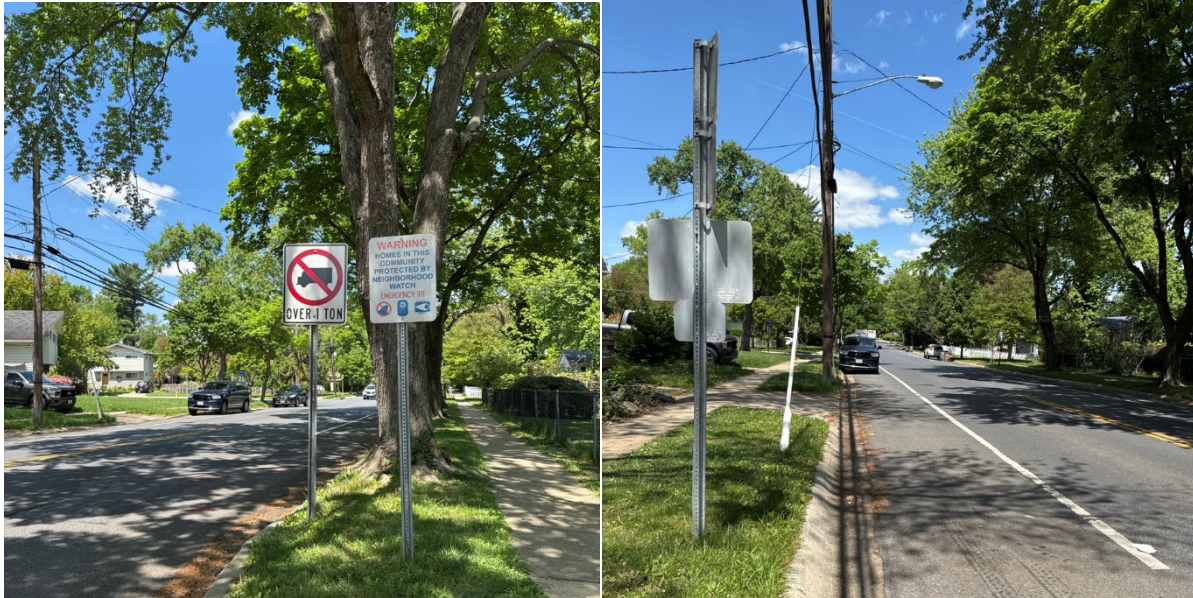
Figure 52: Ardennes Avenue between Halpine Road and Holland Road (looking north)

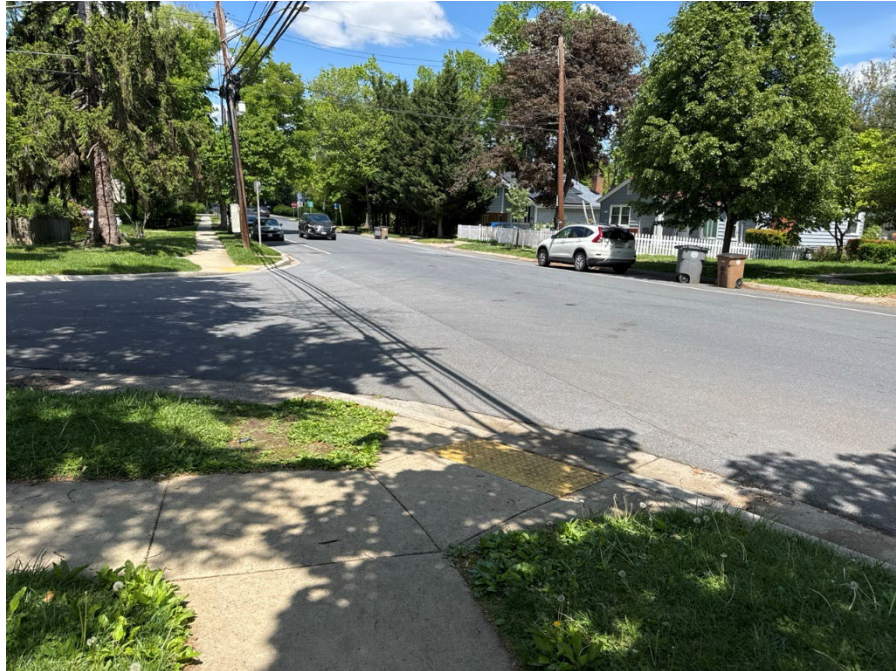
Figure 53. Ardennes Avenue and Holland Road intersection (looking north)
