CITY OF ROCKVILLE

# KING FARM FARMSTEAD PROPERTY CONDITION ASSESSMENT

DEPARTMENT OF RECREATION AND PARKS

JULY 3, 2014

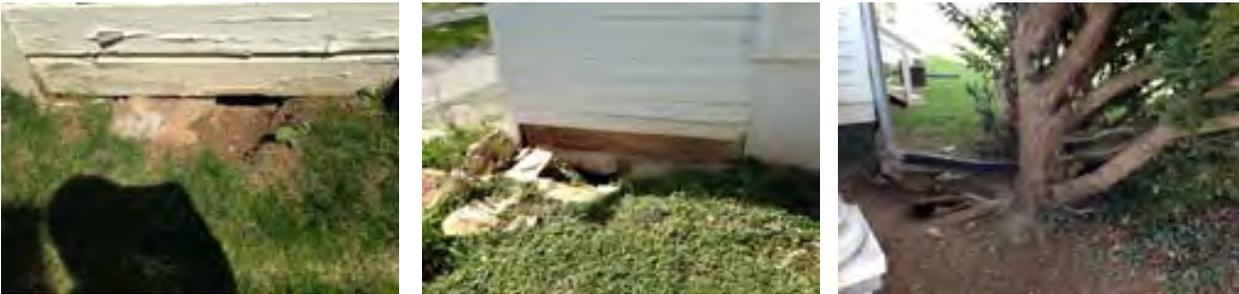
King Farm Property Condition Assessment	
Condition / Deficiency Report	
Report Number:	BLDG 0-1
Priority:	2
Discipline:	ARCH., STRUCT.
Address:	King Farm Park, 16100 Frederick Road, Rockville, MD 20850
Location:	SITE WIDE
Category:	PESTS
Necessity:	STABILIZE
Photo Documentation

Deficiency Description	
<p>Site wide evidence of groundhogs.</p>	
Recommended Action	
<p>Consult with professional service to humanely remove groundhogs. Continuing service will be required for a minimum of two years to effectively eradicate the groundhogs.</p>	
References:	Estimated Cost: \$10,000.00

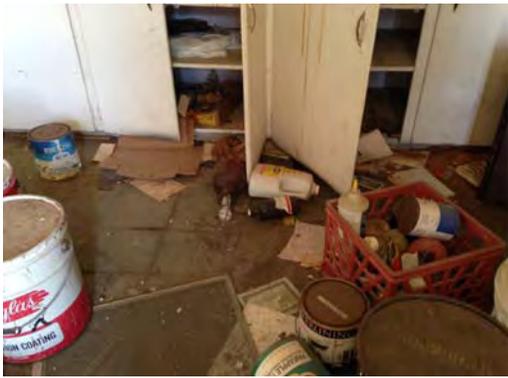
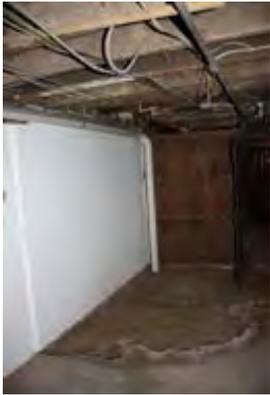
King Farm Property Condition Assessment	
Condition / Deficiency Report	
Report Number:	BLDG 0-2
Priority: 1	Discipline: ARCH.
Address:	King Farm Park, 16100 Frederick Road, Rockville, MD 20850
Location:	SITE WIDE
Category:	HAZARDOUS MATERIALS
Necessity:	STABILIZE
Photo Documentation

Deficiency Description	
<p>Possible hazardous materials were visually observed in a number of buildings around the site, and are likely present throughout the buildings on the site due to the age of the structures and common use of these materials in the construction process over this time period.</p>	
Recommended Action	
<p>A comprehensive hazardous materials survey is necessary to determine the extent of hazardous materials present and the amount of remediation required. Hire an appropriately credentialed and qualified professional service firm to perform these tasks. The estimated cost for this line item concerns solely the hazardous materials survey and associated report - the extent of the remediation effort required (and associated costs) can not be determined until this survey is completed.</p>

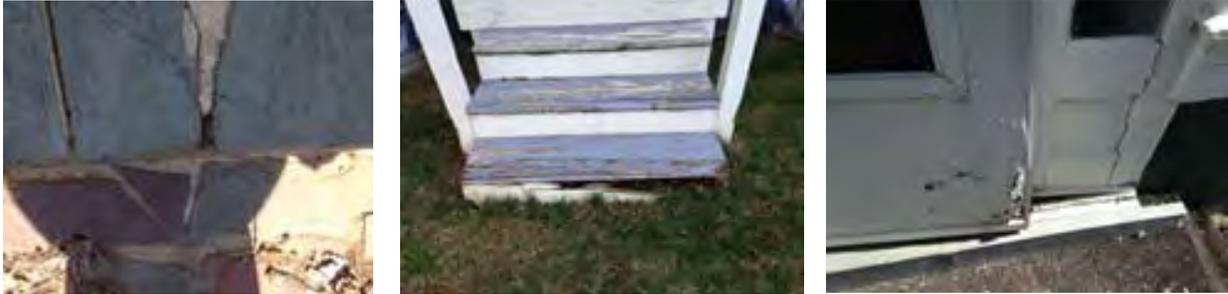
King Farm Property Condition Assessment	
Condition / Deficiency Report	
Report Number:	BLDG 1 - 3
Priority:	9
Discipline:	ARCH.
Address:	King Farm Park, 16100 Frederick Road, Rockville, MD 20850
Location:	BUILDING 1 HOUSE - EXTERIOR
Category:	APPROACH
Necessity:	STABILIZE
Photo Documentation

Deficiency Description	
<ol style="list-style-type: none"> <li>1. Slate path @ elevation B has broken and loose stones. Rusted nails are exposed and grout is deteriorating.</li> <li>2. Deteriorated stoop @ elevation D. Stairs deteriorated @ ground level and railing has exposed, rusted nails. Deteriorated screen door.</li> <li>3. Door surround @ elevation A warped - sidelight bent with strong vertical crack. Stoop buckled and wood molding delaminated.</li> <li>4. Rear porch screen door missing latch and handle.</li> </ol>	
Recommended Action	
<ol style="list-style-type: none"> <li>1. Repair and replace approx. 200 sf slate path as needed. Replace slate stones that have crumbled beyond use; Remove exposed nails. Remove deteriorated grout. Regrout to secure loose stones. Seal as appropriate.</li> <li>2. Remove and replace stoop @ elevation D. Replace screen door.</li> <li>3. Replace door, sidelights and transom @ elevation A.</li> <li>4. Replace screen door.</li> </ol>

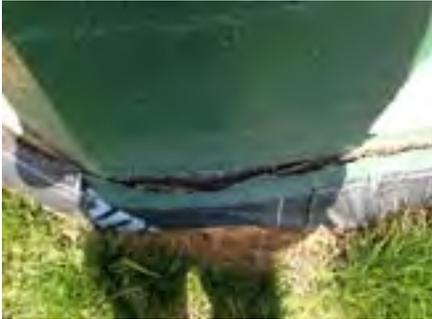
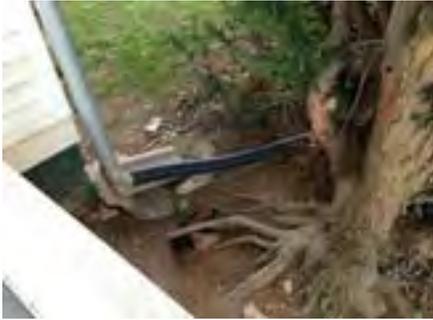
King Farm Property Condition Assessment	
Condition / Deficiency Report	
Report Number:	BLDG 1 - 4
Priority:	2
Discipline:	ARCH.
Address:	King Farm Park, 16100 Frederick Road, Rockville, MD 20850
Location:	BUILDING 1 HOUSE - EXTERIOR
Category:	FOUNDATION
Necessity:	STABILIZE
Photo Documentation

Deficiency Description	
<ol style="list-style-type: none"> <li>1. Delaminating flashing/moisture protection @ elevation B and D;</li> <li>2. Tree roots very close to foundation @ front porch.</li> </ol>	
Recommended Action	
<ol style="list-style-type: none"> <li>1. Provide new sheet waterproofing to grade. Excavate as necessary. Provide sawcut reglet as necessary. See R-7.</li> <li>2. Monitor. Tree removal may become necessary in the future if roots appear to be affecting foundation.</li> </ol>	
References:	R-5, R-7
Estimated Cost:	\$10,000.00

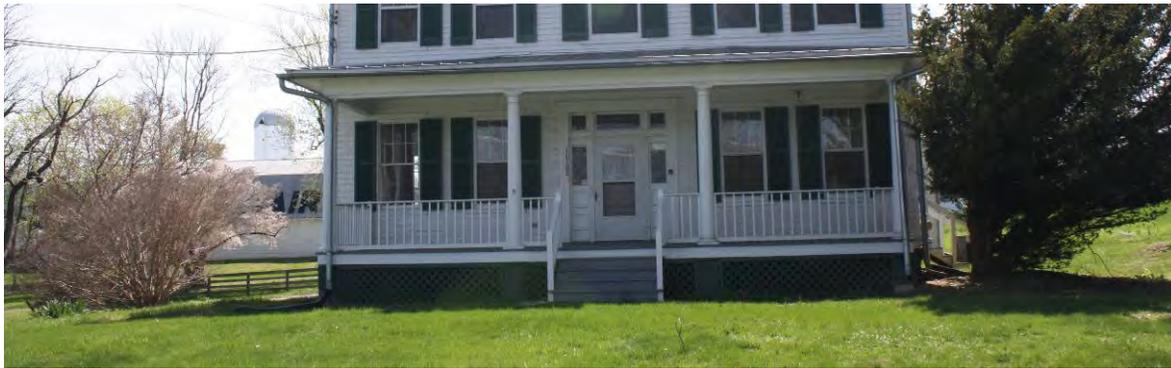
Condition / Deficiency Report		Report Number:	BLDG 1 - 5
Priority:	7	Discipline:	ARCH.
Address:	King Farm Park, 16100 Frederick Road, Rockville, MD 20850		
Location:	BUILDING 1 HOUSE - EXTERIOR		
Category:	FLOORS		
Necessity:	STABILIZE

Soundness of porch floor framing is unknown, but porch appears to have slight dip towards the center.

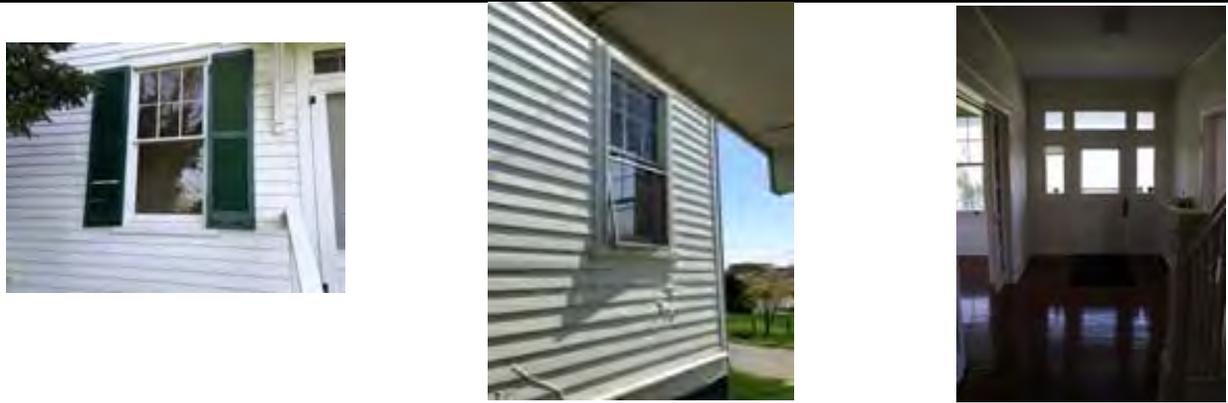
Condition / Deficiency Report		Report Number:	BLDG 1 - 6
Priority:	6	Discipline:	ARCH.
Address:	King Farm Park, 16100 Frederick Road, Rockville, MD 20850		
Location:	BUILDING 1 HOUSE - INTERIOR & EXTERIOR		
Category:	OPENINGS		
Necessity:	STABILIZE

1. Metal latch @ bottom of shutters broken, missing or loose.
2. Damage, rot @ shutters. 58 shutters total.
3. Missing or damaged screens @ 30 of the 44 double hung windows.
4. Some windows are exhibiting some minor deterioration.

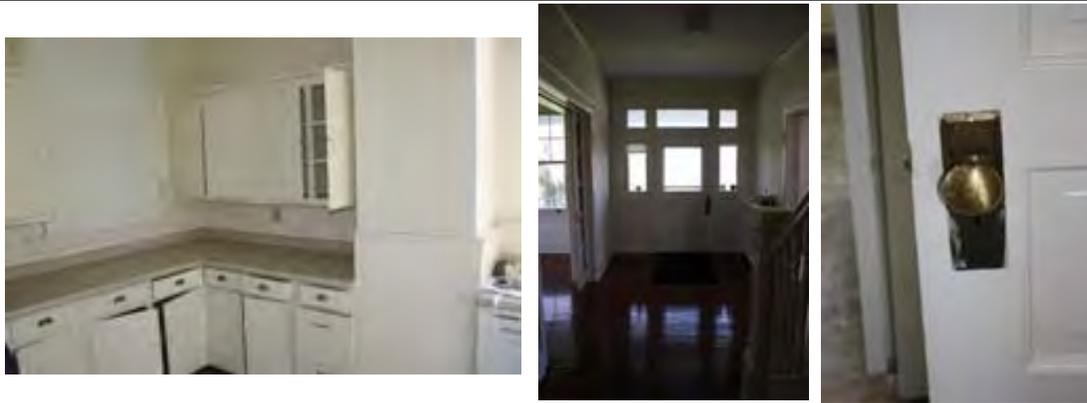
Condition / Deficiency Report		Report Number:	BLDG 1 - 6A
Priority:	19	Discipline:	ARCH.
Address:	King Farm Park, 16100 Frederick Road, Rockville, MD 20850		
Location:	BUILDING 1 HOUSE - INTERIOR		
Category:	OPENINGS		
Necessity:	REHABILITATE

1. All door handles are noncompliant.
2. Hardware in kitchen is painted over. Latches on uppers nonfunctional.
3. Sliding pocket doors on either side of room 1 stick and are very difficult to use.

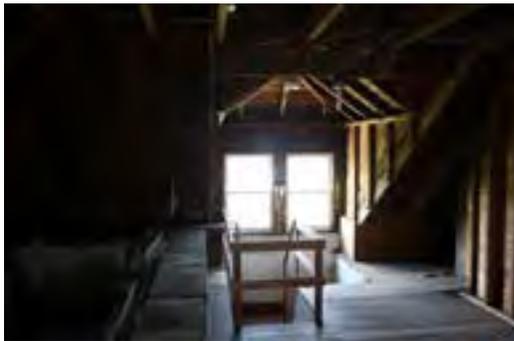
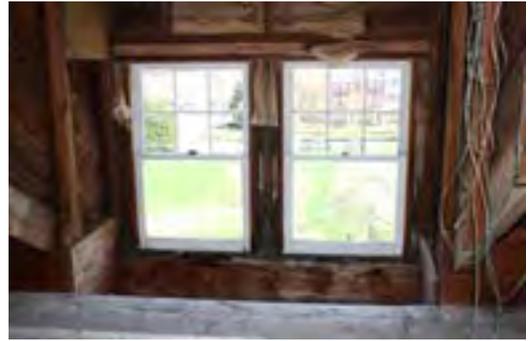
Condition / Deficiency Report		Report Number:	BLDG 1 - 8
Priority:	17	Discipline:	ARCH.
Address:	King Farm Park, 16100 Frederick Road, Rockville, MD 20850		
Location:	BUILDING 1 HOUSE - INTERIOR		
Category:	INSULATION		
Necessity:	REHABILITATE

The attic space is not insulated.

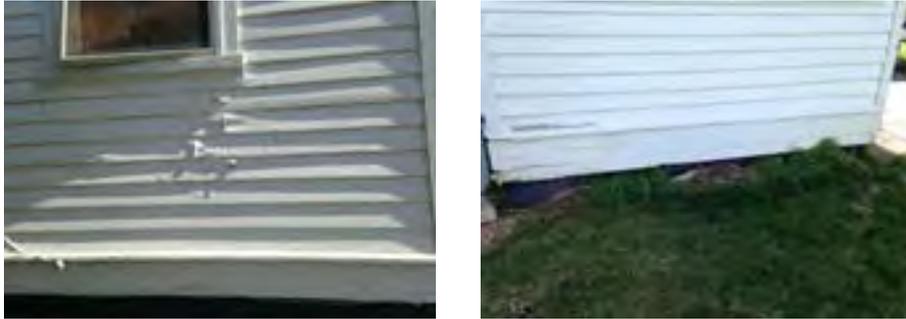
Flaking and chipped paint @ all elevations.

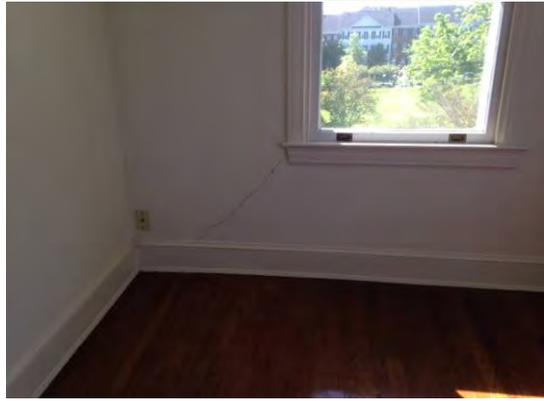
Condition / Deficiency Report		Report Number:	BLDG 1 - 11
Priority:	20	Discipline:	ARCH.
Address:	King Farm Park, 16100 Frederick Road, Rockville, MD 20850		
Location:	BUILDING 1 HOUSE - INTERIOR		
Category:	INTERIOR PAINT		
Necessity:	REHABILITATE

Minor cracks throughout the interior. Flaking paint.

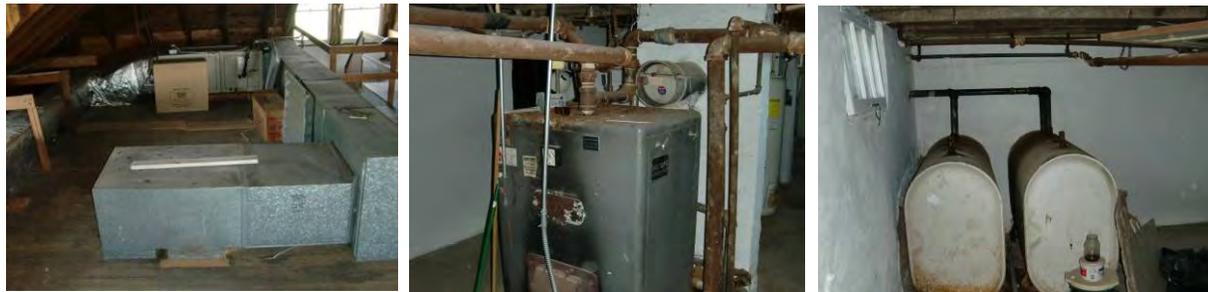
Condition / Deficiency Report		Report Number:	BLDG 1 - 12
Priority:	13	Discipline:	MEP
Address:	King Farm Park, 16100 Frederick Road, Rockville, MD 20850		
Location:	BUILDING 1 HOUSE - INTERIOR & EXTERIOR		
Category:	MECHANICAL EQUIPMENT		
Necessity:	REHABILITATE

Existing A/C system is roughly 30 years old. Existing system is nonfunctional and only serves the 2nd floor area (previous bedrooms). No A/C is provided on the 1st floor. Existing oil fired boiler is operational, but very old (See 1-14).

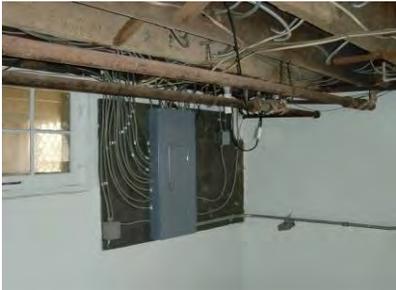
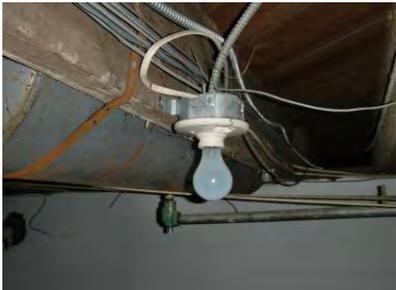
Deficiency Description	
<p>1. A 200A Square D panel was installed in 2004. Wiring was partially upgraded at that time. The condition of the concealed wiring is unknown. MC, romex and "rag" wire are visually present;</p> <p>2. The existing building is served by an ADEMCO VISTA 40 system. Condition is unknown, although city staff indicates that no security alarm system is functional.</p>	
Recommended Action	
<p>1. Rewire the entire house and replace all lighting. Assume the 200A main panel is reusable.</p> <p>2. Provide a new security system if desired for future use and occupancy.</p>

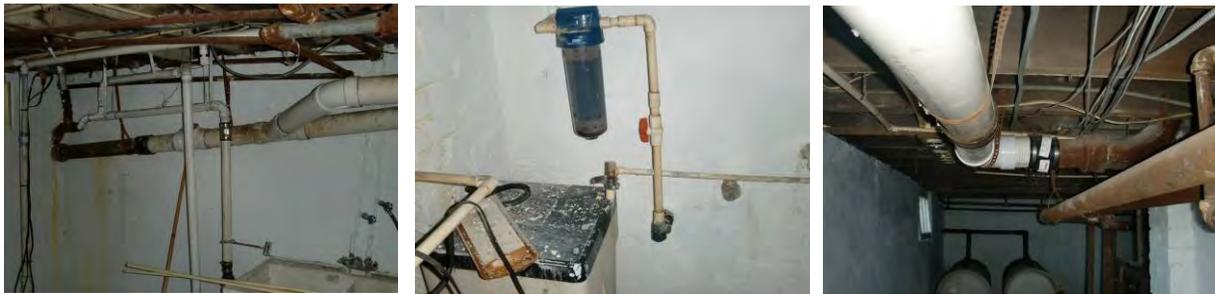
Condition / Deficiency Report		Report Number:	BLDG 1 - 14
Priority:	14	Discipline:	MEP
Address:	King Farm Park, 16100 Frederick Road, Rockville, MD 20850		
Location:	BUILDING 1 HOUSE - INTERIOR & EXTERIOR		
Category:	PLUMBING SYSTEMS		
Necessity:	REHABILITATE

1. Sanitary waste and vent piping is a mixture of materials (cast iron, galvanized pipe, pvc). Not code compliant;
2. Domestic water piping is a mixture of materials - copper/cpvc. Poor workmanship. Not code compliant;
3. Existing oil fired boiler is operational, but very old. Existing boiler is rated 235 MBH. No zone control valves are present to regulate heat in the individual rooms.

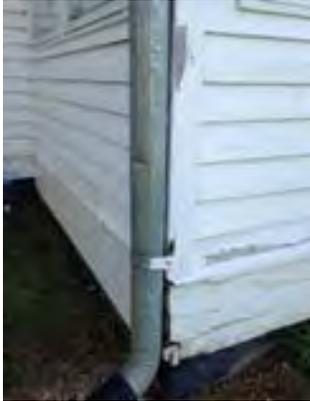
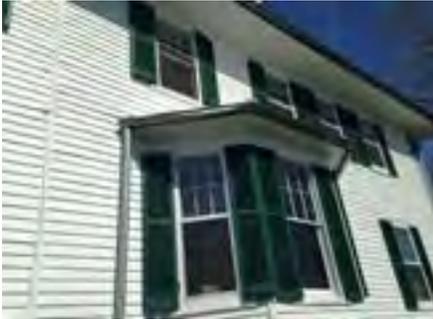
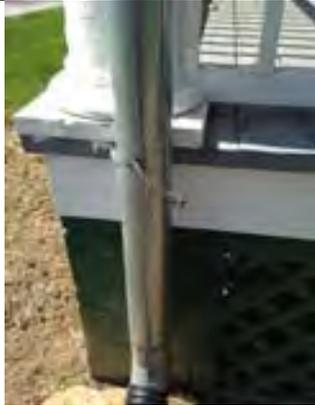
Deficiency Description		
<ol style="list-style-type: none"> <li>1. Warped gutter @ bay window on elevation B;</li> <li>2. Deteriorated, rusted, separated and twisted downspout straps and brackets;</li> <li>3. Missing gutter guards.</li> </ol>		
Recommended Action		
<ol style="list-style-type: none"> <li>1. Repair galvanized 1/2 round gutters as needed.</li> <li>2. Remove and replace galvanized straps as needed.</li> <li>3. Install gutter guards as needed.</li> </ol>		
References:	R-5	
Estimated Cost:	\$2,000.00

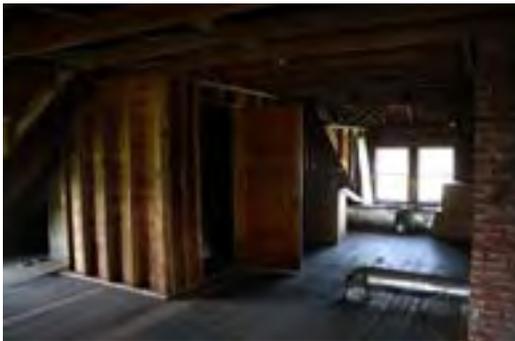
Condition / Deficiency Report		Report Number:	BLDG 1 - 16
Priority:	18	Discipline:	ARCH., STRUCT.
Address:	King Farm Park, 16100 Frederick Road, Rockville, MD 20850		
Location:	BUILDING 1 HOUSE - EXTERIOR		
Category:	ROOF		
Necessity:	REHABILITATE

1. Roof appears to have been recently replaced. Will need further inspection to ensure condition.
2. The roof framing appears sound.

1. Provide minor repairs as needed to roof materials.
2. Replace the connectors for rafter ends and collar beams with pre-fabricated gage metal wood connectors.

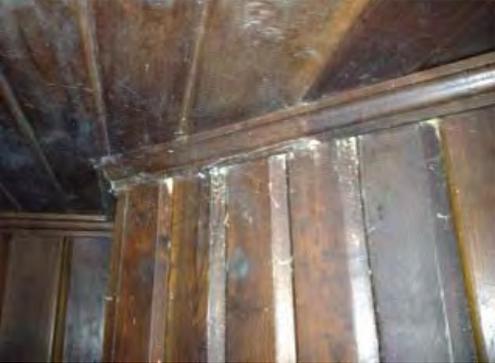
King Farm Property Condition Assessment	
Condition / Deficiency Report	
Report Number:	BLDG 1 - 17
Priority:	3
Discipline:	ARCH., STRUCT.
Address:	King Farm Park, 16100 Frederick Road, Rockville, MD 20850
Location:	BUILDING 1 HOUSE - INTERIOR
Category:	PESTS
Necessity:	STABILIZE
Photo Documentation

Deficiency Description	
<p>Evidence of termite damage in basement. Extent of damage is unknown.</p>	
Recommended Action	
<p>Determine the extent of the termite damage by removing the wood ceiling in the basement. Repair or replace affected areas as appropriate. Replace ceiling, assume 8 floor joists (2x10's) will need replacement. *Please note - an allowance has been provided for select member replacement until an invasive investigation of the area is performed.*</p>	
References:	R-1, SK-1
Estimated Cost:	\$10,000.00

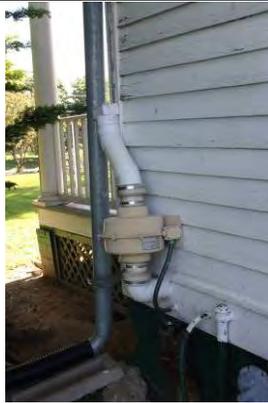
Condition / Deficiency Report		Report Number:	BLDG 1 - 18
Priority:	10	Discipline:	ARCH., MEP
Address:	King Farm Park, 16100 Frederick Road, Rockville, MD 20850		
Location:	BUILDING 1 HOUSE - INTERIOR & EXTERIOR		
Category:	RADON		
Necessity:	STABILIZE

Exterior radon drain @ elevation corner C-D is open to the elements.

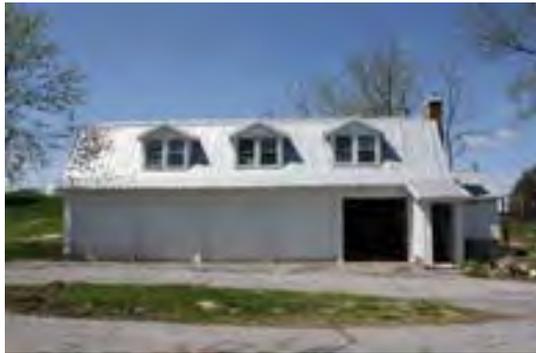
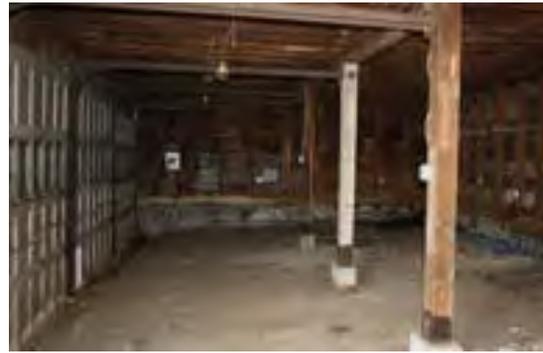
Condition / Deficiency Report		Report Number:	BLDG 2 - 1
Priority:	14	Discipline:	ARCH.
Address:	King Farm Park, 16100 Frederick Road, Rockville, MD 20850		
Location:	BUILDING 2 - GARAGE		
Category:	EGRESS		
Necessity:	REHABILITATE

1. Garage currently does not contain a code compliant means of egress.
2. Second floor contains only one means of egress.

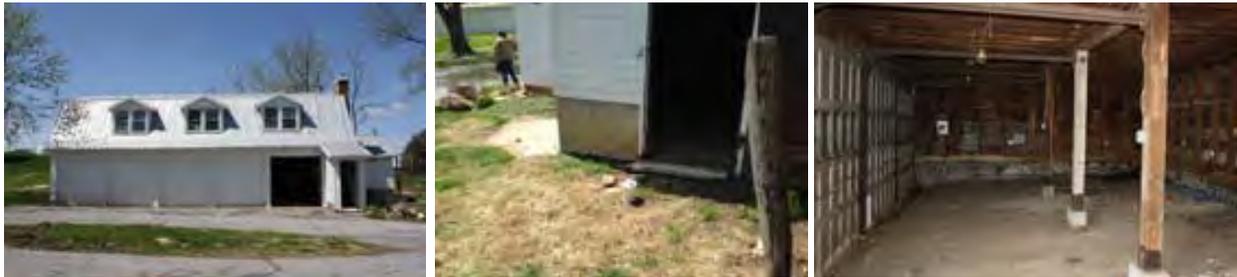
Condition / Deficiency Report		Report Number:	BLDG 2 - 2
Priority:	14	Discipline:	ARCH.
Address:	King Farm Park, 16100 Frederick Road, Rockville, MD 20850		
Location:	BUILDING 2 - GARAGE		
Category:	ACCESSIBILITY		
Necessity:	REHABILITATE

1. No accessible entrance to 2nd floor or smoke room. Pipe stack in front of smoke room blocking possibility of ADA compliant access.
2. The garage space has no man door and the floor has an aggressive slope.

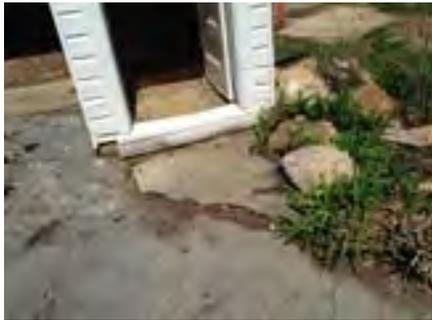
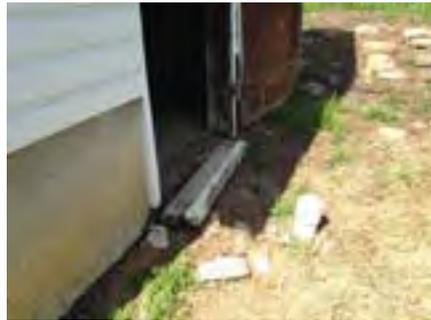
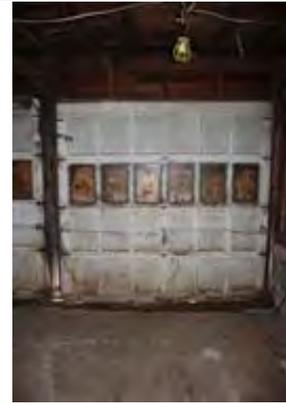
Condition / Deficiency Report		Report Number:	BLDG 2 - 3
Priority:	17	Discipline:	ARCH.
Address:	King Farm Park, 16100 Frederick Road, Rockville, MD 20850		
Location:	BUILDING 2 - GARAGE		
Category:	APPROACH		
Necessity:	REHABILITATE

1. Entry pad to second floor is deteriorated. There is no current entry pad to the smoke room.

1. Remove deteriorated concrete and replace with a 5'-0" x 5'-0" concrete pad. Provide concrete entry pad @ the smoke room door. Remove capped pipe.

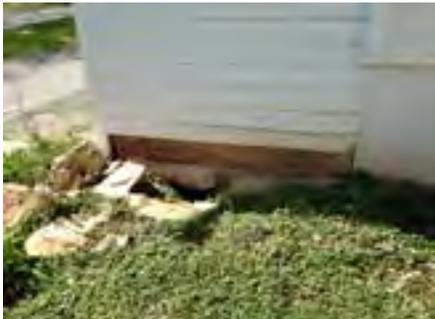
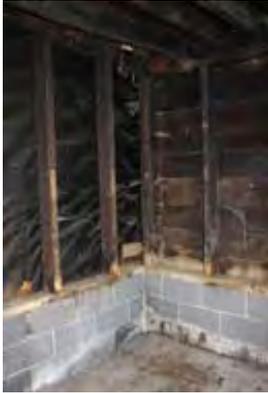
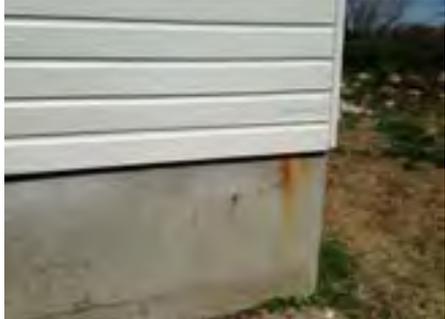
King Farm Property Condition Assessment		
Condition / Deficiency Report		
Report Number:	BLDG 2 - 4	
Priority:	2	
Discipline:	ARCH.	
Address:	King Farm Park, 16100 Frederick Road, Rockville, MD 20850	
Location:	BUILDING 2 - GARAGE	
Category:	FOUNDATION	
Necessity:	STABILIZE	
Photo Documentation

Deficiency Description		
<p>Cracking in brick foundation @ second floor entrance and CMU in smoke room under sill.            Stained and cracked parging @ smoke room.</p>		
Recommended Action		
<p>Repoint existing brick and CMU. Remove and replace parging @ smoke room. Clean and parge elevation C. See R-13.</p>		
References:	R-10, R-13	
Estimated Cost:	\$4,658.00

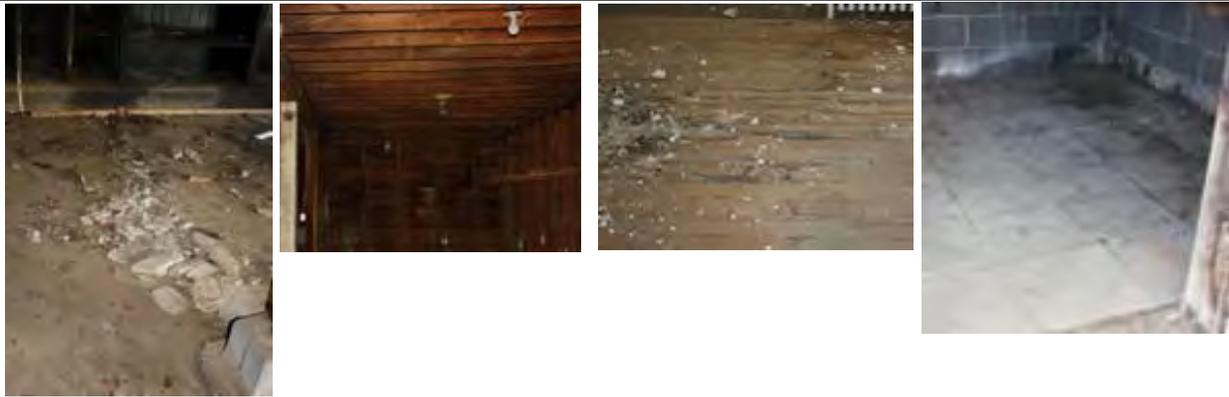
Condition / Deficiency Report		Report Number:	BLDG 2 - 5
Priority:	8	Discipline:	ARCH., STRUCT.
Address:	King Farm Park, 16100 Frederick Road, Rockville, MD 20850		
Location:	BUILDING 2 -GARAGE		
Category:	FLOORS		
Necessity:	STABILIZE

1. Garage floor significantly deteriorated.
2. Second floor joists are bowed. Floor is undersized for residential LL. Floor capacity is below code, with an estimated LL capacity of 20 psf.
3. Concrete tiled floor in smoke room deteriorated.

1. Repair concrete floor. Cut out 12" wide at cracks, dowel to existing and place new concrete.
2. No action needed to stabilize.
3. Repair and repoint smoke room floor as needed.

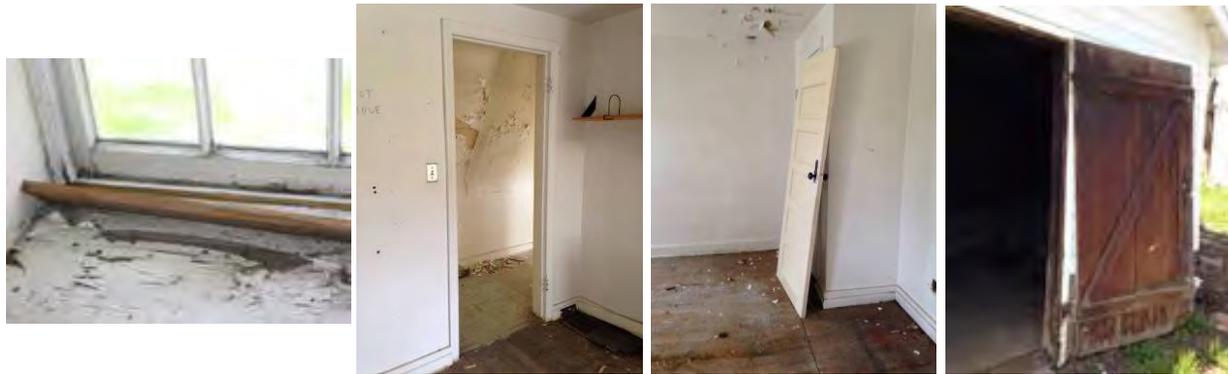
Condition / Deficiency Report		Report Number:	BLDG 2 - 6
Priority:	4	Discipline:	ARCH.
Address:	King Farm Park, 16100 Frederick Road, Rockville, MD 20850		
Location:	BUILDING 2 - GARAGE		
Category:	OPENINGS		
Necessity:	STABILIZE

1. The 11 windows on the second floor have deteriorated sills. The window assemblies themselves are also in poor condition.
2. Doors are strewn about the apt.

1. Replace 4'-0" x 2'-0" windows with 6/6 replicas. Repair sills and flashing where necessary. See 2-7.
2. Remove and retain existing doors on 2nd floor for possible reuse.

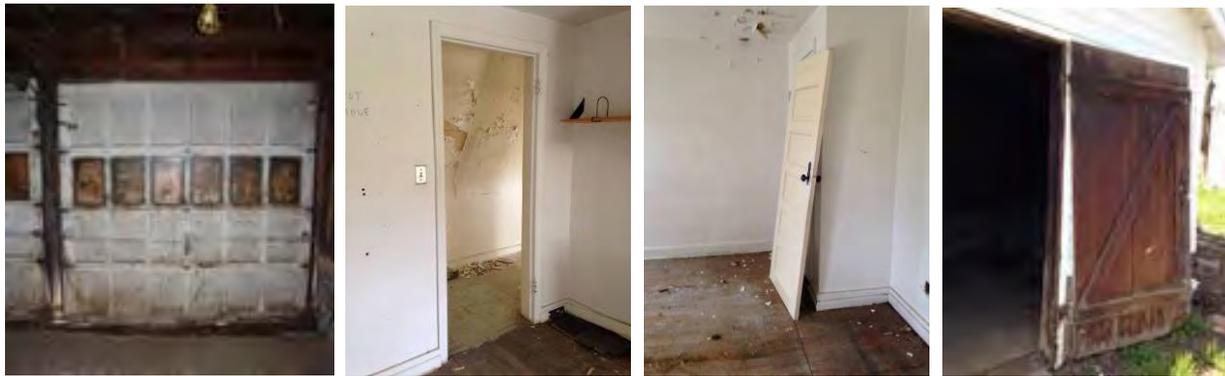
1. Some of the 8 doors, while present, have been removed from their frames.
2. Exterior door to second floor is in poor condition.
3. The door to the smoke room is in poor condition.
4. The garage doors are non-operable and in poor condition.

1. Keep existing doors in place and install those that have been removed. Replace hardware with levers. Make any minor repairs necessary on the door frames. Prep for paint.
2. Repair the exterior door to the second floor and prepare for paint. Replace the glass.
3. Replace 3'-6" x 7'-0" smoke room door with replica. Reuse hardware (other than door handles) after cleaning. Prep for paint.
4. Replace 5 garage doors with custom replicas. The future use will determine if the doors are operable or non-operable and sealed.

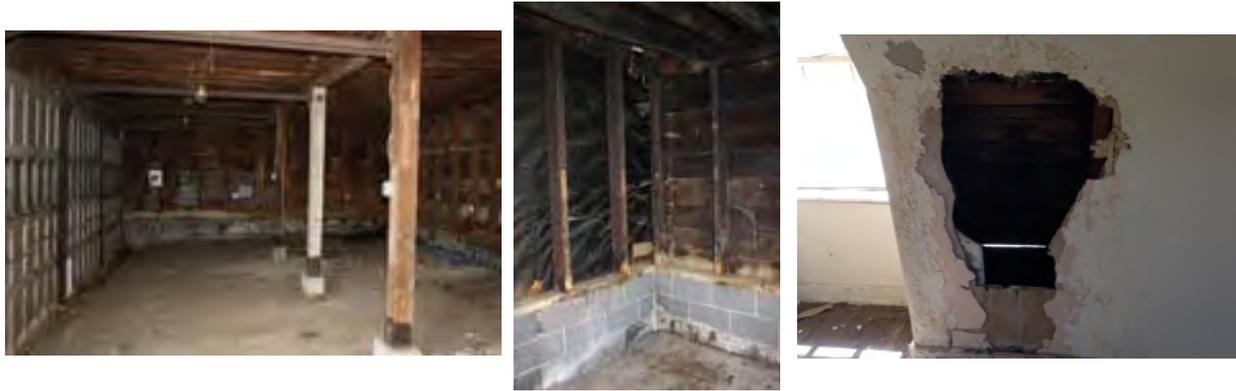
1. Garage is not insulated.
2. Smoke room is not insulated.
3. Insulation on second floor is in poor condition or missing.

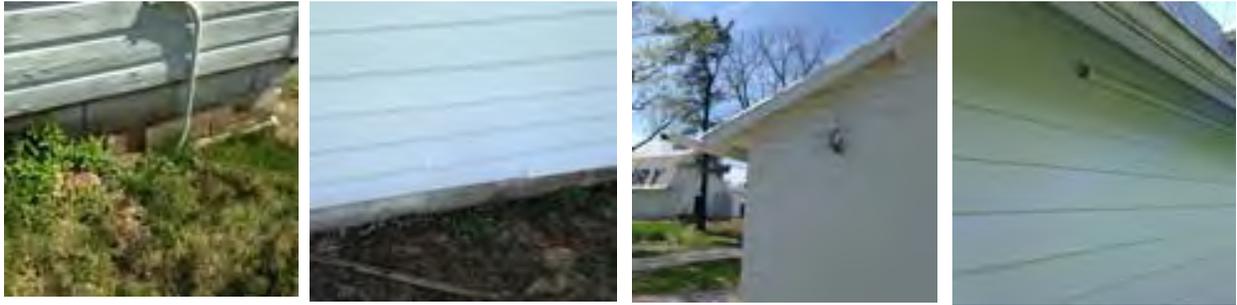
Condition / Deficiency Report		Report Number:	BLDG 2 - 9
Priority:	6	Discipline:	ARCH.
Address:	King Farm Park, 16100 Frederick Road, Rockville, MD 20850		
Location:	BUILDING 2 - GARAGE		
Category:	SIDING		
Necessity:	STABILIZE

Chipped wood siding @ all elevations. Wires and pipes mounted on siding. Small penetrations for wires painted over without removing the penetration obstruction or filling the penetration itself.

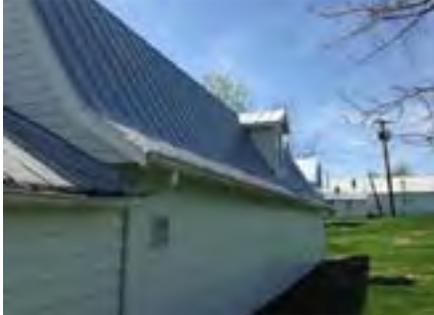
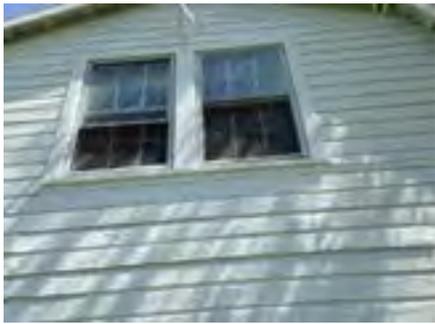
King Farm Property Condition Assessment	
Condition / Deficiency Report	
Report Number:	BLDG 2 - 10
Priority:	7
Discipline:	ARCH.
Address:	King Farm Park, 16100 Frederick Road, Rockville, MD 20850
Location:	BUILDING 2 - GARAGE
Category:	EXTERIOR PAINT
Necessity:	STABILIZE
Photo Documentation

Deficiency Description	
Current paint job masks, but does not remedy siding problems.	
Recommended Action	
Repaint exterior siding, trim and doors. See also 2-6, 2-9.	
References:	R-12, 2-6, 2-9
Estimated Cost:	\$7,341.00

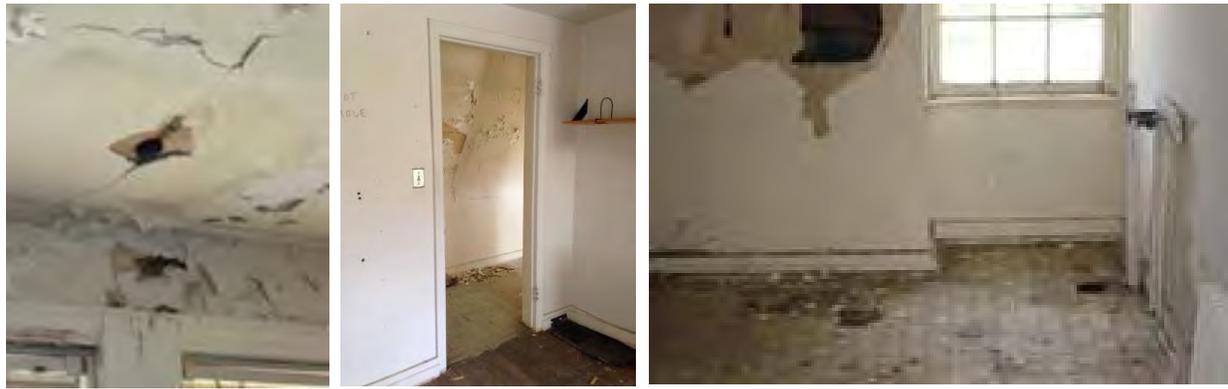
Paint in severely deteriorated condition.

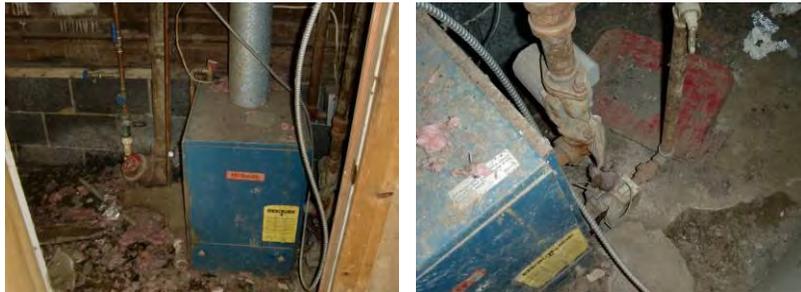
Condition / Deficiency Report		Report Number:	BLDG 2 - 12
Priority:	11	Discipline:	MEP
Address:	King Farm Park, 16100 Frederick Road, Rockville, MD 20850		
Location:	BUILDING 2 - GARAGE		
Category:	MECHANICAL EQUIPMENT		
Necessity:	REHABILITATE

Garage level is unheated. Gas fired boiler in the garage level feeds the apartment above. Boiler is 30 years old, and condition is unknown. Existing hot water heating piping is uninsulated steel feeding up to the hot water baseboard.

Replace corroded sections of piping. Patch and repair as necessary. Remove the existing boiler heating system in its entirety. Provide a new split system gas-fired furnace with add on cooling to serve the lower level of the garage. Air distribution shall be spiral sheet metal ductwork with sidewall duct diffuser. Assume a 3 ton HVAC system for the space. The unit shall be installed in an appropriately sized mechanical room and shall have economizer package along with a 7-day programmable thermostat. Provide a separate gas-fired split system heating / cooling with add on cooling to the upper level apartment area of the garage. Assume rectangular ductwork which would be concealable from bulkheads, utilizing sidewall diffusers and a central return. System for the upper level shall be assumed to be a 2 1/2 ton heating / cooling unit with economizer accessory and 7-day programmable thermostat.

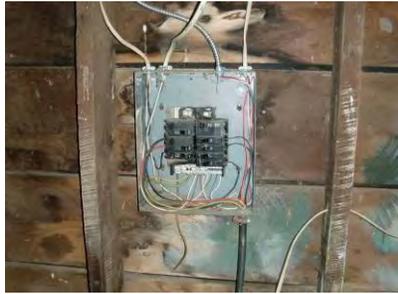
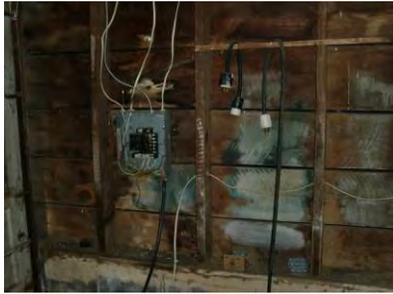
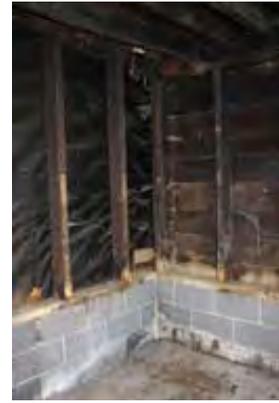
Condition / Deficiency Report		Report Number:	BLDG 2 - 13
Priority:	13	Discipline:	MEP
Address:	King Farm Park, 16100 Frederick Road, Rockville, MD 20850		
Location:	BUILDING 2 - GARAGE		
Category:	ELECTRICAL SYSTEM		
Necessity:	REHABILITATE

Existing building does not have operating electrical service and distribution, panel and wiring methods are non-code compliant. There is no light fixture in the smoke room.

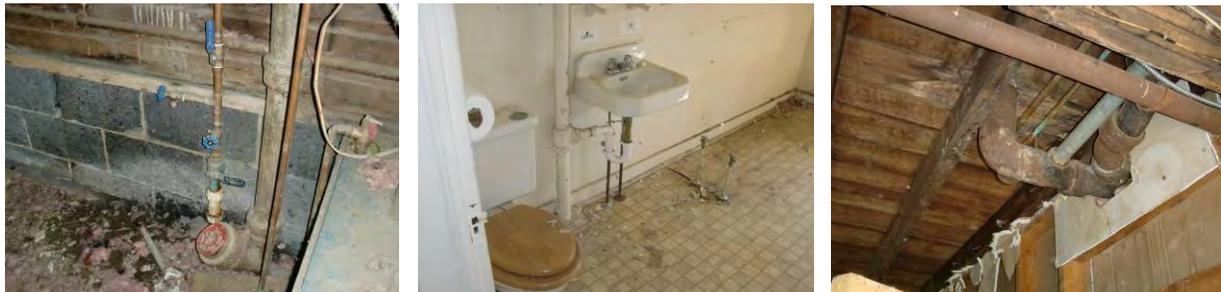
1. Existing domestic cold water piping is uninsulated copper and cpvc. Piping is in poor condition and not code compliant.
2. Existing sanitary piping is a mixture of cast iron, galvanized pipe, pvc and is not code compliant.

1. Replace corroded sections of piping. Patch and repair as necessary. Replumb the domestic water piping to the kitchen and bathroom above, provide new hot water heater.
2. Replumb the sanitary waste and vent for the entire building. Replace all fixtures.

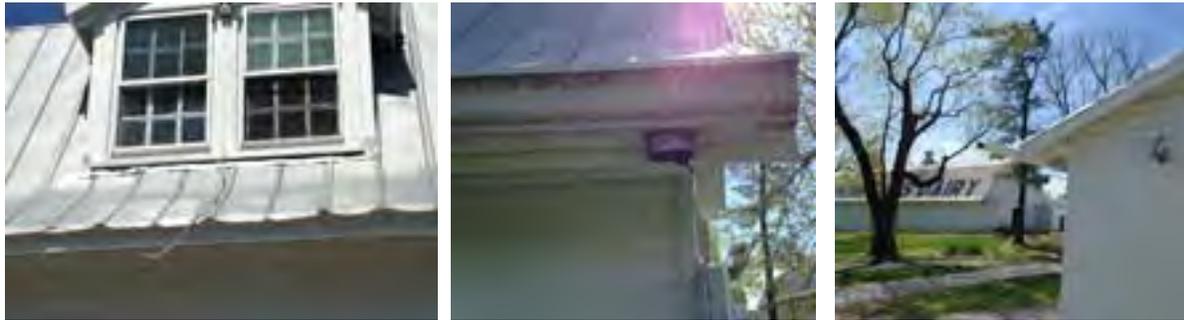
Condition / Deficiency Report		Report Number:	BLDG 2 - 15
Priority:	5	Discipline:	ARCH.
Address:	King Farm Park, 16100 Frederick Road, Rockville, MD 20850		
Location:	BUILDING 2 - GARAGE		
Category:	GUTTER SYSTEM		
Necessity:	STABILIZE

1. Several sections of the roof line are missing gutters. Existing gutters are too small and full of debris. Rusted extended gutter above apartment entrance.
2. Missing downspout @ C-D corner.

1-2. Add gutters where needed. See R-14. Replace gutters with 6" galvanized gutters and install coordinating downspouts. Install brackets and gutter guards as appropriate.

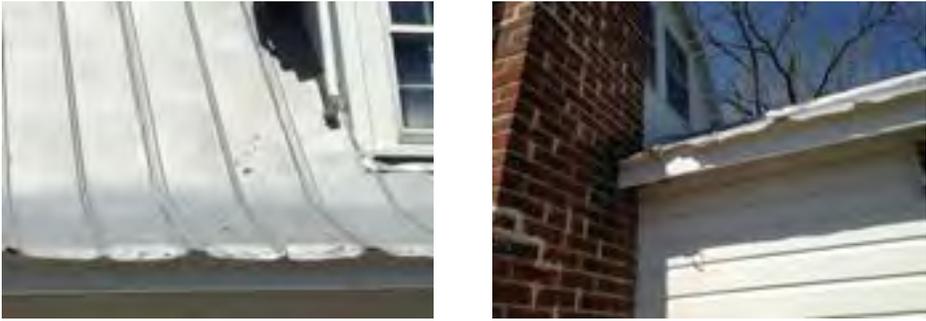
King Farm Property Condition Assessment	
Condition / Deficiency Report	
Report Number:	BLDG 2 - 16
Priority:	3
Discipline:	ARCH., STRUCT.
Address:	King Farm Park, 16100 Frederick Road, Rockville, MD 20850
Location:	BUILDING 2 - GARAGE
Category:	ROOF
Necessity:	STABILIZE
Photo Documentation

Deficiency Description	
<p>Existing roof @ both smoke room and main structure are severely deteriorated. Random exposed wires and piping also present. Damage to roof framing due to water infiltration.</p>	
Recommended Action	
<p>Replace roof @ both smoke room and main structure with standing seam roof. Remove extraneous exterior brackets, conduit, etc. Replace damaged framing members as necessary. Assume 20% of rafters and 10% of exterior studs will need to be replaced.</p>	
References:	R-14, SK-2
Estimated Cost:	\$30,879.00

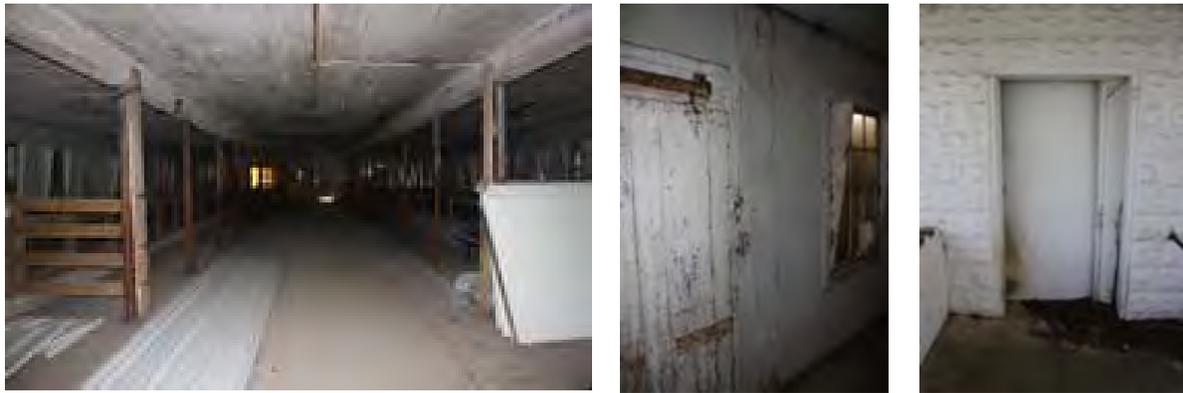
Condition / Deficiency Report		Report Number:	BLDG 3/4 - 1
Priority:	17	Discipline:	ARCH.
Address:	King Farm Park, 16100 Frederick Road, Rockville, MD 20850		
Location:	DAIRY BARNS 3/4		
Category:	EGRESS		
Necessity:	REHABILITATE

1. Existing number of entrances/exits may accommodate a variety of proposed future uses, but all are in significant disrepair. Mechanisms of most are inoperable. See 3/4-6.
2. Existing concrete curbs and cow railings block off side exits from the central aisle.
3. There is no compliant means of egress from the attic area in either barn.

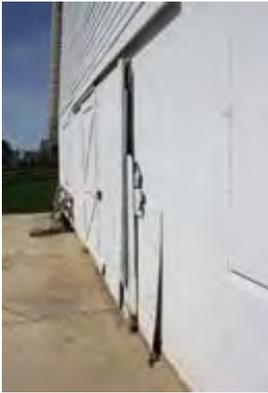
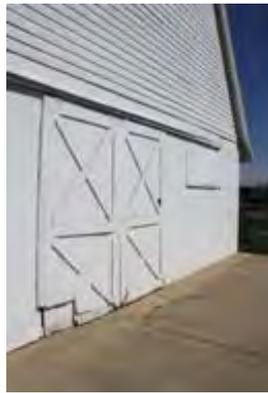
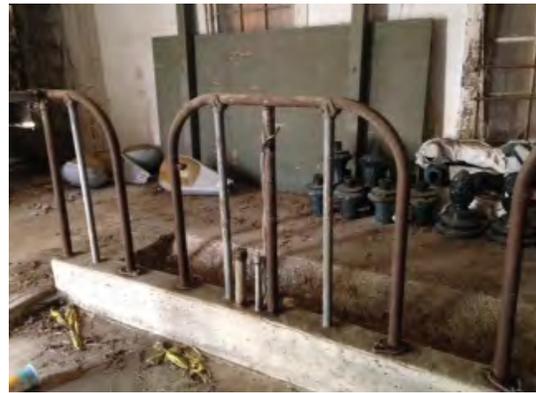
Condition / Deficiency Report		Report Number:	BLDG 3/4 - 2
Priority:	16	Discipline:	ARCH.
Address:	King Farm Park, 16100 Frederick Road, Rockville, MD 20850		
Location:	DAIRY BARNS 3/4		
Category:	ACCESSIBILITY		
Necessity:	REHABILITATE

Main entrances @ front and rear of both barns are the only openings that sit even with the driveway approach; The side aisles in both barns are not currently accessible. The ramps up are too short and have too high of a slope.

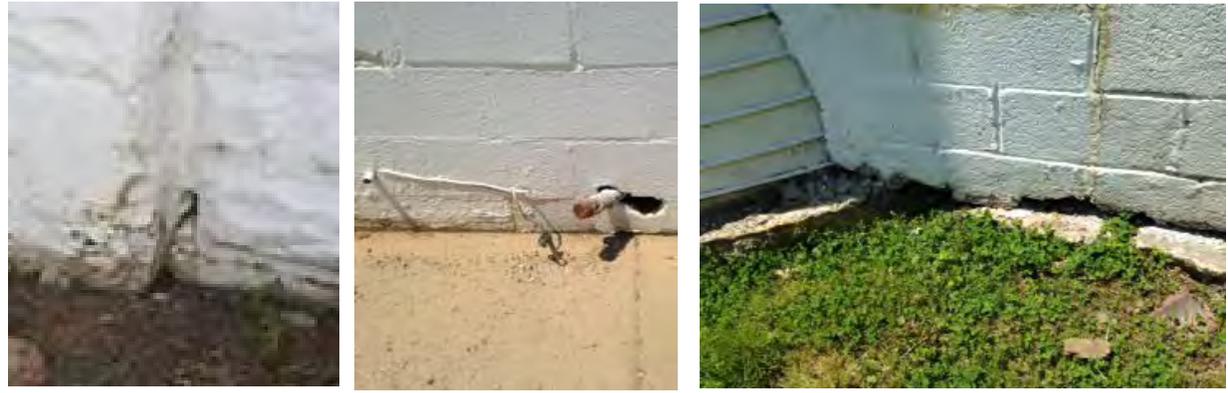
King Farm Property Condition Assessment	
Condition / Deficiency Report	
Report Number:	BLDG 3/4 - 4
Priority:	7
Discipline:	ARCH.
Address:	King Farm Park, 16100 Frederick Road, Rockville, MD 20850
Location:	DAIRY BARNS 3/4
Category:	FOUNDATION
Necessity:	STABILIZE
Photo Documentation

Deficiency Description	
<p>CMU deterioration @ seam on elevation D. Old piping penetration migrating through deteriorated CMU @ elevation C. Disintegrated CMU @ silo on elevation B.</p>	
Recommended Action	
<p>Patch and repair as necessary.</p>	
References:	R-18
Estimated Cost:	\$6,655.00

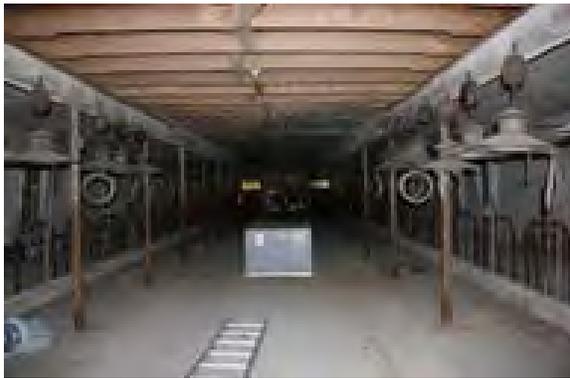
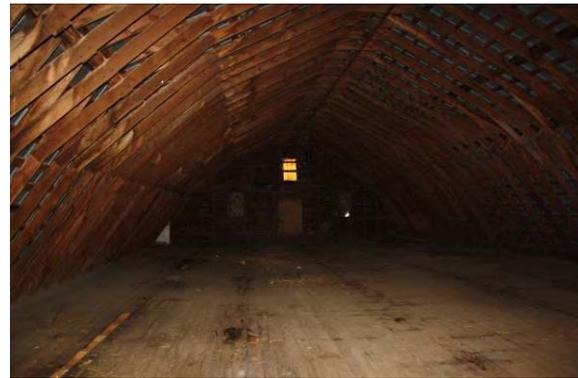
Condition / Deficiency Report		Report Number:	BLDG 3/4 - 5
Priority:	4	Discipline:	ARCH., STRUCT.
Address:	King Farm Park, 16100 Frederick Road, Rockville, MD 20850		
Location:	DAIRY BARNS 3/4		
Category:	FLOORS		
Necessity:	STABILIZE

1. There are patches of deterioration in the concrete @ aisles 1, 2, and 3 in both barns.
2. Flooring @ room 4 deteriorated.
3. Attic floor in both barns shows damage and wear.

1-2. Repair curbs and patch as needed prior to leveling the surface @ all aisles. Patch and repair concrete floor as needed.

3. In barn 3, replace missing tongue and groove ceiling @ the front of aisle 1, approx. 364 sf. In barn 3, replace approx. 20% wood deck in attic with plywood. In barn 4, replace approx. 80% wood deck in attic with plywood. Replace attic floor joists as needed, minor in barn 3, approx. 50% in barn 4. Existing attic floors in both barns (when repaired) only meet LL capacity of 20 psf.

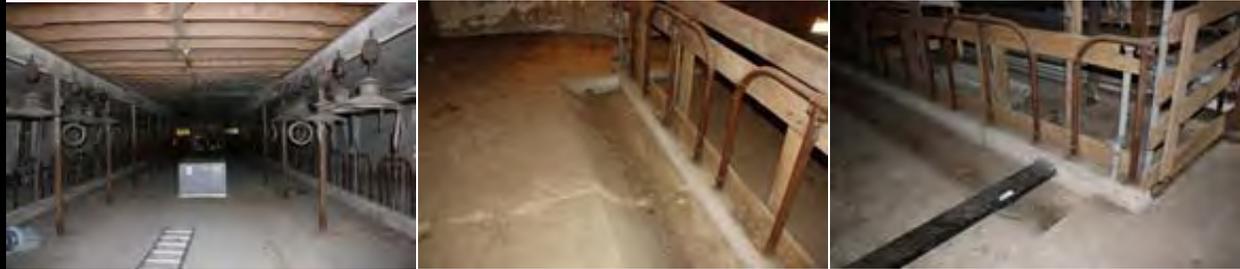
Condition / Deficiency Report		Report Number:	BLDG 3/4 - 5A
Priority:	18	Discipline:	ARCH., STRUCT.
Address:	King Farm Park, 16100 Frederick Road, Rockville, MD 20850		
Location:	DAIRY BARNS 3/4		
Category:	FLOORS		
Necessity:	REHABILITATE

In both barns: Floor is not level @ area 1, 2 and 3; The central aisle is concavely shaped along its short dimension. Height of curve approx. 1 1/2"; 6" curbs and 9" deep troughs are formed into the concrete @ aisles 2 and 3 in both barns.

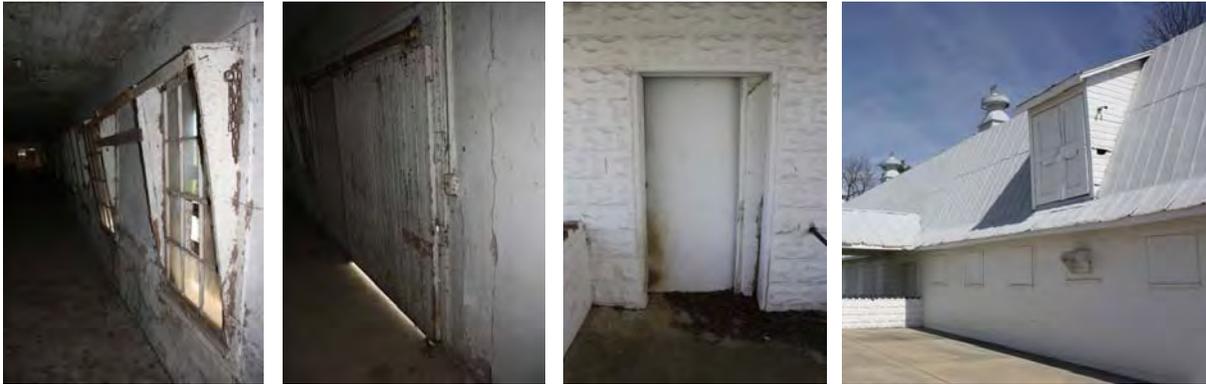
Condition / Deficiency Report		Report Number:	BLDG 3/4 - 6
Priority:	5	Discipline:	ARCH.
Address:	King Farm Park, 16100 Frederick Road, Rockville, MD 20850		
Location:	BUILDING 3/4		
Category:	OPENINGS		
Necessity:	STABILIZE

1. Windows and louver openings @ all locations are in very poor condition. All trim very deteriorated.
2. Barn doors and hardware show evidence of rot and deterioration. Side exits are non-operable.
3. The 3 dormers show significant rot.
4. Milkhouse windows and doors in significant disrepair.

1. Replace all windows and their frames with tilt-in paned replicas. 57 large @ 4'-0" x 5'-0", 14 small @ 3'-0" x 3'-0"; Replace louvers.
2. Replace 4 barn doors and hardware with replica. Replace 4 side doors, interior storage room door, and hardware leading to courtyard with replicas.
3. Replace entire dormer assembly, including necessary reframing, flashing, siding repair, etc. See also 3/4-16.
4. Replace 5 windows and 3 doors in milkhouse with historically accurate replicas. Prep for paint; Replace all trim. Prep for paint.

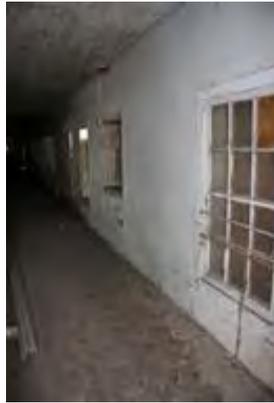
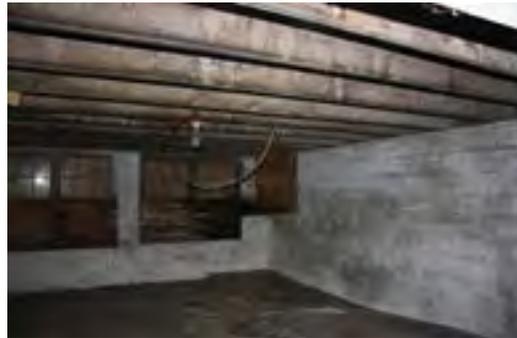
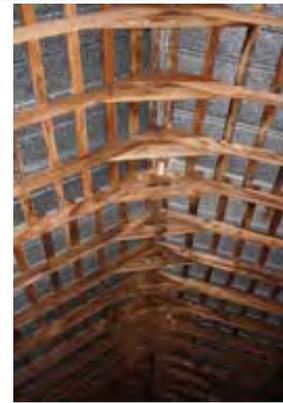
Condition / Deficiency Report		Report Number:	BLDG 3/4 - 8
Priority:	12	Discipline:	ARCH.
Address:	King Farm Park, 16100 Frederick Road, Rockville, MD 20850		
Location:	DAIRY BARNS 3/4		
Category:	INSULATION		
Necessity:	REHABILITATE

Attic space is not insulated. Barn walls are not insulated.

Insulate attic space with R-38 batt insulation. Patch and repair walls as needed. To insulate barns, install wall assembly with gyp. bd., 2" continuous rigid insulation and furring strips.

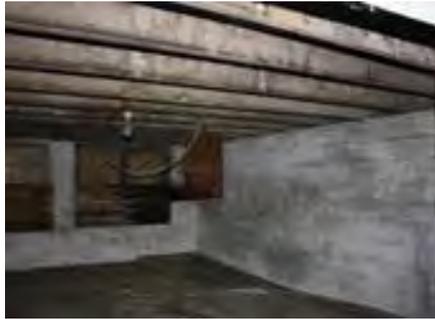
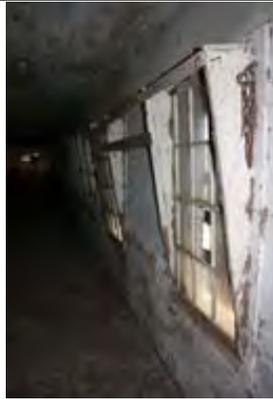
Condition / Deficiency Report		Report Number:	BLDG 3/4 - 11
Priority:	20	Discipline:	ARCH.
Address:	King Farm Park, 16100 Frederick Road, Rockville, MD 20850		
Location:	DAIRY BARNS 3/4		
Category:	INTERIOR PAINT		
Necessity:	REHABILITATE

Painted interior surfaces show significant deterioration. Silo walls show discoloration and deterioration.

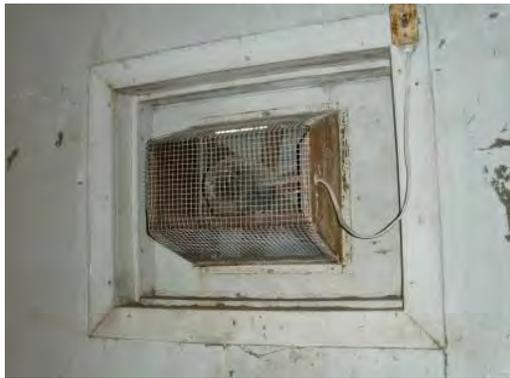
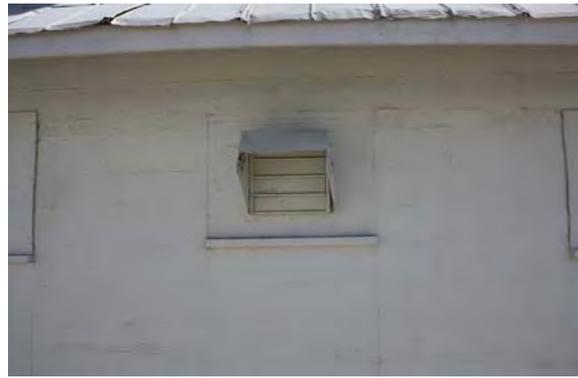
Condition / Deficiency Report		Report Number:	BLDG 3/4 - 12
Priority:	13	Discipline:	MEP
Address:	King Farm Park, 16100 Frederick Road, Rockville, MD 20850		
Location:	DAIRY BARNS 3/4		
Category:	MECHANICAL EQUIPMENT		
Necessity:	REHABILITATE

Existing ventilation fans which served the milking area of the barn are not operational.

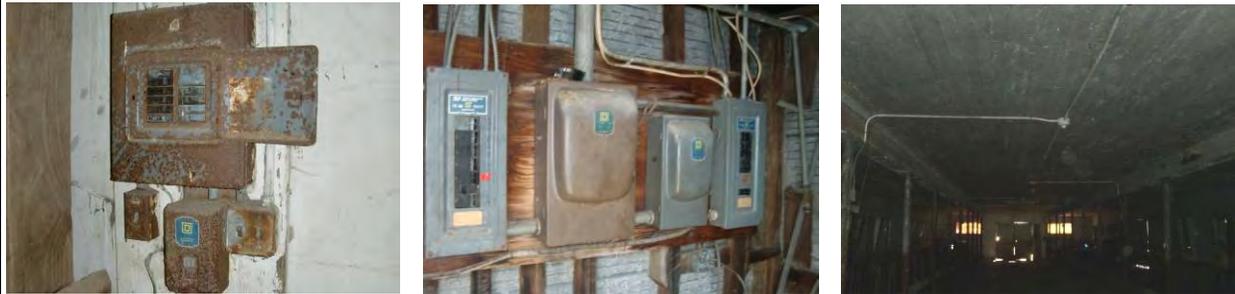
<b>Condition / Deficiency Report</b>		<b>Report Number:</b>	<b>BLDG 3/4 - 13</b>
<b>Priority:</b>	<b>15</b>	<b>Discipline:</b>	<b>MEP</b>
<b>Address:</b>	King Farm Park, 16100 Frederick Road, Rockville, MD 20850		
<b>Location:</b>	DAIRY BARNS 3/4		
<b>Category:</b>	ELECTRICAL SYSTEM		
<b>Necessity:</b>	REHABILITATE

Existing power service, distribution panels and lighting are non-operable. Panel and wiring devices are corroded and noncode compliant.

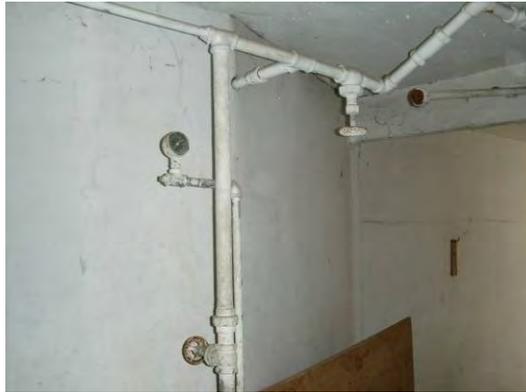
Condition / Deficiency Report		Report Number:	BLDG 3/4 - 14
Priority:	14	Discipline:	MEP
Address:	King Farm Park, 16100 Frederick Road, Rockville, MD 20850		
Location:	DAIRY BARNS 3/4		
Category:	PLUMBING SYSTEMS		
Necessity:	REHABILITATE

Existing domestic cold water service to the milking area of the barn is in poor condition.
