CITY OF ROCKVILLE

# KING FARM FARMSTEAD PROPERTY CONDITION ASSESSMENT

DEPARTMENT OF RECREATION AND PARKS

JULY 3, 2014

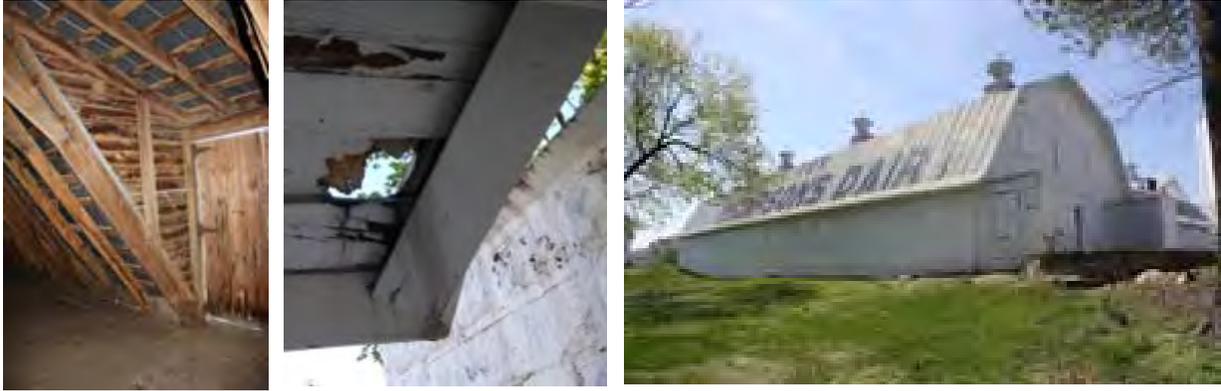
King Farm Property Condition Assessment	
Condition / Deficiency Report	
Report Number:	BLDG 3/4 - 16
Priority:	3
Discipline:	ARCH., STRUCT.
Address:	King Farm Park, 16100 Frederick Road, Rockville, MD 20850
Location:	DAIRY BARNS 3/4
Category:	ROOF
Necessity:	STABILIZE
Photo Documentation

Deficiency Description	
<p>1. Capacity and framing of the roof for both barns are below code.</p> <p>2. The roof and rafters @ both barns show signs of damage and wear. Neither of the barn roofs are weather tight.</p>	
Recommended Action	
<p>1. Barn 3: Replace roof rafters as needed (approx. 2%); Barn 4, replace approx 10% roof rafters.</p> <p>2. Remove and replace roof @ both barns. Replicate "Thompson's Dairy" on barn roof 3. Retain ventilators mounted on both roofs. See 3/4-8.</p>	
References:	R-19, R-20, 3/4-8, SK-3, SK-4
Estimated Cost:	\$399,999.00

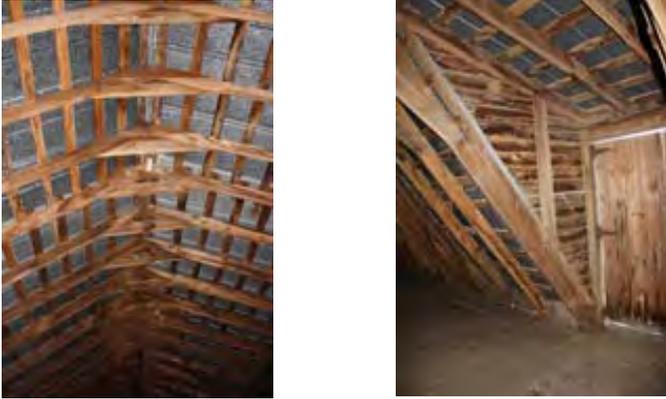
King Farm Property Condition Assessment	
Condition / Deficiency Report	
Report Number:	BLDG 3/4 - 16A
Priority:	11
Discipline:	ARCH., STRUCT.
Address:	King Farm Park, 16100 Frederick Road, Rockville, MD 20850
Location:	DAIRY BARNS 3/4
Category:	ROOF
Necessity:	REHABILITATE
Photo Documentation

Deficiency Description	
<p>1. Capacity and framing of the roof for both barns are below code.</p>	
Recommended Action	
<p>1. In both barns, Install new framing to upgrade roof to code. Estimated new posts @ 9'-0" OC, aligned over existing. Install new roof beams using multiple LVLs. Provide new cross members at posts and kickers down to CMU.</p>	
References:	R-19, R-20, SK-3, SK-4
Estimated Cost:	\$299,475.00

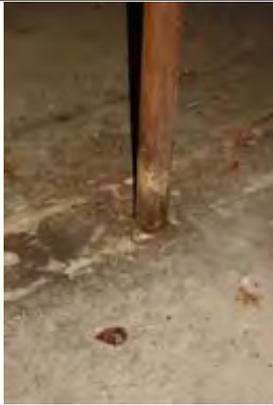
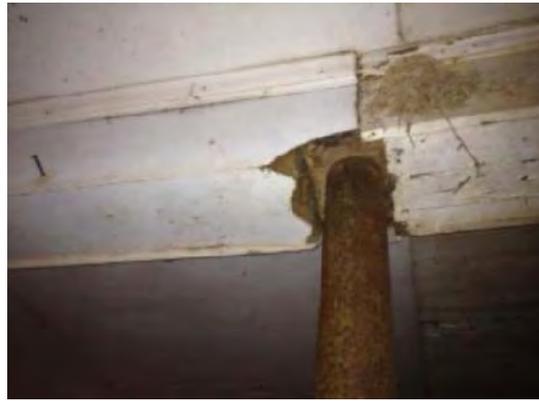
Condition / Deficiency Report		Report Number:	BLDG 3/4 - 17
Priority:	1	Discipline:	ARCH., STRUCT.
Address:	King Farm Park, 16100 Frederick Road, Rockville, MD 20850		
Location:	DAIRY BARNS 3/4		
Category:	COLUMNS		
Necessity:	URGENT

Significantly rusted and deteriorated interior columns along aisle 1 @ barn 4. Columns sheared off their base. Missing column @ barn 4.

Replace missing or failed steel posts (5" round). Provide steel base plates, bolted to existing foundations, and cap plates to accept beams. Replace or provide new beams for damaged ones, approx. 15 beams in barn 4. Temporary shoring as needed.

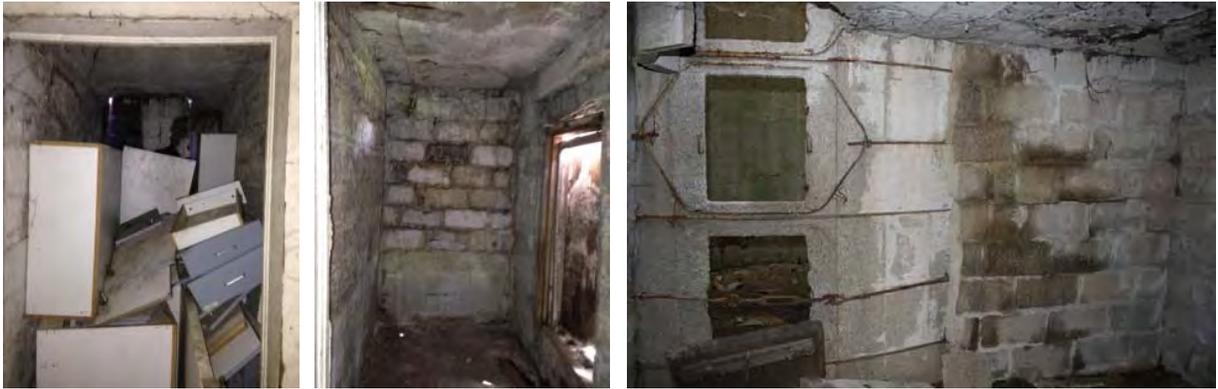
Condition / Deficiency Report		Report Number:	BLDG 3/4 - 18
Priority:	2	Discipline:	ARCH., STRUCT.
Address:	King Farm Park, 16100 Frederick Road, Rockville, MD 20850		
Location:	DAIRY BARNS 3/4		
Category:	SILOS AND CONNECTORS		
Necessity:	URGENT

Concrete, CMU and connector roof are failing @ all silo connector locations. Connectors all show significant water damage.

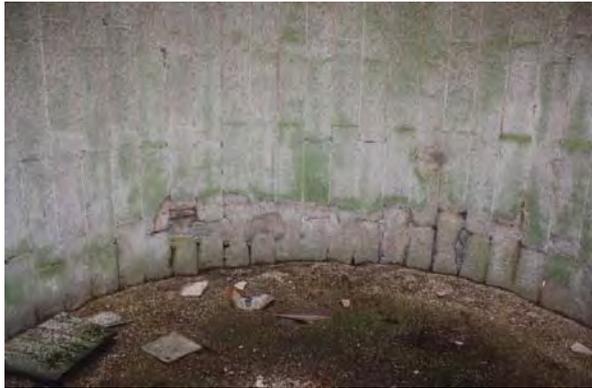
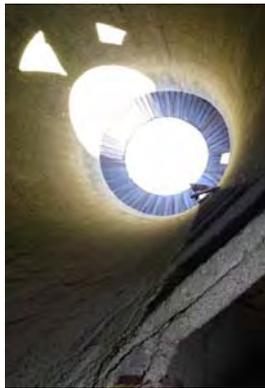
King Farm Property Condition Assessment	
Condition / Deficiency Report	
Report Number:	BLDG 3/4 - 18A
Priority:	6
Discipline:	ARCH., STRUCT.
Address:	King Farm Park, 16100 Frederick Road, Rockville, MD 20850
Location:	DAIRY BARNS 3/4
Category:	SILOS AND CONNECTORS
Necessity:	STABILIZE
Photo Documentation

Deficiency Description	
<ol style="list-style-type: none"> <li>1. Silo 3 shows significant damage @ the floor line on the concrete interior.</li> <li>2. Silo 4 interior concrete ladder is significantly degraded.</li> </ol>	
Recommended Action	
<ol style="list-style-type: none"> <li>1. Patch and repair concrete slabs remaining from barn 3 silo connectors. Remove all "soft" concrete at the base of silo 3 and repair with trowel grade epoxy. Repair silo roofs.</li> <li>2. Patch and repair concrete ladder as necessary.</li> </ol>	
References:	R-15, R-16, SK-4
Estimated Cost:	\$18,634.00

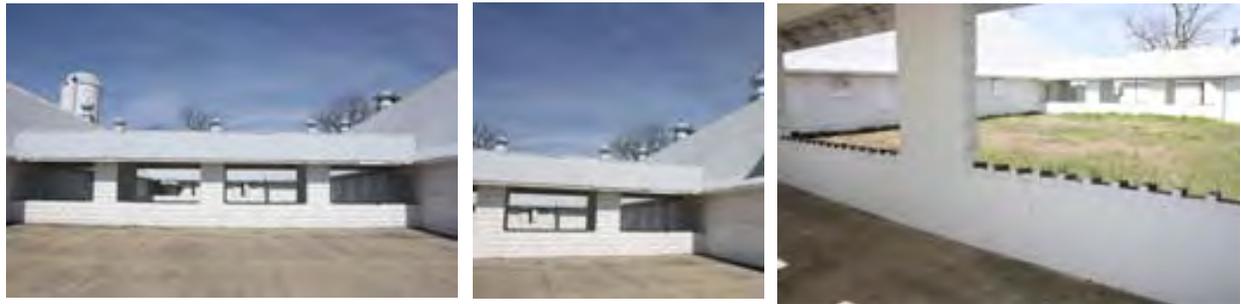
Condition / Deficiency Report		Report Number:	BLDG 3/4 - 19
Priority:	21	Discipline:	ARCH.

Minor cracking in CMU.

Repair CMU as necessary.

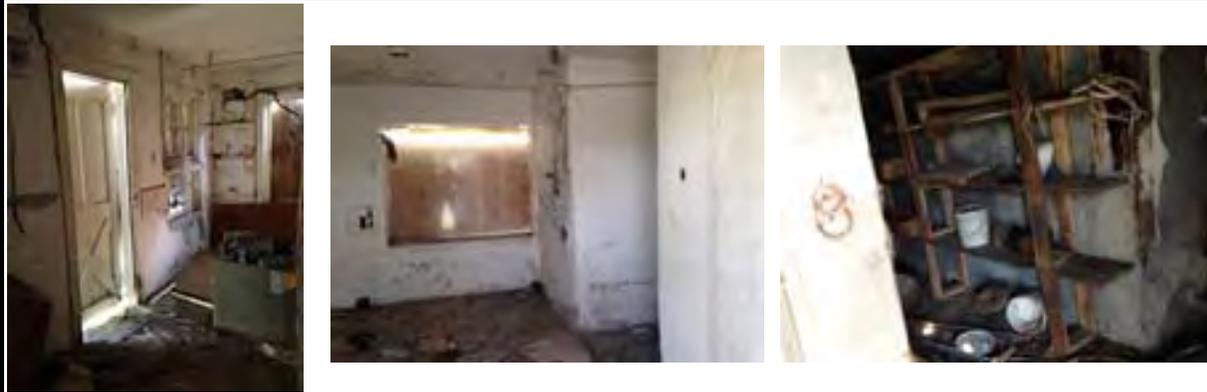
Condition / Deficiency Report		Report Number: <b>BLDG 3/4 - 20</b>
Priority:	<b>10</b>	Discipline: <b>ARCH.</b>
Address: King Farm Park, 16100 Frederick Road, Rockville, MD 20850		
Location: DAIRY BARNS 3/4		
Category: MILK HOUSE		
Necessity: STABILIZE

1. Lots of debris strewn throughout; Concrete walls in disrepair; Wall surfaces deteriorated; Concrete floor in disrepair.
2. Unknown concrete containment tank (sceptic?) in front of milkhouse.

1. Patch and repair concrete walls in utility/storage area as necessary. Repair concrete floor throughout; Patch and repair interior wall surfaces as needed.
2. Hazardous materials survey to provide direction on proposed disposition of existing concrete containment tank; no cost provisions contained in this report at this time.

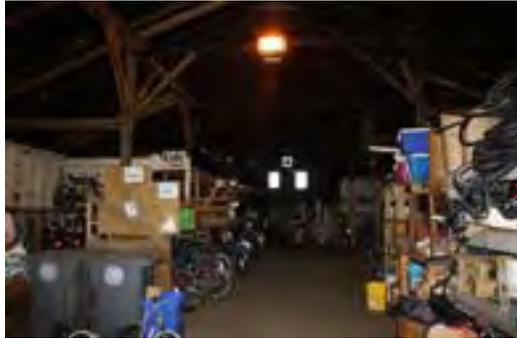
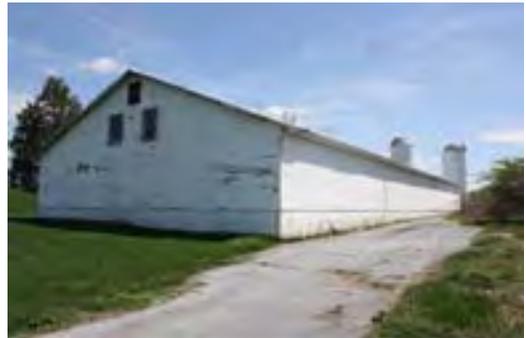
Condition / Deficiency Report		Report Number:	BLDG 5 - 1
Priority:	See 5-17A	Discipline:	ARCH.
Address:	King Farm Park, 16100 Frederick Road, Rockville, MD 20850		
Location:	HORSE BARN - BLDG. 5		
Category:	EGRESS		
Necessity:	REHABILITATE

1. There is no exit to the outside @ room 2.
2. Total number of exits available throughout the building is likely deficient for any proposed future use or occupancy.

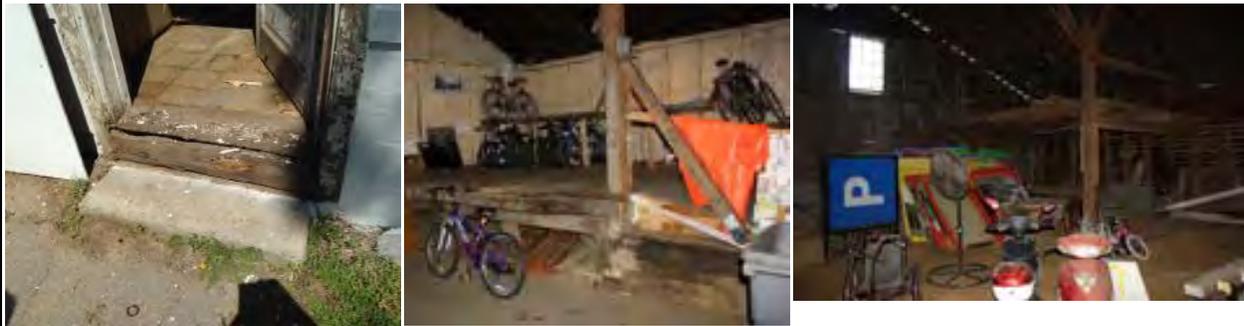
Condition / Deficiency Report		Report Number:	BLDG 5 - 2
Priority:	See 5-17A	Discipline:	ARCH.
Address:	King Farm Park, 16100 Frederick Road, Rockville, MD 20850		
Location:	HORSE BARN - BLDG. 5		
Category:	ACCESSIBILITY		
Necessity:	REHABILITATE

1. There is no accessible entrance @ rooms 1 or 2.
2. Room 7 has a dirt floor.
3. Old hay platforms are not accessible.

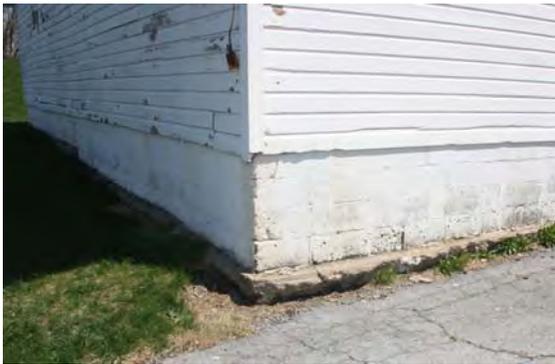
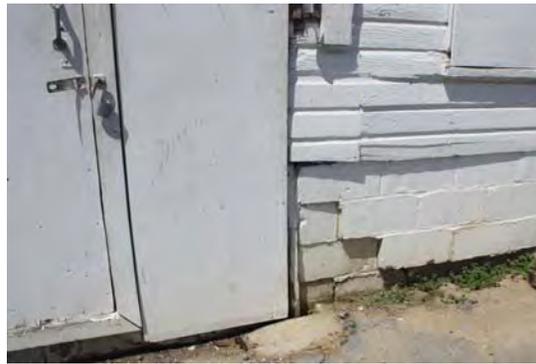
Condition / Deficiency Report		Report Number:	BLDG 5 - 4
Priority:	See 5-17A	Discipline:	ARCH., STRUCT.
Address:	King Farm Park, 16100 Frederick Road, Rockville, MD 20850		
Location:	HORSE BARN - BLDG. 5		
Category:	FOUNDATION		
Necessity:	REHABILITATE

Damaged CMU @ elevation A, C and D. Cracked CMU, dislocated and shifted @ elevation A. Deteriorated concrete base @ C-D corner.

See Building Structure reports. Depending on the proposed use and occupancy, some or most of the foundation could potentially be retained with appropriate repairs. For costing purposes, this assessment includes removal and replacement of the entire foundation.

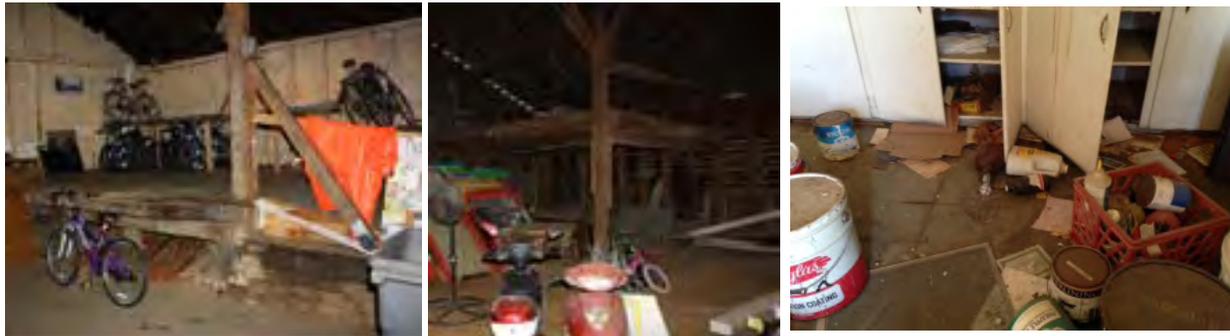
<b>Condition / Deficiency Report</b>		<b>Report Number:</b>	<b>BLDG 5 - 5</b>
<b>Priority:</b>	<b>See 5-17A</b>	<b>Discipline:</b>	<b>ARCH., STRUCT.</b>
<b>Address:</b>	King Farm Park, 16100 Frederick Road, Rockville, MD 20850		
<b>Location:</b>	HORSE BARN - BLDG. 5		
<b>Category:</b>	FLOORS		
<b>Necessity:</b>	REHABILITATE

Minor concrete floor cracking throughout @ room 3. Floor is not level; Dirt floor @ room 2 and 7; Significantly deteriorated floor @ room 1.

See Building Structure reports. Depending on the proposed use and occupancy, some or most of the building floor could potentially be retained with appropriate repairs. For costing purposes, this assessment includes removal and replacement of the entire existing floor.

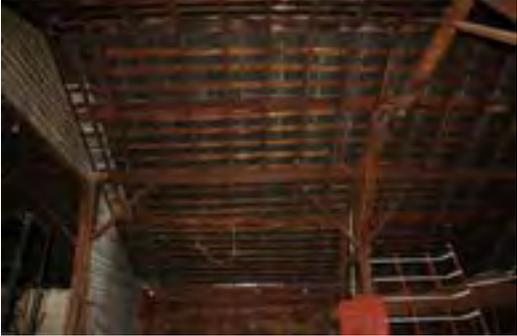
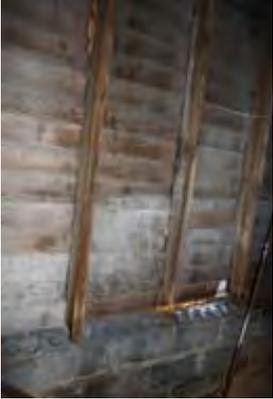
King Farm Property Condition Assessment	
Condition / Deficiency Report	
Report Number:	BLDG 5 - 8
Priority:	See 5-17A
Discipline:	ARCH.
Address:	King Farm Park, 16100 Frederick Road, Rockville, MD 20850
Location:	HORSE BARN - BLDG. 5
Category:	INSULATION
Necessity:	REHABILITATE
Photo Documentation

Deficiency Description	
<p>1. There is no insulation present. Current siding and roof assembly condition will not support insulation.</p> <p>2. Building is not weather tight.</p>	
Recommended Action	
<p>See Building Structure reports. Reconstruction of the barn should include wall and roof assemblies that replicate the historic structure on the exterior, but appropriately protect and insulate the building for a new proposed use and occupancy. For costing purposes, the reconstruction includes insulated wall and roof assemblies.</p>	
References:	R-22, 5-6, 5-9, 5-17, 5-17A
Estimated Cost:	(Price included in 5-17, 5-17A)

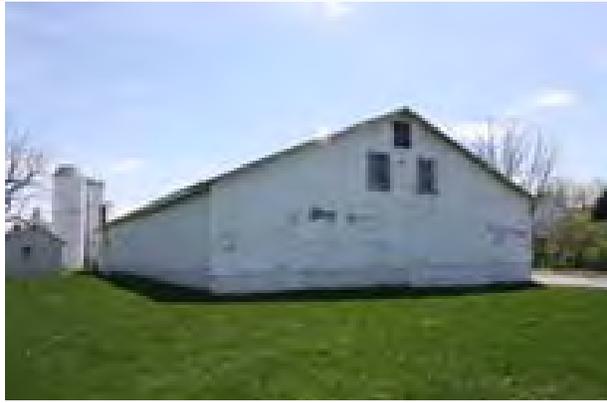
Condition / Deficiency Report		Report Number:	BLDG 5 - 9
Priority:	See 5-17A	Discipline:	ARCH.
Address:	King Farm Park, 16100 Frederick Road, Rockville, MD 20850		
Location:	HORSE BARN - BLDG. 5		
Category:	SIDING		
Necessity:	REHABILITATE

Siding paint chipped and flaking @ all elevations; Various conduit and boards mounted on siding which no longer serve a purpose; numerous perforations @ all elevations.

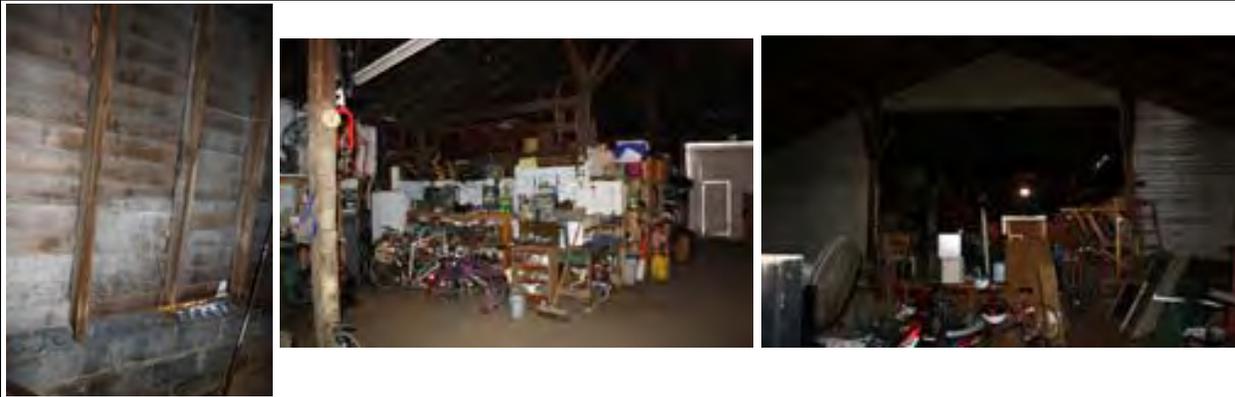
Condition / Deficiency Report		Report Number:	BLDG 5 - 11
Priority:	See 5-17A	Discipline:	ARCH.
Address:	King Farm Park, 16100 Frederick Road, Rockville, MD 20850		
Location:	HORSE BARN - BLDG. 5		
Category:	INTERIOR PAINT		
Necessity:	REHABILITATE

Interior side of perimeter walls and roof unpainted or poorly painted. Walls for rooms 1 and 2 in poor condition. Wall between area 3 and 7 in poor condition.

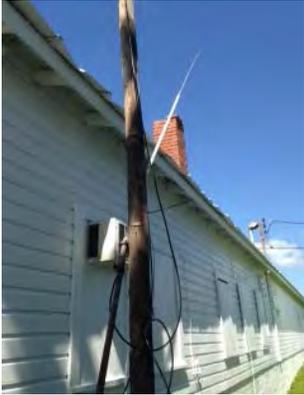
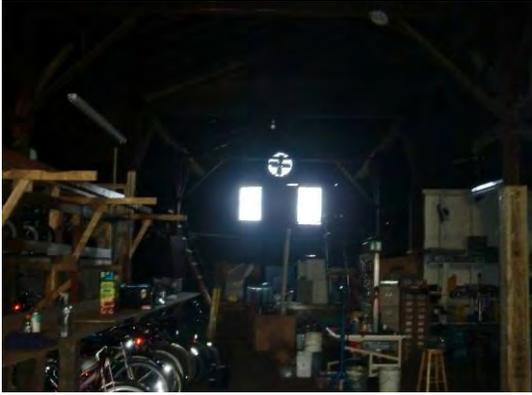
King Farm Property Condition Assessment	
Condition / Deficiency Report	
Report Number:	BLDG 5 - 12
Priority:	3
Discipline:	MEP
Address:	King Farm Park, 16100 Frederick Road, Rockville, MD 20850
Location:	HORSE BARN - BLDG. 5
Category:	MECHANICAL EQUIPMENT
Necessity:	REHABILITATE
Photo Documentation

Deficiency Description	
<p>There is no HVAC system other than wall mounted venting.</p>	
Recommended Action	
<p>Provide a new HVAC system for the entire structure. HVAC system shall consist of a packaged rooftop mounted unit placed on a slab at grade with sidewall air distribution ductwork exiting the rooftop unit and entering the structure. Spiral exposed style ductwork shall run the entire length of the structure to distribute the air through side duct mounted grilles and diffusers utilizing a central return. The HVAC unit shall be 20 ton gas-fired with economizer package and 7-day programmable thermostat.</p>

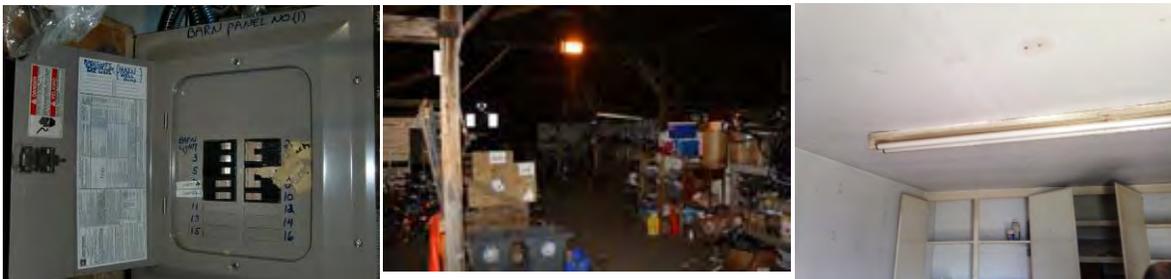
Condition / Deficiency Report		Report Number:	BLDG 5 - 13
Priority:	5	Discipline:	ARCH., MEP
Address:	King Farm Park, 16100 Frederick Road, Rockville, MD 20850		
Location:	HORSE BARN - BLDG. 5		
Category:	ELECTRICAL SYSTEM		
Necessity:	REHABILITATE

1. Existing power panels appear adequate for existing use.
2. Existing / Emergency lighting is poor and not code compliant. There is no lighting @ room 2. Room 1 lighting is non-functional.

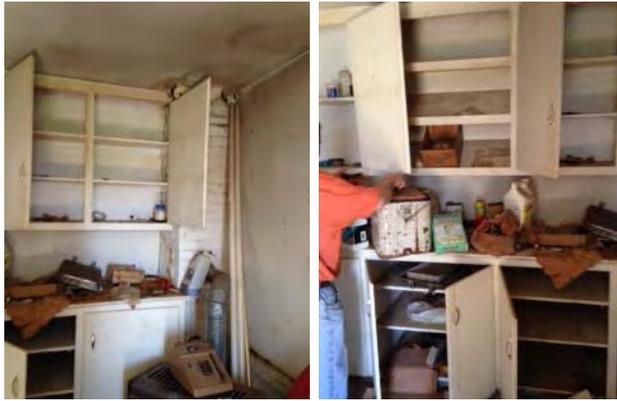
Condition / Deficiency Report		Report Number:	BLDG 5 - 14
Priority:	4	Discipline:	MEP
Address:	King Farm Park, 16100 Frederick Road, Rockville, MD 20850		
Location:	HORSE BARN - BLDG. 5		
Category:	PLUMBING SYSTEMS		
Necessity:	REHABILITATE

There is no existing plumbing service to the building.

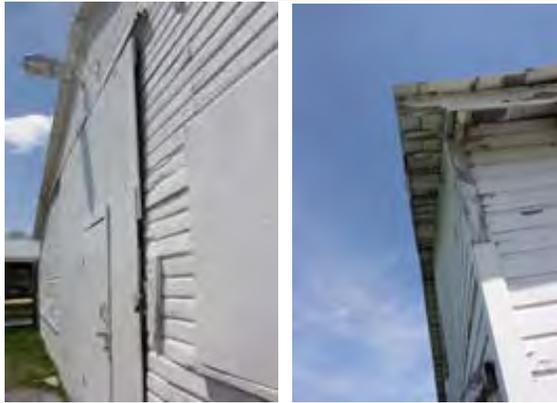
Condition / Deficiency Report		Report Number:	BLDG 5 - 15
Priority:	See 5-17A	Discipline:	ARCH.
Address:	King Farm Park, 16100 Frederick Road, Rockville, MD 20850		
Location:	HORSE BARN - BLDG. 5		
Category:	GUTTER SYSTEM		
Necessity:	REHABILITATE

There is no gutter system present; Fascia is significantly damaged or missing @ all elevations of the building.

See Building Structure reports. If allowed by HDC, provide gutter and downspout system in reconstruction effort to protect the siding from future deterioration.

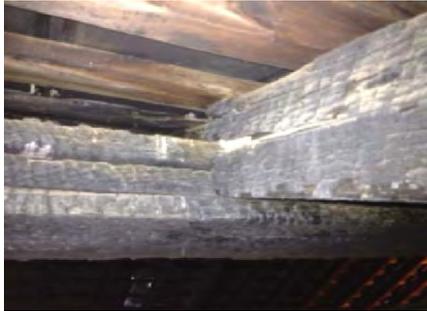
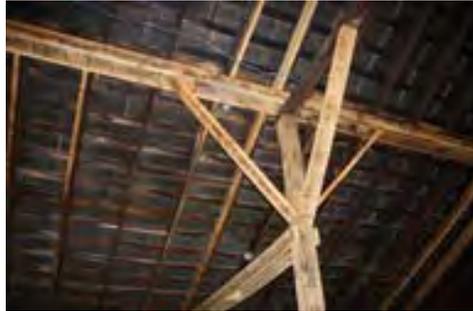
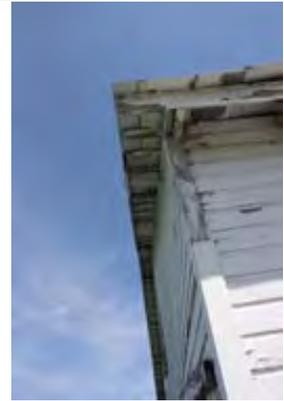
Condition / Deficiency Report		Report Number:	BLDG 5 - 17
Priority:	1	Discipline:	ARCH., STRUCT.
Address:	King Farm Park, 16100 Frederick Road, Rockville, MD 20850		
Location:	HORSE BARN - BLDG. 5		
Category:	BUILDING STRUCTURE		
Necessity:	URGENT

1. The structural issues present in the building framing are myriad. Roof rafters are undersized, connections of rafters to stud wall, to beams, and @ ridge are mostly non-existent. Some roof beams are installed sideways. Braces to beam and columns are undersized and poorly connected. There is no lateral load resisting system. Gable wall studs are interrupted and there is no blocking @ studs.
2. There is fire damage to the structure @ area 3; the two front bays.

Repairs to correct these issues would be extensive. While each of these items could be reconstructed on an individual basis, to do so will require extensive temporary shoring and will consume an inordinately large amount of time and money. For both safety and financial reasons, it is recommended that the building be demolished in an orderly fashion, and in a manner which allows the greatest amount of existing historic material to be salvaged for a possible future reconstruction.

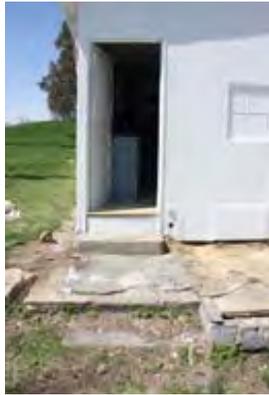
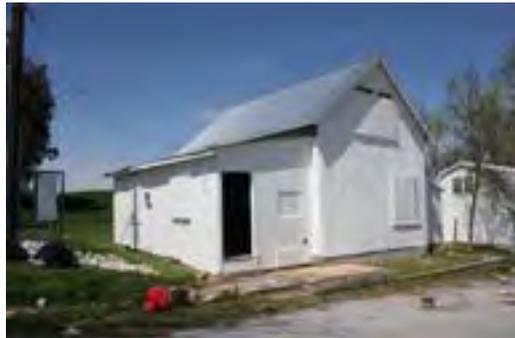
<b>Condition / Deficiency Report</b>	Report Number: <b>BLDG 6 - 1</b>
Priority: <b>9</b>	Discipline: <b>ARCH.</b>

1. Entrances @ elevation A and B are too narrow. There are not enough operable exits.
2. The interior stair is too narrow.

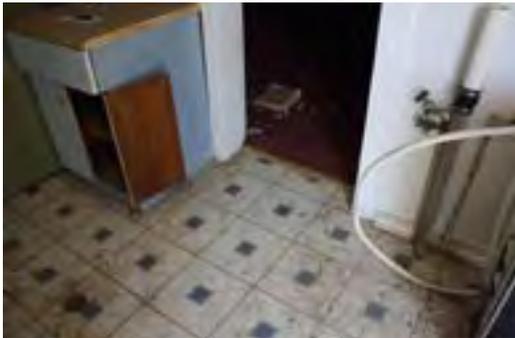
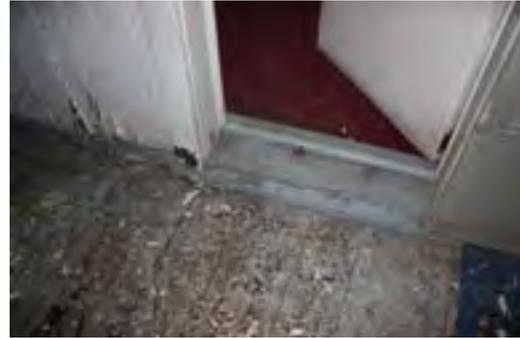
Condition / Deficiency Report		Report Number:	BLDG 6 - 2
Priority:	13	Discipline:	ARCH.
Address:	King Farm Park, 16100 Frederick Road, Rockville, MD 20850		
Location:	TENANT - BLDG. 6		
Category:	ACCESSIBILITY		
Necessity:	REHABILITATE

1. There is no appropriate accessible entrance into the building.
2. There are elevation changes @ thresholds between rooms 1 & 3, and 3 & 4.

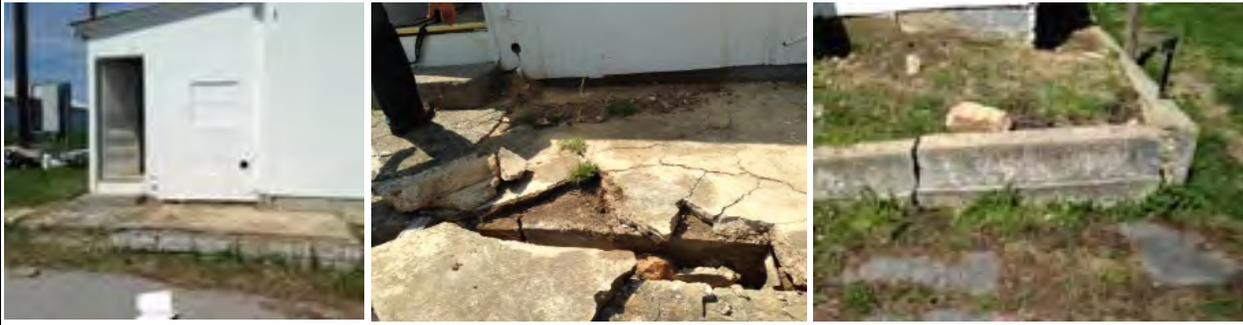
King Farm Property Condition Assessment	
Condition / Deficiency Report	
Report Number:	BLDG 6 - 3
Priority:	5
Discipline:	ARCH.
Address:	King Farm Park, 16100 Frederick Road, Rockville, MD 20850
Location:	TENANT - BLDG. 6
Category:	APPROACH
Necessity:	STABILIZE
Photo Documentation

Deficiency Description	
<p>1. Heaved concrete base with significant cracking. Septic tank located below broken concrete pad. Loose pavers and deteriorated concrete steps.</p> <p>2. The concrete retaining wall @ elevation A in disrepair.</p>	
Recommended Action	
<p>1. Remove septic tank. Demolish concrete base in front of addition 1. See 6-4, 6-7, and 6-9.</p> <p>2. Replace retaining wall after demolition of additions as appropriate for remaining grade.</p>	
References:	R-24, R-25, 6-4, 6-7, 6-9
Estimated Cost:	\$14,774.00

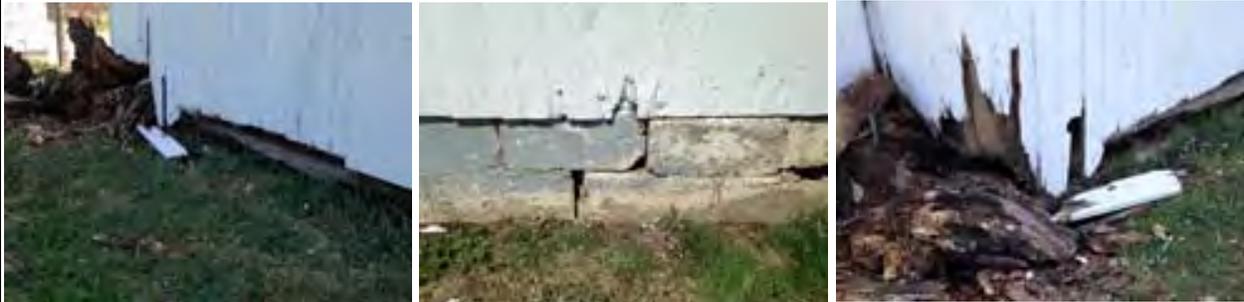
King Farm Property Condition Assessment	
Condition / Deficiency Report	
Report Number:	BLDG 6 - 4
Priority:	1
Discipline:	ARCH., STRUCT.
Address:	King Farm Park, 16100 Frederick Road, Rockville, MD 20850
Location:	TENANT - BLDG. 6
Category:	FOUNDATION
Necessity:	STABILIZE
Photo Documentation

Deficiency Description	
<p>1. Deteriorated foundation cover @ elevation D. Deteriorated wood foundation @ elevations C and D. Deteriorated CMU foundation and grout @ elevation A.</p> <p>2. Siding and foundation is damaged by invasive roots @ elevation C.</p>	
Recommended Action	
<p>1. Demolish addition 1 and 2. Repoint and replace CMU block as appropriate. Remove first floor, excavate to a minimum of 30", underpin existing walls and place new concrete "rat" slab. (See 6-5).</p> <p>2. Grind stump and repair foundation @ the affected corner.</p>	
References:	R-25, SK-6
Estimated Cost:	\$30,127.00

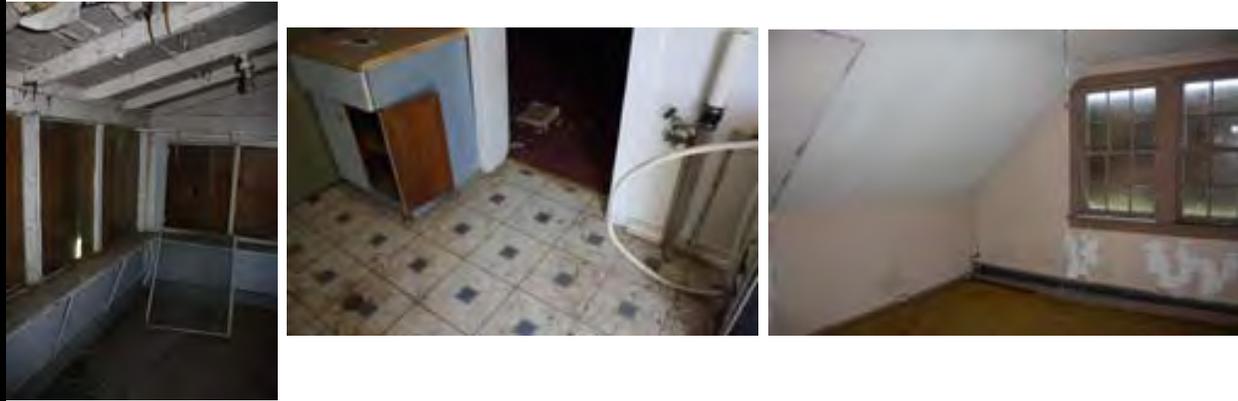
King Farm Property Condition Assessment	
Condition / Deficiency Report	
Report Number:	BLDG 6 - 5
Priority:	2
Discipline:	ARCH., STRUCT.
Address:	King Farm Park, 16100 Frederick Road, Rockville, MD 20850
Location:	TENANT - BLDG. 6
Category:	FLOORS
Necessity:	STABILIZE
Photo Documentation

Deficiency Description	
<ol style="list-style-type: none"> <li>1. Floors @ first and second level are soft and feel spongy. See 6-7.</li> <li>2. Second level is too low, causing the first floor ceiling height to be non-compliant.</li> <li>3. Floors in additions are in very poor condition from extensive moisture damage.</li> </ol>	
Recommended Action	
<p>1-2. Demolish both additions (See 6-4). Demolish second floor. Strip the interior finishes and floors to studs @ room 3. Install new floor framing in remaining space post foundation/crawl space stabilization.</p>	
References:	R-24, R-26, 6-4, SK-6
Estimated Cost:	\$36,842.00

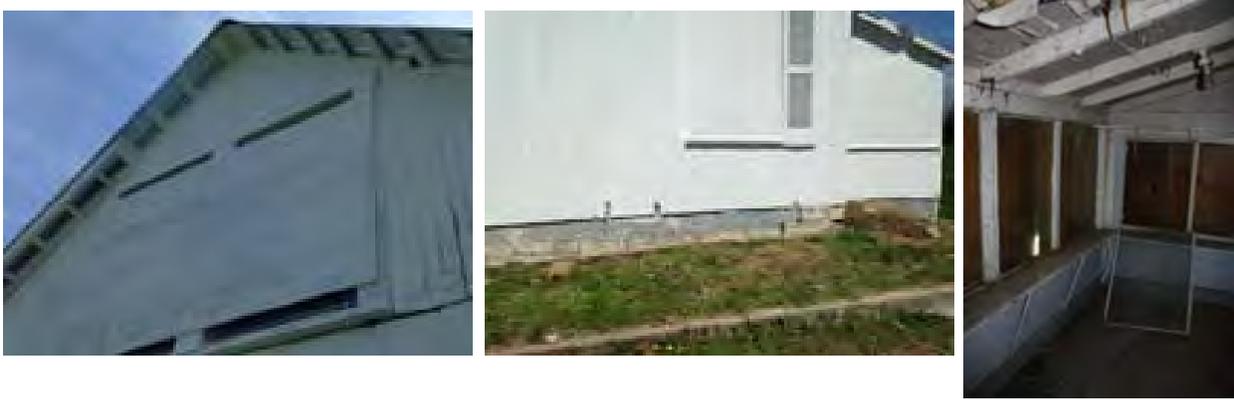
King Farm Property Condition Assessment	
Condition / Deficiency Report	
Report Number:	BLDG 6 - 6
Priority:	6
Discipline:	ARCH.
Address:	King Farm Park, 16100 Frederick Road, Rockville, MD 20850
Location:	TENANT - BLDG. 6
Category:	OPENINGS
Necessity:	STABILIZE
Photo Documentation

Deficiency Description	
<ol style="list-style-type: none"> <li>1. Current doorways into building are significantly deteriorated and located on additions only.</li> <li>2. All windows are in poor condition, particularly @ addition 2.</li> </ol>	
Recommended Action	
<ol style="list-style-type: none"> <li>1. Post demolition (see 6-7): If records are available, reconstruct original barn opening with replica sliding barn door.</li> <li>2. Replace windows below gable @ elevation A and C. Remove window and shutter @ elevation A. Fill with appropriate materials and siding.</li> </ol>	
References:	R-24, R-26, 6-7
Estimated Cost:	\$32,951.00

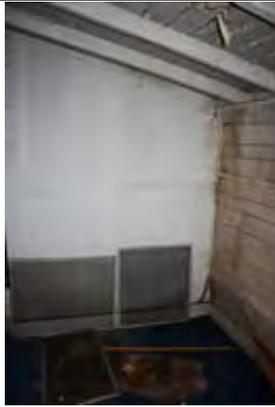
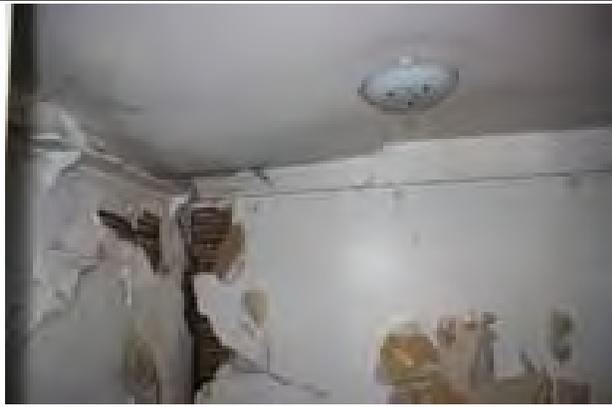
Insulation either not present or in poor condition @ all areas.

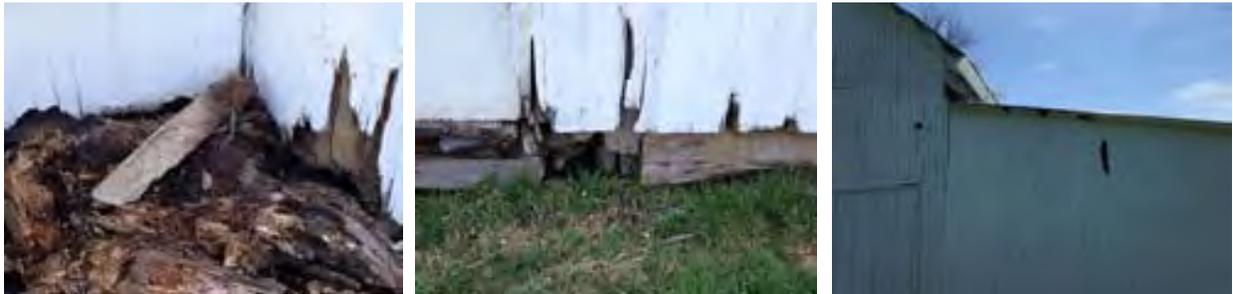
Condition / Deficiency Report		Report Number:	BLDG 6 - 9
Priority:	4	Discipline:	ARCH.
Address:	King Farm Park, 16100 Frederick Road, Rockville, MD 20850		
Location:	TENANT - BLDG. 6		
Category:	SIDING		
Necessity:	STABILIZE

1. Significantly deteriorated siding along foundation line @ all elevations. Siding in deteriorated condition @ all elevations.
2. Fascia is missing or damaged @ elevations B, C, and D.

1. Remove siding and replace with like bead board. Prep for paint.
2. Remove and replace fascia board @ elevations B, C, and D.

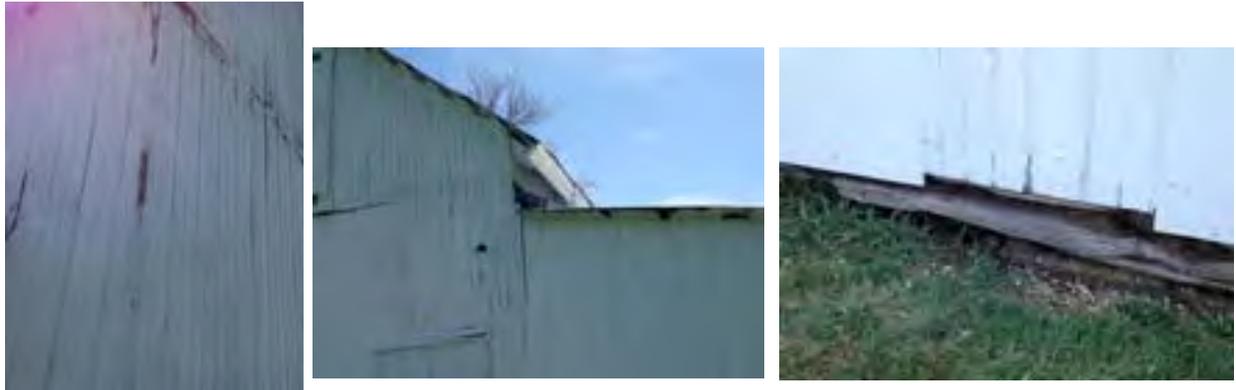
Eaves in poor condition and show flaking paint. Siding paint has deteriorated.

After demolition and re-siding (see 6-4, 6-7, 6-9), repaint all exterior surfaces, including siding, foundation, eaves, trim and fascia.

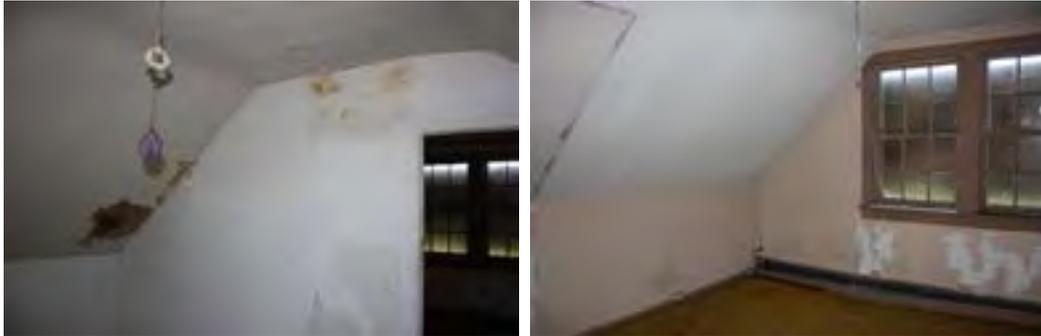
Condition / Deficiency Report		Report Number:	BLDG 6 - 11
Priority:	15	Discipline:	ARCH.
Address:	King Farm Park, 16100 Frederick Road, Rockville, MD 20850		
Location:	TENANT - BLDG. 6		
Category:	INTERIOR PAINT		
Necessity:	REHABILITATE

Interior is in generally very poor condition. Paint is peeling or fallen away all together.

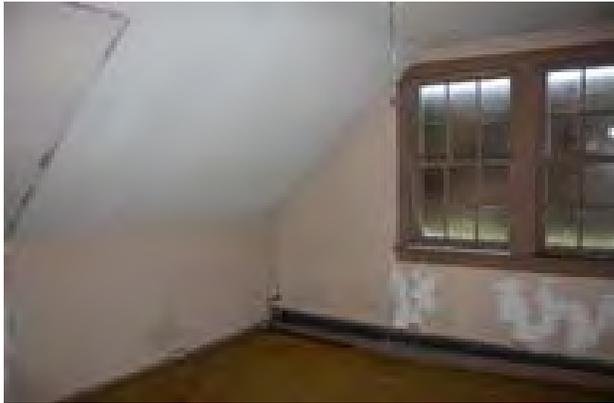
King Farm Property Condition Assessment	
Condition / Deficiency Report	
Report Number:	BLDG 6 - 12
Priority:	10
Discipline:	MEP
Address:	King Farm Park, 16100 Frederick Road, Rockville, MD 20850
Location:	TENANT - BLDG. 6
Category:	MECHANICAL EQUIPMENT
Necessity:	REHABILITATE
Photo Documentation

Deficiency Description	
<p>There is no visible mechanical system present. Electric baseboard heating on the second floor is the only interior environment conditioning equipment.</p>	
Recommended Action	
<p>Provide a ducted gas-fired heating split system cooling unit for the structure. Provide rectangular ductwork concealed within bulkheads utilizing sidewall supply diffusers and central return. Assume 4 ton cooling system required. Distribution shall be for the entire structure. Unit shall have outdoor air connection to it with economizer and a 7-day programmable thermostat. Mount unit in an appropriately sized utility closet.</p>

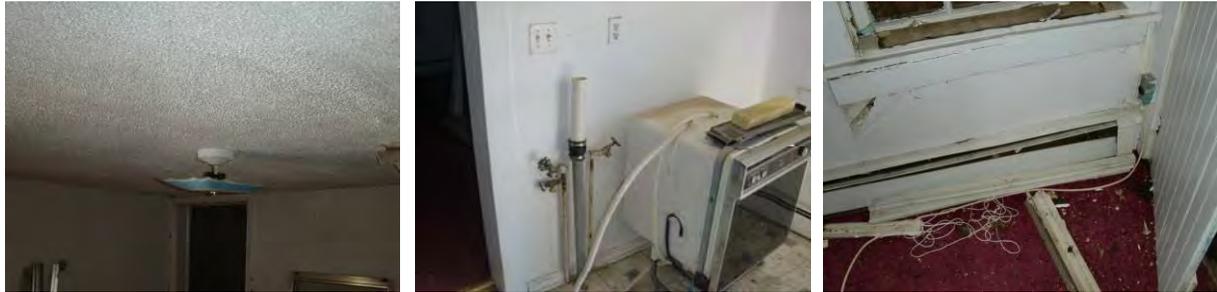
Existing electrical distribution, wiring devices, lighting and electric baseboard heating are in poor, inoperative condition. All are non-code compliant.

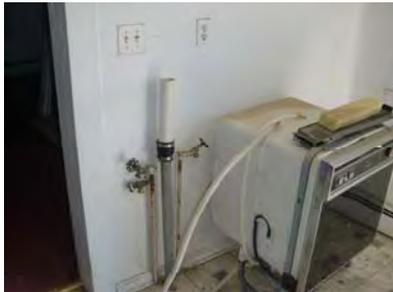
Existing plumbing centered around room 1. Entire plumbing systems, including hot water, cold water and sanitary are nonfunctional and noncode compliant.

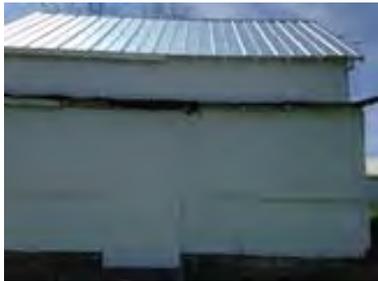
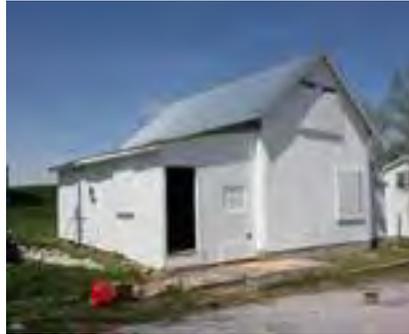
Condition / Deficiency Report		Report Number:	BLDG 6 - 16
Priority:	16	Discipline:	ARCH.
Address:	King Farm Park, 16100 Frederick Road, Rockville, MD 20850		
Location:	TENANT - BLDG. 6		
Category:	ROOF		
Necessity:	REHABILITATE

Roof @ addition 2 clad with varying materials. Flashing is missing; Damaged metal roof @ addition 1; No gutter system present. See 6-15 (gutter system).

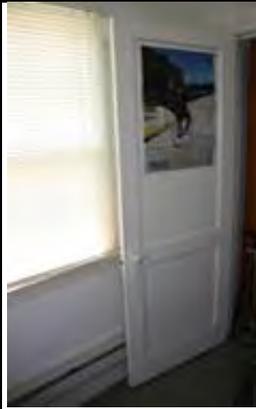
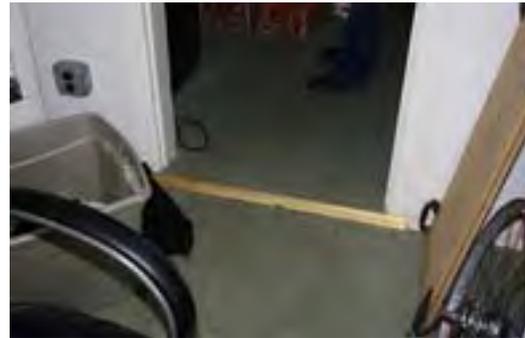
Condition / Deficiency Report	Report Number: <b>BLDG 7 - 1</b>
Priority: <b>13</b>	Discipline: <b>ARCH.</b>

Door widths are too narrow.

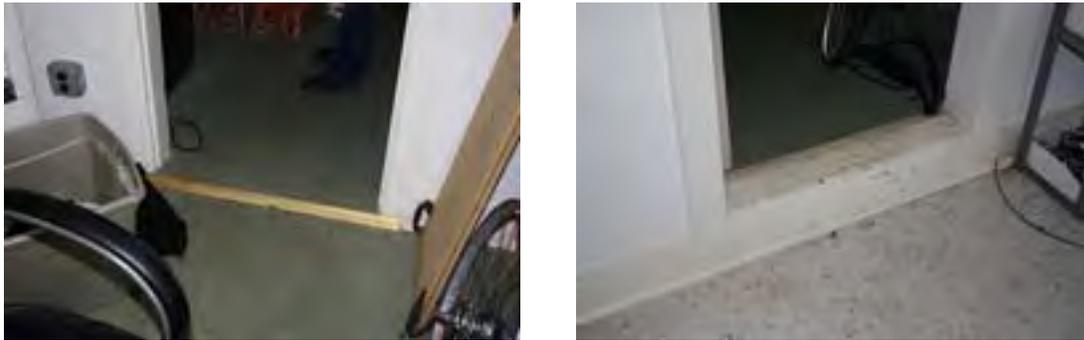
Condition / Deficiency Report		Report Number:	BLDG 7 - 2
Priority:	14	Discipline:	ARCH.
Address:	King Farm Park, 16100 Frederick Road, Rockville, MD 20850		
Location:	TENANT - BLDG. 7		
Category:	ACCESSIBILITY		
Necessity:	REHABILITATE

1. There is no accessible entrance into the building.
2. There are elevation changes @ the transitions between rooms 1 & 3, 1 & 4, and 4 & 5.
3. Door widths are too narrow. Front door clearance is too short.

Post foundation stabilization work (7-4):

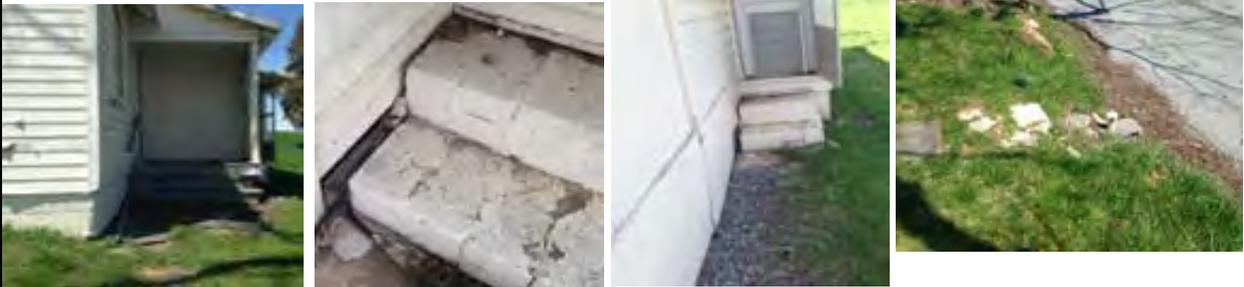
King Farm Property Condition Assessment	
Condition / Deficiency Report	
Report Number:	BLDG 7 - 3
Priority:	15
Discipline:	ARCH.
Address:	King Farm Park, 16100 Frederick Road, Rockville, MD 20850
Location:	TENANT - BLDG. 7
Category:	APPROACH
Necessity:	REHABILITATE
Photo Documentation

Deficiency Description	
<ol style="list-style-type: none"> <li>1. The path to the main entrance is significantly deteriorated.</li> <li>2. The concrete steps @ the secondary entrance are in poor condition.</li> </ol>	
Recommended Action	
<ol style="list-style-type: none"> <li>1. Replace existing remnants of path with like white stone look, approx. 20'-0". Pour slab @ the base of both entrances, 5'0" w x length of steps.</li> <li>2. Replace concrete steps.</li> </ol>	
References:	R-28
Estimated Cost:	\$5,989.00

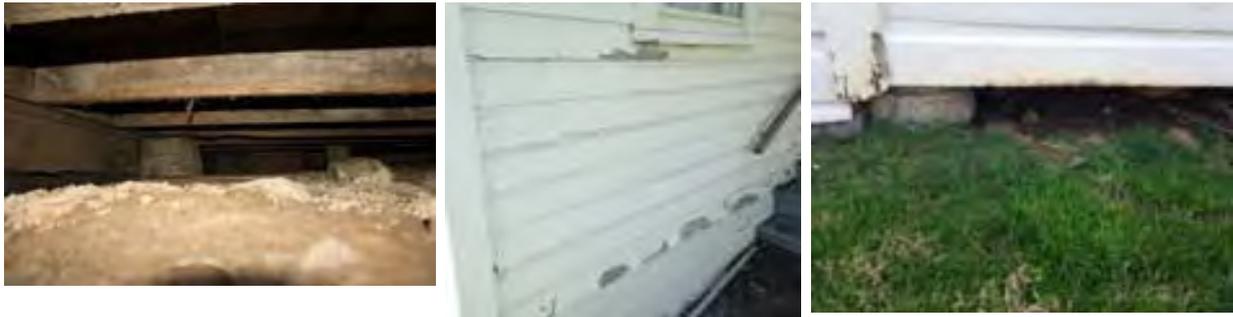
Condition / Deficiency Report		Report Number:	BLDG 7 - 4
Priority:	1	Discipline:	ARCH., STRUCT.
Address:	King Farm Park, 16100 Frederick Road, Rockville, MD 20850		
Location:	TENANT - BLDG. 7		
Category:	FOUNDATION		
Necessity:	STABILIZE

There are 2 different foundation systems. The front end is CMU, the rear is piers. The piers are susceptible to weather damage.

Remove 1st floor, excavate to a minimum of 30", underpin existing walls, place "rat" slab, install new floor. New foundation at SW corner.

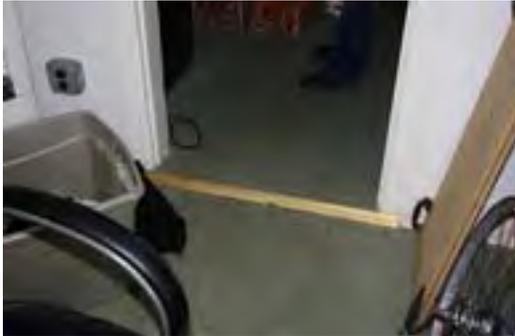
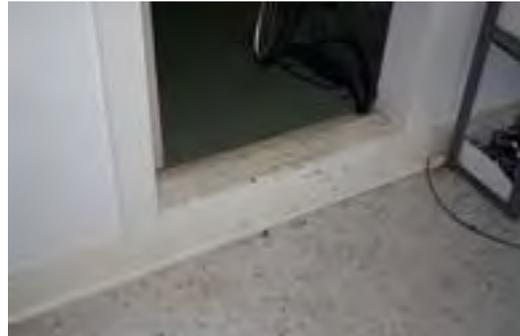
Condition / Deficiency Report		Report Number:	BLDG 7 - 5
Priority:	17	Discipline:	ARCH., STRUCT.
Address:	King Farm Park, 16100 Frederick Road, Rockville, MD 20850		
Location:	TENANT - BLDG. 7		
Category:	FLOORS		
Necessity:	REHABILITATE

Floors are old and dirty. Some areas show signs of wear.

Post foundation stabilization work (7-4): Install new flooring.

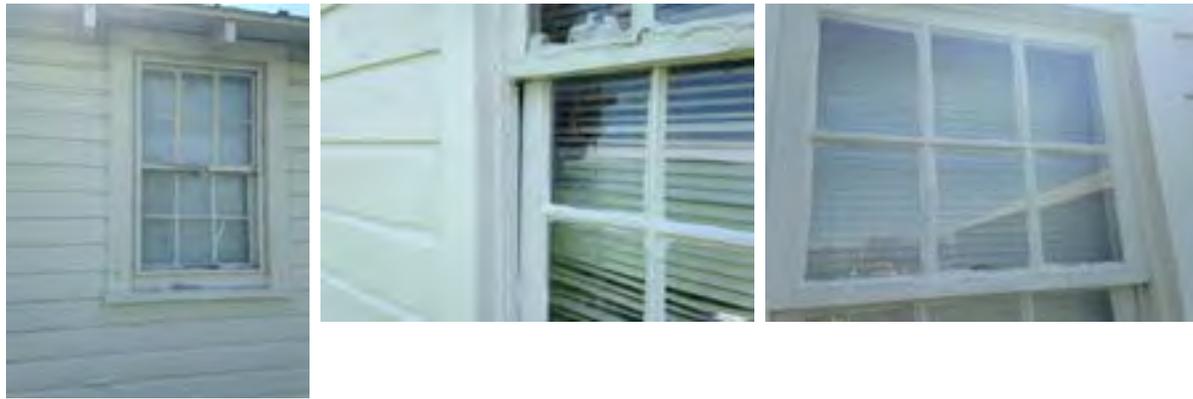
Condition / Deficiency Report		Report Number:	BLDG 7 - 6
Priority:	2	Discipline:	ARCH.
Address:	King Farm Park, 16100 Frederick Road, Rockville, MD 20850		
Location:	TENANT - BLDG. 7		
Category:	OPENINGS		
Necessity:	STABILIZE

1. Gapping window @ elevation D. Deteriorated double hung frames. Windows generally in poor condition and susceptible to moisture infiltration.
2. Door hardware is noncompliant.

1. Replace all 8 windows approx. 3'-0" x 4'-6" with like 6/6 double hung and reflash.
2. See 7-2 and 7-6A for door treatments.

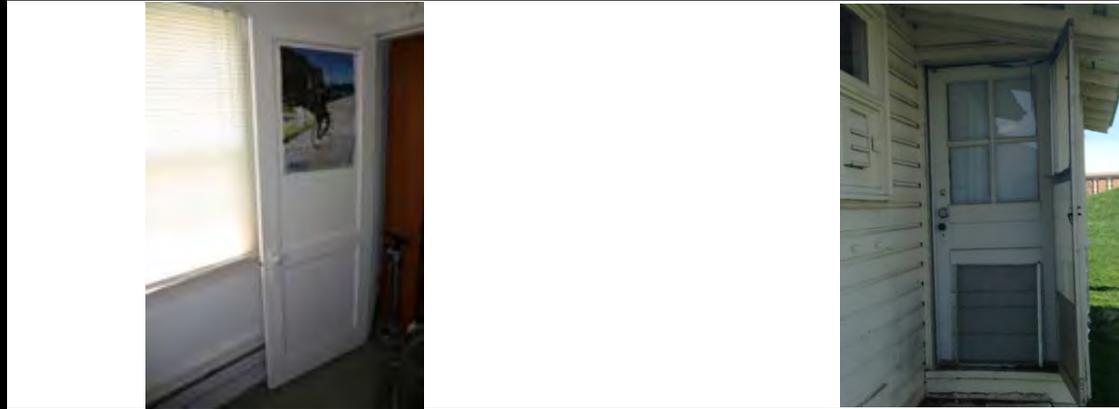
Door hardware is noncompliant.

Replace door hardware with levers.

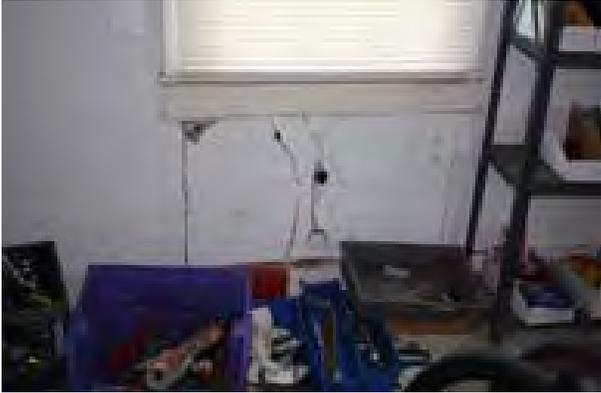
<b>Deficiency Description</b>			
Evidence of water damage @ room 4 interior window sill.			
<b>Recommended Action</b>			
Repair affected studs @ water infiltration, approx. 15 LF. Replace all windows. See 7-6.			
<b>References:</b>	R-28, 7-6	<b>Estimated Cost:</b>	<b>\$2,000.00</b>

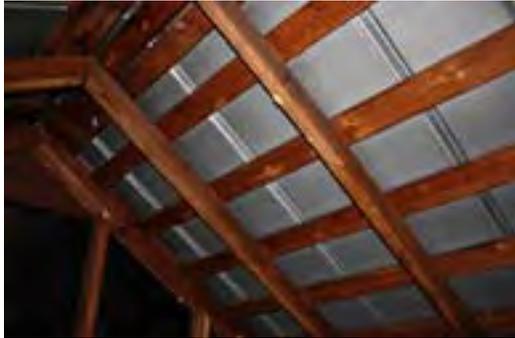
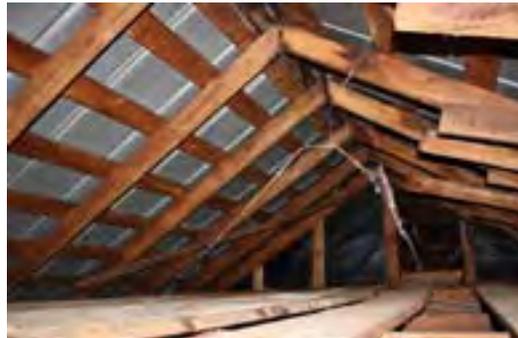
Condition / Deficiency Report		Report Number:	BLDG 7 - 8
Priority:	8	Discipline:	ARCH.
Address:	King Farm Park, 16100 Frederick Road, Rockville, MD 20850		
Location:	TENANT - BLDG. 7		
Category:	INSULATION		
Necessity:	REHABILITATE

The attic is not insulated.

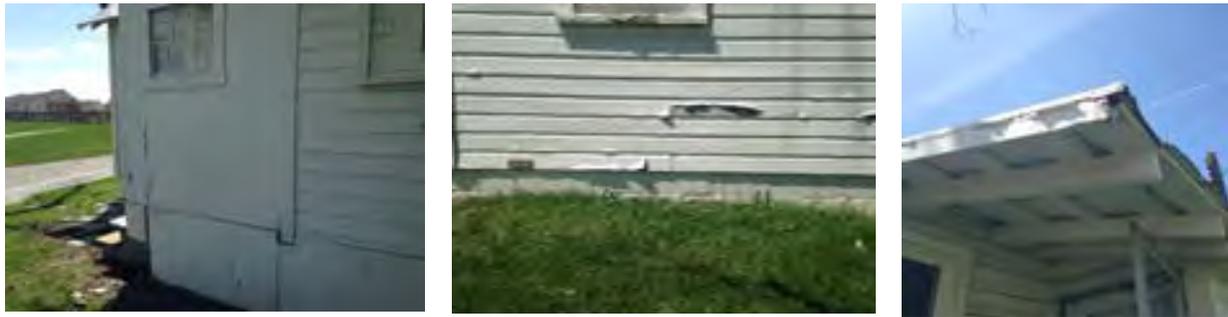
1. Peeling siding with spots of rot along foundation line @ all elevations
2. Cracked and rotting wood panel @ front porch.
3. Corner covers rotted.
4. Fascia board rotted, missing, or in poor condition.

- 1-3. Gently scrape exterior surfaces to remove peeling and loose paint. Repair and replace as necessary. Prep surfaces for paint.
4. Install new fascia board.

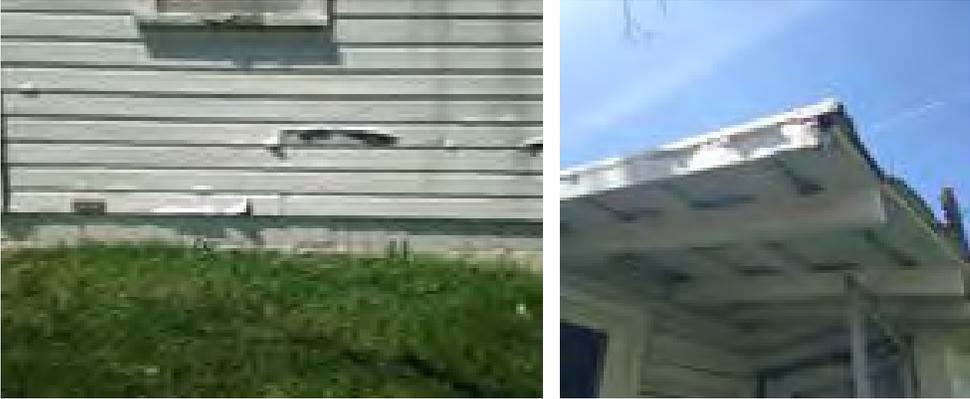
King Farm Property Condition Assessment	
Condition / Deficiency Report	
Report Number:	BLDG 7 - 10
Priority:	5
Discipline:	ARCH.
Address:	King Farm Park, 16100 Frederick Road, Rockville, MD 20850
Location:	TENANT - BLDG. 7
Category:	EXTERIOR PAINT
Necessity:	STABILIZE
Photo Documentation

Deficiency Description	
Paint in poor condition on exterior surfaces.	
Recommended Action	
Repaint all exterior surfaces after proper preparation, including siding, trim, and new fascia board.	
References:	R-29
Estimated Cost:	\$5,856.00
