CITY OF ROCKVILLE

# KING FARM FARMSTEAD PROPERTY CONDITION ASSESSMENT

DEPARTMENT OF RECREATION AND PARKS

JULY 3, 2014

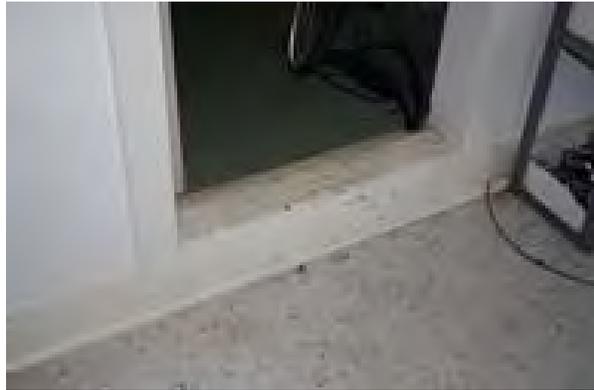
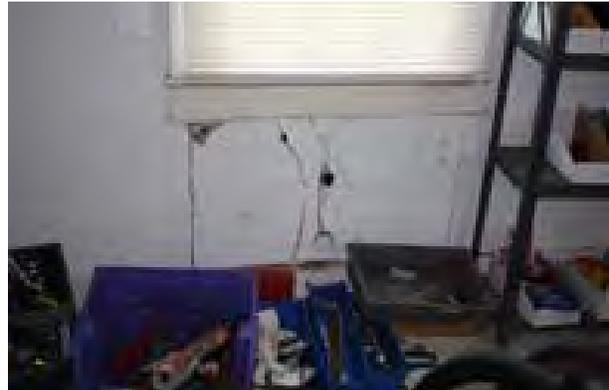
Condition / Deficiency Report		Report Number:	BLDG 7 - 11
Priority:	18	Discipline:	ARCH.
Address:	King Farm Park, 16100 Frederick Road, Rockville, MD 20850		
Location:	TENANT - BLDG. 7		
Category:	INTERIOR PAINT		
Necessity:	REHABILITATE

Interior walls and trim showing minor wear and damage.

Patch and repair as necessary. Prep and paint all walls, trim and baseboard.

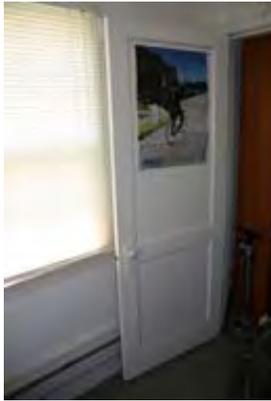
Condition / Deficiency Report		Report Number:	BLDG 7 - 12
Priority:	10	Discipline:	MEP
Address:	King Farm Park, 16100 Frederick Road, Rockville, MD 20850		
Location:	TENANT - BLDG. 7		
Category:	MECHANICAL EQUIPMENT		
Necessity:	REHABILITATE

There is no modern HVAC system present beyond baseboard heating.

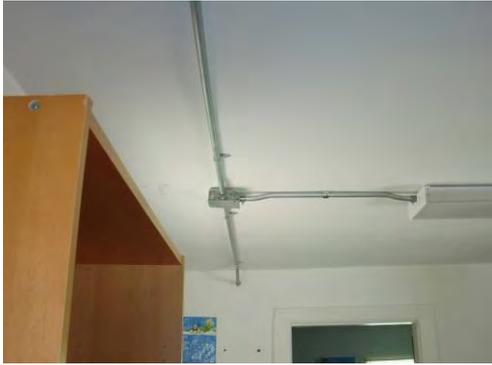
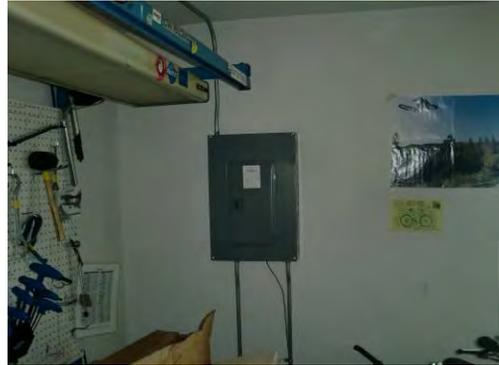
Building was recently rewired, but there are no emergency or exit related signs.

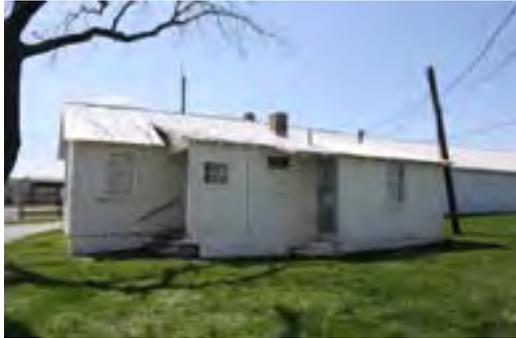
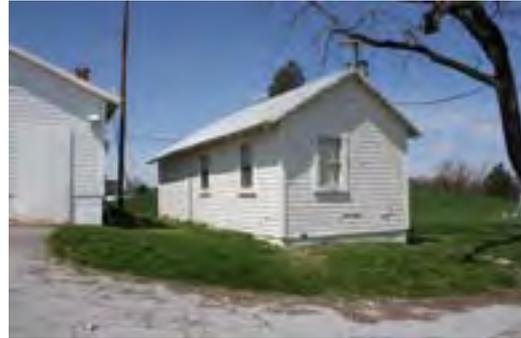
Condition / Deficiency Report		Report Number:	BLDG 7 - 15
Priority:	9	Discipline:	ARCH.
Address:	King Farm Park, 16100 Frederick Road, Rockville, MD 20850		
Location:	TENANT - BLDG. 7		
Category:	GUTTER SYSTEM		
Necessity:	REHABILITATE

There is no gutter system present to control rain water drainage.

Once fascia is repaired, see 7-9, install appropriate gutter system with downspouts and guards (subject to approval from HDC).

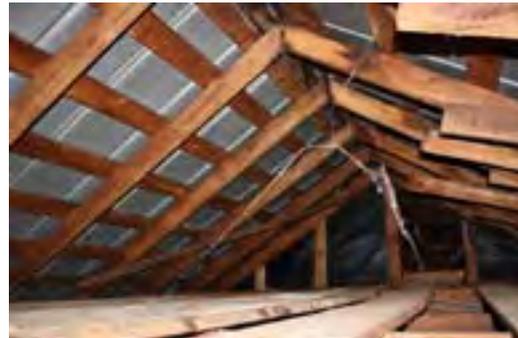
Condition / Deficiency Report		Report Number:	BLDG 7 - 16A
Priority:	7	Discipline:	ARCH., STRUCT.
Address:	King Farm Park, 16100 Frederick Road, Rockville, MD 20850		
Location:	TENANT - BLDG. 7		
Category:	ROOF		
Necessity:	REHABILITATE

Roof framing is undersized.

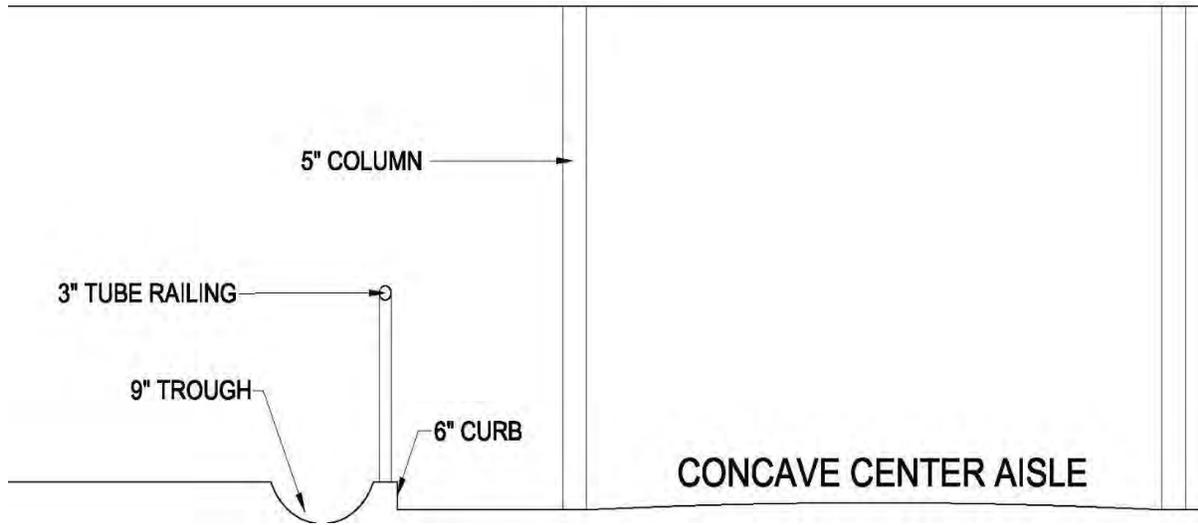
Condition / Deficiency Report		Reference Number:	R-21
Subject:	Concrete Floors	Discipline:	ARCH.

Report	Item	Necessity	References
BLDG 3/4-1	Egress	Rehabilitate	R-15, R-16, R-18, 3/4-6, 3/4-5
BLDG 3/4-2	Accessibility	Rehabilitate	R-15, R-16, R-21, 3/4-5
BLDG 3/4-4	Foundation	Stabilize	R-18
BLDG 3/4-5	Floors	Stabilize	R-15, R-16, R-21, SK-3, SK-4
BLDG 3/4-5A	Floors	Rehabilitate	R-15, R-16, R-21, SK-3, SK-4
BLDG 3/4-6	Openings	Stabilize	R-15, R-16, R-17, 3/4-16
BLDG 3/4-8	Insulation	Rehabilitate	R-15, R-16, R-17
BLDG 3/4-9	Siding	Stabilize	R-18, 3/4-6
BLDG 3/4-10	Exterior Paint	Stabilize	R-18
BLDG 3/4-11	Interior Paint	Rehabilitate	R-15, R-16, 3/4-9, 3/4-8, 3/4-6
BLDG 3/4-12	Mechanical Equipment	Rehabilitate	R-15, R-16, R-17
BLDG 3/4-13	Electrical System	Rehabilitate	R-15, R-16, R-17
BLDG 3/4-14	Plumbing Systems	Rehabilitate	R-15, R-16, R-17
BLDG 3/4-15	Gutter System	Rehabilitate	R-19, R-20, 3/4-16
BLDG 3/4-16	Roof	Stabilize	R-19, R-20, SK-3, SK-4
BLDG 3/4-16A	Roof	Rehabilitate	R-19, R-20, 3/4-8, SK-3, SK-4

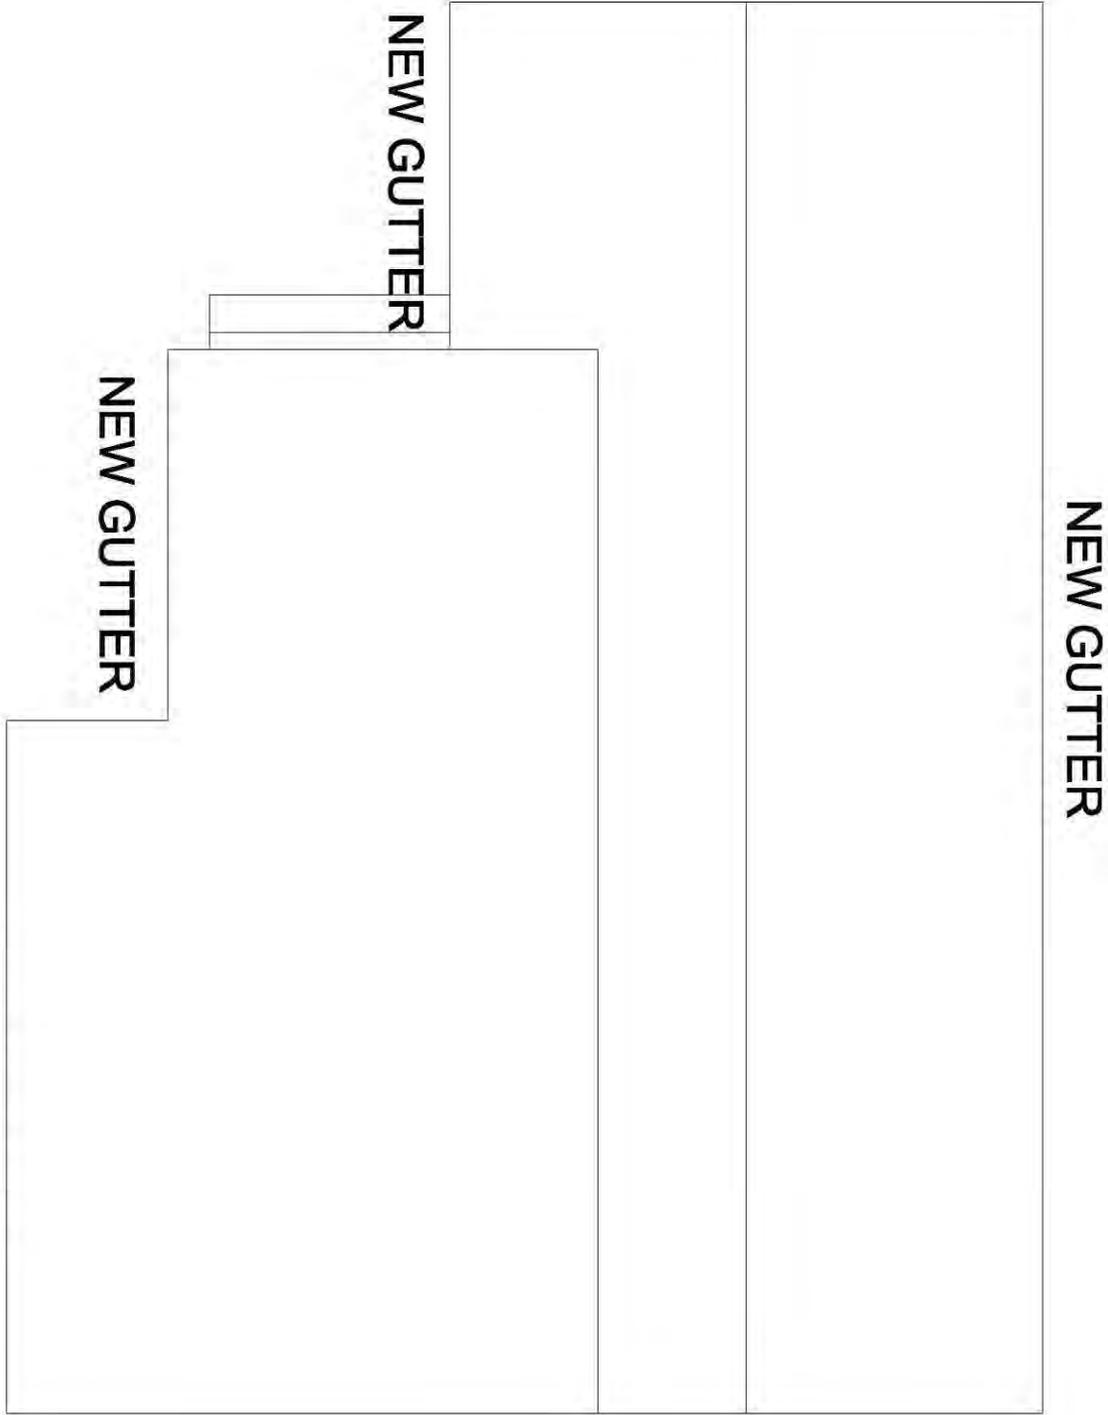
Condition / Deficiency Report		Reference Number:	R-31
Subject:	Gutter Locations	Discipline:	ARCH.

<b>Report</b>	<b>Item</b>	<b>Necessity</b>	<b>References</b>
BLDG 7-1	Egress	Rehabilitate	R-28
BLDG 7-2	Accessibility	Rehabilitate	R-28, 7-4
BLDG 7-3	Approach	Rehabilitate	R-28
BLDG 7-4	Foundation	Stabilize	R-28, R-30, SK-7
BLDG 7-5	Floors	Rehabilitate	R-28
BLDG 7-6	Openings	Stabilize	R-28, R-29, 7-2, 7-6
BLDG 7-6A	Openings	Rehabilitate	R-28, 7-2, 7-6
BLDG 7-7	Moisture Infiltration	Stabilize	R-28, 7-6
BLDG 7-8	Insulation	Rehabilitate	R-28
BLDG 7-9	Siding	Stabilize	R-28, R-29
BLDG 7-10	Exterior Paint	Stabilize	R-29
BLDG 7-11	Interior Paint	Rehabilitate	R-28
BLDG 7-12	Mechanical Equipment	Rehabilitate	R-28
BLDG 7-13	Electrical System	Rehabilitate	R-28
BLDG 7-14	Plumbing Systems	Rehabilitate	R-28
BLDG 7-15	Gutter System	Rehabilitate	R-31, 7-9
BLDG 7-16	Roof	Stabilize	R-31
BLDG 7-16A	Roof	Rehabilitate	R-28

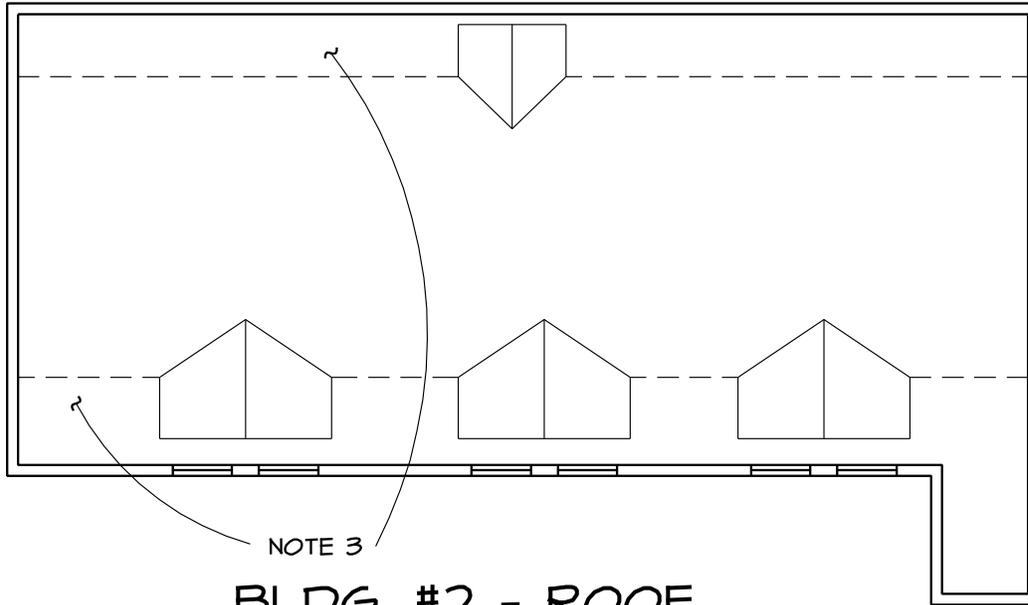
**BLDG. #2 - ROOF**

1. REINF. FLOOR w/ 2x6 BETWEEN EXIST. (FINAL = 2x6 @ 8"o/c). REINF. BM. w/ 2-LVL'S
2. GROUND FLOOR - REPAIR CRACKS IN CONC. FLOOR.
3. WATER DAMAGE TO ROOF FRAMING. REPLACE OR SCAB NEW WOOD FRAMING.
4. REPAIR STUDS/SILL PLATE.

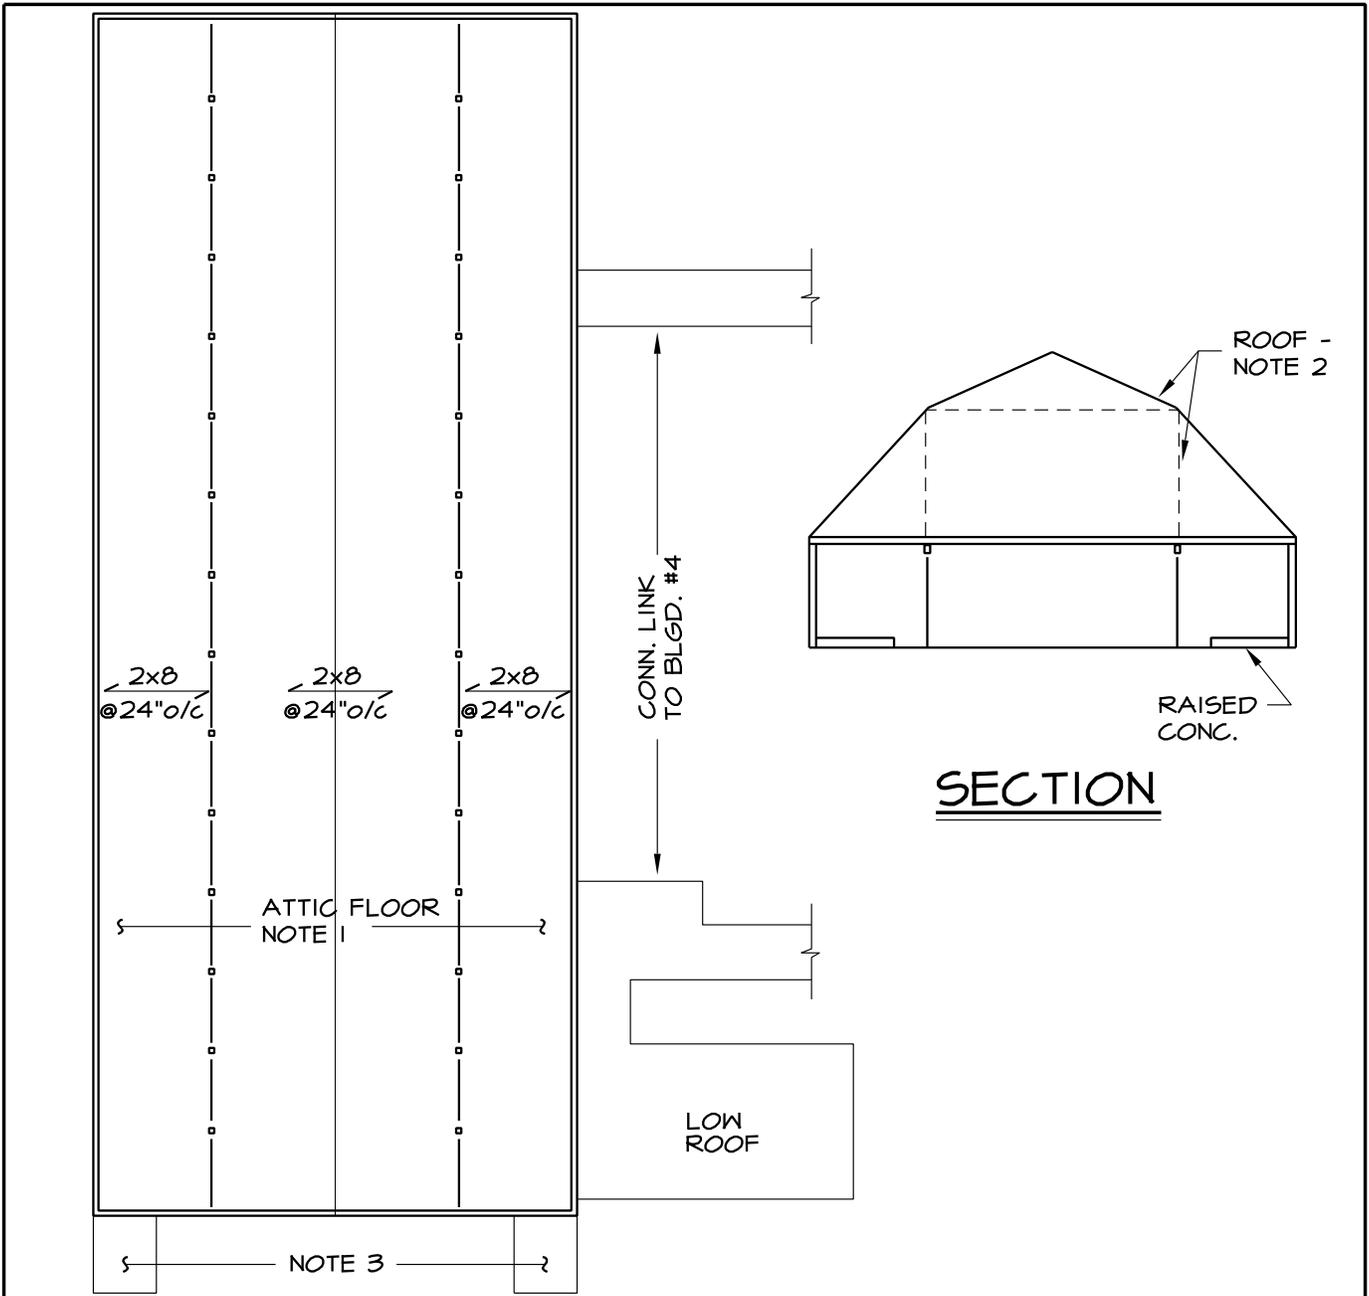
**BLDG. #3 - ROOF PLAN**

- NOTES:
1. REPLACE EXIST. DECK (MINOR).  
ATTIC FLOOR CAPACITY = 20 PSF  
REINF. IF INTEND TO USE.
  2. EXIST. ROOF FRAMING RECOMMENDED  
ADD NEW FRAMING - SEE SECTION.
  3. OLD SILO CONNECTOR - REMOVE EXIST.  
AND REPLACE OR DEMO ALL.

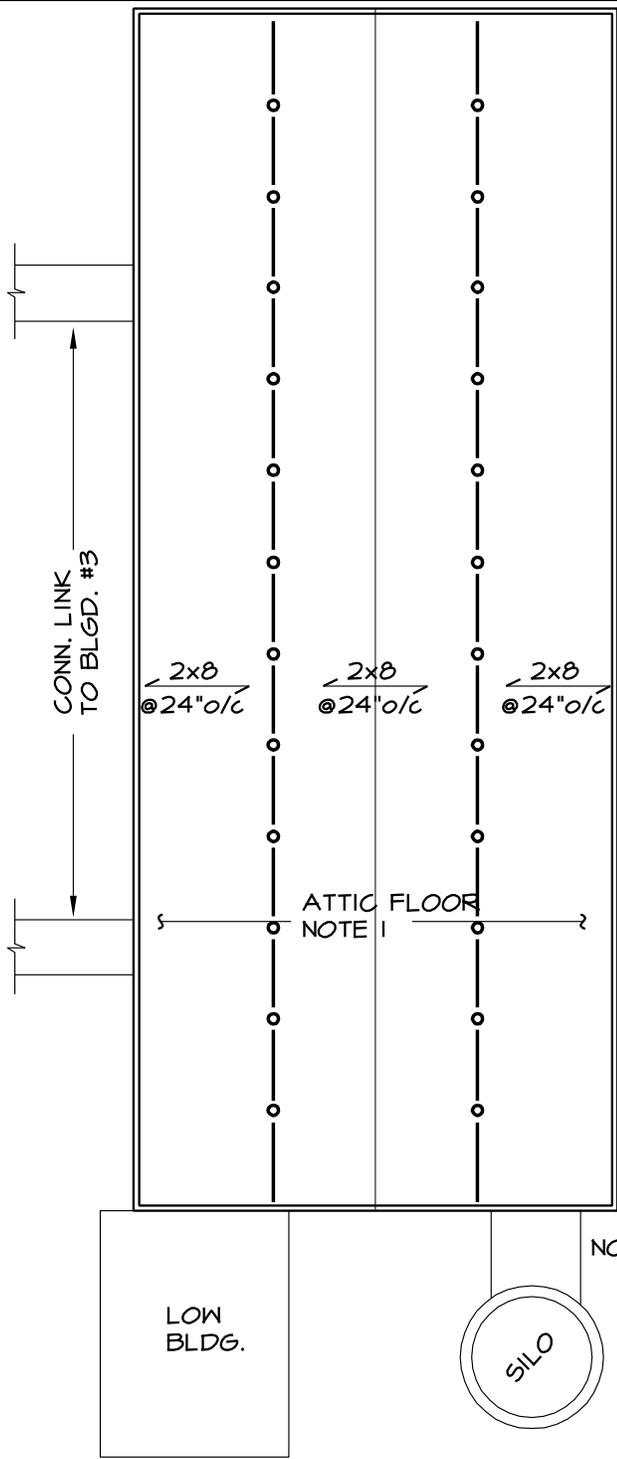
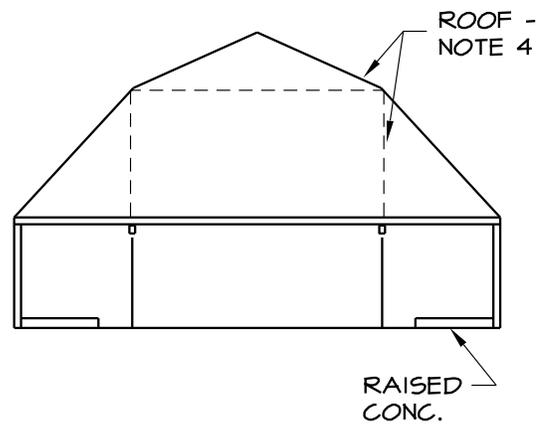
### SECTION

1. ATTIC FLOOR - REPLACE EXIST. DECK (EXTENSIVE). REPLACE DAMAGED JOIST (MINOR). ATTIC FLOOR CAPACITY = 20 PSF REINF. IF INTEND TO USE. REPLACE DAMAGED BEAMS.
2. REPLACE STEEL POSTS (5"Φ). INCLUDE:  
BASE P - EPOXY BOLT TO CONC.  
CAP P - LAG BOLT TO BEAMS
3. SILO - REPAIR CONC. MASONRY AT LOWER 10' OF SILO . ADD NEW ROOF. REPLACE CONN. LINK.
4. EXIST. ROOF FRAMING, RECOMMENED ADDING NEW FRAMING - SEE SECTION.

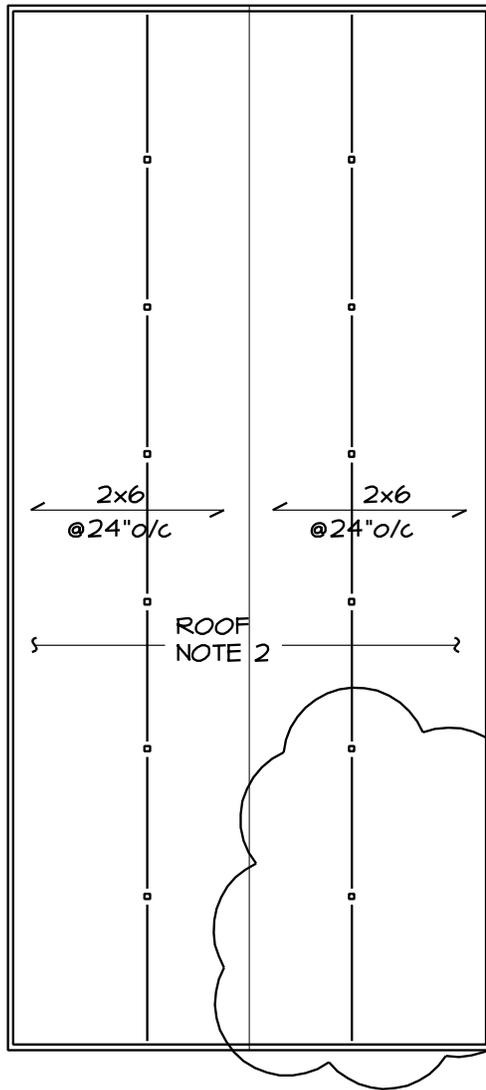
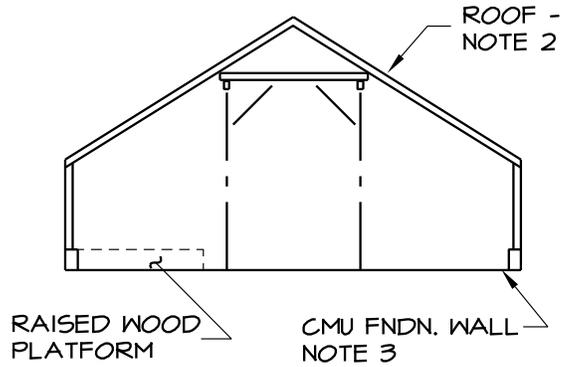
**BLDG. #5 - ROOF PLAN**

1. REPLACE FIRE DAMAGED FRAMING
2. EXIST. ROOF FRAMING NOT MEET CURRENT CODES REQUIREMENTS. IF INTEND TO USE MAJOR REINF./ SUPPLEMENTAL FRAMING NEEDED. RECOMMEND DEMOLISH AND REPLACEMENT.
3. REPAIR CMU FNDN. REPLACE BROKEN CMU, POINT ALL JOINTS.
4. EXIST. FLOOR (NOT SHOWN) UNEVEN SLOPES AND IS DIRT FLOOR WEST TWO BAYS.

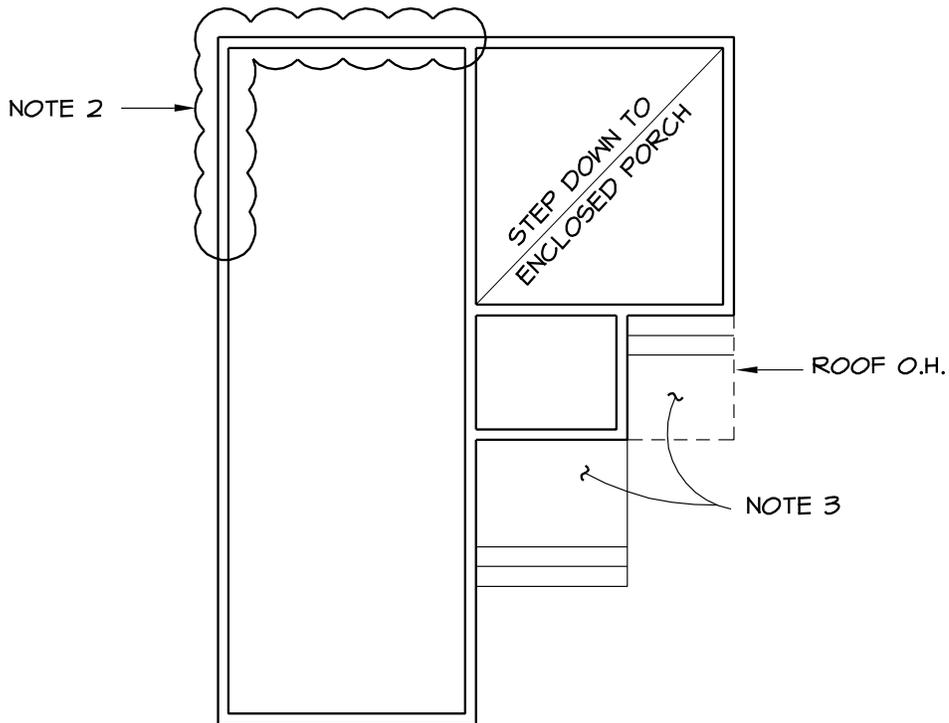
## BLDG. #7 - FLOOR PLAN

1. FINISHES COVER FRAMING.  
SOME WATER DAMAGE VISIBLE.
2. NO FNDN. WALL. EXCAVATE,  
PLACE NEW FTG. AND CMU FNDN. WALL
3. REPAIR STEPS.
4. MAJOR REPAIRS EXPECTED.
5. REMOVE EXIST. FLOOR. EXCAVATE CRAWL SPACE.  
UNDERPIN, REPLACE FLOOR.

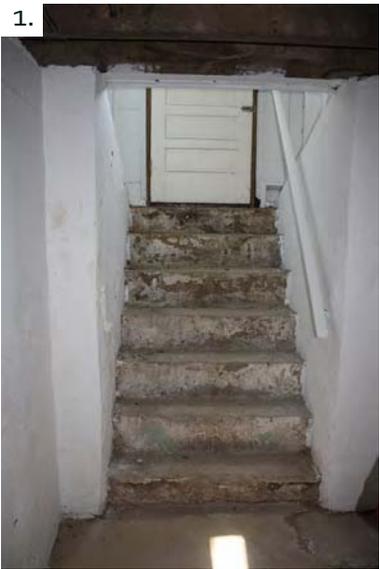
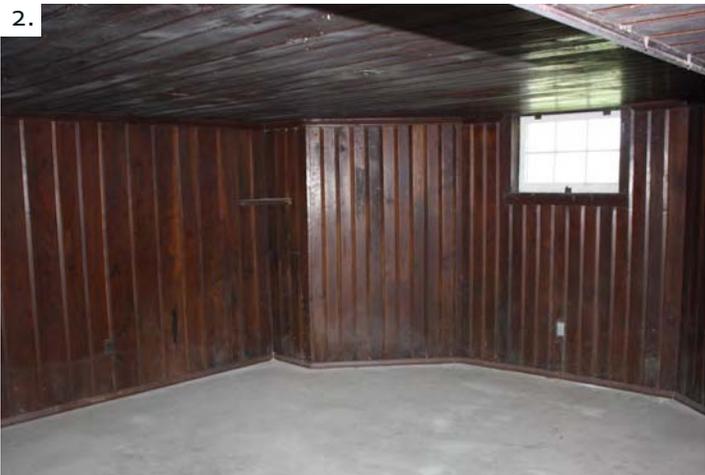
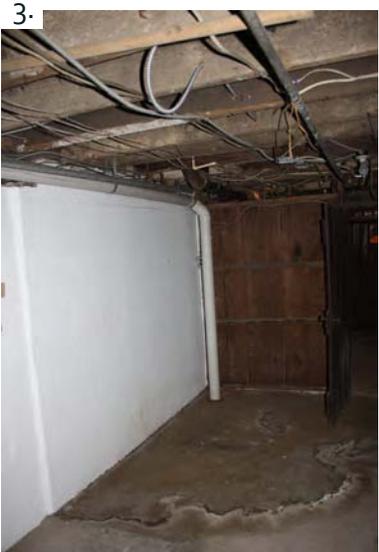
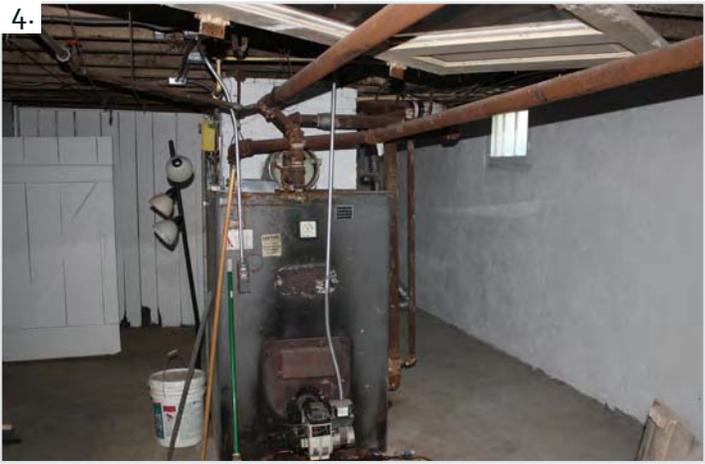
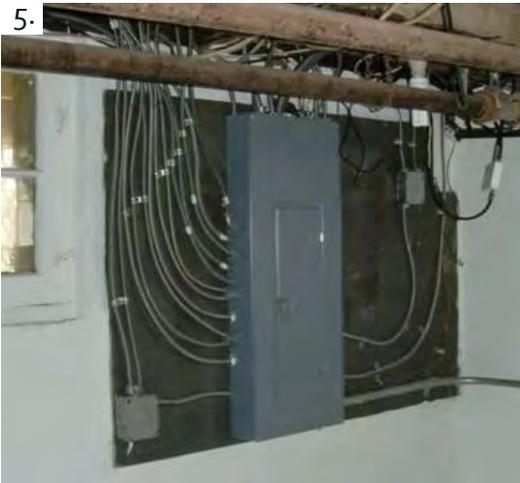
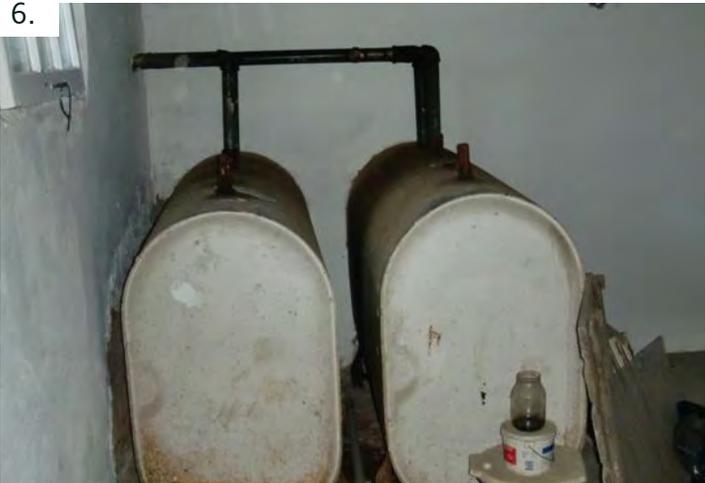
# House, Bldg. 1 BASEMENT

- 1. **Concrete Steps** There is no appropriate exit.
- 2. **Wood Paneled Room** Basement ceiling is too low.
- 3. **Concrete Floor** Old moisture damage.
- 4. **Boiler** Nonfunctioning.
- 5. **Electrical Panel** Replace wiring.
- 6. **Oil Tanks** Nonfunctioning.

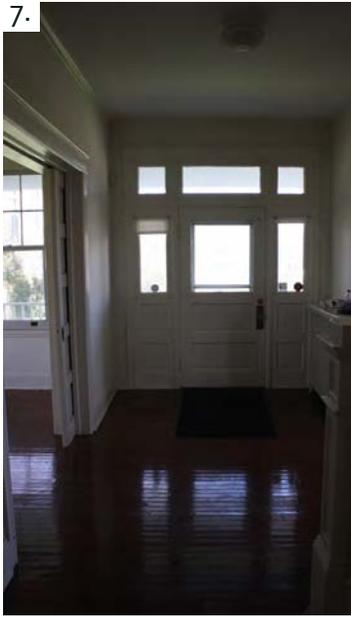
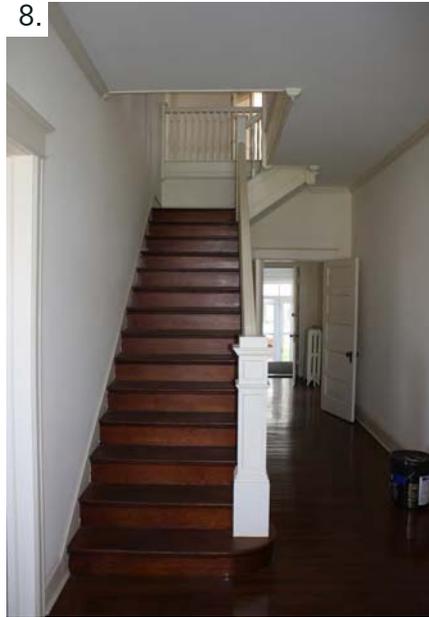
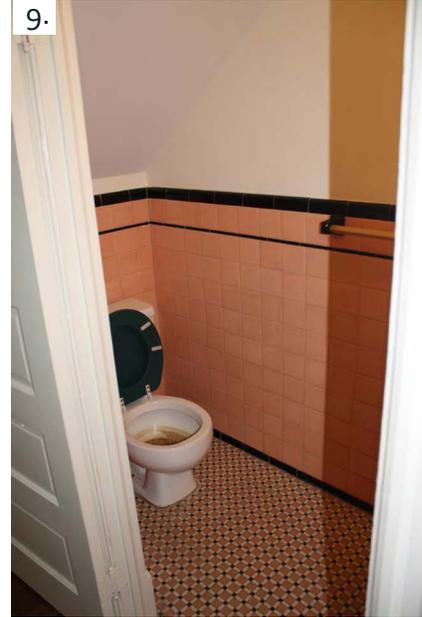
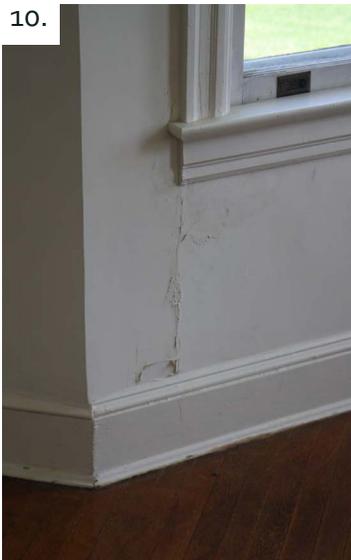
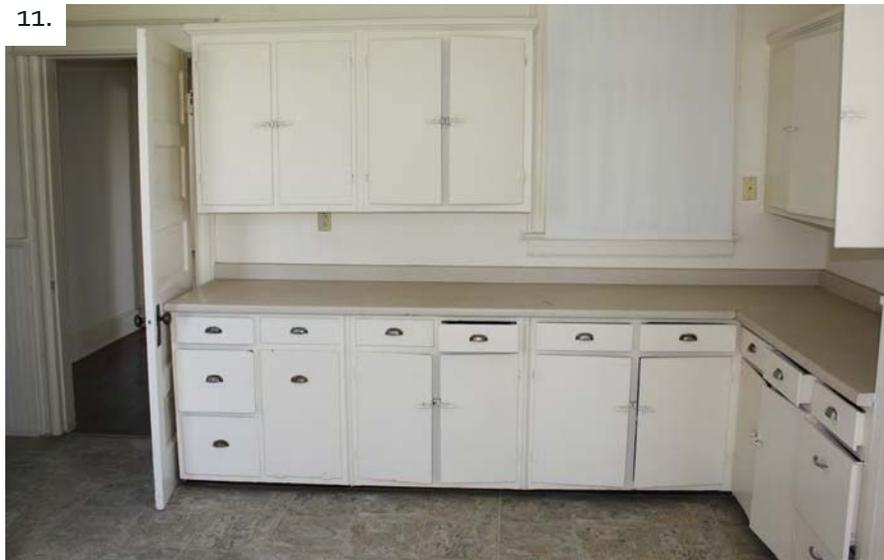
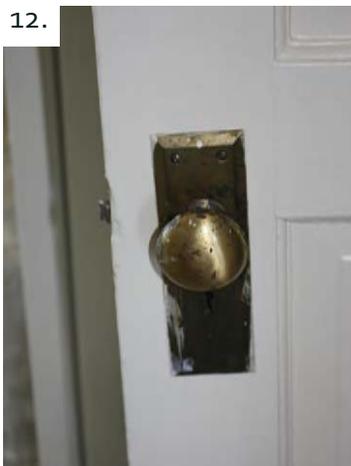
7. **Pocket Doors** Sliders don't work.

8. **Railings** at the foyer stair are too low.

10. **Bay Window** Staining and cracking from moisture.

12. **Door Knobs** Door knobs throughout the first floor. All are noncompliant.

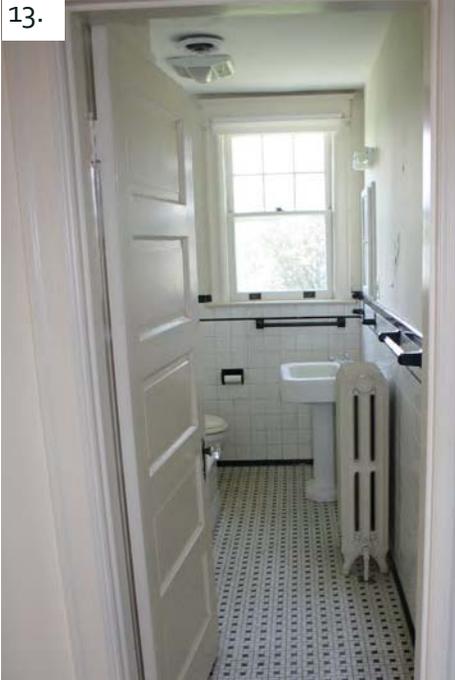
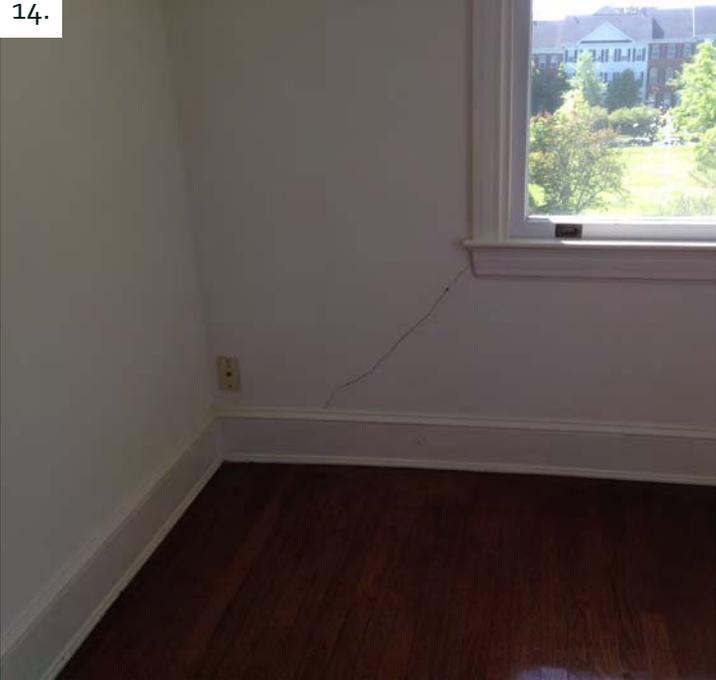
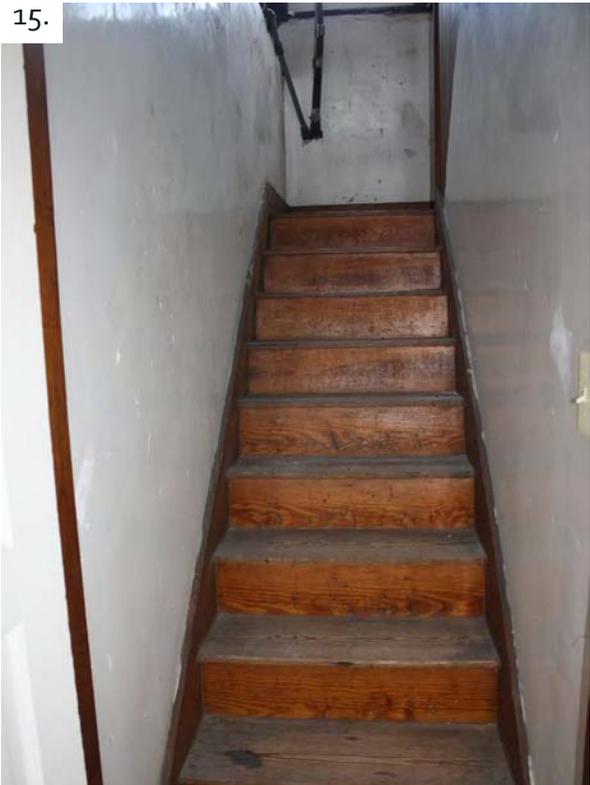
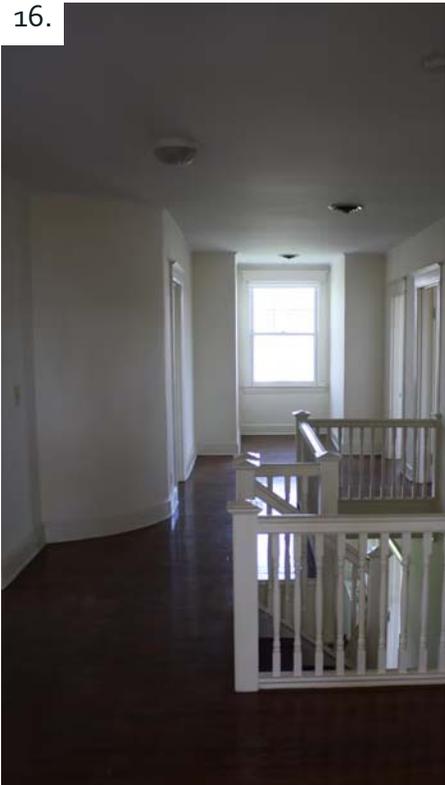
- 13. **2nd Floor Bathroom** Restroom off the second floor central hall. Door is too narrow. Bathroom is not accessible.
- 14. **Rear Bedroom** Minor cracks in the plaster.
- 15. **Attic Stair** Stairs are too narrow and have no railings.
- 16. **2nd Floor Hall** Railings are too low.

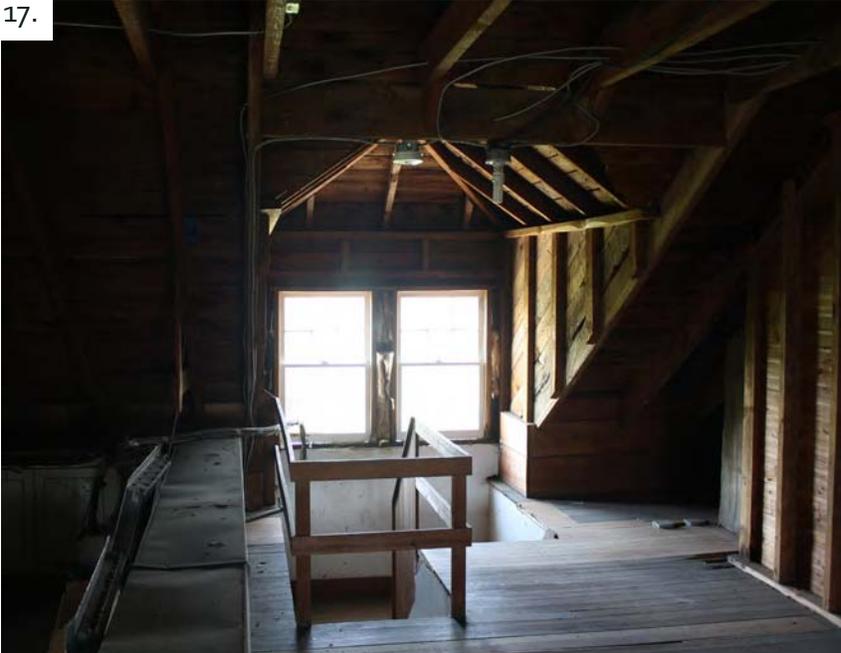
- 17. **Attic Stair Railing** The railing is noncompliant.
- 18. **Edge of Stairwell** Moisture damage on flooring.
- 19. **Attic Sheathing** Moisture staining.
- 20. **Dormer Windows** No insulation.
- 21. **Ductwork** Non-functioning A/C serving the second floor only.

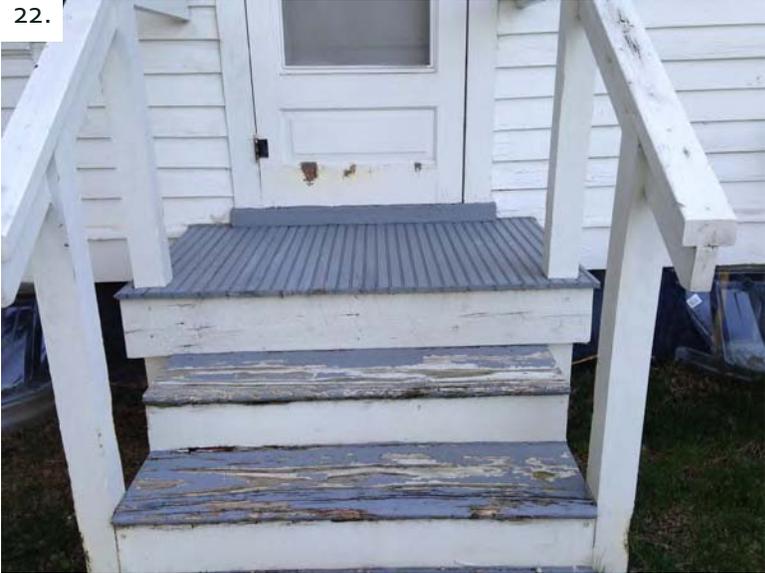
- 22. **Side Entrance** Steps and screen are significantly deteriorated. Railings also needs repair
- 23. **Rear Door** Surround and screen door deteriorated.
- 24. **Shutters** Adjacent to stoop on elevation D. Shutters deteriorated.
- 25. **Slate Path** Slate crumbling, grout deteriorated, exposed, rusted nails.
- 26. **Window** Paint bubbling from leak.
- 27. **Porch Trim** Corner guard and trim.
- 28. **Conduit** Deteriorated.
- 29. **Siding** Soft siding and signs of rot.
- 30. **Flashing** Flashing is delaminated and deteriorating.

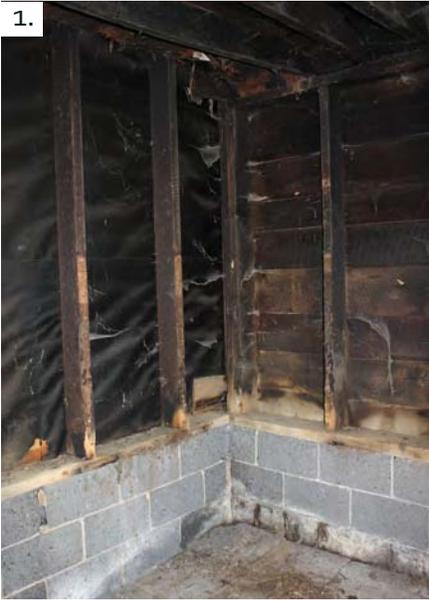
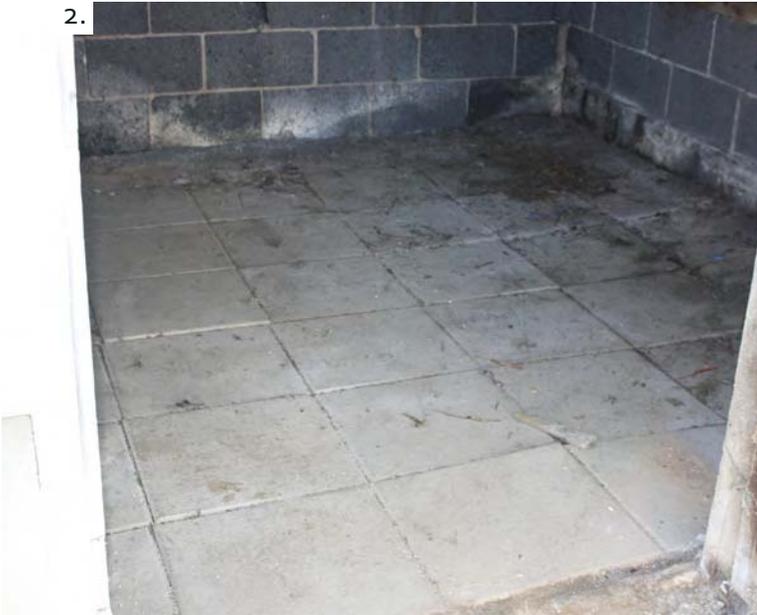
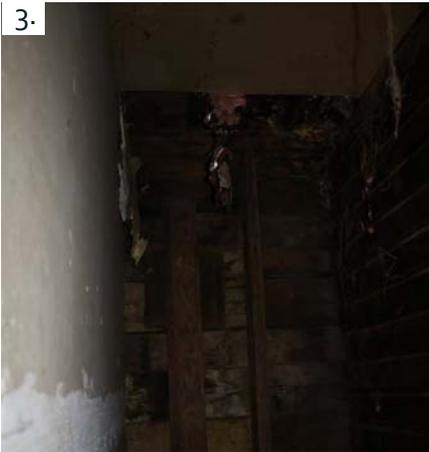
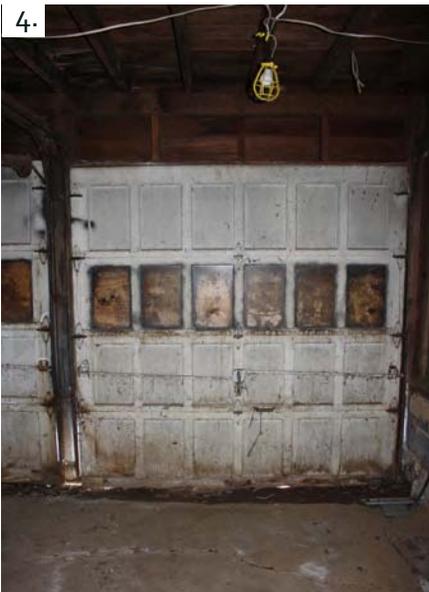
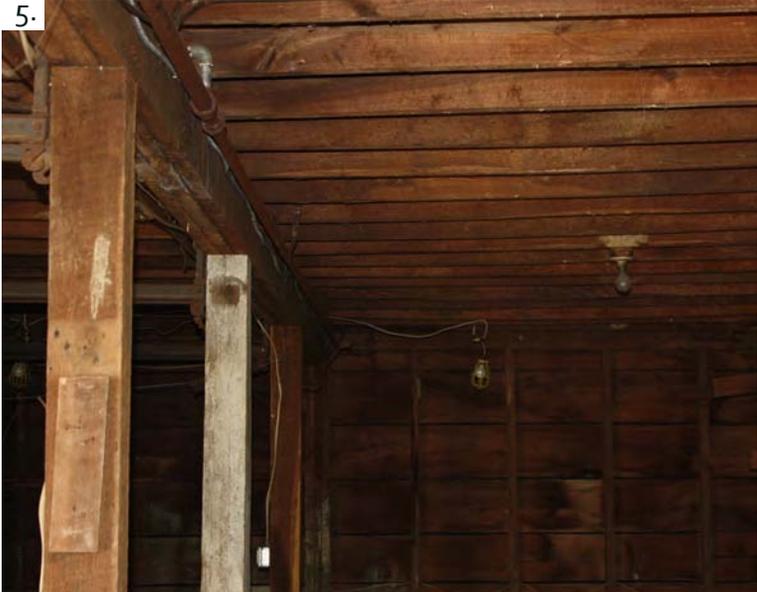
- 1. **Smoke Room Walls** Moisture damage along CMU sill. Uninsulated.
- 2. **Smoke Room Floors** Deteriorated and heaved tiled floor.
- 3. **Mechanical Room** Significant moisture damage.
- 4. **Garage Doors** Nonfunctional and deteriorated.
- 5. **Ceiling Joists** Bowed and below code.

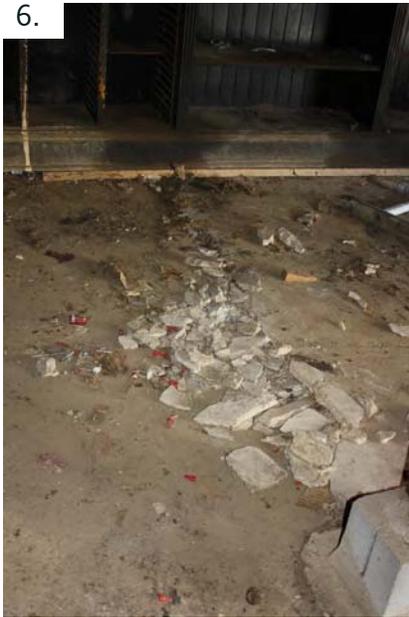
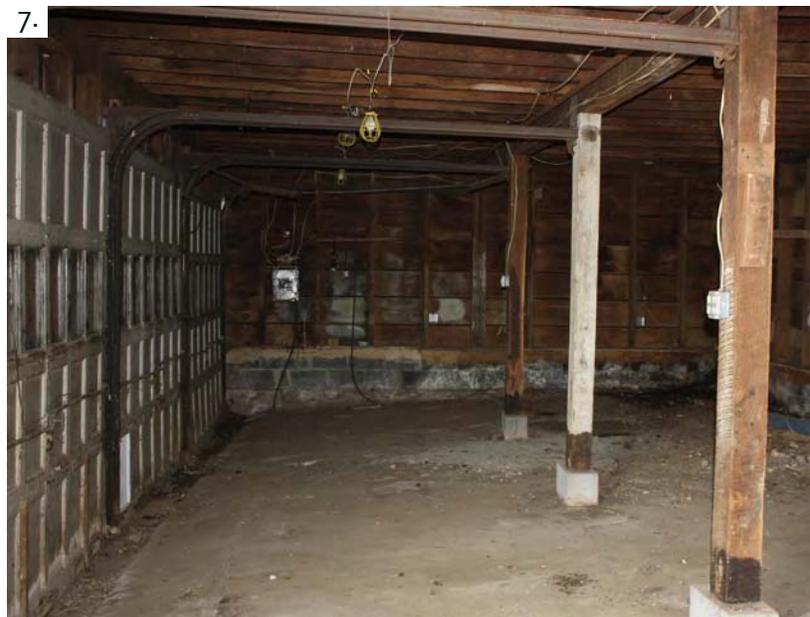
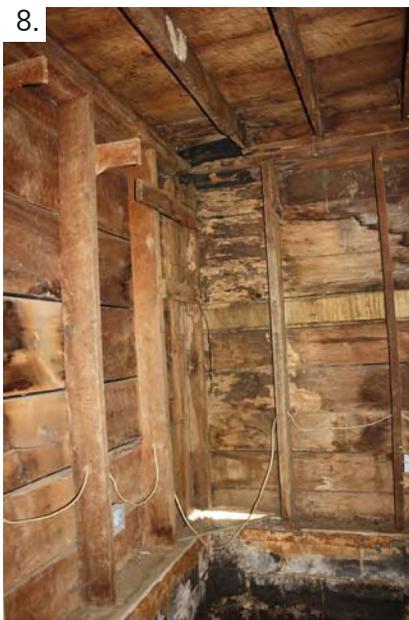
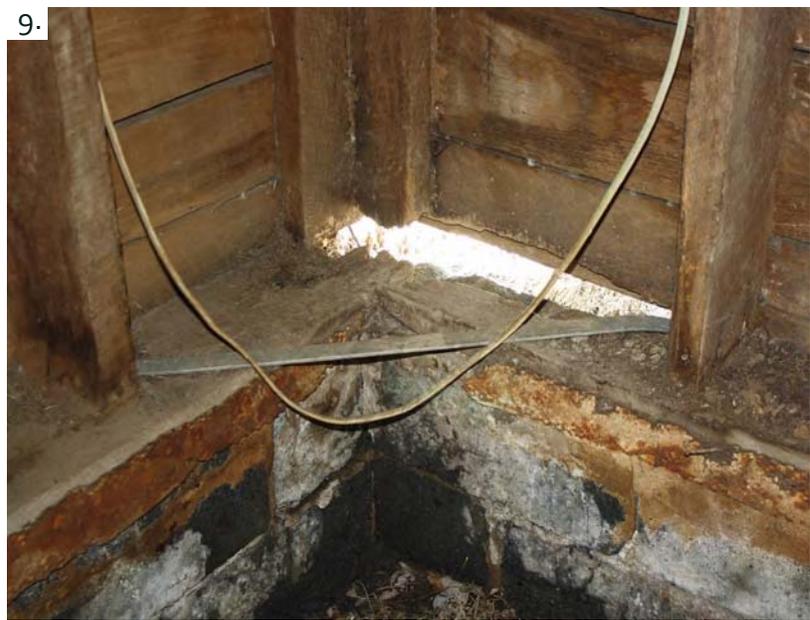
6. **Concrete Floors** Concrete is crumbling.

7. **Garage** No insulation.

8. **SW Corner** Significant moisture damage to sheathing.

9. **SW Sill** Degraded sill with significant moisture damage.

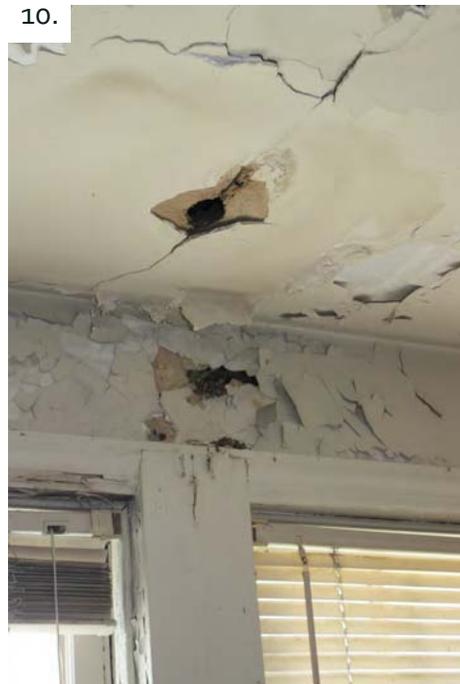
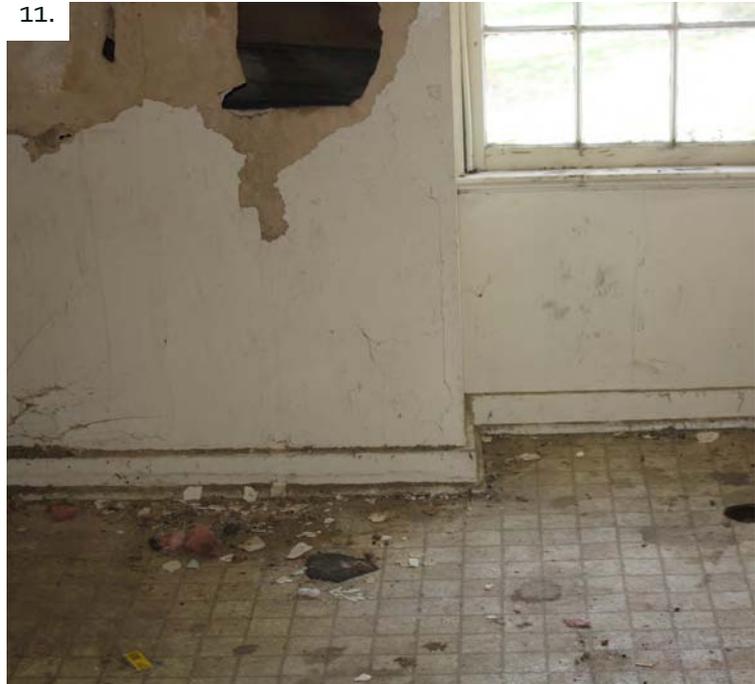
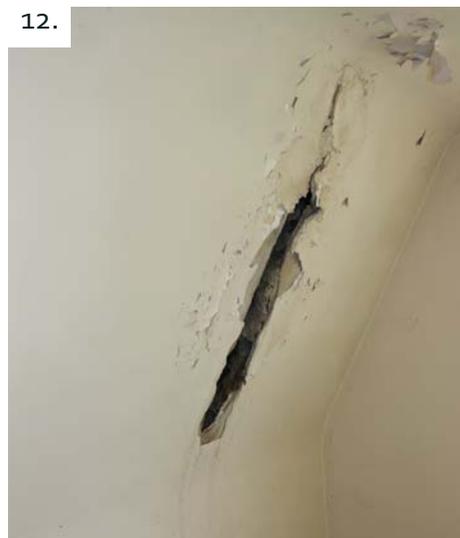
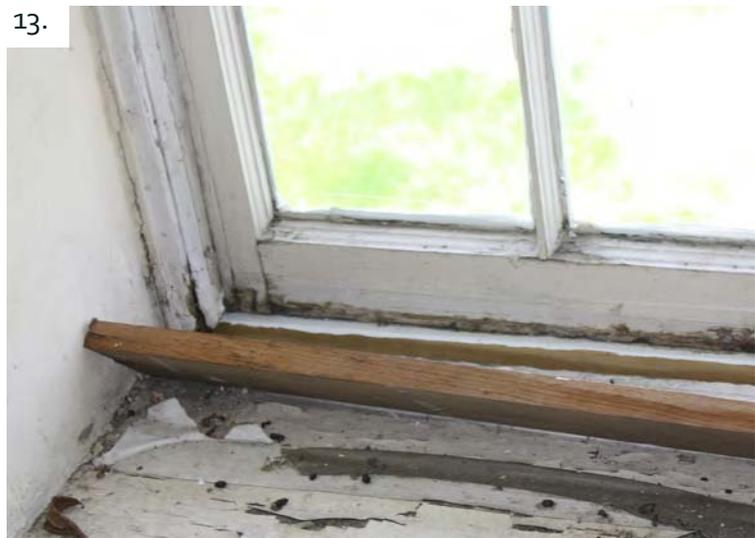
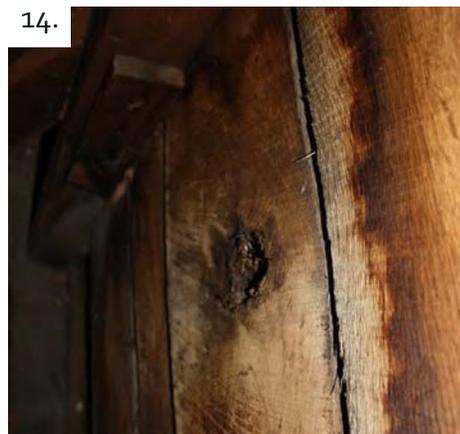
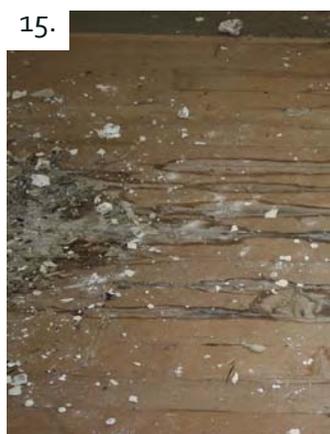
- 10. **Bedroom** Ceiling and wall damage from moisture infiltration.
- 11. **Bathroom** Deteriorated floor & walls. Moisture damage.
- 12. **Walls** Moisture damage, rot, & damaged plaster.
- 13. **Windows** Signs of leaks & sill rot.
- 14. **Sheathing** Water damage and staining.
- 15. **Floors** Deteriorated and stained floors.

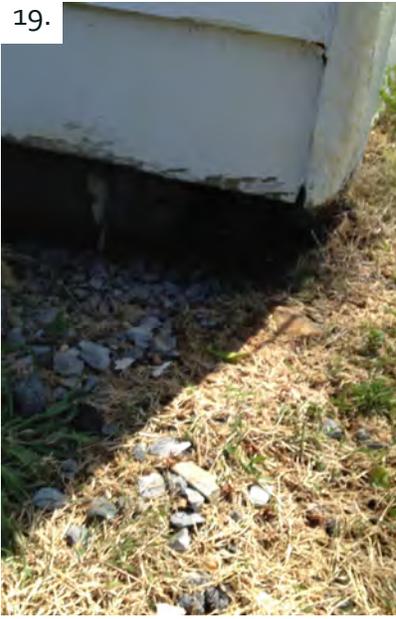
18. **Apartment Entrance** Stoop disconnected from foundation and deteriorated concrete pad.

19. **Foundation** Gaps in SE corner. Deterioration.

20. **Downspouts** SW corner downspout completely missing.

21. **Burrow** Groundhog burrow beneath the stair foundation.
