CITY OF ROCKVILLE

# KING FARM FARMSTEAD PROPERTY CONDITION ASSESSMENT

DEPARTMENT OF RECREATION AND PARKS

JULY 3, 2014

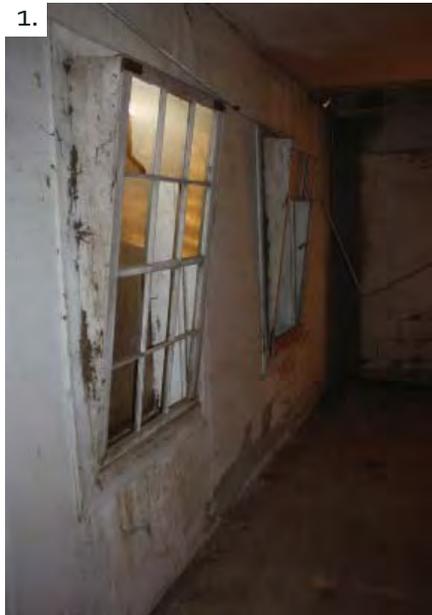
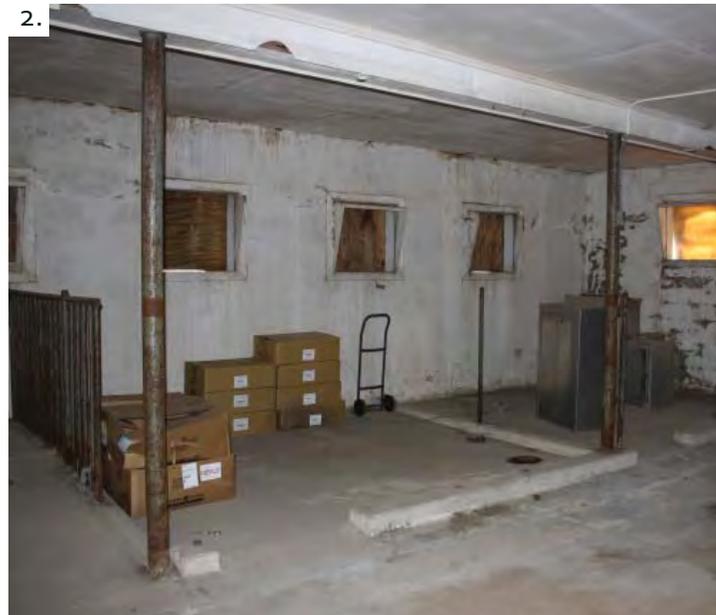
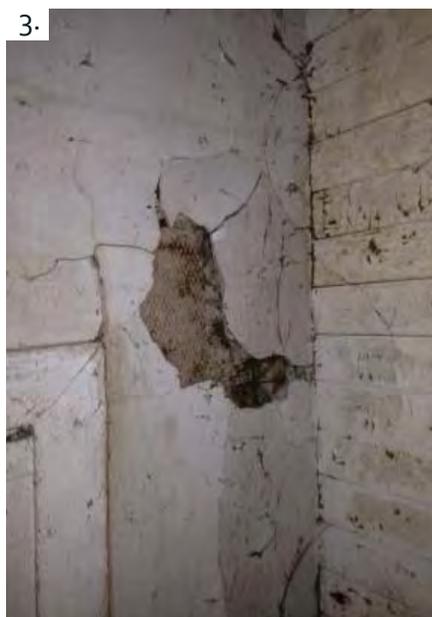
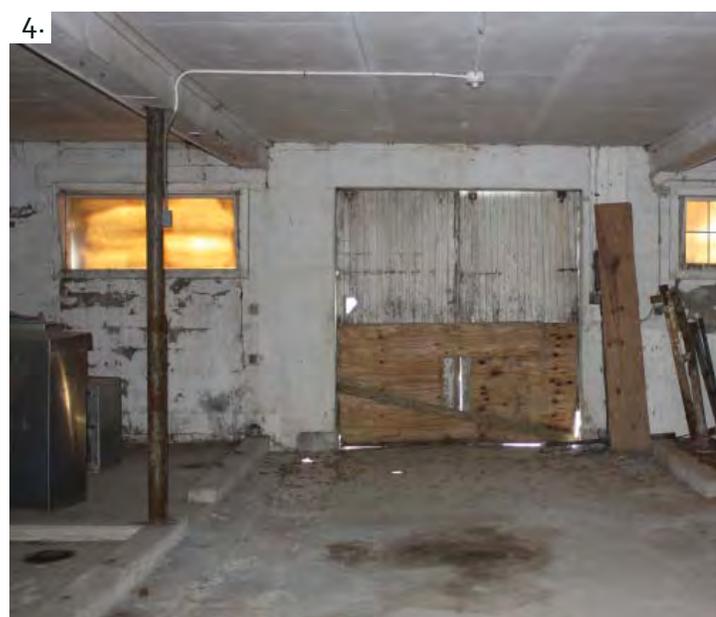
1. **Windows** Missing glass and muntins. Tilted surrounds deteriorated.

2. **Curbs** 6" curbs affect both accessibility and egress.

3. **Plaster** Significant moisture damage.

4. **Barn Doors** Nonfunctional and deteriorated.

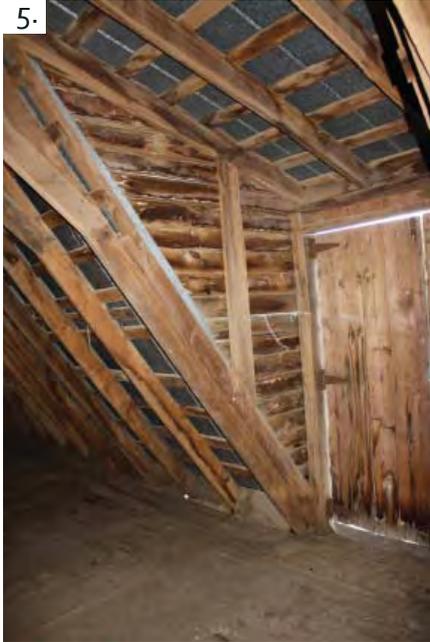
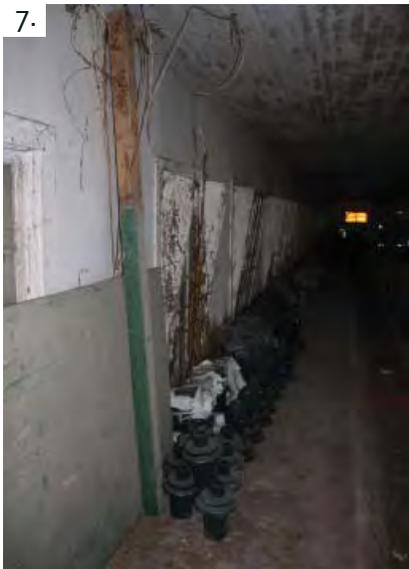
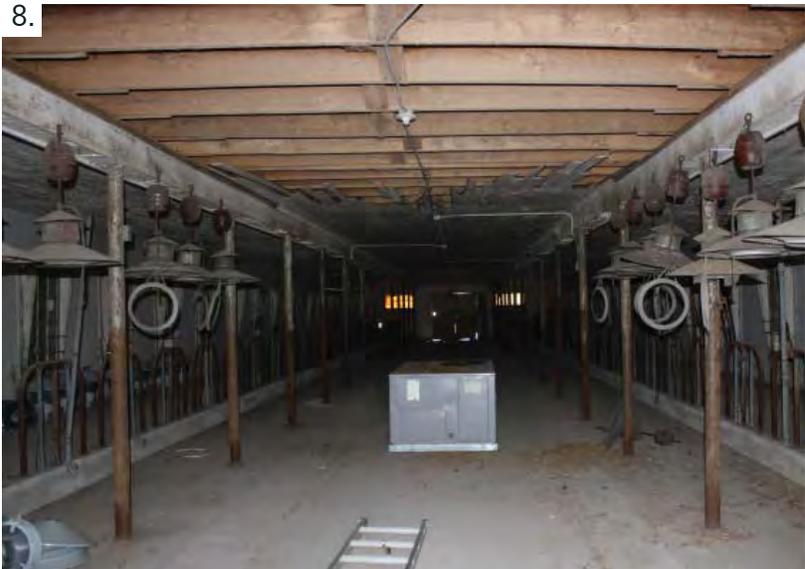
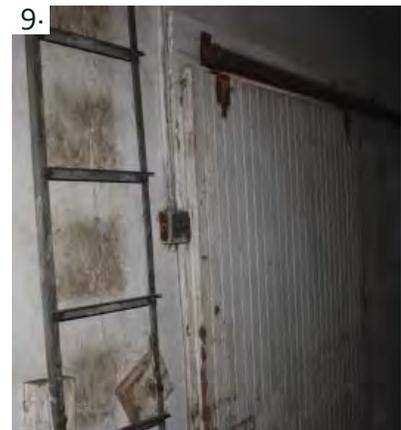
5. **Attic Dormers** Not weather tight and deteriorated doors.

6. **Attic Floor** Floor sheathing is damaged in many places.

7. **Aisles** Side aisles elevated from central aisle with concrete curbs showing signs of wear.

8. **Ceiling** Much of the boarded ceiling is missing or damaged.

9. **Hardware** Rusted, damaged and nonfunctional.

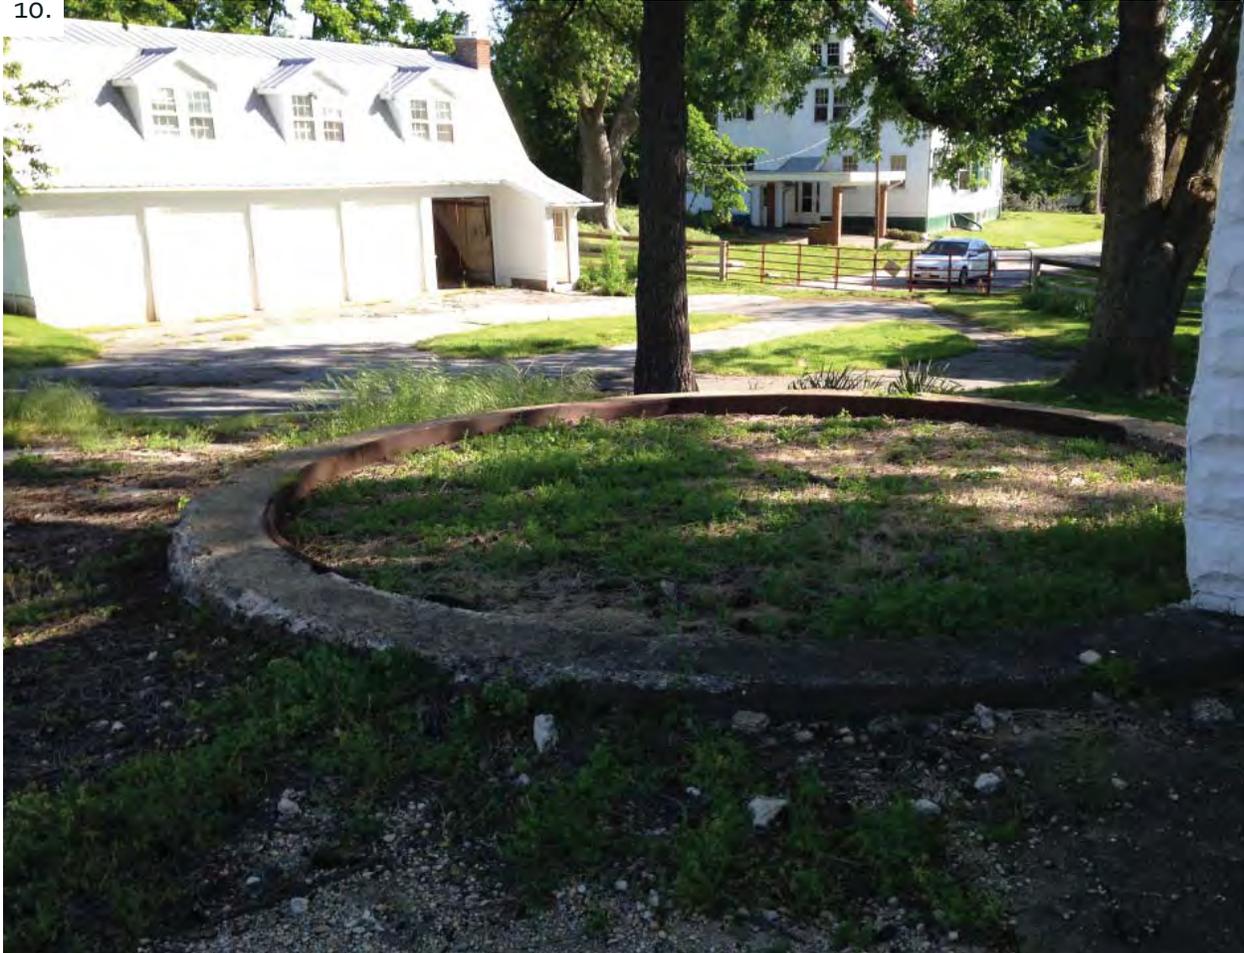
10. **Silo** Torn down. Foundation remains.

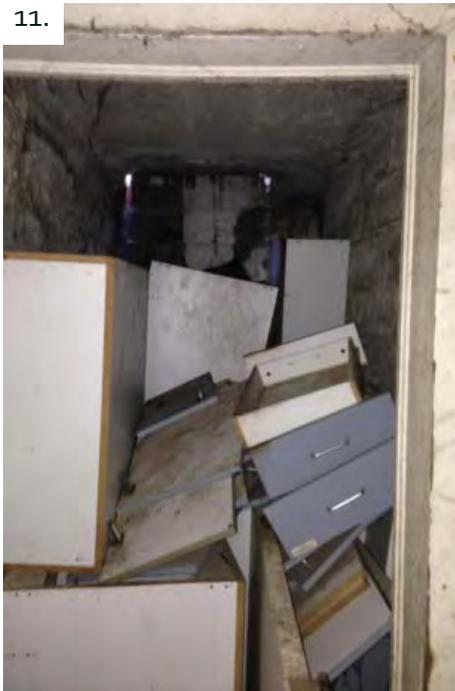
11. **Connector 2** Significantly deteriorated space.

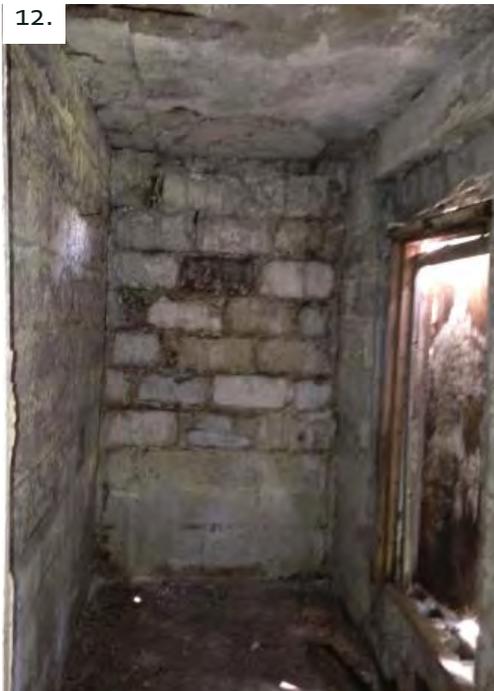
12. **Connector 1** Moisture damage, rot, and crumbling ceiling.

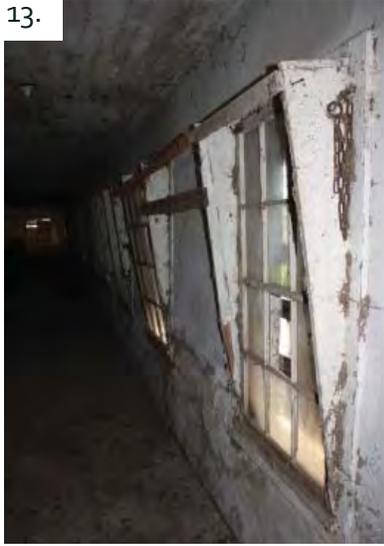
13. **Tilt-ins** Window glass broken or missing. Frames and sills show signs of rot.

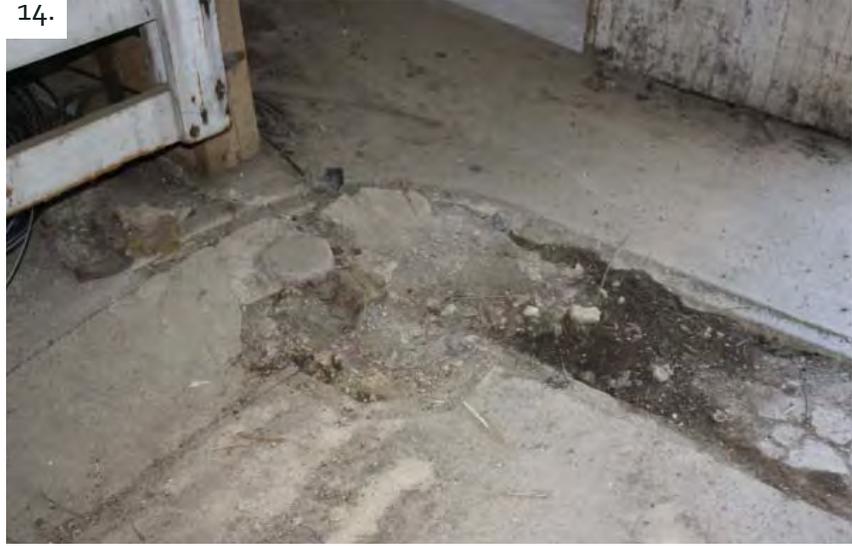
14. **Trench** formed into the concrete floor.

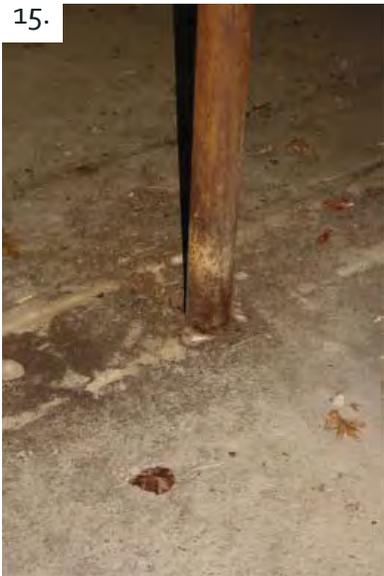
15. **Columns** all show significant signs of wear. Some are missing and others have sheared off their base.

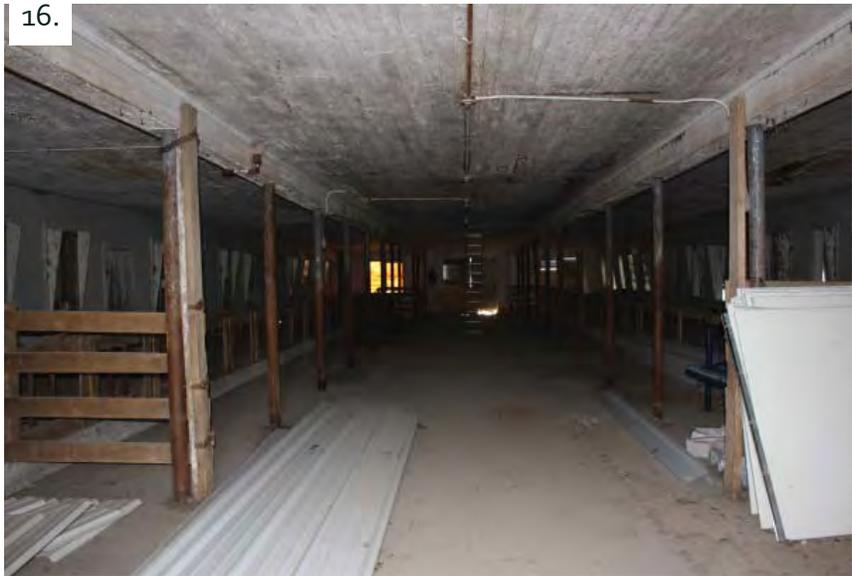
16. **Ceiling** Shows signs of rot and the box beams have deteriorated.

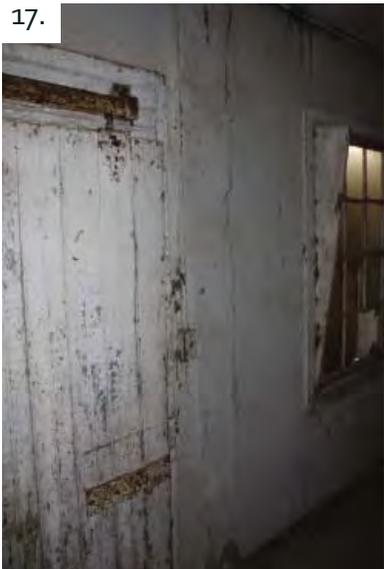
17. **Barn Doors** All doors are rotted. Hardware has rusted and is nonfunctional.

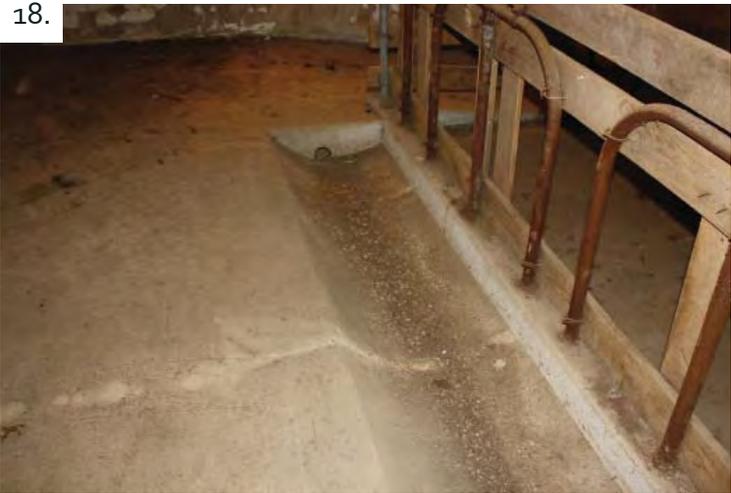
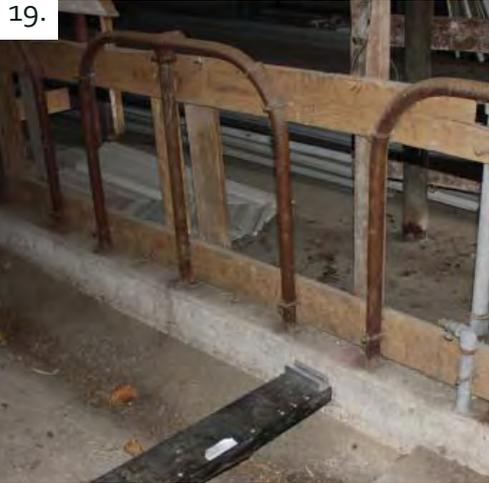
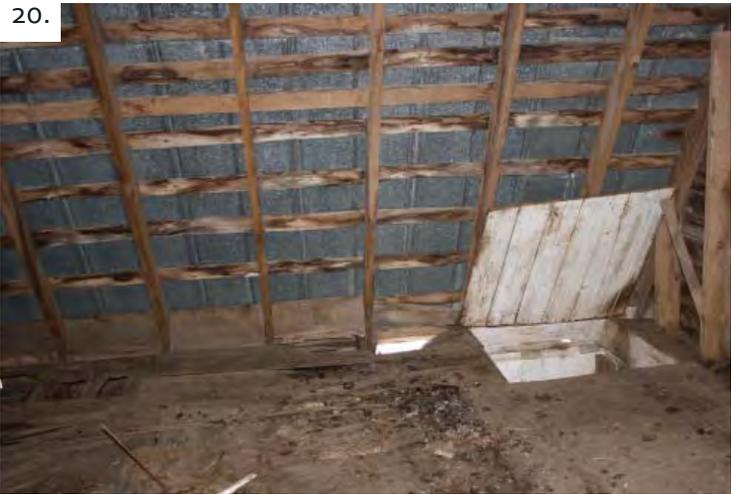
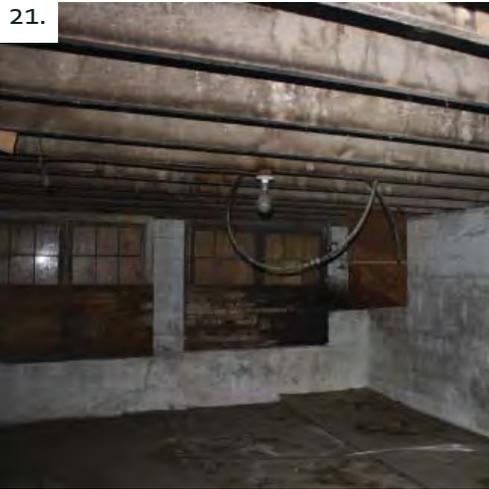
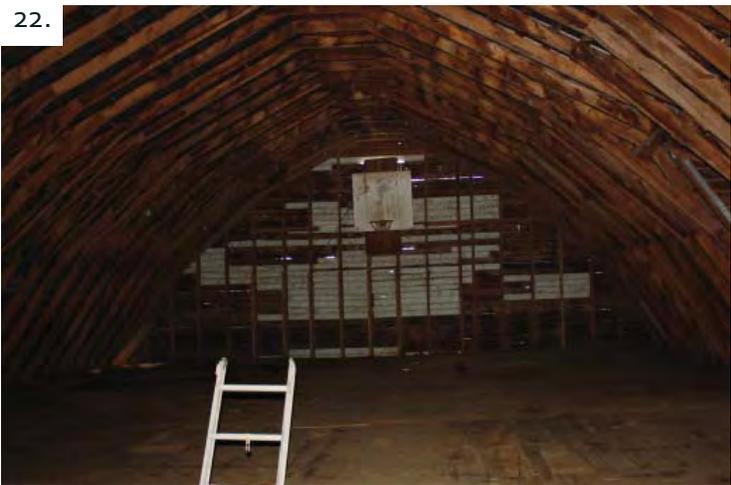
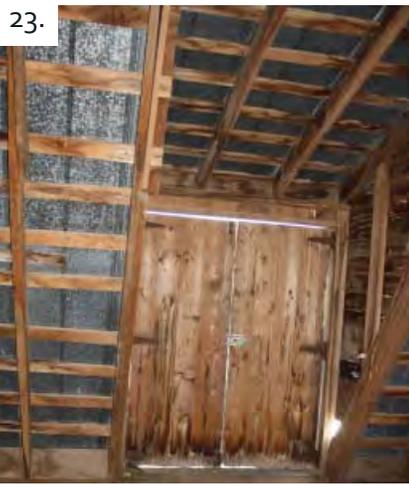
- 18. **Floors** Floor formed w/ 6" curbs, ramps & trenches in concrete. Hollow railings embedded in curb.
- 19. **Drains** Trench drains are clogged. Appurtenances mounted over concrete and railings.
- 20. **Attic Floor** Floor sheathing damaged.
- 21. **Room 4** Joists are rotting and CMU shows water damage.
- 22. **Roof** In poor condition and not weather-tight.
- 23. **Dormer** Doors have rotted as has siding. Not weather-tight.

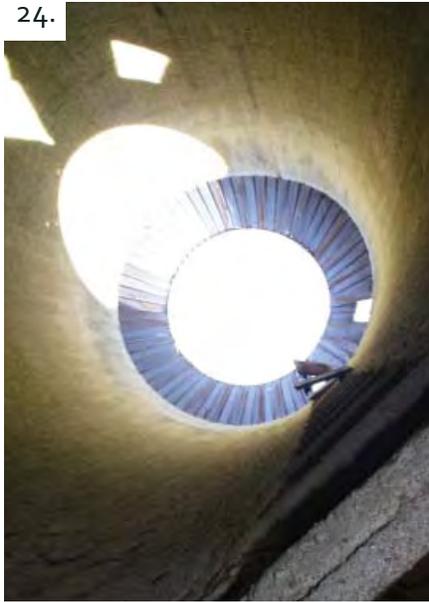
24. *Silo 3* Deteriorated concrete ladder. Roof in disrepair.

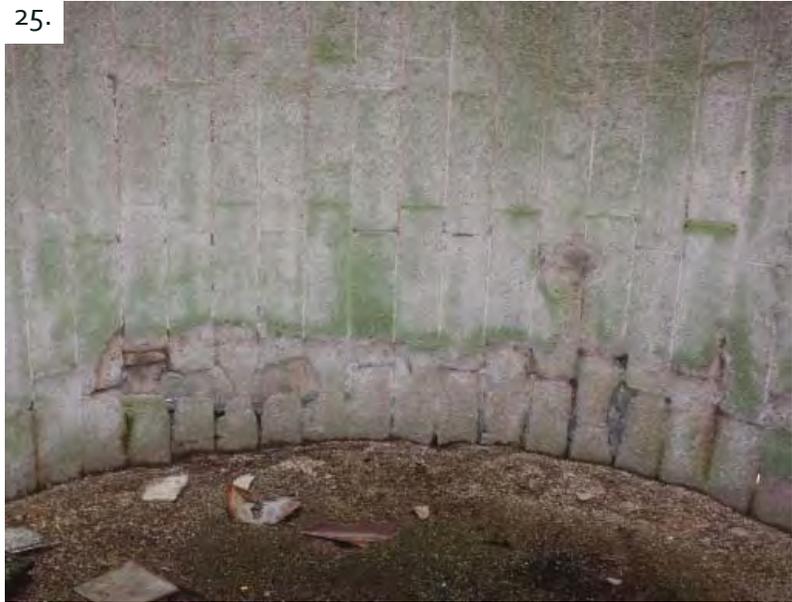
25. *Silo 4* Significant damage along seam between concrete floor and silo wall.

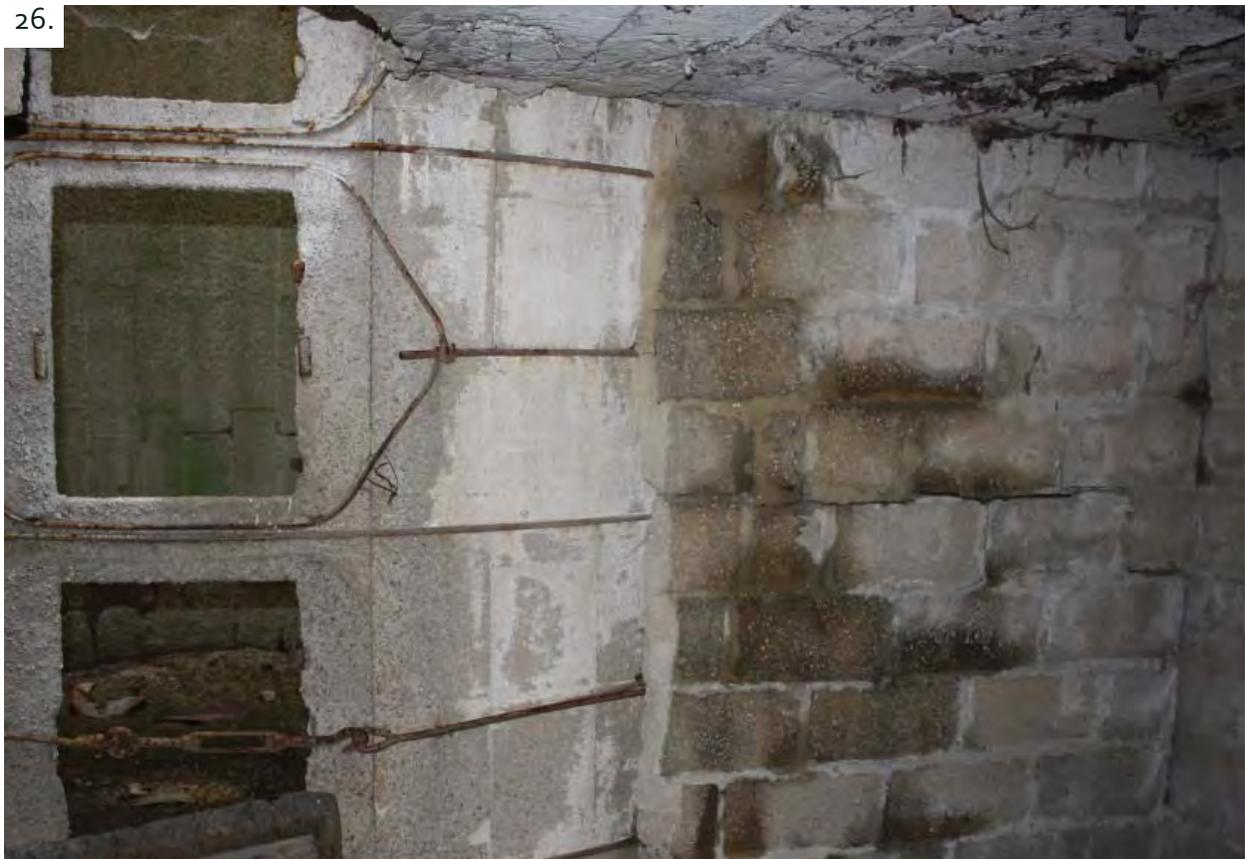
26. *Connector 3* Significantly deteriorated and showing many signs of water damage.

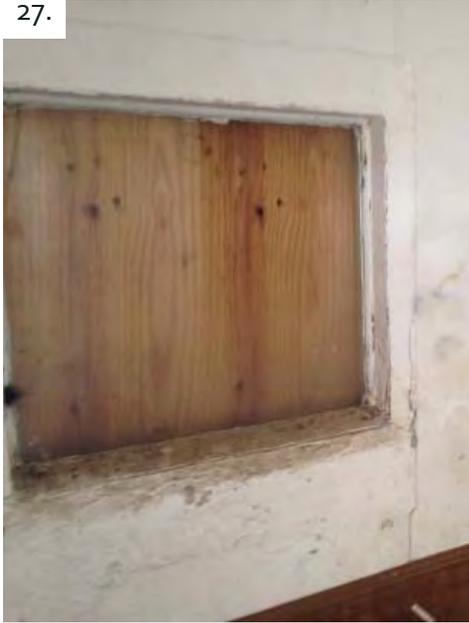
27. **Picture Window** Window glass missing. Sill deteriorated.

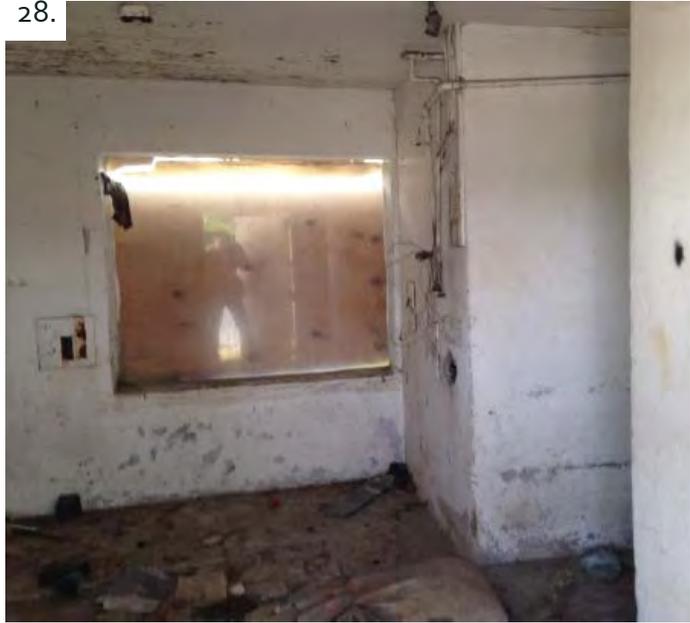
28. **Debris** Flaking plaster, deteriorated wood and concrete accumulating on the floor.

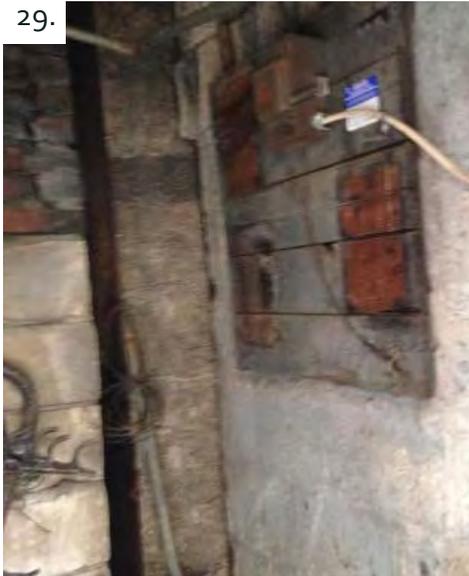
29. **Panel** Old panel missing equipment and deteriorated.

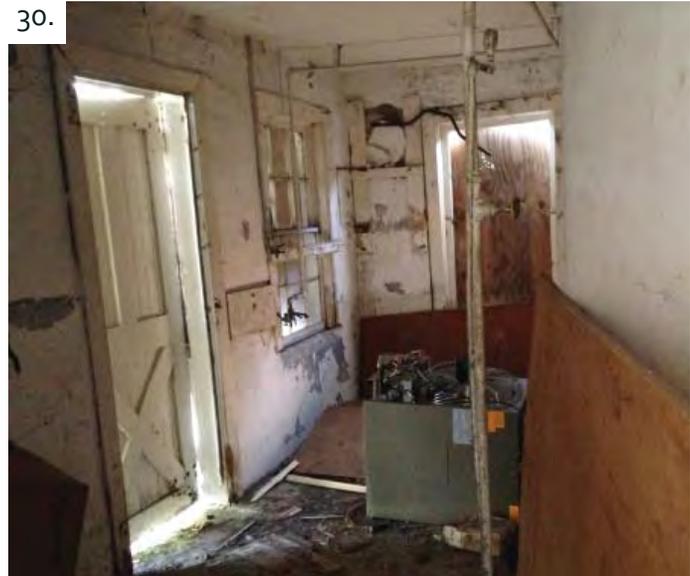
30. **Rear Room** Plaster deterioration, missing window glass and deteriorated sills.

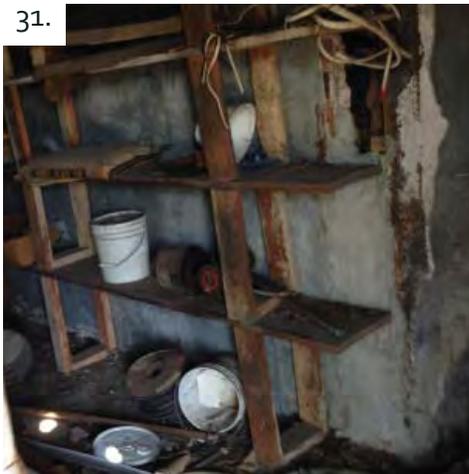
31. **Storage Room** Walls are crumbling.

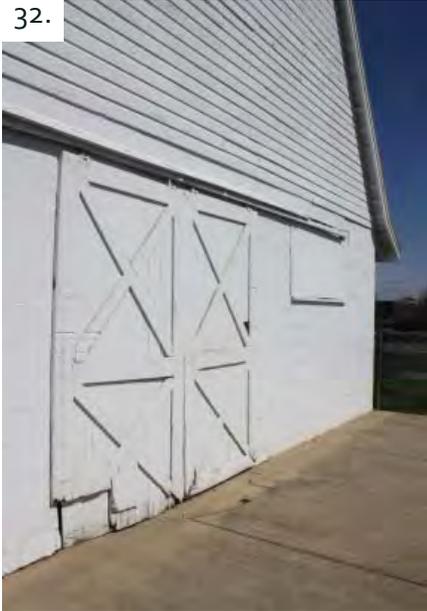
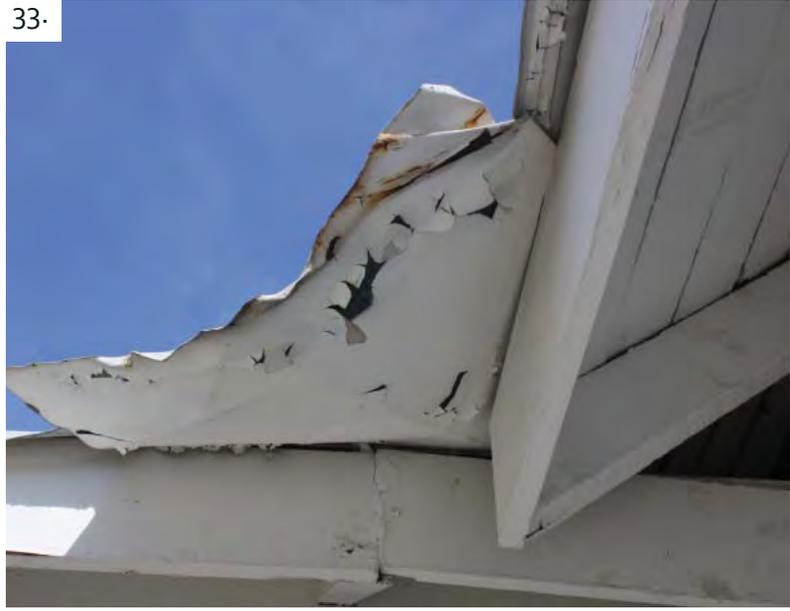
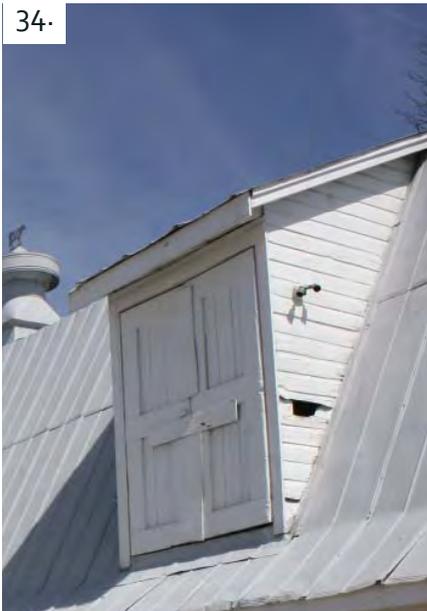
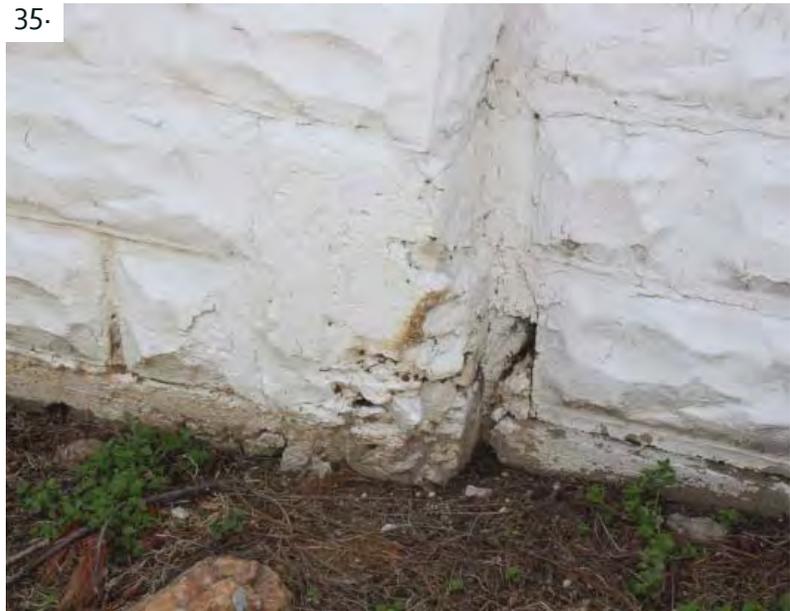
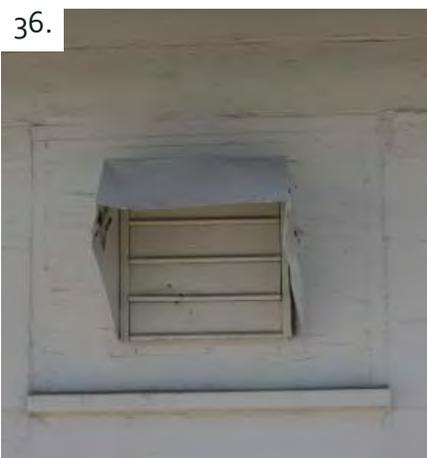
32. **Barn Doors** Rotted and damaged. Sliding hardware in disrepair.

33. **Drainage** No gutter system is present. Corner guards falling apart.

34. **Dormers** Siding showing deterioration.

35. **Foundation** Some decay of CMU and grout.

36. **Vents** are not functioning and show signs of wear.

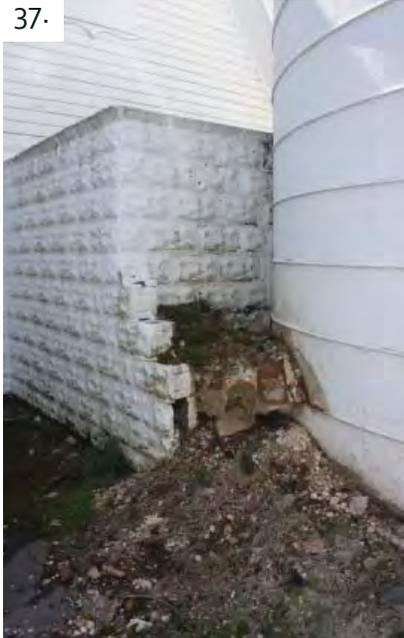
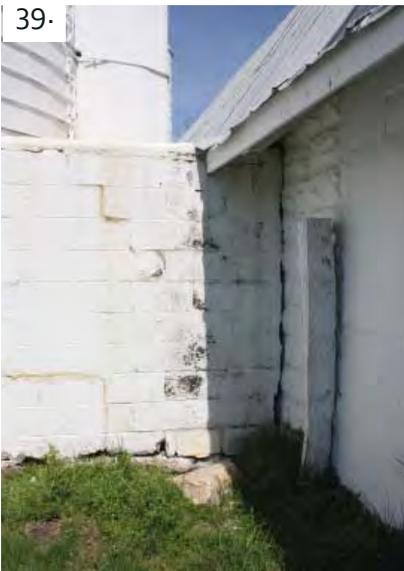
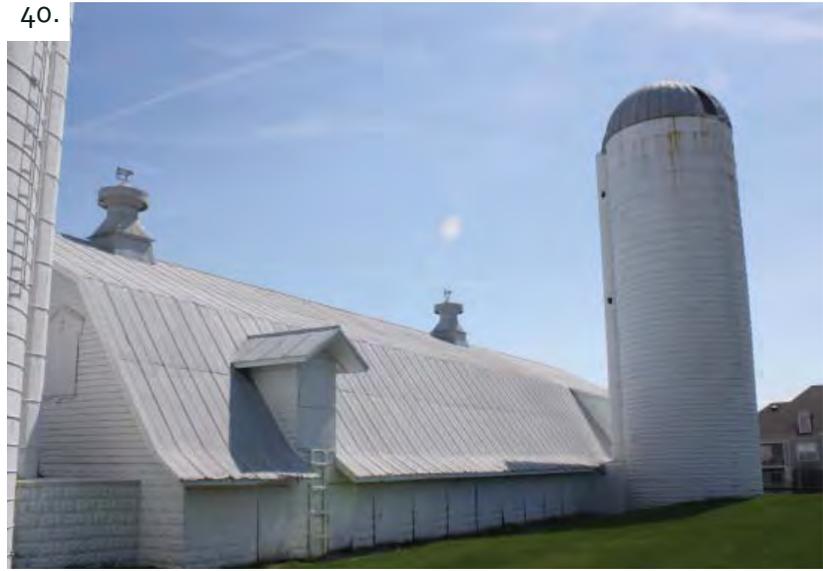
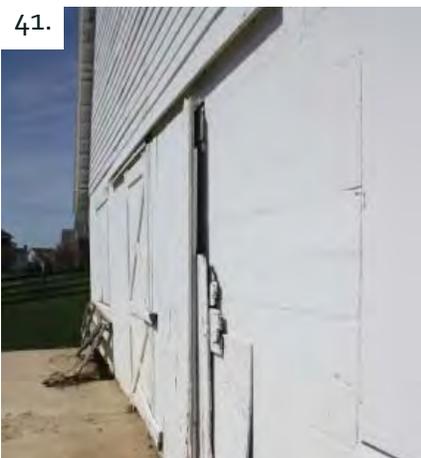
37. **Connector 3** Shows significant damage.

38. **Sliders** Show signs of rot.

39. **Connector 4** Shows significant damage.

40. **Roof** in significant disrepair. Portion of silo roof missing.

41. **Appurtenances** Exterior walls have various plywood boards and other miscellaneous appurtenances on them.

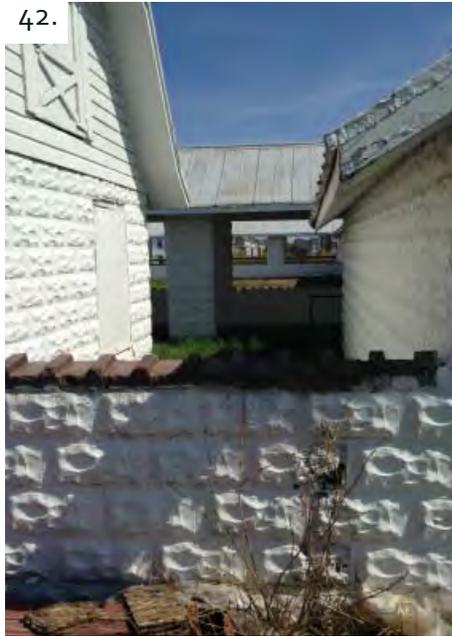
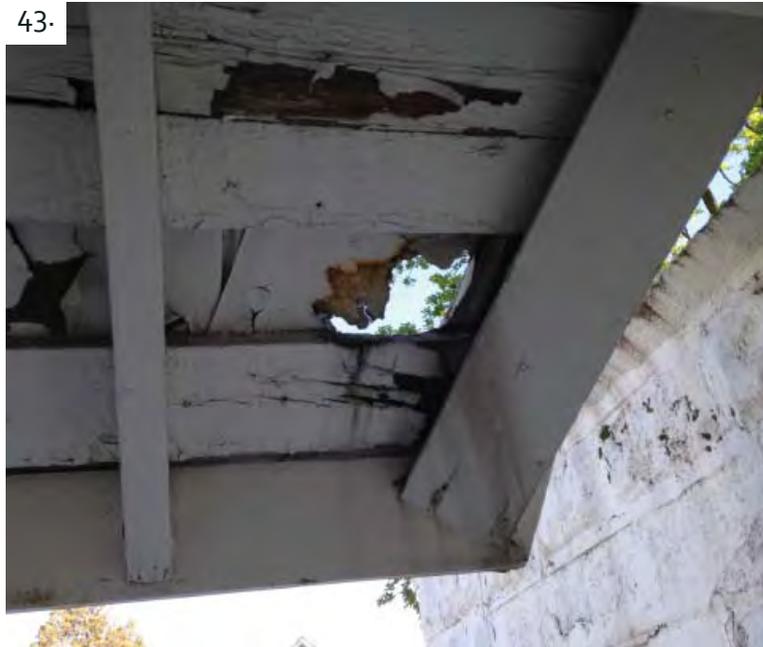
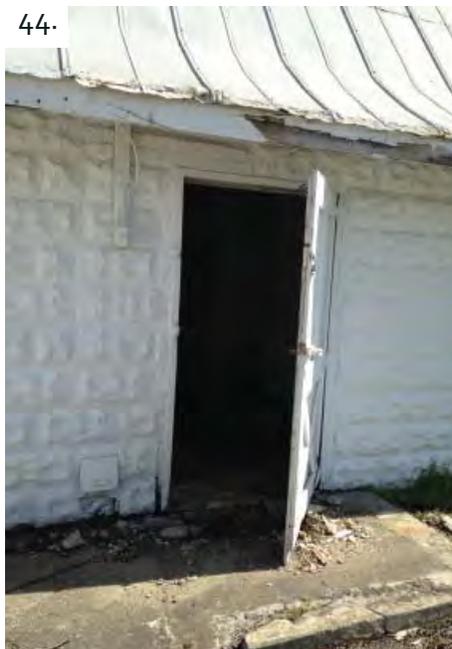
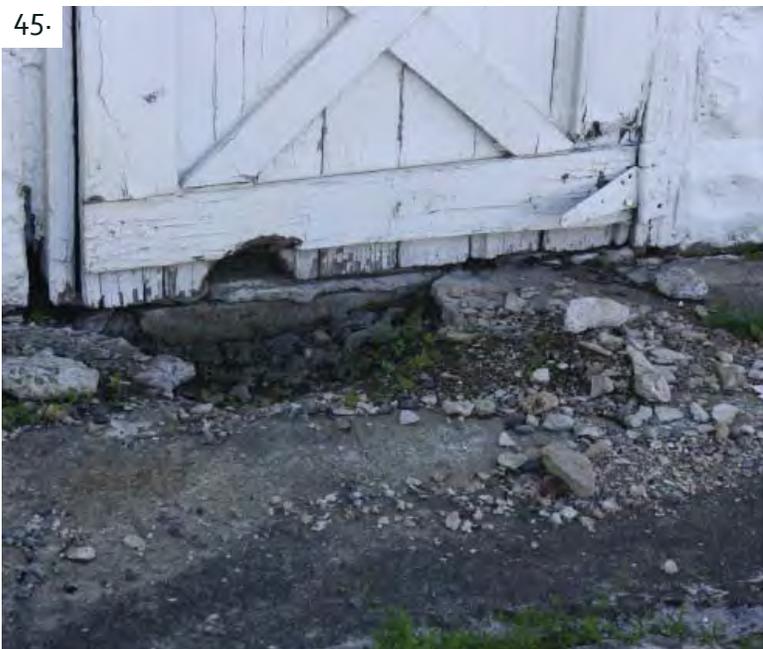
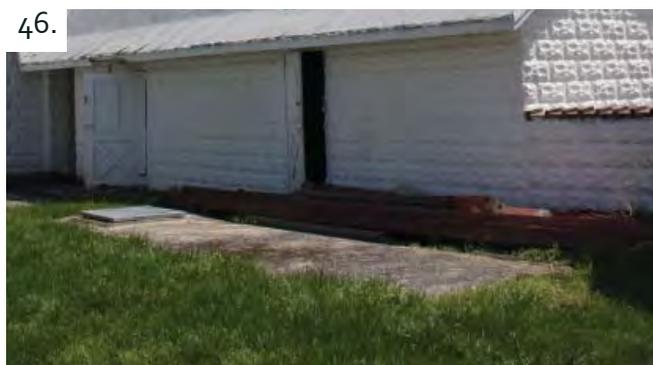
42. **Low Wall** Grout and CMU show signs of deterioration.

43. **Roof** Show signs of rot.

44. **Fascia** Shows significant damage and rot.

45. **Door** Damaged, held by only one hinge and rotted at the bottom.

46. **Concrete containment tank** In front of milk house; Unknown contents

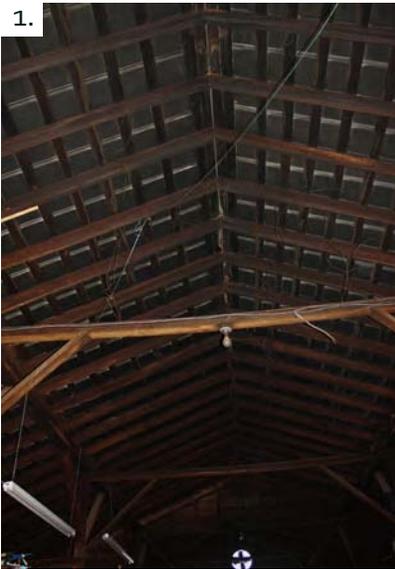
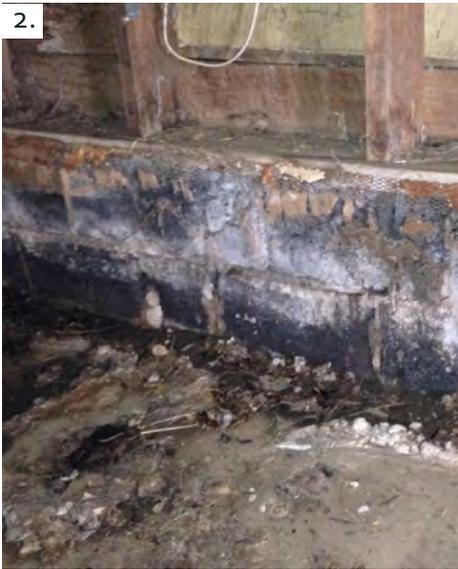
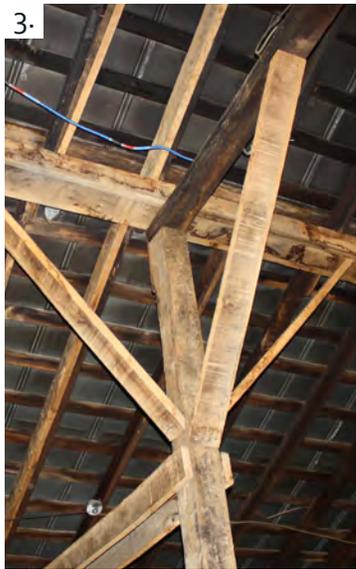
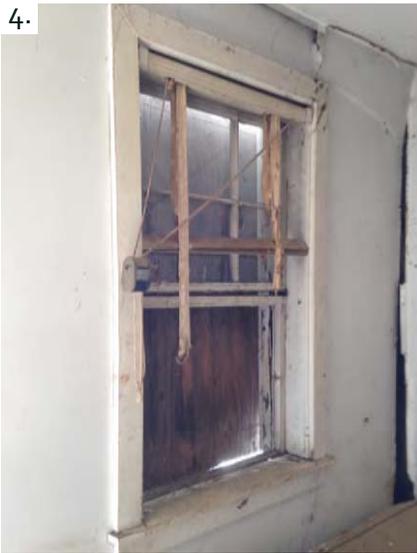
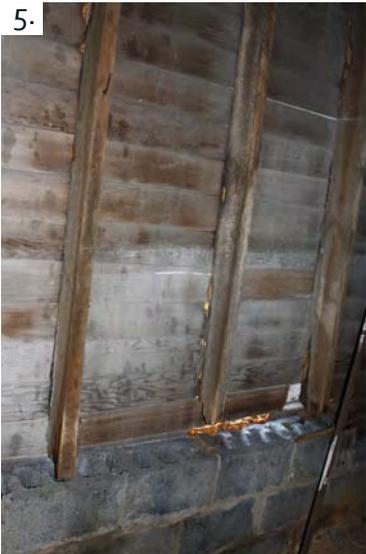
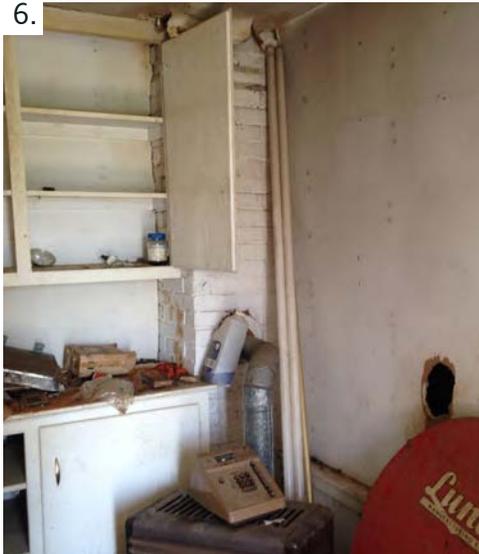
- 1. **Beams** Undersized and bowing in the middle; insufficient connections.
- 2. **Sill** Undersized and showing signs of water damage.
- 3. **Structure** Undersized and showing signs of past fire damage; insufficient connections.
- 4. **Windows** In significant disrepair and missing glass. Sills rotting.
- 5. **Studs** CMU degraded, gaps in sheathing and studs disconnected from sill.
- 6. **Front Room** Walls in disrepair and asbestos floor.
- 7. **Columns** Sheared off their base, fairly recently reinforced but insufficient connections.

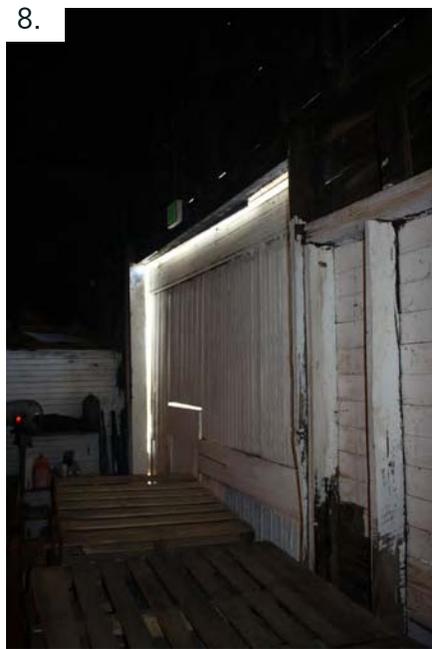
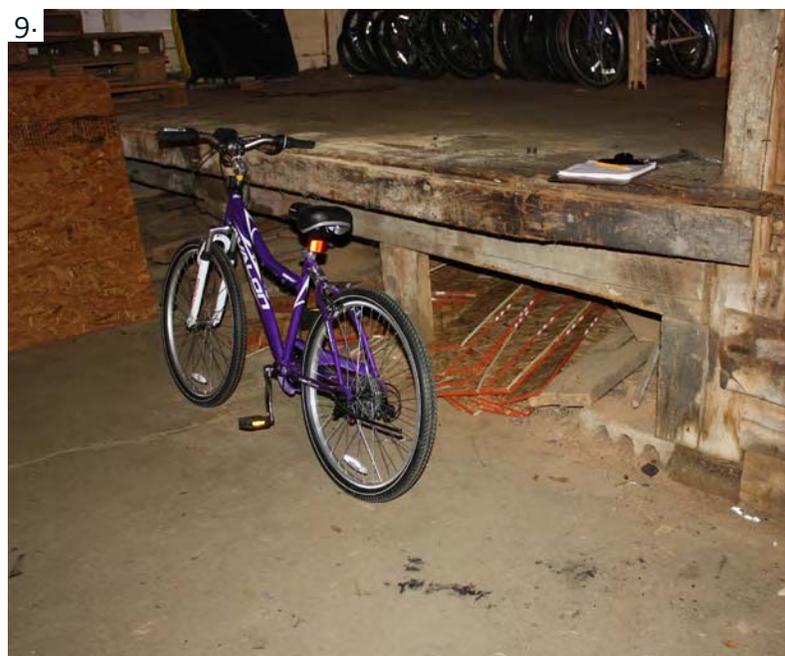
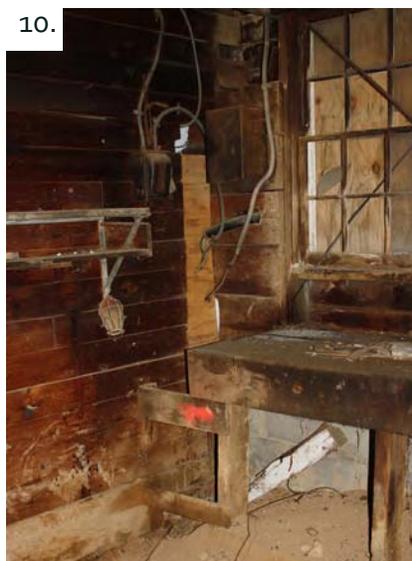
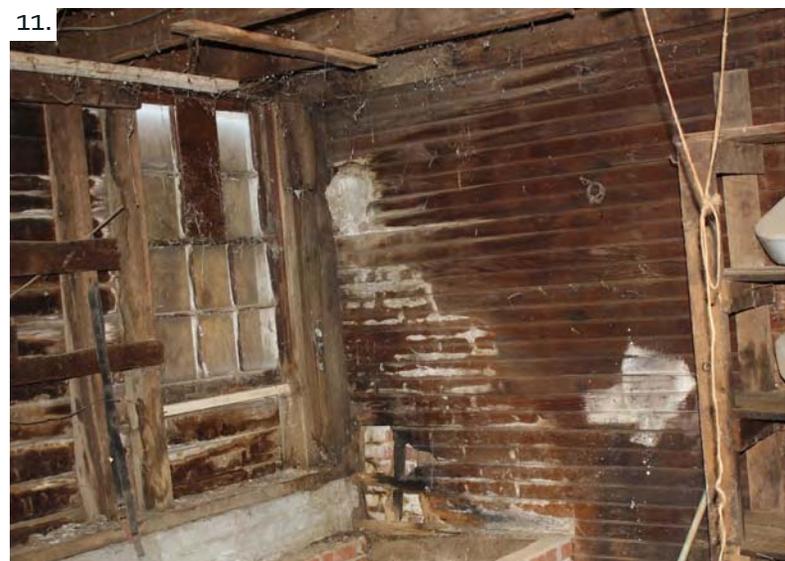
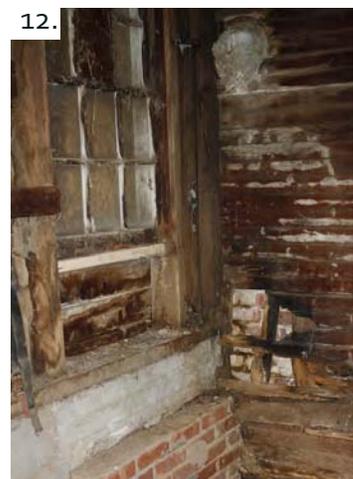
8. **Barn Door** In disrepair, shows signs of rot.
9. **Platforms** In disrepair, shows signs of rot, dirt floor underneath.
10. **Room 2** Walls in disrepair, wires and such hang from the ceiling, and dirt floor.
11. **Hearth** Brick hearth disconnected from chimney above.
12. **Windows** Missing glass, deteriorated surround, rotted sill and damaged muntins.

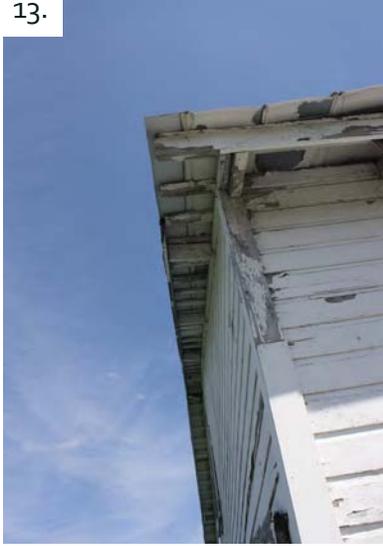
13. **Fascia** Either missing or showing signs of significant rot and water damage.

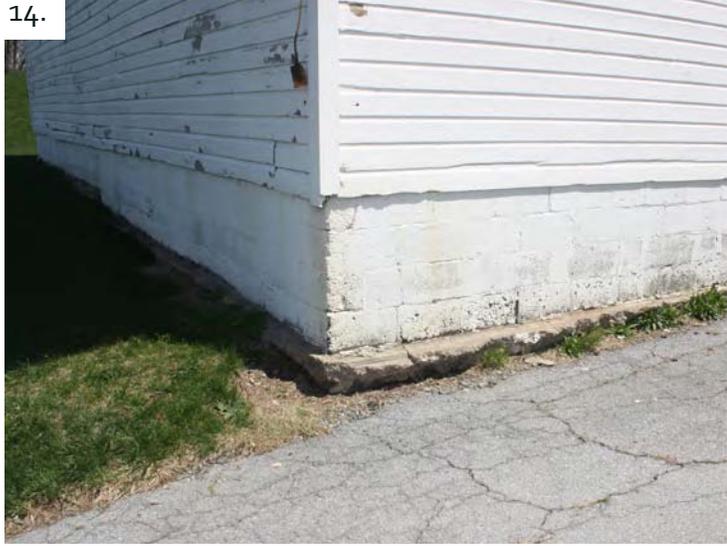
14. **Foundation** Exposed and crumbling concrete foundation exposed.

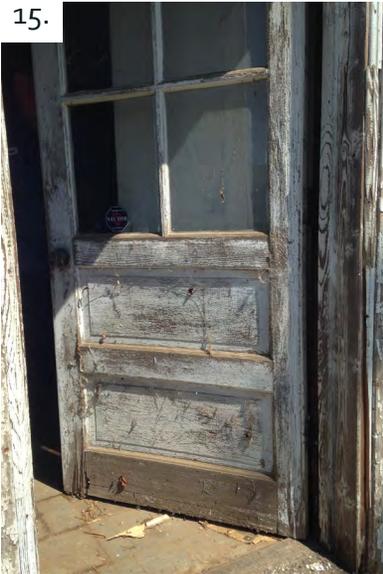
15. **Door** Showing signs of decay and rot.

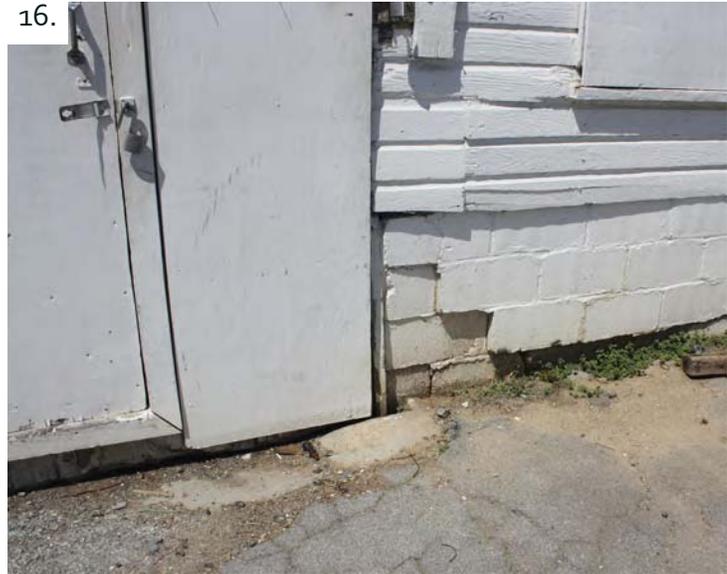
16. **CMU Sill** Stepped crack, shifted foundation and slight bulge in CMU.

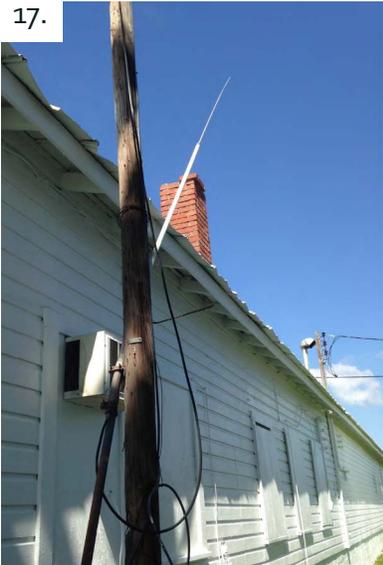
17. **Siding** In disrepair. Shows many pinholes.

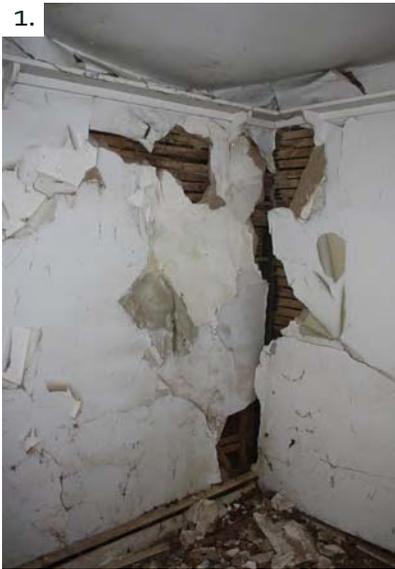
1. **SW Corner** Significant water damage, plaster falling away and exposing rotted lath.

2. **Ceiling** bowed in and in danger of collapse.

3. **Threshold** Stepped down and decaying.

4. **Addition 2** Window glass missing, surround rotting. All finishes in disrepair.

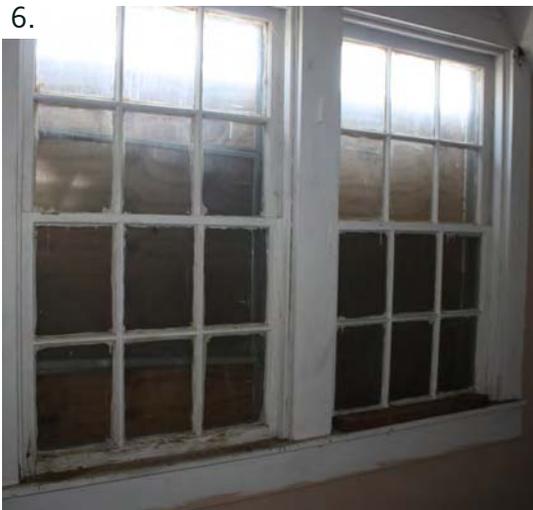
6. **Stair Windows** Sill in disrepair.

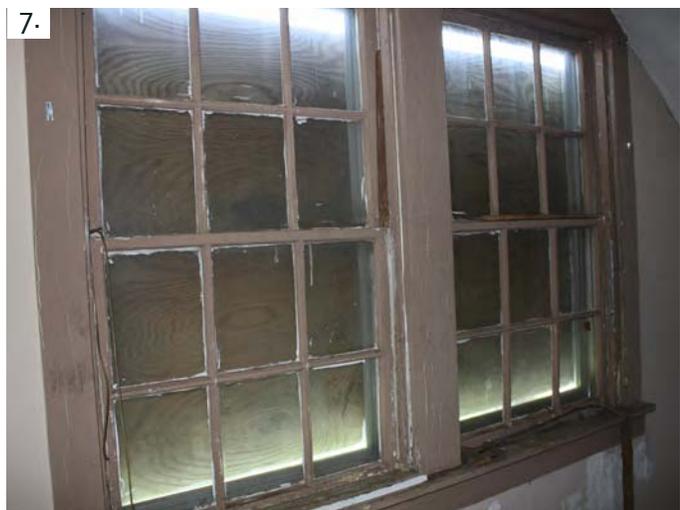
7. **Rear Windows** In disrepair, deteriorated sill and muntins.

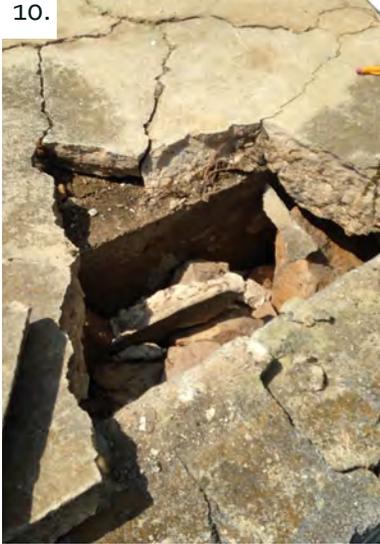
10. **Septic Tank** Deteriorating and nonfunctioning.

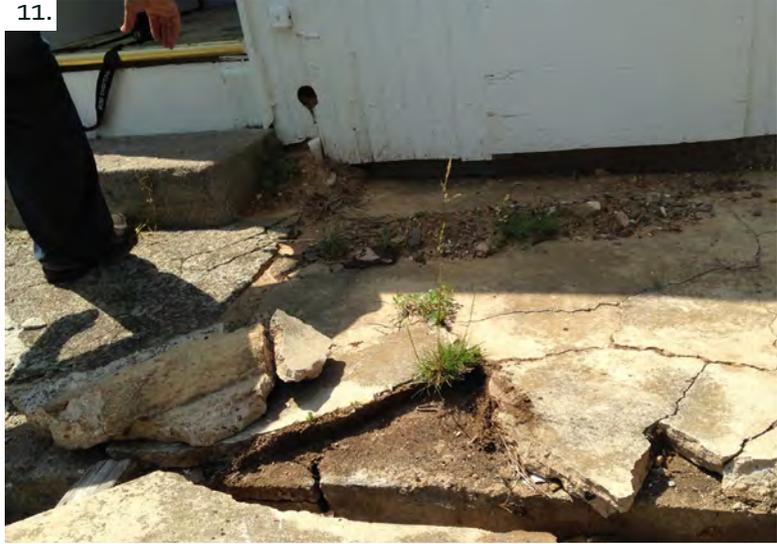
11. **Concrete Pad** Crumbling concrete with loose pieces.
