CITY OF ROCKVILLE

# KING FARM FARMSTEAD PROPERTY CONDITION ASSESSMENT

DEPARTMENT OF RECREATION AND PARKS

JULY 3, 2014

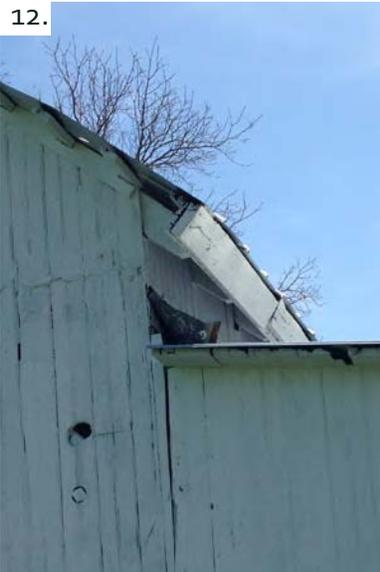
12. **Fascia** Rotted or missing.

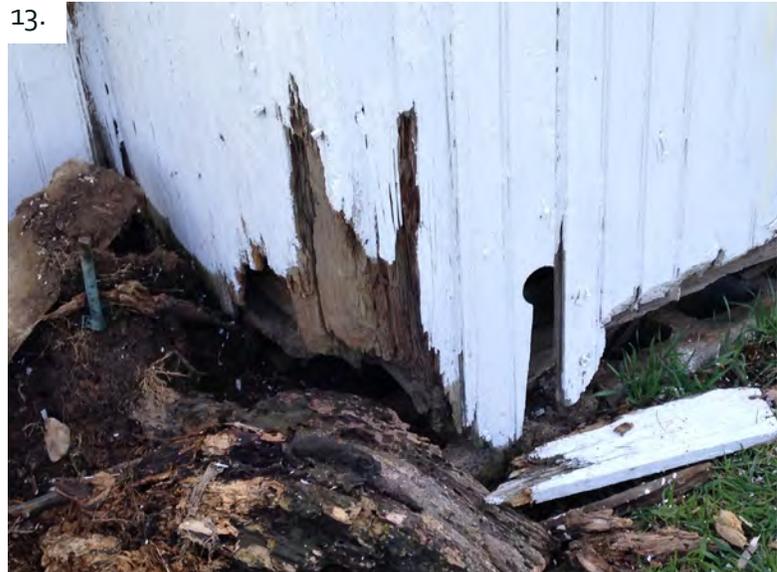
13. **Siding** Rotted siding all along foundation. Invasive tree roots.

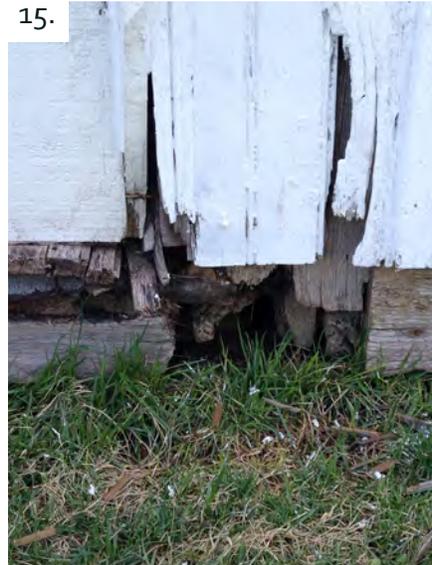
15. **Foundation** Too close to grade and deteriorated.

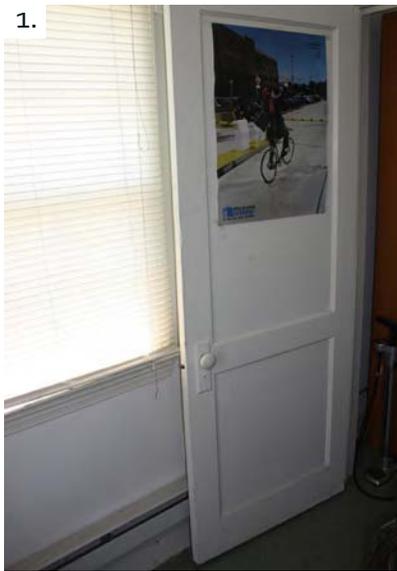
1. **Doors** All are too narrow, including framed openings.

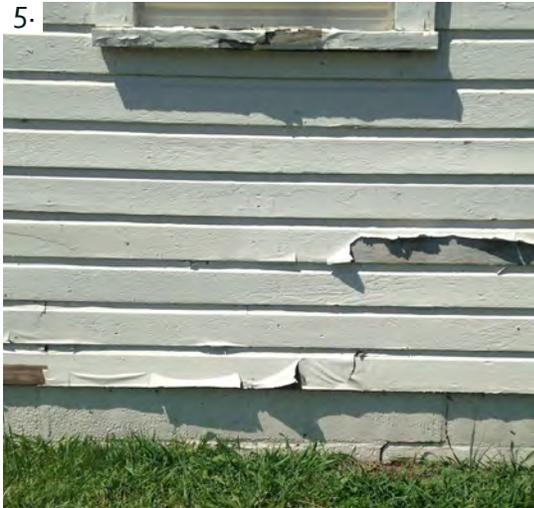
5. **Siding** Flaking paint. Sills show signs of rot.

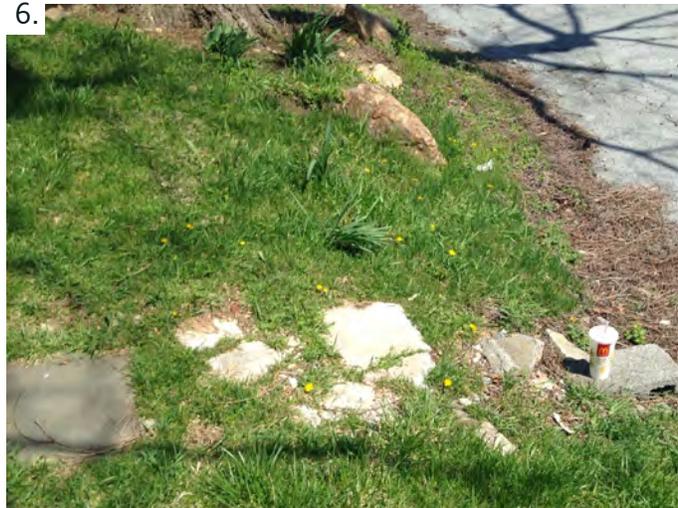
6. **Path** Very steep and not accessible.

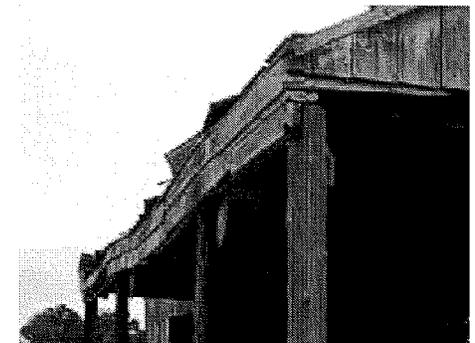
Condition of plates

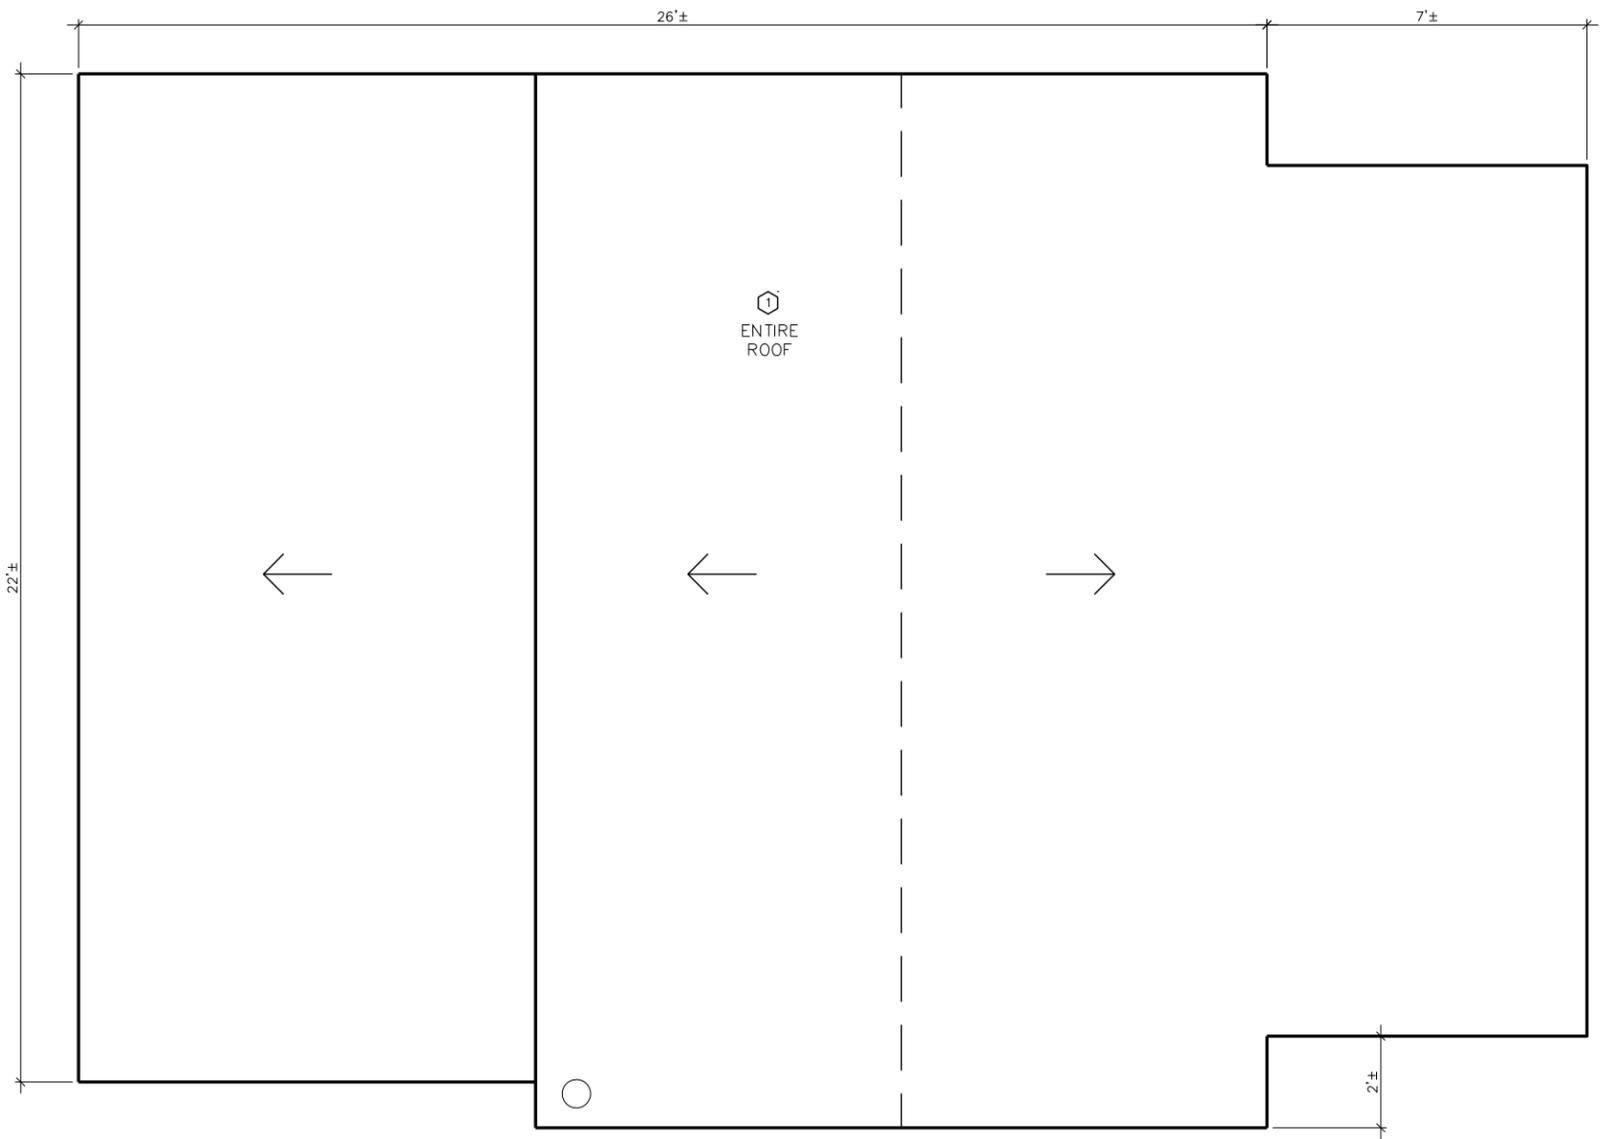
KEY NOTES:  
 ① ROOF SYSTEM IN POOR CONDITION

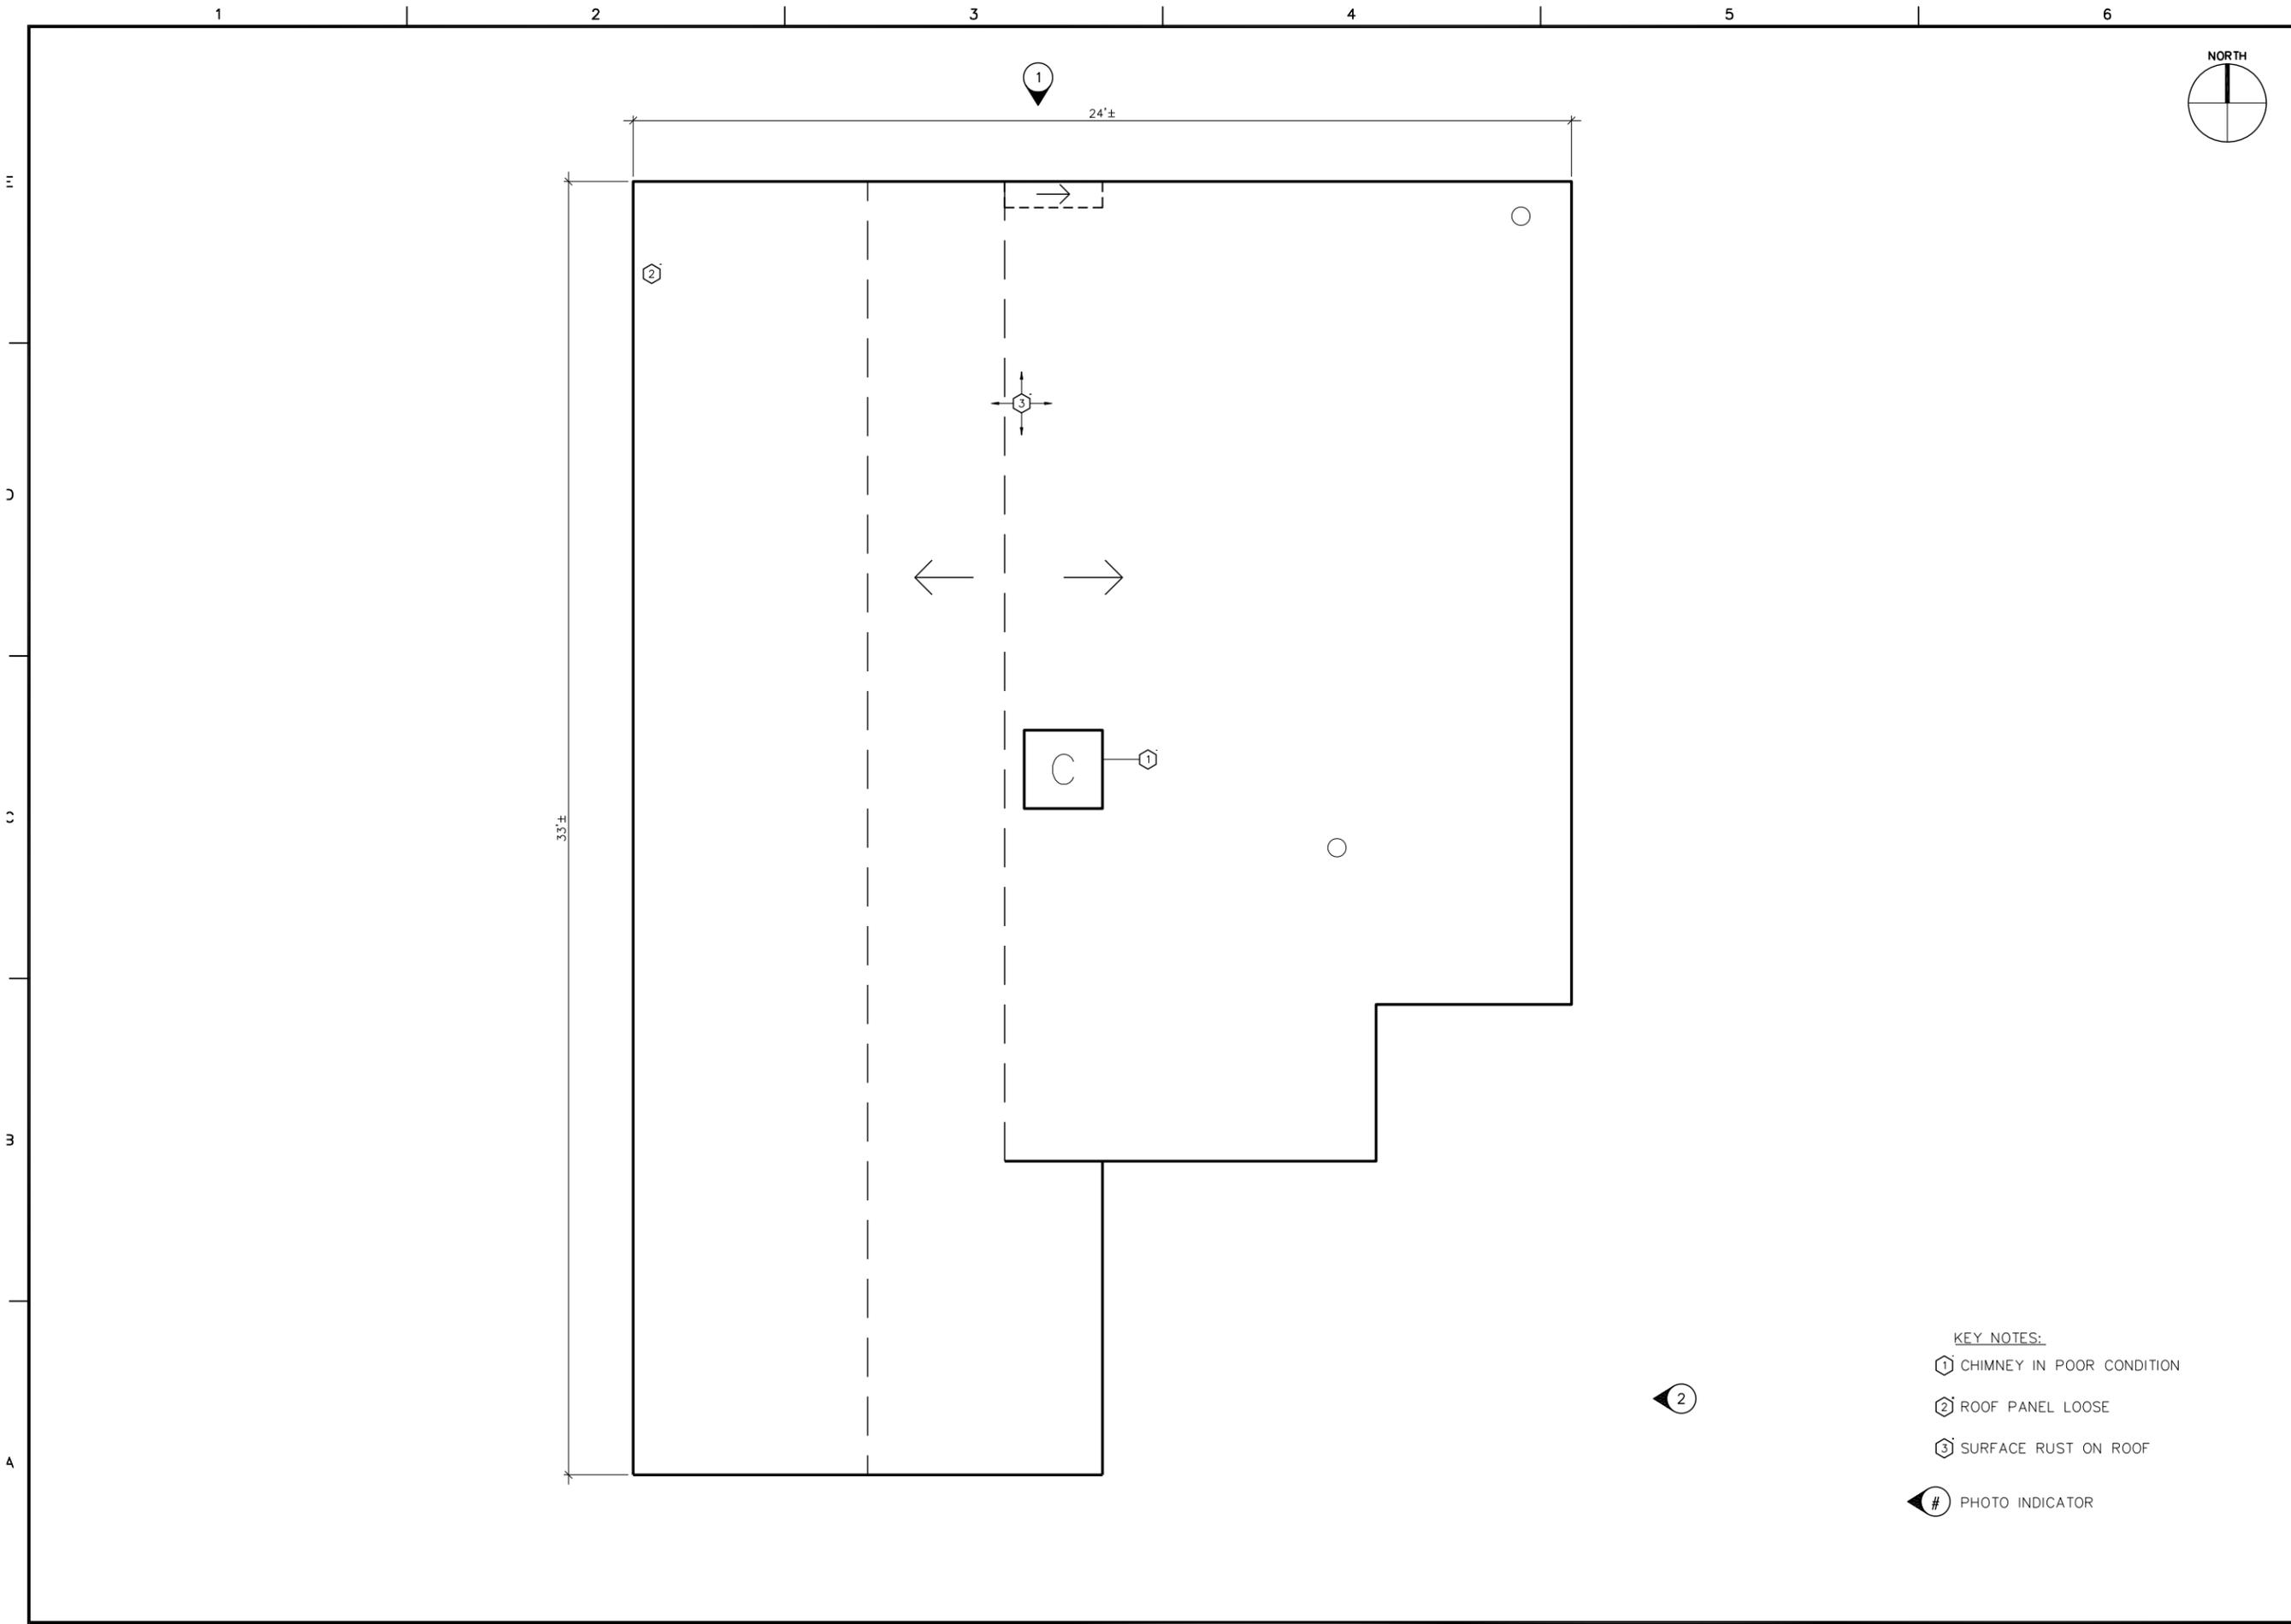
- KEY NOTES:**
- ① CHIMNEY IN POOR CONDITION
  - ② ROOF PANEL LOOSE
  - ③ SURFACE RUST ON ROOF
  - ④ PHOTO INDICATOR

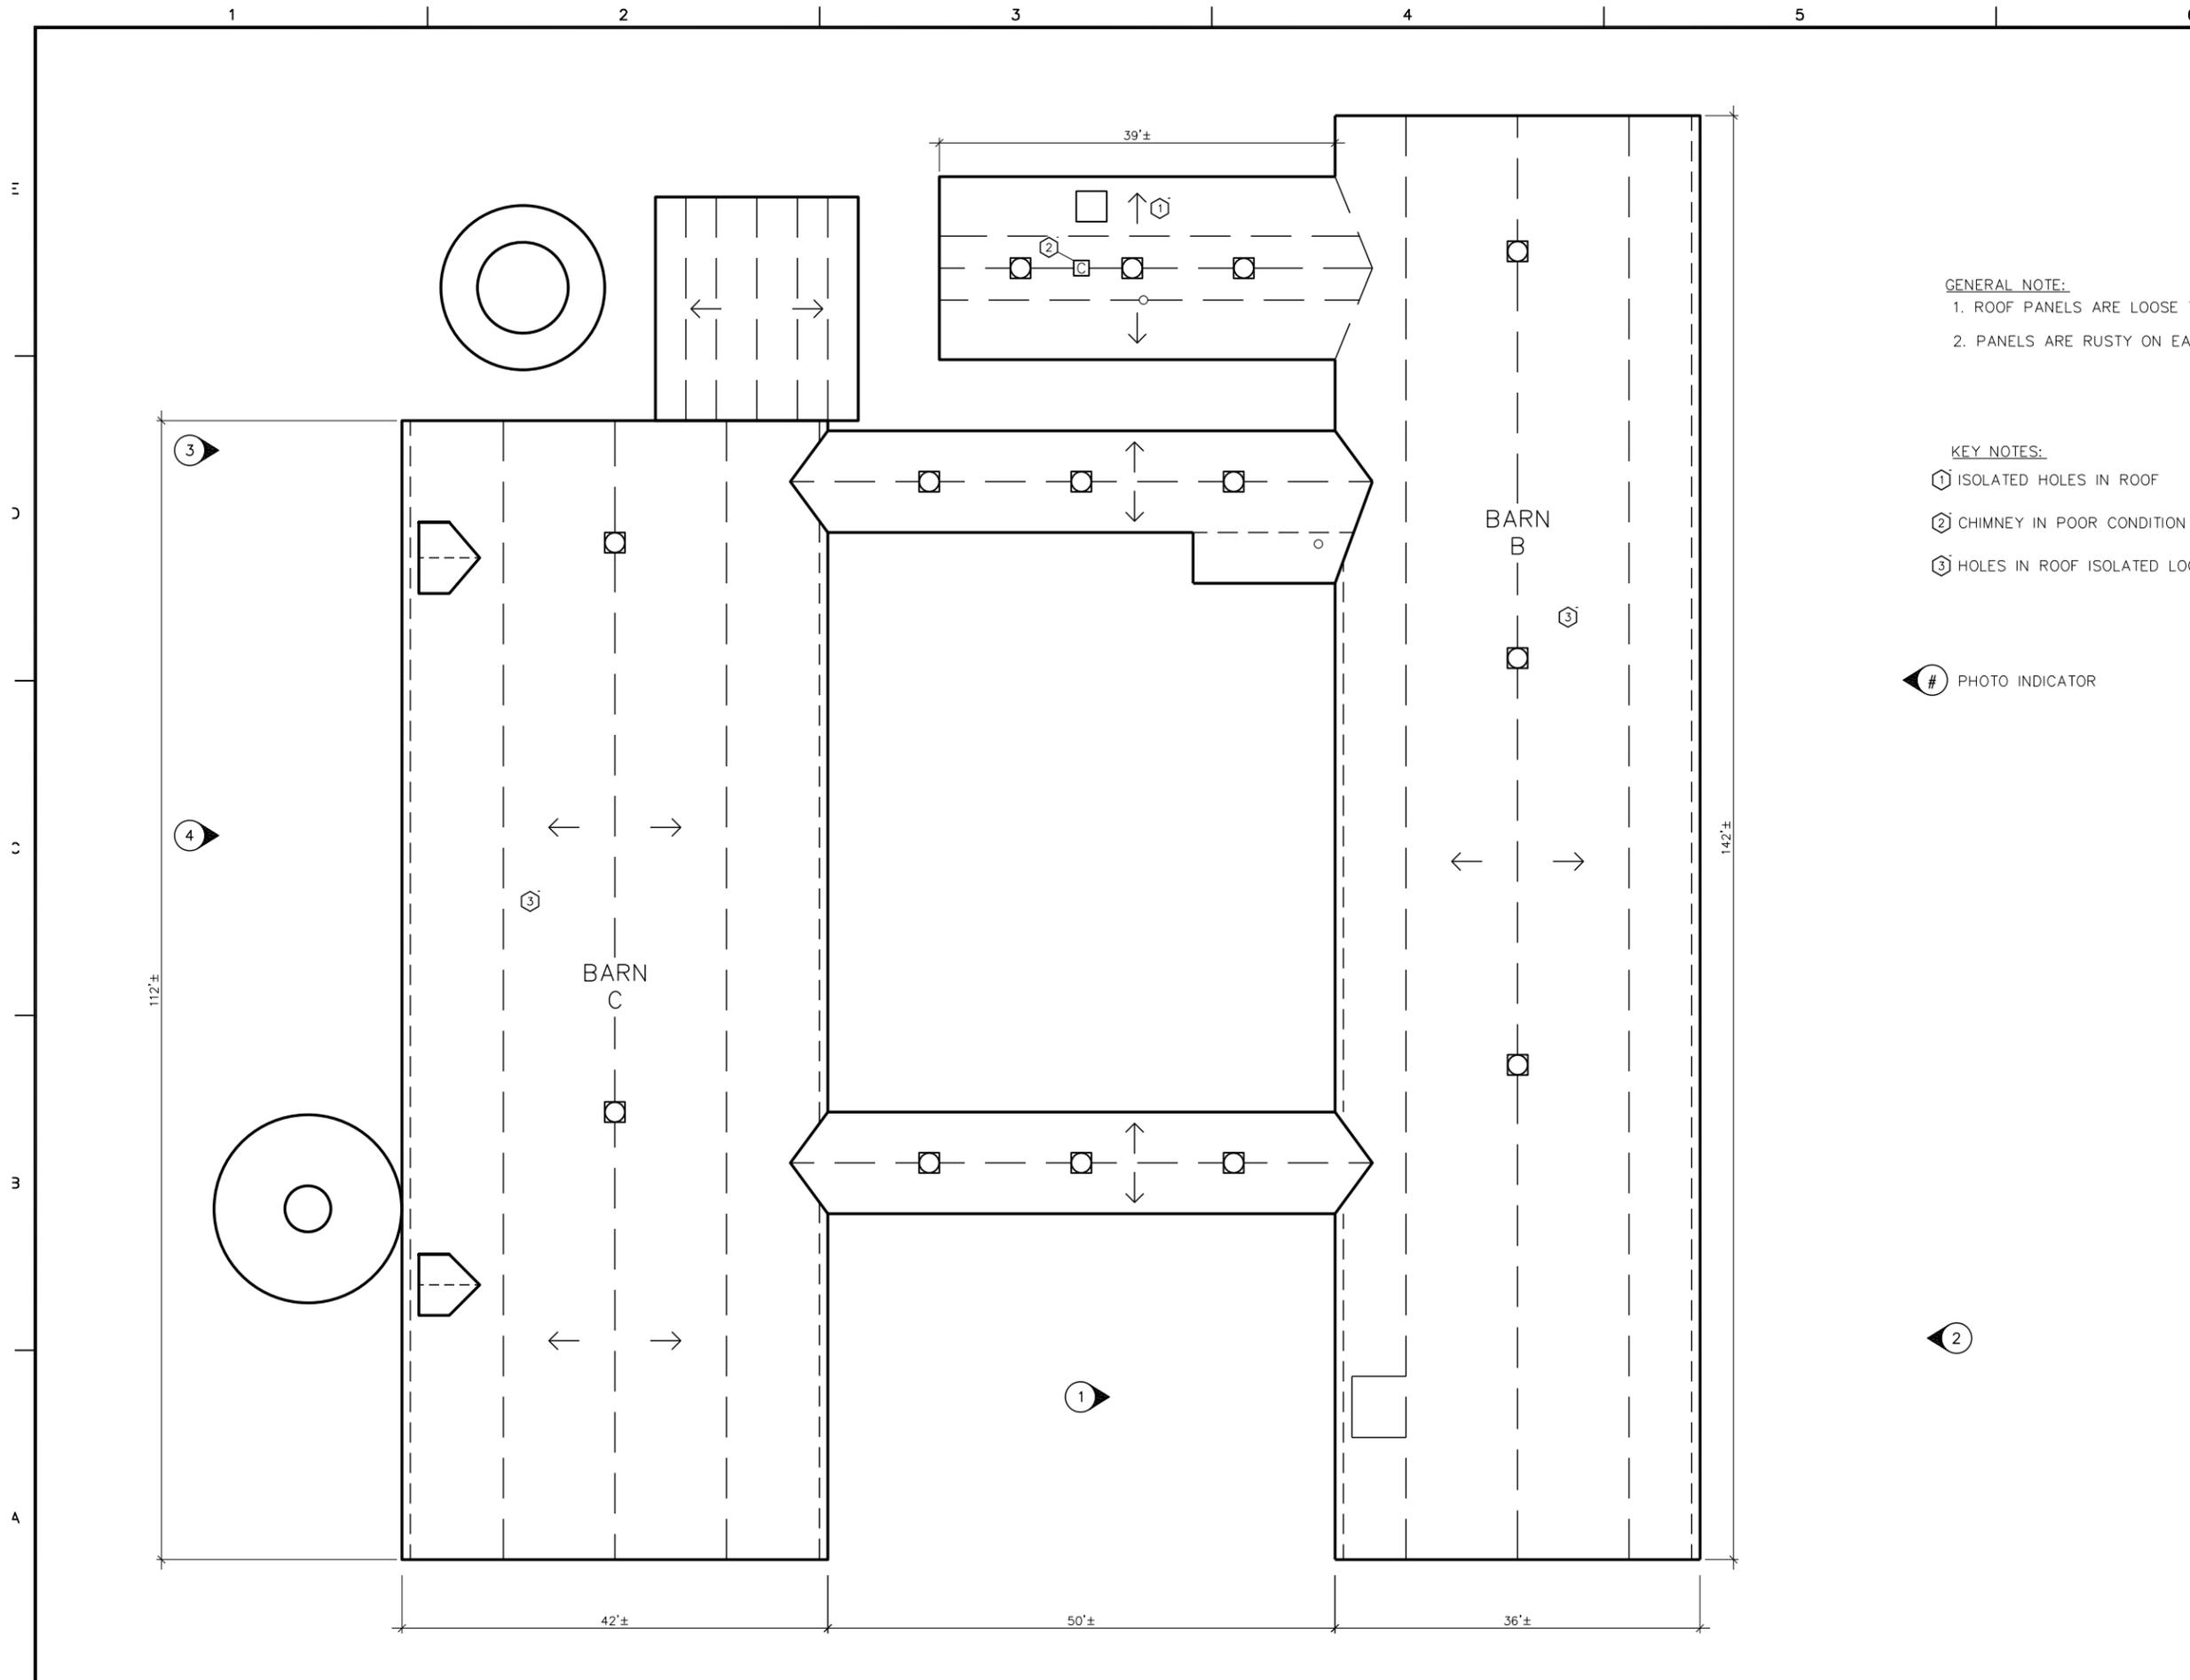
**GENERAL NOTE:**  
 1. ROOF PANELS ARE LOOSE THROUGHOUT.  
 2. PANELS ARE RUSTY ON EAVE EDGE.
