**CITY OF ROCKVILLE**

**KING FARM FARMSTEAD PROPERTY**

**CONDITION ASSESSMENT**

DEPARTMENT OF RECREATION AND PARKS  
JULY 3, 2014

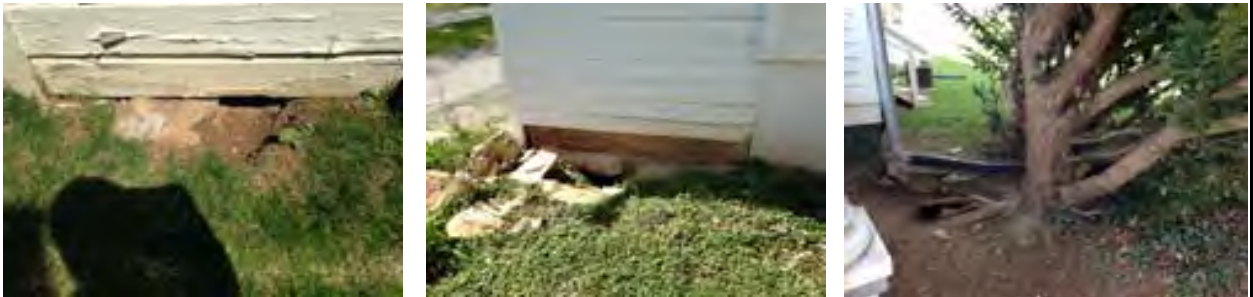
| King Farm Property Condition Assessment | |
|---|---|
| Condition / Deficiency Report | Report Number: BLDG 0-1 |

| King Farm Property Condition Assessment | |
|---|---|
| <p>Site wide evidence of groundhogs.</p> | |

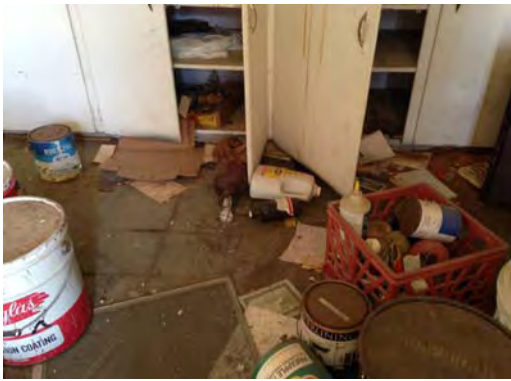
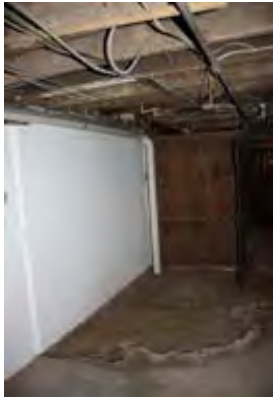
| King Farm Property Condition Assessment | |
|---|---|
| <p>Possible hazardous materials were visually observed in a number of buildings around the site, and are likely present throughout the buildings on the site due to the age of the structures and common use of these materials in the construction process over this time period.</p> | |

| King Farm Property Condition Assessment | |
|---|---|
| <p>A comprehensive hazardous materials survey is necessary to determine the extent of hazardous materials present and the amount of remediation required. Hire an appropriately credentialed and qualified professional service firm to perform these tasks. The estimated cost for this line item concerns solely the hazardous materials survey and associated report - the extent of the remediation effort required (and associated costs) can not be determined until this survey is completed.</p> | |

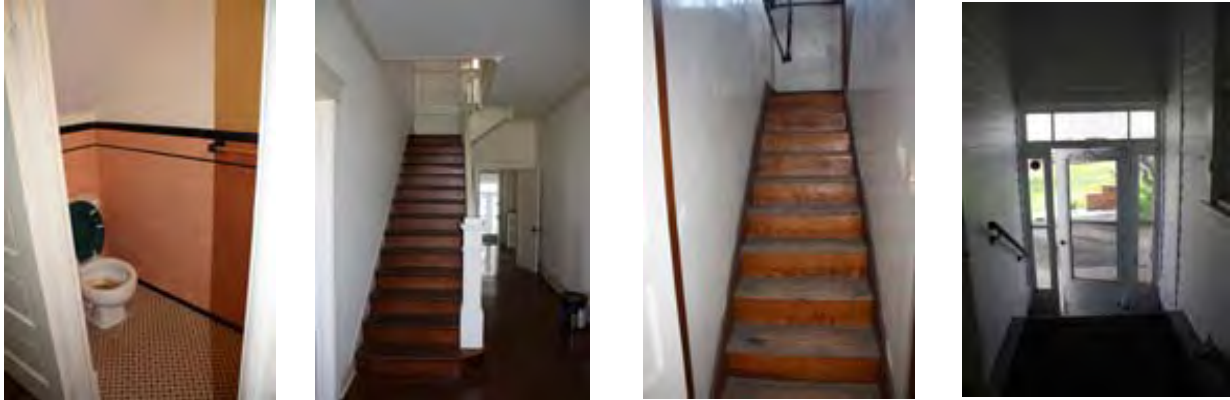
| King Farm Property Condition Assessment | |
|---|---|
| <p>1. There is no accessible restroom available on first floor.</p> <p>2. There is no available accessible entrance for the building. The rear entrance provides the closest vertical height differential from grade, roughly 21".</p> <p>3. There is no accessible means of access to the second floor.</p> | |

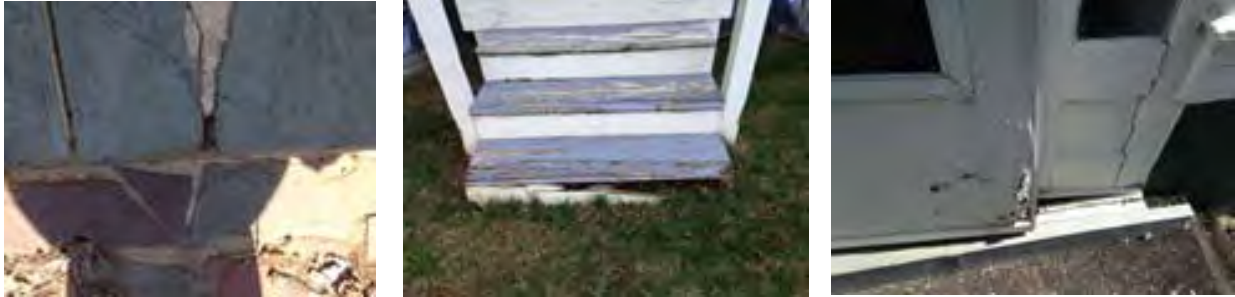
| King Farm Property Condition Assessment | |
|---|---|
| <p>1. Slate path @ elevation B has broken and loose stones. Rusted nails are exposed and grout is deteriorating.</p> <p>2. Deteriorated stoop @ elevation D. Stairs deteriorated @ ground level and railing has exposed, rusted nails. Deteriorated screen door.</p> <p>3. Door surround @ elevation A warped - sidelight bent with strong vertical crack. Stoop buckled and wood molding delaminated.</p> <p>4. Rear porch screen door missing latch and handle.</p> | |

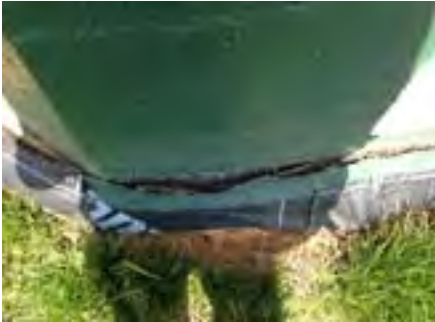
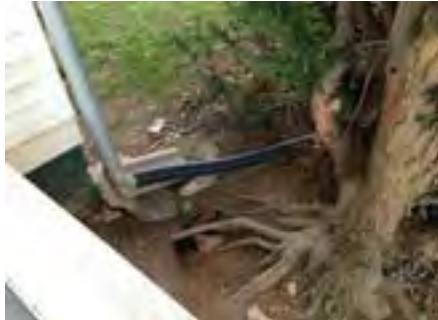
| King Farm Property Condition Assessment | |
|---|---|
| <ol style="list-style-type: none"> <li>1. Delaminating flashing/moisture protection @ elevation B and D;</li> <li>2. Tree roots very close to foundation @ front porch.</li> </ol> | |

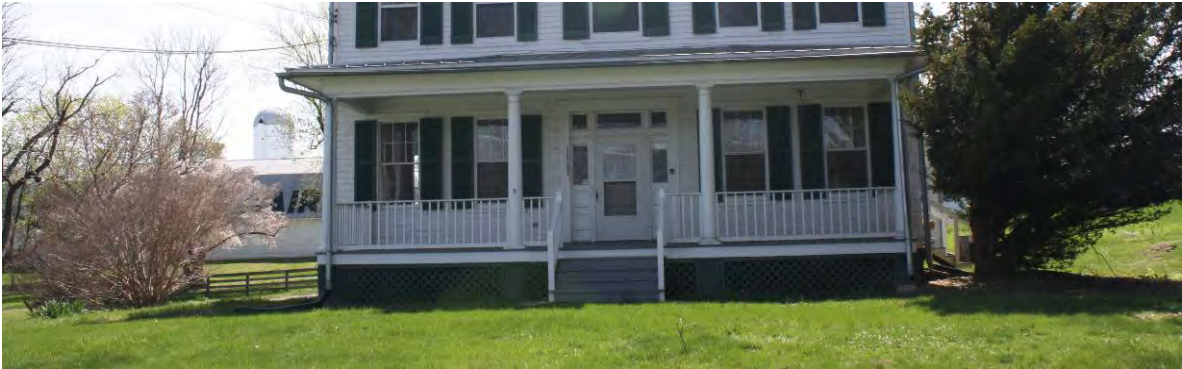
| King Farm Property Condition Assessment | |
|---|---|
| <p>Soundness of porch floor framing is unknown, but porch appears to have slight dip towards the center.</p> | |

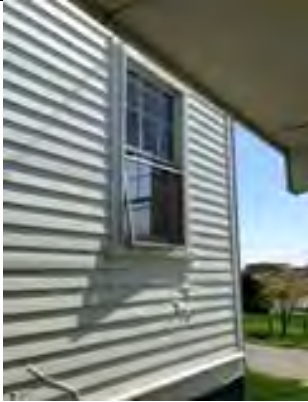
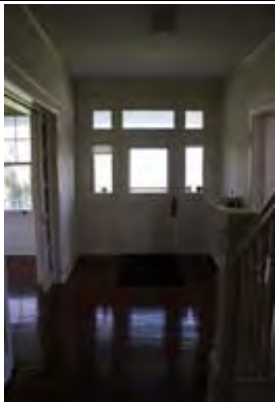
| King Farm Property Condition Assessment | |
|---|---|
| <ol style="list-style-type: none"> <li>1. Metal latch @ bottom of shutters broken, missing or loose.</li> <li>2. Damage, rot @ shutters. 58 shutters total.</li> <li>3. Missing or damaged screens @ 30 of the 44 double hung windows.</li> <li>4. Some windows are exhibiting some minor deterioration.</li> </ol> | |

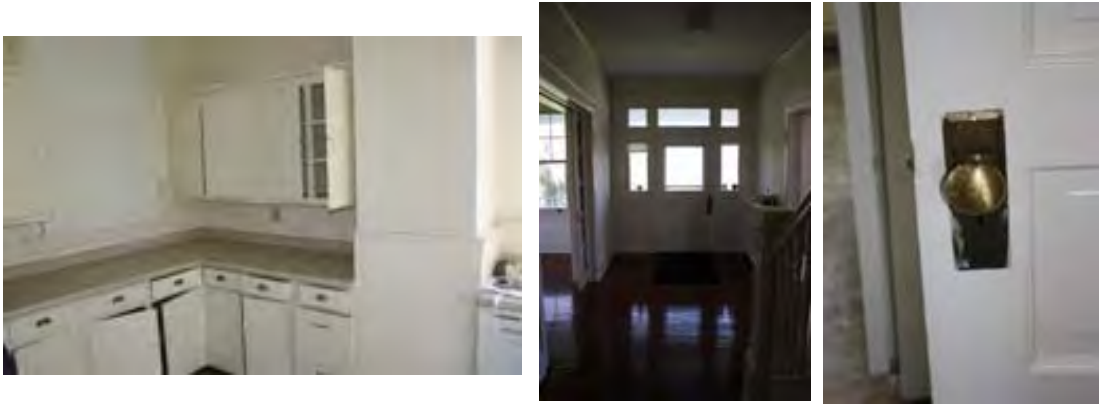
| King Farm Property Condition Assessment | |
|---|---|
| <ol style="list-style-type: none"> <li>1. All door handles are noncompliant.</li> <li>2. Hardware in kitchen is painted over. Latches on uppers nonfunctional.</li> <li>3. Sliding pocket doors on either side of room 1 stick and are very difficult to use.</li> </ol> | |

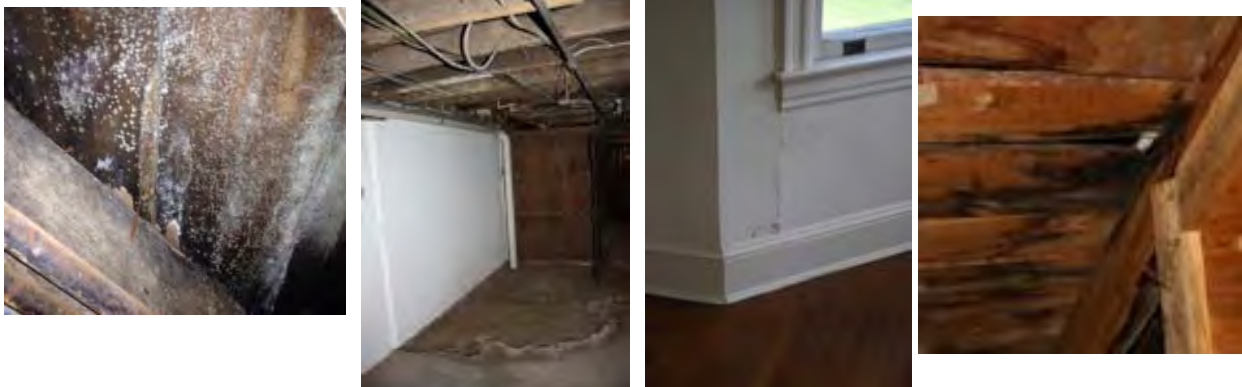
| King Farm Property Condition Assessment | |
|---|---|
| <ol style="list-style-type: none"> <li>1. Soft spot beneath vinyl flooring in kitchen @ pantry open doorway. Water damage @ floor deck;</li> <li>2. Staining and drywall cracks @ bay window;</li> <li>3. Staining @ rafters in attic;</li> <li>4. Stained concrete @ basement floor.</li> </ol> | |

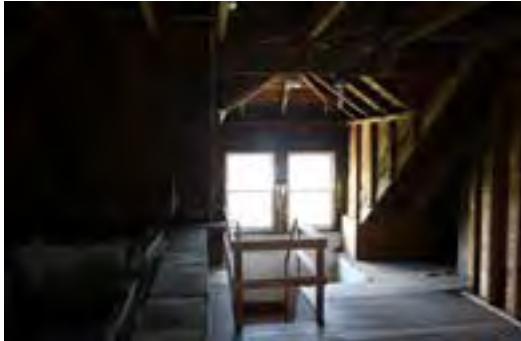
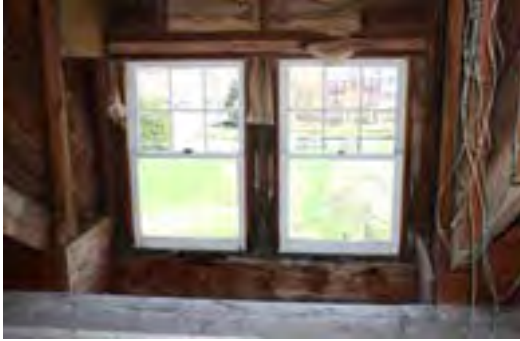
| King Farm Property Condition Assessment | |
|---|---|
| The attic space is not insulated. | |

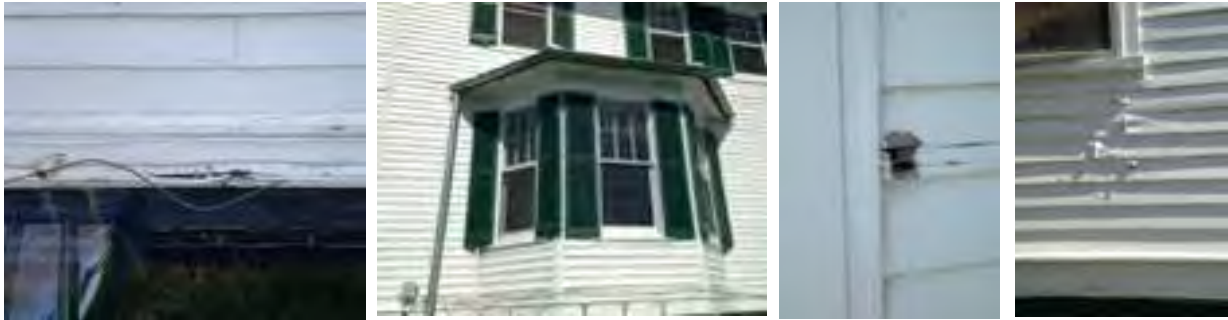
| King Farm Property Condition Assessment | |
|---|---|
| <ol style="list-style-type: none"> <li>1. Deteriorated conduit @ elevation B and D;</li> <li>2. Unused brackets @ elevation B;</li> <li>3. Soft, deteriorated siding @ elevation A porch;</li> <li>4. Flaking and chipped paint @ all elevations.</li> </ol> | |

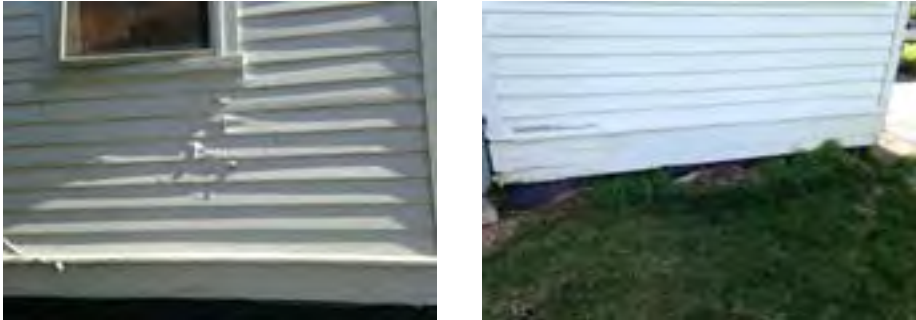
| King Farm Property Condition Assessment | |
|---|---|
| <p>Flaking and chipped paint @ all elevations.</p> | |

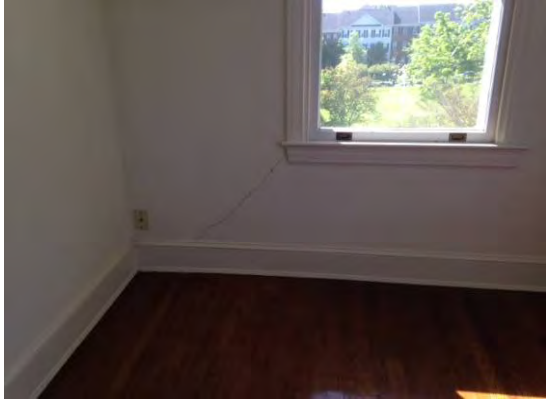
| King Farm Property Condition Assessment | |
|---|---|
| <p>Minor cracks throughout the interior. Flaking paint.</p> | |

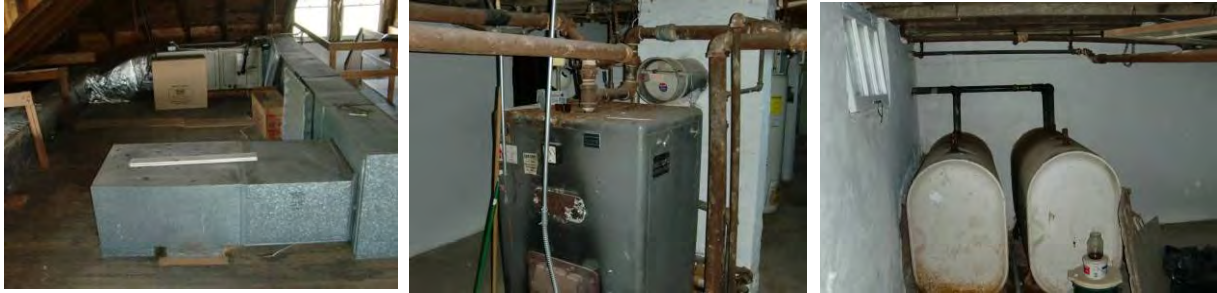
| King Farm Property Condition Assessment | |
|---|---|
| <p>Existing A/C system is roughly 30 years old. Existing system is nonfunctional and only serves the 2nd floor area (previous bedrooms). No A/C is provided on the 1st floor.</p> <p>Existing oil fired boiler is operational, but very old (See 1-14).</p> | |

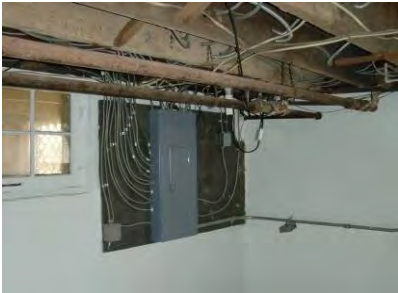
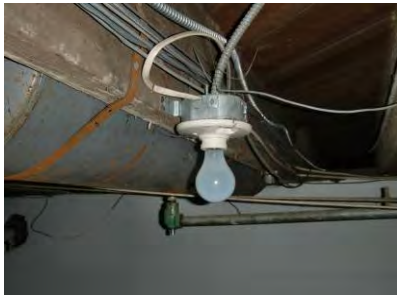
| King Farm Property Condition Assessment | |
|---|---|
| <p>1. A 200A Square D panel was installed in 2004. Wiring was partially upgraded at that time. The condition of the concealed wiring is unknown. MC, romex and "rag" wire are visually present;</p> <p>2. The existing building is served by an ADEMCO VISTA 40 system. Condition is unknown, although city staff indicates that no security alarm system is functional.</p> | |

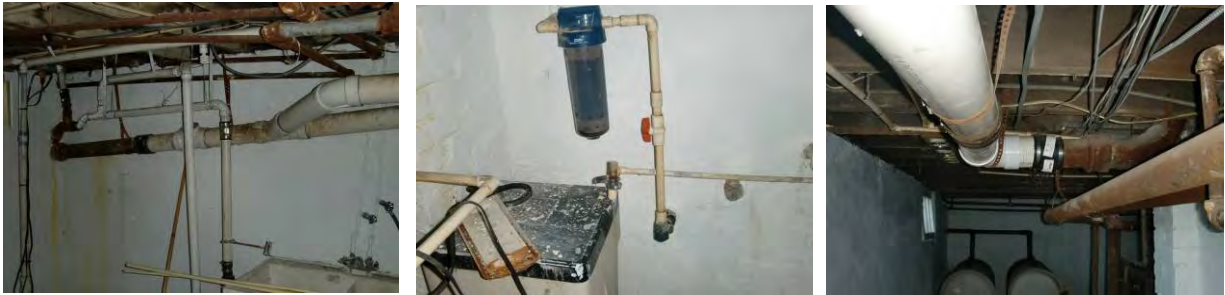
| King Farm Property Condition Assessment | |
|---|---|
| <p>1. Sanitary waste and vent piping is a mixture of materials (cast iron, galvanized pipe, pvc). Not code compliant;</p> <p>2. Domestic water piping is a mixture of materials - copper/cpvc. Poor workmanship. Not code compliant;</p> <p>3. Existing oil fired boiler is operational, but very old. Existing boiler is rated 235 MBH. No zone control valves are present to regulate heat in the individual rooms.</p> | |

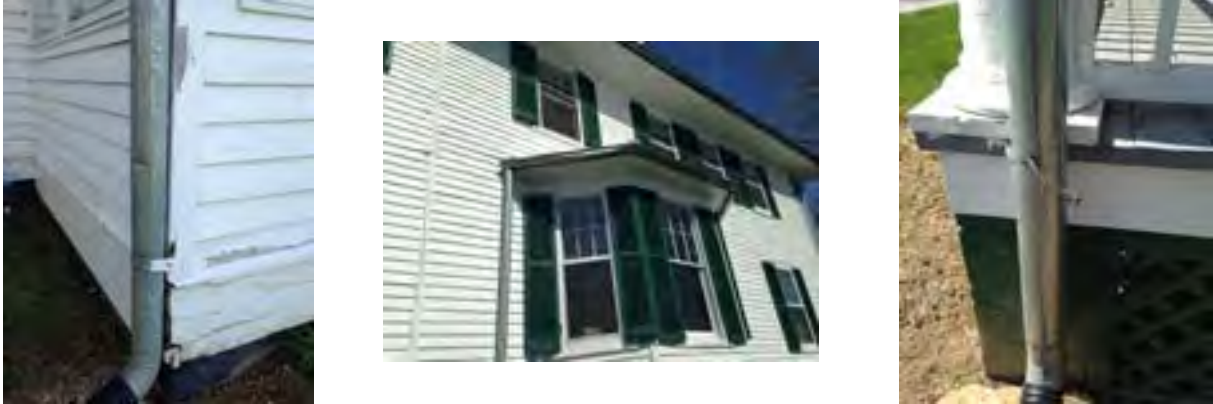
| King Farm Property Condition Assessment | |
|---|---|
| <ol style="list-style-type: none"> <li>1. Warped gutter @ bay window on elevation B;</li> <li>2. Deteriorated, rusted, separated and twisted downspout straps and brackets;</li> <li>3. Missing gutter guards.</li> </ol> | |

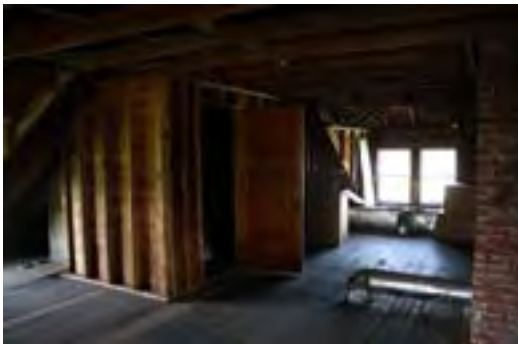
| King Farm Property Condition Assessment | |
|---|---|
| <p>1. Roof appears to have been recently replaced. Will need further inspection to ensure condition.</p> <p>2. The roof framing appears sound.</p> | |

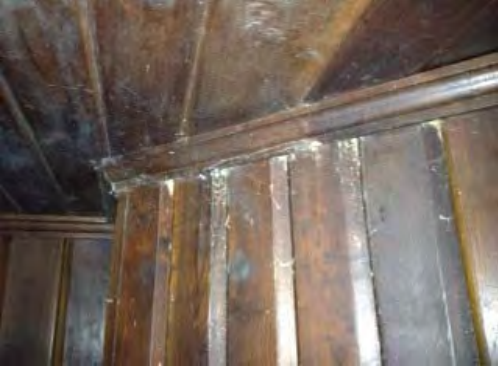
| King Farm Property Condition Assessment | |
|---|---|
| Evidence of termite damage in basement. Extent of damage is unknown. | |

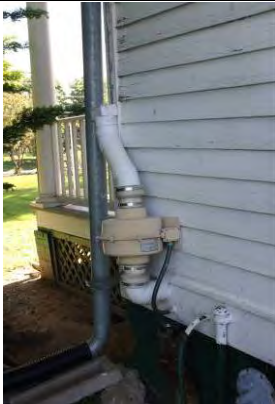
| King Farm Property Condition Assessment | |
|---|---|
| <p>Exterior radon drain @ elevation corner C-D is open to the elements.</p> | |

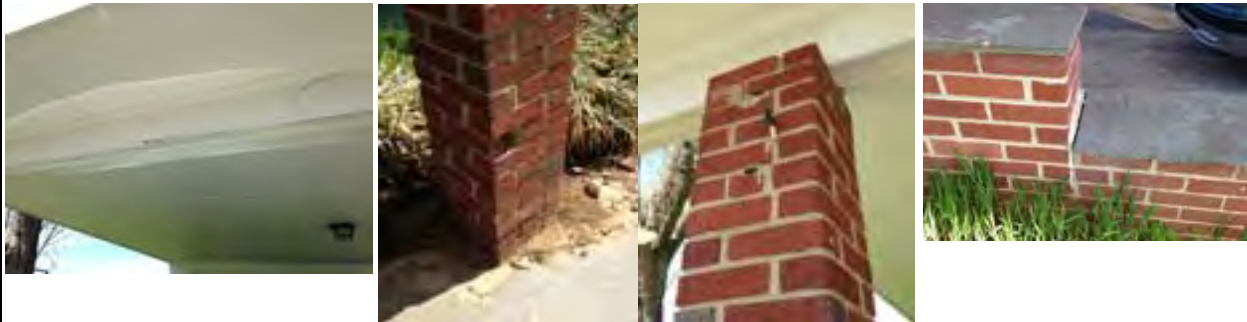
| King Farm Property Condition Assessment | |
|---|---|
| <ol style="list-style-type: none"> <li>1. Contact damage @ wood box beam;</li> <li>2. Exposed wire ends with missing lighting fixture @ columns 1, 3 and 4;</li> <li>3. Crumbling brick @ column 1.</li> <li>4. Deteriorated grout @ stepped brick half wall along column 3.</li> </ol> | |

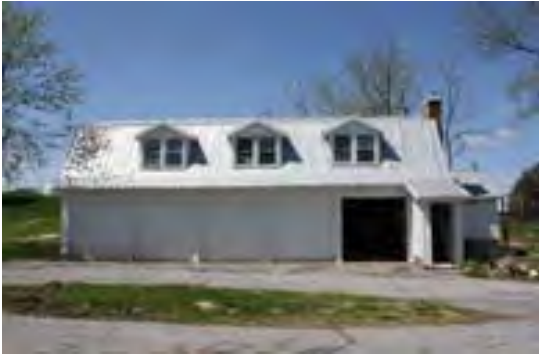
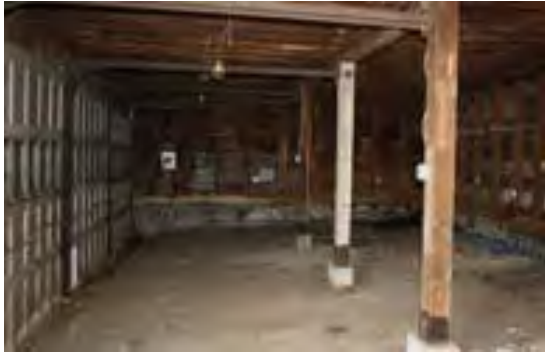
| King Farm Property Condition Assessment | |
|---|---|
| <ol style="list-style-type: none"> <li>Garage currently does not contain a code compliant means of egress.</li> <li>Second floor contains only one means of egress.</li> </ol> | |

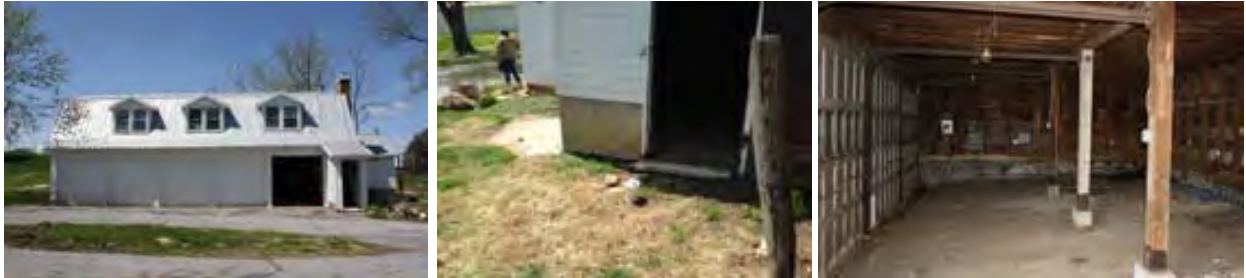
| King Farm Property Condition Assessment | |
|---|---|
| <p>1. No accessible entrance to 2nd floor or smoke room. Pipe stack in front of smoke room blocking possibility of ADA compliant access.</p> <p>2. The garage space has no man door and the floor has an aggressive slope.</p> | |

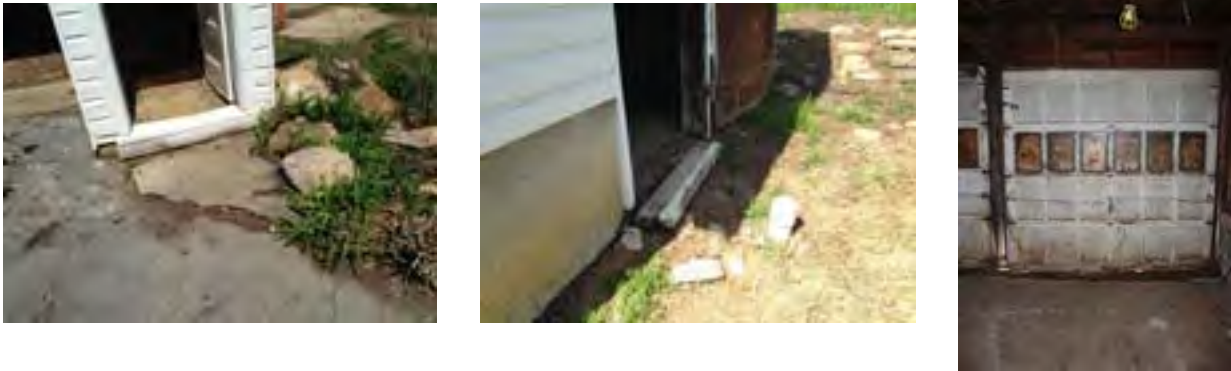
| King Farm Property Condition Assessment | |
|---|---|
| <p>1. Entry pad to second floor is deteriorated. There is no current entry pad to the smoke room.</p> | |

| King Farm Property Condition Assessment | |
|---|---|
| <p>1. Remove deteriorated concrete and replace with a 5'-0" x 5'-0" concrete pad. Provide concrete entry pad @ the smoke room door. Remove capped pipe.</p> | |

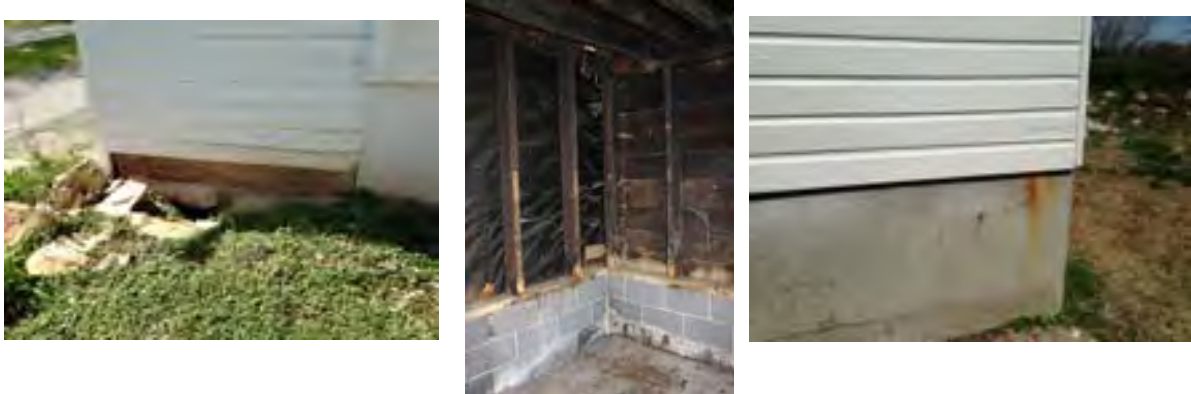
| King Farm Property Condition Assessment | |
|---|---|
| Condition / Deficiency Report | Report Number: BLDG 2 - 4 |

| King Farm Property Condition Assessment | |
|---|---|
| <p>Cracking in brick foundation @ second floor entrance and CMU in smoke room under sill.</p> <p>Stained and cracked parging @ smoke room.</p> | |

| King Farm Property Condition Assessment | |
|---|---|
| <p>Repoint existing brick and CMU. Remove and replace parging @ smoke room. Clean and parge elevation C. See R-13.</p> | |

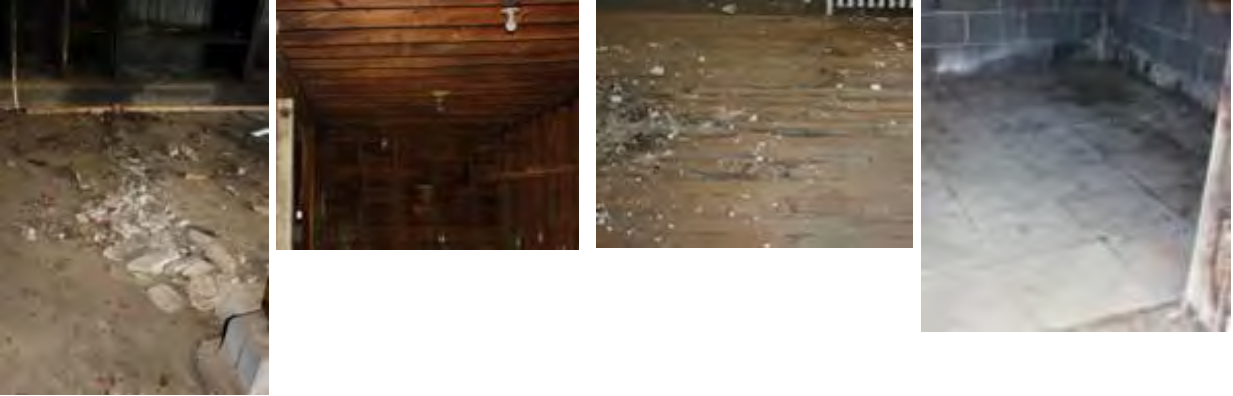
| King Farm Property Condition Assessment | |
|---|---|
| <ol style="list-style-type: none"> <li>1. Garage floor significantly deteriorated.</li> <li>2. Second floor joists are bowed. Floor is undersized for residential LL. Floor capacity is below code, with an estimated LL capacity of 20 psf.</li> <li>3. Concrete tiled floor in smoke room deteriorated.</li> </ol> | |

| King Farm Property Condition Assessment | |
|---|---|
| <ol style="list-style-type: none"> <li>1. Repair concrete floor. Cut out 12" wide at cracks, dowel to existing and place new concrete.</li> <li>2. No action needed to stabilize.</li> <li>3. Repair and repoint smoke room floor as needed.</li> </ol> | |

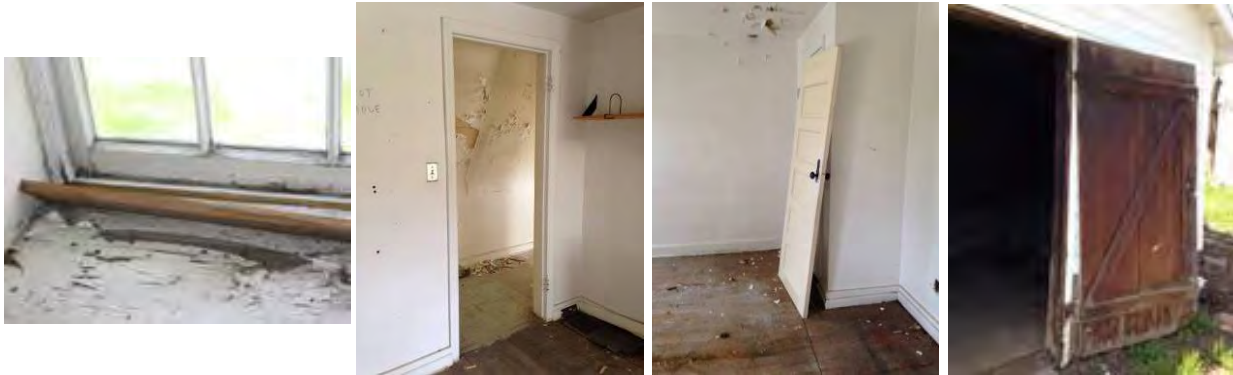
| King Farm Property Condition Assessment | |
|---|---|
| Condition / Deficiency Report | Report Number: BLDG 2 - 6 |

| King Farm Property Condition Assessment | |
|---|---|
| <p>1. The 11 windows on the second floor have deteriorated sills. The window assemblies themselves are also in poor condition.</p> <p>2. Doors are strewn about the apt.</p> | |

| King Farm Property Condition Assessment | |
|---|---|
| <p>1. Replace 4'-0" x 2'-0" windows with 6/6 replicas. Repair sills and flashing where necessary. See 2-7.</p> <p>2. Remove and retain existing doors on 2nd floor for possible reuse.</p> | |

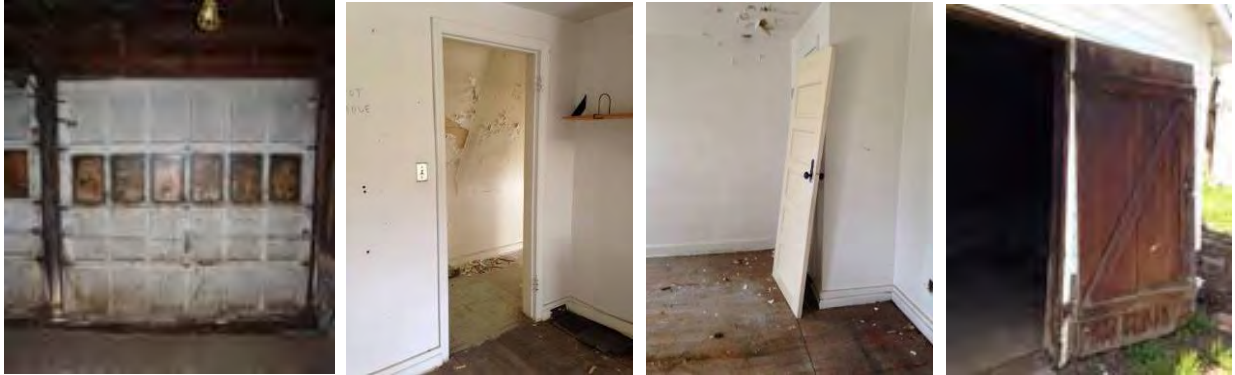
| King Farm Property Condition Assessment | |
|---|---|
| <ol style="list-style-type: none"> <li>1. Some of the 8 doors, while present, have been removed from their frames.</li> <li>2. Exterior door to second floor is in poor condition.</li> <li>3. The door to the smoke room is in poor condition.</li> <li>4. The garage doors are non-operable and in poor condition.</li> </ol> | |

| King Farm Property Condition Assessment | |
|---|---|
| <ol style="list-style-type: none"> <li>1. Keep existing doors in place and install those that have been removed. Replace hardware with levers. Make any minor repairs necessary on the door frames. Prep for paint.</li> <li>2. Repair the exterior door to the second floor and prepare for paint. Replace the glass.</li> <li>3. Replace 3'-6" x 7'-0" smoke room door with replica. Reuse hardware (other than door handles) after cleaning. Prep for paint.</li> <li>4. Replace 5 garage doors with custom replicas. The future use will determine if the doors are operable or non-operable and sealed.</li> </ol> | |

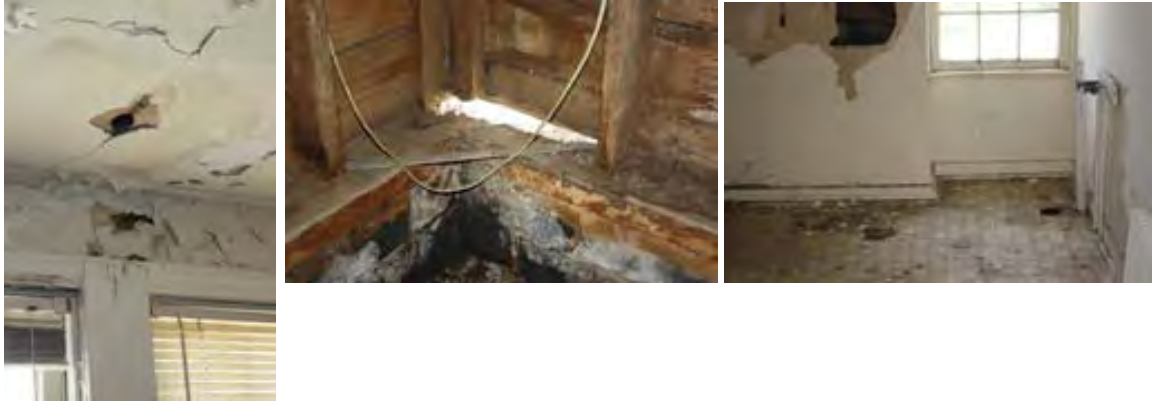
| King Farm Property Condition Assessment | |
|---|---|
| <p>1. Significant water damage @ elevation D side of apartment. Water damage and deteriorated gypsum board.</p> <p>2. Holes in floor. Significant water damage on floors and ceiling throughout apartment.</p> <p>3. Evident sill rot @ elevation C-D interior corner. Rusted bands and mold growth. Extensive water damage on wood sheathing. Damaged top plate.</p> | |

| King Farm Property Condition Assessment | |
|---|---|
| <p>1-2. Take the apartment down to studs and subfloor, including removal of cabinetry. Retain door frames, floor boards and doors. See 2-8, 2-6 and 2-5.</p> <p>3. Remove 16'-0" of foundation wall, top plate and sill, support as needed. Replace corner studs, leave siding in place. Replace assembly, including 6 2x6 studs and adding 2x6 to ceiling for extra support.</p> | |

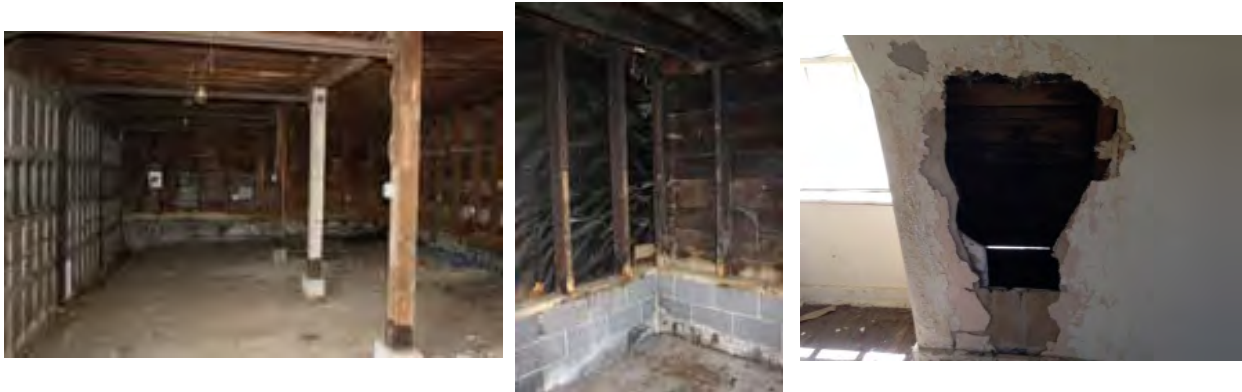
| King Farm Property Condition Assessment | |
|---|---|
| <ol style="list-style-type: none"> <li>1. Garage is not insulated.</li> <li>2. Smoke room is not insulated.</li> <li>3. Insulation on second floor is in poor condition or missing.</li> </ol> | |

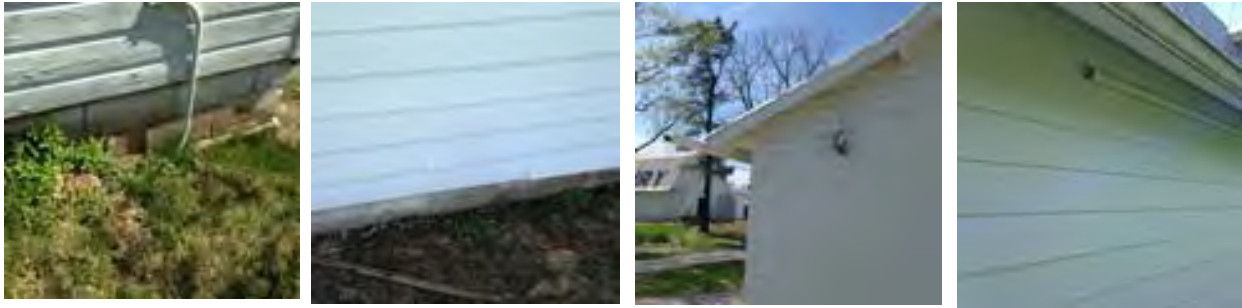
| King Farm Property Condition Assessment | |
|---|---|
| Condition / Deficiency Report | Report Number: BLDG 2 - 9 |

| King Farm Property Condition Assessment | |
|---|---|
| <p>Chipped wood siding @ all elevations. Wires and pipes mounted on siding. Small penetrations for wires painted over without removing the penetration obstruction or filling the penetration itself.</p> | |

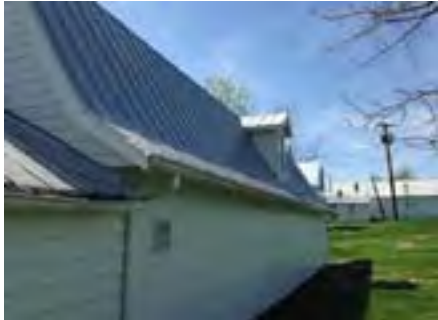
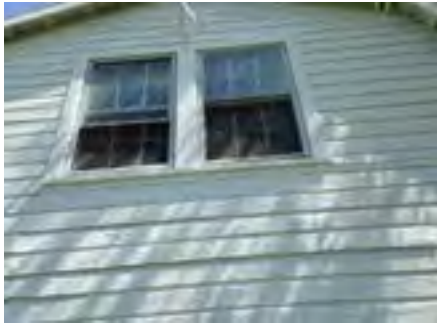
| King Farm Property Condition Assessment | |
|---|---|
| Condition / Deficiency Report | Report Number: BLDG 2 - 10 |

| King Farm Property Condition Assessment | |
|---|---|
| Current paint job masks, but does not remedy siding problems. | |

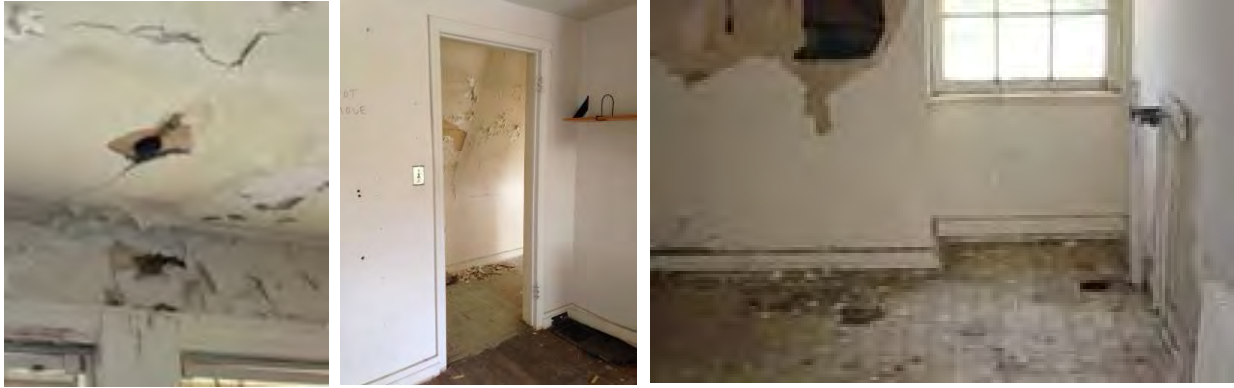
| King Farm Property Condition Assessment | |
|---|---|
| Condition / Deficiency Report | Report Number: BLDG 2 - 11 |

| King Farm Property Condition Assessment | |
|---|---|
| <p>Paint in severely deteriorated condition.</p> | |

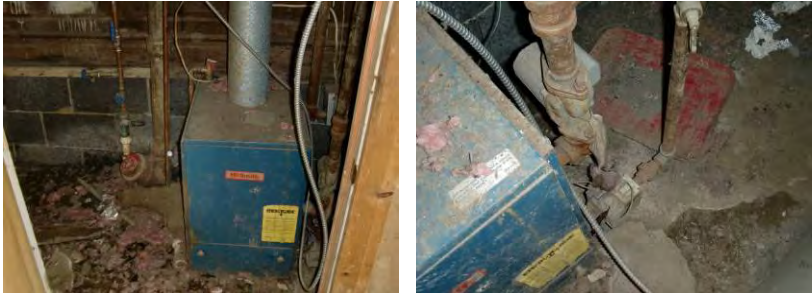
| King Farm Property Condition Assessment | |
|---|---|
| <p>Garage level is unheated. Gas fired boiler in the garage level feeds the apartment above. Boiler is 30 years old, and condition is unknown. Existing hot water heating piping is uninsulated steel feeding up to the hot water baseboard.</p> | |

| King Farm Property Condition Assessment | |
|---|---|
| <p>Replace corroded sections of piping. Patch and repair as necessary. Remove the existing boiler heating system in its entirety. Provide a new split system gas-fired furnace with add on cooling to serve the lower level of the garage. Air distribution shall be spiral sheet metal ductwork with sidewall duct diffuser. Assume a 3 ton HVAC system for the space. The unit shall be installed in an appropriately sized mechanical room and shall have economizer package along with a 7-day programmable thermostat. Provide a separate gas-fired split system heating / cooling with add on cooling to the upper level apartment area of the garage. Assume rectangular ductwork which would be concealable from bulkheads, utilizing sidewall diffusers and a central return. System for the upper level shall be assumed to be a 2 1/2 ton heating / cooling unit with economizer accessory and 7-day programmable thermostat.</p> | |

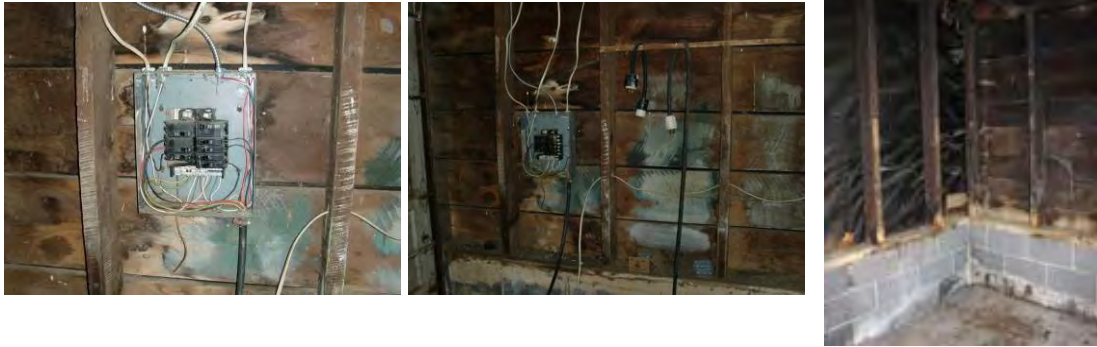
| King Farm Property Condition Assessment | |
|---|---|
| <p>Existing building does not have operating electrical service and distribution, panel and wiring methods are non-code compliant. There is no light fixture in the smoke room.</p> | |

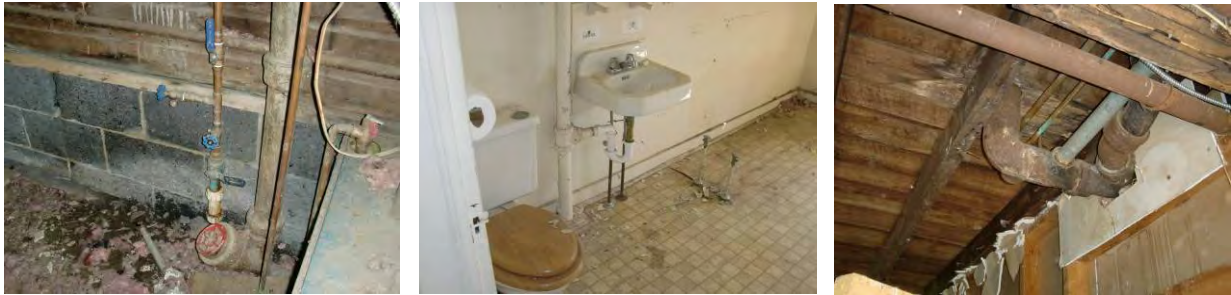
| King Farm Property Condition Assessment | |
|---|---|
| <p>1. Existing domestic cold water piping is uninsulated copper and cpvc. Piping is in poor condition and not code compliant.</p> <p>2. Existing sanitary piping is a mixture of cast iron, galvanized pipe, pvc and is not code compliant.</p> | |

| King Farm Property Condition Assessment | |
|---|---|
| <p>1. Replace corroded sections of piping. Patch and repair as necessary. Replumb the domestic water piping to the kitchen and bathroom above, provide new hot water heater.</p> <p>2. Replumb the sanitary waste and vent for the entire building. Replace all fixtures.</p> | |

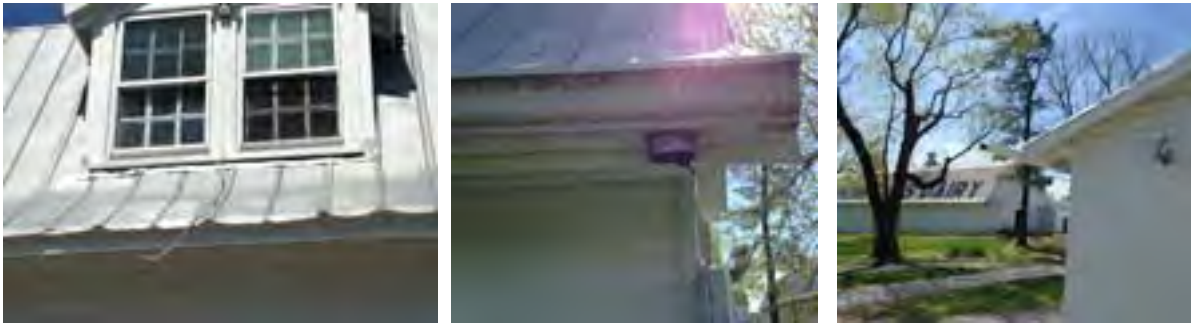
| King Farm Property Condition Assessment | |
|---|---|
| Condition / Deficiency Report | Report Number: BLDG 2 - 15 |

| King Farm Property Condition Assessment | |
|---|---|
| <p>1. Several sections of the roof line are missing gutters. Existing gutters are too small and full of debris. Rusted extended gutter above apartment entrance.</p> <p>2. Missing downspout @ C-D corner.</p> | |

| King Farm Property Condition Assessment | |
|---|---|
| <p>1-2. Add gutters where needed. See R-14. Replace gutters with 6" galvanized gutters and install coordinating downspouts. Install brackets and gutter guards as appropriate.</p> | |

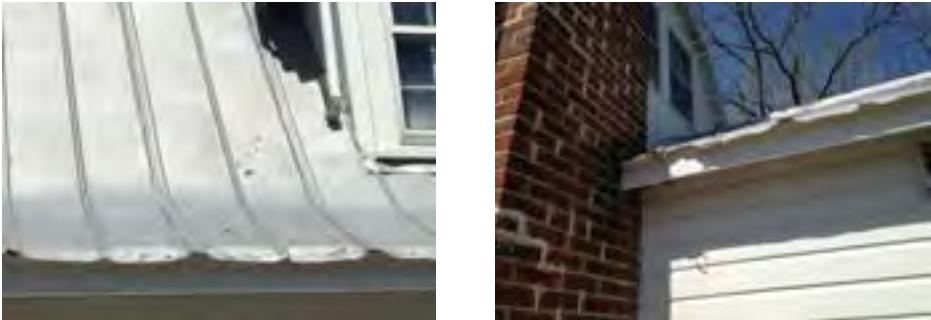
| King Farm Property Condition Assessment | |
|---|---|
| Condition / Deficiency Report | Report Number: BLDG 2 - 16 |

| King Farm Property Condition Assessment | |
|---|---|
| <p>Existing roof @ both smoke room and main structure are severely deteriorated. Random exposed wires and piping also present. Damage to roof framing due to water infiltration.</p> | |

| King Farm Property Condition Assessment | |
|---|---|
| <p>Replace roof @ both smoke room and main structure with standing seam roof. Remove extraneous exterior brackets, conduit, etc. Replace damaged framing members as necessary. Assume 20% of rafters and 10% of exterior studs will need to be replaced.</p> | |

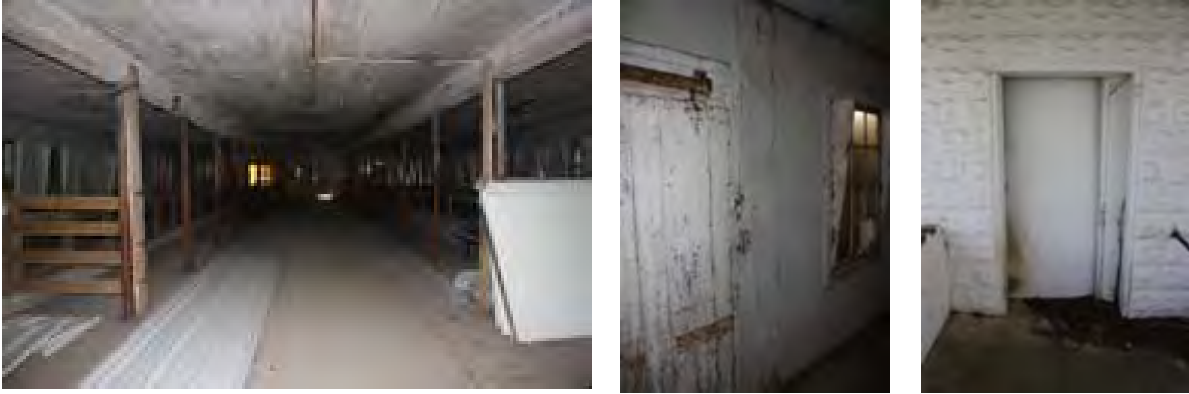
| King Farm Property Condition Assessment | |
|---|---|
| <p>1. Existing number of entrances/exits may accommodate a variety of proposed future uses, but all are in significant disrepair. Mechanisms of most are inoperable. See 3/4-6.</p> <p>2. Existing concrete curbs and cow railings block off side exits from the central aisle.</p> <p>3. There is no compliant means of egress from the attic area in either barn.</p> | |

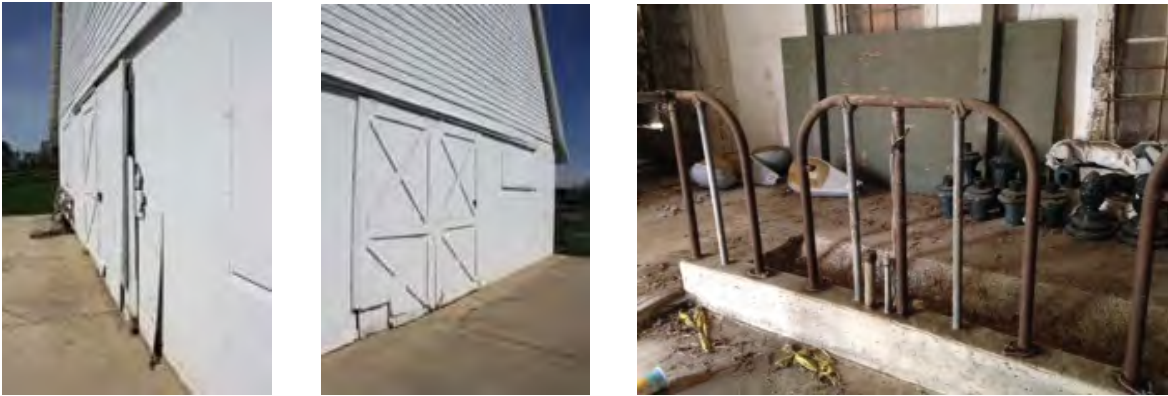
| King Farm Property Condition Assessment | |
|---|---|
| Condition / Deficiency Report | Report Number: BLDG 3/4 - 2 |

| King Farm Property Condition Assessment | |
|---|---|
| <p>Main entrances @ front and rear of both barns are the only openings that sit even with the driveway approach; The side aisles in both barns are not currently accessible. The ramps up are too short and have too high of a slope.</p> | |

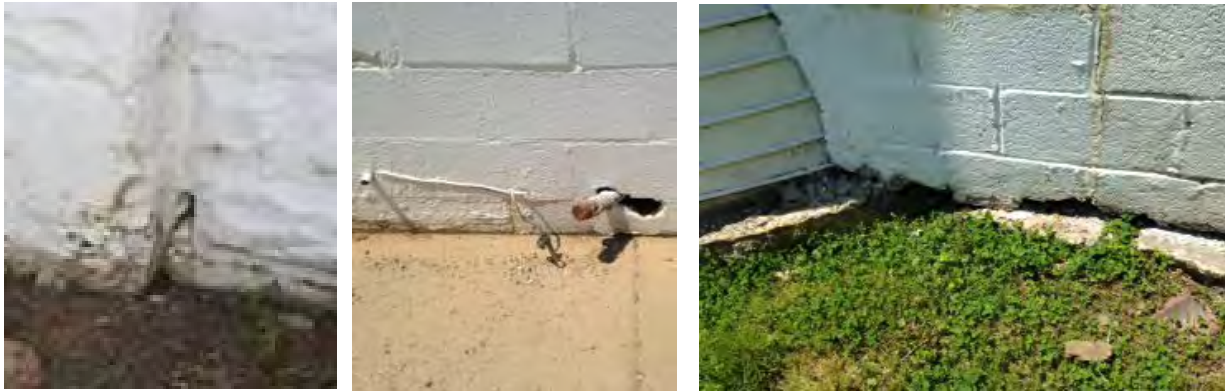
| King Farm Property Condition Assessment | |
|---|---|
| Condition / Deficiency Report | Report Number: BLDG 3/4 - 4 |

| King Farm Property Condition Assessment | |
|---|---|
| <p>CMU deterioration @ seam on elevation D. Old piping penetration migrating through deteriorated CMU @ elevation C. Disintegrated CMU @ silo on elevation B.</p> | |

| King Farm Property Condition Assessment | |
|---|---|
| <p>Patch and repair as necessary.</p> | |

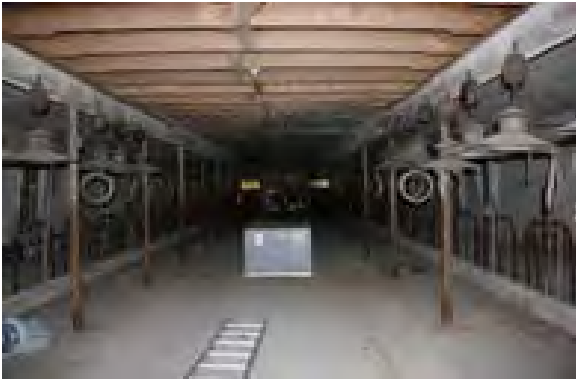
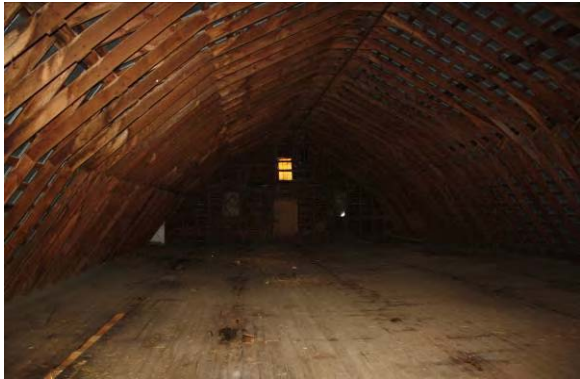
| King Farm Property Condition Assessment | | | |
|---|---|---|---|
| <ol style="list-style-type: none"> <li>1. There are patches of deterioration in the concrete @ aisles 1, 2, and 3 in both barns.</li> <li>2. Flooring @ room 4 deteriorated.</li> <li>3. Attic floor in both barns shows damage and wear.</li> </ol> | | | |

| King Farm Property Condition Assessment | | | |
|---|---|---|---|
| <p>1-2. Repair curbs and patch as needed prior to leveling the surface @ all aisles. Patch and repair concrete floor as needed.</p> <p>3. In barn 3, replace missing tongue and groove ceiling @ the front of aisle 1, approx. 364 sf. In barn 3, replace approx. 20% wood deck in attic with plywood. In barn 4, replace approx. 80% wood deck in attic with plywood. Replace attic floor joists as needed, minor in barn 3, approx. 50% in barn 4. Existing attic floors in both barns (when repaired) only meet LL capacity of 20 psf.</p> | | | |

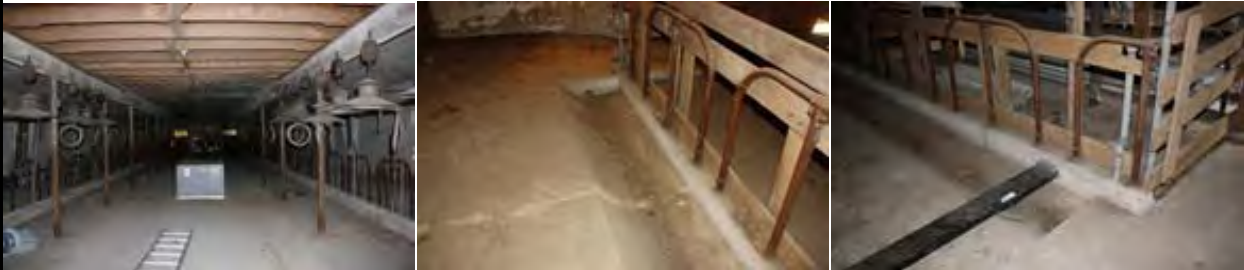
| King Farm Property Condition Assessment | |
|---|---|
| Condition / Deficiency Report | Report Number: BLDG 3/4 - 5A |

| King Farm Property Condition Assessment | |
|---|---|
| <p>In both barns: Floor is not level @ area 1, 2 and 3; The central aisle is concavely shaped along its short dimension. Height of curve approx. 1 1/2"; 6" curbs and 9" deep troughs are formed into the concrete @ aisles 2 and 3 in both barns.</p> | |

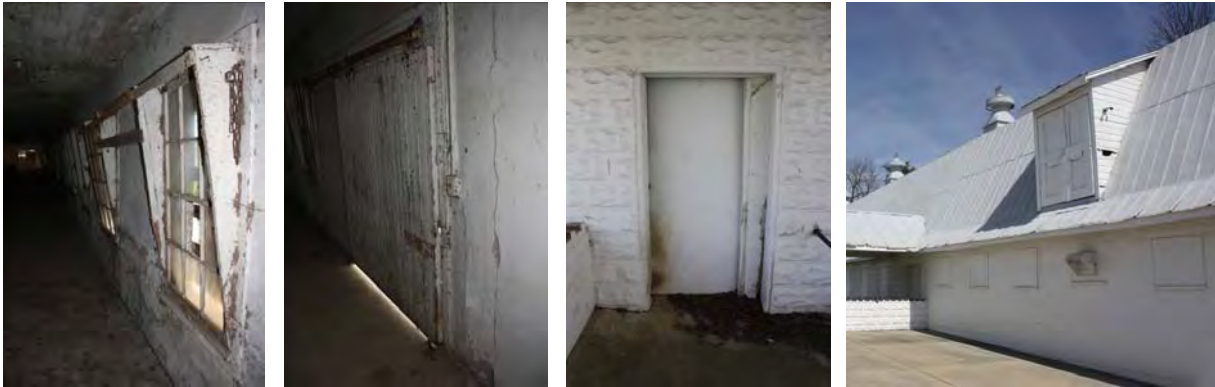
| King Farm Property Condition Assessment | |
|---|---|
| <p>1. Windows and louver openings @ all locations are in very poor condition. All trim very deteriorated.</p> <p>2. Barn doors and hardware show evidence of rot and deterioration. Side exits are non-operable.</p> <p>3. The 3 dormers show significant rot.</p> <p>4. Milkhouse windows and doors in significant disrepair.</p> | |

| King Farm Property Condition Assessment | |
|---|---|
| <p>1. Replace all windows and their frames with tilt-in paned replicas. 57 large @ 4'-0" x 5'-0", 14 small @ 3'-0" x 3'-0"; Replace louvers.</p> <p>2. Replace 4 barn doors and hardware with replica. Replace 4 side doors, interior storage room door, and hardware leading to courtyard with replicas.</p> <p>3. Replace entire dormer assembly, including necessary reframing, flashing, siding repair, etc. See also 3/4-16.</p> <p>4. Replace 5 windows and 3 doors in milkhouse with historically accurate replicas. Prep for paint; Replace all trim. Prep for paint.</p> | |

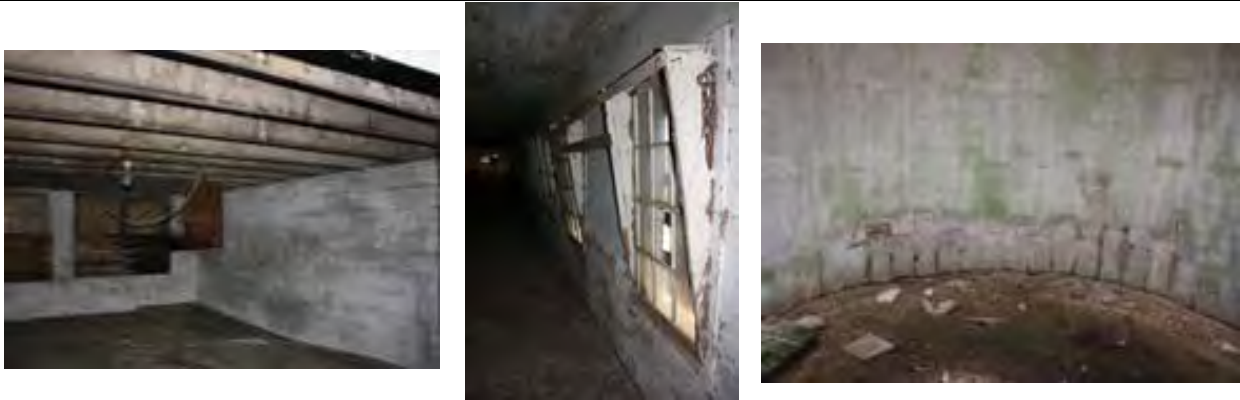
| King Farm Property Condition Assessment | |
|---|---|
| <p>Painted interior surfaces show significant deterioration. Silo walls show discoloration and deterioration.</p> | |
