**CITY OF ROCKVILLE**

**KING FARM FARMSTEAD PROPERTY**

**CONDITION ASSESSMENT**

DEPARTMENT OF RECREATION AND PARKS  
JULY 3, 2014

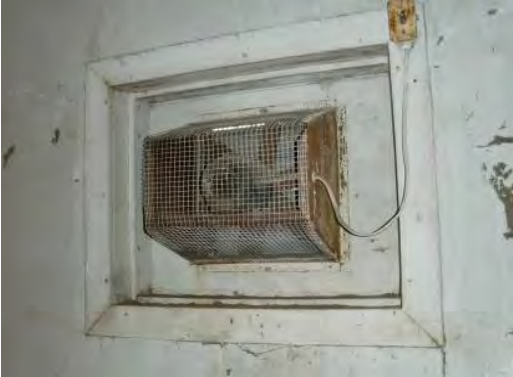
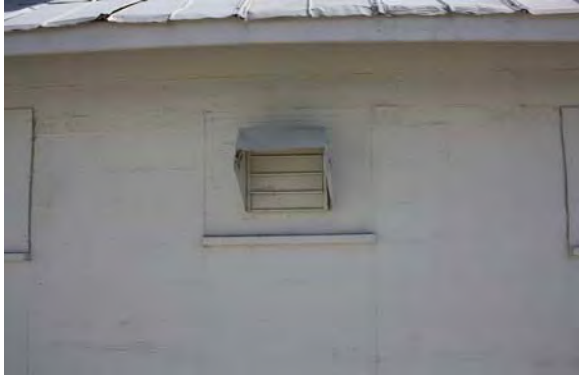
| King Farm Property Condition Assessment | |
|---|---|
| Existing ventilation fans which served the milking area of the barn are not operational. | |

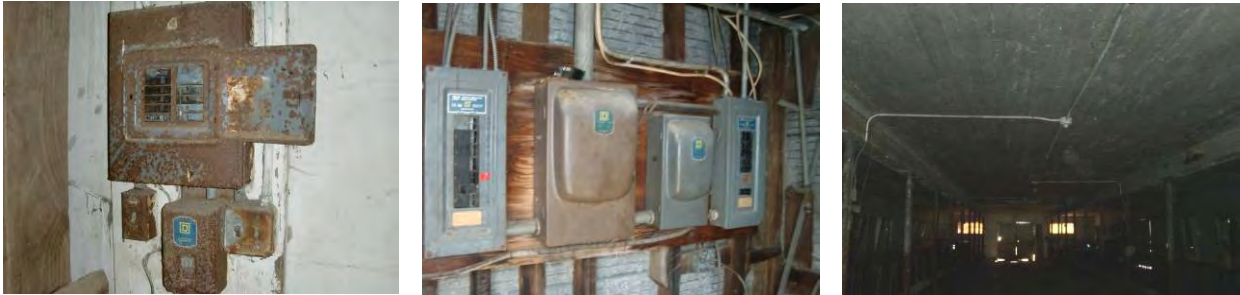
| King Farm Property Condition Assessment | |
|---|---|
| <p>Existing power service, distribution panels and lighting are non-operable. Panel and wiring devices are corroded and noncode compliant.</p> | |

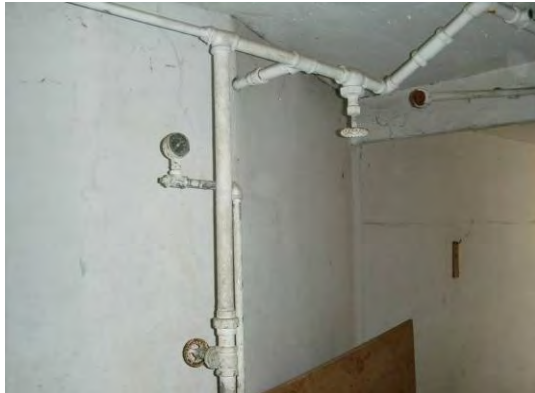
| King Farm Property Condition Assessment | |
|---|---|
| Existing domestic cold water service to the milking area of the barn is in poor condition. | |

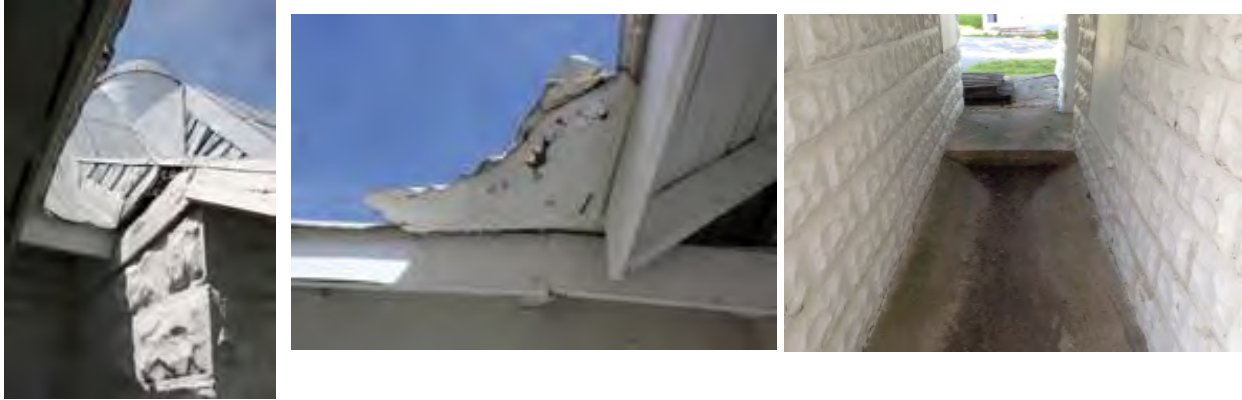
| King Farm Property Condition Assessment | |
|---|---|
| <p>For both barns:</p> <ol style="list-style-type: none"> <li>1. There is no gutter system present. Some damage to fascia.</li> <li>2. Corner drainage pieces show significant signs of wear.</li> <li>3. Water pools at various locations @ barn 3 sidewalk.</li> </ol> | |

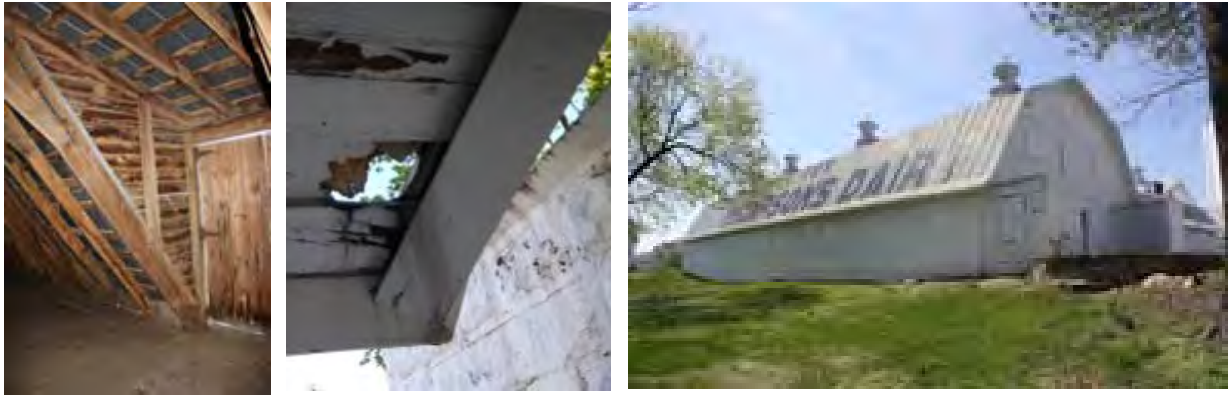
| King Farm Property Condition Assessment | |
|---|---|
| <p>1. Capacity and framing of the roof for both barns are below code.</p> <p>2. The roof and rafters @ both barns show signs of damage and wear. Neither of the barn roofs are weather tight.</p> | |

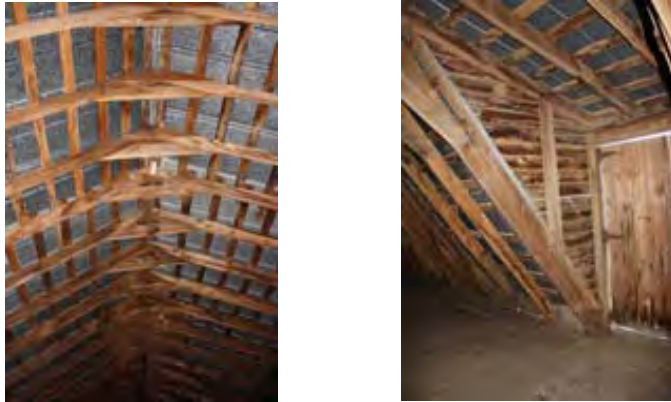
| King Farm Property Condition Assessment | |
|---|---|
| <p>1. Capacity and framing of the roof for both barns are below code.</p> | |

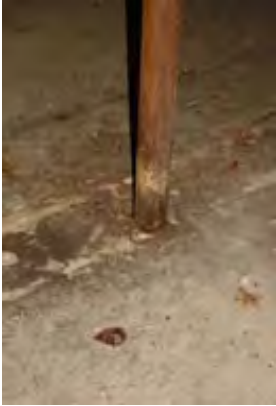
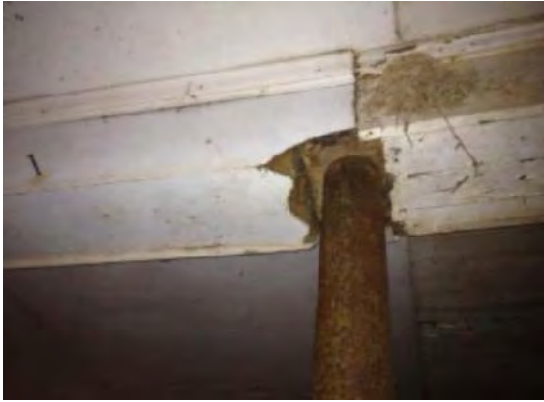
| King Farm Property Condition Assessment | |
|---|---|
| <p>Significantly rusted and deteriorated interior columns along aisle 1 @ barn 4. Columns sheared off their base. Missing column @ barn 4.</p> | |

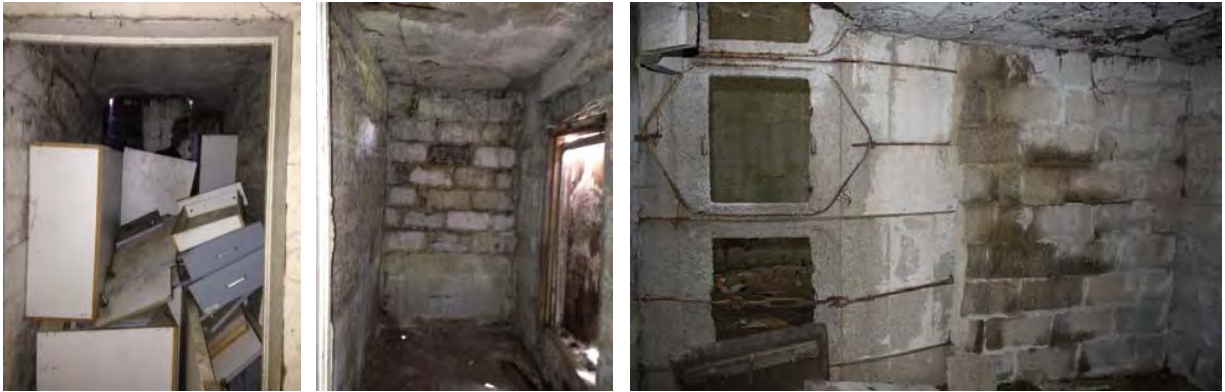
| King Farm Property Condition Assessment | |
|---|---|
| <p>Concrete, CMU and connector roof are failing @ all silo connector locations. Connectors all show significant water damage.</p> | |

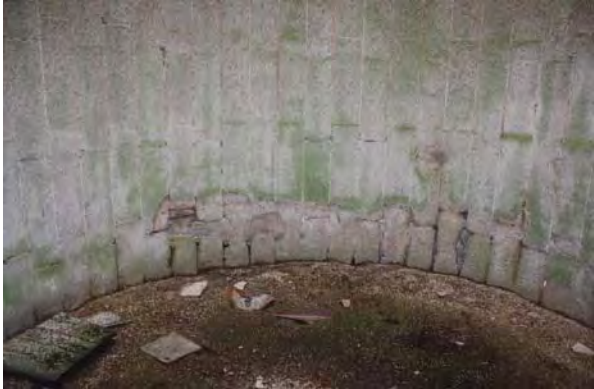
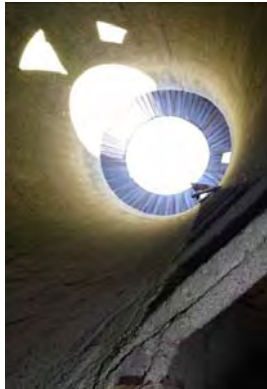
| King Farm Property Condition Assessment | |
|---|---|
| <ol style="list-style-type: none"> <li>1. Silo 3 shows significant damage @ the floor line on the concrete interior.</li> <li>2. Silo 4 interior concrete ladder is significantly degraded.</li> </ol> | |

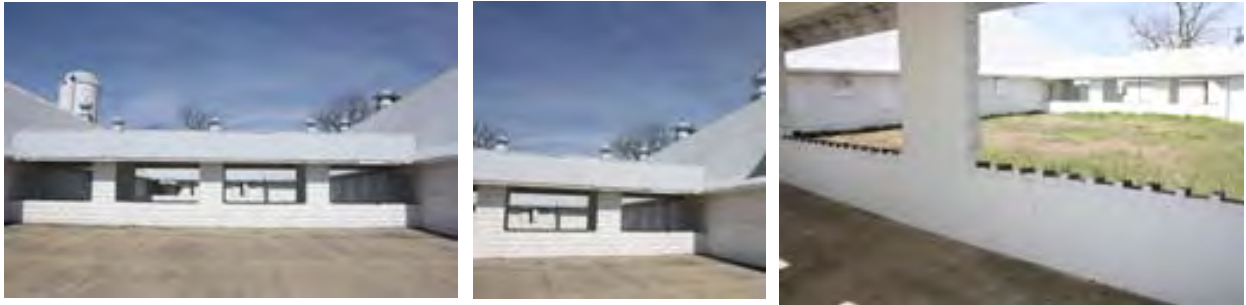
| King Farm Property Condition Assessment | |
|---|---|
| Minor cracking in CMU. | |

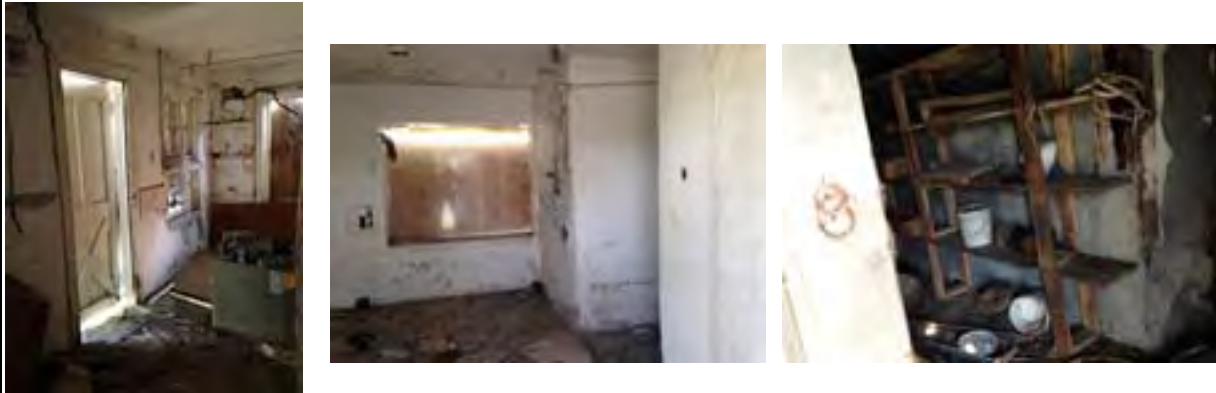
| King Farm Property Condition Assessment | |
|---|---|
| <p>1. Lots of debris strewn throughout; Concrete walls in disrepair; Wall surfaces deteriorated; Concrete floor in disrepair.</p> <p>2. Unknown concrete containment tank (sceptic?) in front of milkhouse.</p> | |

| King Farm Property Condition Assessment | |
|---|---|
| <p>1. Patch and repair concrete walls in utility/storage area as necessary. Repair concrete floor throughout; Patch and repair interior wall surfaces as needed.</p> <p>2. Hazardous materials survey to provide direction on proposed disposition of existing concrete containment tank; no cost provisions contained in this report at this time.</p> | |

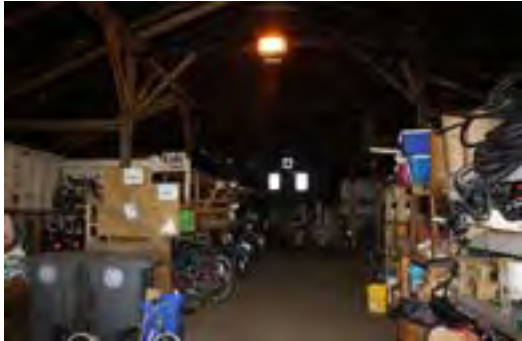
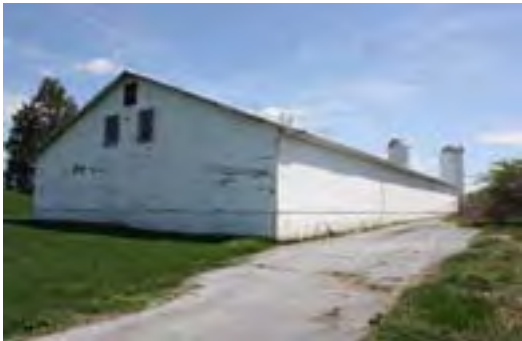
| King Farm Property Condition Assessment | |
|---|---|
| Condition / Deficiency Report | Report Number: BLDG 5 - 1 |

| King Farm Property Condition Assessment | |
|---|---|
| <p>1. There is no exit to the outside @ room 2.</p> <p>2. Total number of exits available throughout the building is likely deficient for any proposed future use or occupancy.</p> | |

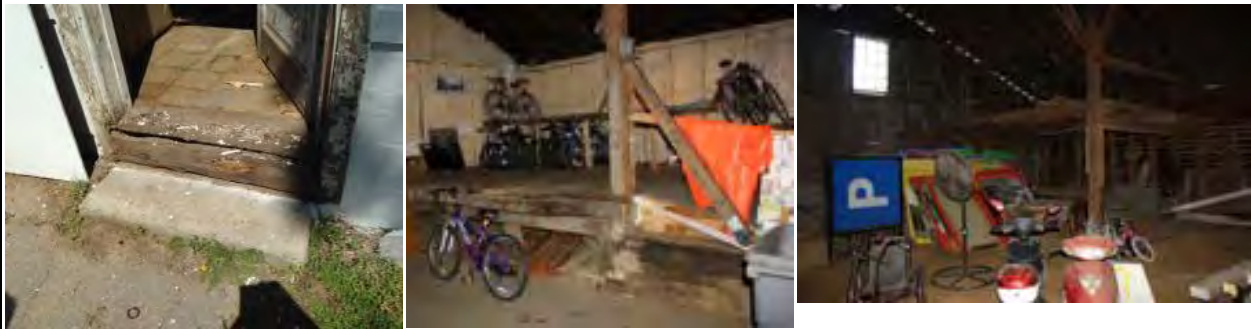
| King Farm Property Condition Assessment | |
|---|---|
| Condition / Deficiency Report | Report Number: BLDG 5 - 2 |

| King Farm Property Condition Assessment | |
|---|---|
| <ol style="list-style-type: none"> <li>1. There is no accessible entrance @ rooms 1 or 2.</li> <li>2. Room 7 has a dirt floor.</li> <li>3. Old hay platforms are not accessible.</li> </ol> | |

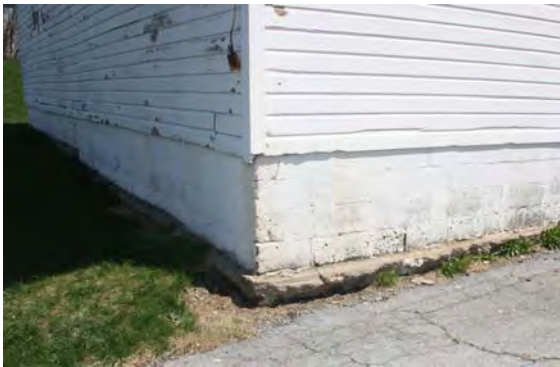
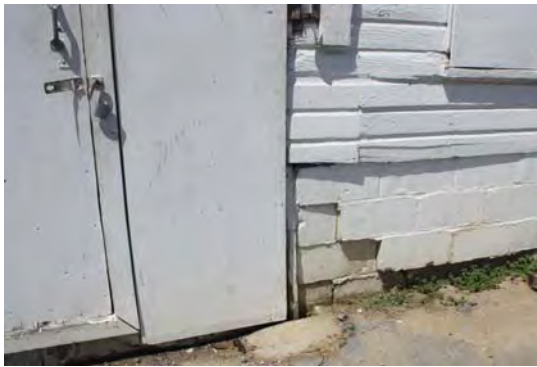
| King Farm Property Condition Assessment | |
|---|---|
| <p>Damaged CMU @ elevation A, C and D. Cracked CMU, dislocated and shifted @ elevation A. Deteriorated concrete base @ C-D corner.</p> | |

| King Farm Property Condition Assessment | |
|---|---|
| <p>See Building Structure reports. Depending on the proposed use and occupancy, some or most of the foundation could potentially be retained with appropriate repairs. For costing purposes, this assessment includes removal and replacement of the entire foundation.</p> | |

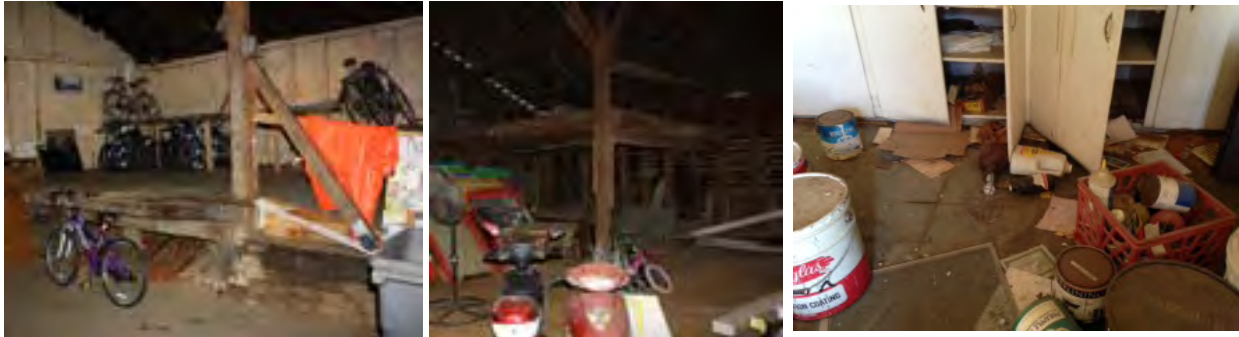
| King Farm Property Condition Assessment | |
|---|---|
| <p>Minor concrete floor cracking throughout @ room 3. Floor is not level; Dirt floor @ room 2 and 7; Significantly deteriorated floor @ room 1.</p> | |

| King Farm Property Condition Assessment | |
|---|---|
| <p>See Building Structure reports. Depending on the proposed use and occupancy, some or most of the building floor could potentially be retained with appropriate repairs. For costing purposes, this assessment includes removal and replacement of the entire existing floor.</p> | |

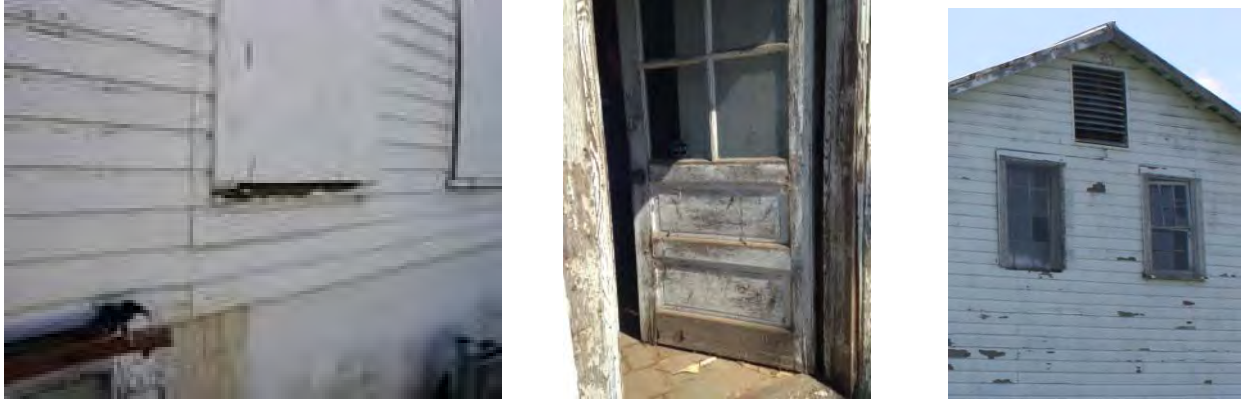
| King Farm Property Condition Assessment | |
|---|---|
| <p>Sliding barn door in poor condition and rotted at the bottom; Front door @ room 1 deteriorated; Sill rot @ elevation B windows. Windows beneath gable @ elevation C in poor condition; No reasonable access into room 2.</p> | |

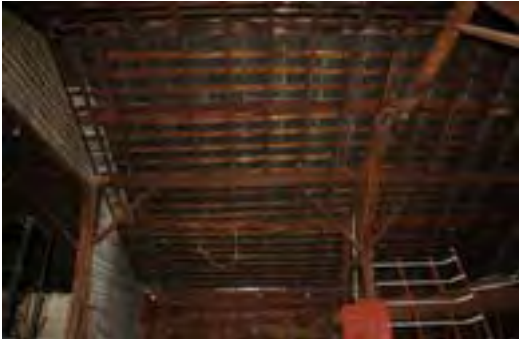
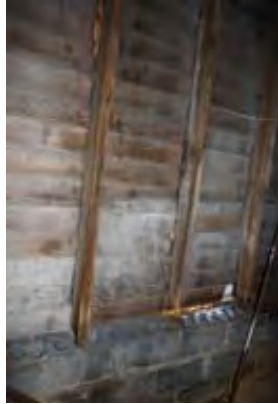
| King Farm Property Condition Assessment | |
|---|---|
| <p>1. There is no insulation present. Current siding and roof assembly condition will not support insulation.</p> <p>2. Building is not weather tight.</p> | |

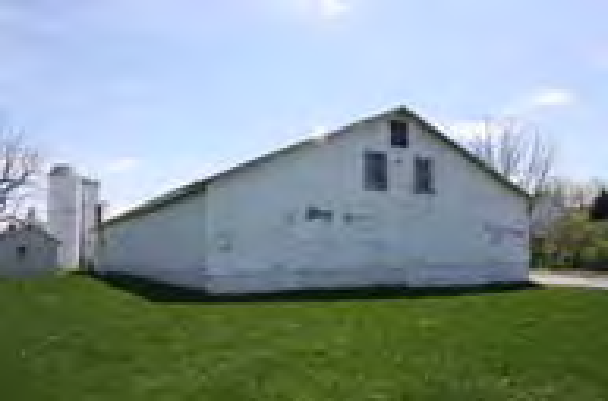
| King Farm Property Condition Assessment | |
|---|---|
| Condition / Deficiency Report | Report Number: BLDG 5 - 9 |

| King Farm Property Condition Assessment | |
|---|---|
| <p>Siding paint chipped and flaking @ all elevations; Various conduit and boards mounted on siding which no longer serve a purpose; numerous perforations @ all elevations.</p> | |

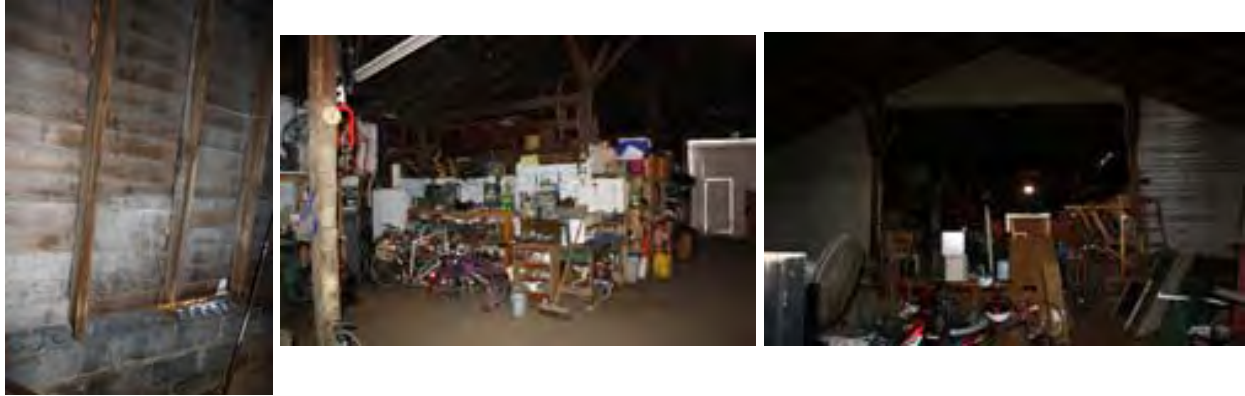
| King Farm Property Condition Assessment | |
|---|---|
| Condition / Deficiency Report | Report Number: BLDG 5 - 11 |

| King Farm Property Condition Assessment | |
|---|---|
| <p>Interior side of perimeter walls and roof unpainted or poorly painted. Walls for rooms 1 and 2 in poor condition. Wall between area 3 and 7 in poor condition.</p> | |

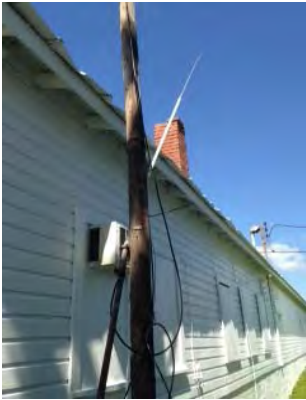
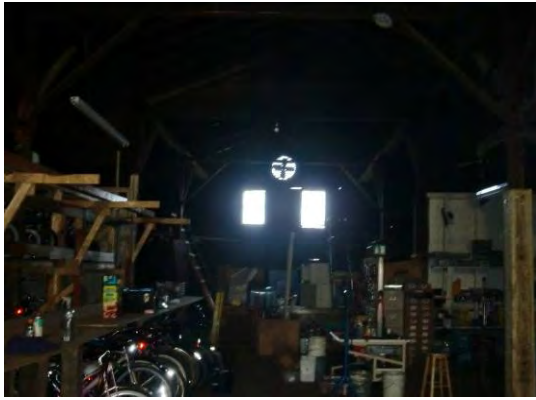
| King Farm Property Condition Assessment | |
|---|---|
| <p>There is no HVAC system other then wall mounted venting.</p> | |

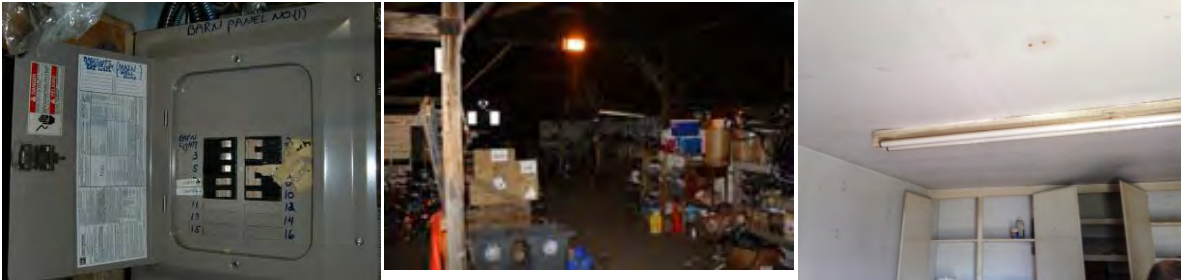
| King Farm Property Condition Assessment | |
|---|---|
| <p>1. Existing power panels appear adequate for existing use.</p> <p>2. Existing / Emergency lighting is poor and not code compliant. There is no lighting @ room 2. Room 1 lighting is non-functional.</p> | |

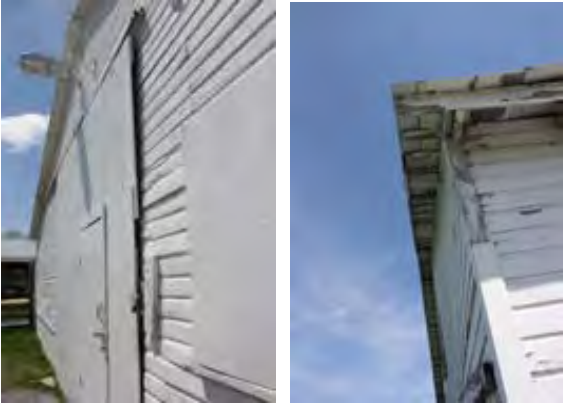
| King Farm Property Condition Assessment | |
|---|---|
| Condition / Deficiency Report | Report Number: BLDG 5 - 15 |

| King Farm Property Condition Assessment | |
|---|---|
| <p>There is no gutter system present; Fascia is significantly damaged or missing @ all elevations of the building.</p> | |

| King Farm Property Condition Assessment | |
|---|---|
| <p>See Building Structure reports. If allowed by HDC, provide gutter and downspout system in reconstruction effort to protect the siding from future deterioration.</p> | |

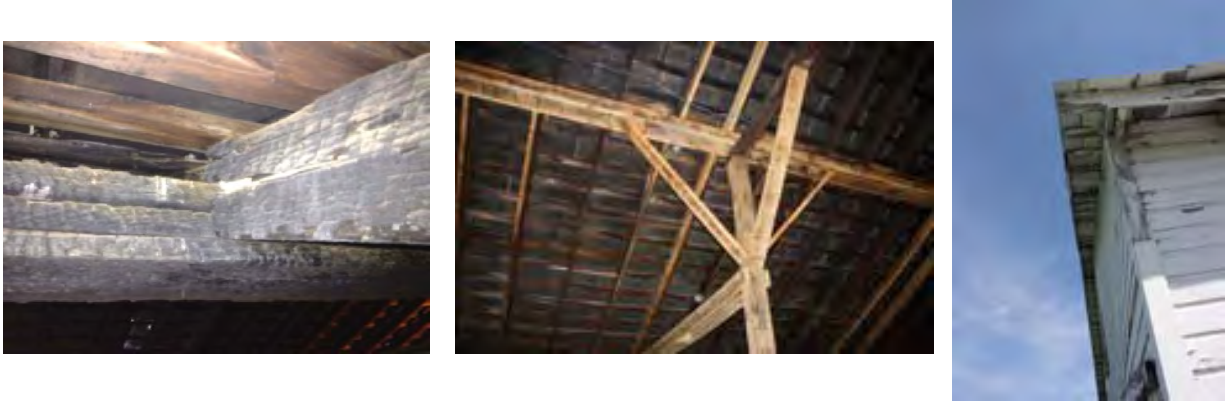
| King Farm Property Condition Assessment | |
|---|---|
| <p>1. The structural issues present in the building framing are myriad. Roof rafters are undersized, connections of rafters to stud wall, to beams, and @ ridge are mostly non-existent. Some roof beams are installed sideways. Braces to beam and columns are undersized and poorly connected. There is no lateral load resisting system. Gable wall studs are interrupted and there is no blocking @ studs.</p> <p>2. There is fire damage to the structure @ area 3; the two front bays.</p> | |

| King Farm Property Condition Assessment | |
|---|---|
| <p>Repairs to correct these issues would be extensive. While each of these items could be reconstructed on an individual basis, to do so will require extensive temporary shoring and will consume an inordinately large amount of time and money. For both safety and financial reasons, it is recommended that the building be demolished in an orderly fashion, and in a manner which allows the greatest amount of existing historic material to be salvaged for a possible future reconstruction.</p> | |

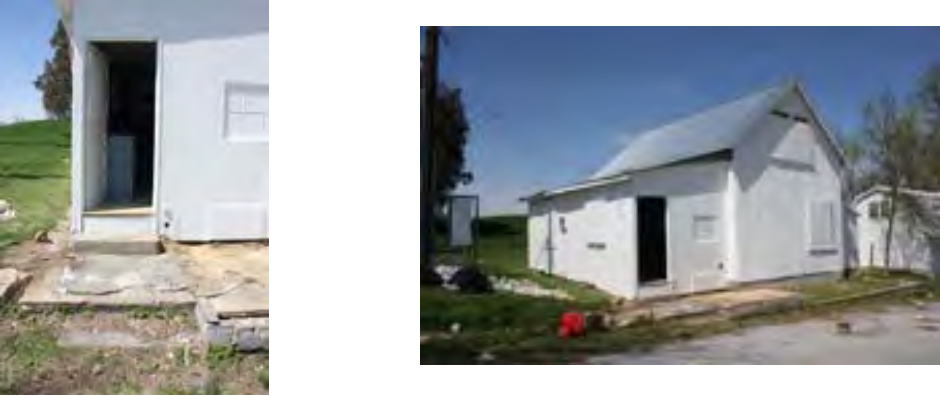
| King Farm Property Condition Assessment | |
|---|---|
| Condition / Deficiency Report | Report Number: BLDG 6 - 1 |

| King Farm Property Condition Assessment | |
|---|---|
| <p>1. Entrances @ elevation A and B are too narrow. There are not enough operable exits.</p> <p>2. The interior stair is too narrow.</p> | |

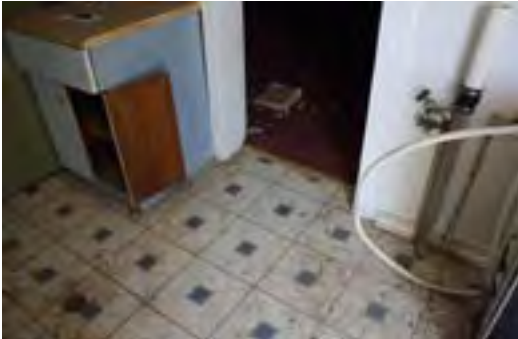
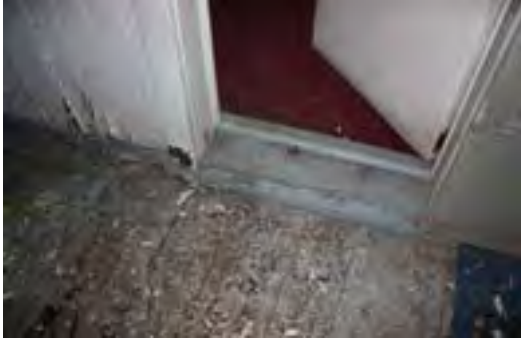
| King Farm Property Condition Assessment | |
|---|---|
| Condition / Deficiency Report | Report Number: BLDG 6 - 2 |

| King Farm Property Condition Assessment | |
|---|---|
| <p>1. There is no appropriate accessible entrance into the building.</p> <p>2. There are elevation changes @ thresholds between rooms 1 &amp; 3, and 3 &amp; 4.</p> | |

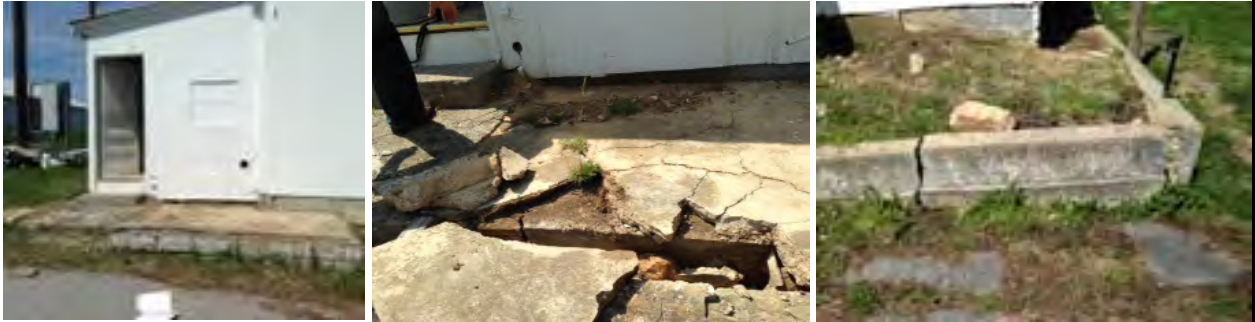
| King Farm Property Condition Assessment | |
|---|---|
| Condition / Deficiency Report | Report Number: BLDG 6 - 3 |

| King Farm Property Condition Assessment | |
|---|---|
| <p>1. Heaved concrete base with significant cracking. Septic tank located below broken concrete pad. Loose pavers and deteriorated concrete steps.</p> <p>2. The concrete retaining wall @ elevation A in disrepair.</p> | |

| King Farm Property Condition Assessment | |
|---|---|
| <p>1. Remove septic tank. Demolish concrete base in front of addition 1. See 6-4, 6-7, and 6-9.</p> <p>2. Replace retaining wall after demolition of additions as appropriate for remaining grade.</p> | |

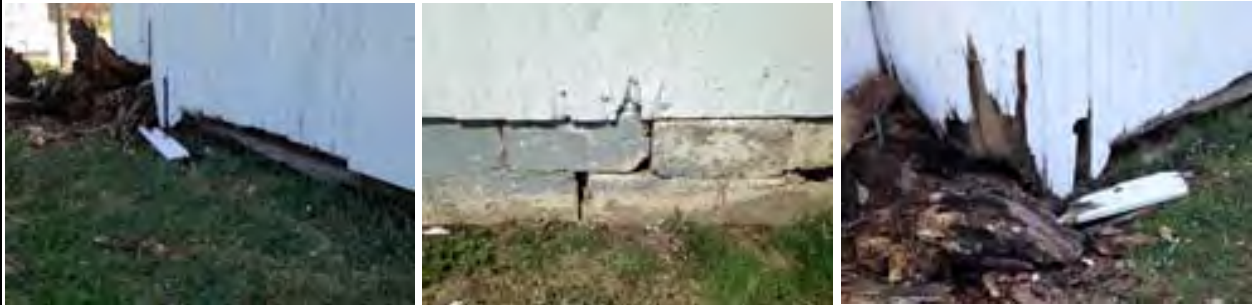
| King Farm Property Condition Assessment | |
|---|---|
| <p>1. Deteriorated foundation cover @ elevation D. Deteriorated wood foundation @ elevations C and D. Deteriorated CMU foundation and grout @ elevation A.</p> <p>2. Siding and foundation is damaged by invasive roots @ elevation C.</p> | |

| King Farm Property Condition Assessment | |
|---|---|
| <p>1. Demolish addition 1 and 2. Repoint and replace CMU block as appropriate. Remove first floor, excavate to a minimum of 30", underpin existing walls and place new concrete "rat" slab. (See 6-5).</p> <p>2. Grind stump and repair foundation @ the affected corner.</p> | |

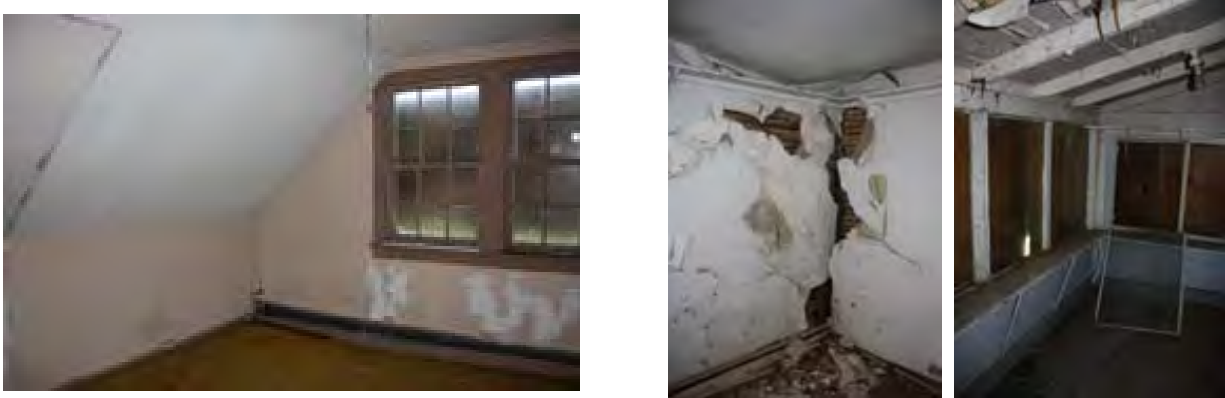
| King Farm Property Condition Assessment | |
|---|---|
| <p>1. Pervasive water damage, mold and rot. Lath @ room 2 is exposed by deteriorated plaster. Wall and roof assembly @ room 2 in danger of collapse.</p> <p>2. Significant deterioration from moisture infiltration @ addition 2.</p> <p>3. Second level has significant evidence of mold. Strong mold odor throughout building. Significant framing damage suspected.</p> | |

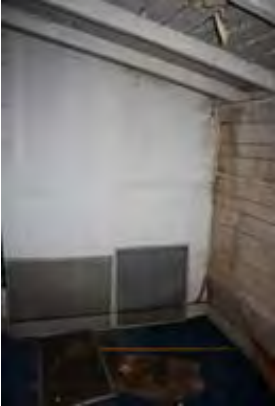
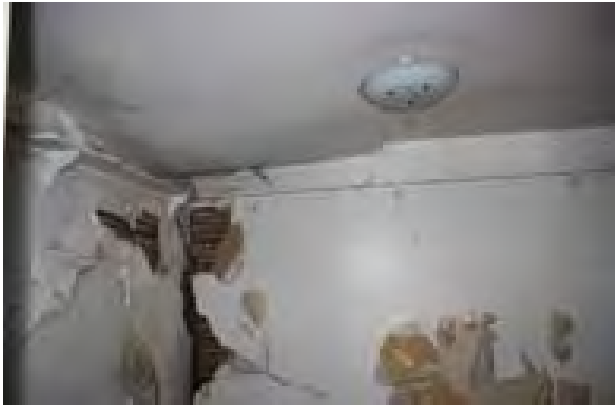
| King Farm Property Condition Assessment | |
|---|---|
| <p>Insulation either not present or in poor condition @ all areas.</p> | |

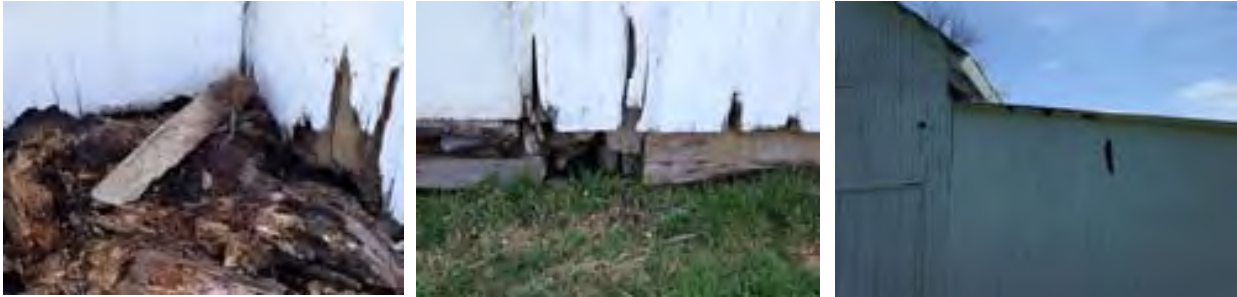
| King Farm Property Condition Assessment | |
|---|---|
| <p>1. Significantly deteriorated siding along foundation line @ all elevations. Siding in deteriorated condition @ all elevations.</p> <p>2. Fascia is missing or damaged @ elevations B, C, and D.</p> | |

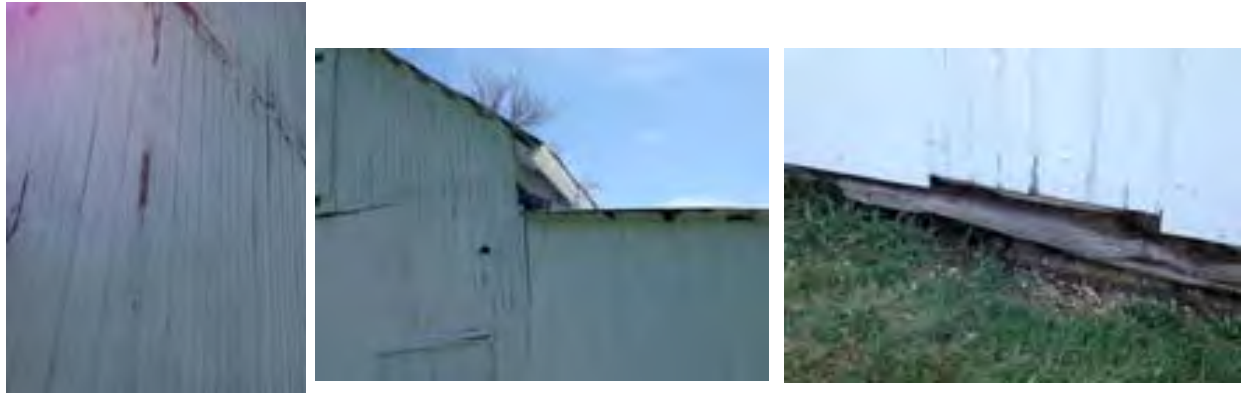
| King Farm Property Condition Assessment | |
|---|---|
| <p>Eaves in poor condition and show flaking paint. Siding paint has deteriorated.</p> | |

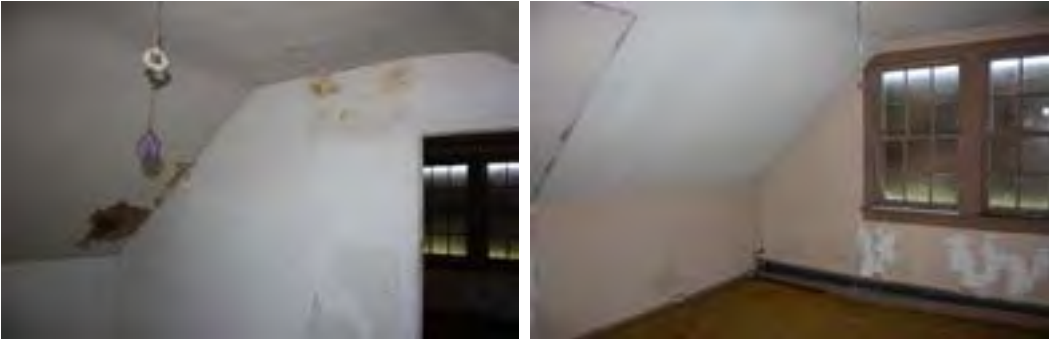
| King Farm Property Condition Assessment | |
|---|---|
| <p>Interior is in generally very poor condition. Paint is peeling or fallen away all together.</p> | |

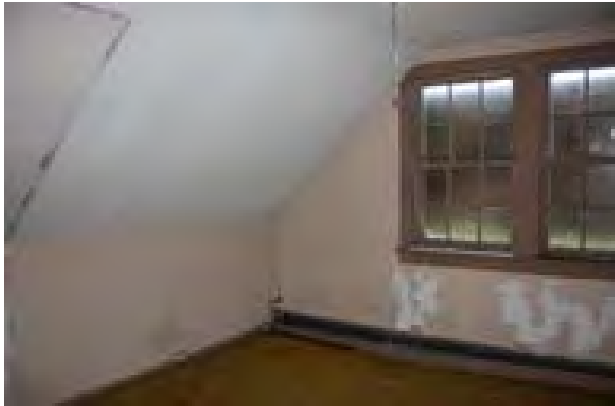
| King Farm Property Condition Assessment | |
|---|---|
| <p>There is no visible mechanical system present. Electric baseboard heating on the second floor is the only interior environment conditioning equipment.</p> | |

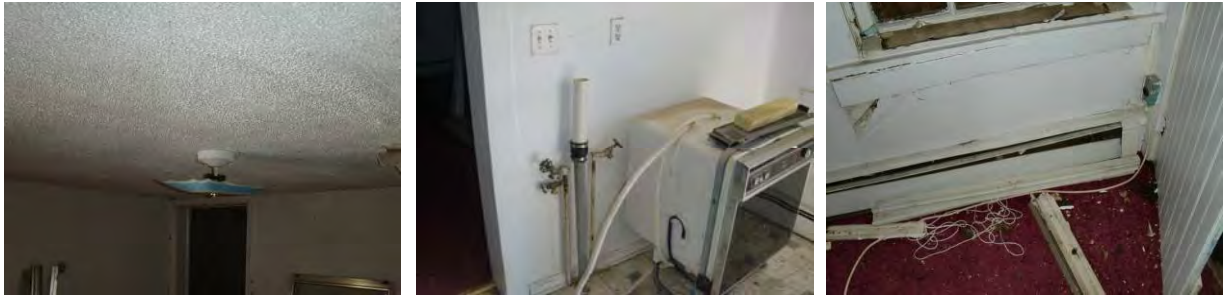
| King Farm Property Condition Assessment | |
|---|---|
| <p>Existing electrical distribution, wiring devices, lighting and electric baseboard heating are in poor, inoperative condition. All are non-code compliant.</p> | |

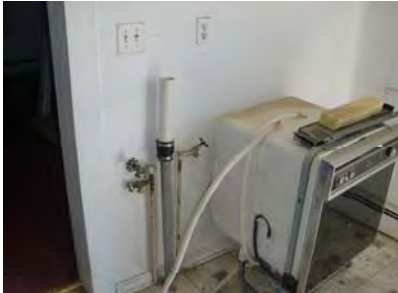
| King Farm Property Condition Assessment | |
|---|---|
| Existing plumbing centered around room 1. Entire plumbing systems, including hot water, cold water and sanitary are nonfunctional and noncode compliant. | |

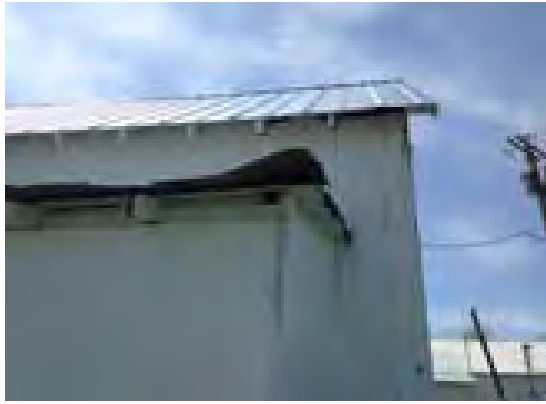
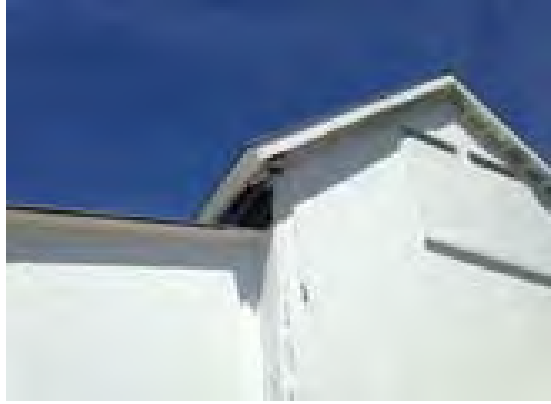
| King Farm Property Condition Assessment | |
|---|---|
| There is no proper gutter system present. | |

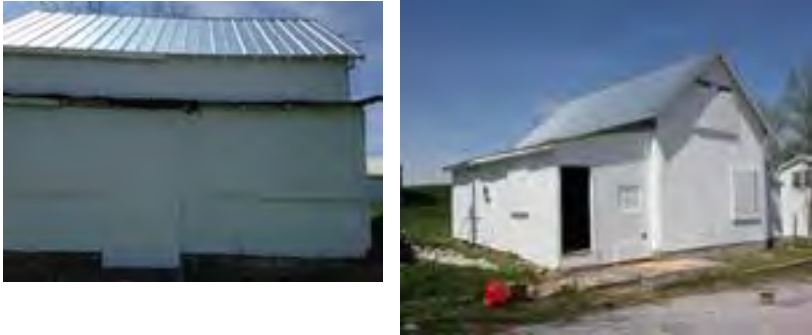
| King Farm Property Condition Assessment | |
|---|---|
| Condition / Deficiency Report | Report Number: BLDG 6 - 16 |

| King Farm Property Condition Assessment | |
|---|---|
| <p>Roof @ addition 2 clad with varying materials. Flashing is missing; Damaged metal roof @ addition 1; No gutter system present. See 6-15 (gutter system).</p> | |

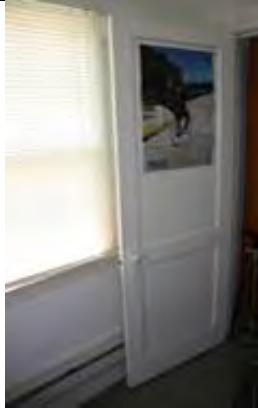
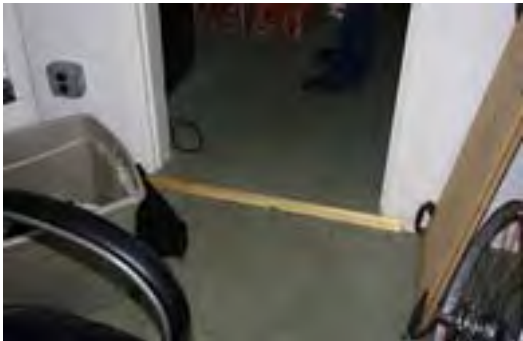
| King Farm Property Condition Assessment | |
|---|---|
| Condition / Deficiency Report | Report Number: BLDG 7 - 1 |

| King Farm Property Condition Assessment | |
|---|---|
| Door widths are too narrow. | |

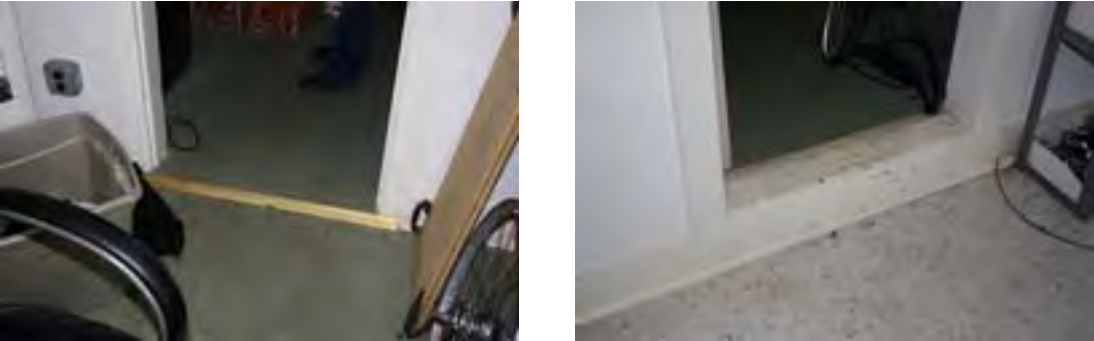
| King Farm Property Condition Assessment | |
|---|---|
| <ol style="list-style-type: none"> <li>1. There is no accessible entrance into the building.</li> <li>2. There are elevation changes @ the transitions between rooms 1 &amp; 3, 1 &amp; 4, and 4 &amp; 5.</li> <li>3. Door widths are too narrow. Front door clearance is too short.</li> </ol> | |

| King Farm Property Condition Assessment | |
|---|---|
| <p>Post foundation stabilization work (7-4):</p> <ol style="list-style-type: none"> <li>1. Provide concrete ramp to the main entrance.</li> <li>2. Install level floor throughout structure. Where elevation changes are necessary between rooms, provide ADA compliant slope. Note the square footage of this building is very limited.</li> </ol> <p>The most appropriate action may be to seek a historic exemption from ADA requirements for the entire building.</p> | |

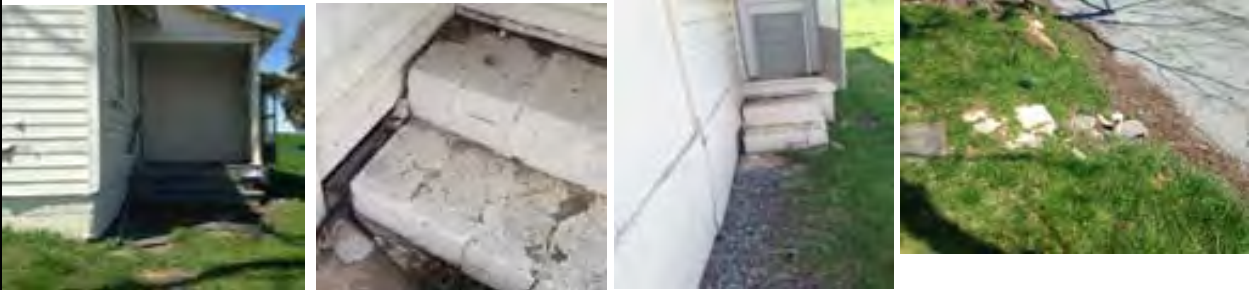
| King Farm Property Condition Assessment | |
|---|---|
| Condition / Deficiency Report | Report Number: BLDG 7 - 3 |

| King Farm Property Condition Assessment | |
|---|---|
| <p>1. The path to the main entrance is significantly deteriorated.</p> <p>2. The concrete steps @ the secondary entrance are in poor condition.</p> | |

| King Farm Property Condition Assessment | |
|---|---|
| <p>1. Replace existing remnants of path with like white stone look, approx. 20'-0". Pour slab @ the base of both entrances, 5'0" w x length of steps.</p> <p>2. Replace concrete steps.</p> | |

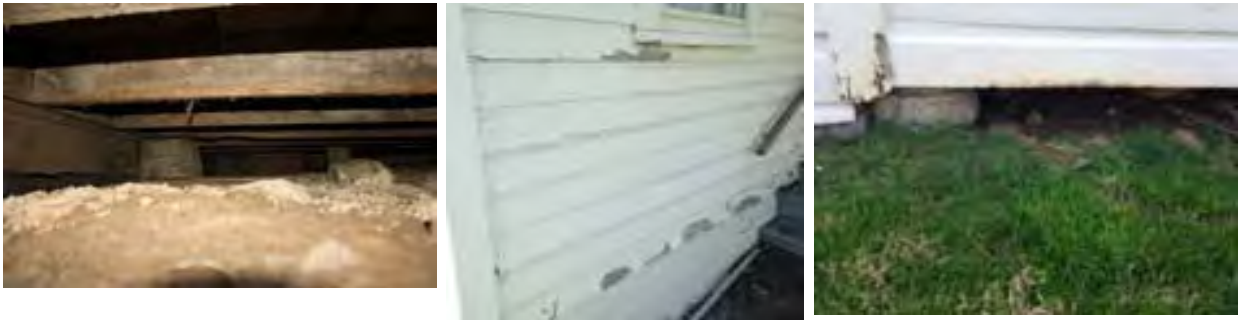
| King Farm Property Condition Assessment | |
|---|---|
| Condition / Deficiency Report | Report Number: BLDG 7 - 4 |

| King Farm Property Condition Assessment | |
|---|---|
| <p>There are 2 different foundation systems. The front end is CMU, the rear is piers. The piers are susceptible to weather damage.</p> | |

| King Farm Property Condition Assessment | |
|---|---|
| <p>Remove 1st floor, excavate to a minimum of 30", underpin existing walls, place "rat" slab, install new floor. New foundation at SW corner.</p> | |

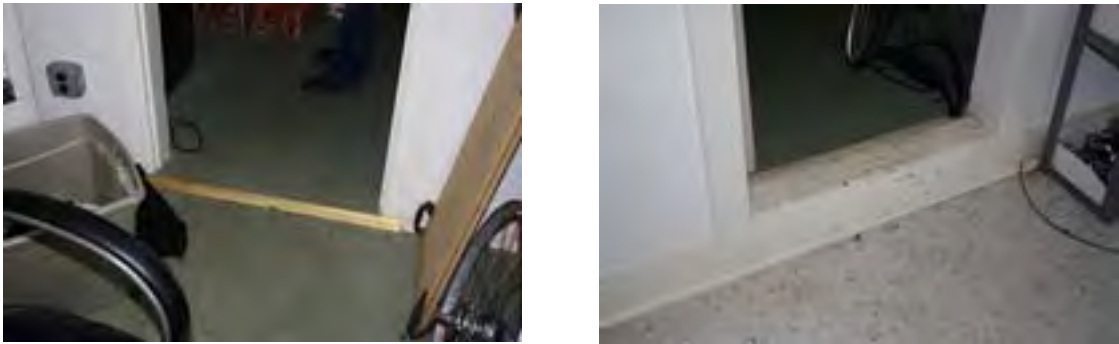
| King Farm Property Condition Assessment | |
|---|---|
| Condition / Deficiency Report | Report Number: BLDG 7 - 5 |

| King Farm Property Condition Assessment | |
|---|---|
| <p>Floors are old and dirty. Some areas show signs of wear.</p> | |

| King Farm Property Condition Assessment | |
|---|---|
| <p>Post foundation stabilization work (7-4): Install new flooring.</p> | |

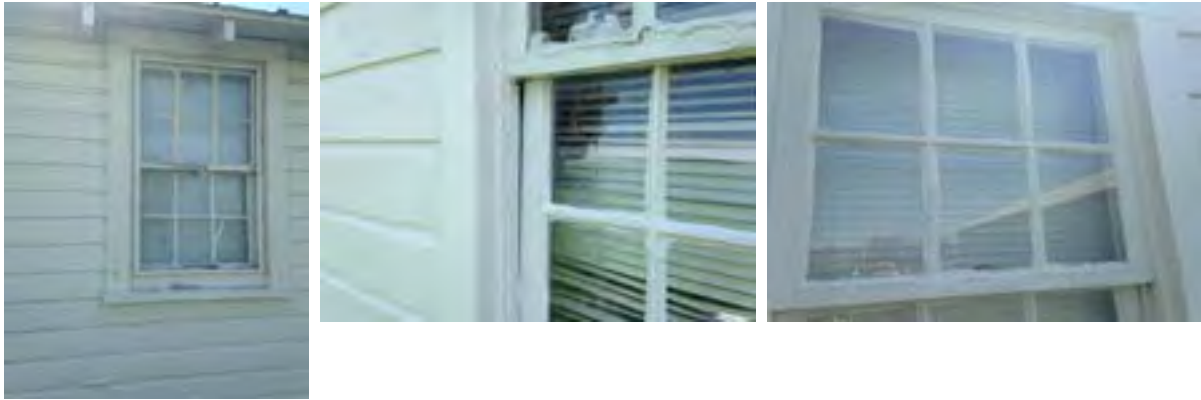
| King Farm Property Condition Assessment | |
|---|---|
| Condition / Deficiency Report | Report Number: BLDG 7 - 6 |

| King Farm Property Condition Assessment | |
|---|---|
| <p>1. Gapping window @ elevation D. Deteriorated double hung frames. Windows generally in poor condition and susceptible to moisture infiltration.</p> <p>2. Door hardware is noncompliant.</p> | |

| King Farm Property Condition Assessment | |
|---|---|
| <p>1. Replace all 8 windows approx. 3'-0" x 4'-6" with like 6/6 double hung and reflash.</p> <p>2. See 7-2 and 7-6A for door treatments.</p> | |

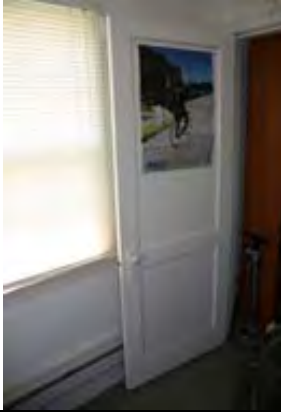
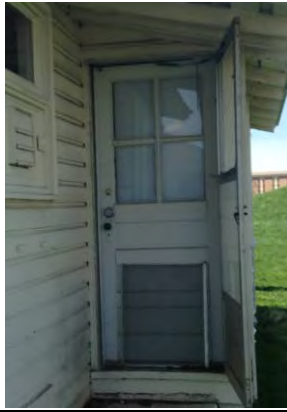
| King Farm Property Condition Assessment | |
|---|---|
| Condition / Deficiency Report | Report Number: BLDG 7 - 6A |

| King Farm Property Condition Assessment | |
|---|---|
| Door hardware is noncompliant. | |

| King Farm Property Condition Assessment | |
|---|---|
| Replace door hardware with levers. | |

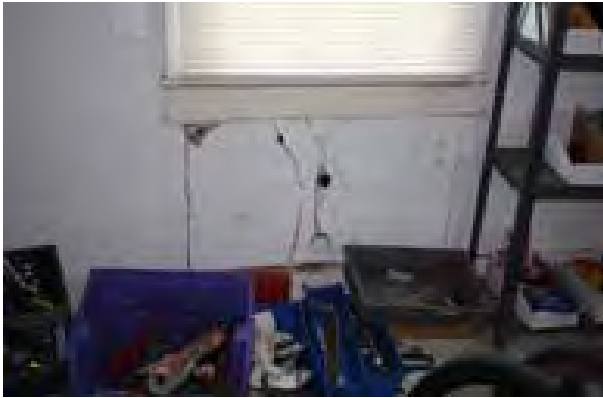
| King Farm Property Condition Assessment | |
|---|---|
| Condition / Deficiency Report | Report Number: BLDG 7 - 7 |

| King Farm Property Condition Assessment | |
|---|---|
| Evidence of water damage @ room 4 interior window sill. | |

| King Farm Property Condition Assessment | |
|---|---|
| Repair affected studs @ water infiltration, approx. 15 LF. Replace all windows. See 7-6. | |

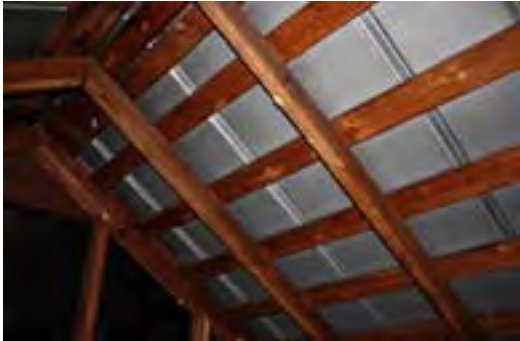
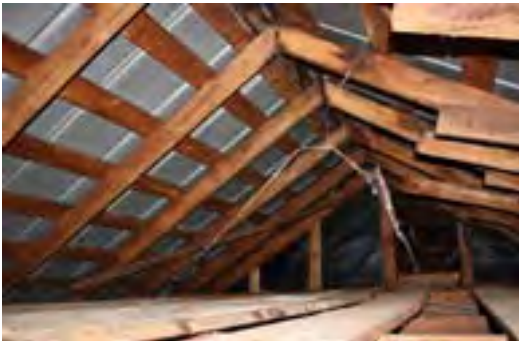
| King Farm Property Condition Assessment | |
|---|---|
| Condition / Deficiency Report | Report Number: BLDG 7 - 8 |

| King Farm Property Condition Assessment | |
|---|---|
| The attic is not insulated. | |

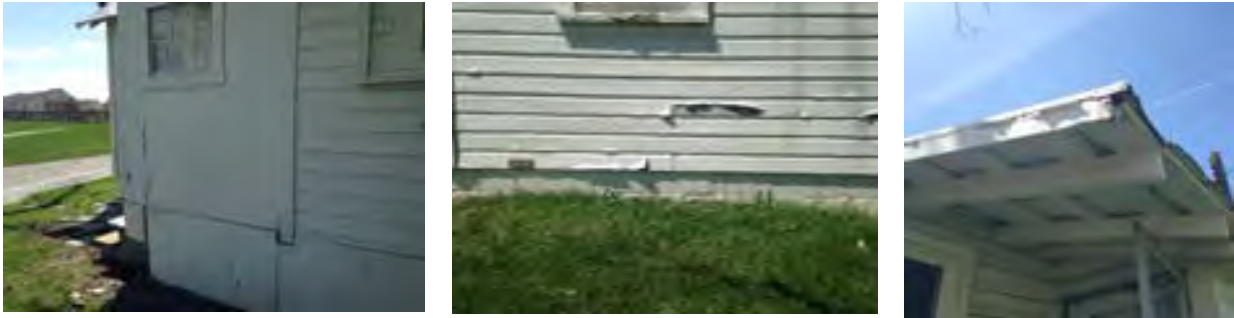
| King Farm Property Condition Assessment | |
|---|---|
| <ol style="list-style-type: none"> <li>1. Peeling siding with spots of rot along foundation line @ all elevations</li> <li>2. Cracked and rotting wood panel @ front porch.</li> <li>3. Corner covers rotted.</li> <li>4. Fascia board rotted, missing, or in poor condition.</li> </ol> | |

| King Farm Property Condition Assessment | |
|---|---|
| <ol style="list-style-type: none"> <li>1-3. Gently scrape exterior surfaces to remove peeling and loose paint. Repair and replace as necessary. Prep surfaces for paint.</li> <li>4. Install new fascia board.</li> </ol> | |

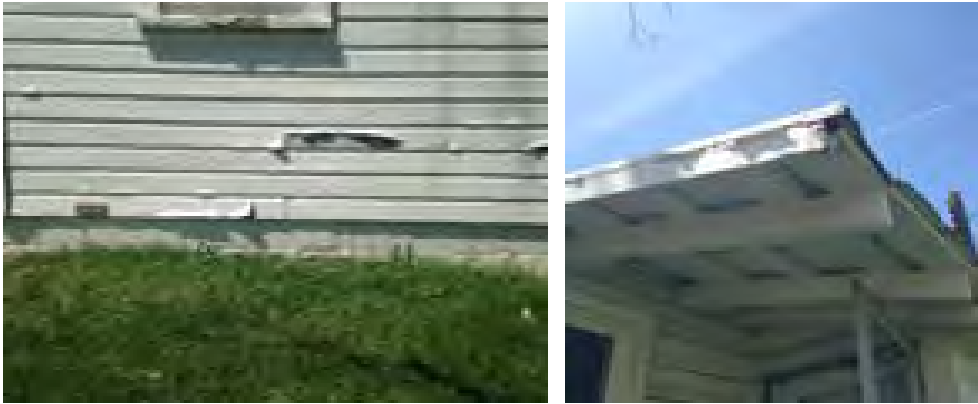
| King Farm Property Condition Assessment | |
|---|---|
| Condition / Deficiency Report | Report Number: BLDG 7 - 10 |

| King Farm Property Condition Assessment | |
|---|---|
| <p>Paint in poor condition on exterior surfaces.</p> | |
