**CITY OF ROCKVILLE**

**KING FARM FARMSTEAD PROPERTY**

**CONDITION ASSESSMENT**

DEPARTMENT OF RECREATION AND PARKS  
JULY 3, 2014

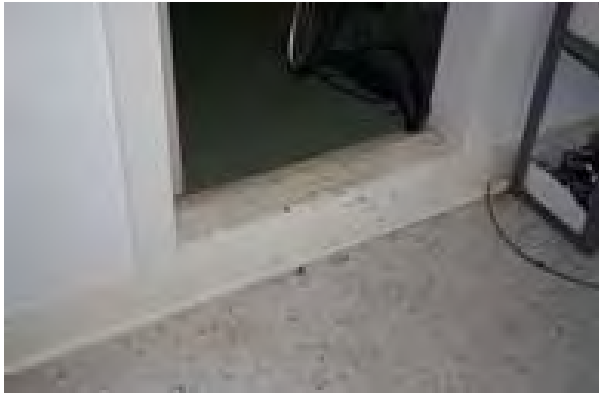
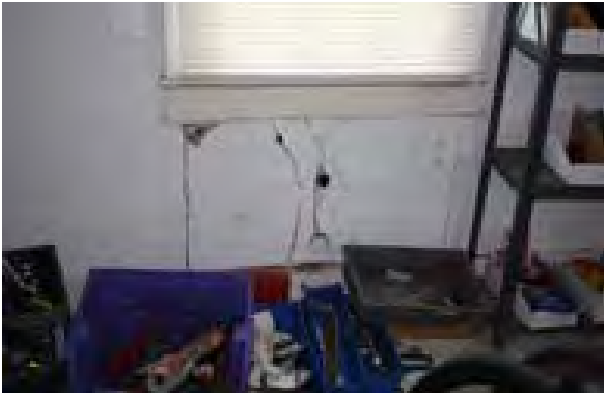
| King Farm Property Condition Assessment | |
|---|---|
| Condition / Deficiency Report | Report Number: BLDG 7 - 11 |

| King Farm Property Condition Assessment | |
|---|---|
| Interior walls and trim showing minor wear and damage. | |

| King Farm Property Condition Assessment | |
|---|---|
| Patch and repair as necessary. Prep and paint all walls, trim and baseboard. | |

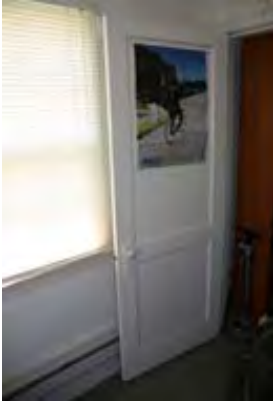
| King Farm Property Condition Assessment | |
|---|---|
| <p>There is no modern HVAC system present beyond baseboard heating.</p> | |

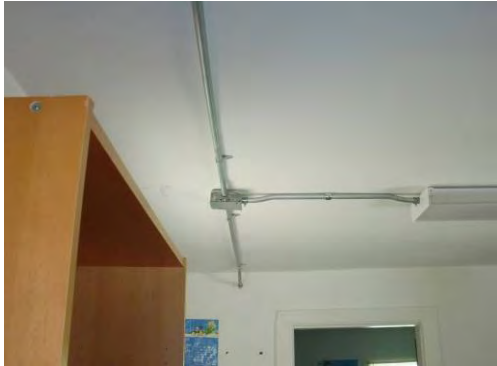
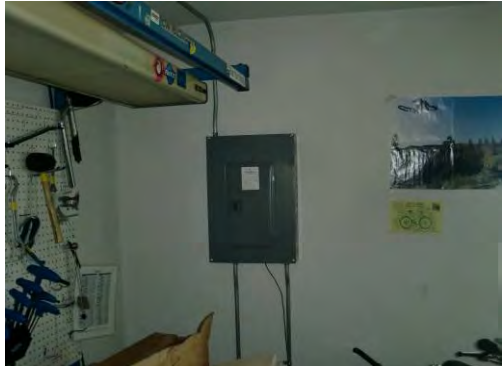
| King Farm Property Condition Assessment | |
|---|---|
| Condition / Deficiency Report | Report Number: BLDG 7 - 13 |

| King Farm Property Condition Assessment | |
|---|---|
| Building was recently rewired, but there are no emergency or exit related signs. | |

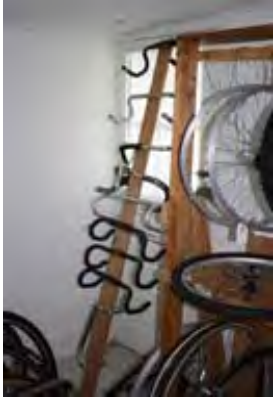
| King Farm Property Condition Assessment | |
|---|---|
| Condition / Deficiency Report | Report Number: BLDG 7 - 14 |

| King Farm Property Condition Assessment | |
|---|---|
| No existing plumbing systems are present. | |

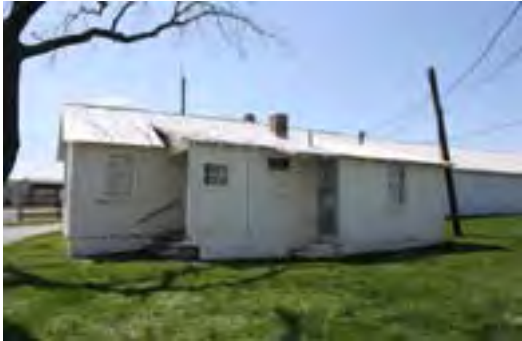
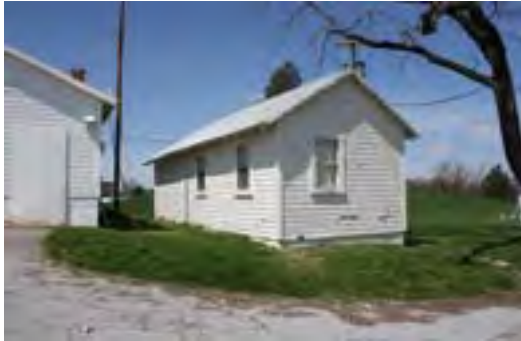
| King Farm Property Condition Assessment | |
|---|---|
| Condition / Deficiency Report | Report Number: BLDG 7 - 15 |

| King Farm Property Condition Assessment | |
|---|---|
| There is no gutter system present to control rain water drainage. | |

| King Farm Property Condition Assessment | |
|---|---|
| Once fascia is repaired, see 7-9, install appropriate gutter system with downspouts and guards (subject to approval from HDC). | |

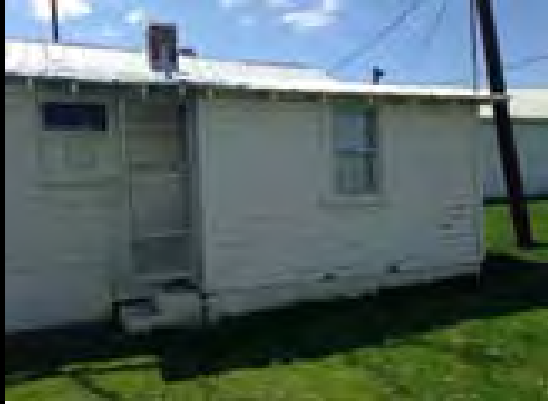
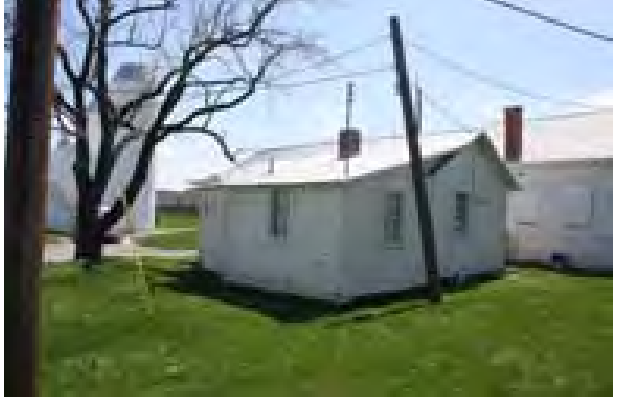
| King Farm Property Condition Assessment | |
|---|---|
| Condition / Deficiency Report | Report Number: BLDG 7 - 16 |

| King Farm Property Condition Assessment | |
|---|---|
| Minor damage to roof and eaves. | |

| King Farm Property Condition Assessment | |
|---|---|
| Patch and repair roof and eaves as appropriate. | |

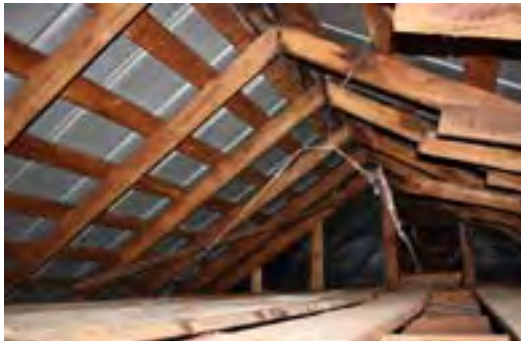
| King Farm Property Condition Assessment | |
|---|---|
| Condition / Deficiency Report | Report Number: BLDG 7 - 16A |

| King Farm Property Condition Assessment | |
|---|---|
| Roof framing is undersized. | |

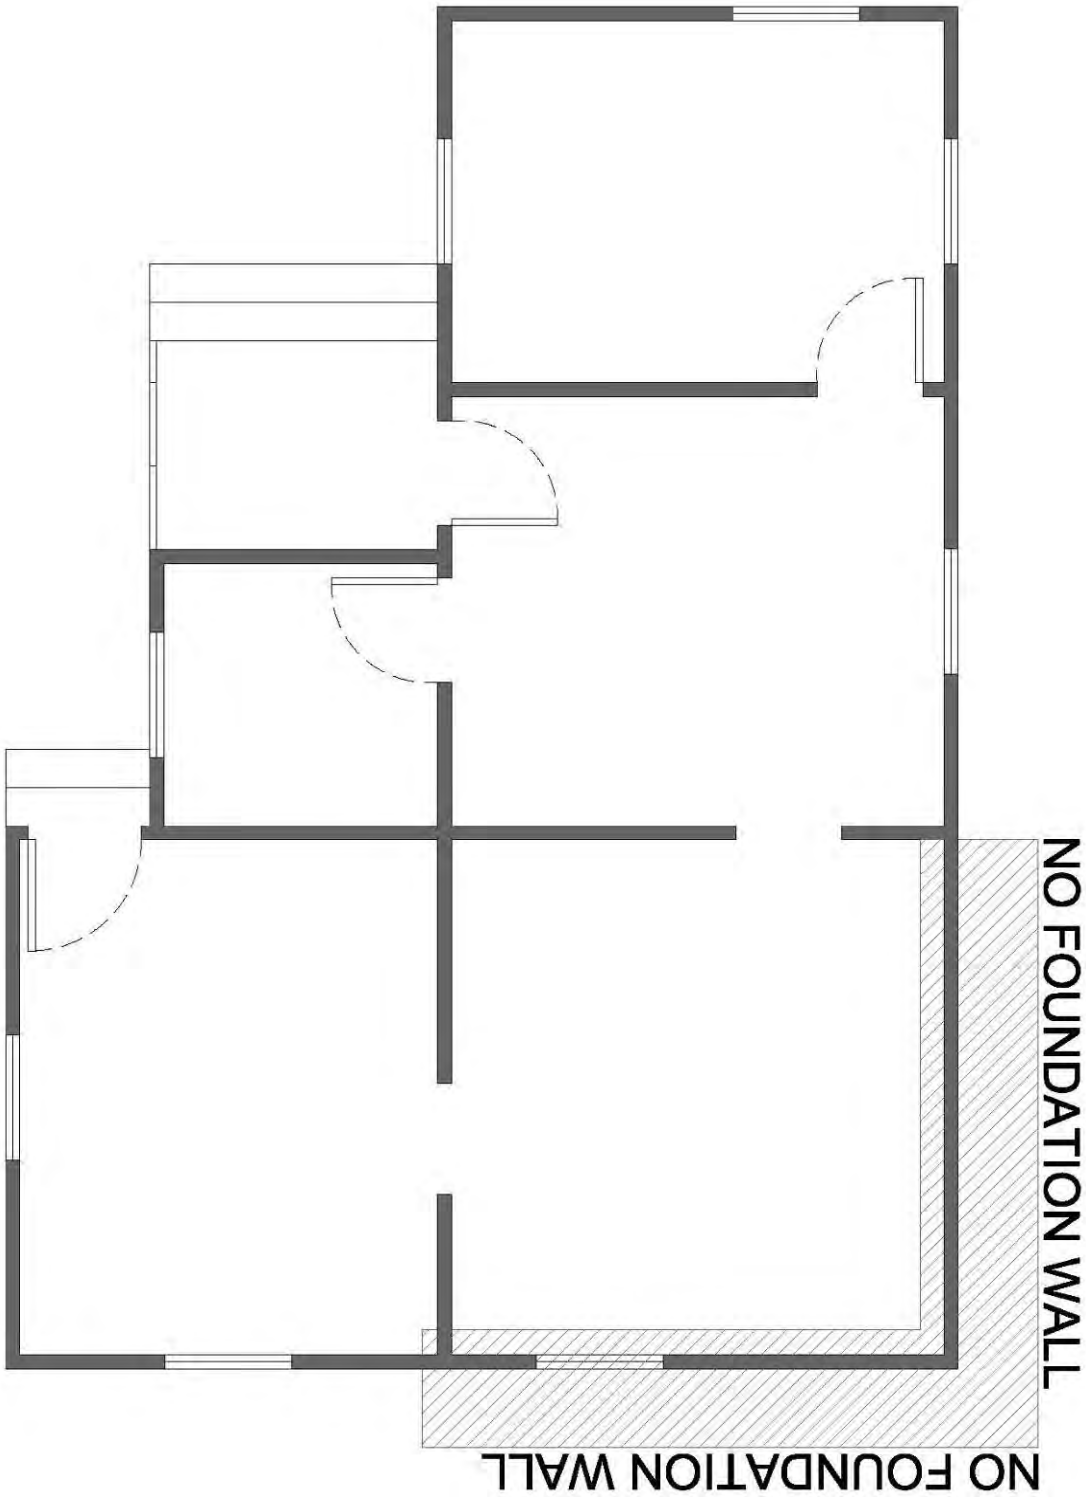
| King Farm Property Condition Assessment | | | |
|---|---|---|---|
| <p>The diagram is a technical drawing of a building's foundation. It shows a large rectangular footprint with several internal walls and a smaller rectangular area to the left. The walls are represented by thick black lines. The foundation is indicated by a hatched pattern. The text 'NO FOUNDATION WALL' is written vertically on the right side and horizontally at the bottom of the diagram.</p> | | | |

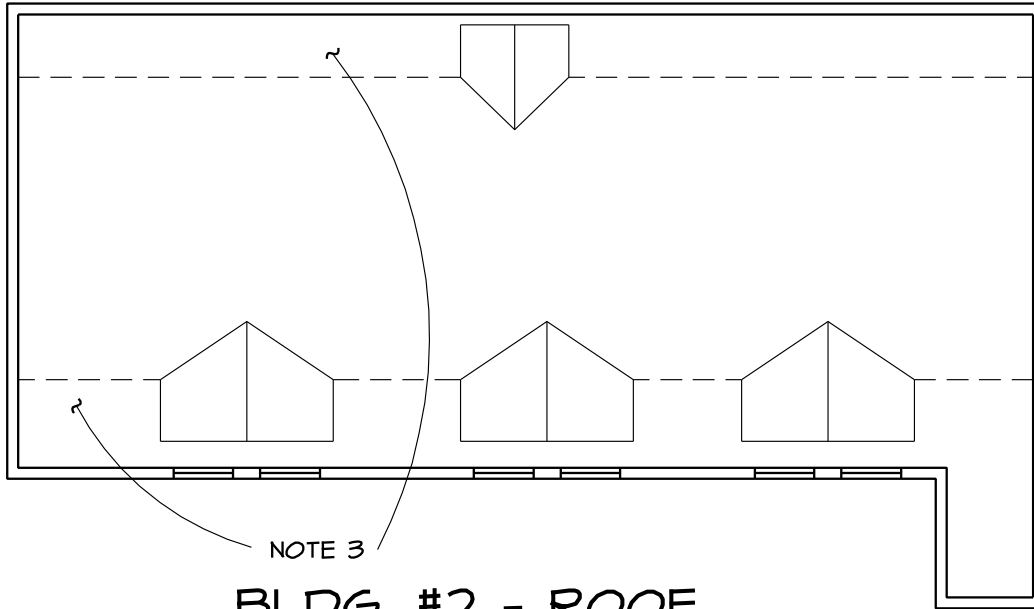
## BLDG. #2 - ROOF

1. REINF. FLOOR w/ 2x6 BETWEEN EXIST.  
(FINAL = 2x6 @ 8" o/c). REINF. BM. w/ 2-LVL'S
2. GROUND FLOOR - REPAIR CRACKS IN CONC. FLOOR.
3. WATER DAMAGE TO ROOF FRAMING.  
REPLACE OR SCAB NEW WOOD FRAMING.
4. REPAIR STUDS/SILL PLATE.

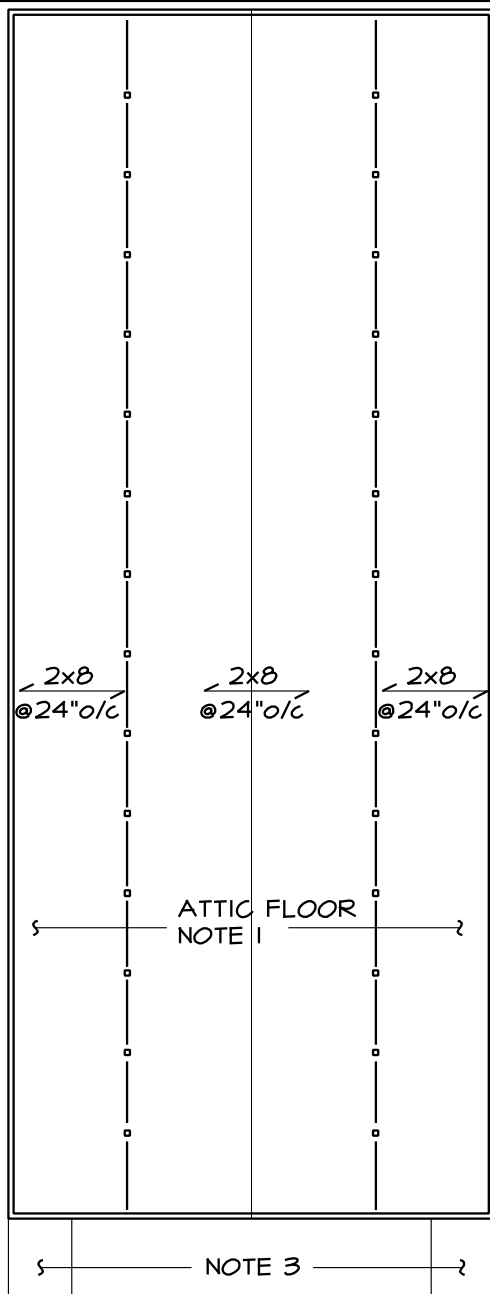
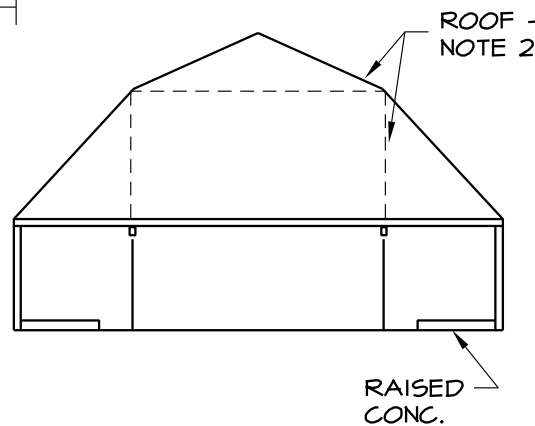
## BLDG. #3 - ROOF PLAN

1. REPLACE EXIST. DECK (MINOR).  
ATTIC FLOOR CAPACITY = 20 PSF  
REINF. IF INTEND TO USE.
2. EXIST. ROOF FRAMING RECOMMENDED  
ADD NEW FRAMING - SEE SECTION.
3. OLD SILO CONNECTOR - REMOVE EXIST.  
AND REPLACE OR DEMO ALL.

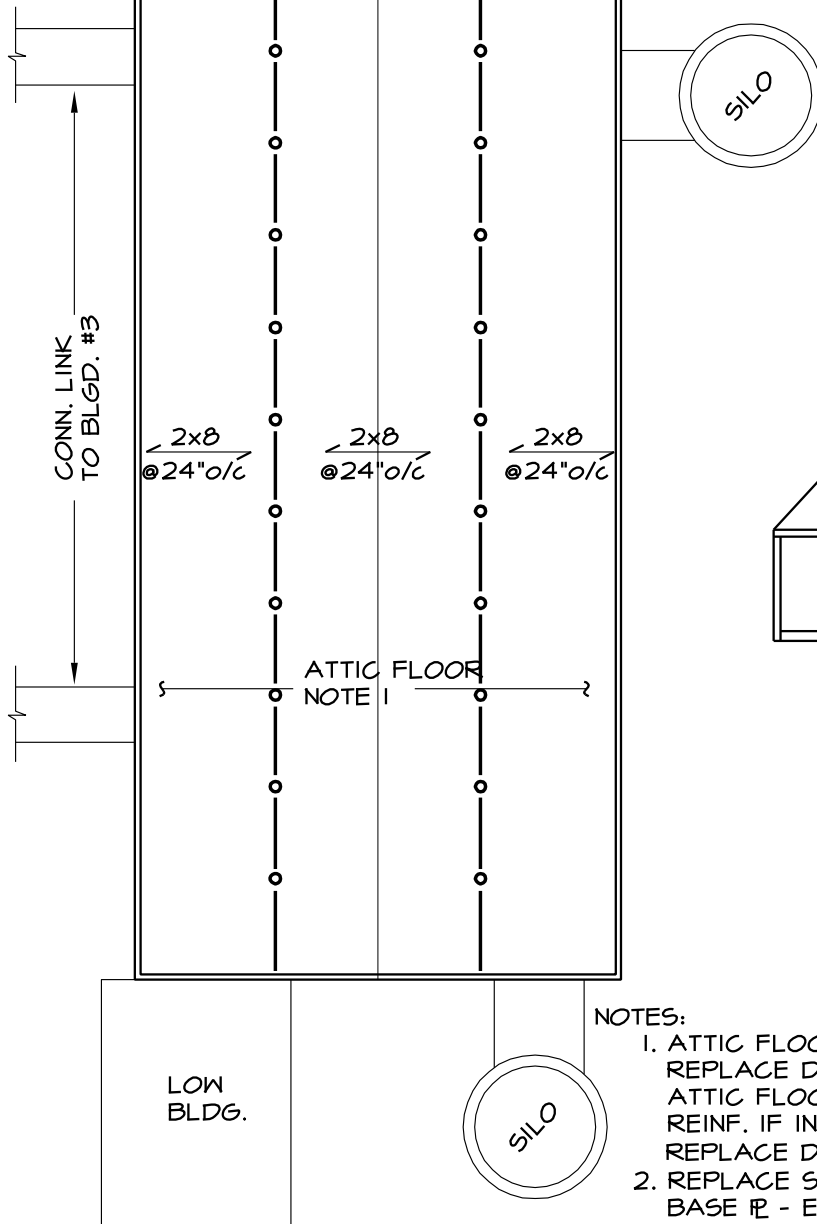
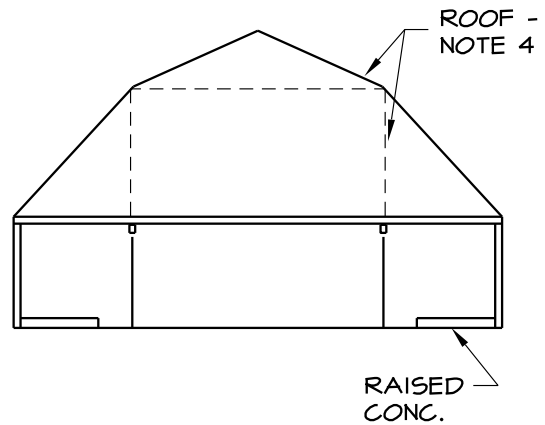
1. ATTIC FLOOR - REPLACE EXIST. DECK (EXTENSIVE). REPLACE DAMAGED JOIST (MINOR). ATTIC FLOOR CAPACITY = 20 PSF REINF. IF INTEND TO USE. REPLACE DAMAGED BEAMS.
2. REPLACE STEEL POSTS (5"Φ). INCLUDE:  
BASE P - EPOXY BOLT TO CONC.  
CAP P - LAG BOLT TO BEAMS
3. SILO - REPAIR CONC. MASONRY AT LOWER 10' OF SILO. ADD NEW ROOF. REPLACE CONN. LINK.
4. EXIST. ROOF FRAMING, RECOMMENED ADDING NEW FRAMING - SEE SECTION.

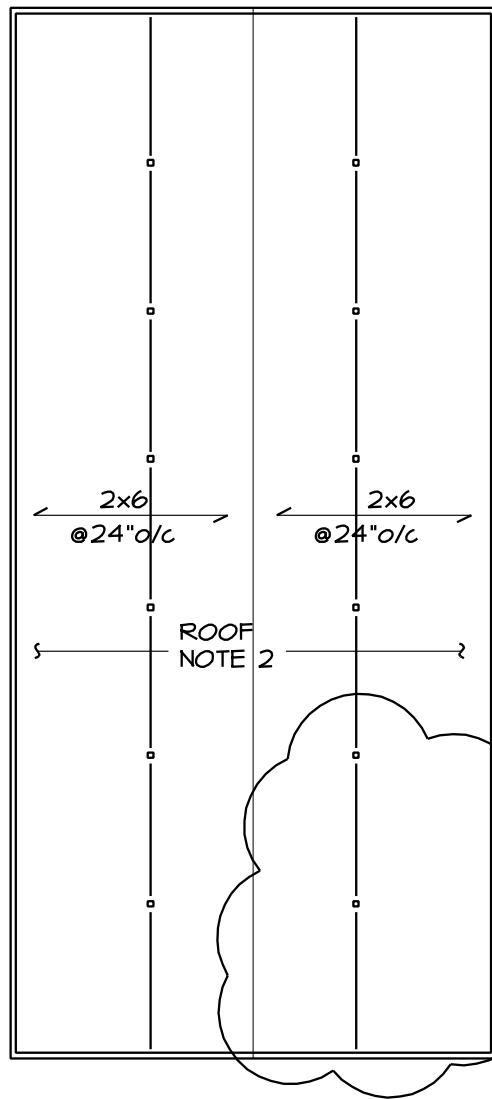
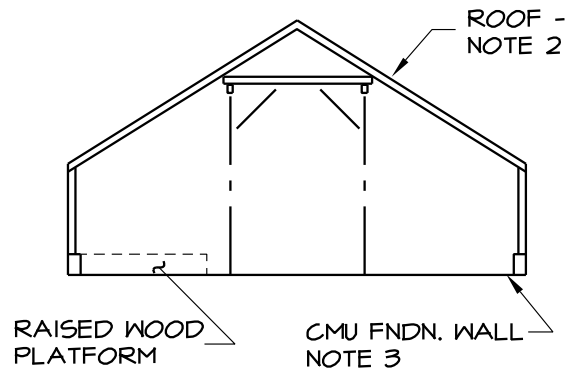
## BLDG. #5 - ROOF PLAN

1. REPLACE FIRE DAMAGED FRAMING
2. EXIST. ROOF FRAMING NOT MEET CURRENT CODES REQUIREMENTS. IF INTEND TO USE MAJOR REINF./ SUPPLEMENTAL FRAMING NEEDED. RECOMMEND DEMOLISH AND REPLACEMENT.
3. REPAIR CMU FNDN. REPLACE BROKEN CMU, POINT ALL JOINTS.
4. EXIST. FLOOR (NOT SHOWN) UNEVEN SLOPES AND IS DIRT FLOOR WEST TWO BAYS.

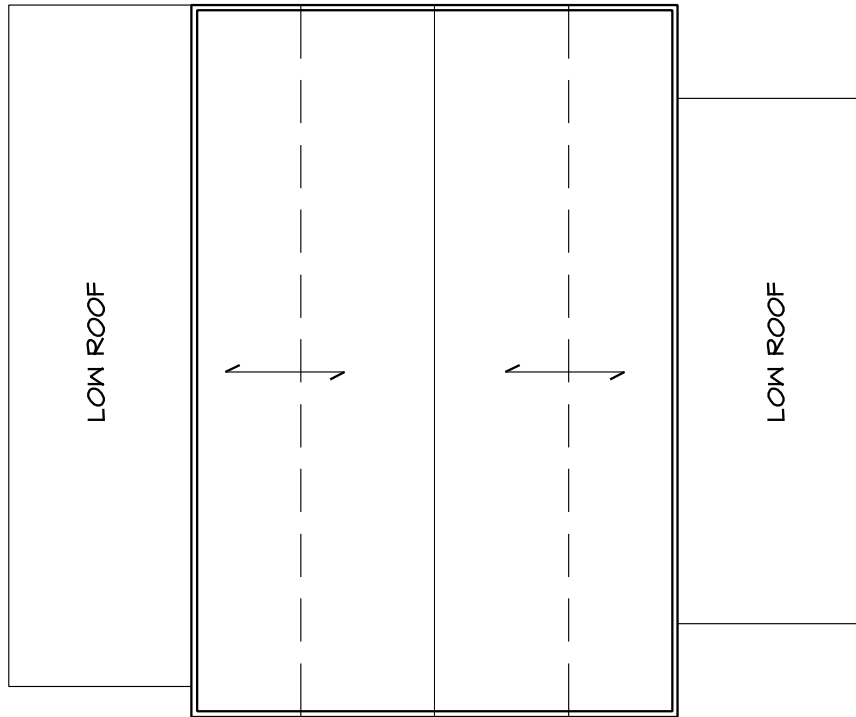
## BLDG. #6 - ROOF PLAN

1. FINISHES COVER FRAMING.
2. WATER DAMAGE VISIBLE.
3. FRAMED FLOORS (1st & 2nd) FEEL "SPONGY".
4. EXTERIOR SIDING IS DAMAGED.
5. MAJOR FRAMING REPAIRS NEEDED.
6. REMOVE EXIST. FLOOR. EXCAVATE CRAWL SPACE. UNDERPIN, REPLACE FLOOR.

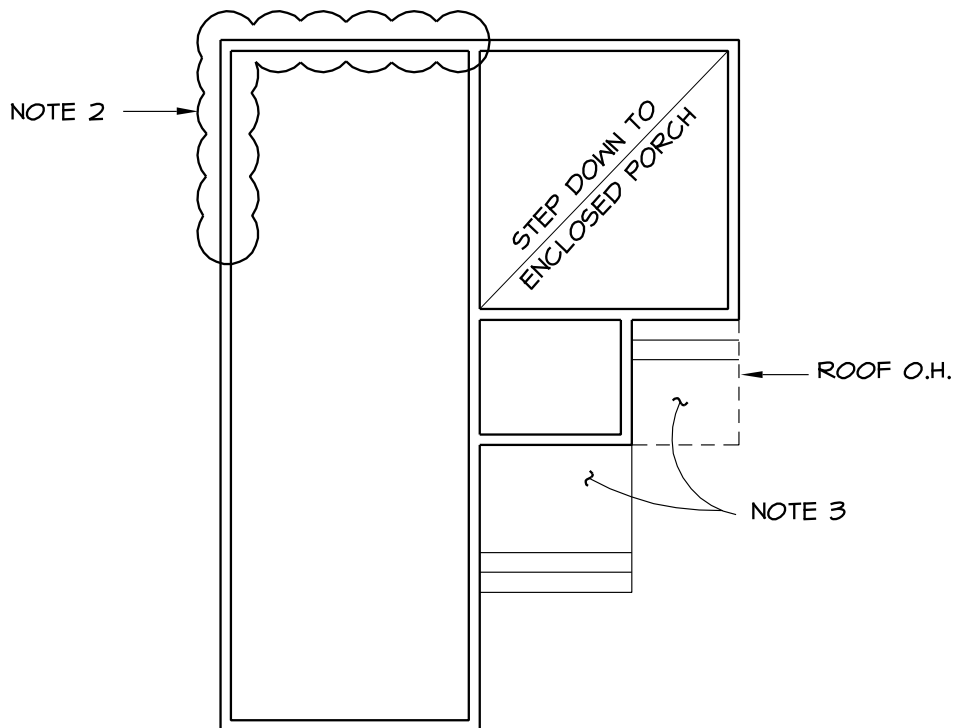
## BLDG. #7 - FLOOR PLAN

1. FINISHES COVER FRAMING.  
SOME WATER DAMAGE VISIBLE.
2. NO FNDN. WALL. EXCAVATE,  
PLACE NEW FTG. AND CMU FNDN. WALL
3. REPAIR STEPS.
4. MAJOR REPAIRS EXPECTED.
5. REMOVE EXIST. FLOOR. EXCAVATE CRAWL SPACE.  
UNDERPIN, REPLACE FLOOR.

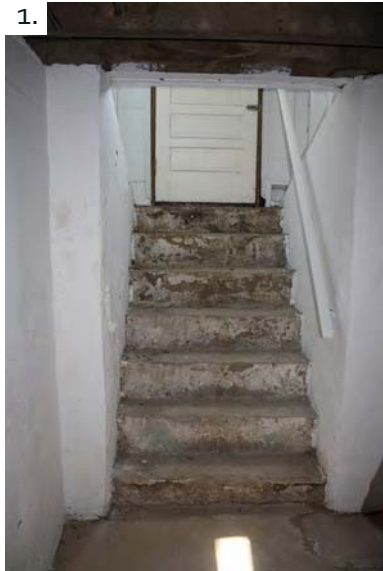
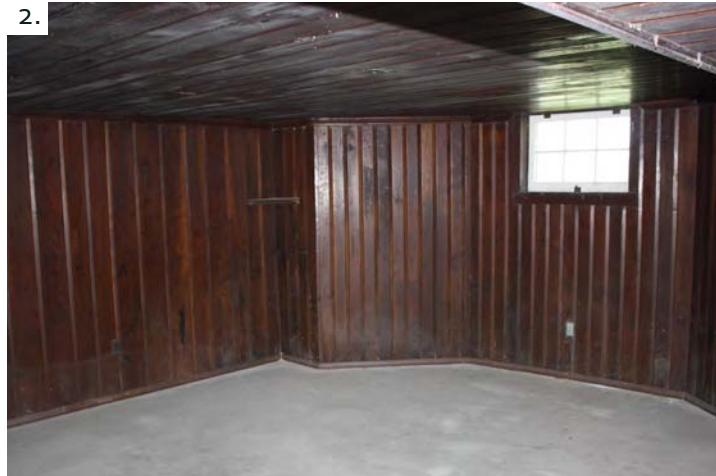
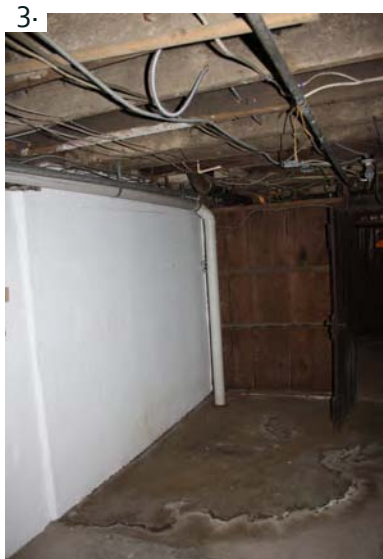
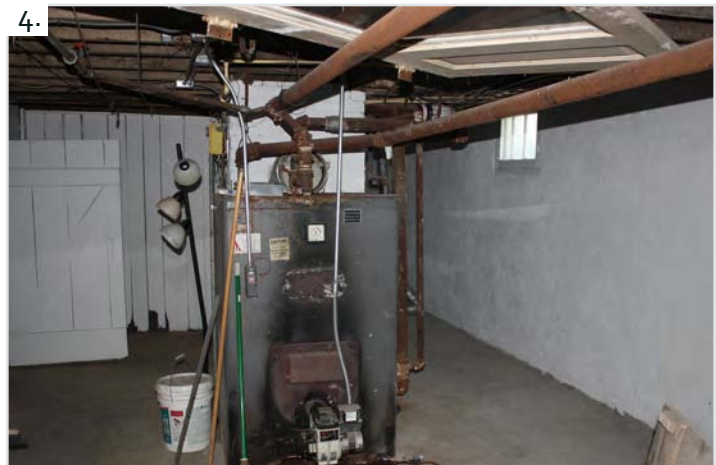
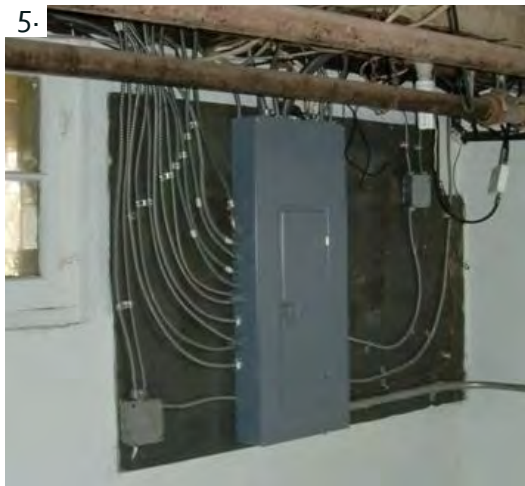
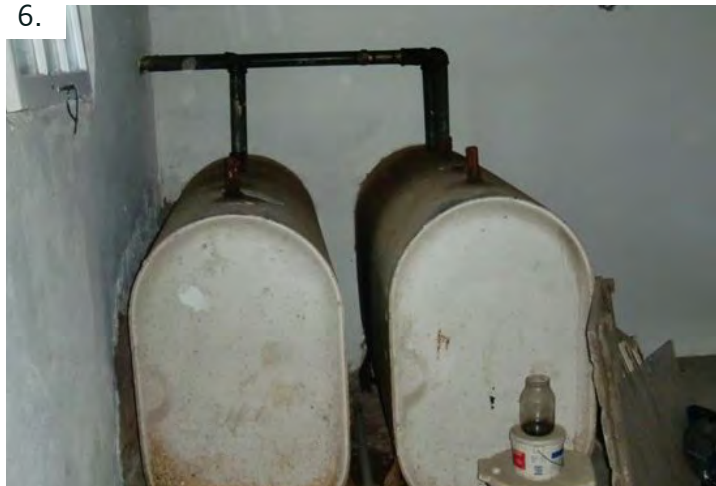
# House, Bldg. 1 BASEMENT

1. **Concrete Steps** There is no appropriate exit.
2. **Wood Paneled Room** Basement ceiling is too low.
3. **Concrete Floor** Old moisture damage.
4. **Boiler** Nonfunctioning.
5. **Electrical Panel** Replace wiring.
6. **Oil Tanks** Nonfunctioning.

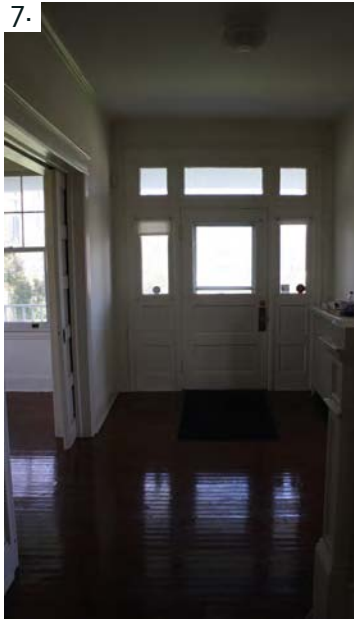
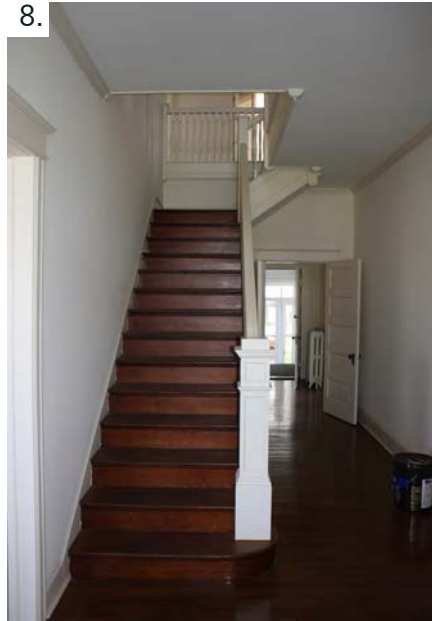
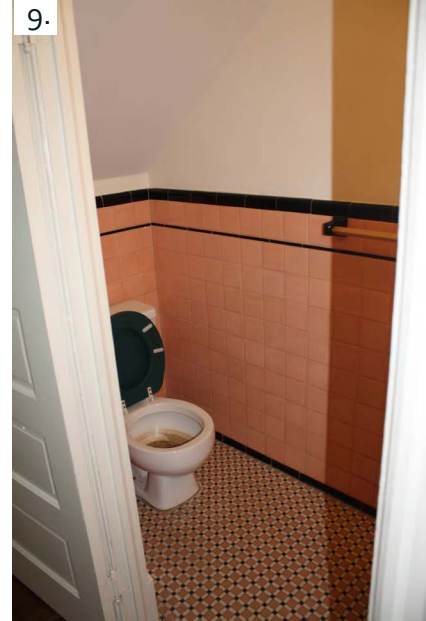
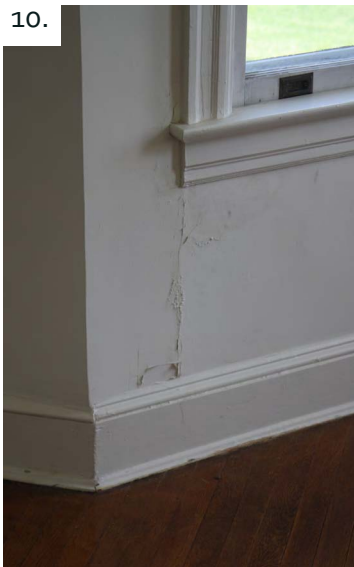
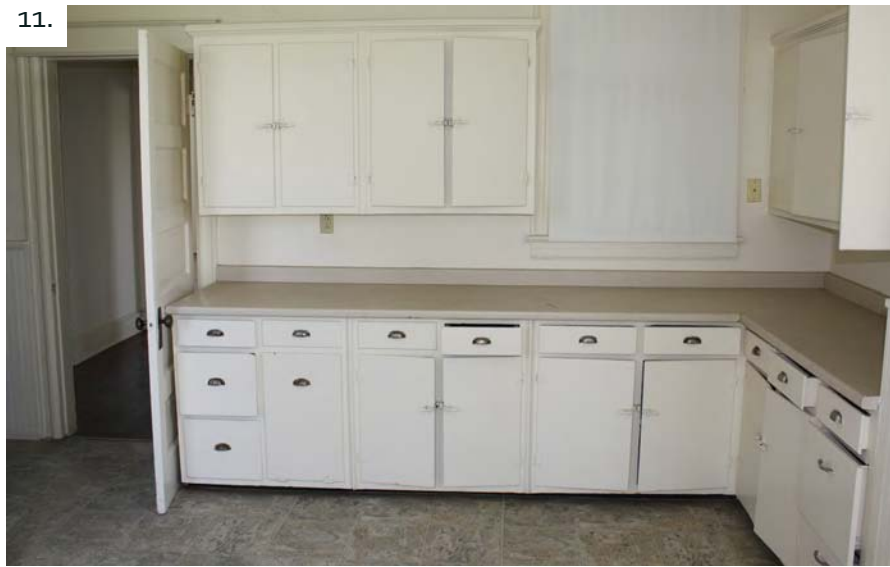
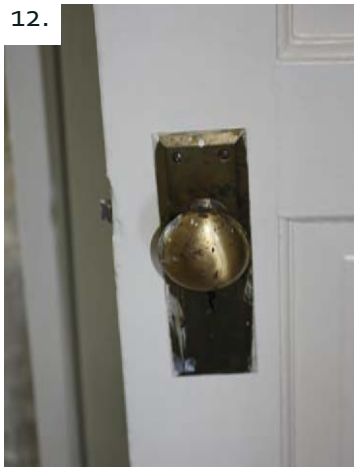
7. **Pocket Doors** Sliders don't work.

8. **Railings** at the foyer stair are too low.

10. **Bay Window** Staining and cracking from moisture.

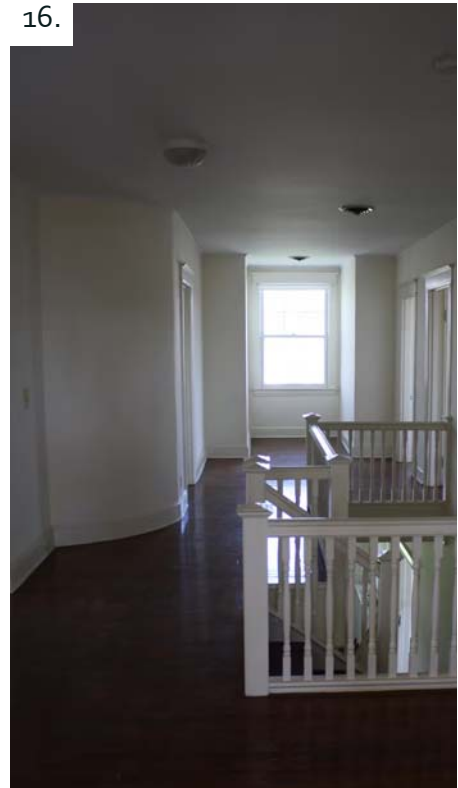
16. **2nd Floor Hall** Railings are too low.

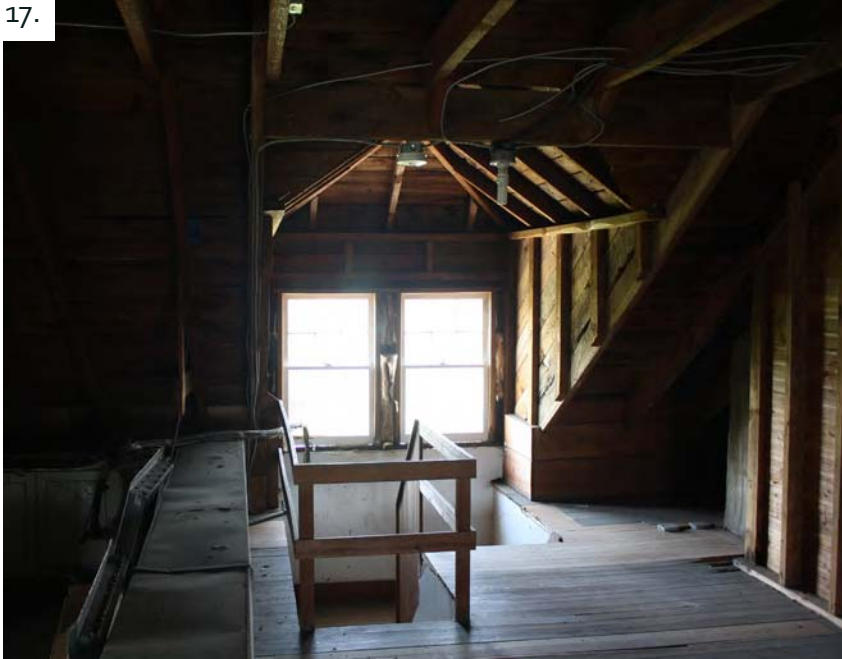
17. **Attic Stair Railing** The railing is noncompliant.

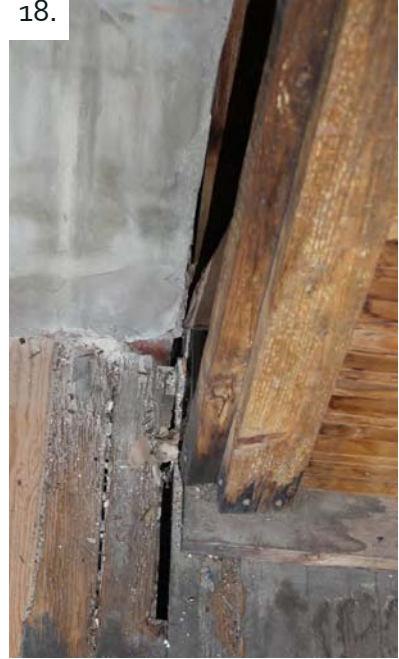
18. **Edge of Stairwell** Moisture damage on flooring.

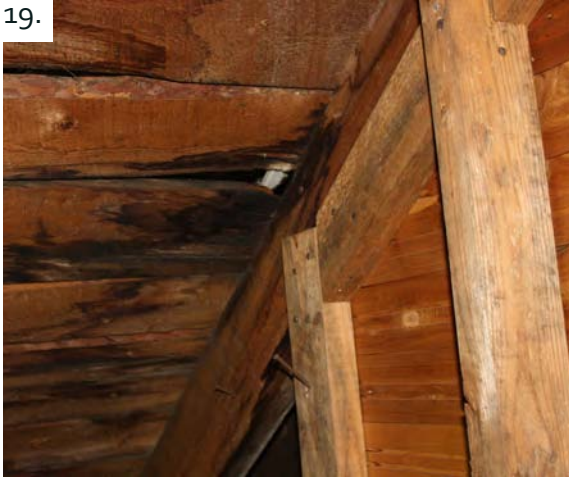
19. **Attic Sheathing** Moisture staining.

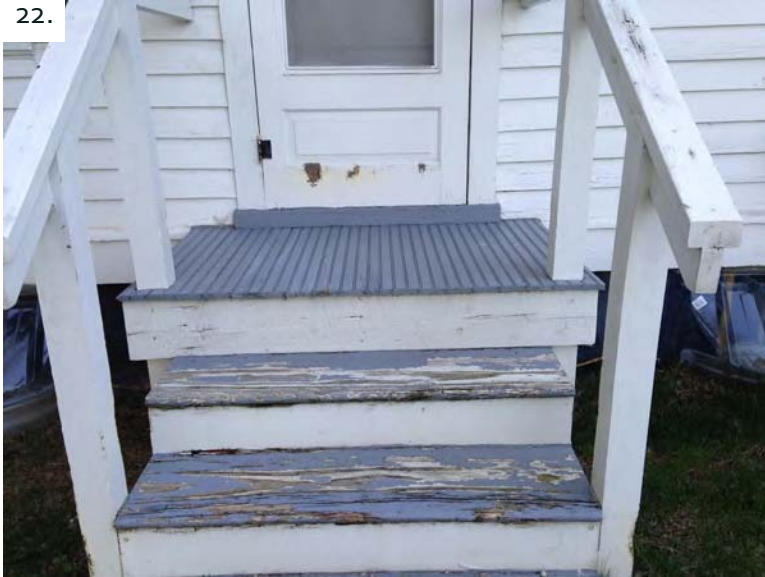
- 22. **Side Entrance** Steps and screen are significantly deteriorated. Railings also needs repair
- 23. **Rear Door** Surround and screen door deteriorated.
- 24. **Shutters** Adjacent to stoop on elevation D. Shutters deteriorated.
- 25. **Slate Path** Slate crumbling, grout deteriorated, exposed, rusted nails.
- 26. **Window** Paint bubbling from leak.
- 27. **Porch Trim** Corner guard and trim.
- 28. **Conduit** Deteriorated.
- 29. **Siding** Soft siding and signs of rot.
- 30. **Flashing** Flashing is delaminated and deteriorating.

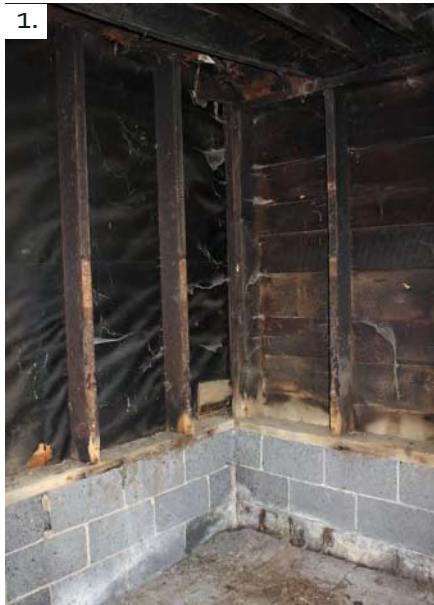
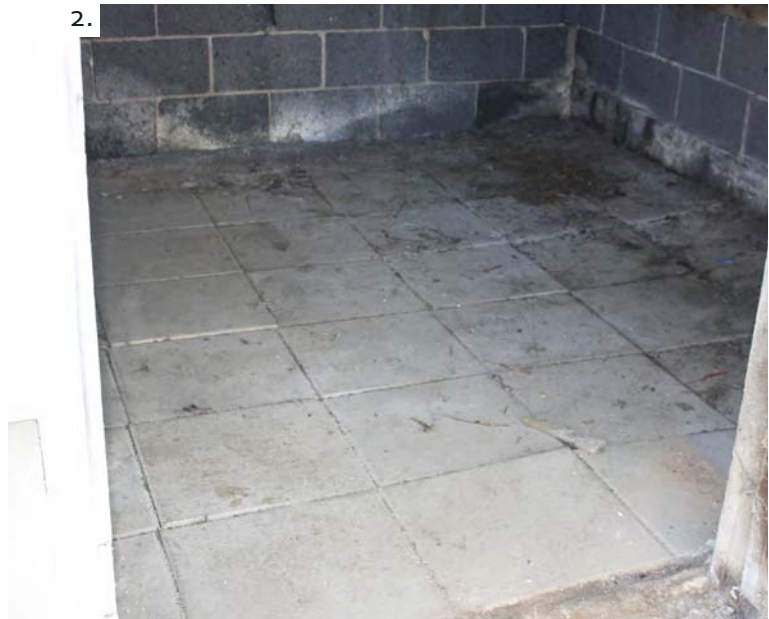
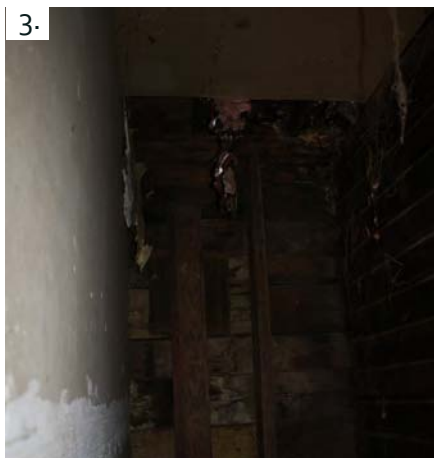
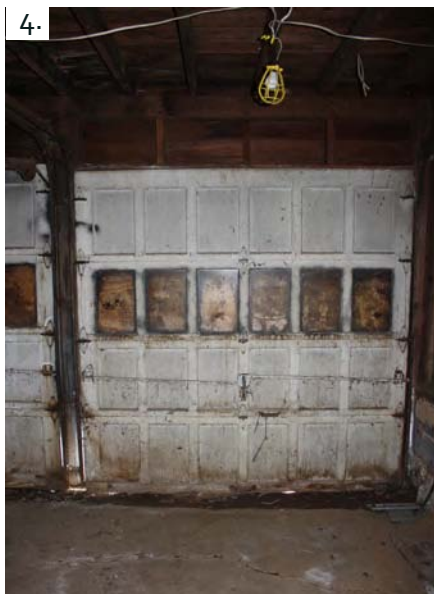
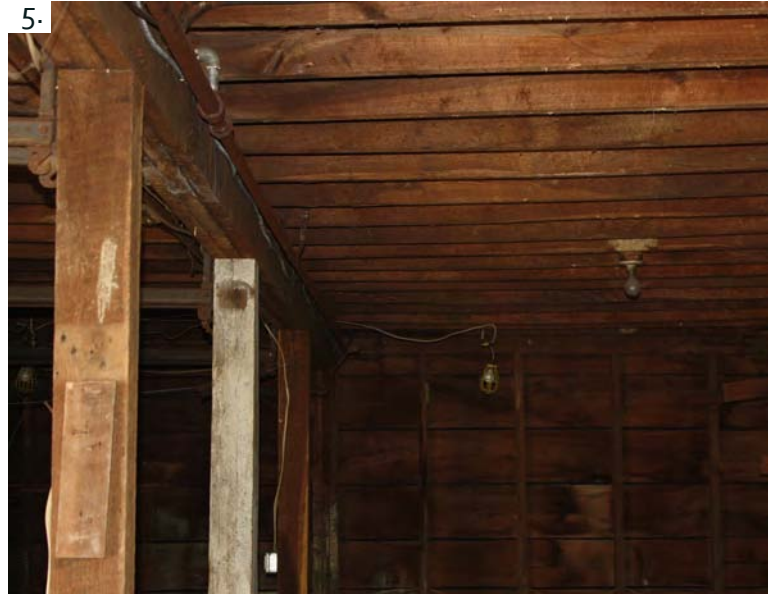
1. ***Smoke Room Walls*** Moisture damage along CMU sill. Uninsulated.
2. ***Smoke Room Floors*** Deteriorated and heaved tiled floor.
3. ***Mechanical Room*** Significant moisture damage.
4. ***Garage Doors*** Nonfunctional and deteriorated.
5. ***Ceiling Joists*** Bowed and below code.

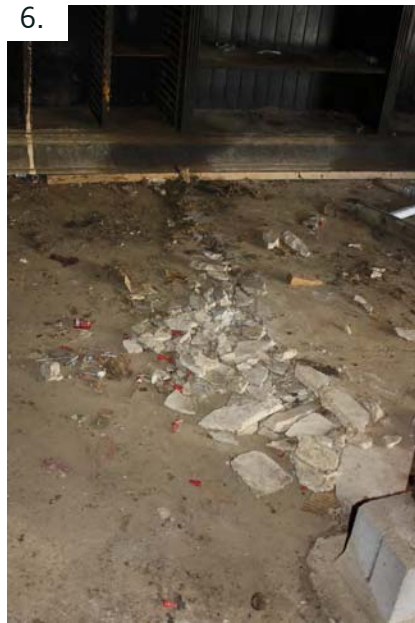
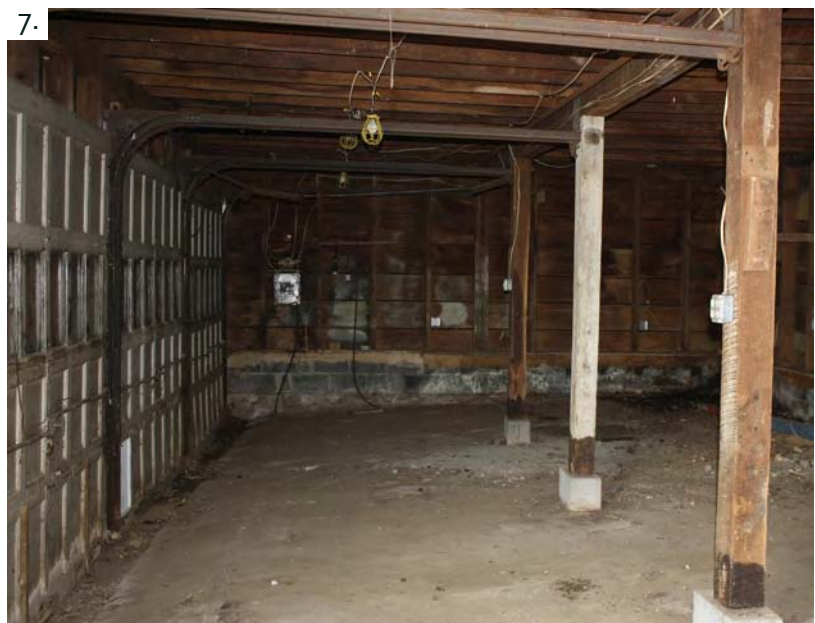
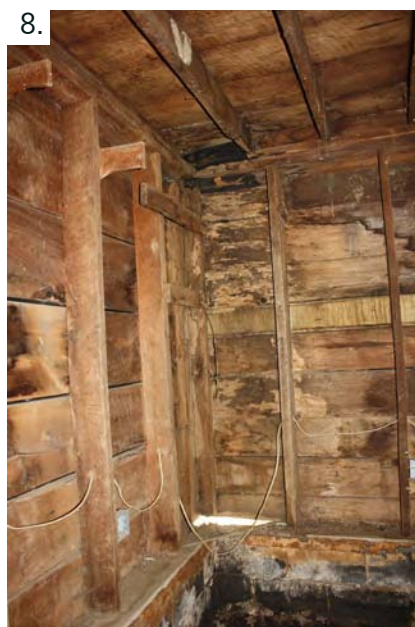
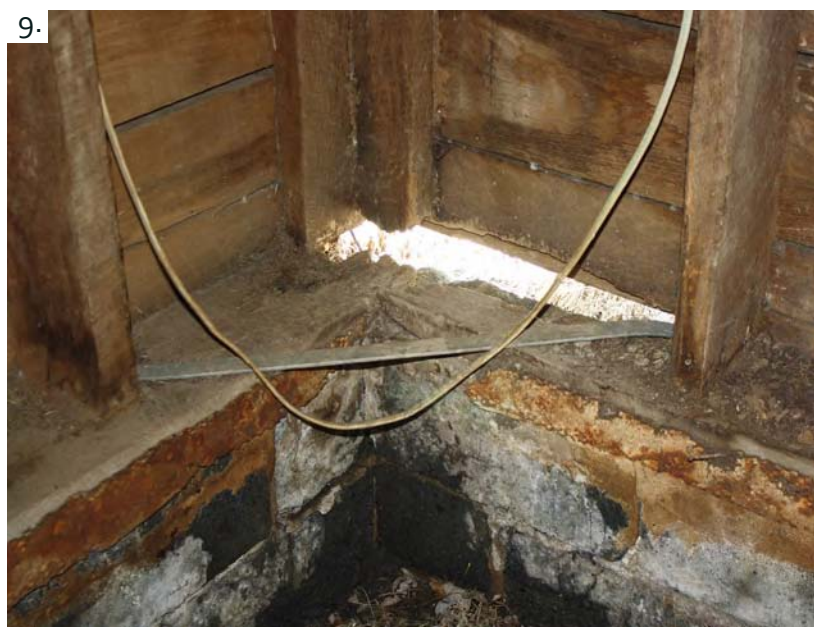
6. **Concrete Floors** Concrete is crumbling.

7. **Garage** No insulation.

8. **SW Corner** Significant moisture damage to sheathing.

9. **SW Sill** Degraded sill with significant moisture damage.

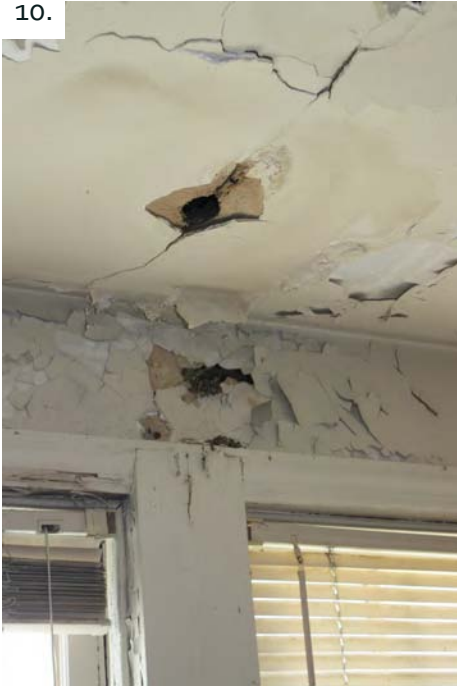
- 10. **Bedroom** Ceiling and wall damage from moisture infiltration.
- 11. **Bathroom** Deteriorated floor & walls. Moisture damage.
- 12. **Walls** Moisture damage, rot, & damaged plaster.
- 13. **Windows** Signs of leaks & sill rot.
- 14. **Sheathing** Water damage and staining.
- 15. **Floors** Deteriorated and stained floors.

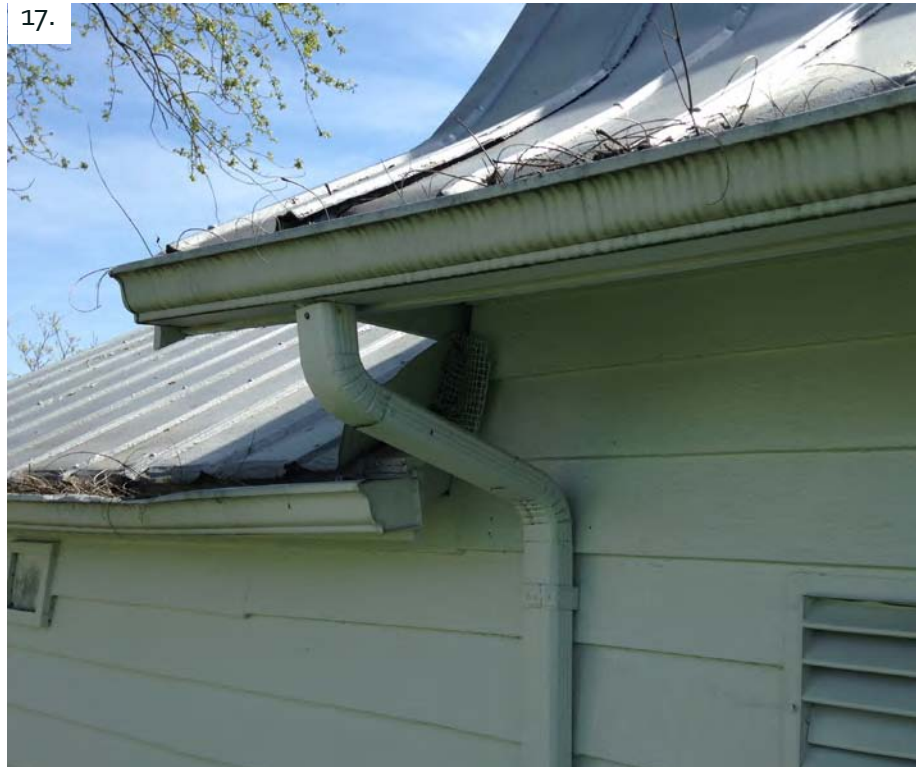
17. **Flared Eave** Gutters very full of debris, and showing signs of deterioration.

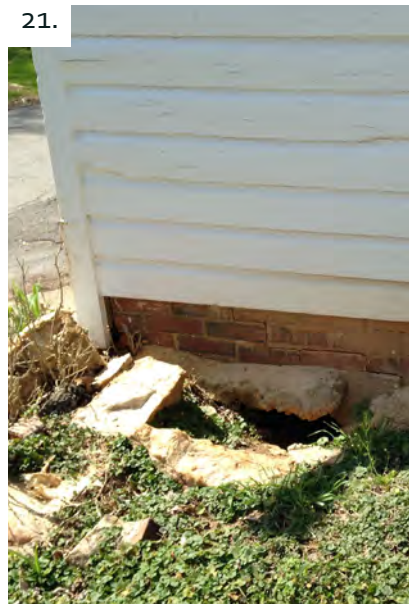
21. **Burrow** Groundhog burrow beneath the stair foundation.

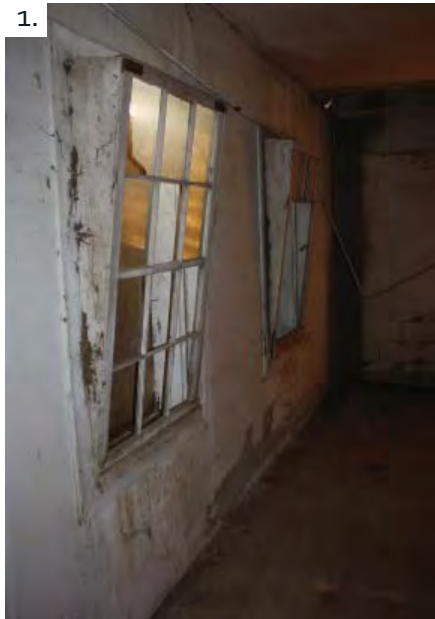
1. **Windows** Missing glass and muntins. Tilted surrounds deteriorated.

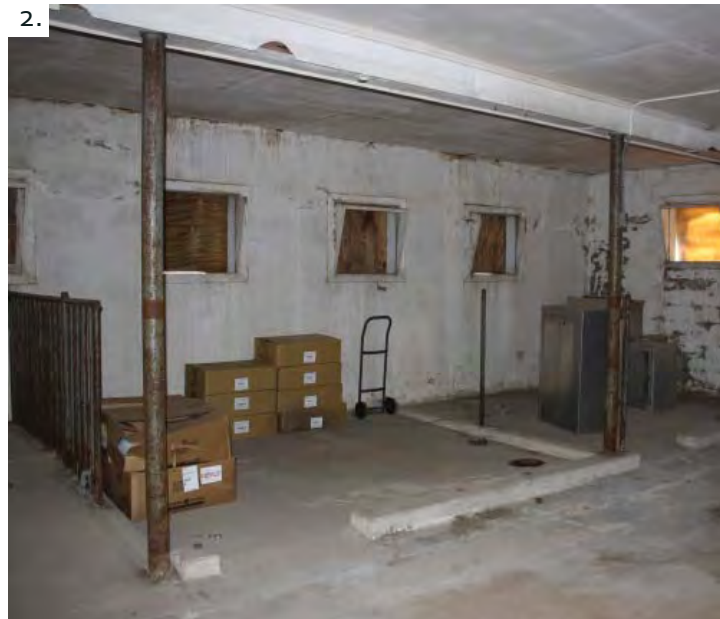
2. **Curbs** 6" curbs affect both accessibility and egress.

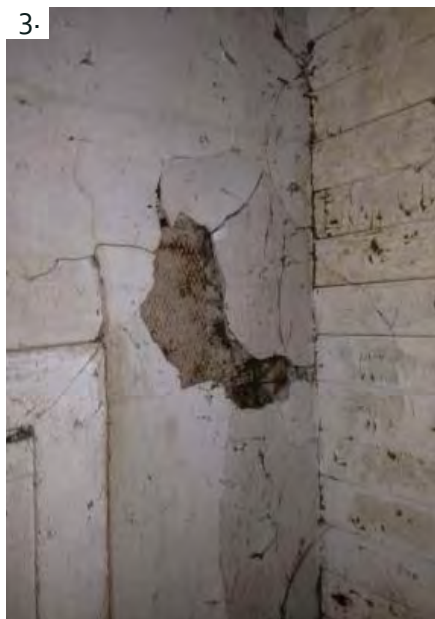
3. **Plaster** Significant moisture damage.

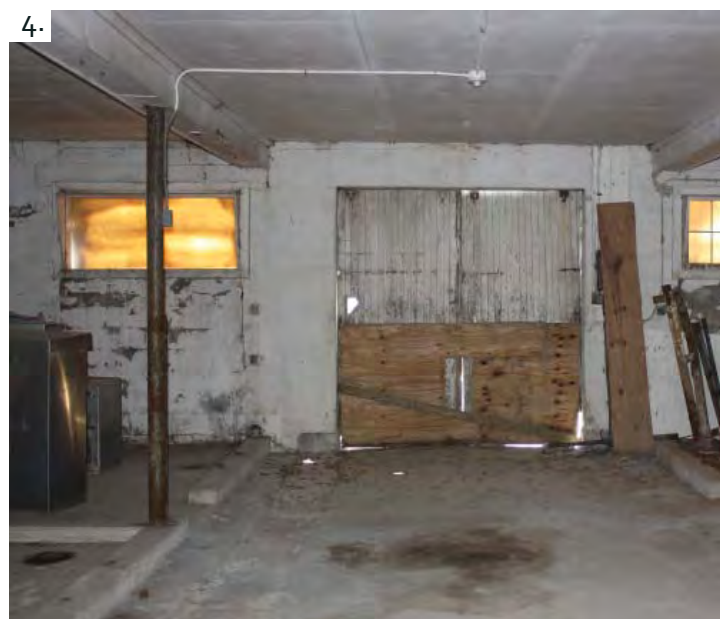
4. **Barn Doors** Nonfunctional and deteriorated.

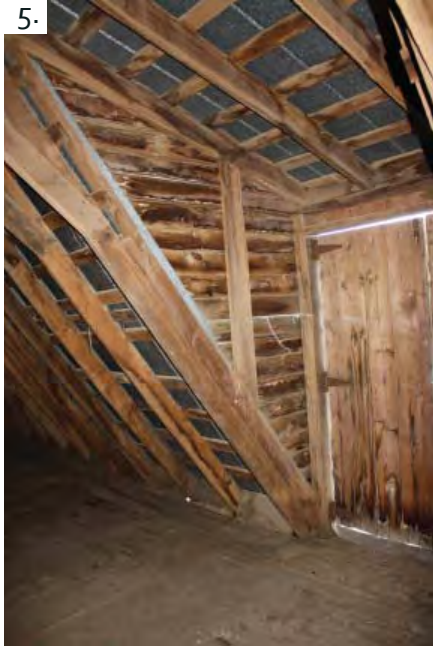
5. **Attic Dormers** Not weather tight and deteriorated doors.

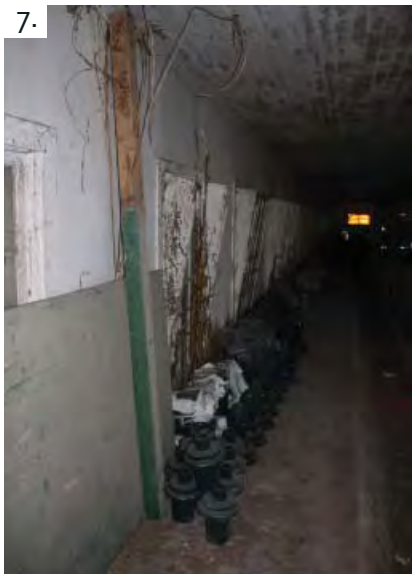
7. **Aisles** Side aisles elevated from central aisle with concrete curbs showing signs of wear.

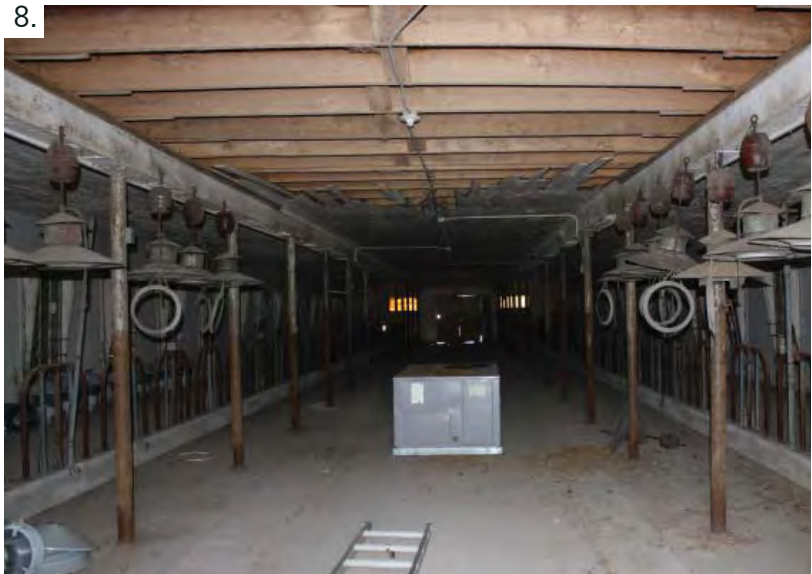
8. **Ceiling** Much of the boarded ceiling is missing or damaged.

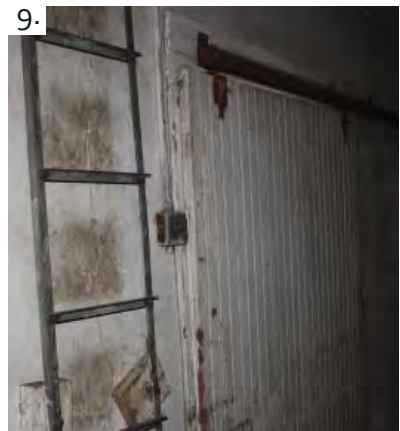
9. **Hardware** Rusted, damaged and nonfunctional.
