**CITY OF ROCKVILLE**

**KING FARM FARMSTEAD PROPERTY**

**CONDITION ASSESSMENT**

DEPARTMENT OF RECREATION AND PARKS  
JULY 3, 2014

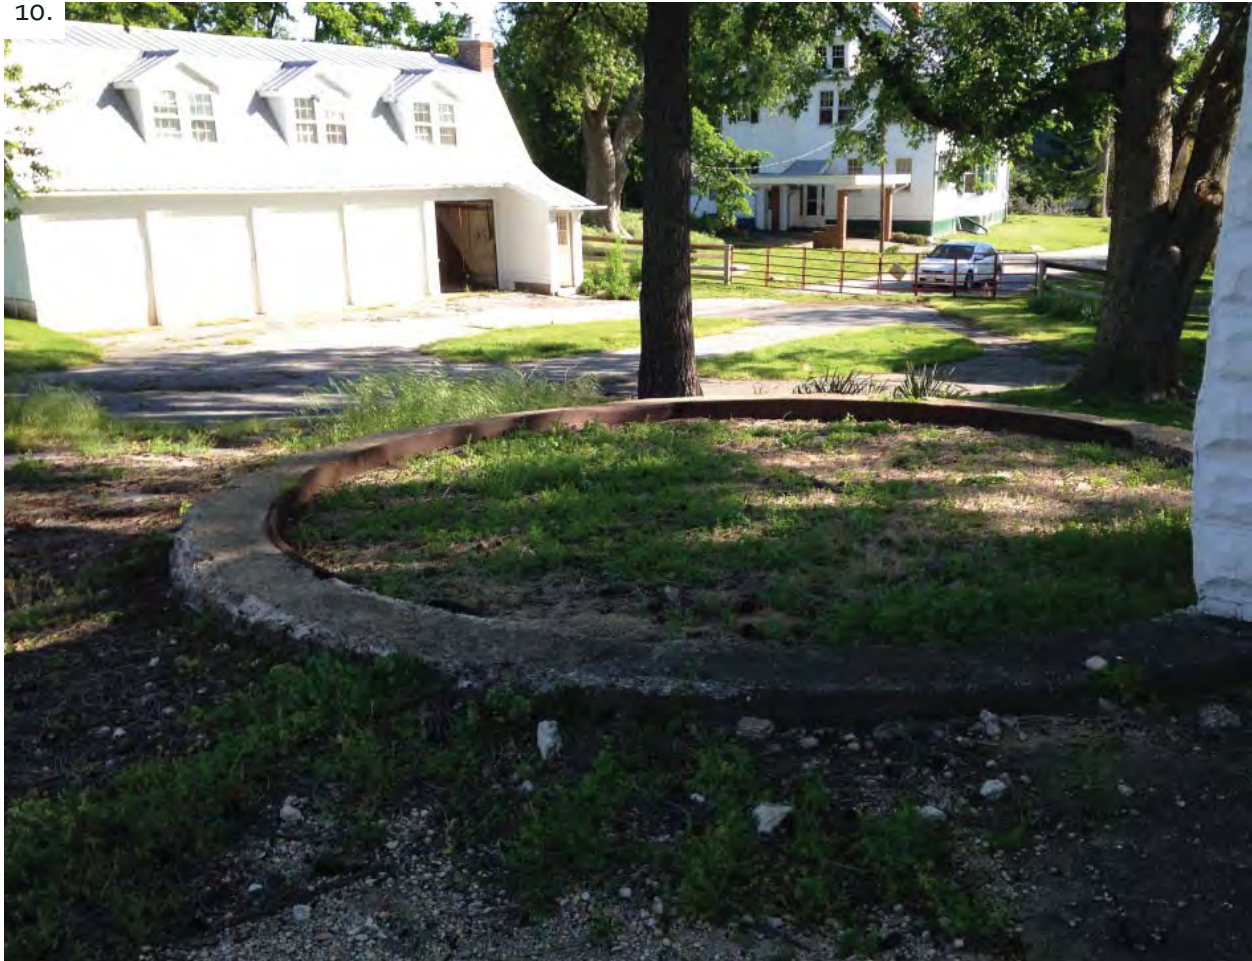
10. **Silo** Torn down. Foundation remains.

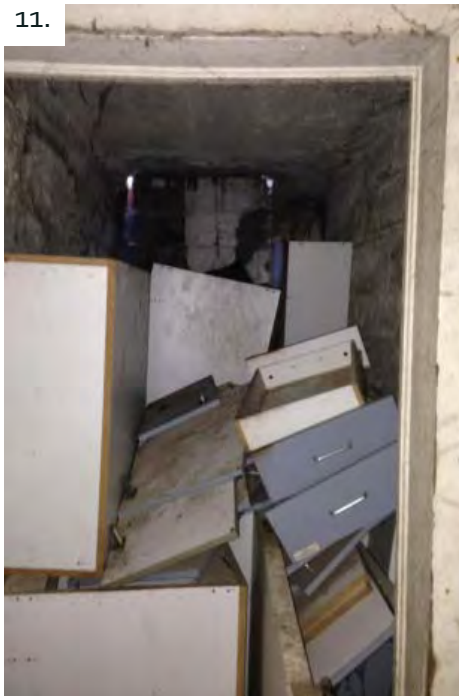
11. **Connector 2** Significantly deteriorated space.

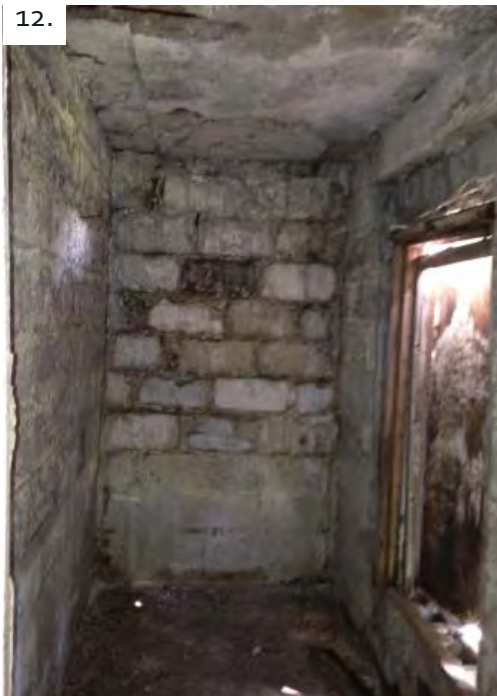
12. **Connector 1** Moisture damage, rot, and crumbling ceiling.

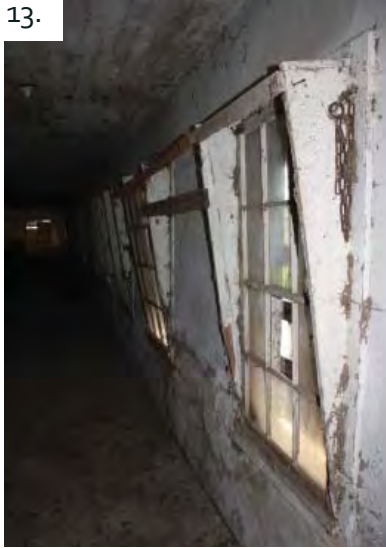
13. **Tilt-ins** Window glass broken or missing. Frames and sills show signs of rot.

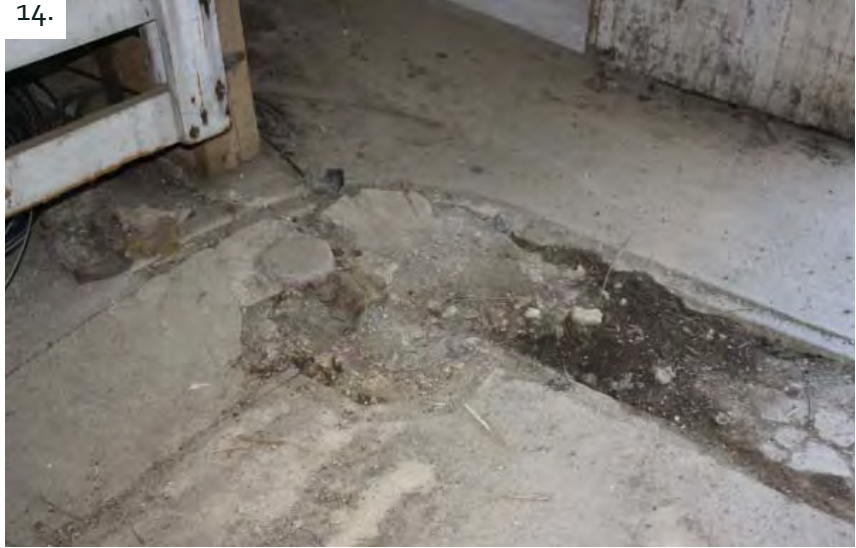
14. **Trench** formed into the concrete floor.

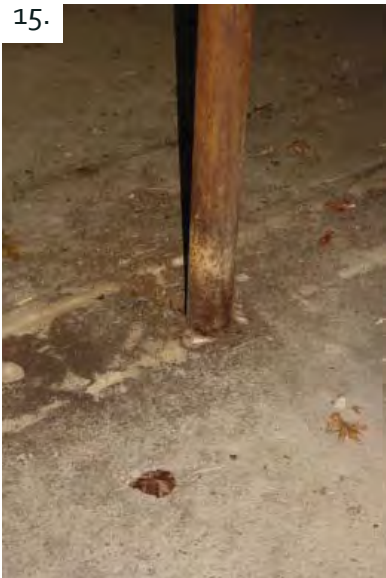
15. **Columns** all show significant signs of wear. Some are missing and others have sheared off their base.

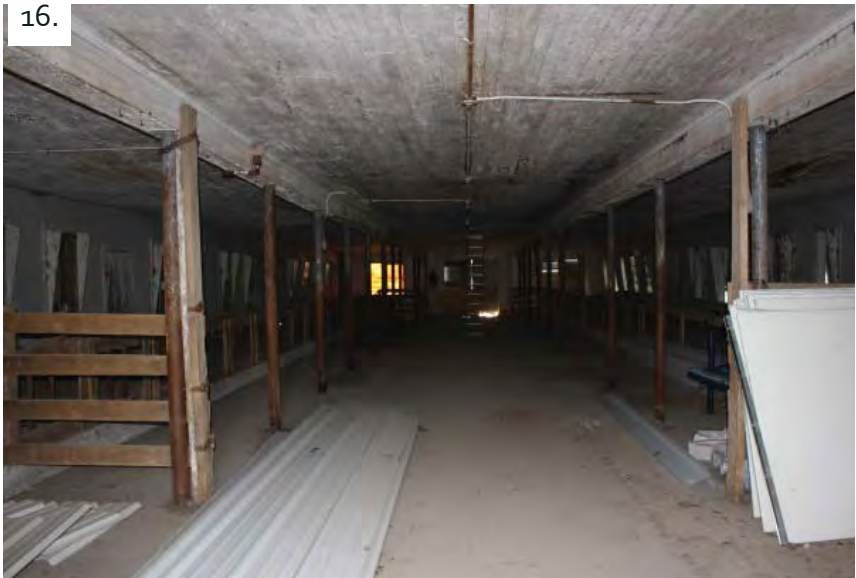
16. **Ceiling** Shows signs of rot and the box beams have deteriorated.

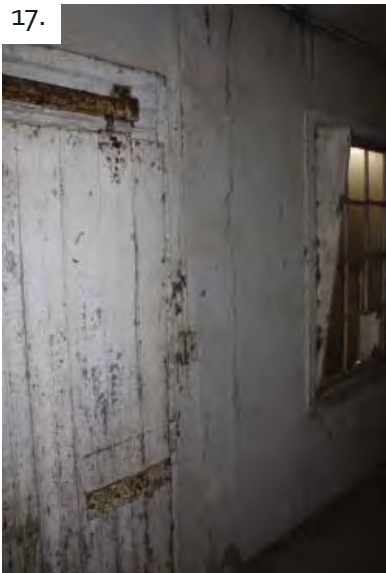
17. **Barn Doors** All doors are rotted. Hardware has rusted and is nonfunctional.

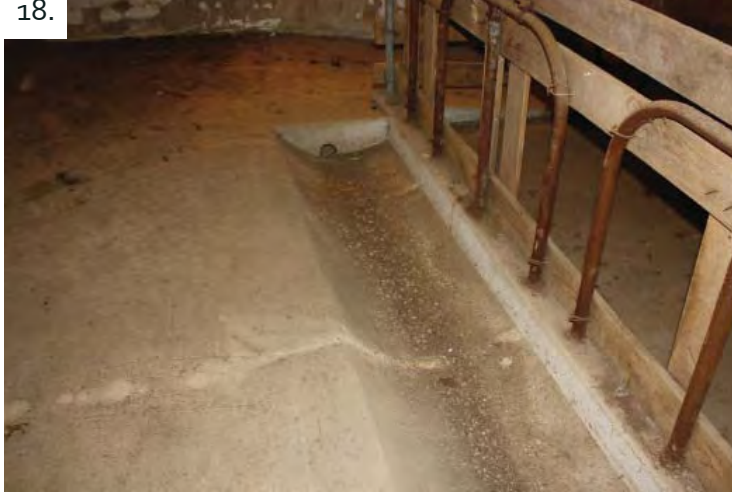
18. **Floors** Floor formed w/ 6" curbs, ramps & trenches in concrete. Hollow railings embedded in curb.

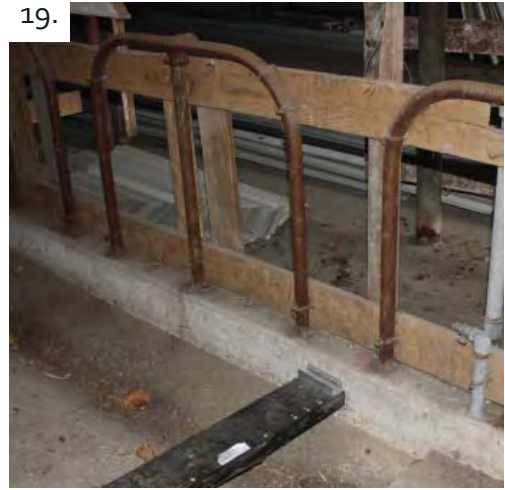
19. **Drains** Trench drains are clogged. Appurtenances mounted over concrete and railings.

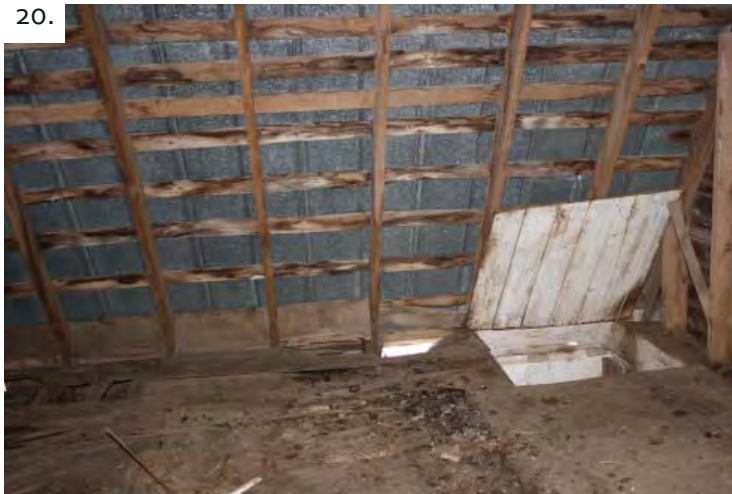
20. **Attic Floor** Floor sheathing damaged.

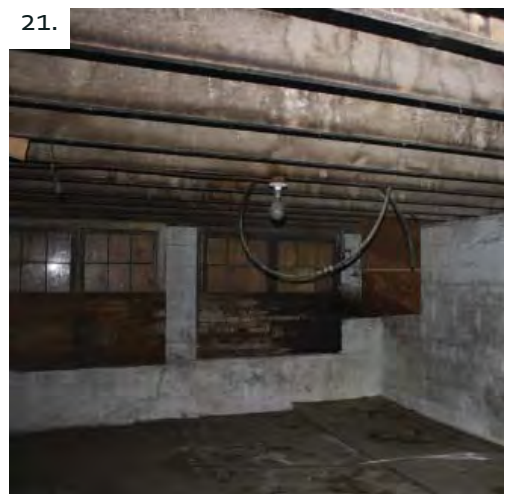
21. **Room 4** Joists are rotting and CMU shows water damage.

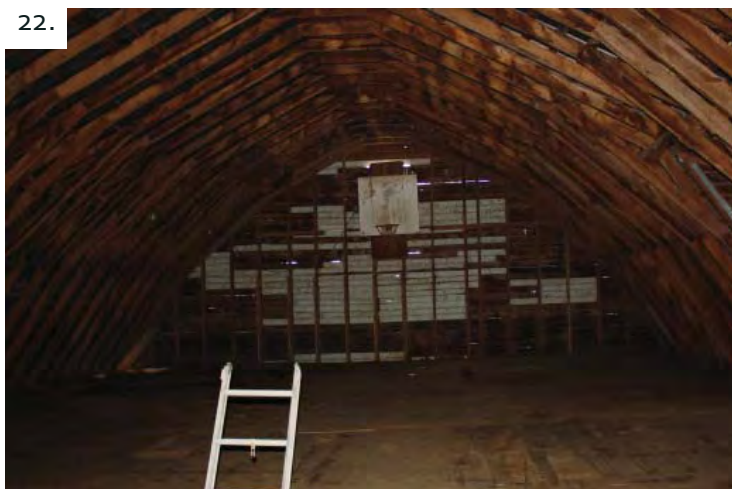
22. **Roof** In poor condition and not weather-tight.

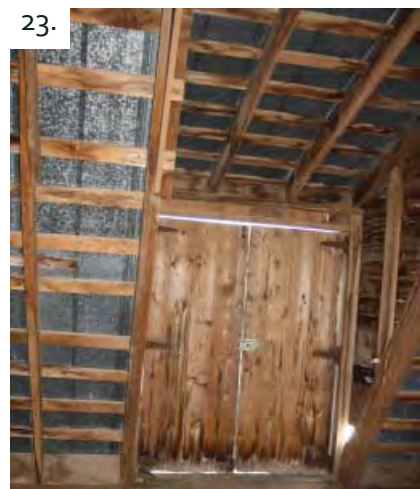
23. **Dormer** Doors have rotted as has siding. Not weather-tight.

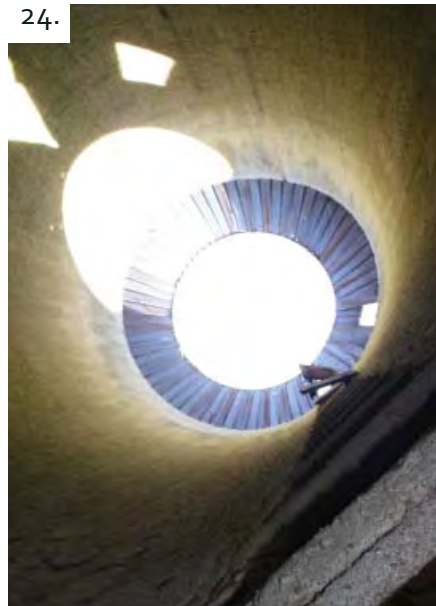
24. **Silo 3** Deteriorated concrete ladder. Roof in disrepair.

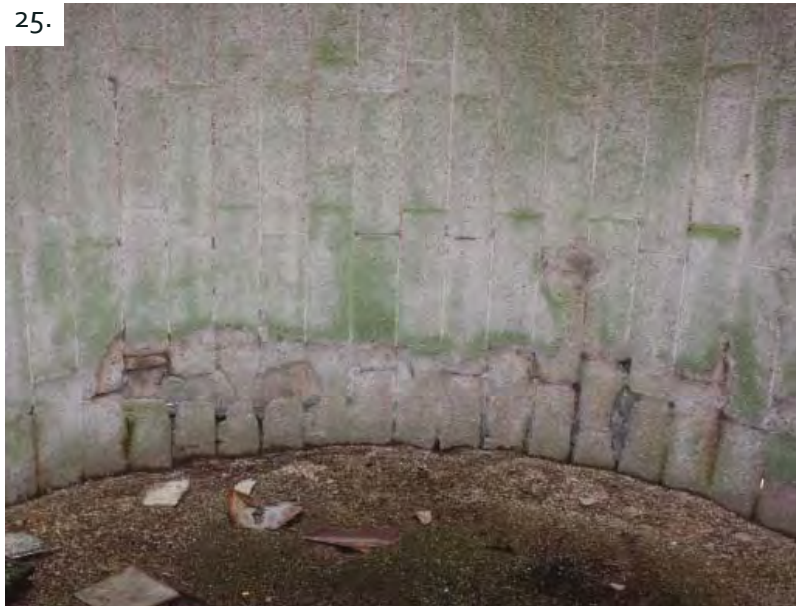
25. **Silo 4** Significant damage along seam between concrete floor and silo wall.

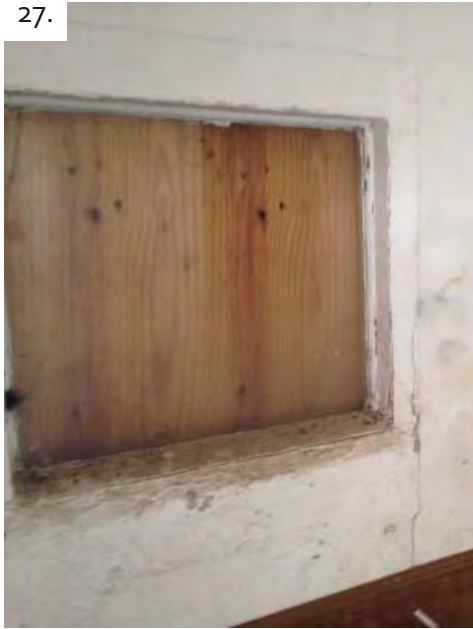
27. **Picture Window** Window glass missing. Sill deteriorated.

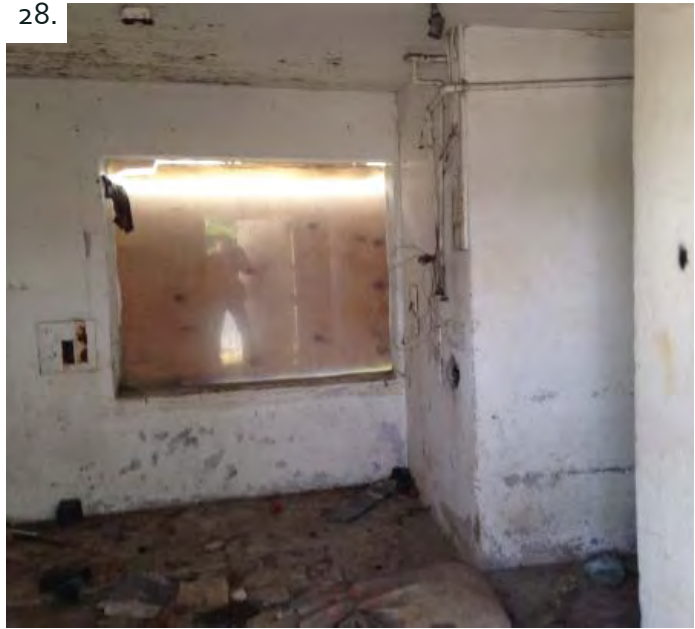
28. **Debris** Flaking plaster, deteriorated wood and concrete accumulating on the floor.

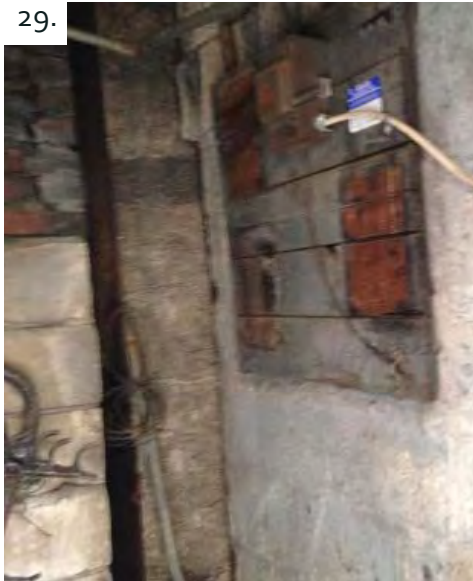
29. **Panel** Old panel missing equipment and deteriorated.

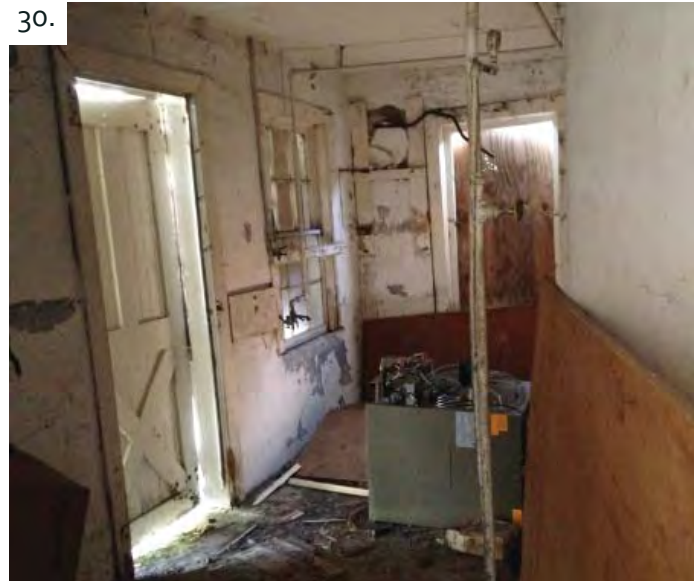
30. **Rear Room** Plaster deterioration, missing window glass and deteriorated sills.

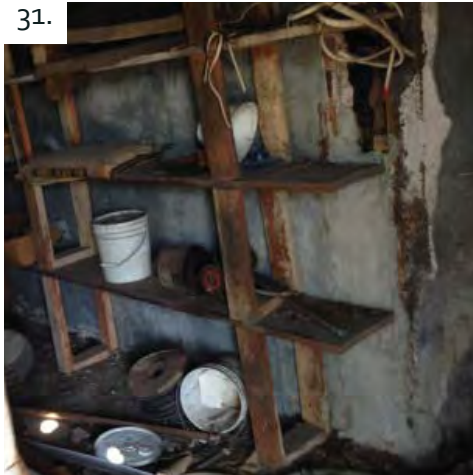
31. **Storage Room** Walls are crumbling.

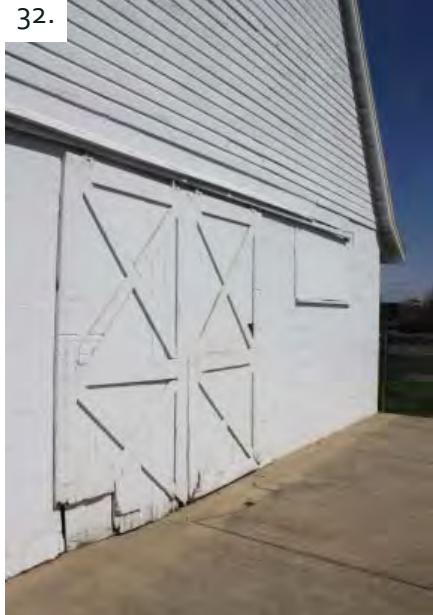
32. **Barn Doors** Rotted and damaged. Sliding hardware in disrepair.

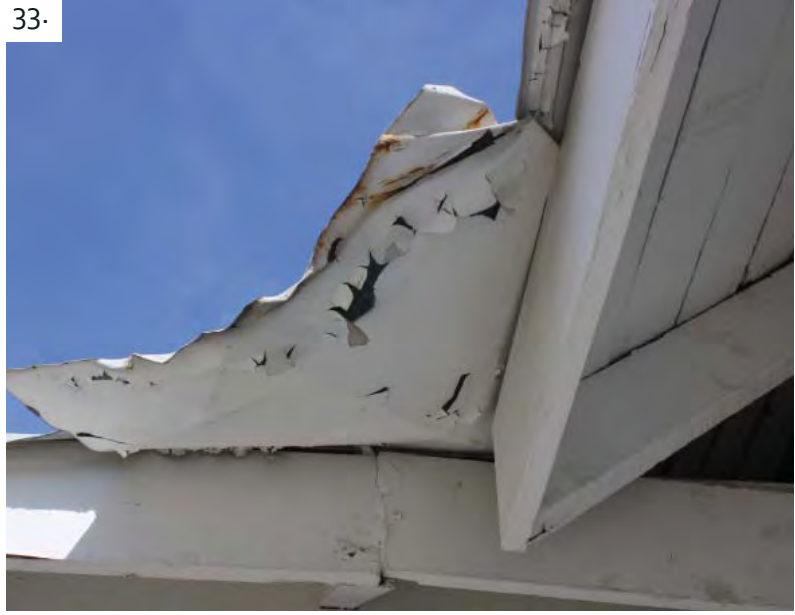
33. **Drainage** No gutter system is present. Corner guards falling apart.

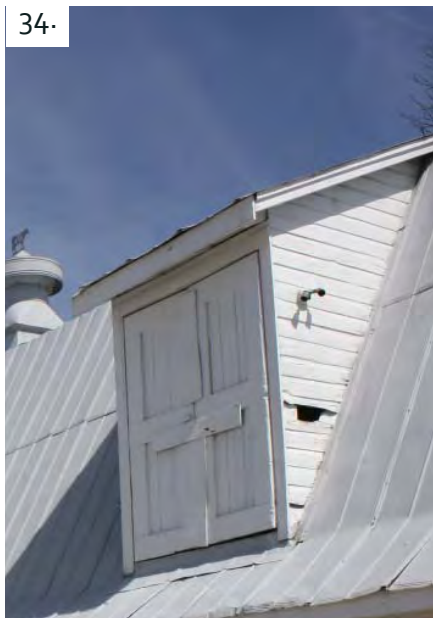
34. **Dormers** Siding showing deterioration.

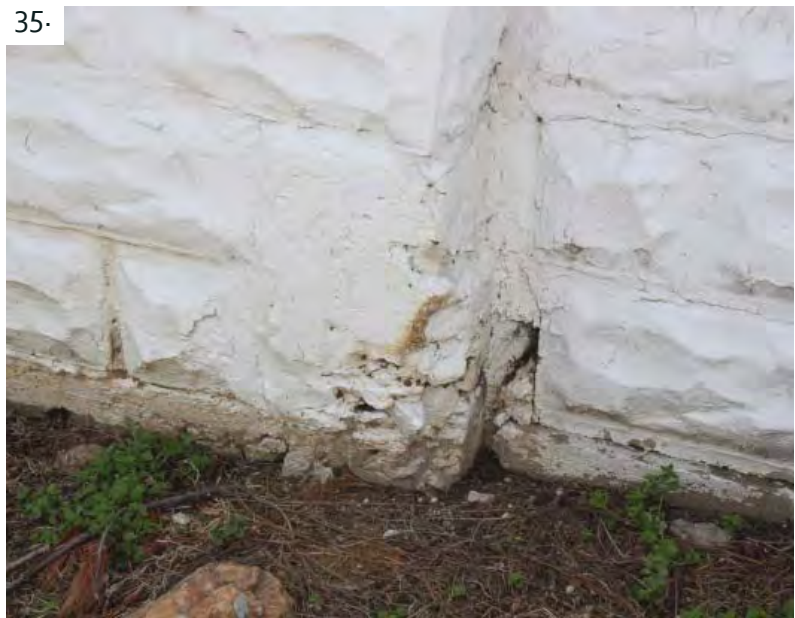
35. **Foundation** Some decay of CMU and grout.

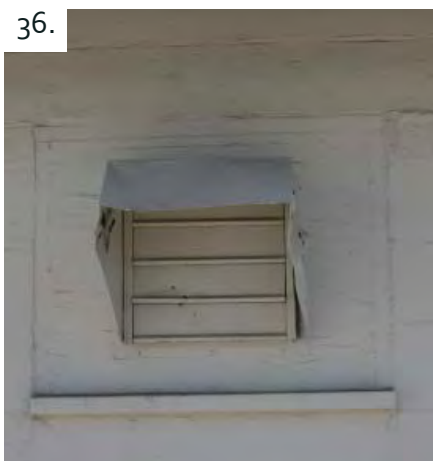
36. **Vents** are not functioning and show signs of wear.

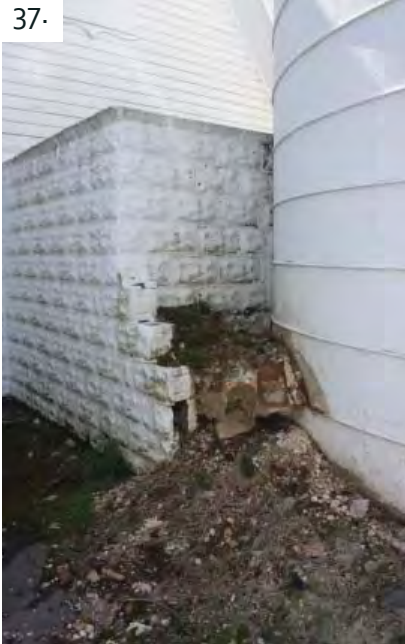
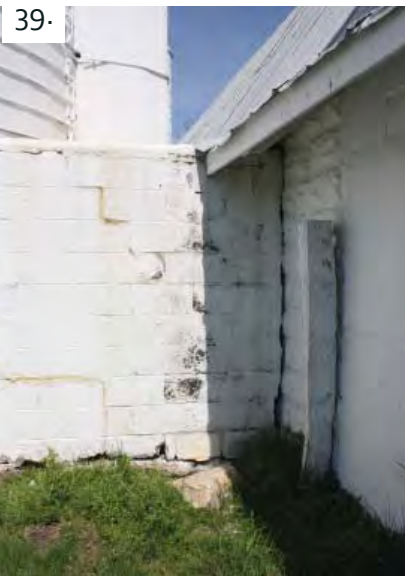
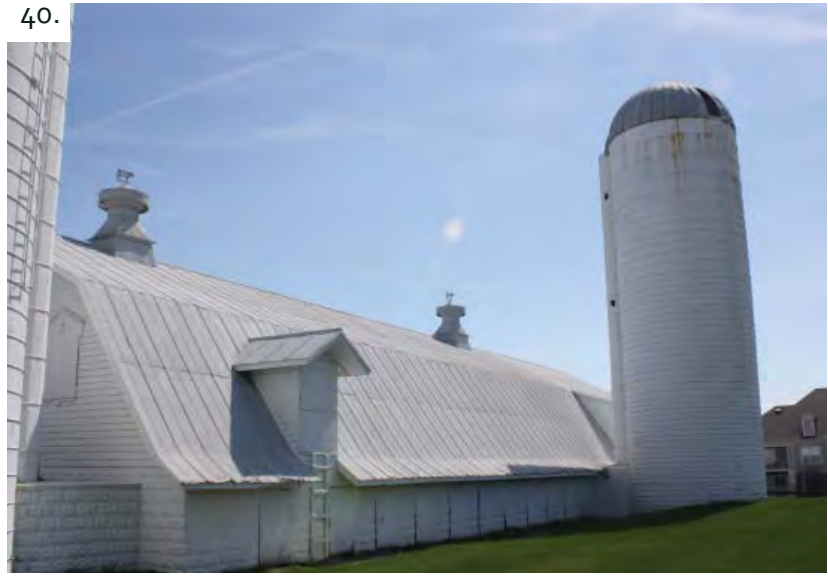
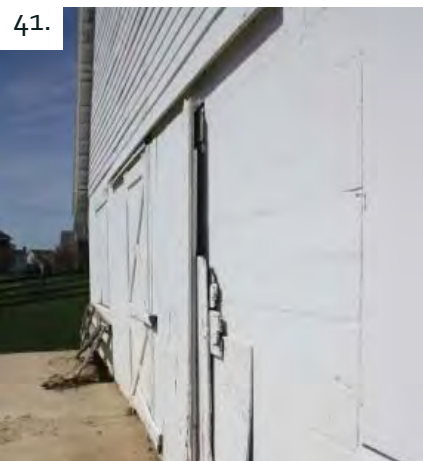
37. **Connector 3** Shows significant damage.

38. **Sliders** Show signs of rot.

39. **Connector 4** Shows significant damage.

40. **Roof** in significant disrepair. Portion of silo roof missing.

41. **Appurtenances** Exterior walls have various plywood boards and other miscellaneous appurtenances on them.

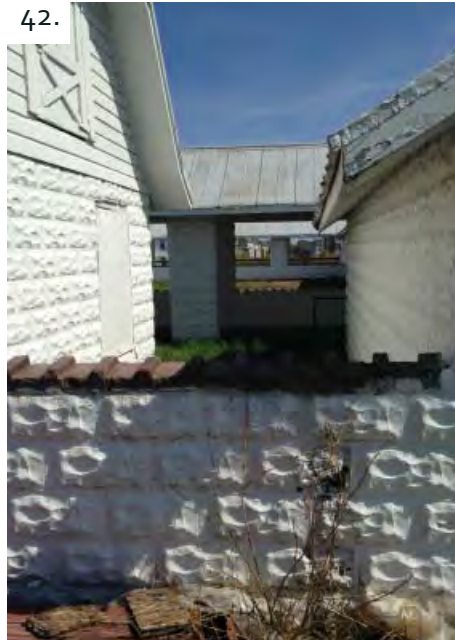
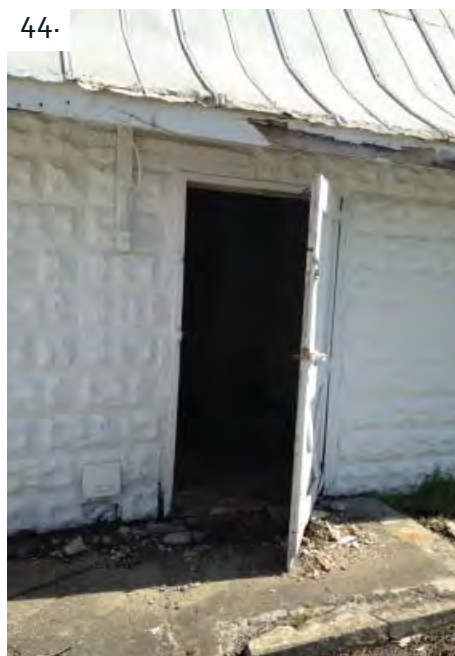
42. **Low Wall** Grout and CMU show signs of deterioration.

43. **Roof** Show signs of rot.

44. **Fascia** Shows significant damage and rot.

45. **Door** Damaged, held by only one hinge and rotted at the bottom.

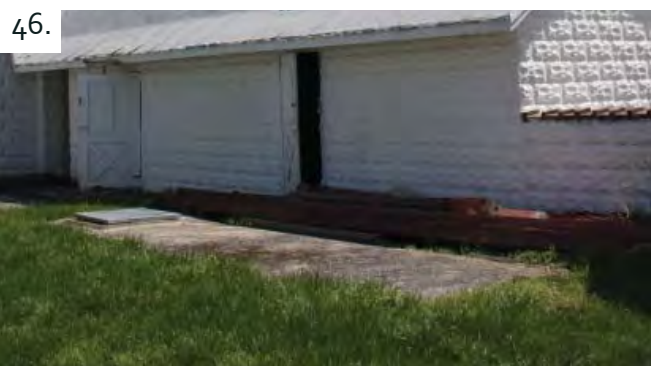
46. **Concrete containment tank** In front of milk house; Unknown contents

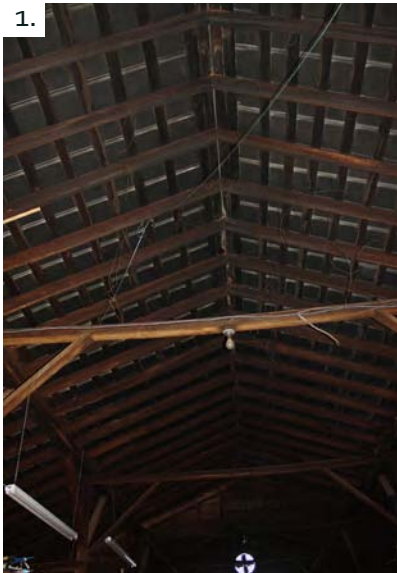
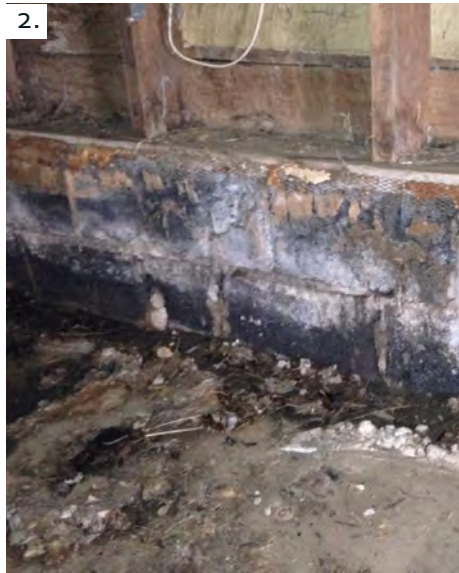
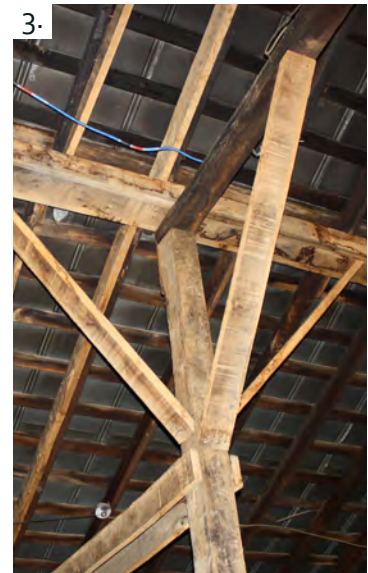
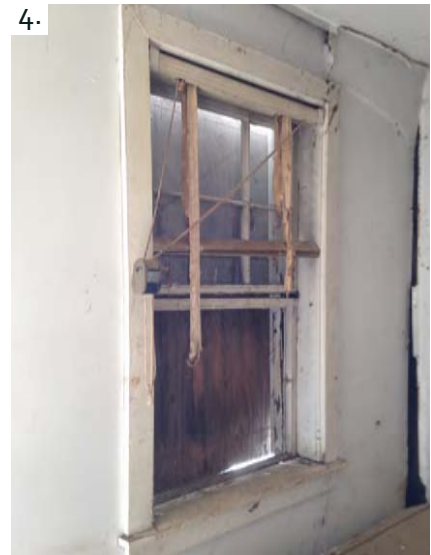
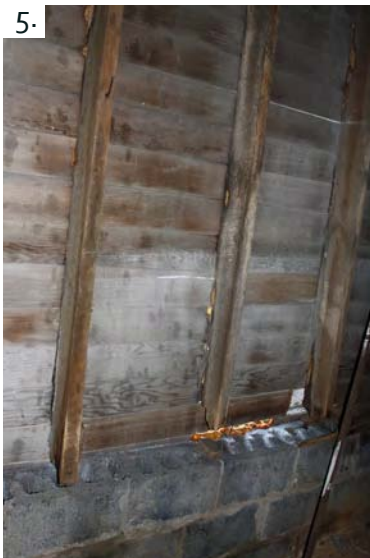
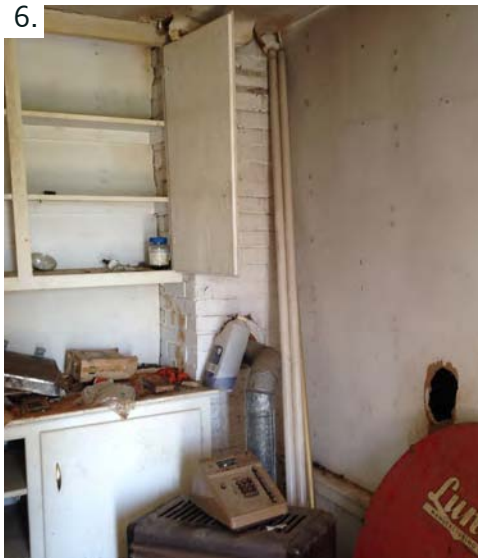
1. **Beams** Undersized and bowing in the middle; insufficient connections.
2. **Sill** Undersized and showing signs of water damage.
3. **Structure** Undersized and showing signs of past fire damage; insufficient connections.
4. **Windows** In significant disrepair and missing glass. Sills rotting.
5. **Studs** CMU degraded, gaps in sheathing and studs disconnected from sill.
6. **Front Room** Walls in disrepair and asbestos floor.
7. **Columns** Sheared off their base, fairly recently reinforced but insufficient connections.

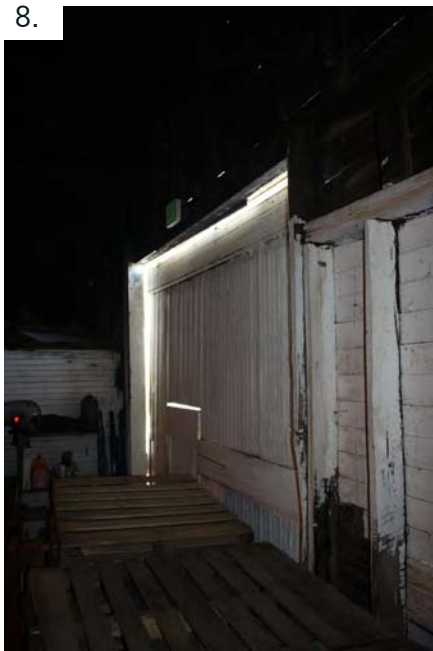
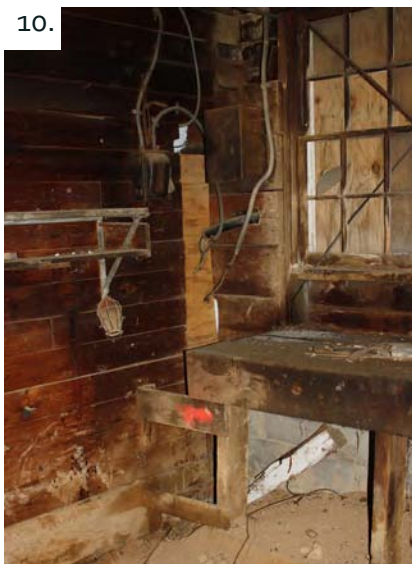
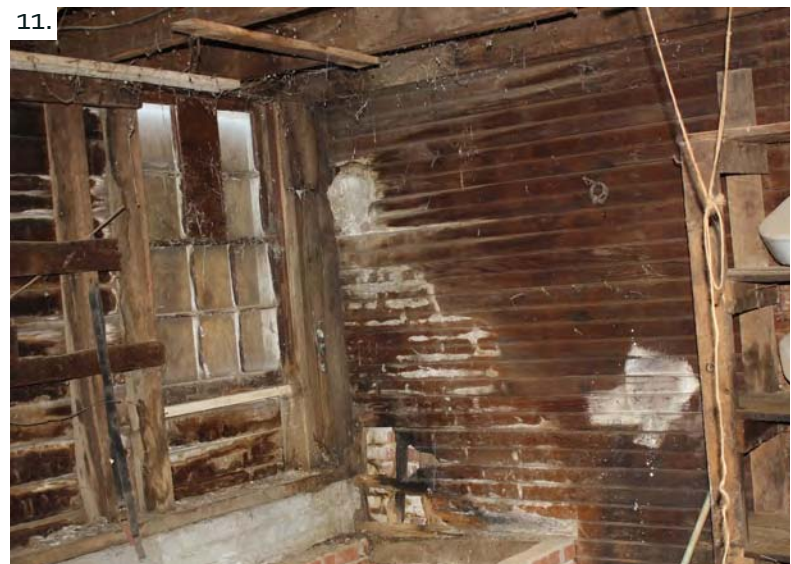
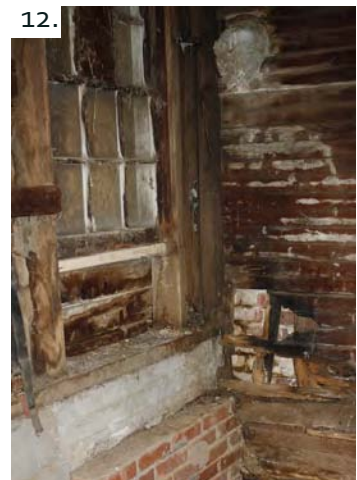
8. **Barn Door** In disrepair, shows signs of rot.

9. **Platforms** In disrepair, shows signs of rot, dirt floor underneath.

12. **Windows** Missing glass, deteriorated surround, rotted sill and damaged muntins.

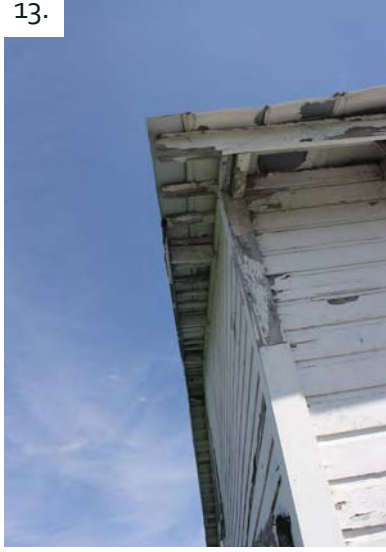
13. **Fascia** Either missing or showing signs of significant rot and water damage.

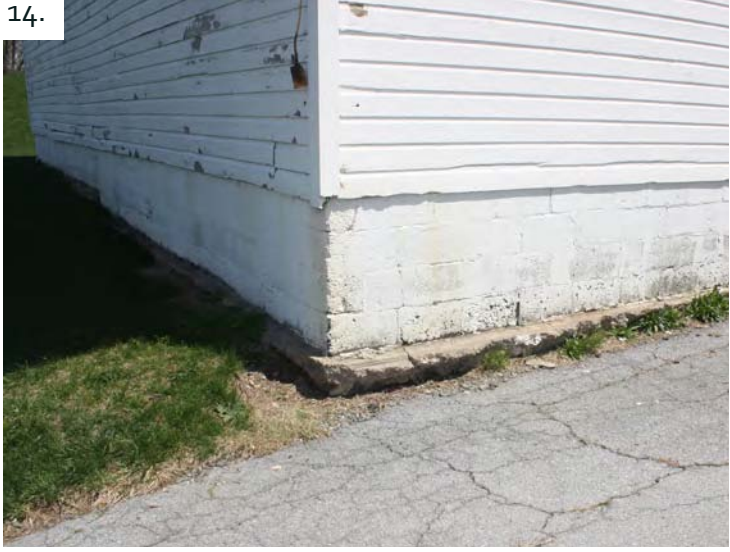
14. **Foundation** Exposed and crumbling concrete foundation exposed.

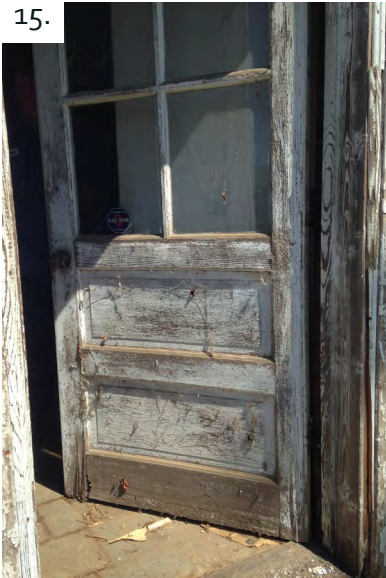
15. **Door** Showing signs of decay and rot.

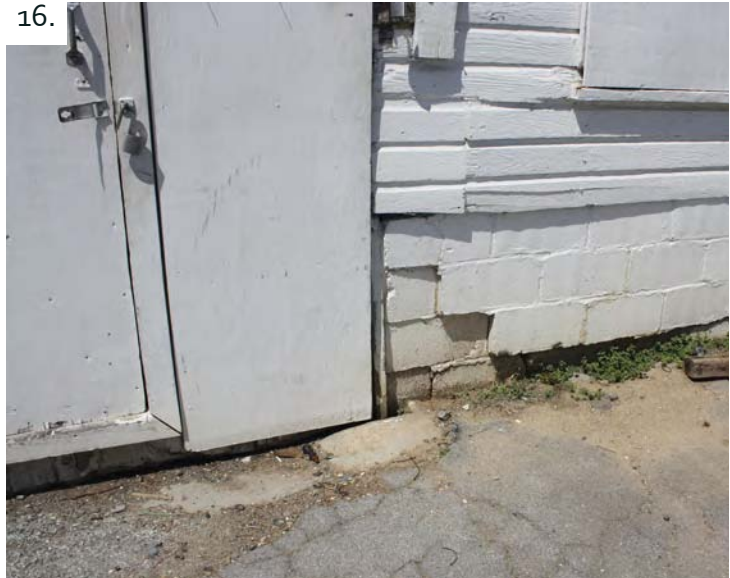
16. **CMU Sill** Stepped crack, shifted foundation and slight bulge in CMU.

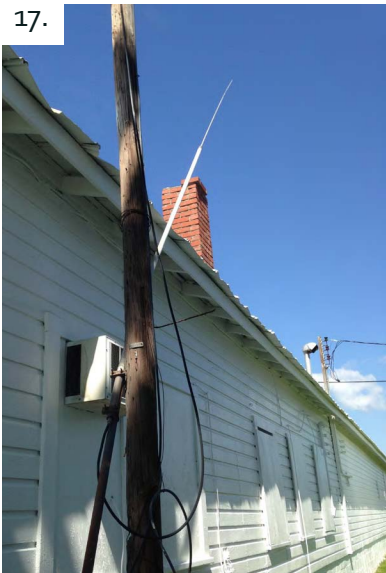
17. **Siding** In disrepair. Shows many pinholes.

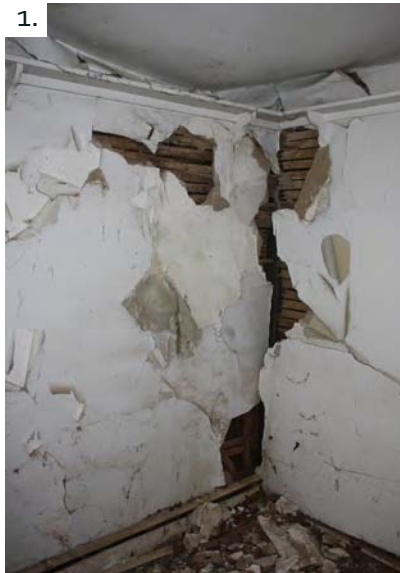
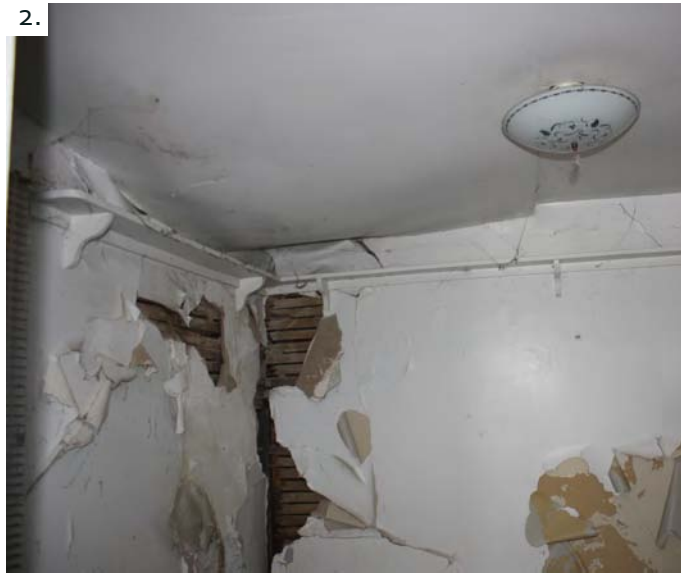
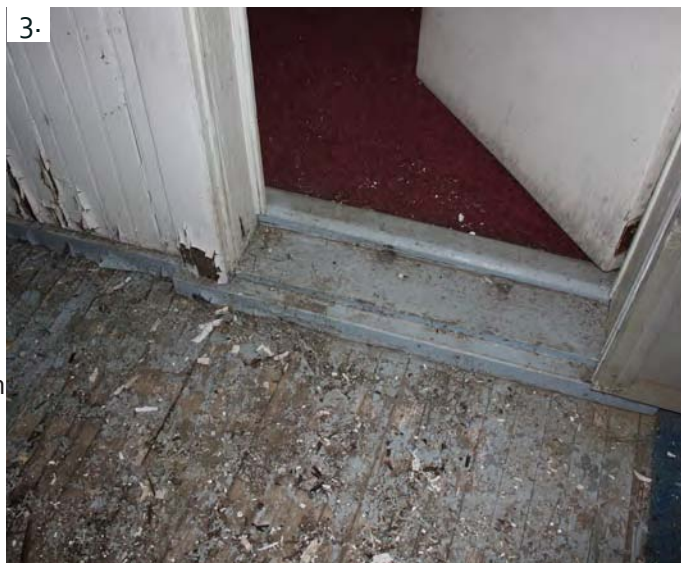
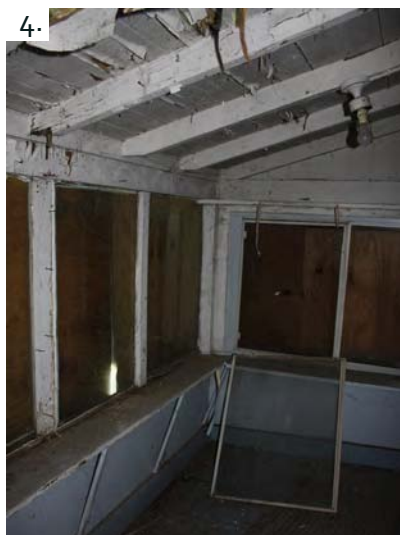
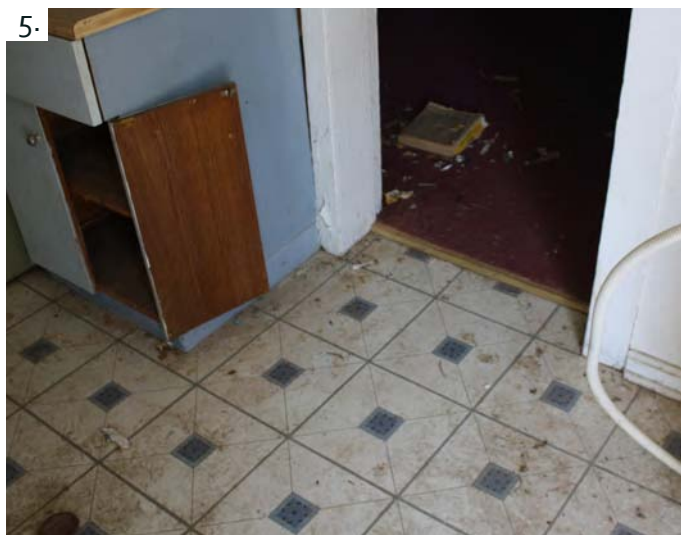
1. **SW Corner** Significant water damage, plaster falling away and exposing rotted lath.

2. **Ceiling** bowed in and in danger of collapse.

3. **Threshold** Stepped down and decaying.

4. **Addition 2** Window glass missing, surround rotting. All finishes in disrepair.

5. **Floor** Carpet exhibiting signs of mold growth underneath. Vinyl showing signs of disrepair.

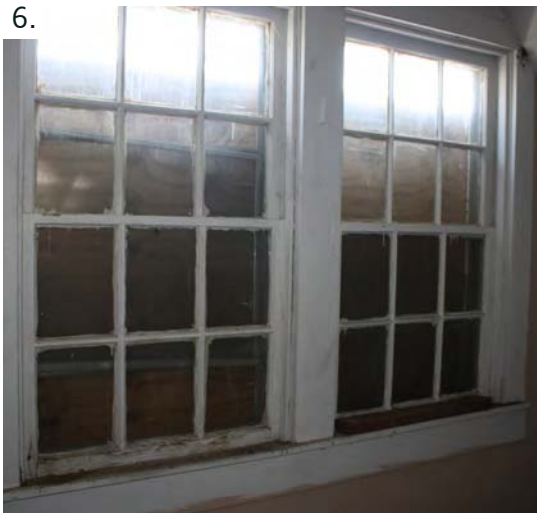
6. **Stair Windows** Sill in disrepair.

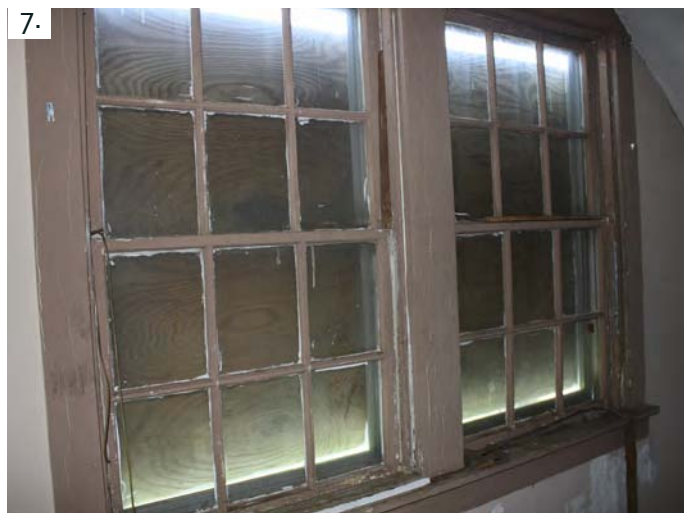
7. **Rear Windows** In disrepair, deteriorated sill and muntins.

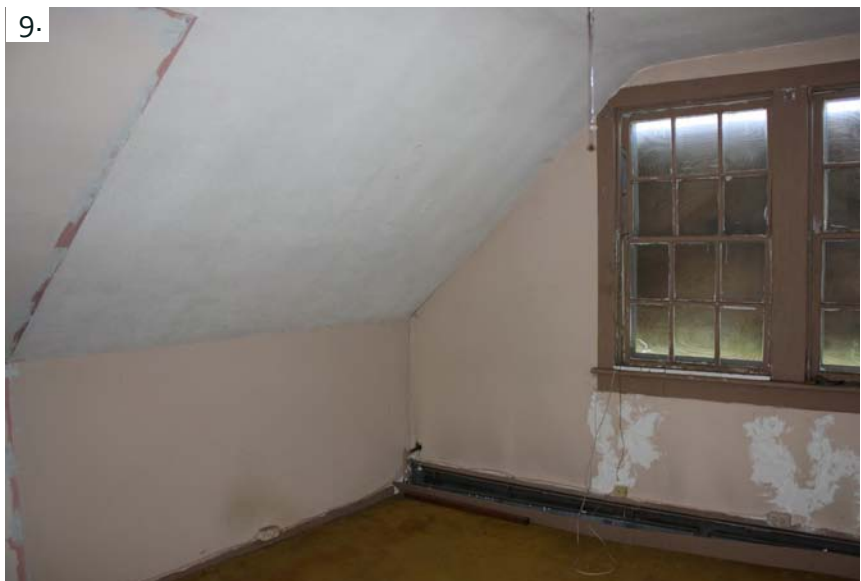
9. **Rear Room** Significant signs of mold growth, base heating nonfunctional.

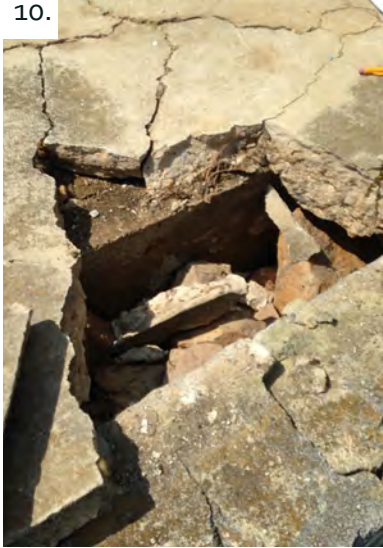
10. **Septic Tank** Deteriorating and nonfunctioning.

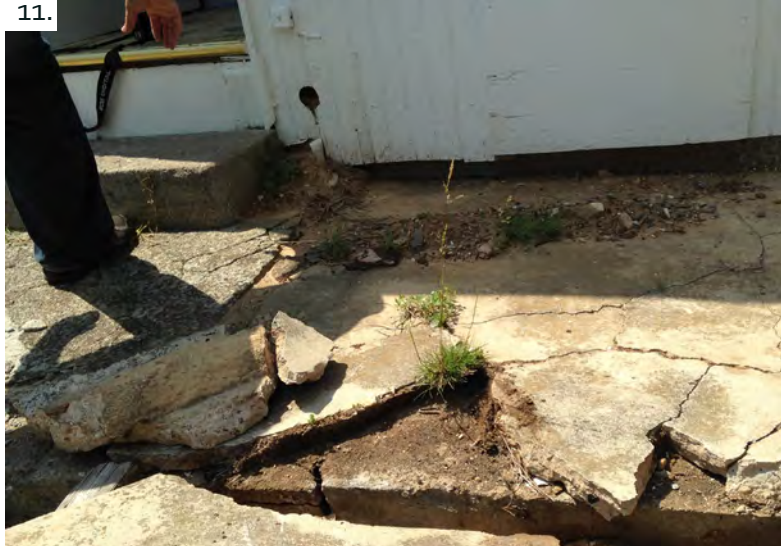
11. **Concrete Pad** Crumbling concrete with loose pieces.

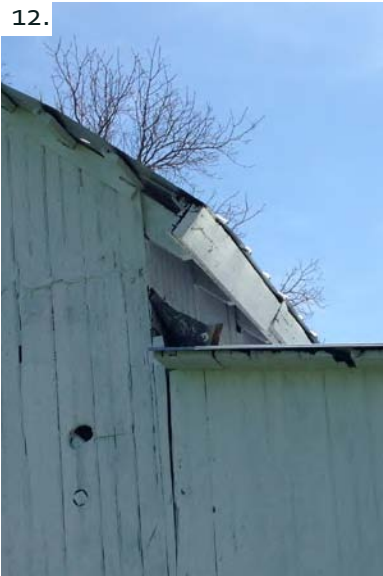
12. **Fascia** Rotted or missing.

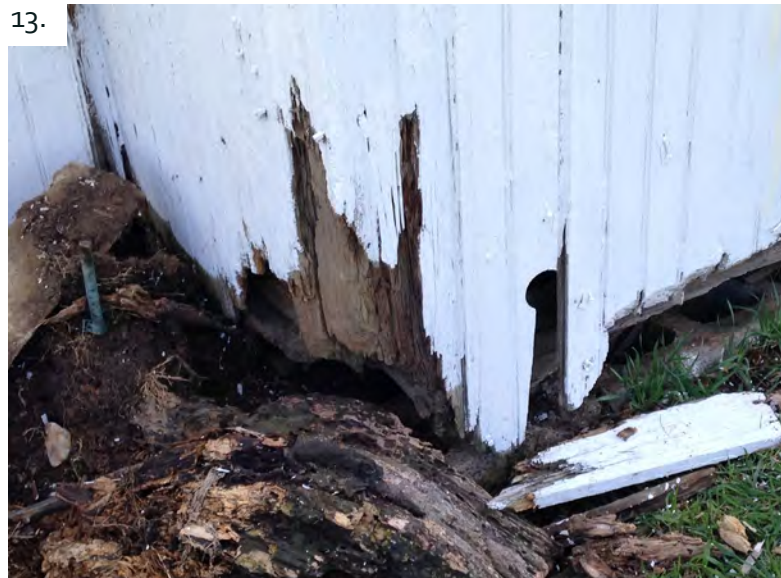
13. **Siding** Rotted siding all along foundation. Invasive tree roots.

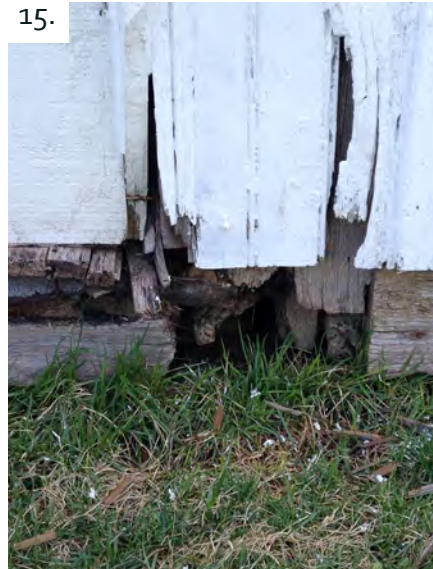
15. **Foundation** Too close to grade and deteriorated.

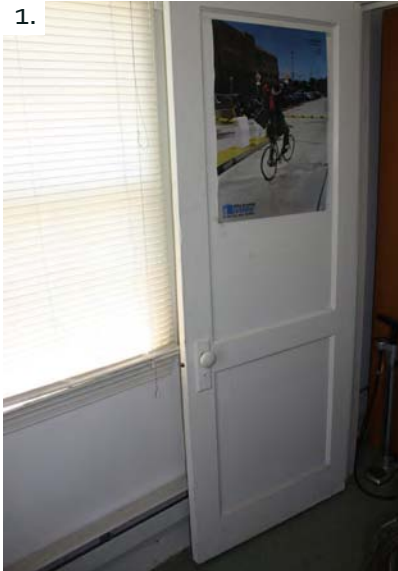
1. **Doors** All are too narrow, including framed openings.

2. **Ceiling** No insulation.

3. **Windows** Show signs of moisture infiltration.

4. **Threshold** Floor elevation change.

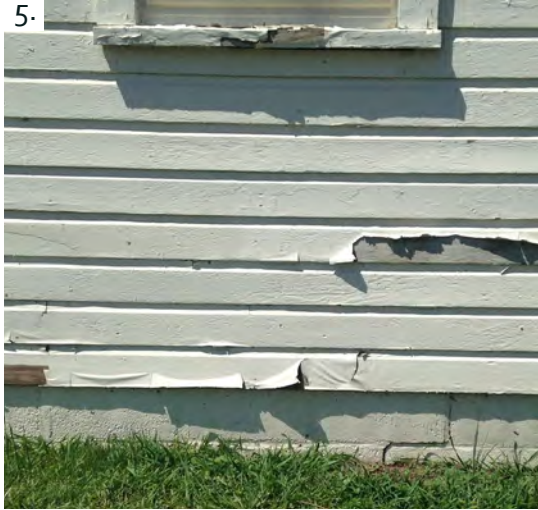
5. **Siding** Flaking paint. Sills show signs of rot.

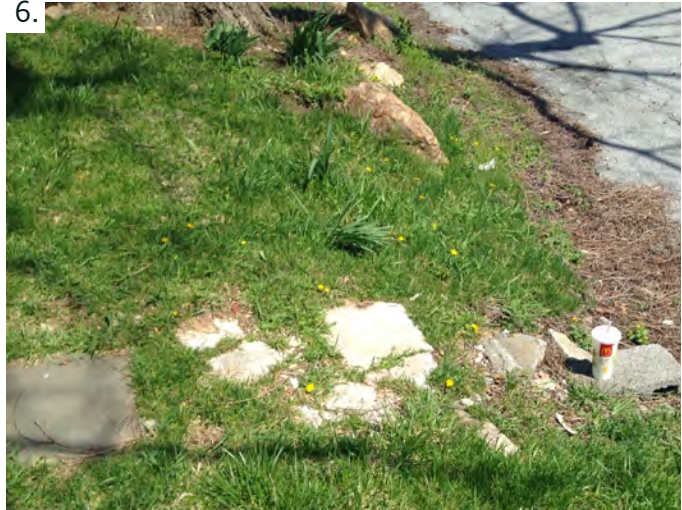
6. **Path** Very steep and not accessible.

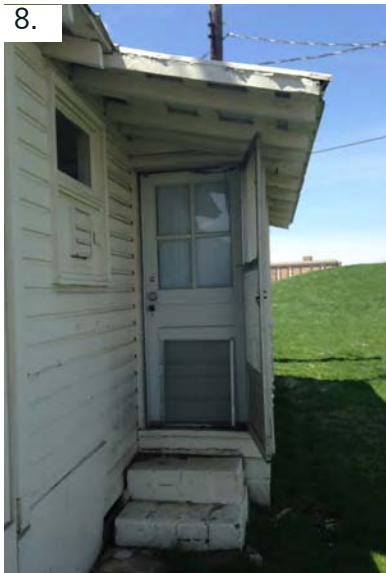
8. **Side Entrance** Rafters and fascia in disrepair. CMU steps separated from siding and crumbling.

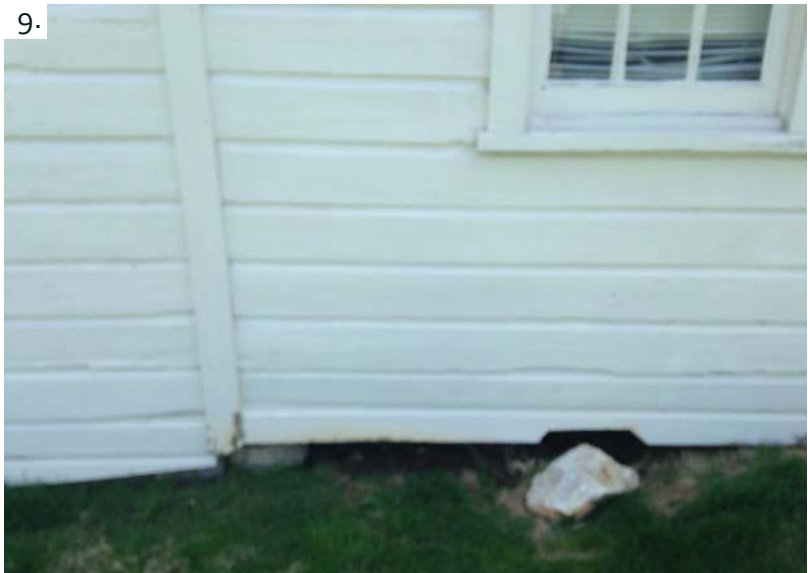
9. **Foundation** Too close to grade and multiple foundation types have been used.

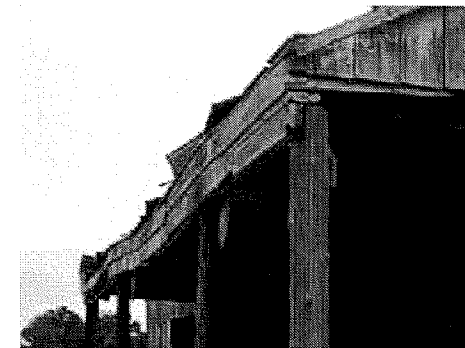
Condition of plates

**General:** The Hay Drying Shed sits on a flat area, with overgrown weeds and shrubs. The metal roof is in poor condition, and the sagging plate indicates some structural deficiencies. The shed is open on three sides, but has a drying loft or room at the north end, supported by metal pipes to carry the weight of the machinery inside.
