**CITY OF ROCKVILLE**

**KING FARM FARMSTEAD PROPERTY**

**CONDITION ASSESSMENT**

DEPARTMENT OF RECREATION AND PARKS  
JULY 3, 2014

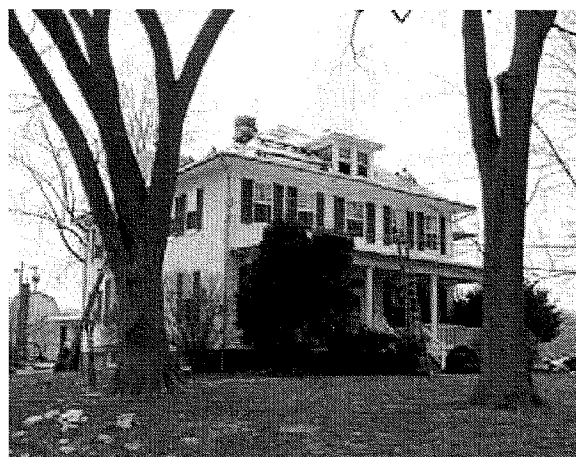
**East Façade:** This four-bay façade has irregularly placed openings, including the first floor polygonal bay at the living room. A two-story sleeping porch at the south end has been enclosed and sided with wood clapboard to match the rest of the siding. There is a single window at the first and second floors of the enclosed sleeping porch. The remainder of the facade includes four windows at the second floor level, and two windows at the first floor level. All the windows, including those in the bay, have operable shutters. In the attic level, there is a single hipped dormer, with paired 6/1 double-hung windows, placed off-center. There is an internal brick chimney high on the roof hip.

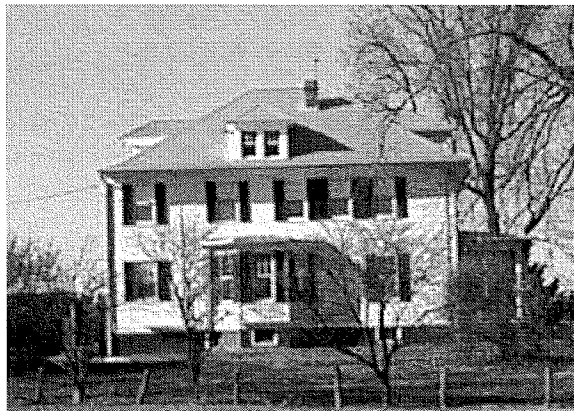
**South Façade:** The South façade has three bays, with three sets of paired 6/1 double-hung windows at the second floor level. On the first floor level, there are two single windows in the enclosed sleeping porch, and an opening with a storm door that leads to an enclosed exterior hallway. This leads to steps leading up to the back door. To the left of this, there is a weather enclosure over the basement steps. At the west side, there is a one-story sun porch, with large glazed openings, and an exterior door with its flight of steps. A hipped-roof dormer with paired 6/1 double-hung wood windows is centered in the rear roof hip. There is an interior brick chimney just to the left of the dormer. A low carport with brick columns and a flat roof was built just south of the house. It has a roof extension connecting to the rear entrance to the house.

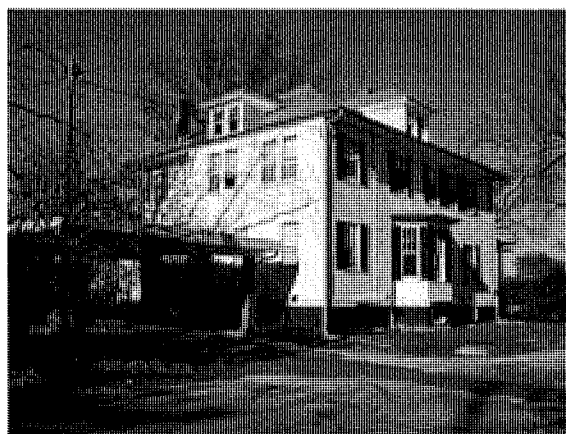
**West:** The west façade has irregularly placed openings. At the first floor level, there are four bays. A single window sits to the left of the side door, with transom above. This side entry and steps are protected with a hipped roof, supported by large curving brackets. The bay to the right includes a pair of small windows, with operable folding shutters on either side. The south bay consists of a small, one-story sunroom addition, with a flat roof and a pair of large jalousie windows. At the second floor level, there are five irregularly placed windows, including one dropped to match an internal stair landing. At the attic level, there is one hipped dormer, set off-center. To the left of a dormer, there is an internal brick chimney.

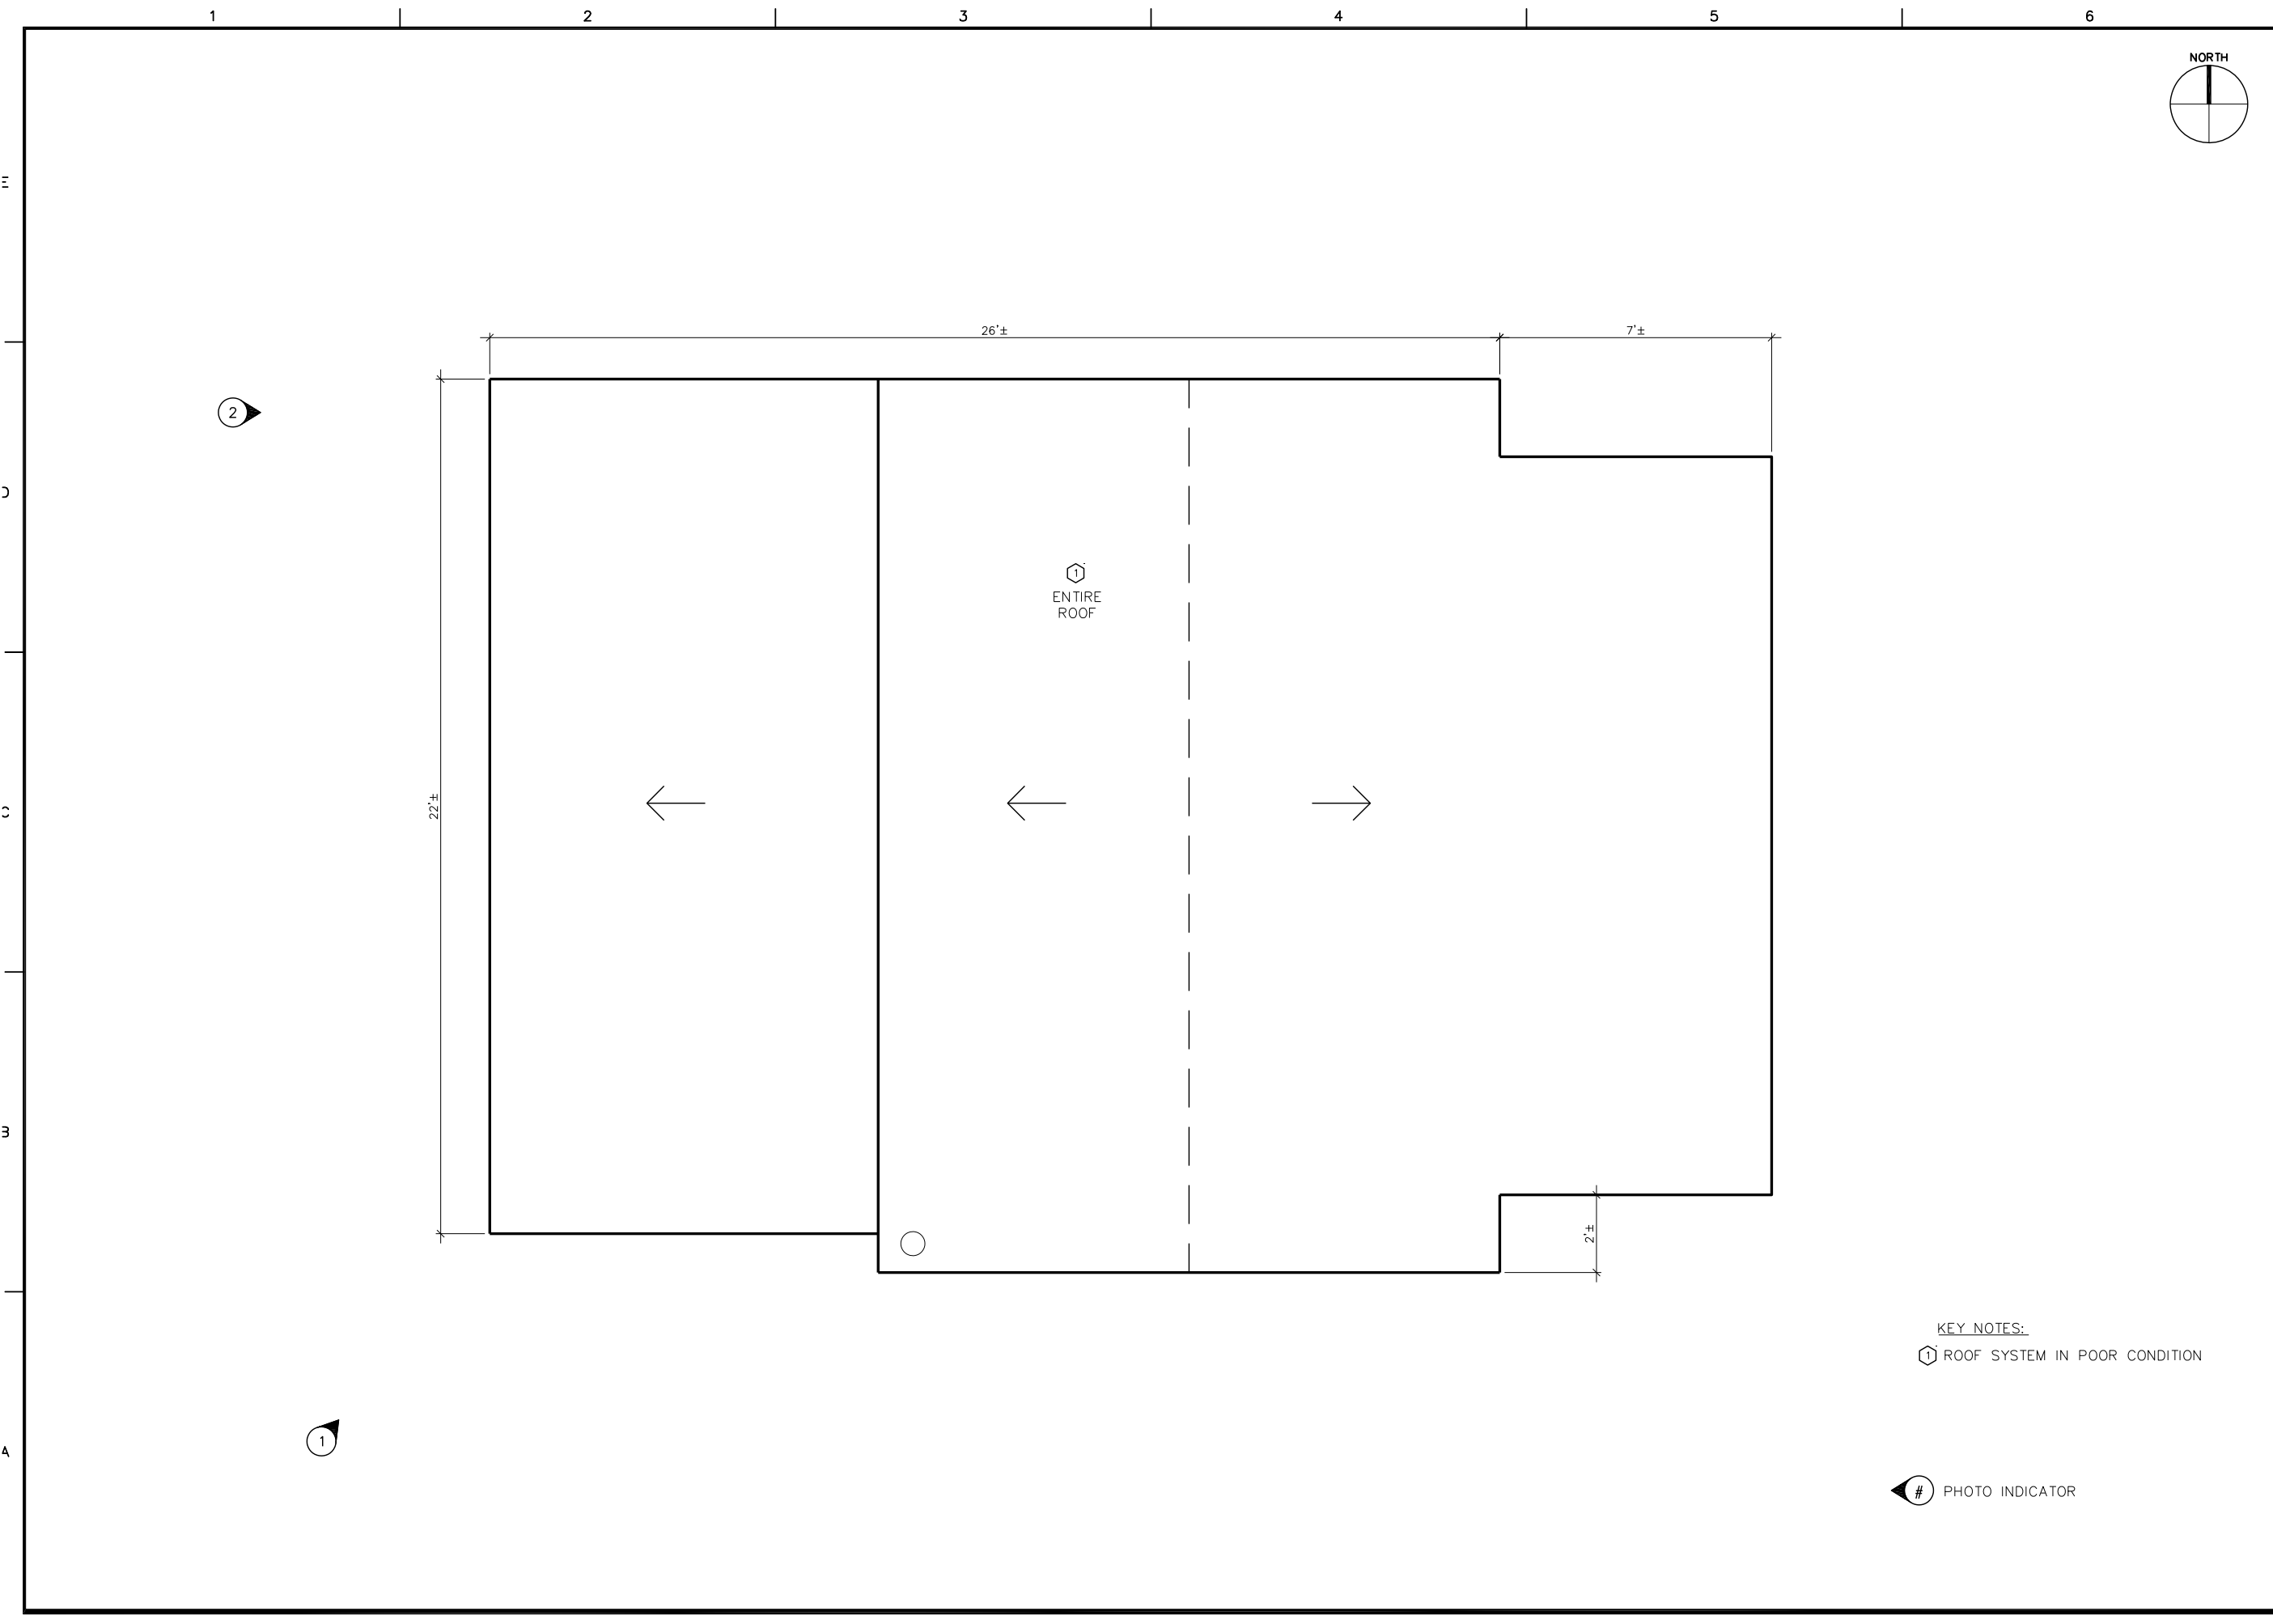
KEY NOTES:  
ROOF SYSTEM IN POOR CONDITION
