**RedGate Park Clubhouse  
Condition Assessment Report  
City of Rockville**

**September 29, 2022**

**RedGate Park Clubhouse**  
**Condition Assessment Report**

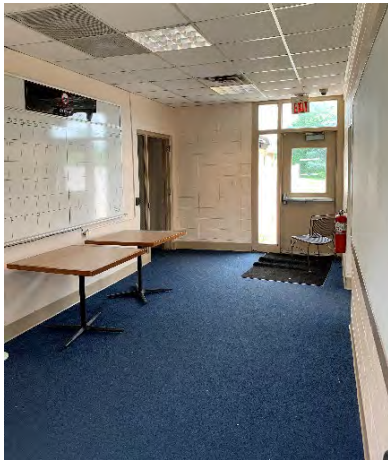
Fig 18: Typical Carpet

The floor finishes vary per room. The retail space, vestibule, entry, offices, and dining area are all level loop broadloom carpet. The storage areas, snack bar, and corridor are all 12"x12" textured VCT floor tile. The mechanical rooms are exposed concrete without any finishes. The toilet rooms are 6"x6" quarry tile with matching tile cove base.

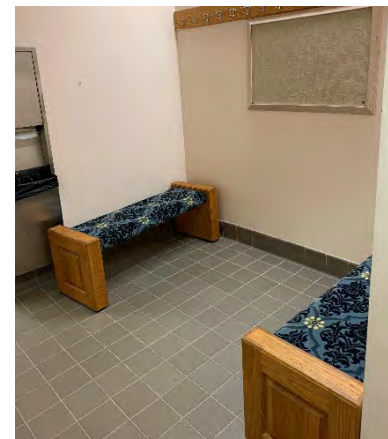
Fig. 21: Typical Toilet Room Tile

The toilet rooms wall finishes are painted gypsum board. Floor finishes are 6"x6" quarry tile and cove base. Floor tile in both toilet rooms is cracked near the back wall and where the building expansion transition begins. The floors do not align with the original construction. Plumbing fixtures and stall widths do not have enough clearance to be ADA compliant. The edge of sink to stall face doesn't accommodate a person in a wheelchair and someone trying to get into the stall behind them. The paper towel dispensers project too far into the path of travel.

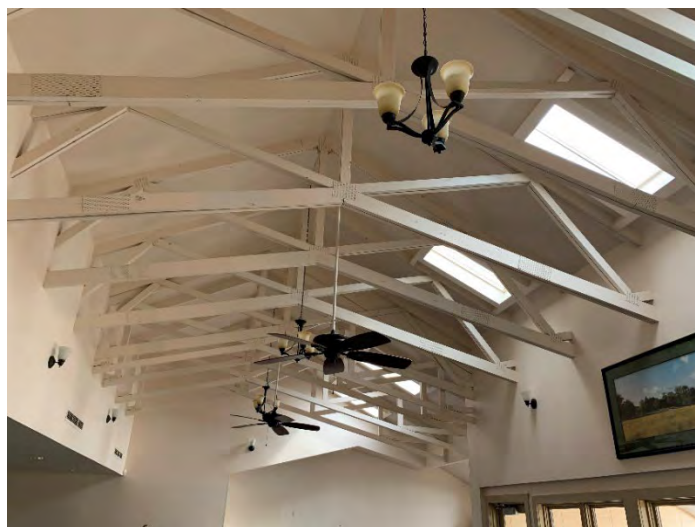
Fig. 25: Exposed Truss Ceiling with Gypsum Board

The ceiling cladding consists of 24"x24" lay-in ceiling panels with a 15/16" metal grid. A great deal of moisture has been absorbed by the ceiling tiles, causing them to sag; water stains are also present. The dining area has gypsum board ceiling with exposed, painted trusses; no acoustic materials are present. There are joint cracks and water damage within the adjacent gypsum board clad bulkheads.

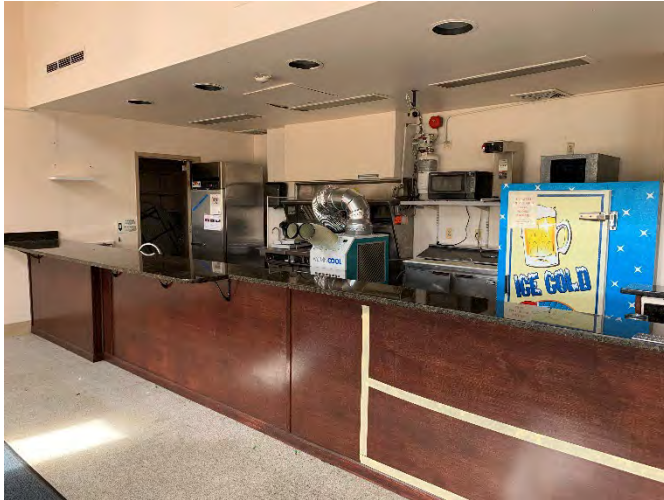
Fig. 31: Snack Bar

The snack bar equipment and casework is beyond its useful life. The finished walls are painted gypsum board with a vinyl wall base. The finished floor is 12"x12" textured VCT tile with level loop broadloom carpet in the dining area. Water damage and mold is evident under the sink.

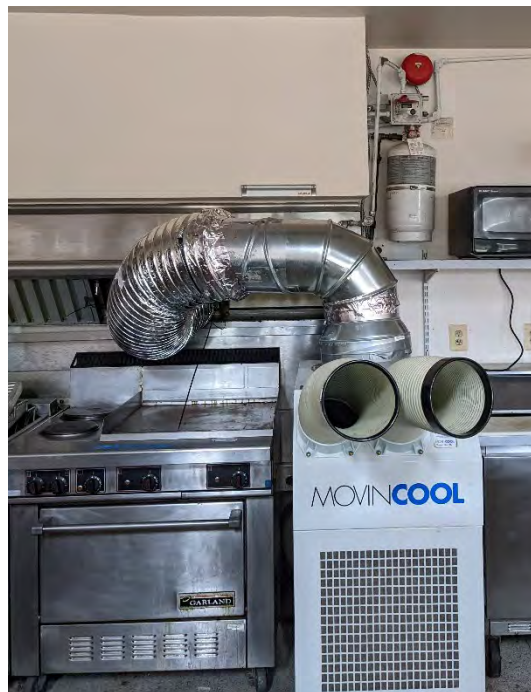
**Figure 41: Kitchen Hood with ANSUL Fire Protection System and Temporary Cooling System**

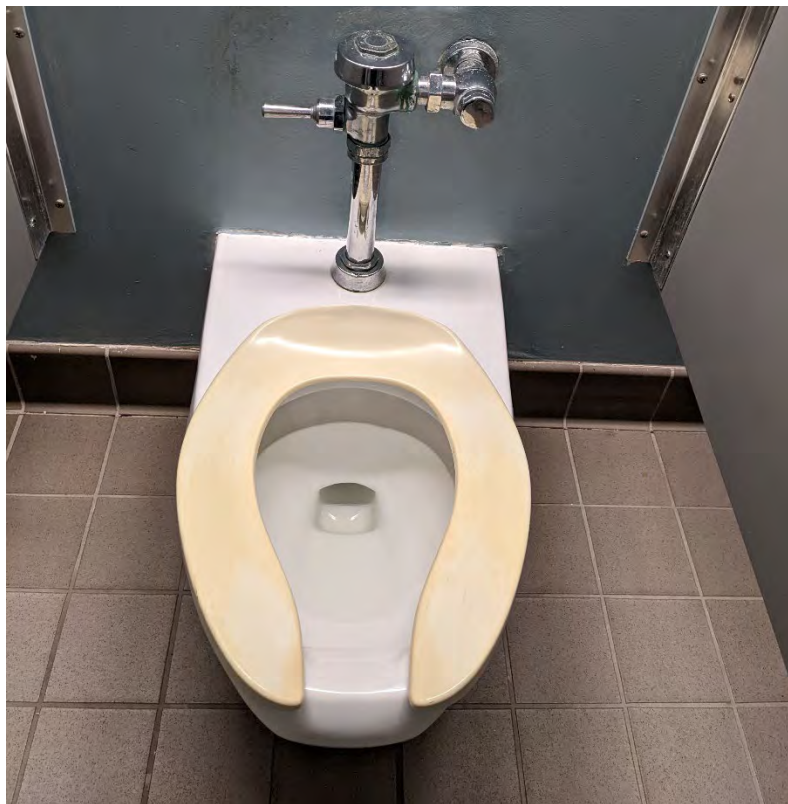
**Figure 43: Typical Water Closet**

The existing plumbing system serves the toilet rooms located in the southwest corner of the building and the plumbing fixtures within the snack bar area of the dining room. Additionally, there is a mop sink and electric water cooler located near the toilet rooms. The domestic hot water system is served by a single electric storage water heater located in a closet adjacent to the toilet rooms which is fifteen years old, but appears in good condition. The Women's toilet room contains four (4) water closets and three (3) lavatories while the Men's toilet room contains three (3) water closets, two (2) urinals, and three (3) lavatories. The snack bar contains a hand sink and a three-compartment sink, the latter of which drains to a floor mounted grease interceptor. There was no backflow preventer located on the domestic water system, and where visible, the domestic water insulation appeared in poor condition.

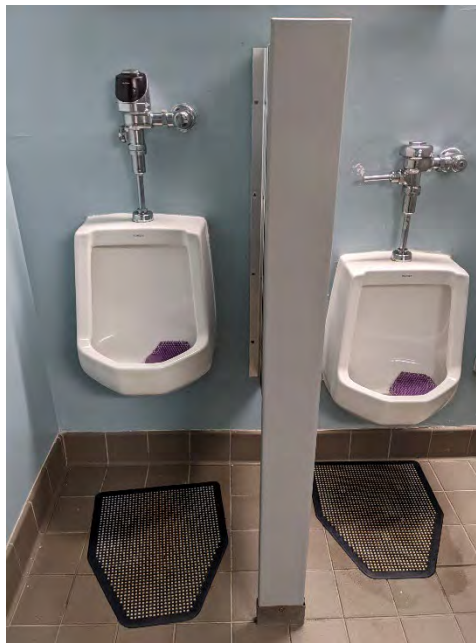
**Figure 44: Urinals – One Sensor Flush Valve, One Manual Flush Valve**

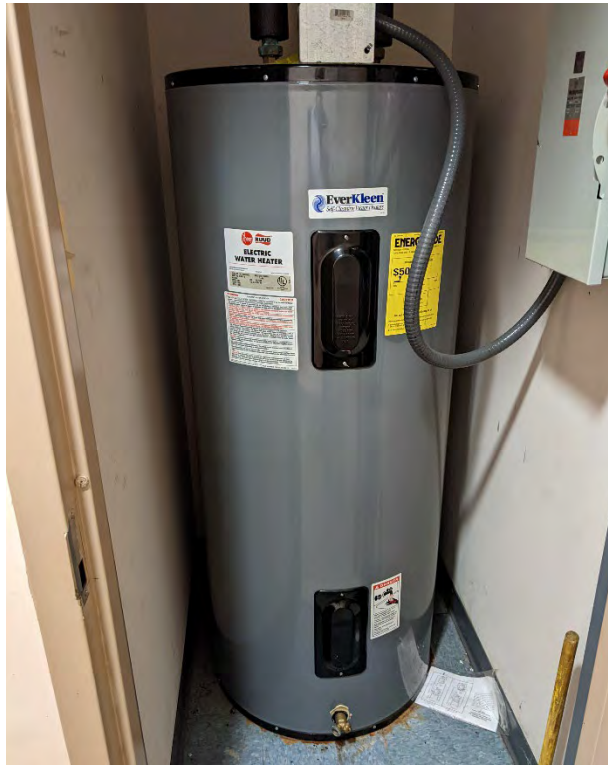
**Figure 46: Electric Storage Water Heater**

To meet current plumbing codes, there are several items that will require updates. A backflow preventer is required to be installed upstream of the domestic water system. Additionally, there is no hot water recirculation on the domestic water system, which is also required per current code. This will require the installation of a small inline pump at the inlet of the domestic water heater, as well as routing hot water recirculation piping to each fixture with balance valves to regulate the flow. With the three-compartment sink in the snack bar, grease interceptor requirements will apply. Currently, this sink is served by a floor-mounted grease interceptor. Depending on the new usage of the space and the current codes, a larger grease interceptor could be required. Due to offsets in the sanitary lines below the lavatories, the P-trap insulation appears to have been poorly installed (see Figure 45). The purpose of this insulation is to prevent wheelchair users from scalding their legs on the sanitary pipe if hot water is drained, so this insulation should be checked and replaced if necessary to ensure it completely covers the pipe.

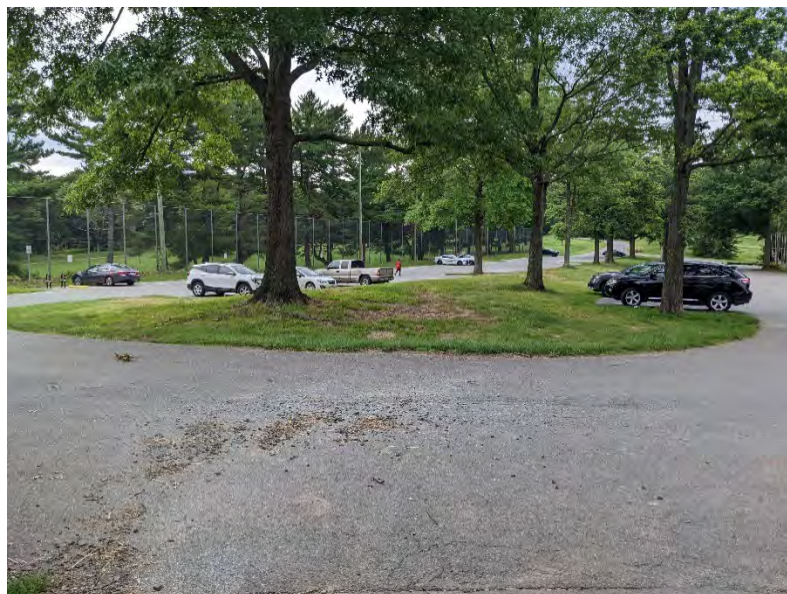
Figure 50: Parking Lot from top of Drop-off Loop

An ADA accessible route is currently not provided from the parking lot to the building. The western portion of the parking lot is too steep to provide ADA parking. ADA accessible parking may be provided within the eastern portion of the lot with possible minor pavement replacement and the installation of ADA signage and striping. An ADA accessible ramp with handrails will be required to provide access from the parking lot to the building. The area surrounding the main entrance is rather flat, but may require minor improvements (including concrete and asphalt replacement) to meet ADA code requirements with the redevelopment of the building.
