**CABIN JOHN CREEK  
WATERSHED ASSESSMENT AND  
MANAGEMENT  
RECOMMENDATIONS**

**FINAL REPORT**

**ENVIRONMENTAL MANAGEMENT DIVISION  
DEPARTMENT OF PUBLIC WORKS  
CITY OF ROCKVILLE, MARYLAND**

**Approved July 18, 2011**

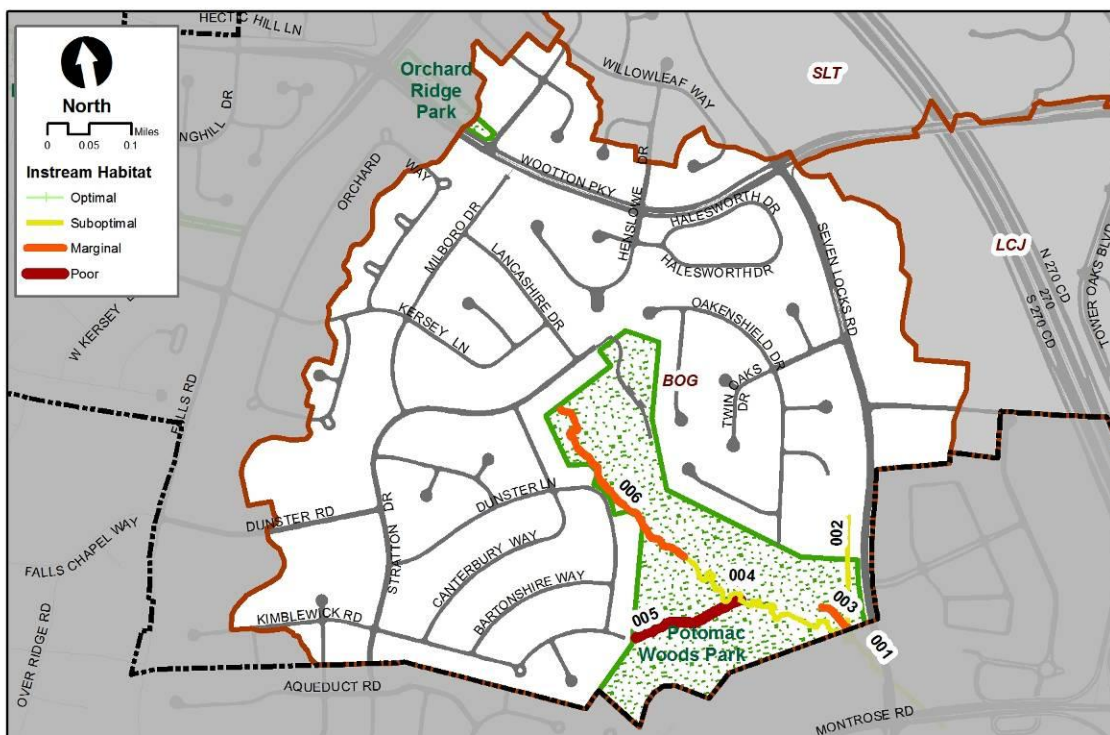
FIGURE 16: BOGLEY BRANCH HABITAT ASSESSMENT

The geomorphic assessment was performed on Reach 001 in the Bogley Branch sub-watershed just upstream of the City limits above Seven Locks Road. This reach is in transition from a C4 channel type at the downstream end to an F4 channel type at the upstream end. The C4 type is characterized as more stable with lower gradient and having good floodplain access.

Floodplain access was noted at the start of the assessed reach. Moderate to severe erosion was noted on outside meanders and large gravel dominated point bars were prevalent on inside meanders. One rock vane and one imbricated stone wall were noted at the most upstream portion of the assessed reach; however, no other stream restoration, stabilization, or bank armoring was present.

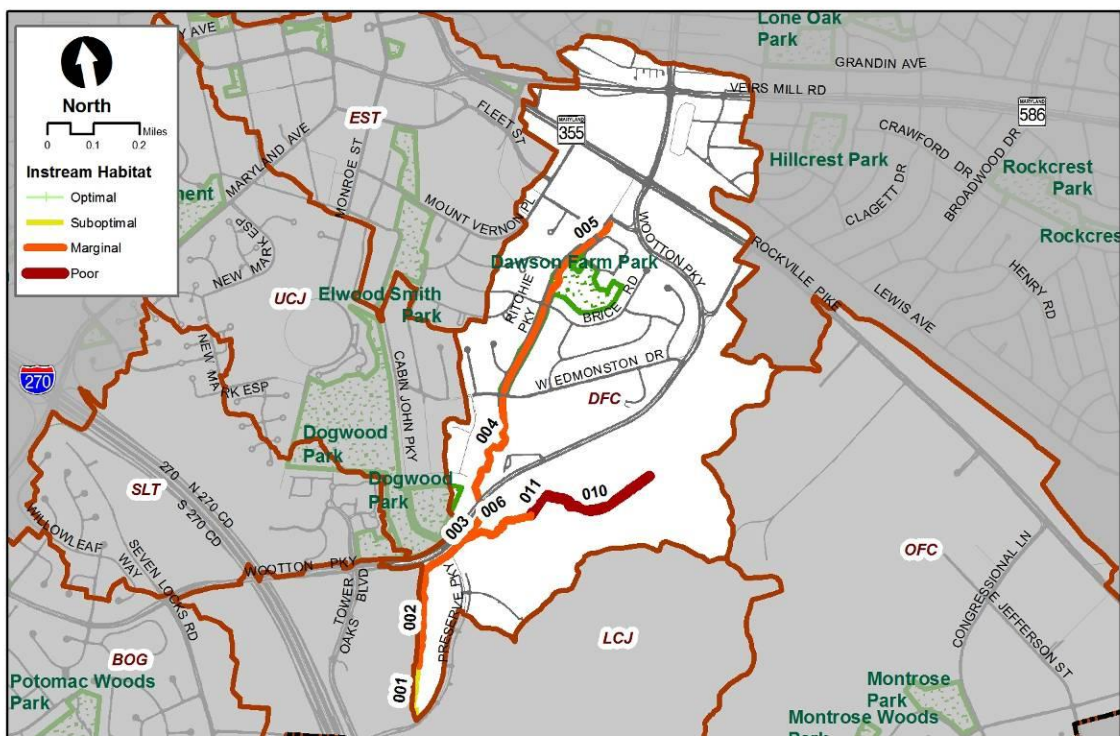
FIGURE 23: DAWSON FARM CREEK HABITAT ASSESSMENT

Along this reach, areas where sedimentation has occurred are beginning to colonize with thick grasses and scattered trees helping to create a more natural channel. Much of the buffer is heavily forested along Preserve Parkway although there are areas where the buffer is narrow with many invasive species, specifically between Brice Road and West Edmonston Drive. Habitat along the mainstem ranges from the mid-marginal to the mid-suboptimal range with riffles and pools as the dominant habitats. Impediments to fish passage are found along Reach 003, where designed low flow channels have filled with sediment and at the culvert under West Edmonston Drive along Reach 005. No buffer encroachment from residents was observed.

Reaches that are tributaries to the mainstem of Dawson Farm Creek are heavily impacted by practices at the Woodmont Country Club. Stream channels are generally stable with localized areas of erosion along outside meanders. Habitat is in the poor to low marginal range due to the amount of algae covering the channel bed and the lack of a sufficient riparian buffer. Along Reach 010, which lies between two fairways, all vegetation has been removed with the exception of several trees and it appears that herbicides have been applied along the stream banks to inhibit growth.

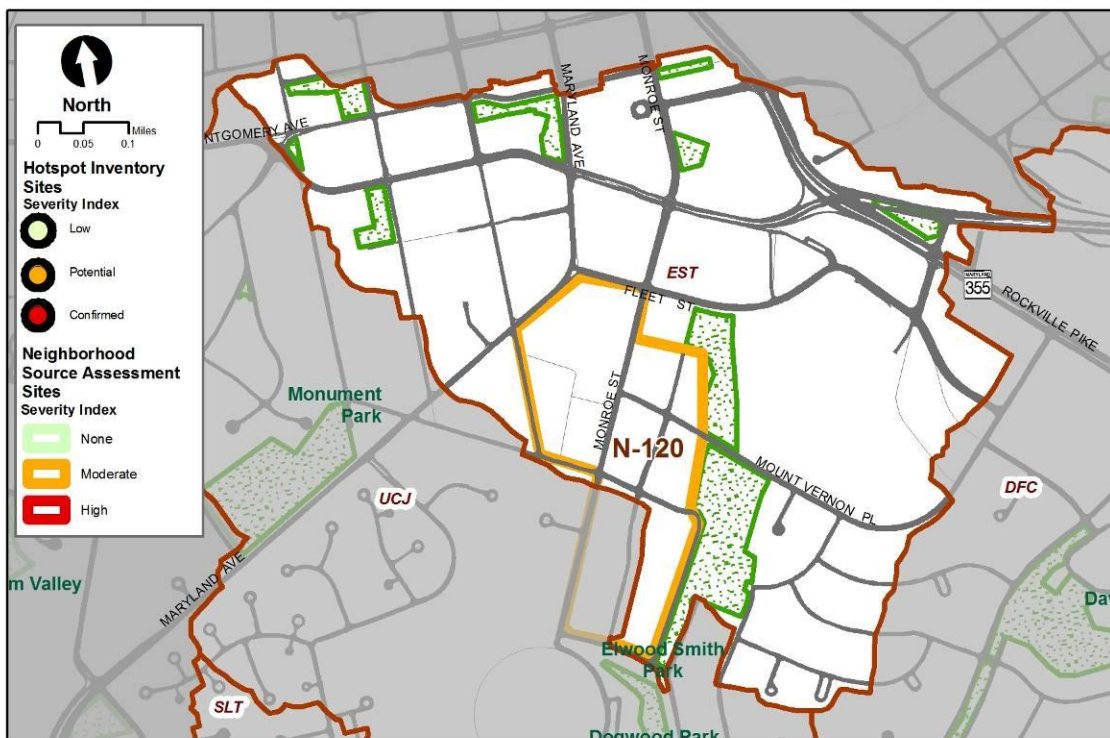
FIGURE 32: ELWOOD SMITH TRIBUTARY, NSA / HSI RESULTS

There were no hotspot sites and only one residential area assessed in this sub-watershed. While the residential area consisted of a mix of single-family detached and multi-family structures, built from the 1920s to the 1980s, the area assessed (N-120) was a uniform neighborhood of duplexes built in the

1950s. Lawn care practices were not a significant pollutant source, being primarily low maintenance. There was some evidence of trash and litter, and tree canopy was relatively low (less than 40 percent).

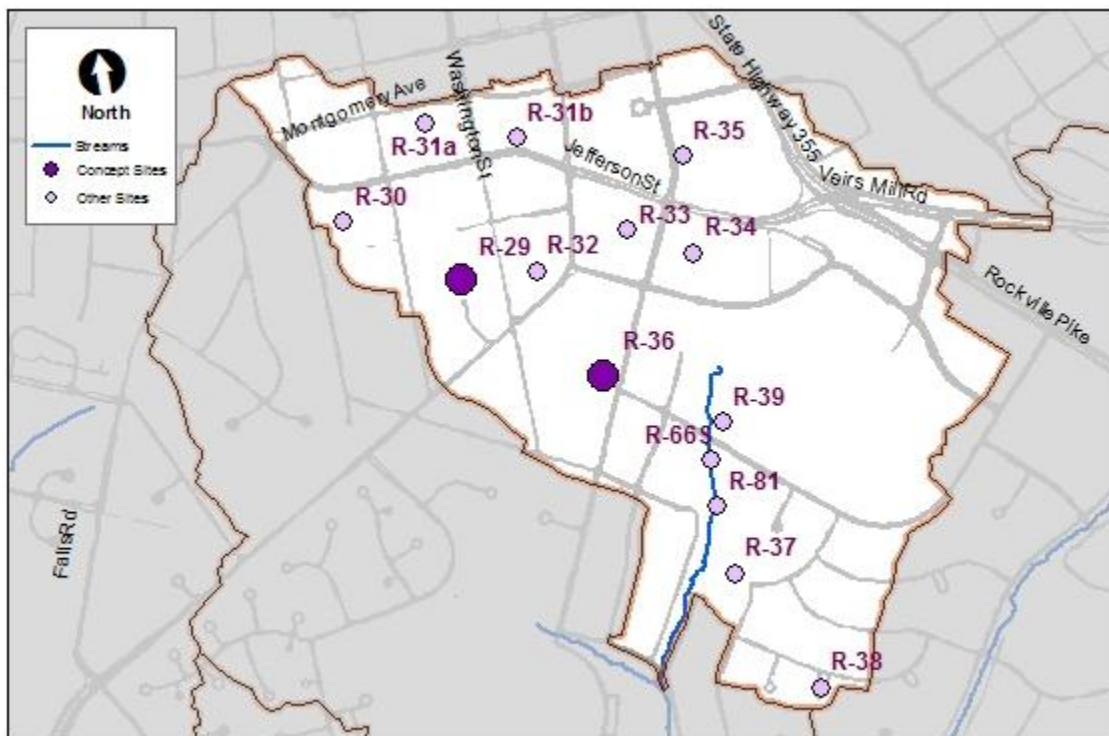
FIGURE 33: ELWOOD SMITH TRIBUTARY, CANDIDATE SITES FOR IMPROVEMENTS

R-66S Stream Restoration This stream channel lies completely within Elwood Smith Park, between Mt. Vernon Place and Cabin John Parkway. The downstream end of Mt. Vernon Place culvert is severely eroded with a large scour hole that is beginning to undermine the concrete end wall and apron at the pipe outlet. Channel stability in this reach was moderately stable with only a few isolated areas of bank erosion due to channel widening. The rest of channel through Elwood Smith Park was previously stabilized with riprap and is in good condition.

This storm drain rehabilitation project is recommended to be implemented through the CIP. The project will repair the concrete end wall and apron at the Mt. Vernon Place outfall to protect the culverts from erosion and structural failure. This storm drain repair may be paired with lining/replacement of the corrugated metal pipe culvert on the same reach at the Elwood Smith Recreation Center's pedestrian bridge. Stream buffer management and repair schedule will be discussed with the Department of Recreation and Parks and the surrounding neighbors at time of design. (Note: no concept was prepared for this project since it is primarily storm drain structure repair.)

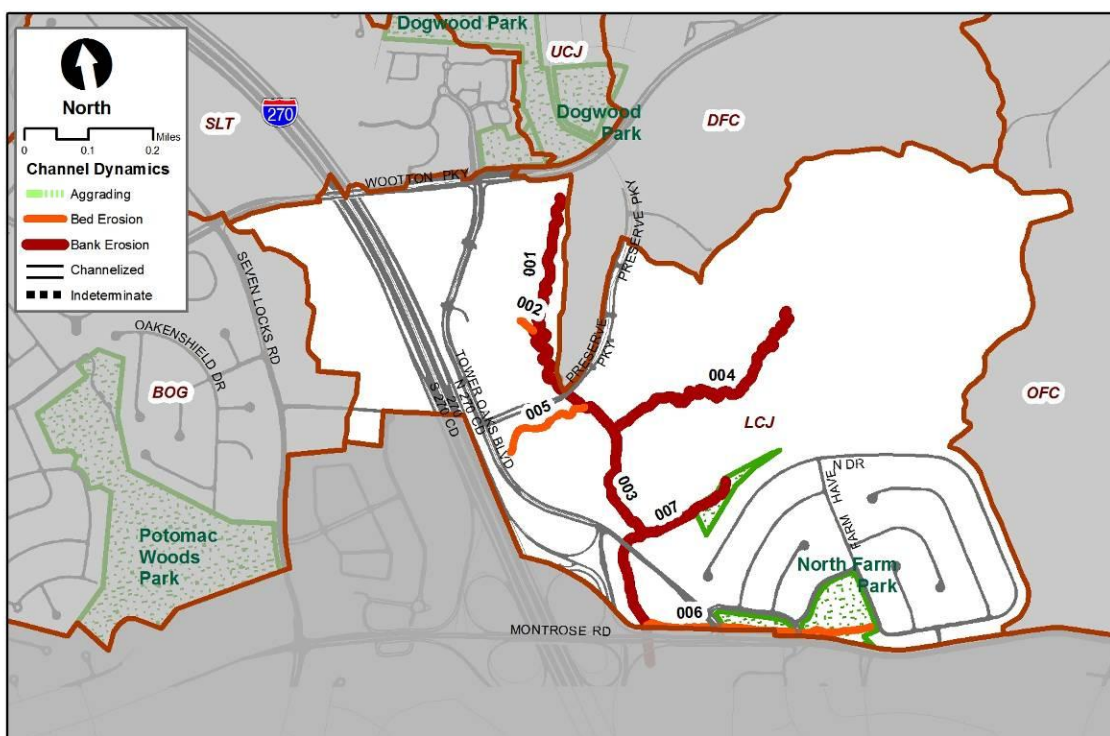
FIGURE 36: LOWER CABIN JOHN CHANNEL DYNAMICS ASSESSMENT

A geomorphic assessment was performed on Reach 001 of the Lower Cabin John Creek sub-watershed. Based on the surveyed information, this reach was identified as an F4 channel. The assessed reach is sinuous and overwidened with moderate to severe erosion on outside meanders. Large point bars with sand and gravel were prevalent. The channel is entrenched and overwidened with no apparent floodplain access even during high flow events. A resident is excavating portions of this surveyed reach with a shovel, effectively shortening meanders and creating a single long riffle instead of a riffle/pool morphology. This channel appears unstable and is moving large amounts of sediment during high flow events. No stream restoration, stabilization, or bank armoring was present in the assessed reach.

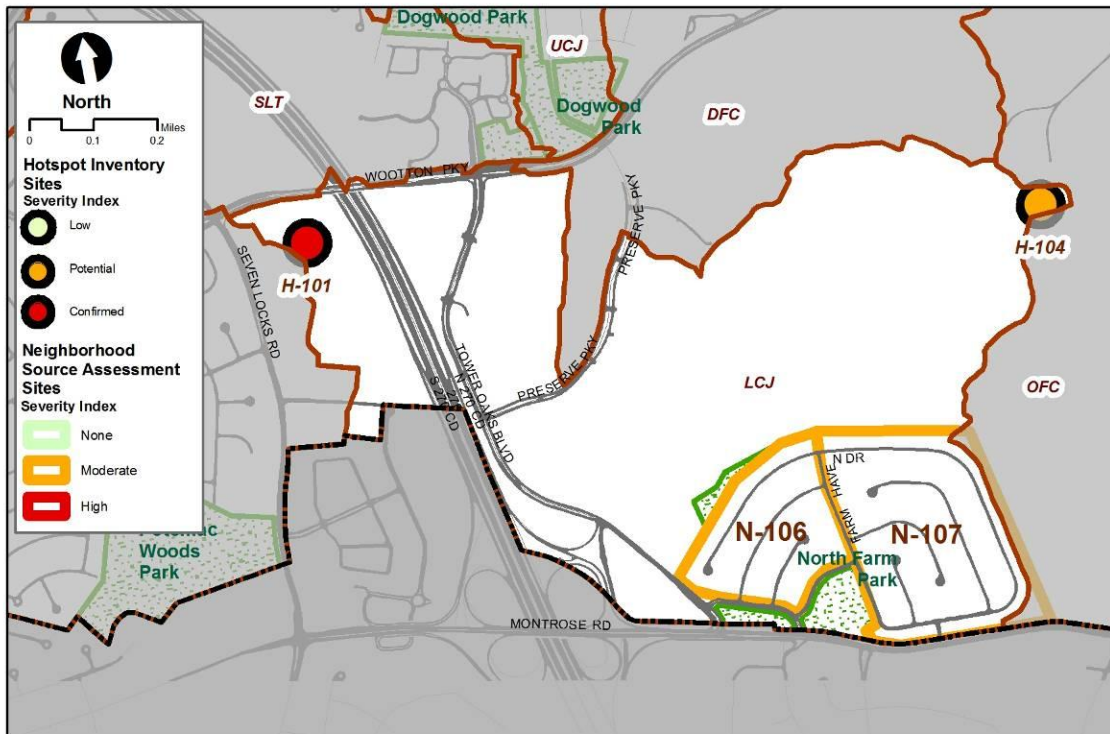
FIGURE 37: LOWER CABIN JOHN NSA / HSI RESULTS

The two hotspots were the Woodmont Country Club facilities (H-104) and the Montgomery County Seven Locks Maintenance Yard vehicle facility (H-101). The Country Club facilities included vehicle operations for golf cart fueling, repair and washing, material storage, (soil and mulch) and waste management. This site was rated a potential hotspot for severity.

Potential pollution sources for the vehicle shop included vehicle operations (repair, fueling, washing, and storage), outdoor gravel storage, and waste materials, garbage and construction materials, and the physical plant. Vehicles were stored outside, and leaks were observed. Dumpsters were overflowing. One parking lot was in poor enough condition to be contributing sediment when it rains. Severity was rated as confirmed.

The two NSA sites were part of the North Farm subdivision, a single-family detached development on 1/4 acre lots built in the late 1970s and 1980s. Very little infill or redevelopment was noted. All the lawns were maintained with either high or medium management status. A large percentage of the downspouts were disconnected from impervious surfaces. Some rain garden potential was noted in each neighborhood for treatment of rooftop, driveway and sidewalk runoff. Stormwater is conveyed through curb, gutter, inlets, and pipes, and a portion of the neighborhood is treated by an existing dry pond. They were both rated moderate for pollution potential.

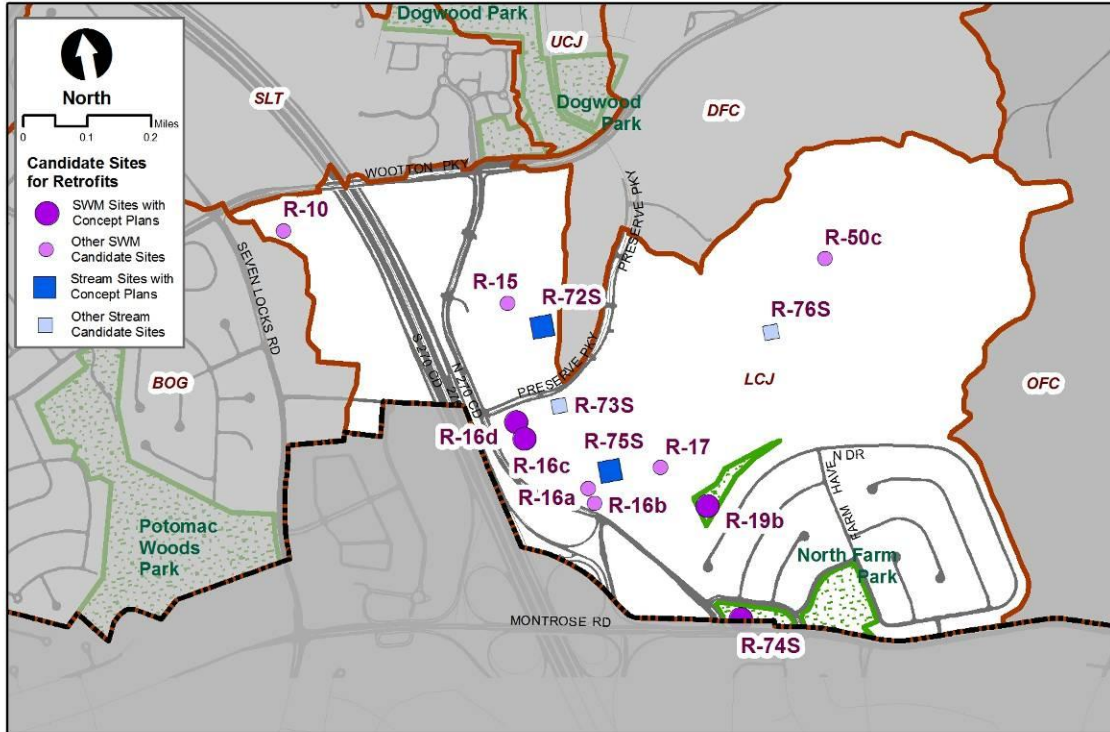
FIGURE 38: LOWER CABIN JOHN, CANDIDATE SITES FOR IMPROVEMENTS

R-16C GEICO Pond Retrofit, and R-16D Tower Oaks / Preserve Parkway New Pond Concept plans, included in Appendix A, were developed for these two abutting sites that proposed enlarging the existing dry pond and converting it into an extended detention pond with micropools. Due to high cost and tree impacts, this project was replaced with a more beneficial and cost-effective stream restoration project (see description below for site R-73S) using the RSC method.

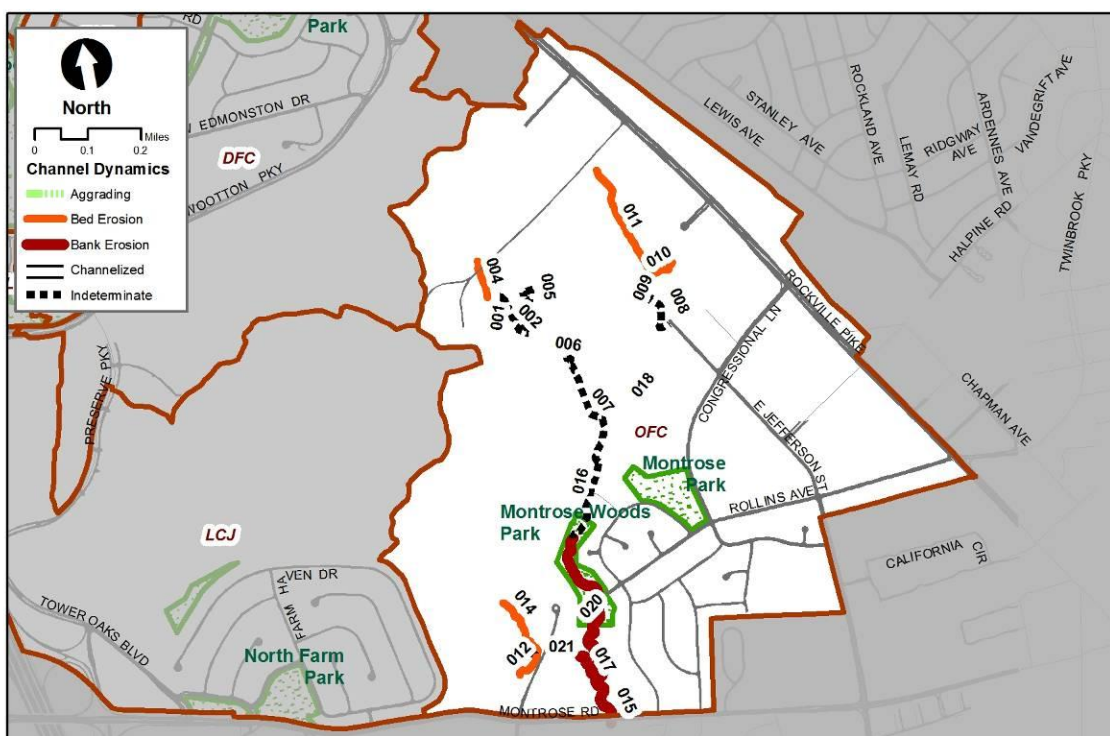
FIGURE 41: OLD FARM CREEK CHANNEL DYNAMICS ASSESSMENT

A geomorphic assessment was performed on Reach 015 in the Old Farm Creek sub-watershed. Based on the surveyed information, this reach was identified as an F4 channel. Although the assessed reach was classified as such, this reach differed from other F4 classified channels in the Cabin John watershed. This reach has low sinuosity and appeared mostly stable with only moderate erosion on one outside meander. Despite this stability, the channel is entrenched and overwidened with little floodplain access. Several bedrock outcrops were present in the channel bed and large gravel and small cobbles made up the substrate in the channel, which increases overall stability. Gravel and cobble bars were present, but were relatively small features within the channel. Riffles and runs dominated the reach as the channel had relatively steep slopes.

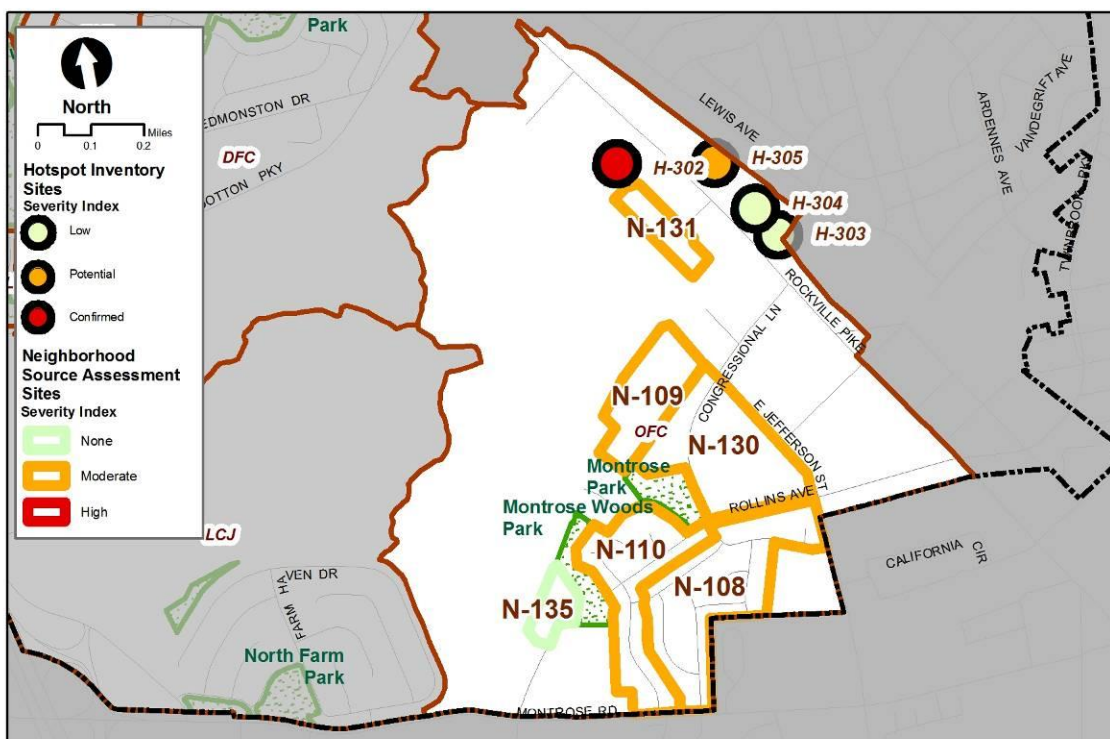
FIGURE 43: OLD FARM CREEK NSA / HSI RESULTS

The two single-family detached areas that were assessed were both part of the Montrose community and were adjacent to each other in the lower part of the watershed at the City line. Houses were built on 1/4 acre lots in the early 1960s. No evidence of infill or redevelopment was seen. Lawns were maintained well, but were not high-management status. Stormwater was conveyed through curb, gutter, inlets, and storm drains, and there did not appear to be any existing stormwater management facilities. None of the storm drain inlets were stenciled.

The four multi-family areas were situated throughout the watershed and were a mix of townhouses built in the 1980s, garden apartments and high-rise apartments built in the 1960s. All storm drainage was conveyed through curb, gutter, inlets, and storm drains. No inlets were stenciled. Lawns and common areas were well maintained, and no trash or pet waste was observed. Tree canopy was less than optimum at all the sites, which is to be expected for the higher density developments. However, it could be improved at the single-family residential areas N-108 and N-110. The newer developments were treated with stormwater management facilities. All six areas were rated with low or moderate severity for pollutants.

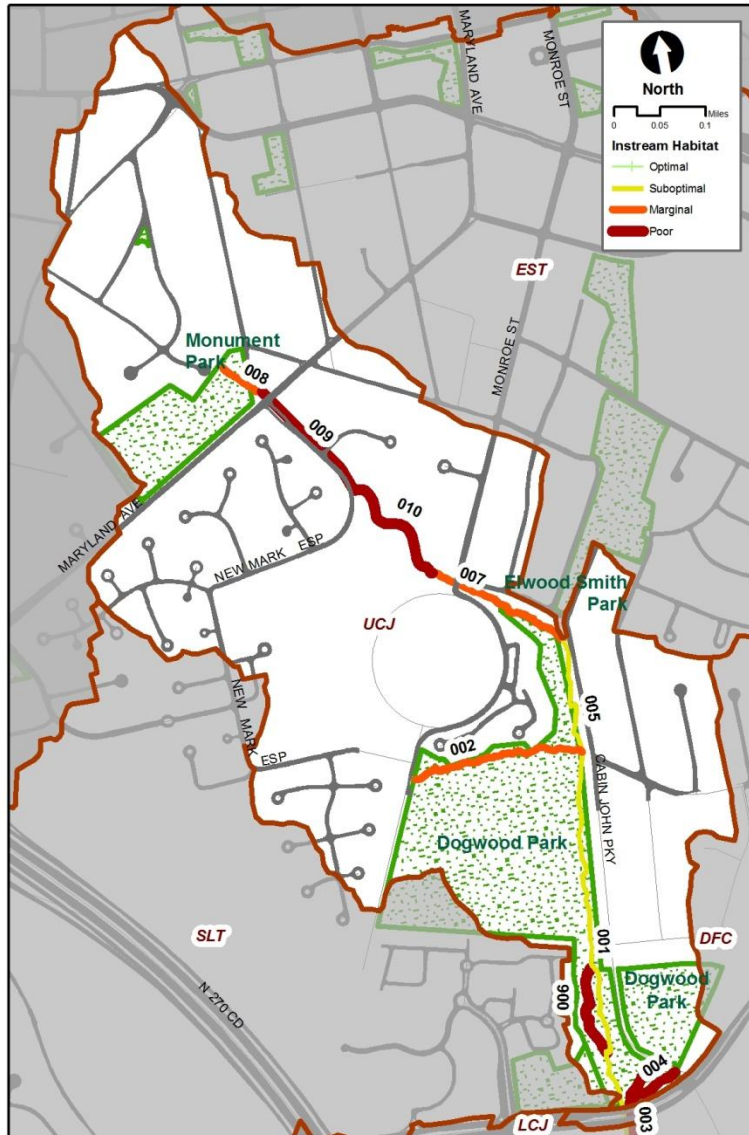
FIGURE 54: UPPER CABIN JOHN HABITAT ASSESSMENT

Tributary channels to the mainstem range from a good quality wetland (Reach 004) to piped reaches and trapezoidal channels. In general, channels are eroding and overwidened. Reach 002, specifically, is very unstable and experiencing extensive bank and bed erosion. Stream buffers through park areas are generally adequate but with areas where mowed grass is the dominant vegetation. Invasive species are prevalent, especially along Cabin John Parkway. Habitat ranged from poor to mid-marginal with areas of erosion, lack of habitat and algae negatively impacting habitat quality.

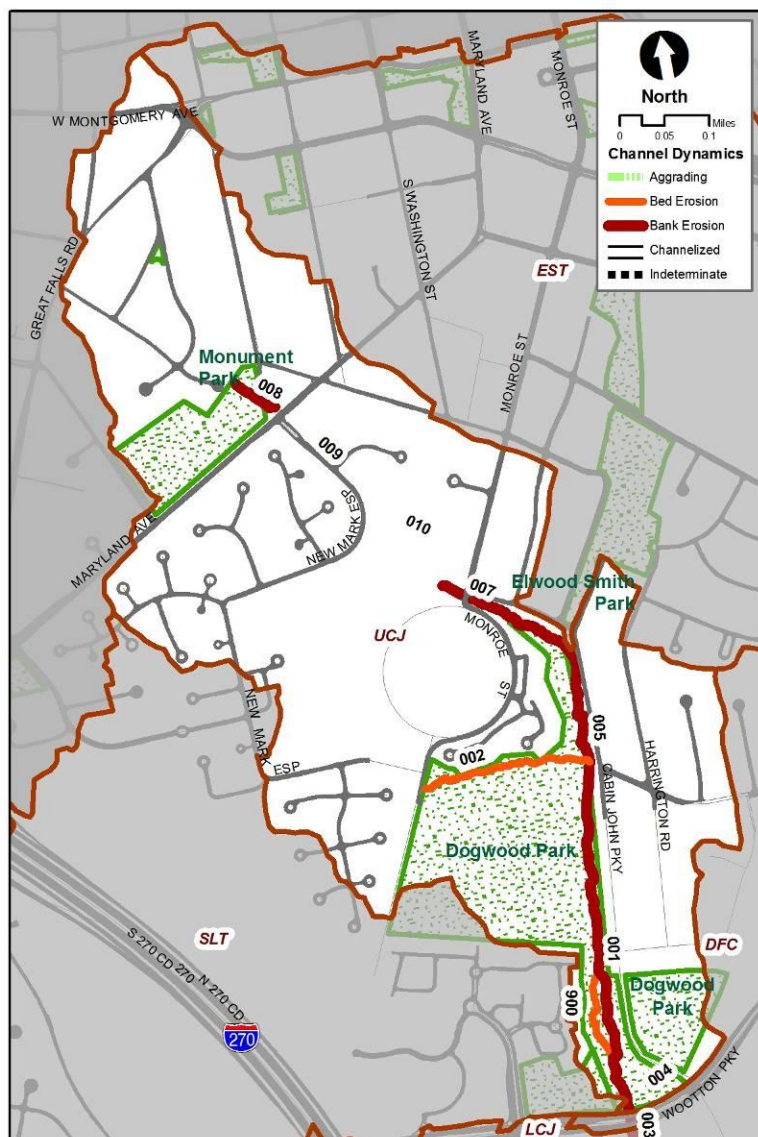
FIGURE 55: UPPER CABIN JOHN CHANNEL DYNAMICS ASSESSMENT

Portions of the channel between rock vanes have become long, shallow runs instead of riffles or pools. Gravel dominated the substrate in the channel and some gravel point bars were present in the channel.

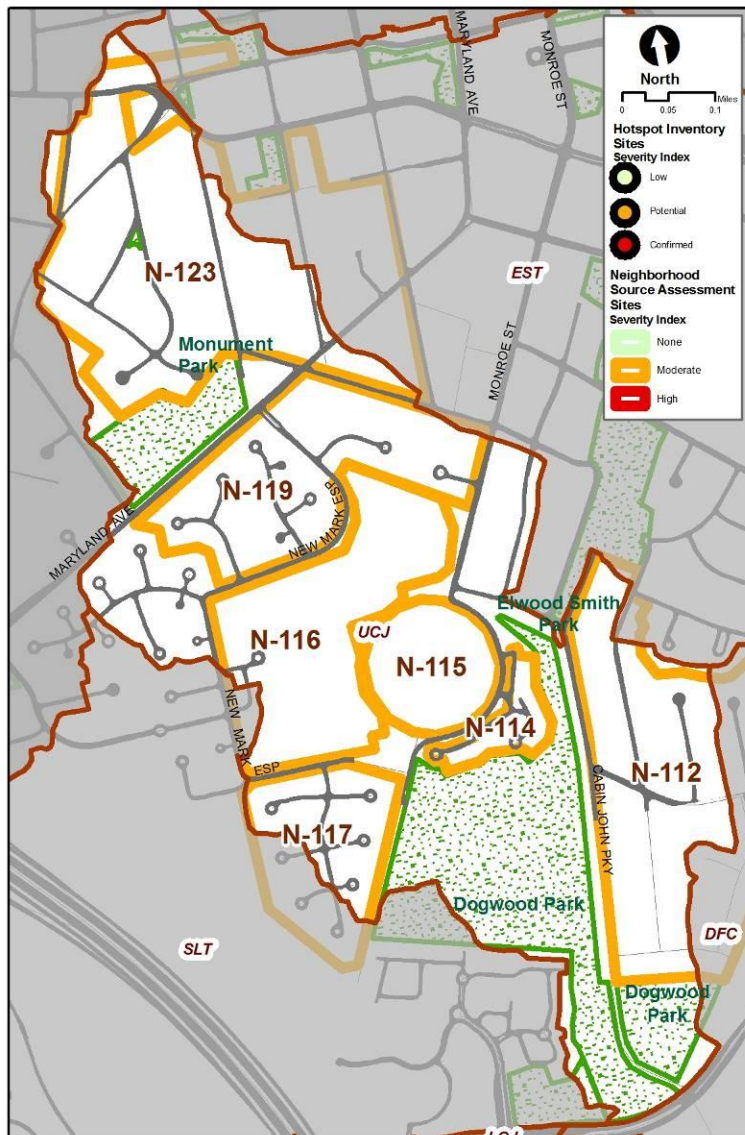
FIGURE 56: UPPER CABIN JOHN NSA / HSI RESULTS

Six residential areas were assessed in Upper Cabin John Creek. No hotspot sites were investigated because there is so little commercial or institutional land coverage. The residential areas consisted of a mix of single-family and multi-family developments at a variety of densities, built from the 1940s to the 1990s, with most of the development occurring in the 1960s and 1970s. Pollutant-causing behaviors and potential actions also varied widely across the different areas. Tree canopy was over 40 percent in all the single-family areas. Lawn care practices were primarily medium intensity, with lower impact on streams. Downspouts were over 40 percent disconnected in all neighborhoods except N-114. There were invasive species noted in Dogwood Park, adjacent to the neighborhood.

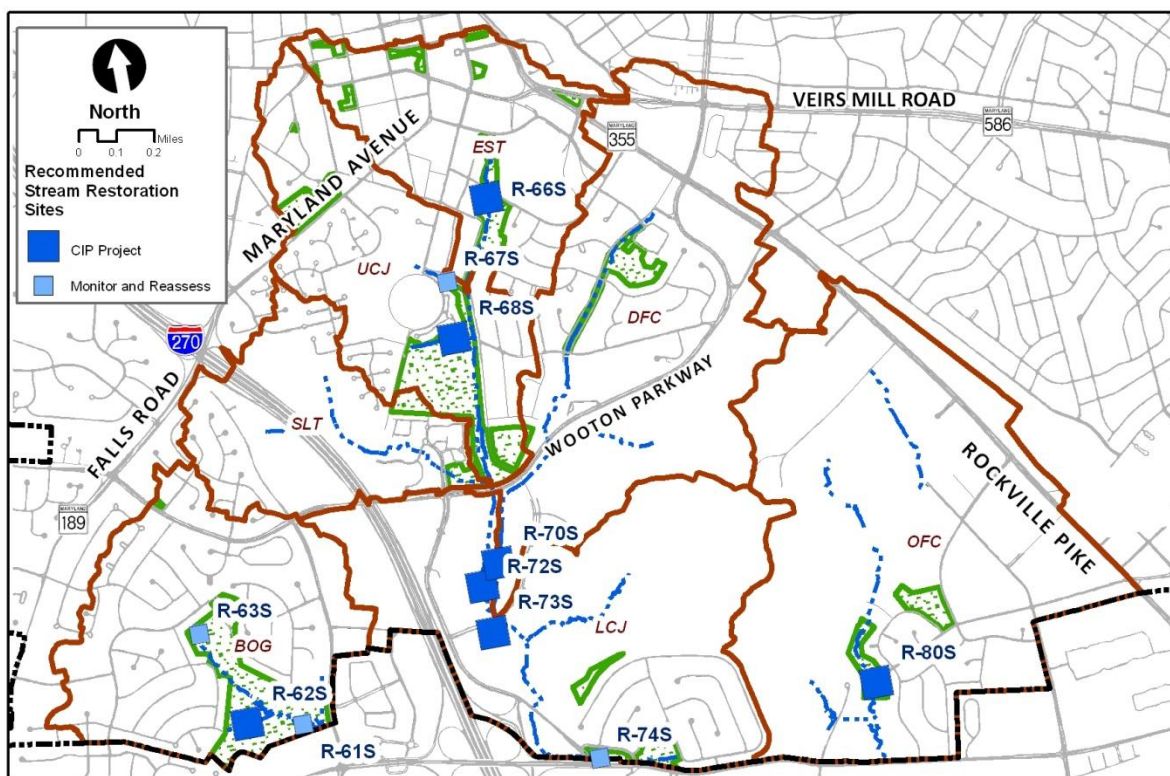
FIGURE 59: RECOMMENDED STREAM RESTORATION SITES

| Subwater-shed | Current Site ID | Location | Notes |
|---|---|---|---|
| Upper Cabin John | R-67S | Cabin John mainstem adjacent to Cabin John Pkwy between Monroe St. and W. Lynfield Dr. | Stream is immediately adjacent to street, and was straightened and channelized for road construction. Gabions were installed in 1997 at W. Lynfield Dr./Cabin John Pkwy and are still stable. Moderate spot erosion, but no signs of accelerated conditions. Monitor annually for worsening erosion, especially at gabions for road stability. |
| Lower Cabin John | R-74S | North Farm Creek between Montrose Road and North Farm Drive/Farm Pond Ln. | Channel has several large storm drain outfalls and large drainage area. Upstream portion of channel by tennis courts is stabilized with riprap in good condition. Reach shows slight erosion and has few bends. Middle section near playground & basketball courts has moderate spot erosion, with deposition of apparent dumped concrete or road grit. Channel is poorly aligned with the culvert headwall under North Farm Drive, but shows little scour/erosion. The lower reach between North Farm Drive and Tower Oaks Blvd. is very stable. Monitor middle section for worsening erosion or repeated deposited materials. |

Recommended projects for stream restoration are shown in Table 43 and Figure 59. Twelve concept plans resulted from the selection of candidate sites and review of field data.
