# Proposed Fleet Street - ED Marsh Retrofit\*

# Proposed Dogwood Park - Off-Line ED Marsh Retrofit

# Proposed Wootton Parkway ED Weirs: (1 of 2)

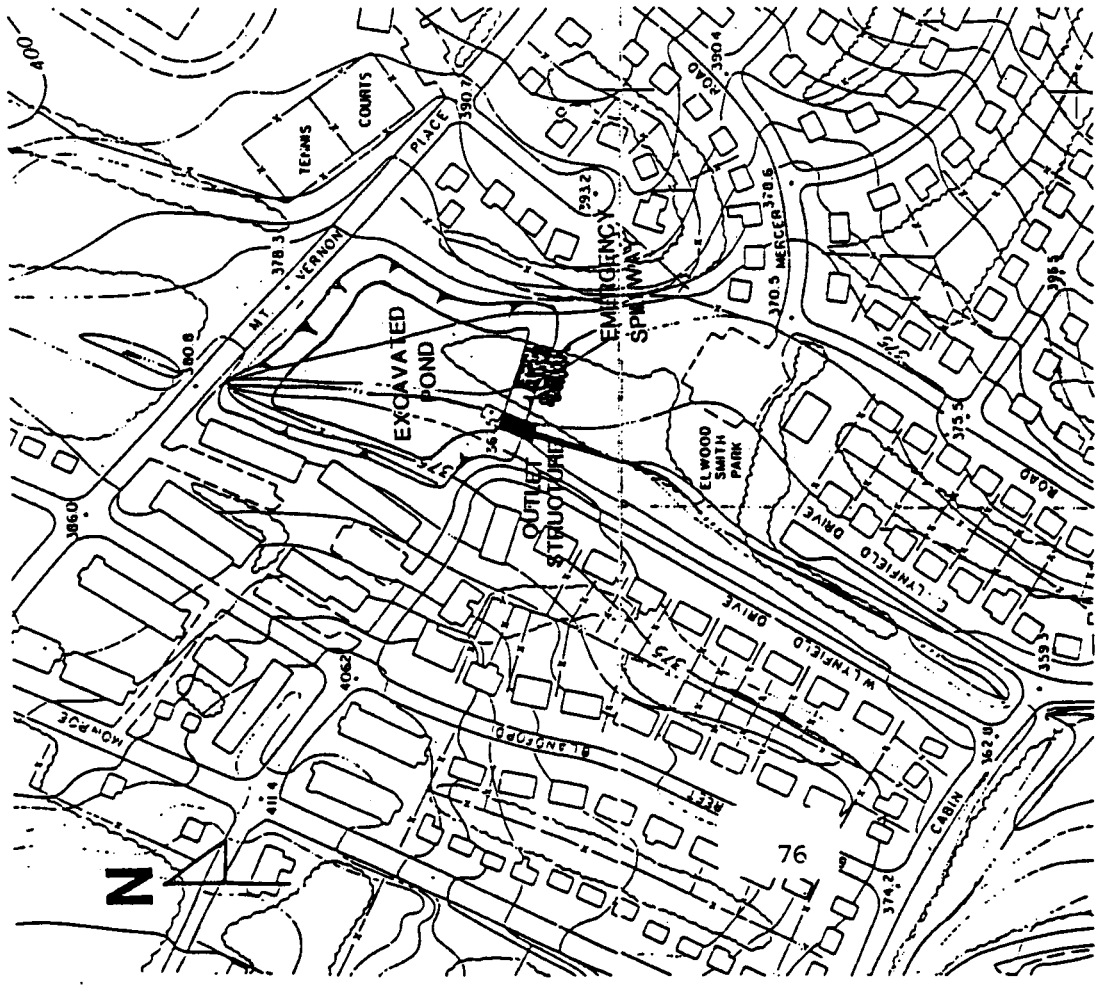
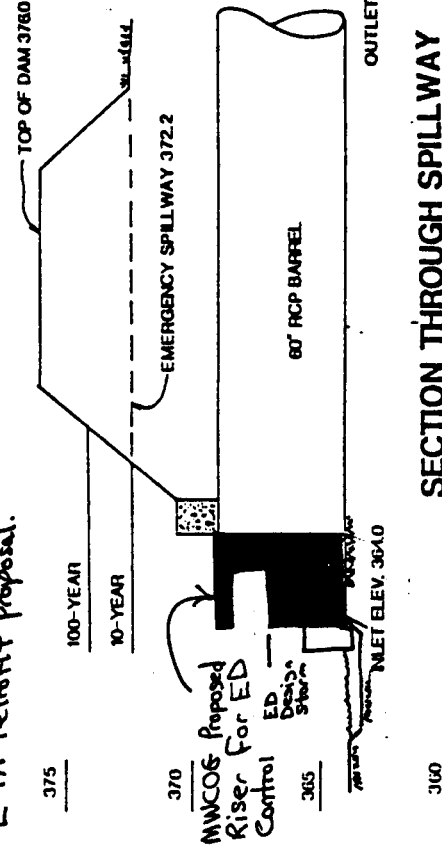
## SECTION THROUGH SPILLWAY

- D.A. - 184.6 ac
- Imperviousness - 45%
- Impervious Area - 83.1 ac
- ED Design - variable
- ED Storage Vol. - 15.1 ac-ft (Max.)

\* Note, COE concept adds ED control feature to earlier ETA retrofit proposal.

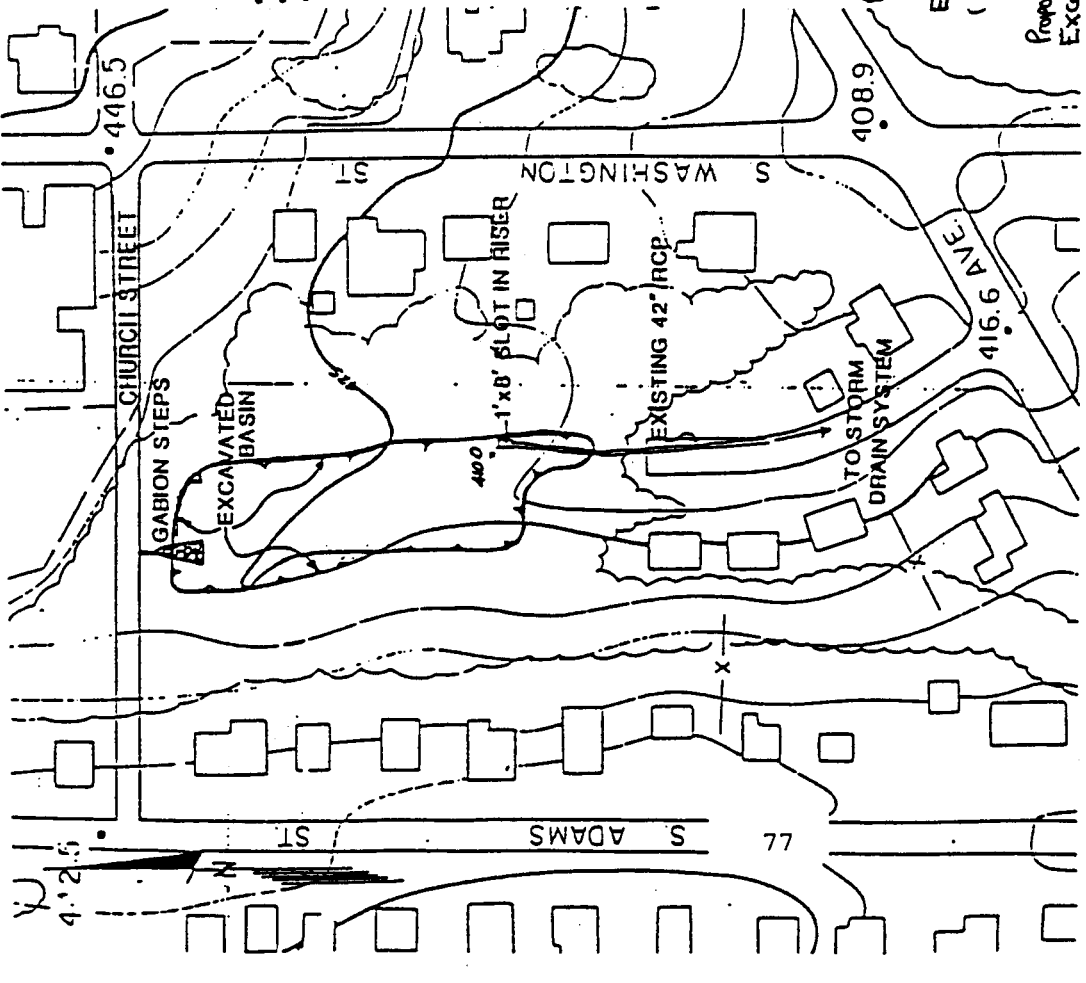
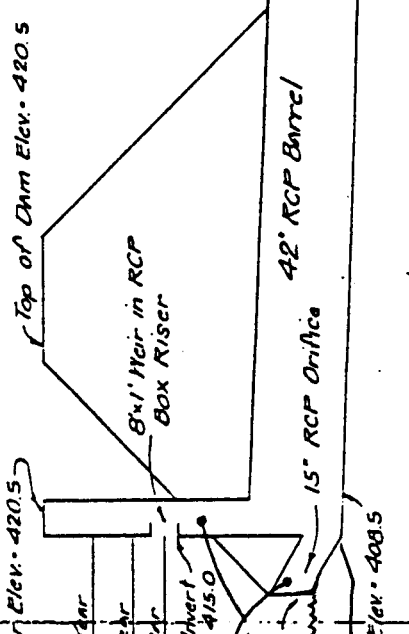
SECTION THROUGH FACILITY

- D.A. - 24.29
- Imperviousness - 45%
- ImperVIOUS
- Average - 10.9 ac pool
- Remanufactured Surface Area - 0.18 ac
- Permanent Pool Vol. - 0.27 ac-ft
- ED Design - 0.5 gpa/ac
- ED Storage Vol. - 0.45 ac-ft

\* Note MWHOG retrofit concept sacrifices current 10-yr storage. Riser Elev. 420.5

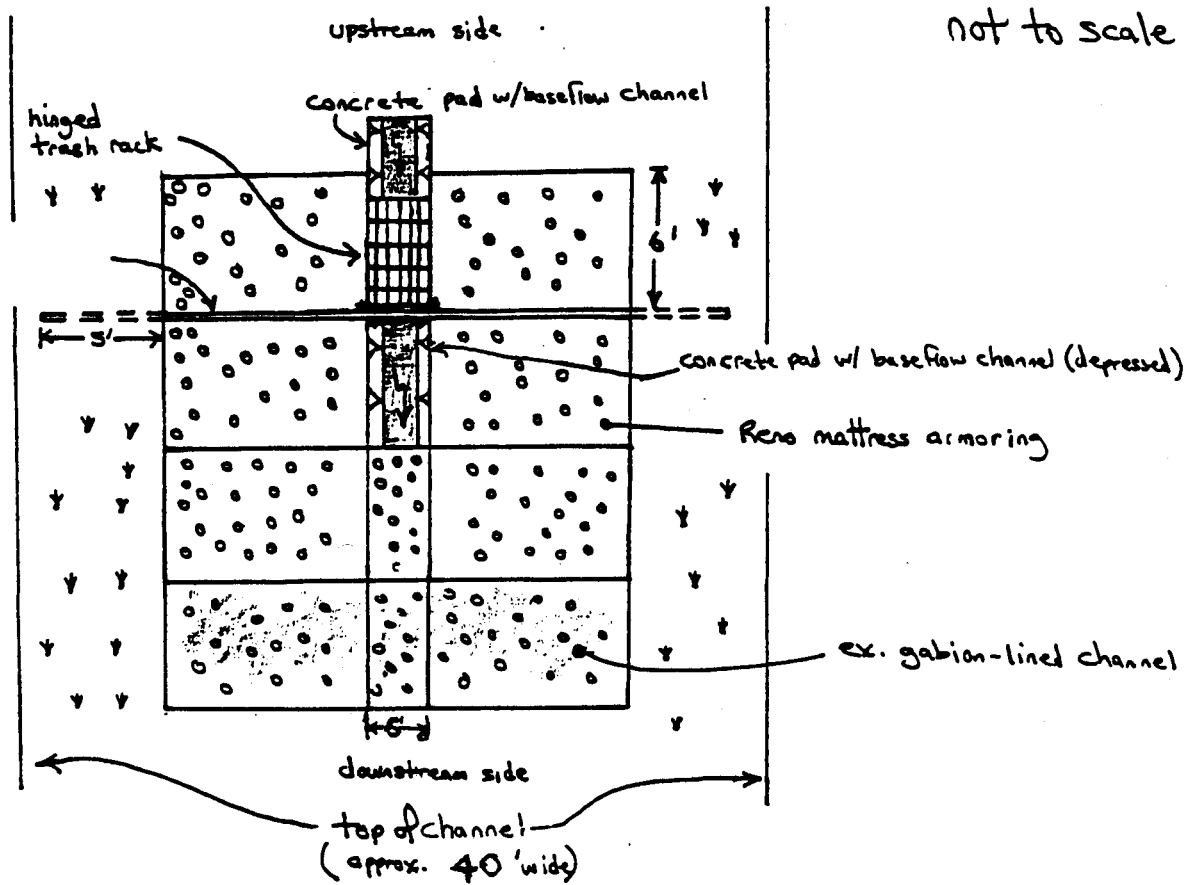
## Plan View:

# Possible Channel Modification for ED Weir System: (2 of 2)

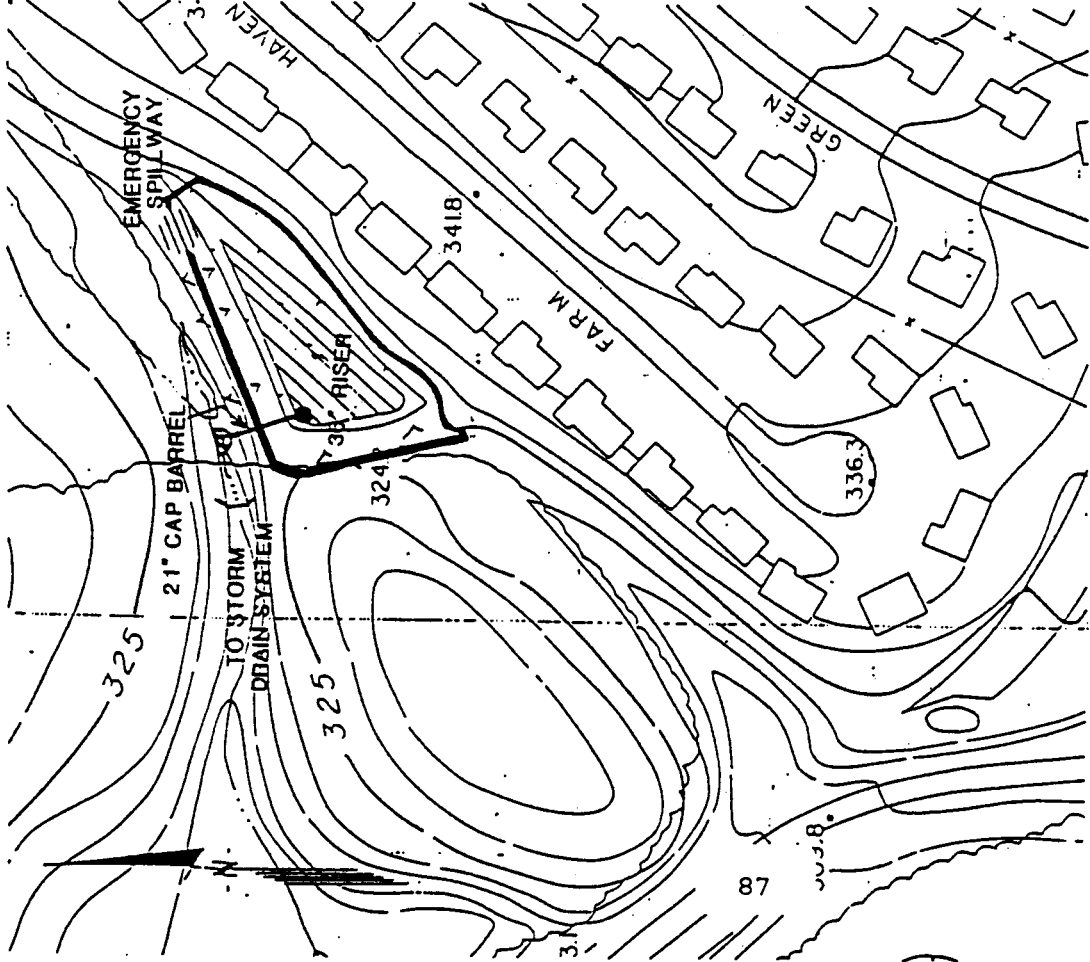
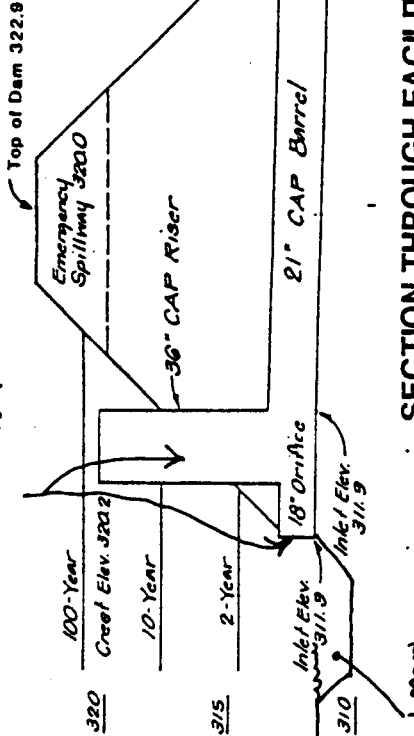
**Proposed Riser Modifications for ED control**

Proposed Excavated Marsh

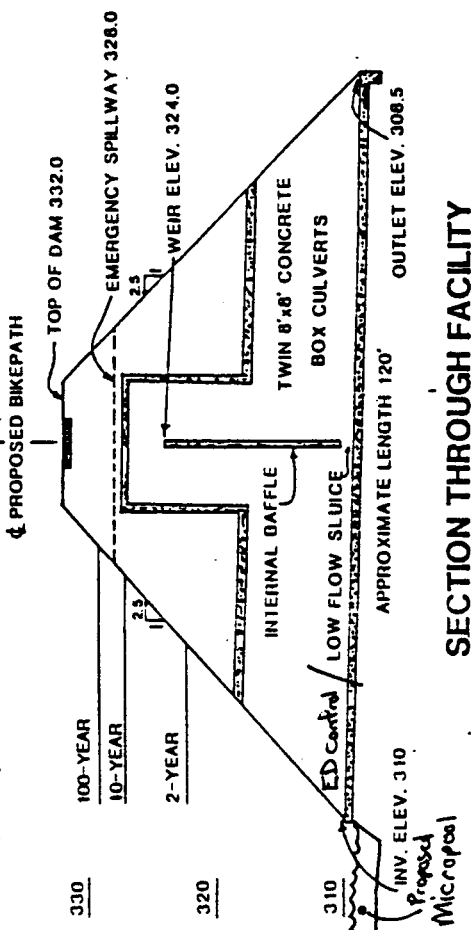
## SECTION THROUGH FACILITY

ELEVATION	STORAGE	INFLOW (cfs)		OUTFLOW (cfs)	
		Existing	Future	Existing	Future
W/A	W/A				
Normal Pool	522.5 FT.	94	282	313	218
2-Year Storm	323.7 FT.	358	839	718	582
10-Year Storm	329.6 FT.	758	1188	1182	933
100-Year Storm					1888

\* Note, MNCOG Concept involves adding ED Control to existing ETA concept as well as incorporation of a Micro-pool feature.
