NATURAL RESOURCE INVENTORY - FSD - GENERAL NOTES

THE CITY OF ROCKVILLE DEPARTMENT OF PUBLIC WORKS IS DESIGNING A NEW ACCESS ROAD TO THE ROCKVILLE SENIOR CENTER PARKING LOT FROM THE INTERSECTION OF WEST GUDE AND PICCARD DRIVES AND MODIFICATIONS TO THE TRAFFIC SIGNAL IN ORDER TO ADD THIS NEW LEG TO THE INTERSECTION. CURRENTLY, THERE IS NO ACCESS TO THE ROCKVILLE SENIOR CENTER FROM WEST GUDE DRIVE.

CITY OF ROCKVILLE, MARYLAND

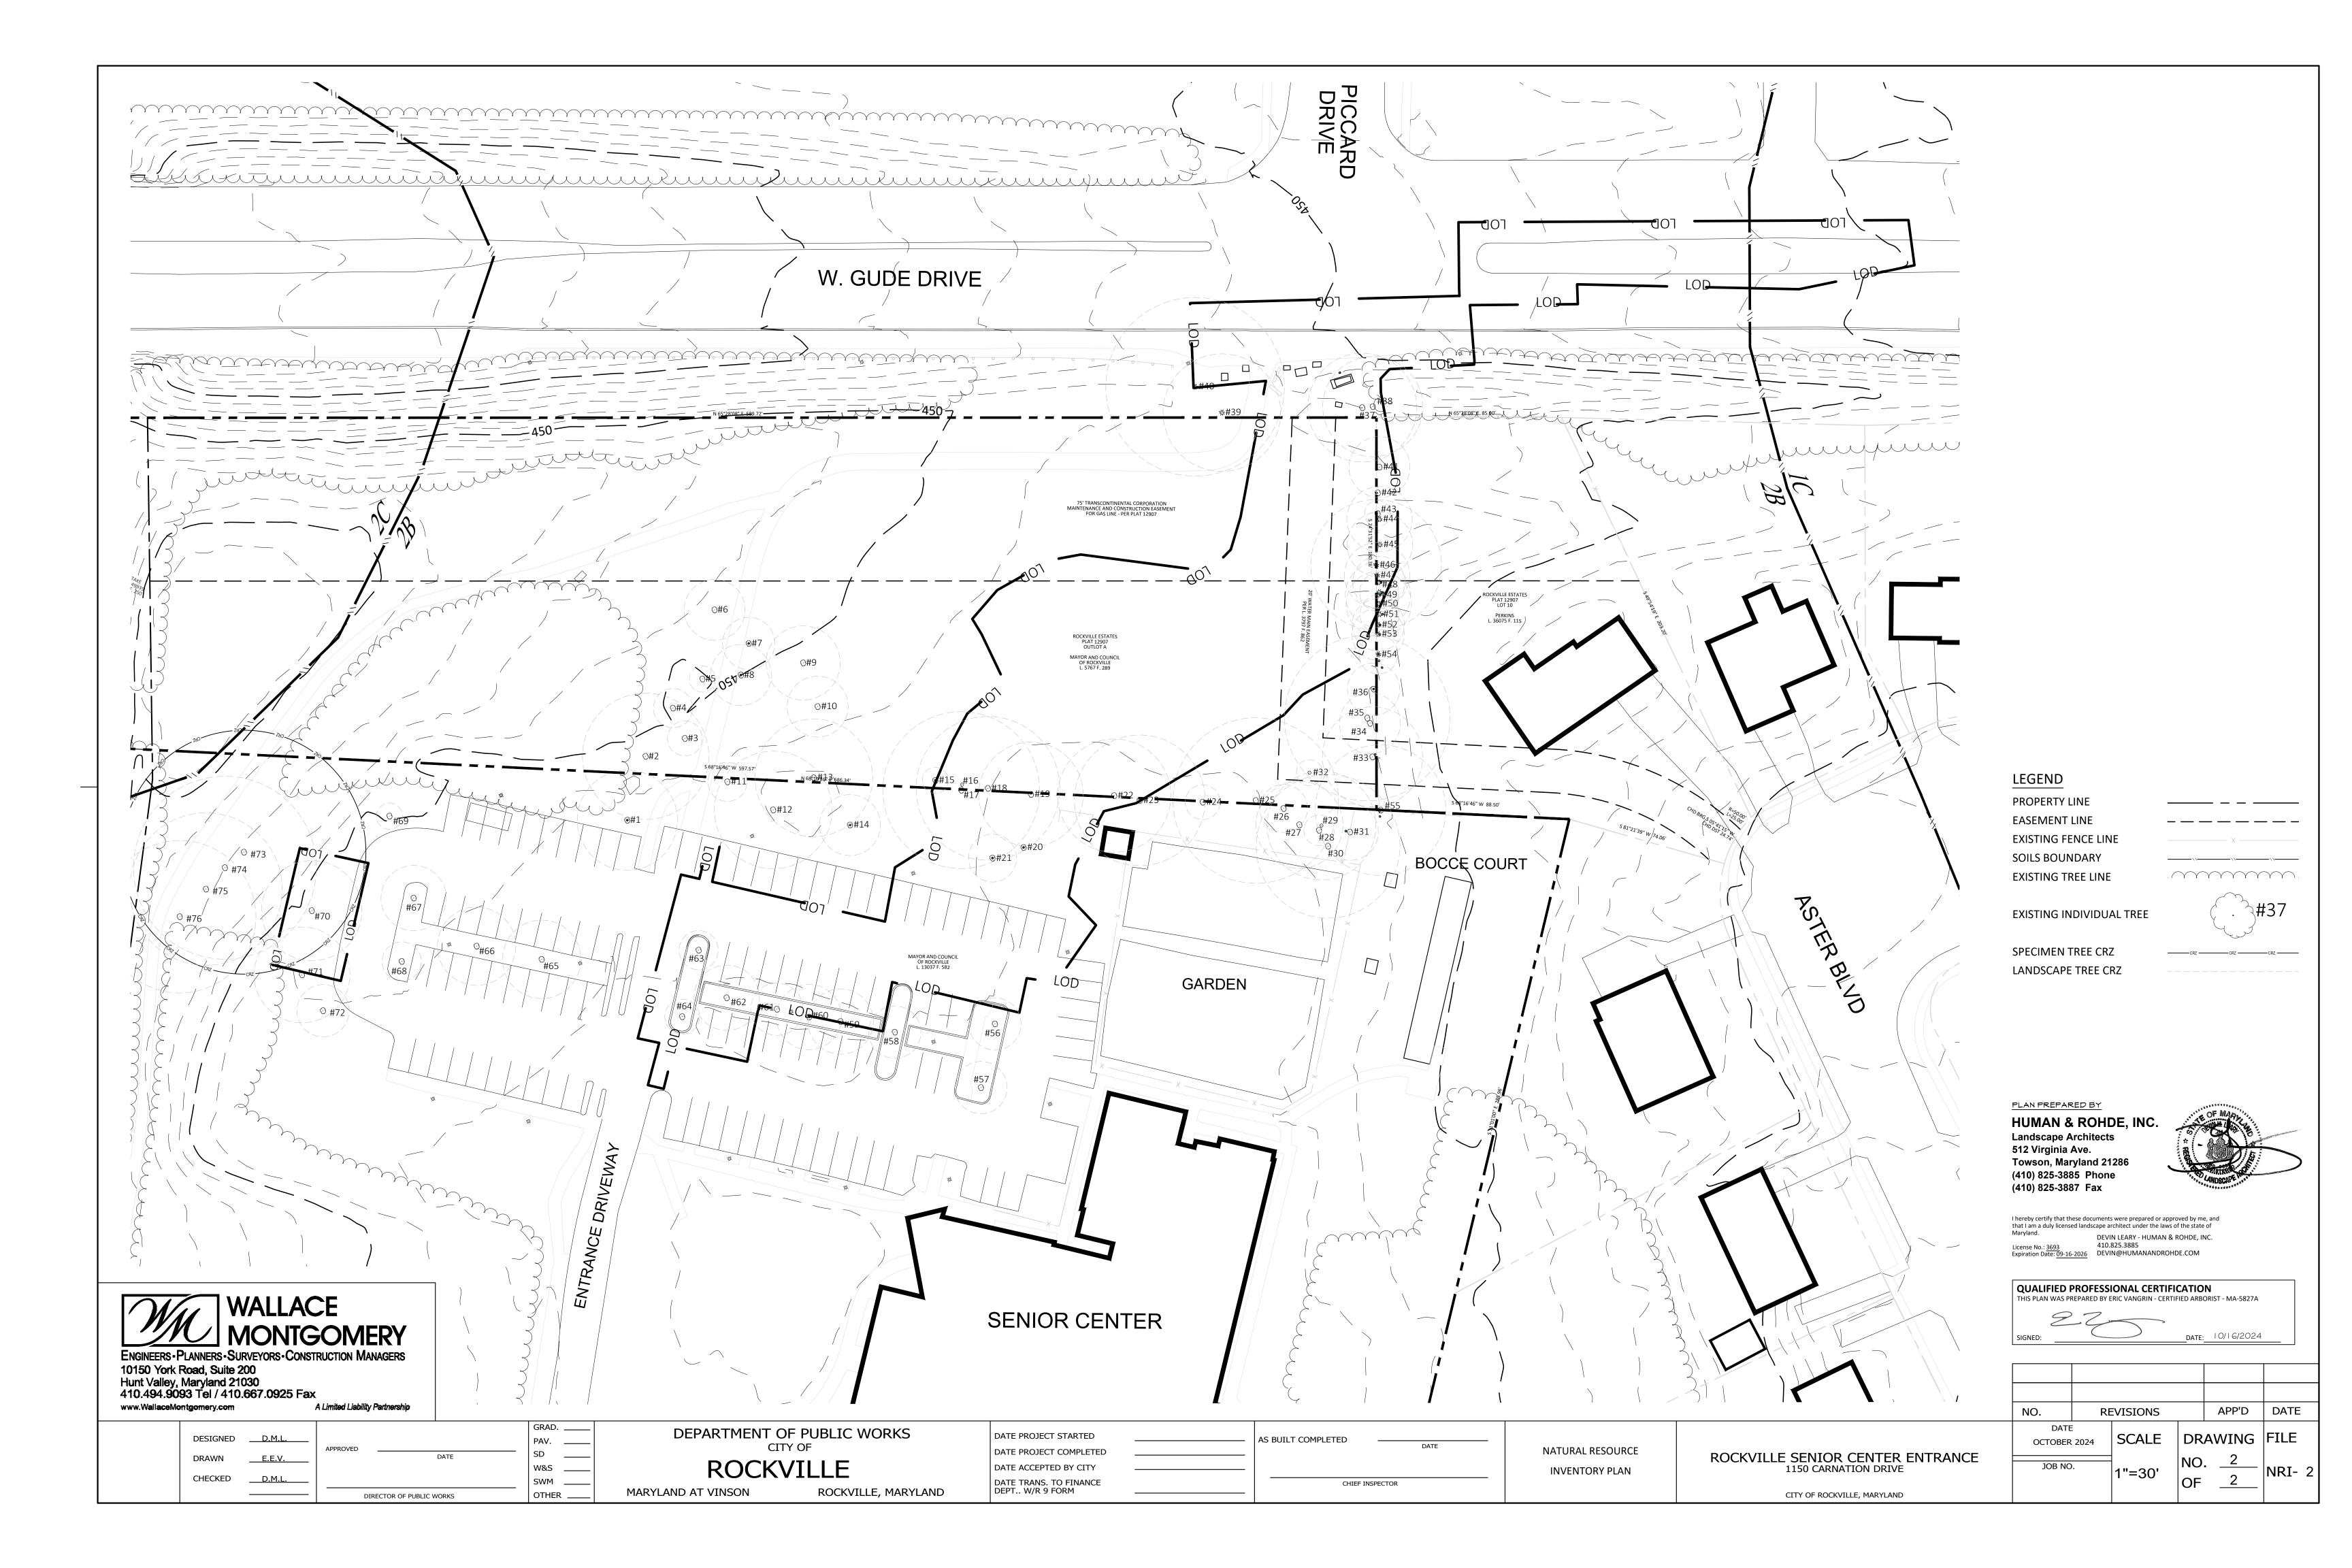
THE PROJECT CONSISTS OF DESIGN OF THE ROCKVILLE SENIOR CENTER ENTRANCE AND PARKING LOT ACCESS ROAD IN ACCORDANCE WITH THE CITY'S SITE PLAN DEVELOPMENT PROCESS. THIS WILL INCLUDE A NEW DRIVE AISLE ENTRANCE, CURBS AND GUTTERS, PAVEMENT, DRAINAGE, POSSIBLE UTILITY RELOCATION, RIGHT-OF-WAY ACQUISITION, STORMWATER MANAGEMENT, SIDEWALKS, STREET LIGHTING, SIGNAGE AND LANDSCAPING. THE PROJECT WILL ALSO INCLUDE A GATE/BARRIER SYSTEM TO PREVENT CUT-THROUGH TRAFFIC BETWEEN THE NEW WEST GUDE DRIVE ENTRANCE AND THE EXISTING ENTRANCE ON CARNATION DRIVE AND RELOCATION OF A STONE STATUE AND CONCRETE PAD ON THE CENTER'S GROUNDS
