MEMORANDUM

SUBJECT: 401 S. Horners Lane: The Pump House  
Evaluation for Historical, Architectural or Cultural Significance

## Maryland Inventory of Historic Properties Form

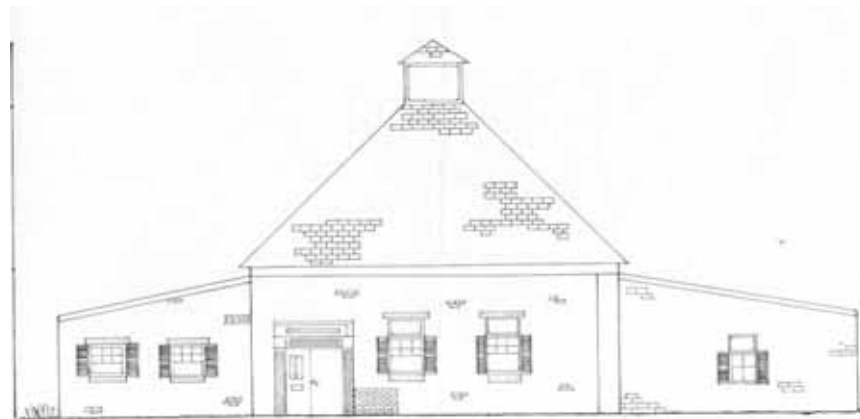
Plan and front elevation drawings prepared 2003, for Peerless Rockville under the direction of Corri Jimenez

The Pump House consists of a brick central block and two side wings. The center block measures 32' square, and has a pyramidal roof topped with a cupola. The basic design includes shallow pilasters at each corner to hold up the deep fascia board under the wide eaves. To this basic design, a large chimney base was added at the southwest corner, and subsequent chimneys have been added at the NE and SE corners. The brick is laid in American bond (7-stretchers to 1-headers), with stone lintels and sills at original openings. All of the original door and window openings have been altered and/or downsized. The center block of the Pump House has asphalt shingles on the pyramidal roof. The wide eaves measure approximately 18" and there is a complementary wood trim band under the eaves, which measures approximately 1'. The small cupola measures approximately 5' square, and it also has a pyramidal roof with asphalt shingles. A metal weather vane sits atop the cupola, with a bird alighting on a ball mounted on the north arrow. The north, east and south faces of the cupola are filled in, while the west face has two ventilation openings. The brick south wing has a shed roof and measures approximately 18' x 32'. The concrete block north wing also has a shed roof, and measures 23' x 19' with the west side flush with the west elevation of the main block.

The East (front) façade has three-bays on the central block, with a side hallway on the south side and a large room to the north. The double-width front door has been reduced in both height and width within the original opening that is still apparent. The door opening has a stone lintel measuring approximately 10" in depth approximately 30" above the height of the existing doorway. The current doorway has a Greek Revival style wood frame with implied fluted pilasters, corner blocks, and fluting above the door. There is a single-leaf solid flush door and a smaller in-fill side panel with two narrow windows. To the right of the entrance, replacement windows are set within the two original window openings. The new window configuration includes a wood in-fill panel above a double-hung 6/6 wood window, with flanking shutters attached to the brick wall. The small brick addition at the south side of the building has a shed roof that begins under the eaves of the center portion of the building. There are two double-hung windows on this south addition, and a low chimney at the south corner.

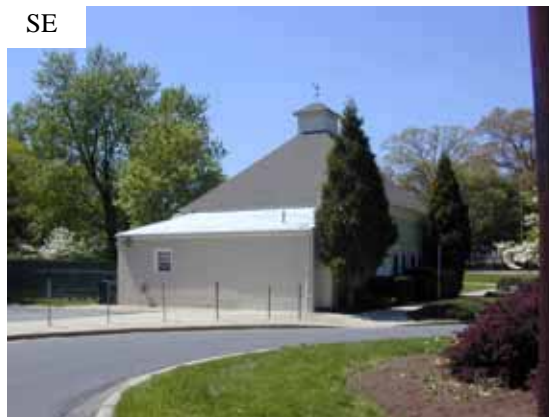
SE

The South (left side) elevation of the brick shed-roof addition extends the full-width of the center block of the Pump House. Two doorways have been blocked up on this elevation. One has been altered for a small window. There are no stone lintels on this elevation.

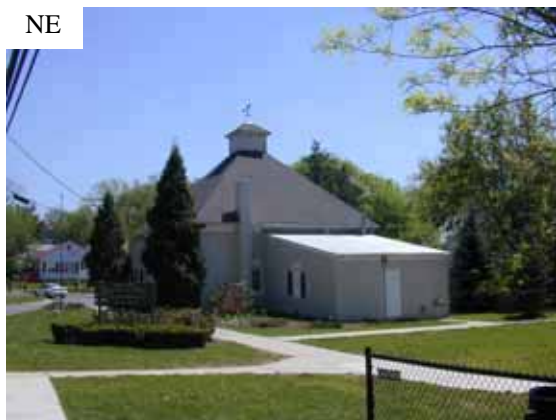
NE

The North (right side) façade of the Pump House has a concrete block addition that is held back from the front (east) façade, but is flush with the west façade. This shed-roof addition measures approximately 19' wide by 23' long. The roof sits under the original eaves of the main block of the Pump House. It has a single door on the north façade, and a single window on the east façade, which is designed to match the existing infill windows on the east façade. It has an in-fill panel above the 2/2 double-hung window, and flanking non-functioning shutters. A window opening on the west side of this addition has been blocked up. The door and two windows are centered on their respective elevations. Where the concrete block addition has been held back from the east façade, a

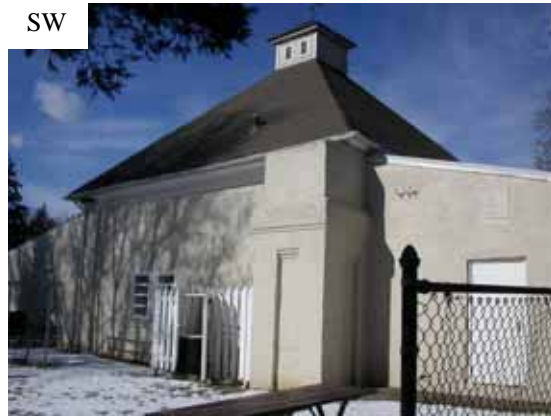
SW

The West (rear) elevation of the central portion of the Pump House has paired double-hung replacement 2/2 (horizontally divided) windows in a downsized opening. The lintel appears to be wood, while the [stone] sill has been parged and painted. Its smooth rectangular shape stands in contrast to the rustic stone lintels and sills on the front façade. To the right of these windows, two stacked window openings that are next to the remnant of the original brick chimney have been filled in. The top window extends all the way to the wooden fascia under the eaves. With decorative relieving arches on each of the three exposed facades and a decorative brick band above, the chimney remnant measures approximately 2'x3' and stands 14' tall, ending at the bottom of the soffit.<sup>1</sup> A wooden enclosure has been built at the north side of the chimney to hide a heat condenser. There is a single doorway on the west elevation of the brick shed-roof addition. A single window has been blocked up on the west elevation of the concrete block shed-roof addition.
