# Rockville Swim and Fitness Center Outdoor Recreation Pool Renovations Findings Report

February, 2023

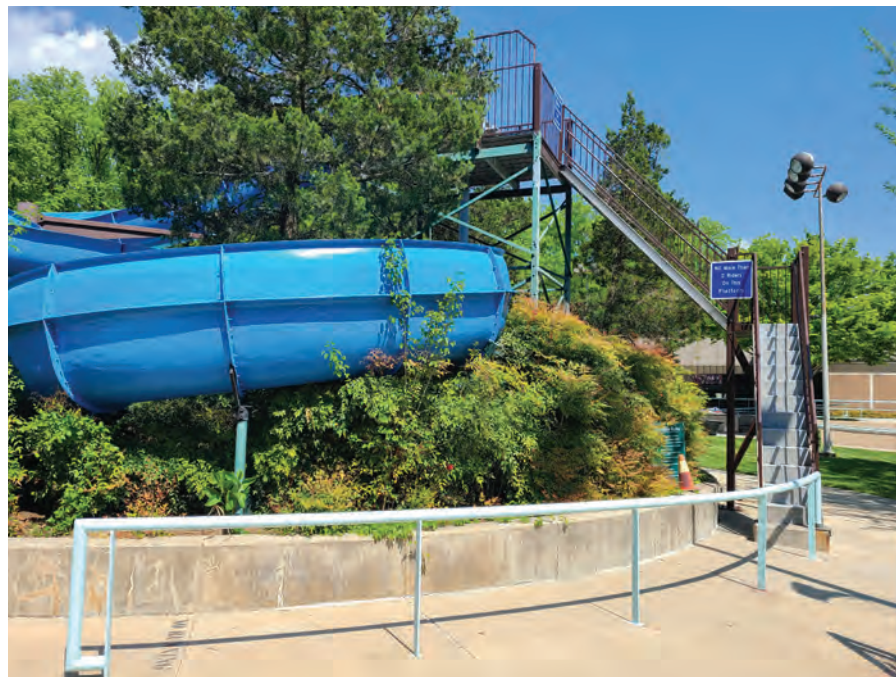
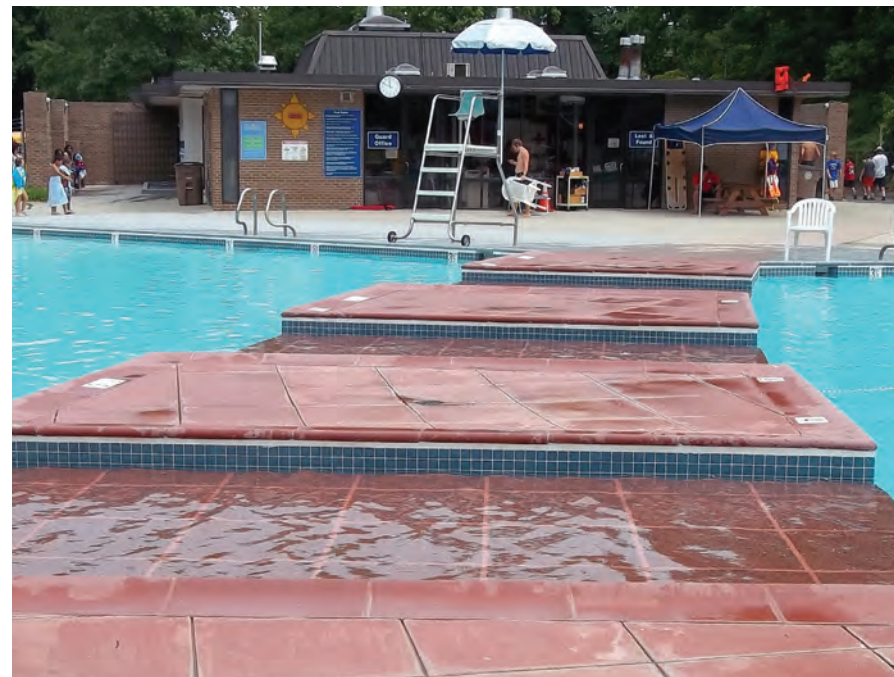
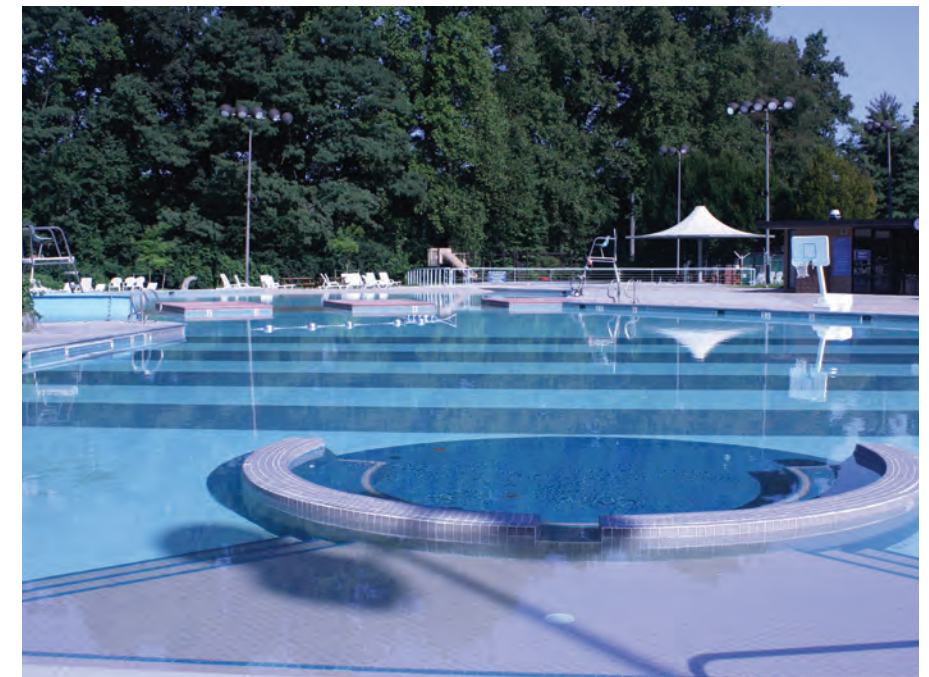
## Site Safety

- slide location and surrounding vegetation impacts lifeguard visibility
- renovations to include emergency egress from inside pool area
- lifeguard station locations need to be flexible and allow for staff to be adjusted based on bather load
- avoid multiple pool features that require a dedicated staff member
- avoid site design and amenity placement that limits water visibility
- current bulkhead “bridge” provides desirable separation between shallow and deeper areas

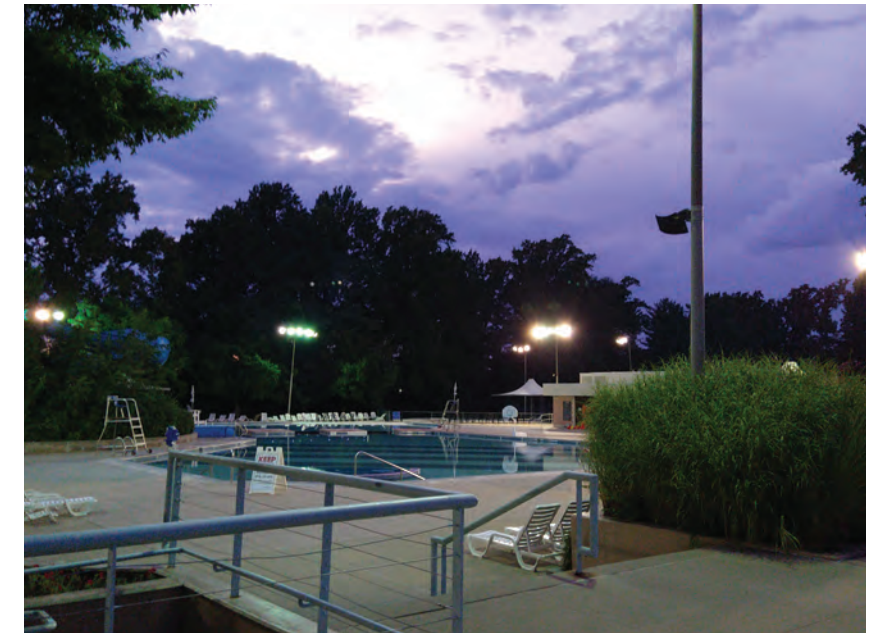
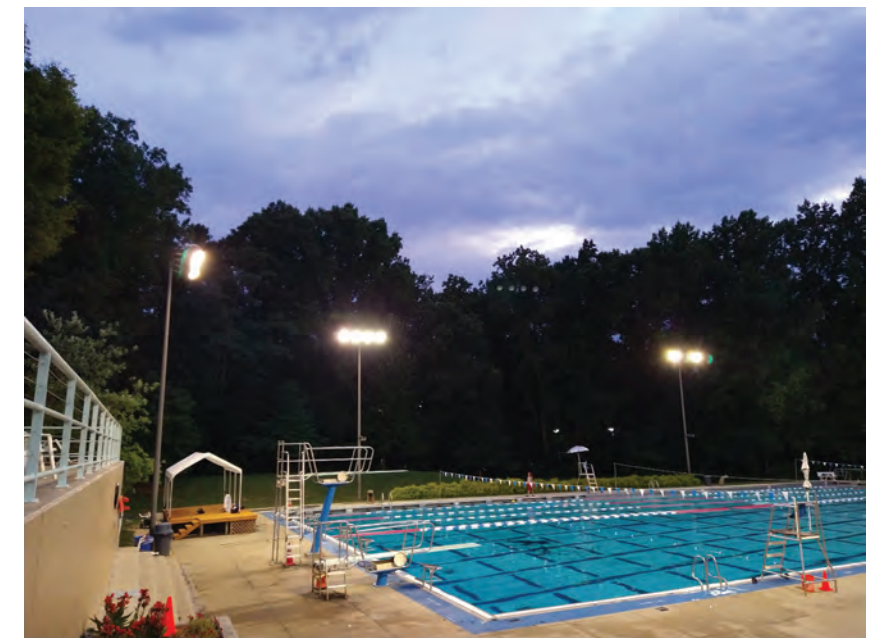
## Site Lighting

- lighting upgrades include outdoor recreation pool and fitness pool
- current pole locations provide even coverage in most areas
- lighting can be improved in following areas:
  - ADA ramp on the upper terrace
  - sprayground
  - slide
  - perimeter of the bathhouse
  - pool pavilion
- current lighting needs:
  - summer sunset is between 7:30 to 8:45 pm and by the end of November it is 4:50 pm
  - outdoor fitness pool closes at 9:00 pm in summer
  - outdoor recreation pool closes at 7:00 or 8:00 pm in summer, people do walk through this space until close
- numerous existing light poles are leaning
- existing light pole foundations will need to be evaluated for reuse as numerous poles are leaning

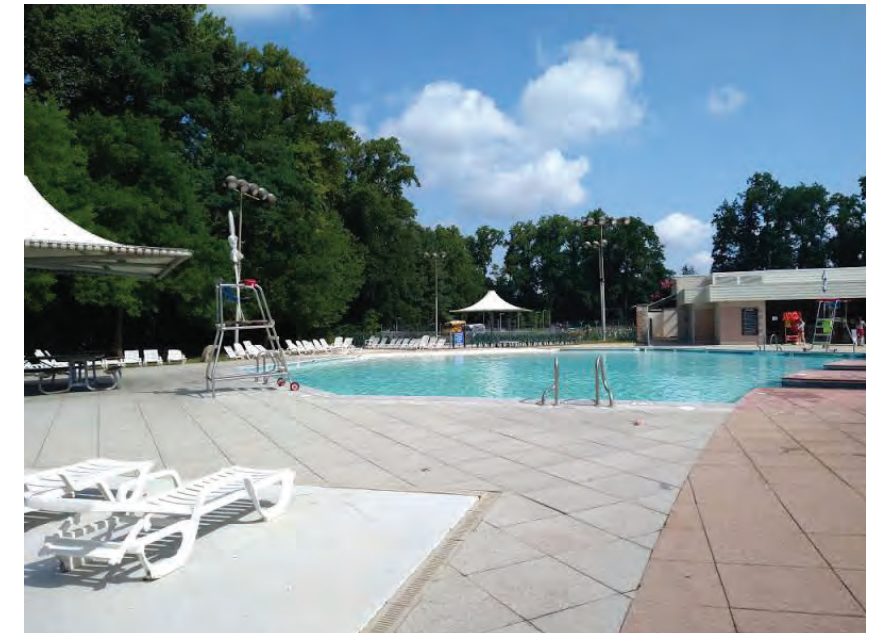
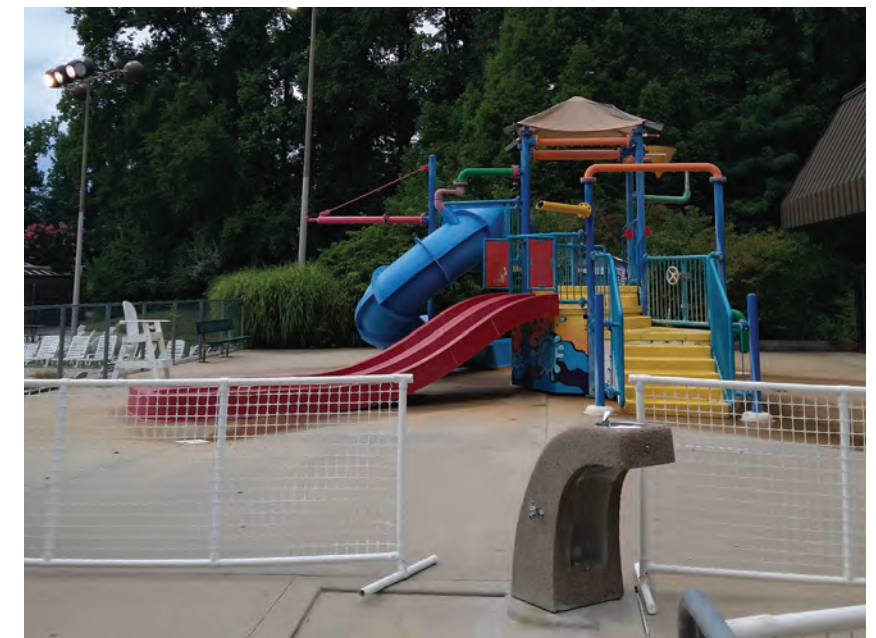
## Site Elements

- more picnic tables and shaded seating options are needed
- trees are not directly overhanging the pool areas
- existing shade structures do not provide opportunity for reservation
- drinking fountains are not well used
- twist knob of foot washing stations are left running by patrons
- more trash cans are needed based on discussions with RSFC staff
- certain deck areas are underutilized and provide opportunities for aquatic area expansion

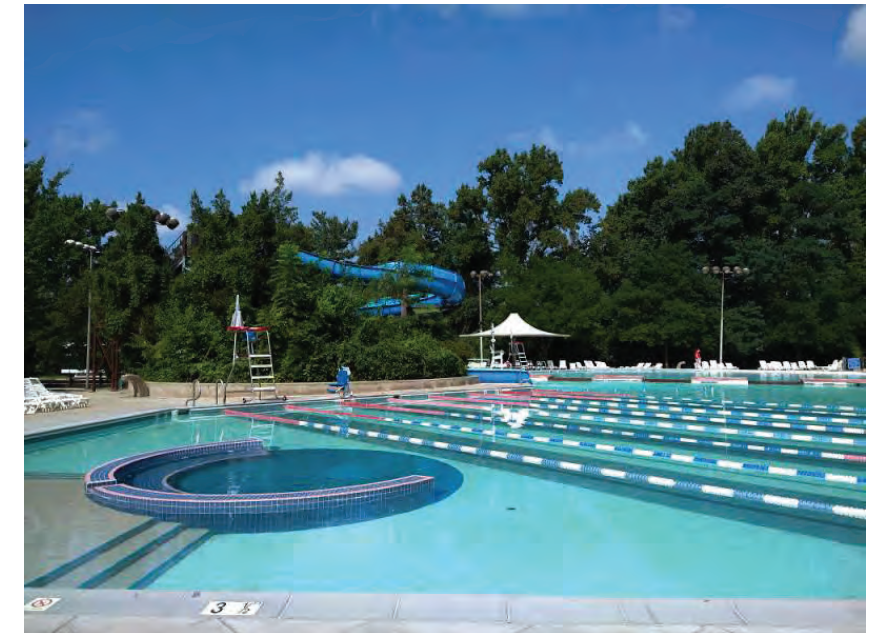
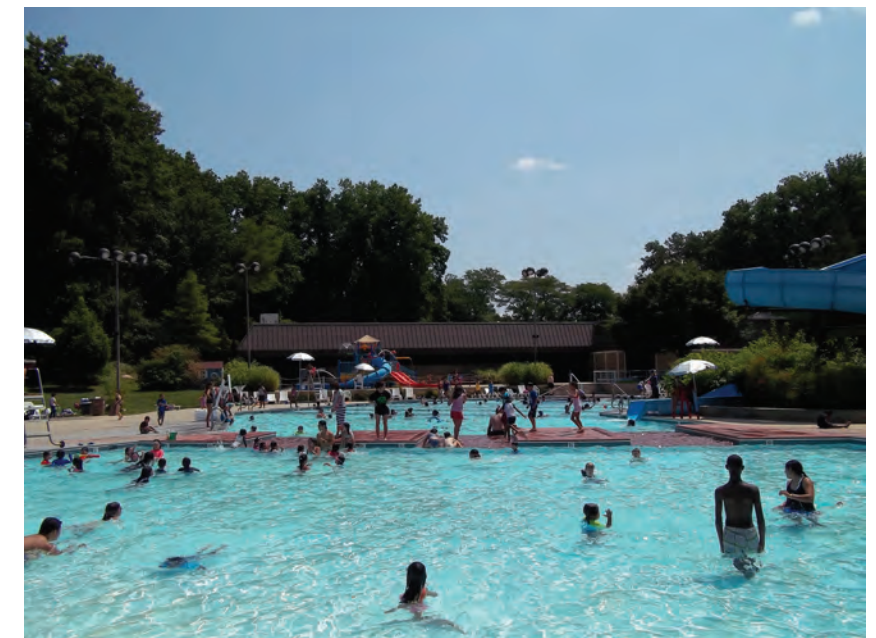
## Recreation Pool

- water slide
  - smaller children have trouble making it all the way down the current slide
  - current stairs are narrow and slippery, despite adding a specialized paint
  - no easy exit option for children that decide not to go down slide
  - slide line becomes long at peak times
  - current location impacts overall circulation and is inefficient
- spa seating area near the pool entrance stairs impedes circulation within the pool and is a safety concern.
- The current bridge that separates the shallow and deep end is very useful for guardians and prevents non-swimmers from going beyond 3.5' deep. However it is maintenance heavy and is a safety concern due to kids running or diving from the edge.
- pool area is lacking in recreational amenities aside from water slide and sprayground

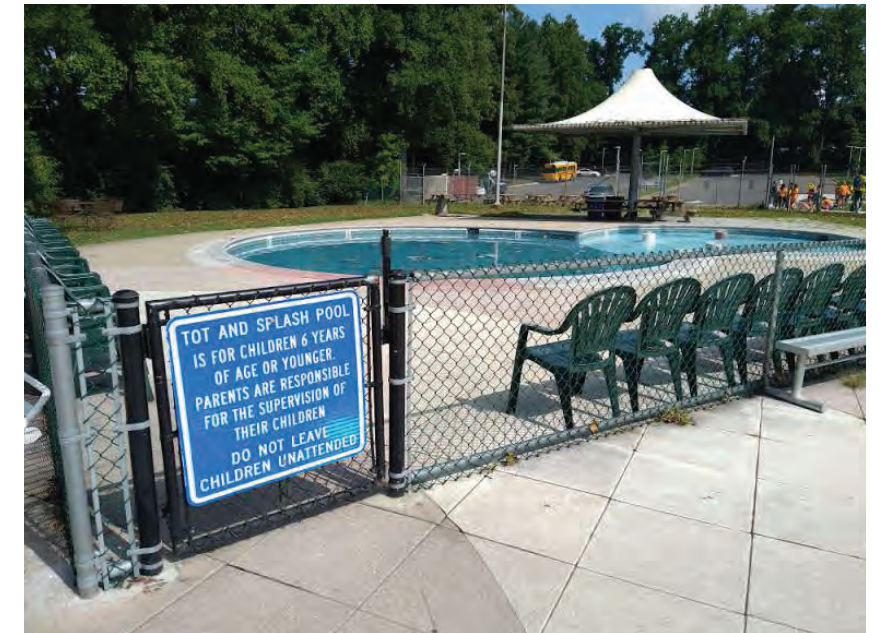
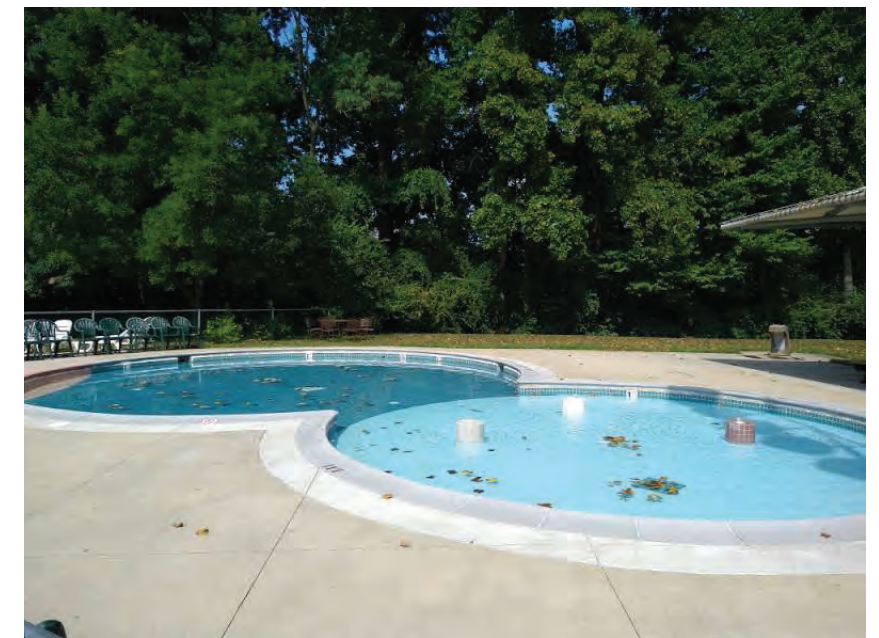
### Tot Pool

- need better sightlines and connections to recreation area
- area is not shaded and is on asphalt
- area could be better integrated

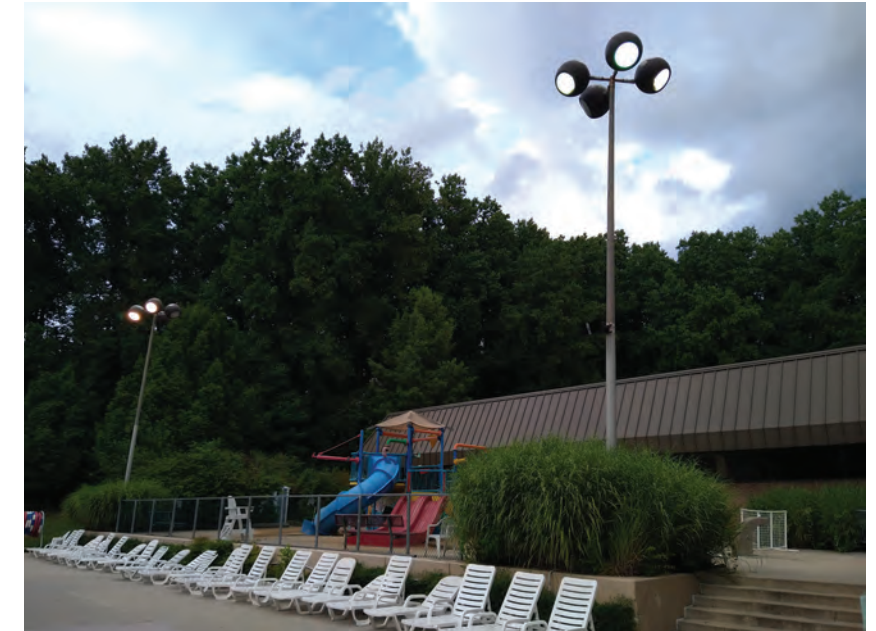
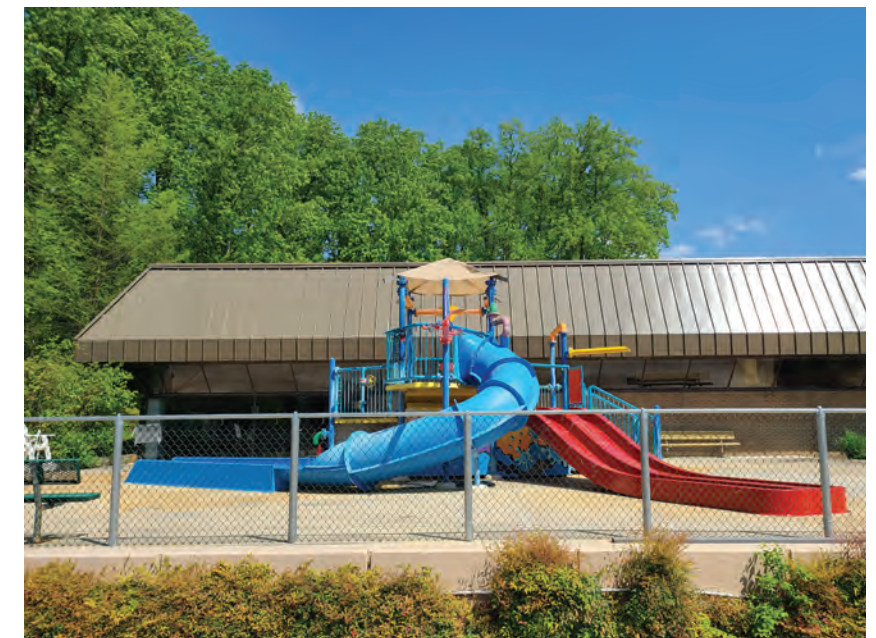
### Sprayground

- current sprayground is outdated
- lifeguard not required, but one is stationed
- too close to the building and causes problems with splashing
- equipment shed needs to be replaced
- sprayground and tot pool are too far from each other
- excited children often run and slip on the concrete surface

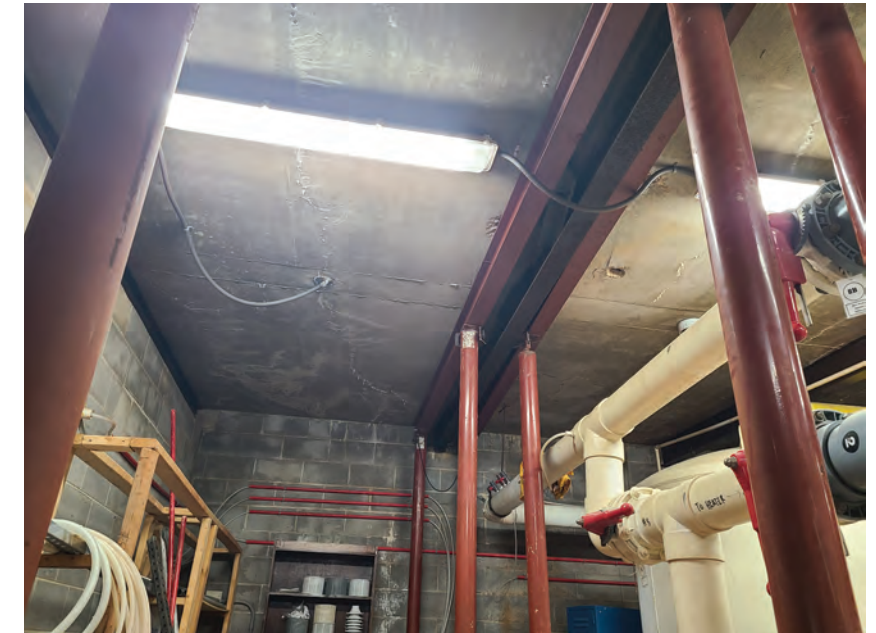
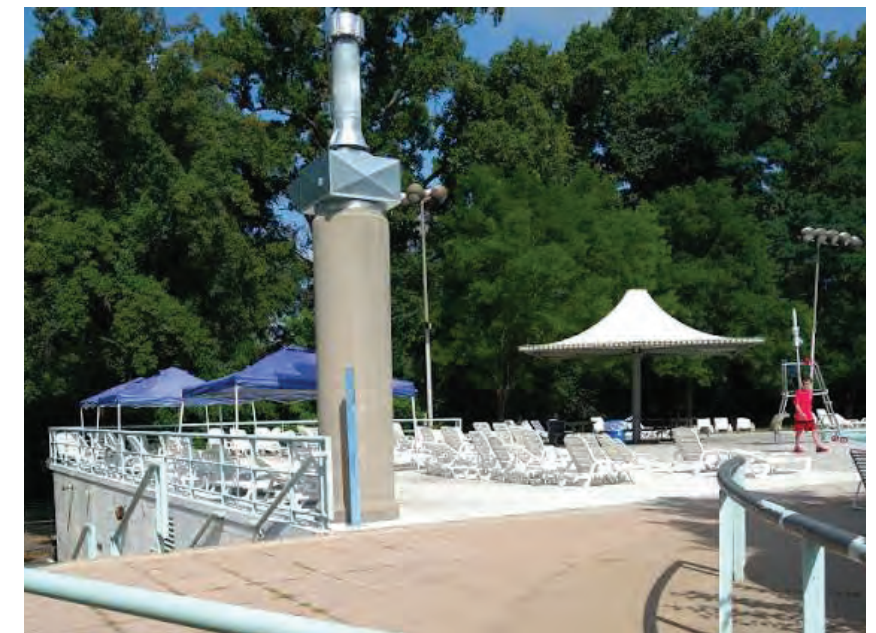
## Infrastructure

- Rockville's 2015 study noted structural concerns within existing pump room
- filtration system update required to meet needs of new design
- pool heat
  - heater exhaust tower requires clear space around the top vent

- A Structural Condition Assessment Report was conducted for the pump room, see Appendix 2 for the full report.  
The observations and recommendations include:

- considering a membrane to address water infiltration, through the walls that face soil, and accelerated heavy staining and pipe corrosion.
  - There is step cracking in the CMU walls. Many cracks may be able to be addressed by tuckpointing (re-grouting).

- repairs to concrete spalls in the soffit (ceiling) of the pump room
  - repair/replace interior wall
  - address beams and columns that need to be isolated, painted, or further investigation

- apply membrane to existing sunning deck

- Pump room structural repairs to failing CMU blocks and installation of a groundwater protection system
- Facility safety addressing emergency access, ambulance access, security systems
- Recommend sustainable equipment and features to improve the carbon footprint of the facility
- Replace existing pump room equipment as needed, considering newer energy efficient components
