PUBLIC ARTWORK CONDITION ASSESSMENT CITY OF ROCKVILLE, MD

City of Rockville, City Hall
111 Maryland Avenue
Rockville, MD 20850

Debora Rodrigues
Catherine Hayes
Past Matters, LLC
107 E Montgomery Street
Baltimore, MD

July 2017

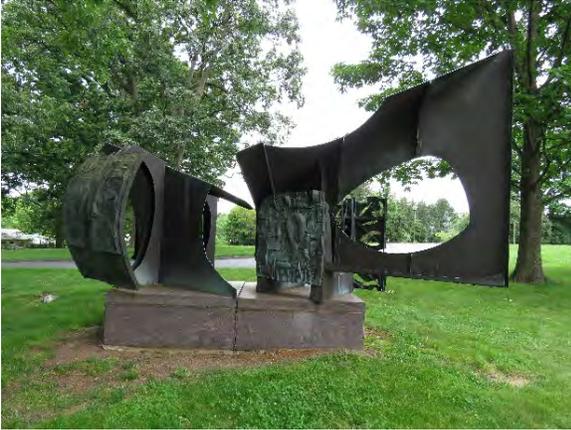
Title: Untitled

- Bird guano and insect nests in several areas.
- Sealant in the joints of the granite base has failed completely, with material losses, allowing the infiltration of water within.

- Damage of granite at corners, with scratches, nicks, and small losses. 17"-long vertical crack and 21"-long diagonal abrasion on the front (northwest) side. Some of this damage could be due to lawnmower strikes.

- Corrosion of the metals is most visible on the reliefs and hardware. They contain concentrated areas of powdery bright green corrosion products, possibly indicative of bronze disease. Flat skyward-facing areas also exhibit light brown staining, possibly from overhanging trees.

- Considerable scratching of the brass, particularly around flat bolt heads.
- Incompatible weld solder has been used to immobilize bolts and nuts, which has promoted galvanic corrosion due to high iron content.

- Lack of positive drainage is promoting corrosion on lower elevations and within recesses of the sculpture.
- Erosion at ground level has exposed the concrete footing for the base.

- Corrosion of mild steel bolts used to anchor the sculpture.
- Copper corrosion from the top is streaking down over the sides of the sculpture, along seams where water is preferentially running.

5. Remove existing sealant from joints of granite base and provide new sealant similar in color to existing, or as approved by the City of Rockville.
6. Inject cracks with a conservation-grade micro-injection grout (Jahn or comparable).

7. Reduce bright green corrosion, especially on bronze reliefs, with pressure washing and Scotch Brite pads. Consider using Renaissance Metal DeCorroder to further reduce corrosion, testing to ensure compatibility and appropriateness.

9. Apply a second coat of wax at ambient temperatures, allow to set, and perform a final buffing to enhance the luster of the protective coating.
10. Replace any deteriorated hardware as needed, preferably with bronze hardware.
11. Consider replacing existing lighting fixtures.

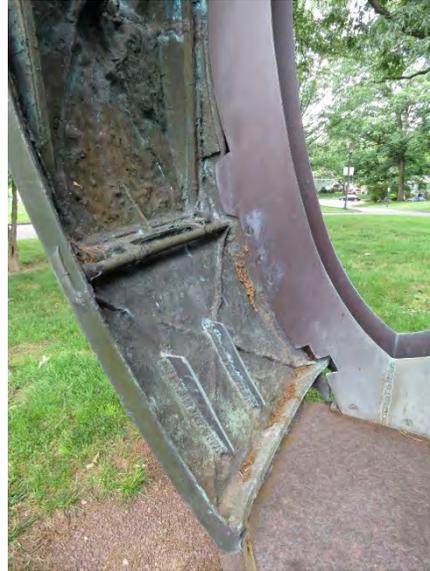
Spots of powdery bright green corrosion, possibly indicative of bronze disease.

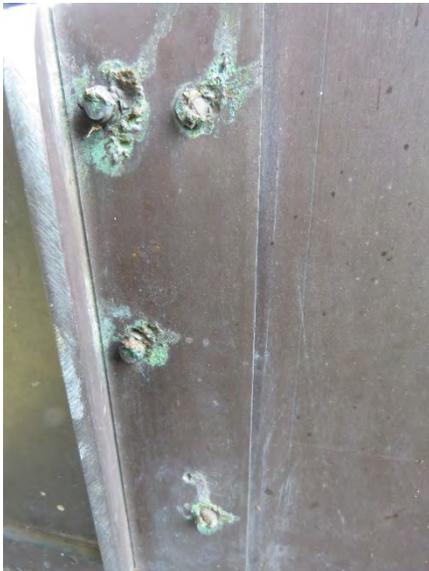
Corrosion around nuts due to improper metal use.

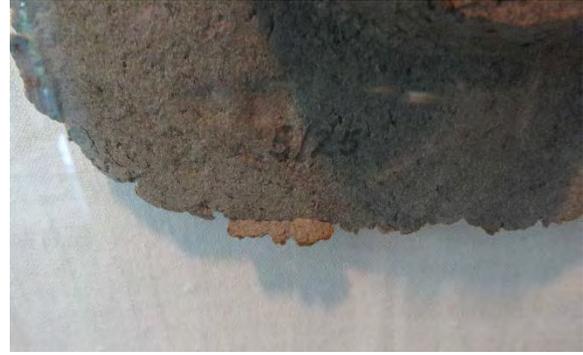
Bending of cast paper at edges, most likely original to the artwork. Note number 5 of 25 pieces produced.

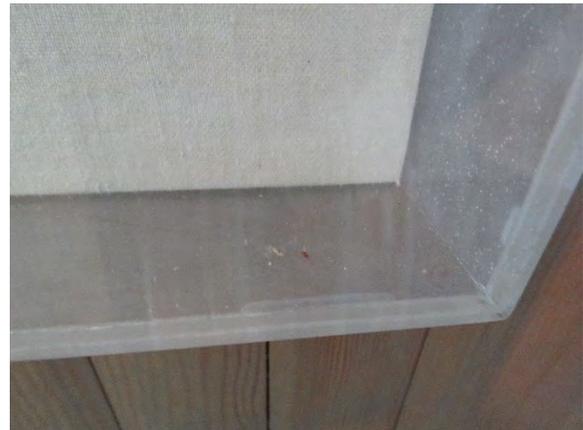
Dust and other debris inside the frame.

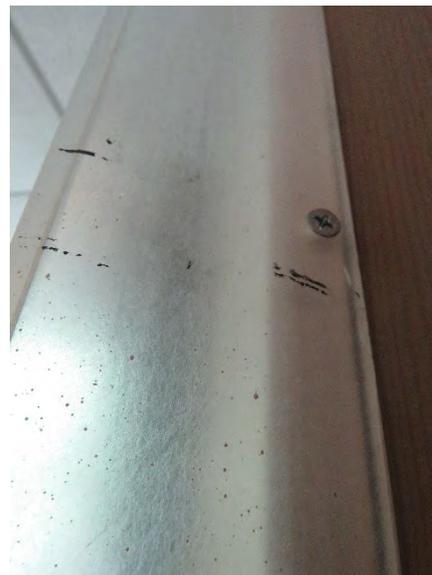
What appear to be paint accretions on the side of the frame. Note the use of frosted Plexiglas for the sides and a phillips screw securing Plexiglas to frame.

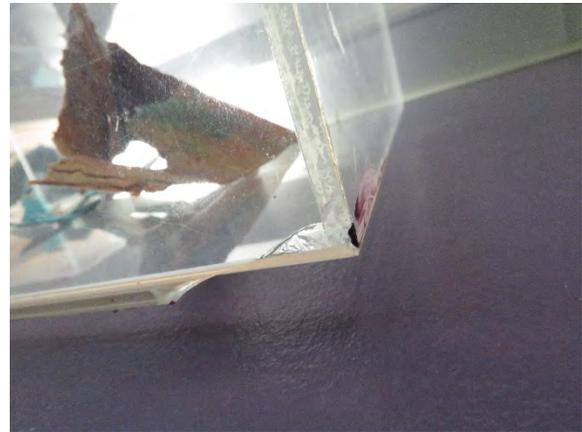
A break in the lower right back corner of the Plexiglas, with what appears to be a paint accretion.

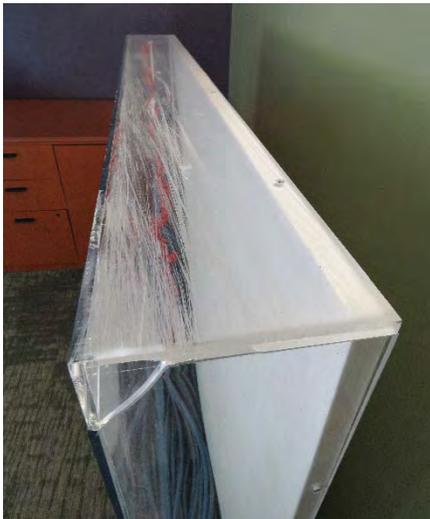
Break in the proper upper left corner of the Plexiglas frame, with multiple linear scratches at the top.

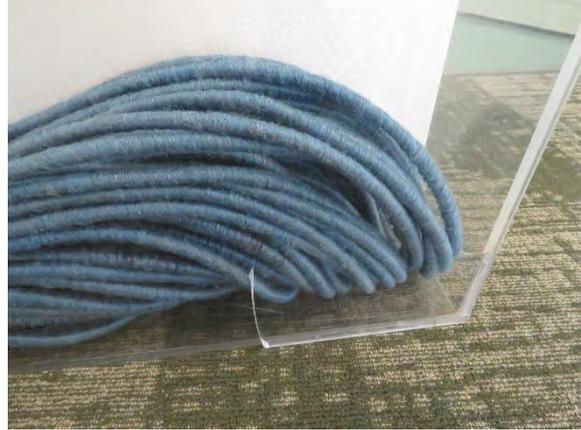
Break in the proper lower left corner of the Plexiglas frame, making it unstable.

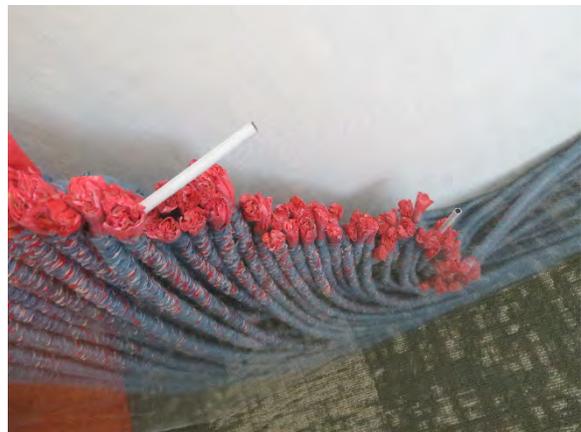
These two tubes have detached from the top of the frame, causing deformation of the artwork.

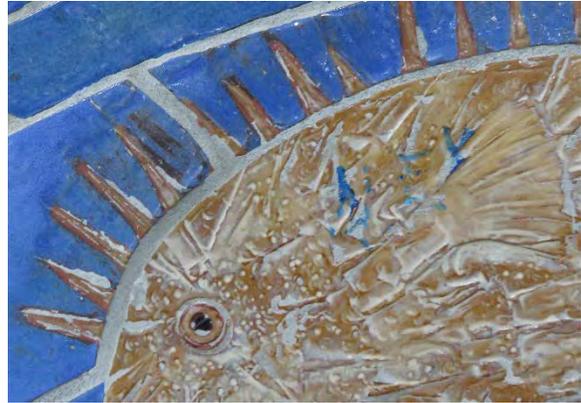
Graffiti tag on puffer fish using blue felt marker.

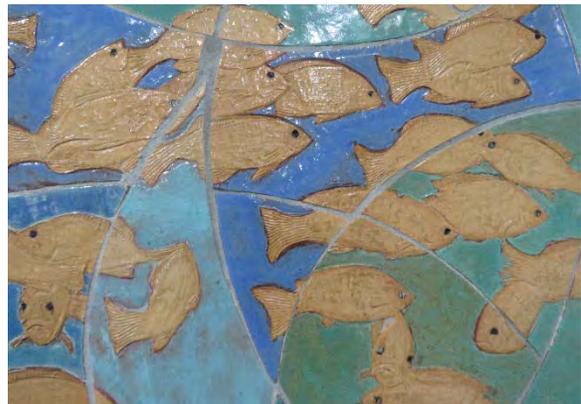
School of fish with minor loss of finishes at eyes.

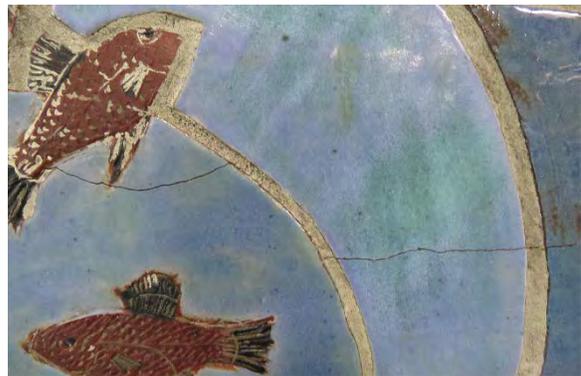
Cracking in ceramic tiles.

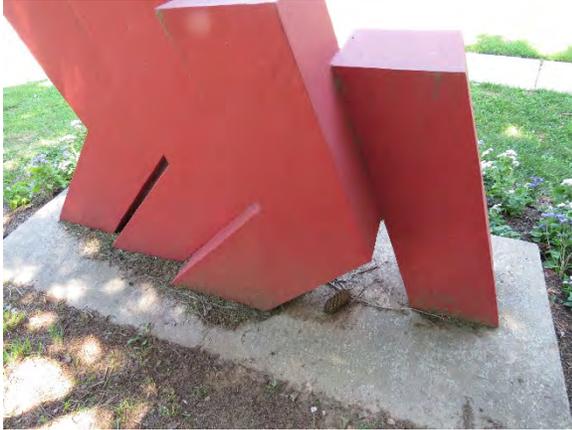
Accumulation of dirt and plant debris on the back side of the sculpture. Capable of retaining moisture, these materials can lead to discoloring and losses to the sculpture.

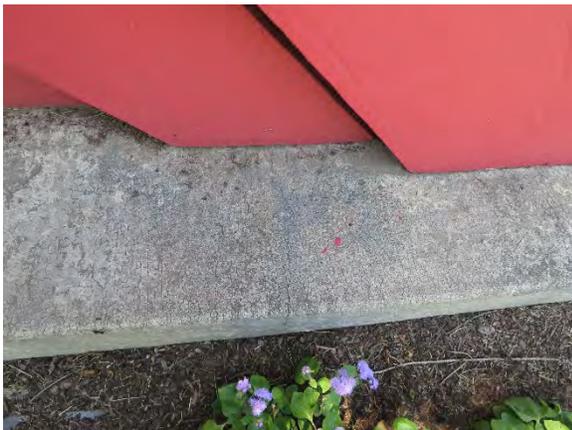
Hairline crack at the top of the base. Note small paint accretion, which is same color as sculpture.

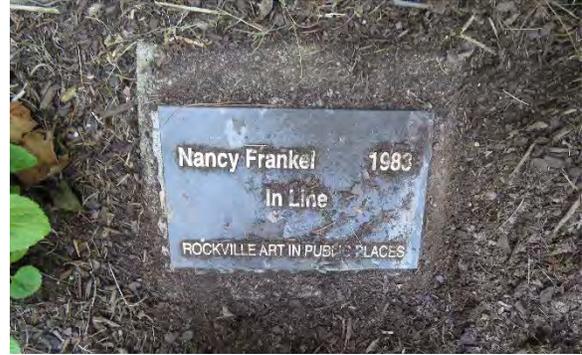
Associated plaque and concrete base found partially covered with surrounding soil and mulch.

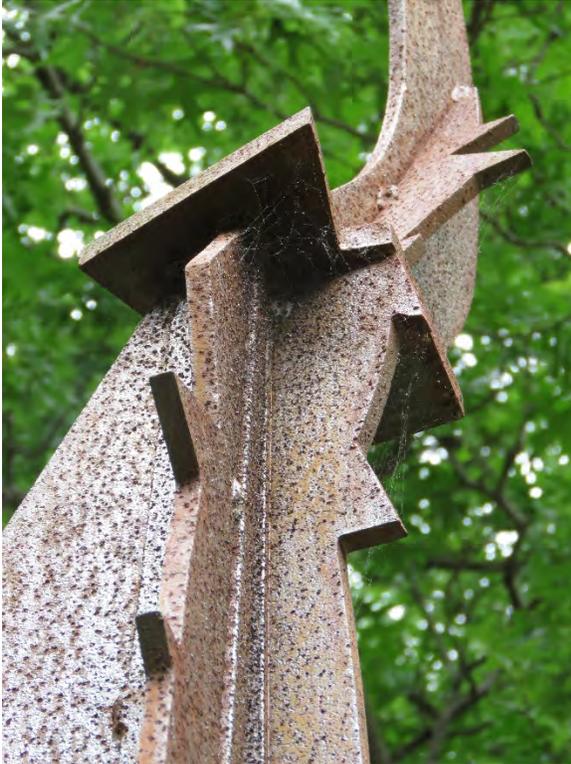
Note regular pitting of steel surfaces due to exterior location, and concentration of cobwebs on the undersides.

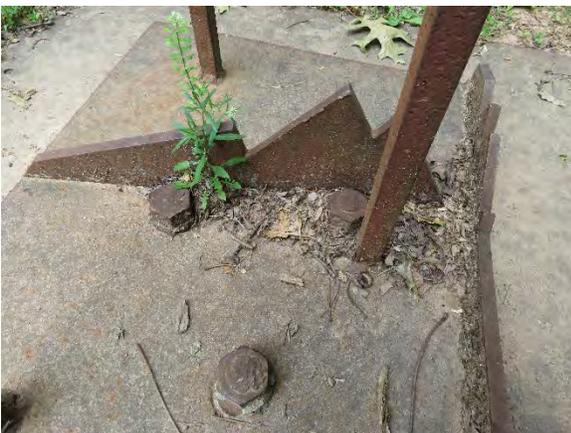
Dirt, sticks, leaves, and other organic matter concentrated at the base of the sculpture. Note heavy soiling promoting plant growth in this area.

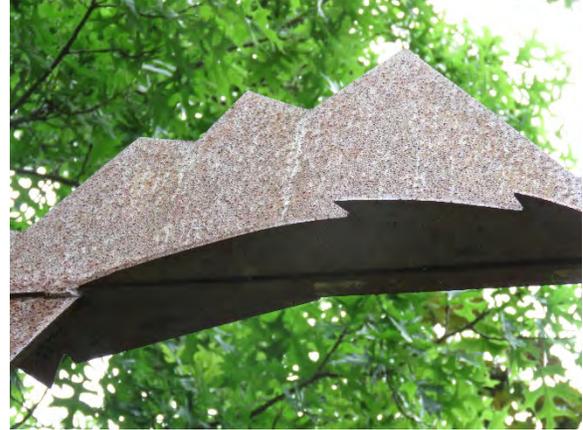
Weathering of the piece is more or less uniform, with some localized drip marks and washing down patterns.

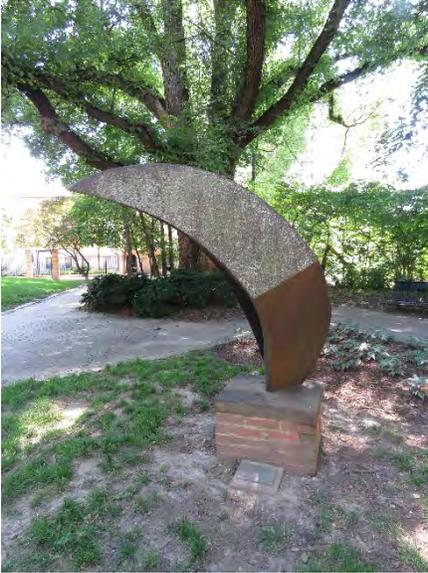
Bronze name plaque mounted on a concrete base. Note small loss at upper left corner, as well as tarnishing and staining.

5. If deemed necessary, treat biological growth with non-toxic, biodegradable D/2 Biological Solution, as needed, testing to ensure compatibility and effectiveness.
6. Remove bird droppings with swabs as needed.
7. Wash associated plaque and base with same detergent solution as above, allow to dry, and apply a thin coat of an appropriate outdoor sculpture wax at ambient temperature. After set, repeat with a second coat as before, buffing to a lustrous finish in between applications.
8. Prune back tree canopy to promote ready drying of the sculpture.
9. Monitor mortar joints. Repointing is not needed at this time.

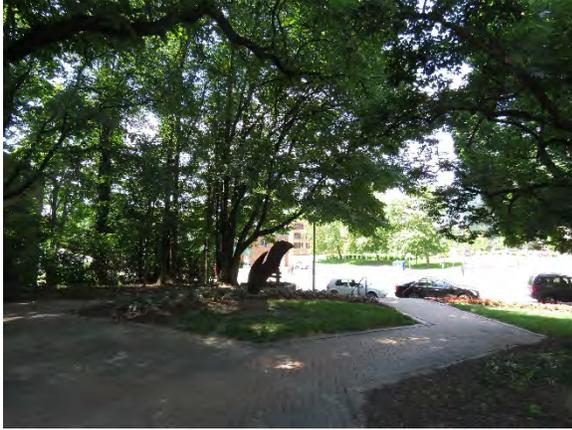
Location of the sculpture at James Monroe Park, in constant shade underneath a canopy of trees.

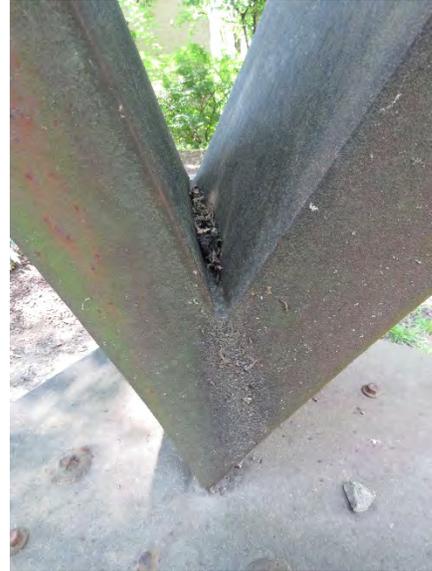
Soiling and accumulation of organic matter on the sculpture.

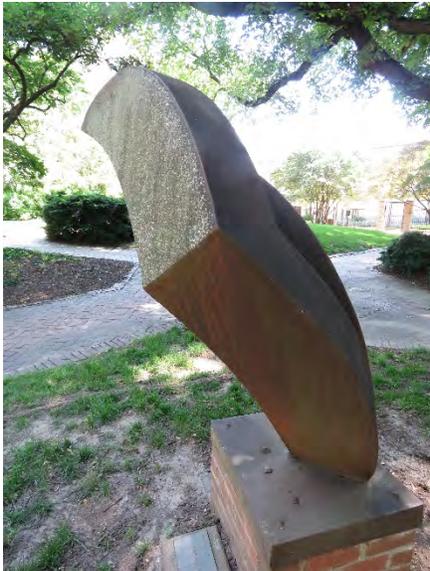
Note streaking caused by biological growth.

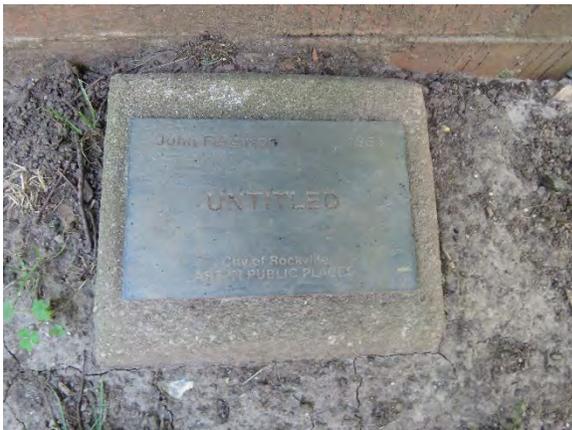
Bronze plaque mounted to a low concrete base, installed in front of the sculpture.

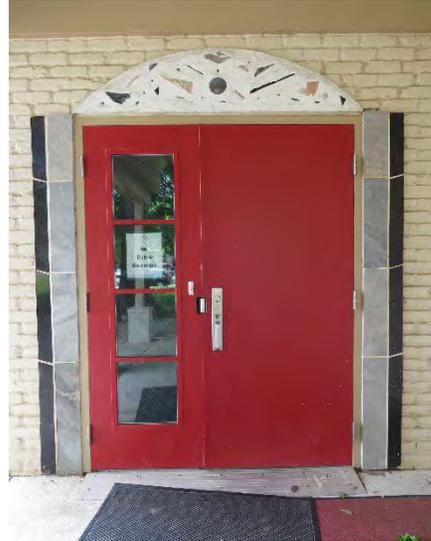
Door surround is of marble and stucco.

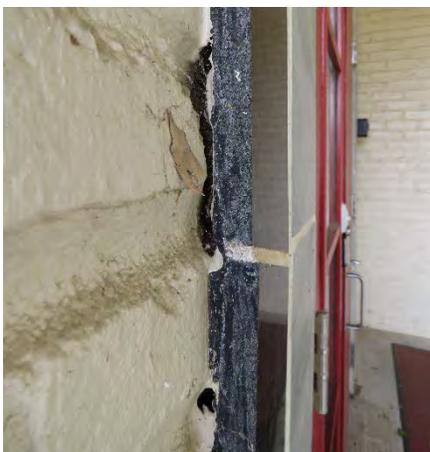
voids behind the marble veneers.

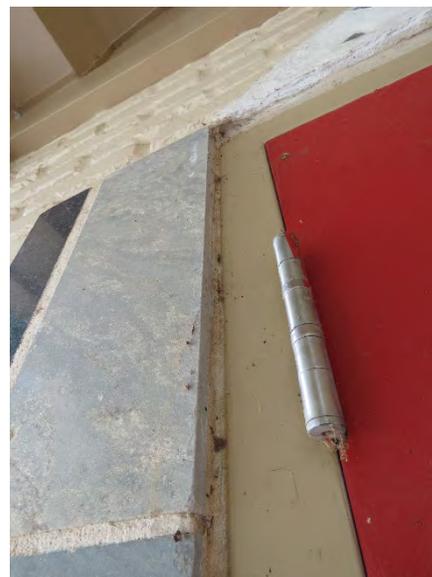
Dust, soiling, and insect activity.

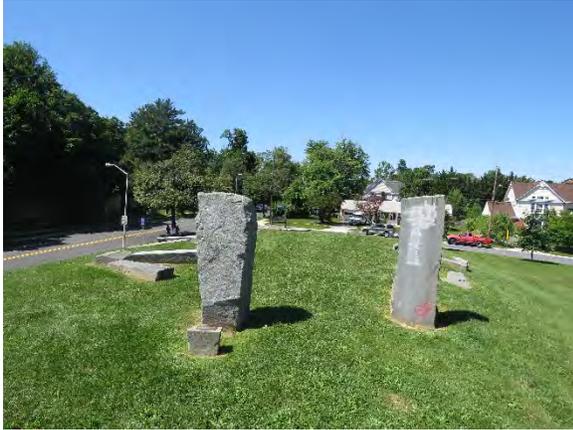
- Many of the blocks have settling cracks, with several having multiple cracks. Some blocks display cracking between bed plains.
- The upright "L" has several painted-on graffiti tags.

The sculptural environment as seen from the northeast. Note the several graffiti tags on the upright “L.”

4. Reduce iron stains by spot cleaning with appropriate chemical, if deemed necessary.
5. Test removal of the graffiti with appropriate solvent, paint stripper, or poultice material. Should none of these products work, use blasting methods such as dry ice, sponge jet, or soda blasting. This should be undertaken by a conservator experienced with these mediums.

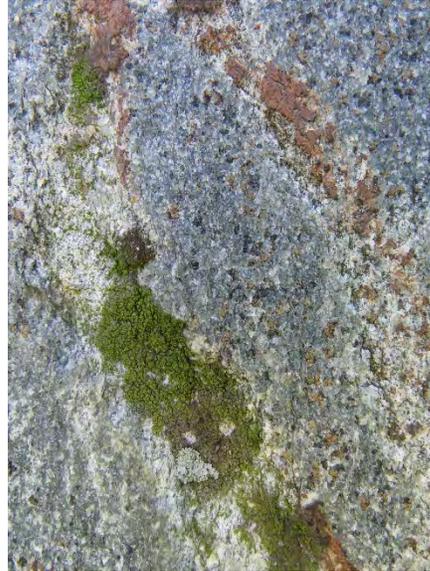
- Overall atmospheric soiling, bird guano, accumulations of organic debris.
- Linear streaks of iron corrosion are present on the tops and sides of many of the blocks. The streaks on the sides are attributable to lawn mower strikes, whereas the streaks on other surfaces may be the result of tools used during installation or quarrying. Other lines and grooves observed on the stone also appear to be due to installation or quarrying.

Iron staining and biological growth on surfaces of the stone.

3. Wash entire sculpture with a dilute solution of pH-neutral, conservation-grade detergent (Orvus WA Paste or comparable) in potable water and rinse thoroughly. Apply biocide such as non-toxic, biodegradable D2 Biological Solution in localized areas, as needed.

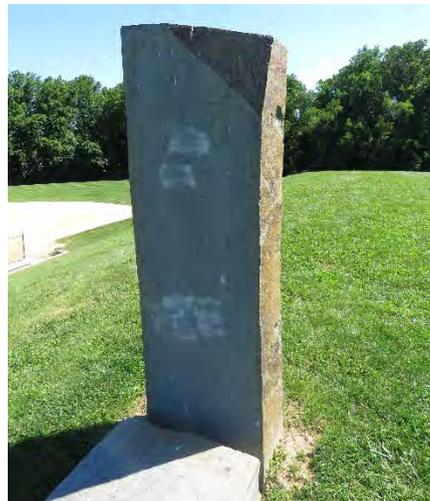
Graffiti tags on the upright “L.”

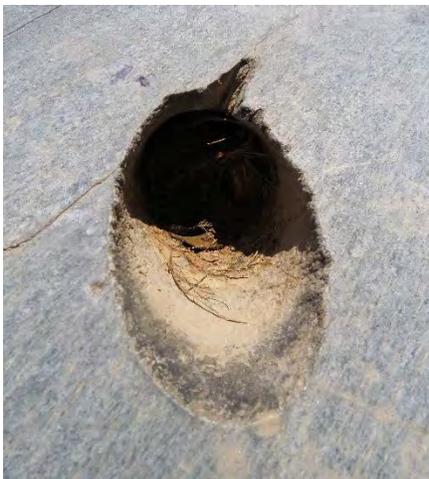
Circular cuts in the stone to facilitate quarrying and installation.

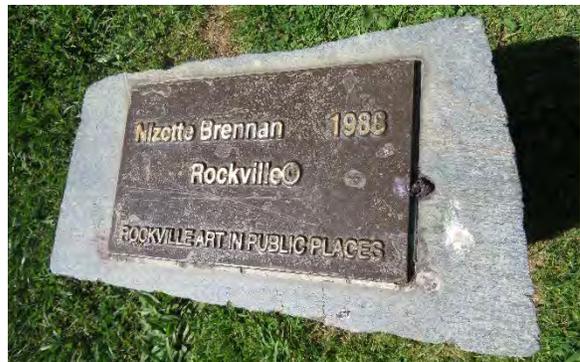
- The plaque has scratches, bird guano, and failing lacquer.
- Many blocks have numerous spalls and losses along their edges and multiple scratches and abrasions on their faces.

Name plaque installed on bluestone base. Note deterioration of lacquer coat.

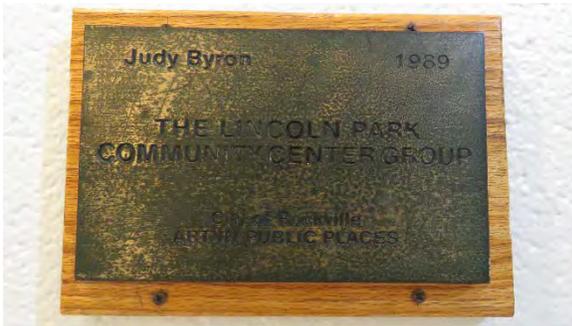
- The pieces are hung crookedly, which give the artwork a slightly unstable appearance.
- There are a few scratches on the glazing.
- Coating on name plaque is deteriorated and bronze is tarnished. There is white paint on the back edges of the wood base, most likely from painting the wall without protecting or removing the plaque.

Name plaque exhibits heavy tarnishing, which is mottling the once polished surface of the bronze.

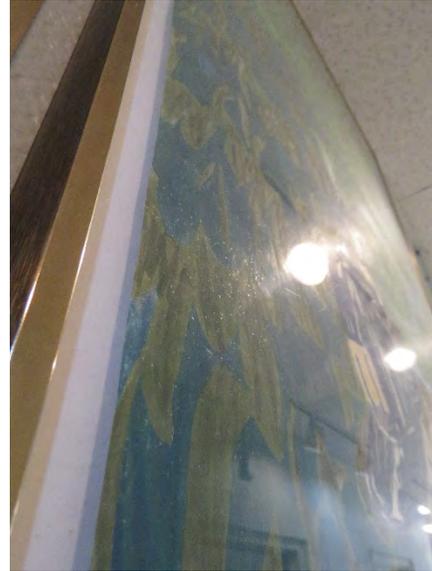
Dust and minor scratches on the surface of the Plexiglas.

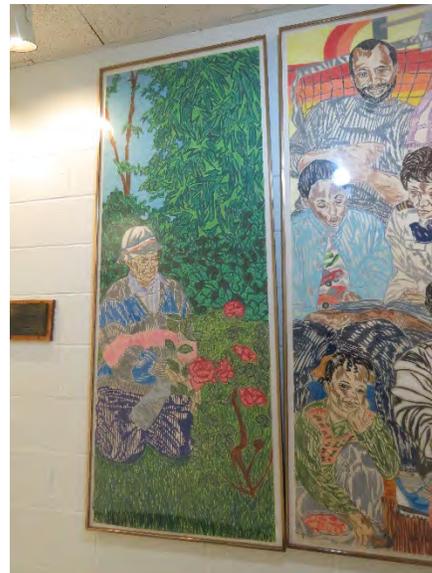
Without felt bumpers on the lower reverse corners, the frames can easily move on the wall when bumped, leading to them hanging out of alignment.

1. Access the artwork with a 6' ladder or smaller step ladder as needed.
2. Remove all three pieces from wall and rehang evenly. Take the opportunity to inspect back side to confirm if the art piece has proper archival-safe backing materials. Replace any inadequate hanging hardware with anti-theft, museum-grade hanging hardware such as link hangers or T-screw security hangers. Use archival, self-adhesive silicone or felt bumpers at the lower back corners.

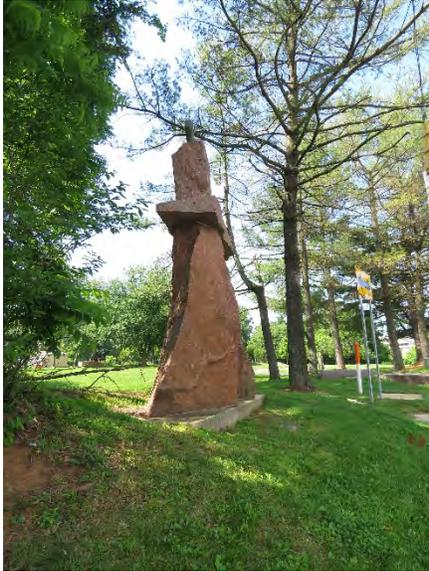
The sculpture is located at the top of a small hill, surrounded on the back side by overhanging trees.

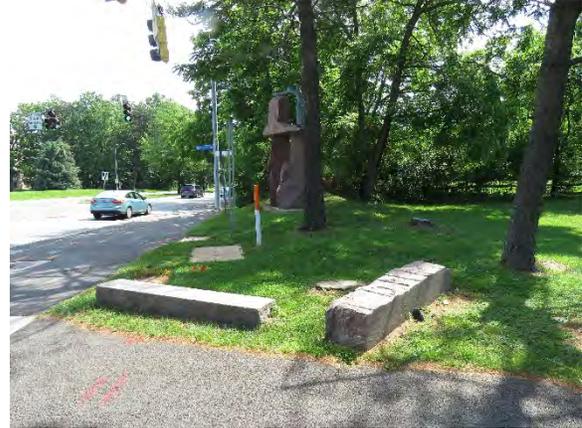
Two low stone benches are west of the main sculptural assembly, next to the footpath into the park.

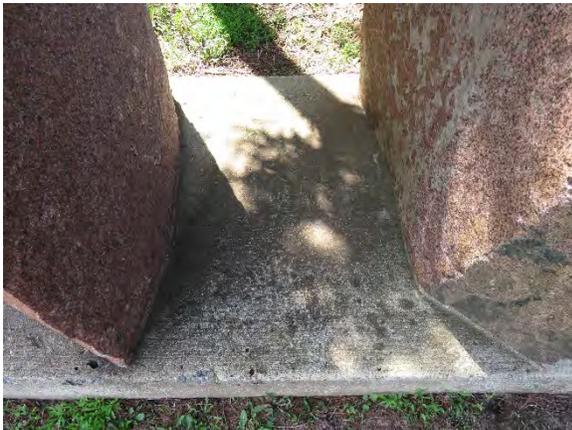
Concentration of atmospheric soiling on the concrete base.

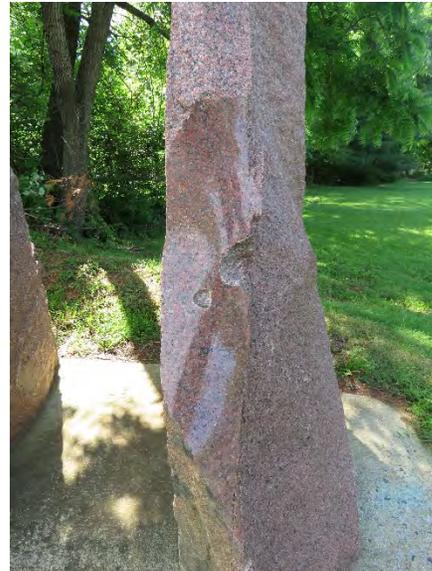
Both polished and unpolished surfaces. Note the small losses at center, which appear to be original to installation.

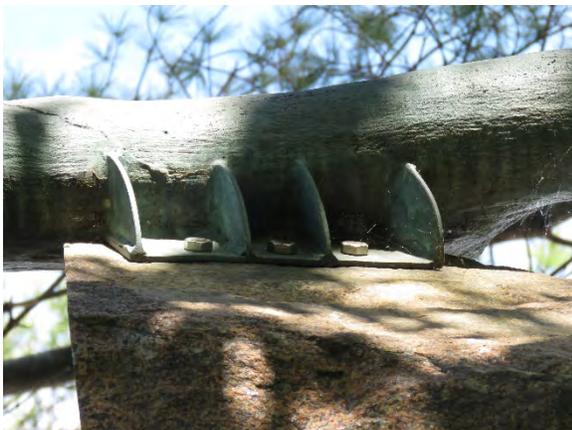
Attachment of the bronze branch to the granite, using three stainless steel bolts.

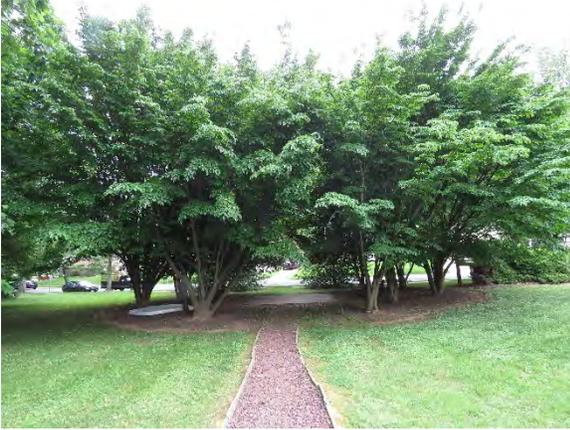
Location of the granite map at Broome Athletic Park, surrounded by trees on all sides.

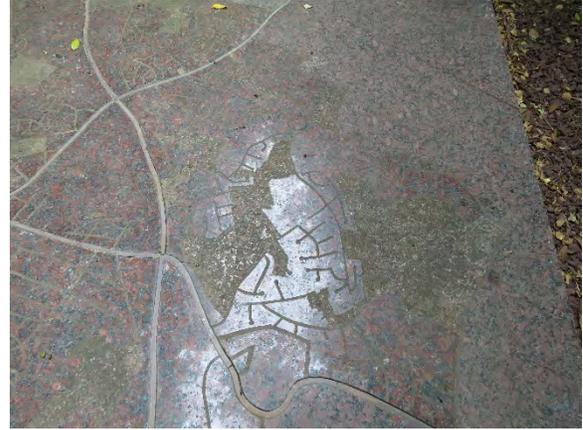
Various finishes were used to vary the surface of the granite, as seen above. Polished surfaces are now dulled.

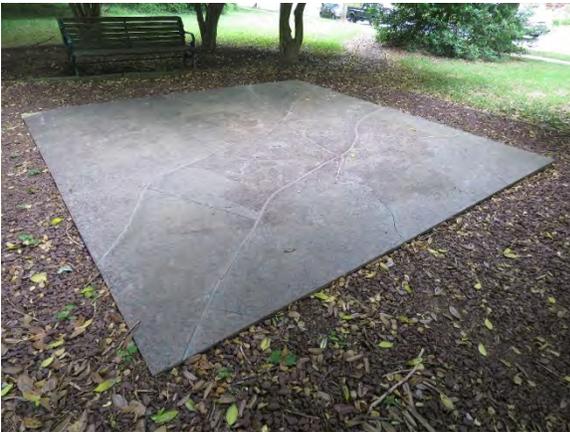
The 12'-square map is installed on a poured concrete foundation.

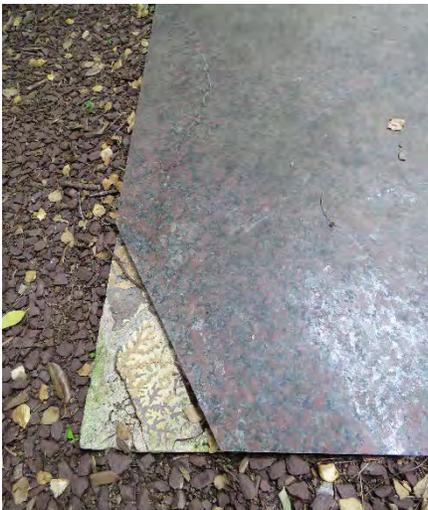
Large triangular-shaped loss at proper right (or east) corner.

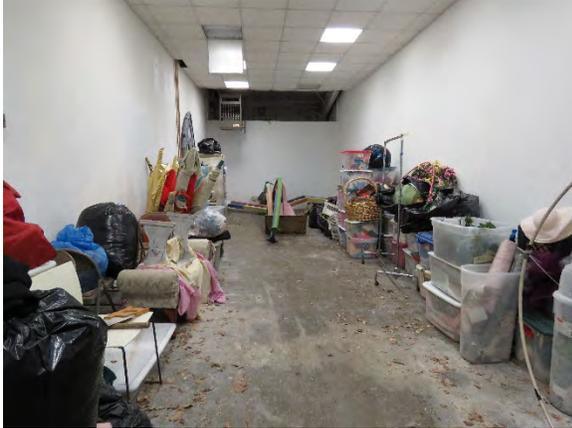
The artwork was de-installed and is stored inside a storage unit, piled directly on the concrete floor without any cushioning or protection.

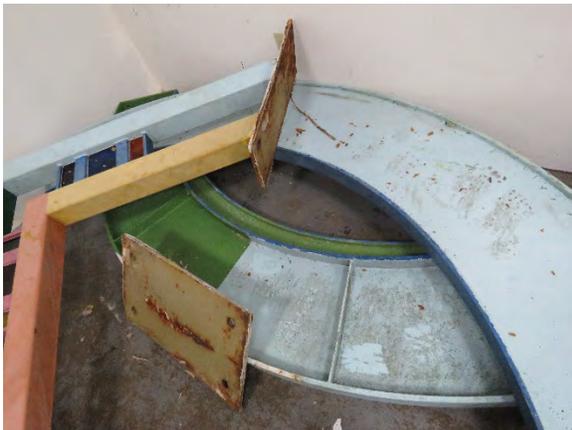
Heavy soiling on surfaces, with accretions and staining. Note corrosion of base plates.

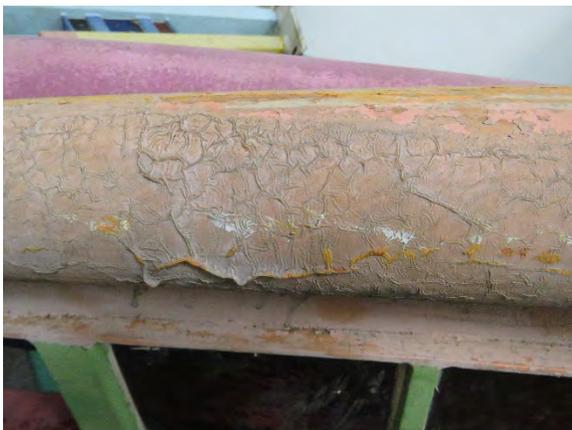
Wrinkle pattern of non-original paint layer, due to heavy application.

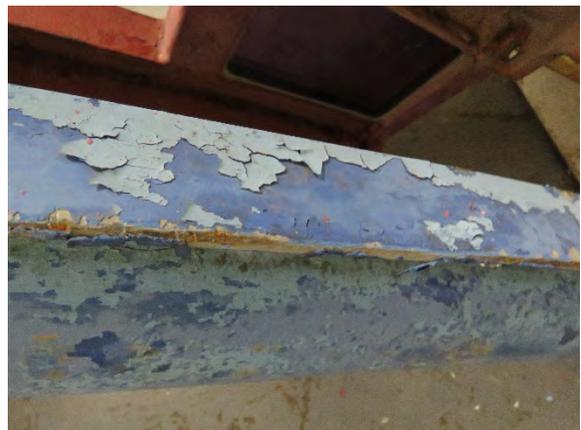
Actively flaking paint, with significant losses.

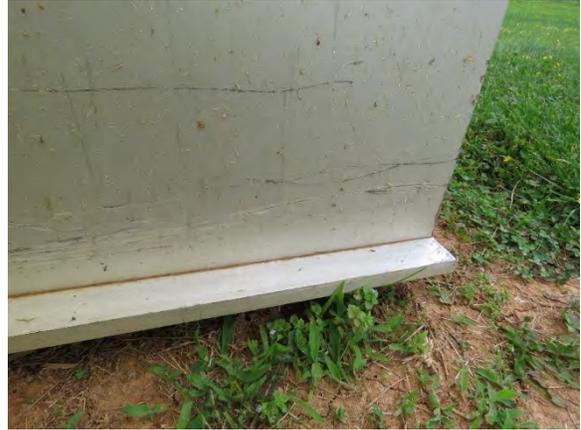
Linear abrasions and scratches on aluminum, with nicks at edges.

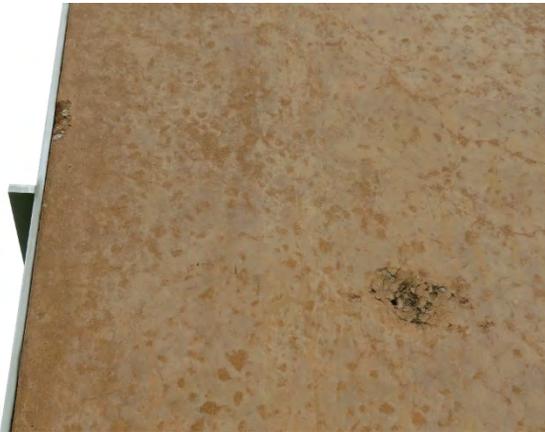
Typical of losses observed on the concrete.

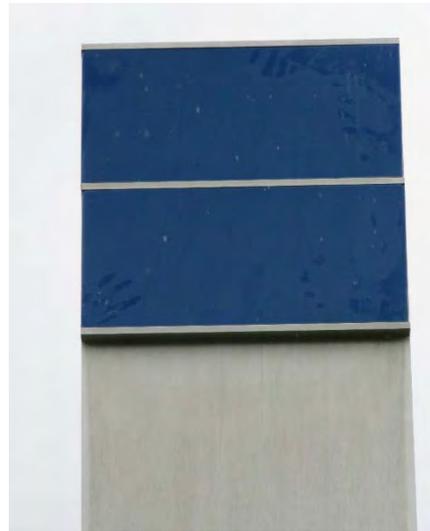
Fingerprints on Lucite plates.

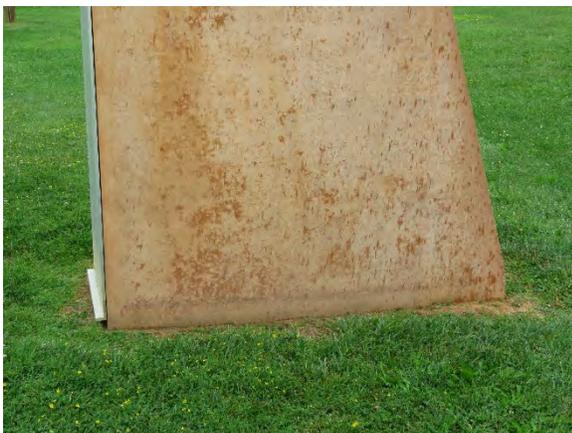
Linear abrasions and scratches at base, most likely due to lawnmower activity.

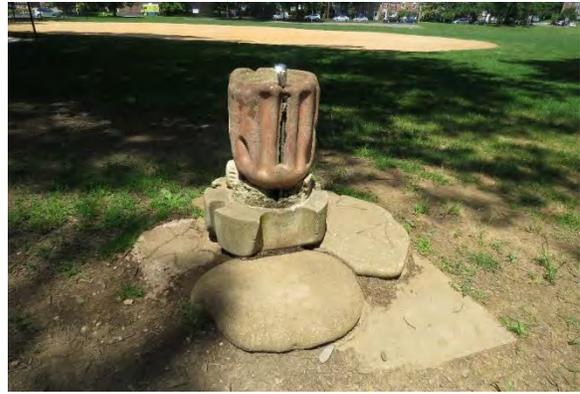
Water fountain, with loss of concrete on the body and base of the fountain. Biological growth can also be observed on the sides.

5. Apply biocide such as non-toxic, biodegradable D2 Biological Solution in localized areas, as needed.
6. Consider inspecting drinking fountain to ensure it is operational and that the plumbing is adequate according to local codes. Make any necessary repairs to plumbing.

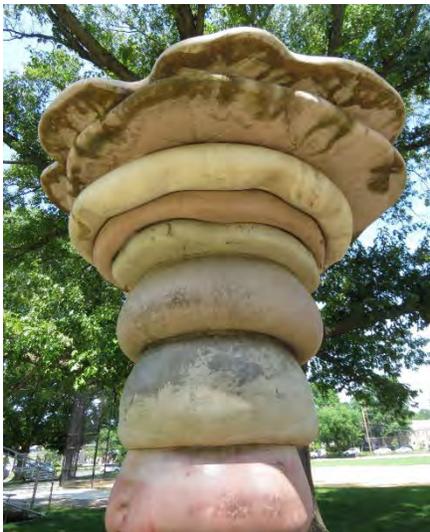
- Staining, mostly concentrated on the undersides of the mushroom caps on the columns. The staining appears to be attributable to biological growth and concentrated atmospheric soiling from water run-off.

Loss of finishes and staining, the latter concentrated on the undersides of the mushroom caps and partly attributable to rain runoff. Some of this staining appears to be biological growth.

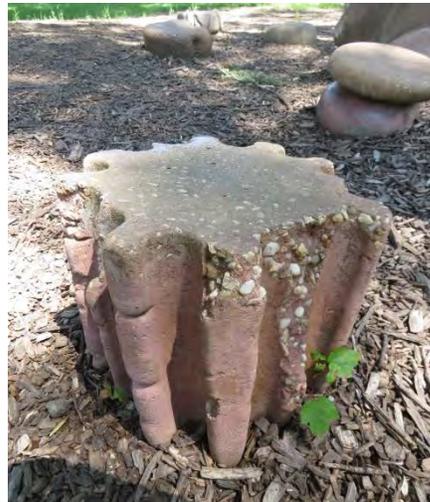
Loss of concrete at sides, with exposed aggregate. Note fading of finishes, with loss on the skyward-facing surface.

7. Reinstall displaced components on bases with new pins according to their original location, and as directed by the structural engineer's report. Patch losses in concrete with Jahn Restoration Mortars or comparable and refinish with artist recommended finishes. Touch up all finishes in original color scheme.

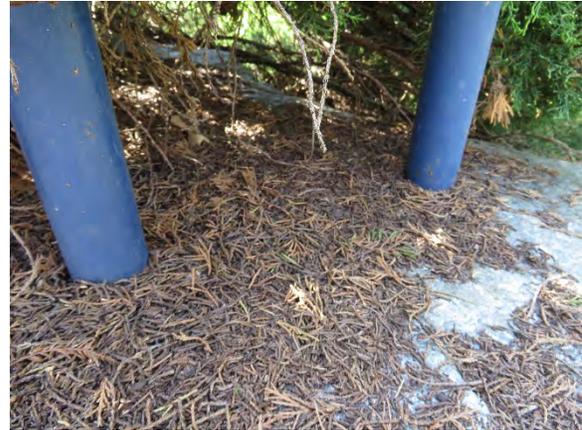
Accumulation of plant debris at base of sculpture.

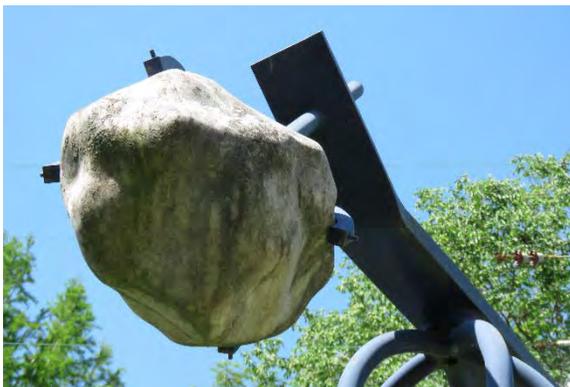
Pink granite at the end of the arm, heavily soiled with biological growth.

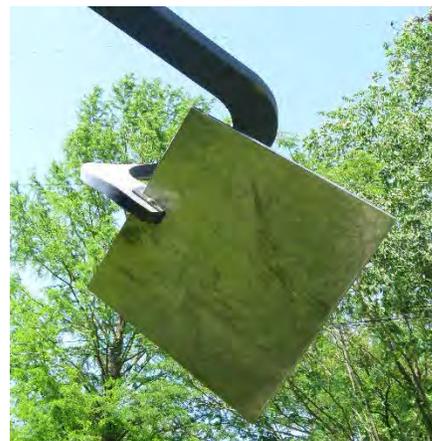
Stainless steel plate, with what appears to be localized staining and minor corrosion.

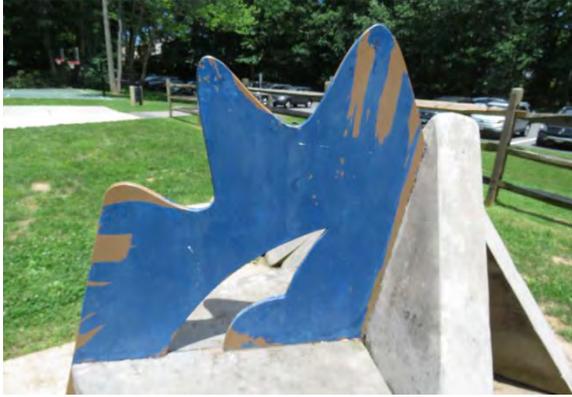
No information on any previous treatment. It is unclear why the dragon’s head has two different paint colors, and whether it was part of some previous repair. Although it appears that blue is the original color, discussions with the artist or analysis will determine the appropriate color to use for repainting.

Metal component on the dragon's head, exhibiting two colors; much of the brown overpaint has flaked away.

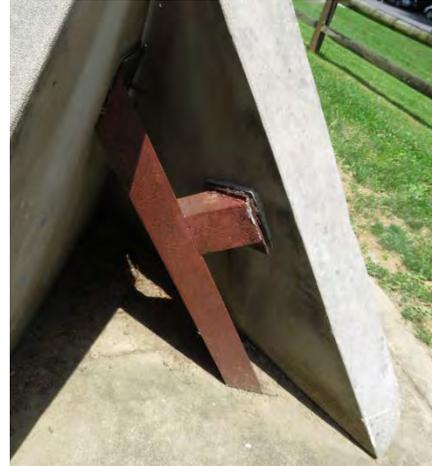
Corrosion of the steel support bracket due to loss of paint, with heavier concentrations at brace points where water enters.

1. Remove all accumulations of dirt and debris from sculpture by sweeping away with soft bristle brushes.
2. Wash entire sculpture with a dilute solution of pH-neutral, conservation-grade detergent (Orvus WA Paste or comparable) in potable water and rinse thoroughly. Apply biocide such as non-toxic, biodegradable D2 Biological Solution in localized areas, as needed.
3. Repaint artwork according to the artist’s specifications using a superior grade of exterior paint and primer, such as Tnemec, following manufacturer’s recommendations. As needed, fill loss in steel with an appropriate conservation-grade epoxy material. If possible, the support bracket should be de-installed for

corrosion removal and painting, and then reset. During reinstallation, all seams should be caulked to prevent water from getting trapped within brace points. The tail may require replacement of steel sections.

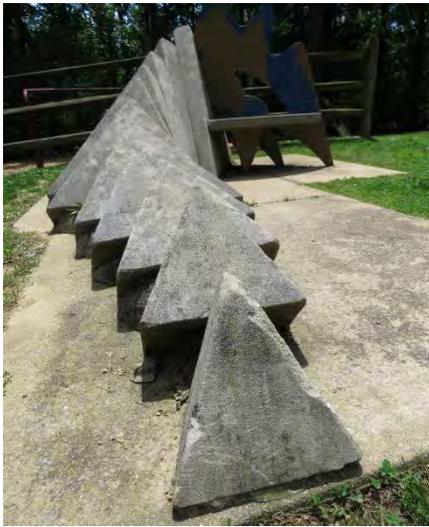
Counterbalanced limestone pieces, with heavy staining, biological growth, scratches and abrasions, and loss of material.

4. Provide Type N mortar for limestone triangles at dragon’s head, as needed, blending to match with existing. Patch stone in areas of loss, where appropriate, using Jahn Restoration mortars or comparable.
5. Remove existing deteriorated caulk and re-caulk artwork with appropriate caulking material.
6. Regrade area to encourage positive drainage and arrest washing of soils onto sculpture components.
7. If skateboarding activity for the benches increases, consider installing skateboard stoppers.
8. Monitor stars for any additional damage.

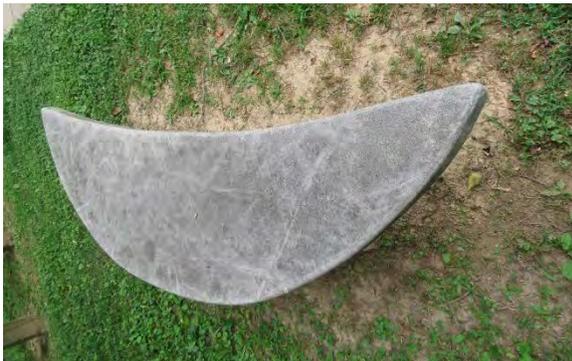
- Deteriorated caulking material in seams where the limestone seat and back rest on the dragon's head meet the metal components.
- Benches have heavy scratches/abrasions on skyward-facing surfaces of the limestone seats, possibly due to skateboarding or other activity.

One of two benches, both of which exhibit general soiling, with scratches and abrasions of the limestone seats and deterioration of finishes on the painted steel legs, with corrosion of the exposed metal.

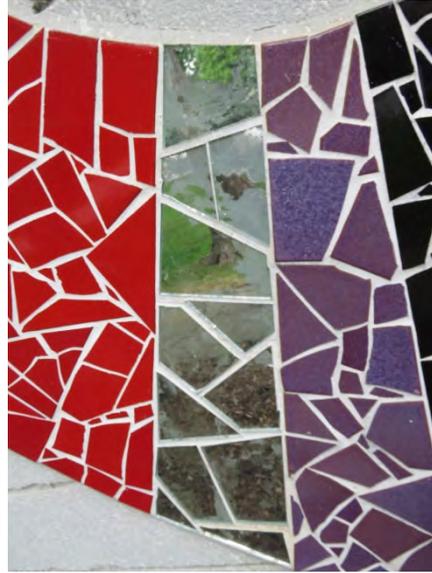
Typical of silvering out on glass tiles.

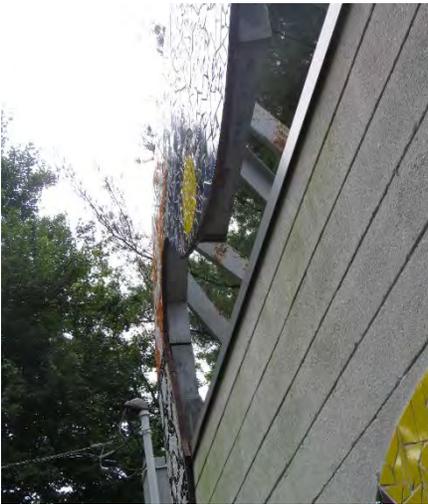
Deterioration of paint finishes can be observed on metal and wood elements. Corrosion of exposed metal and open joints between wood support bracing is also noted.

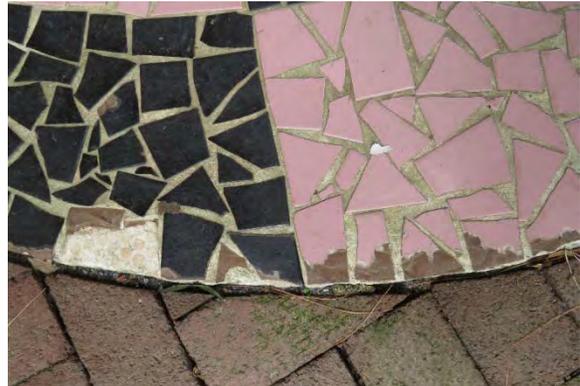
Typical of damage on tiles installed on horizontal surfaces, with losses at edges and deterioration of border sealant.

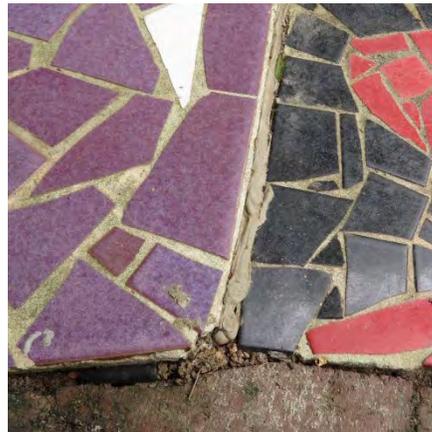
Displacement of tiles at pavers, with loss of caulk at edge.

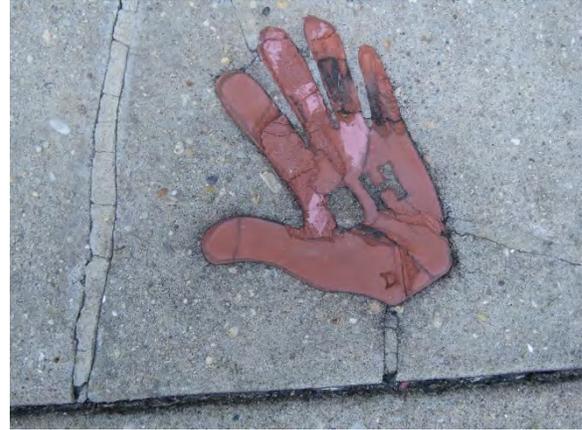
Cracks in a handprint with loss of glazing and tile and pink paint accretions.

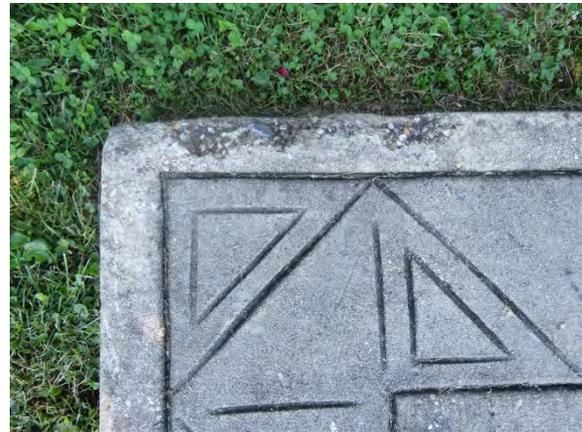
Losses at edges of plaza area, possibly due to lawnmower strikes.

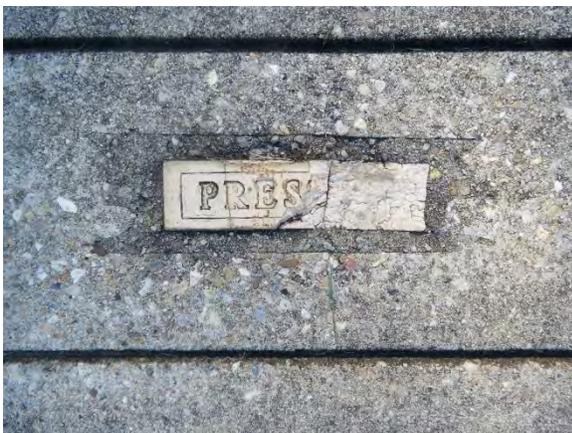
Typical loss of tiles incised with words.

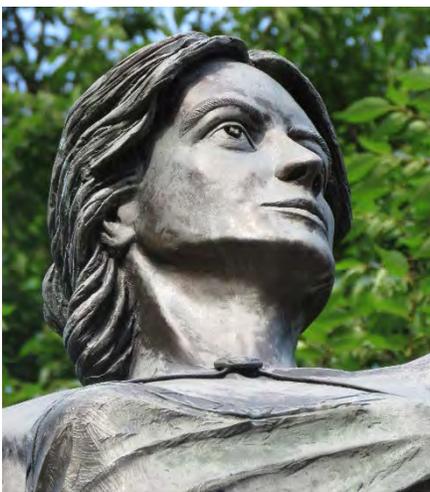
Evidence of a deteriorated protective coating can be observed on the figure.

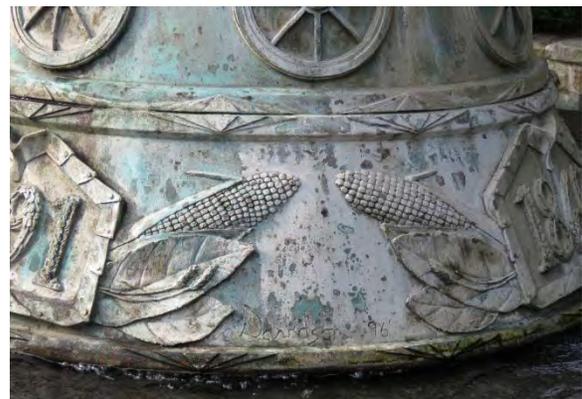
Significant blue green corrosion with heavy layer of mineral deposits.

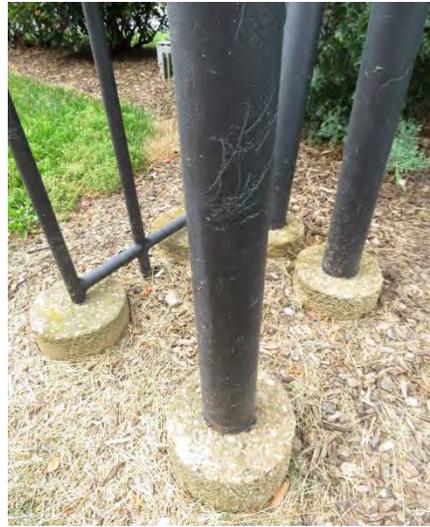
Pronounced scratches on the post (foreground); mulch beginning to cover bases and arch components (background).

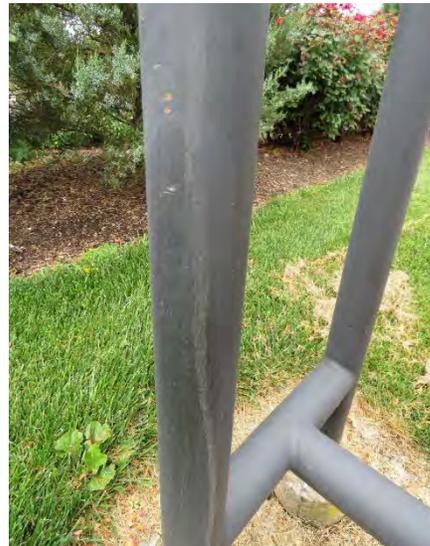
Dull, weathered paint with minor scratches and exposed foundation from soil erosion.

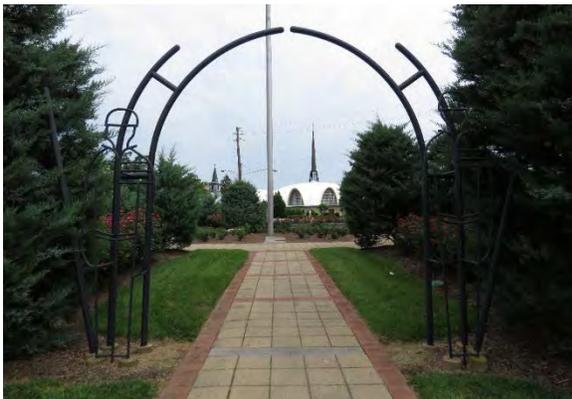
Small chips in the paint, exposing underlying steel. Note streaking from rainwater effluent.

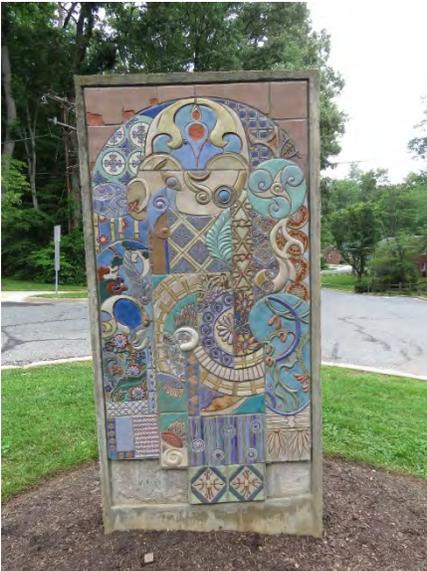
- Some of the losses in the surfaces of the tiles appear to be due to freeze/thaw cycles.
- Minute white efflorescence crystals are noted on the mauve tiles in areas of loss. While the efflorescence is minimal, it can contribute to losses.

Tile breakage and loss with associated efflorescence due to water ingress behind glaze.

3. Stabilize areas of friable ceramic with a solution of B-72 in solvent, applying to surfaces with a fine brush until it is no longer absorbed. Use same solution to inject cracks.

4. Infill losses using an appropriate fill material such as Superfine White Milliput, sculpting by hand or with the aid of stainless steel sculpting and carving tools to match the profile of adjacent surfaces. After cure, lightly sand with fine-grit sandpaper and in-paint with acrylic paints such as Golden Artist Colors, mixed with Golden Polymer Medium to adjust gloss and mimic the surrounding glaze.

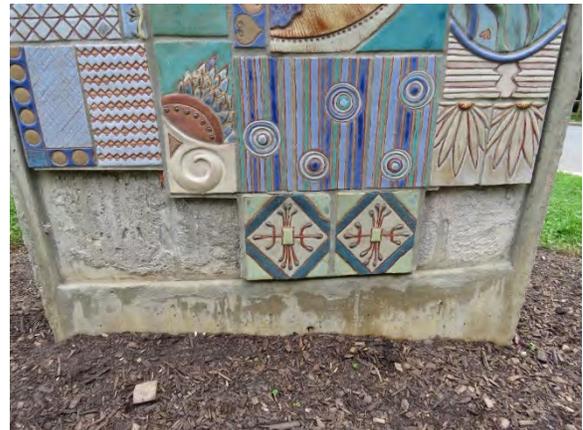
West side of artwork.

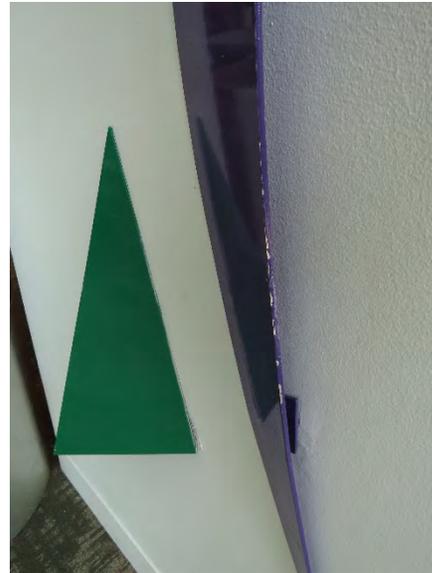
- Vertical purple wavy line at the north entrance does not appear to be well secured to the wall. The mounting screws are starting to pull away from the wall, perhaps due to the weight of the piece. On the south side, the purple wavy line exhibits similar conditions, as does other artwork components, indicating the mount screws and anchors used throughout might be inappropriate.

Wall relief at the north entrance. The purple vertical squiggly line appears to be slightly unstable.

7. Consider replacing mounting screws and anchors for the wall reliefs. Discussions will be needed with the artist and City of Rockville. If mounting screws are found to be adequate, tighten loosened screws.
