PUBLIC ARTWORK CONDITION ASSESSMENT CITY OF ROCKVILLE, MD

City of Rockville, City Hall
111 Maryland Avenue
Rockville, MD 20850

Debora Rodrigues
Catherine Hayes
Past Matters, LLC
107 E Montgomery Street
Baltimore, MD

July 2017

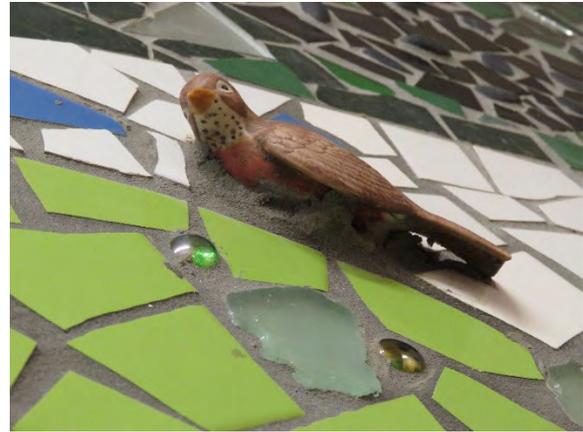
Loss of grout at tile joint.

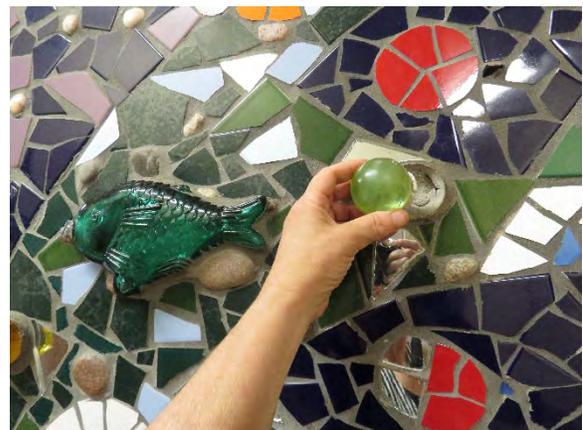
An unstable fungus insert, which is partially detaching from the mural, with some losses.

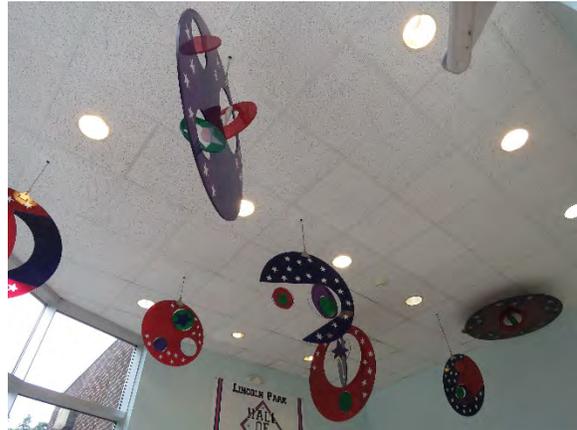
Stainless steel cables appear sound, but are covered with dust.

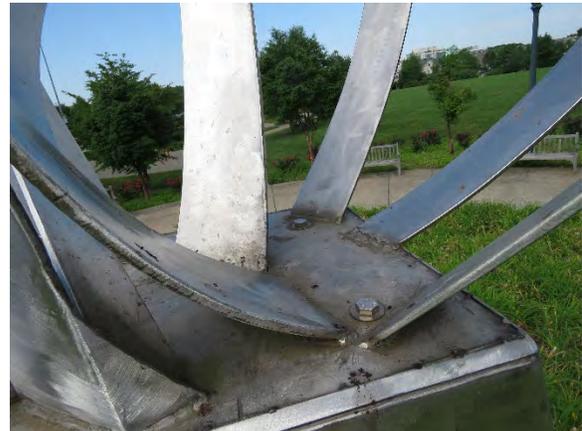
Accumulation of dirt where the metal strips meet the base, with observable bird guano.

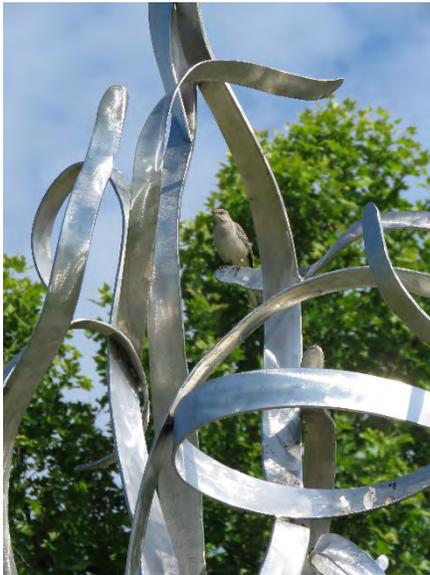
Birds regularly perch on the sculpture.

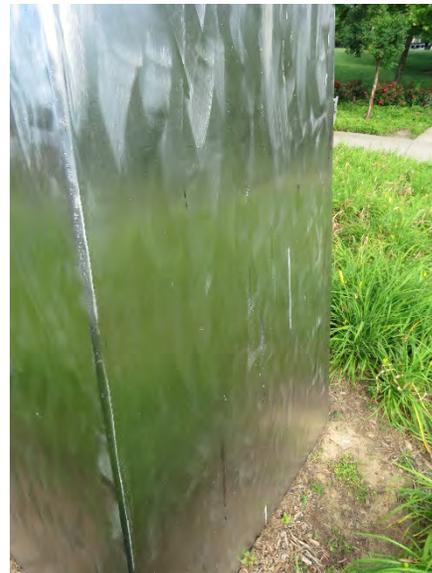
Bird guano down the side of the base. Note the encroachment of plants.

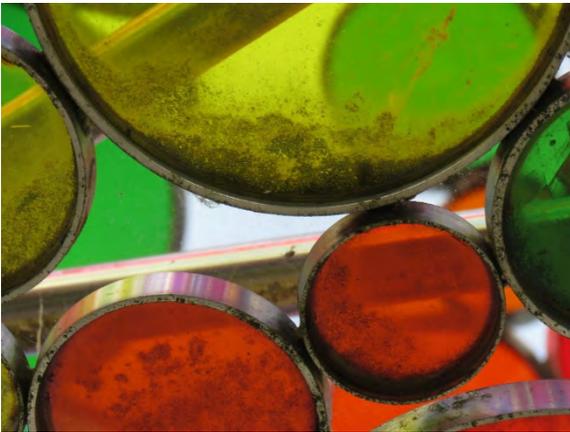
- At least two missing pieces of colored glass. There also appears to be some cracks in the glass.
- Accumulation of dirt and other atmospheric pollutants on the glass, most notable on interior horizontal surfaces.

Heavy accumulations of dirt on glass surfaces.

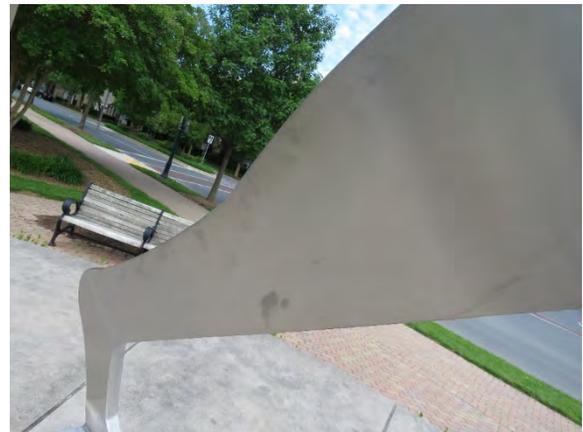
Fingerprints from people touching the artwork.

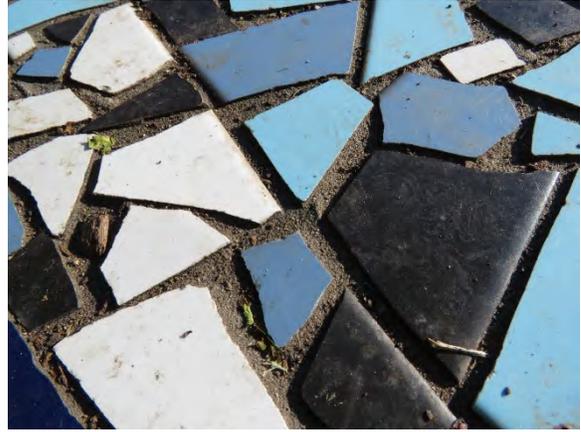
Soiling from dirt and footprints.

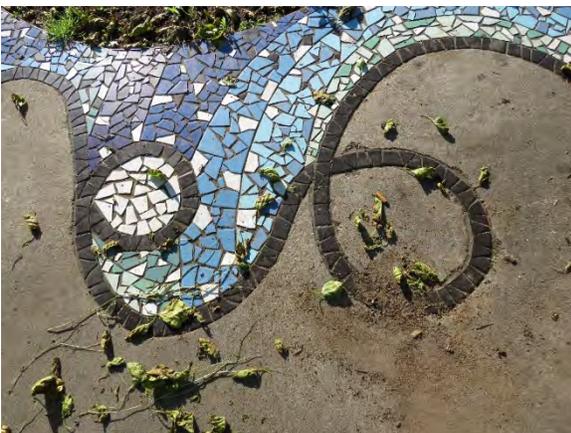
Collection of garden soil and leaf debris covering the mosaic.

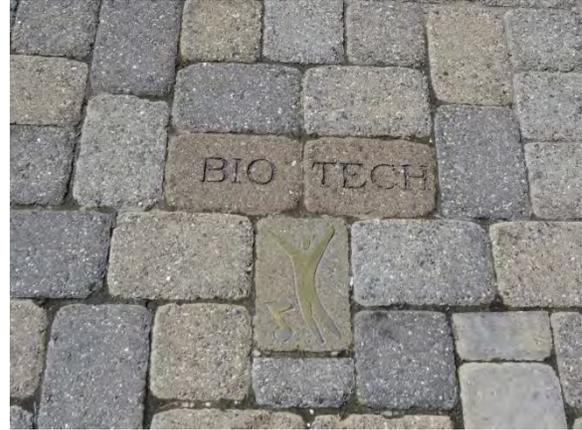
Text paver next to a paver with a brass inlay. Note slight tarnishing and minor corrosion of brass.

3. Remove gum accretions with non-abrasive probes and solvent as needed.
4. Reduce corrosion on the bronze elements with Scotch Brite pads, rinsing well during the process. Apply two coats of an appropriate outdoor sculpture wax at ambient temperature, allow each coat to set, and buff to a soft sheen in between applications.
5. Re-stain select pavers with black concrete stain to match existing.
6. Repoint compass rose in areas of loss.

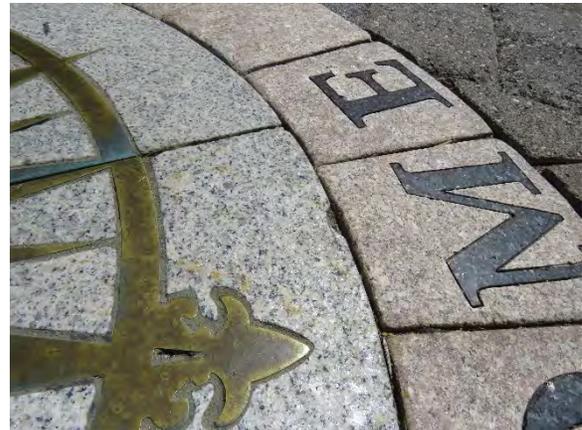
Close-up view of the compass rose with inlaid brass and black granite. The brass exhibits tarnishing and minor corrosion.

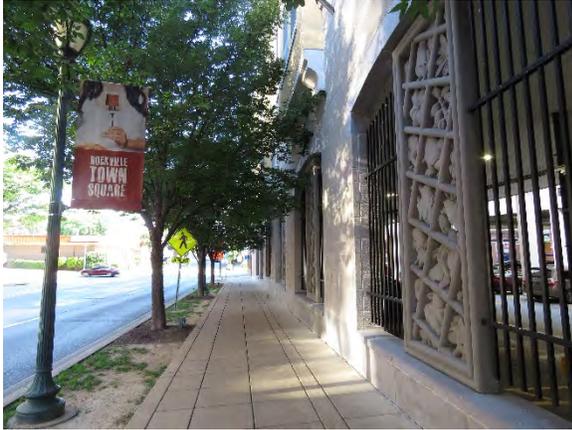
Sidewalk view of artwork. Slope of sidewalk towards the street appears to create positive water drainage.

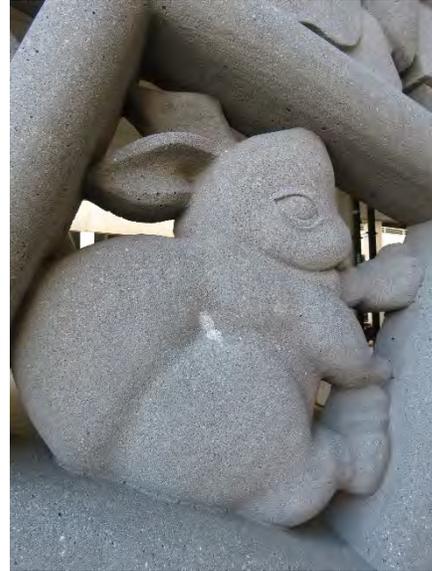
Close-up of atmospheric soiling and bird dropping.

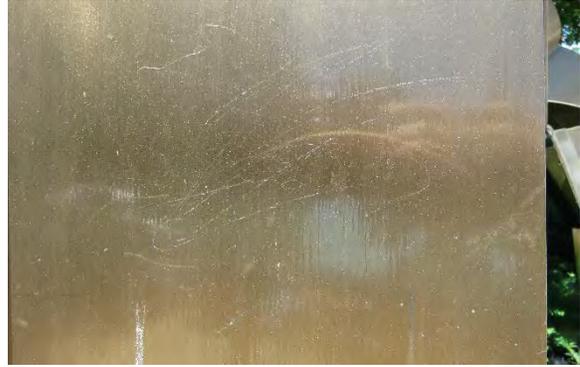
Scratches from public interaction.

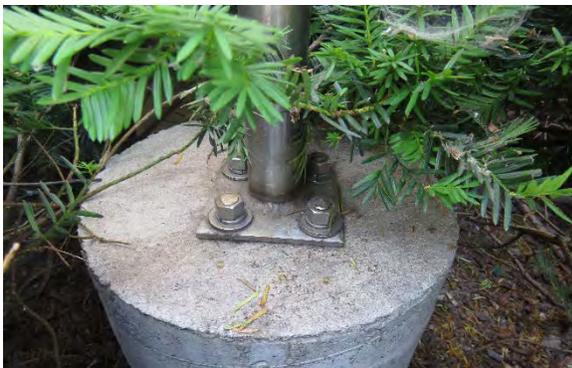
Concrete base/footing with mounted stainless steel post. Note minor brown discoloration of post due to corrosion.

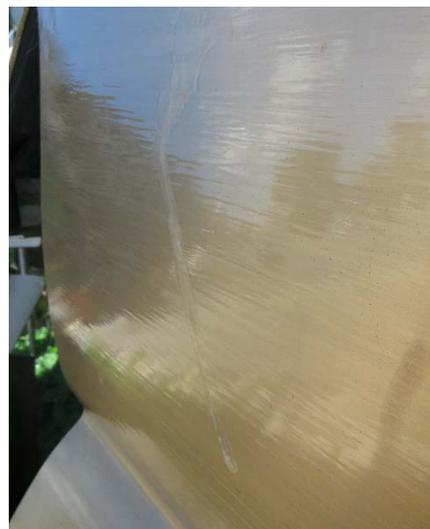
Etched coating from bird dropping. Note the brush-applied lacquer coating.

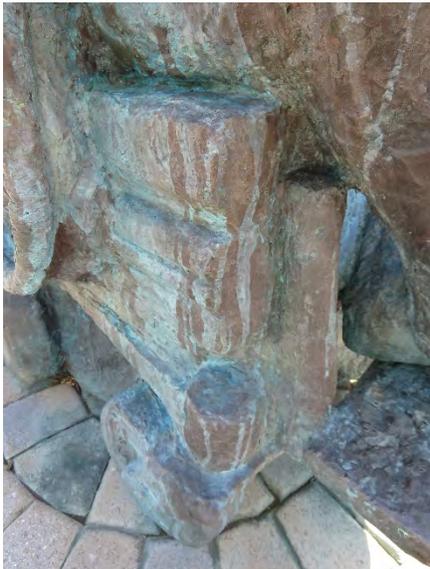
Washing down pattern of the corrosion.

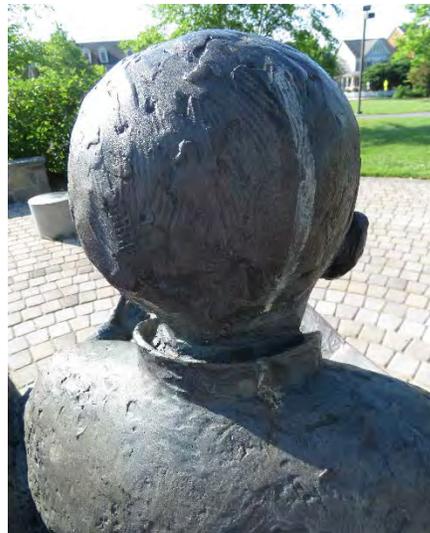
Bird guano dripping down the back side of the boy's head, onto his shoulder and back.

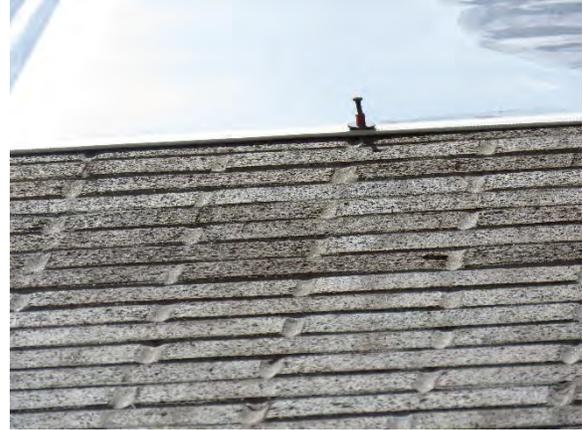
Close-up of masonry nail and washer.

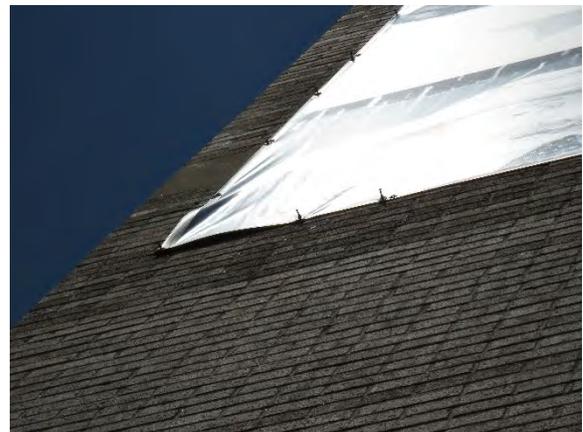
Buckling and rippling in the vinyl is most severe at the low left corner.

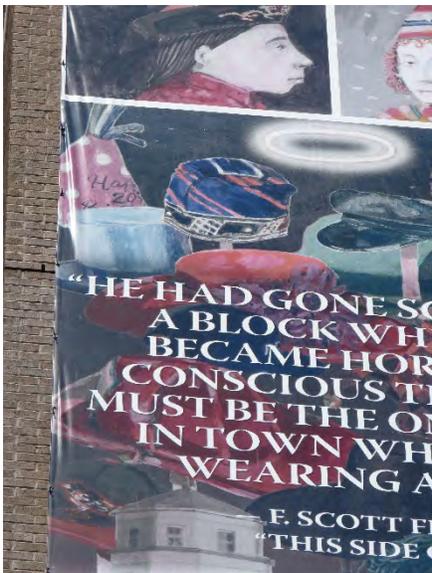
Close-up view showing ripples along edges from uneven tension created at the time of nail insertion.

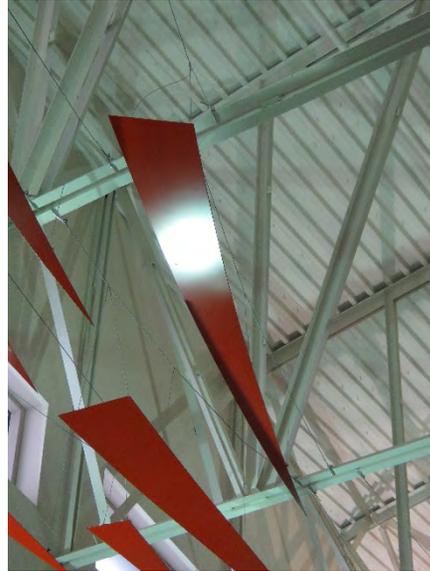
Unstable arrow due to loose cable.

1. Use a 25' scissor lift to access the artwork.
2. Dust with a microfiber cloth to remove loose dust from the artwork and cables. Remove tangled balloons.
3. Remove gum with wooden probes and solvent as needed. Test solubility of paint prior to solvent use.
4. Wash with a dilute solution of pH-neutral, conservation-grade detergent (Orvus WA Paste or comparable) in distilled water. Use hand-held sprayer for washing, rinse with distilled water, and dry thoroughly with absorbent toweling/cloths.
5. Tighten cable to remove slack from hanging wire. Inspect all cables to ensure stability.

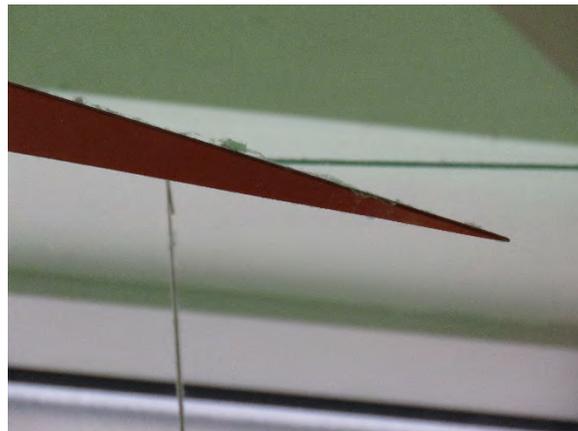
Concentration of dust on upward-facing surfaces and the cables.

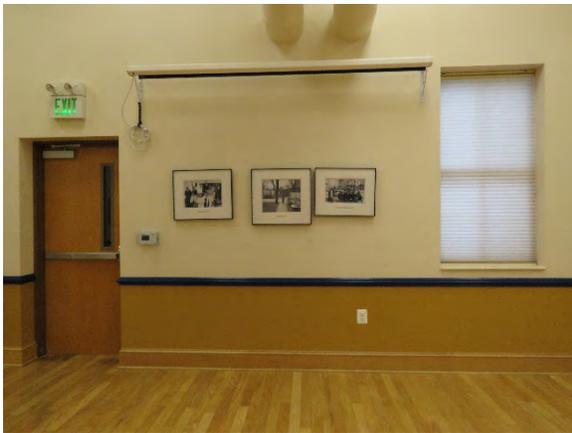
White speck of paint on the glazing material.

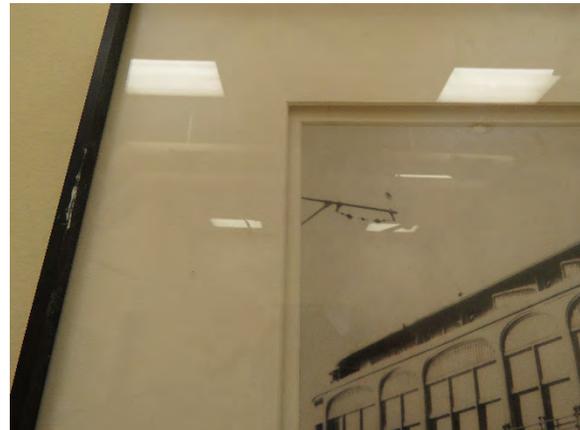
One frame is hung slightly crooked.

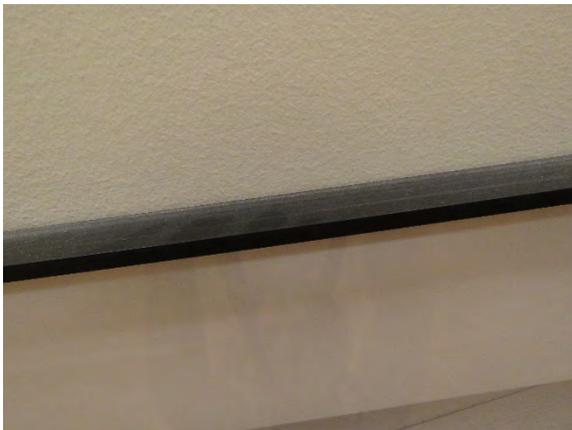
White paint accretion on the metal frame.

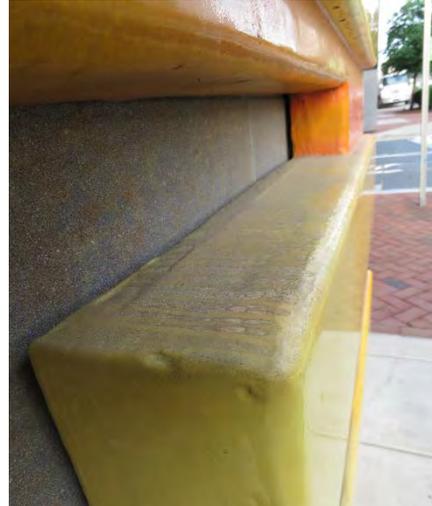
Typical of heavy concentrations of atmospheric soiling on horizontal surfaces.

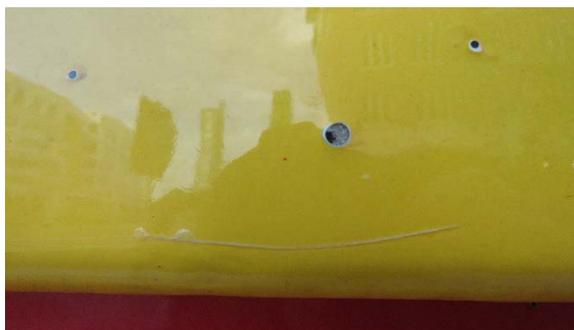
Pockmarks and linear scratch.

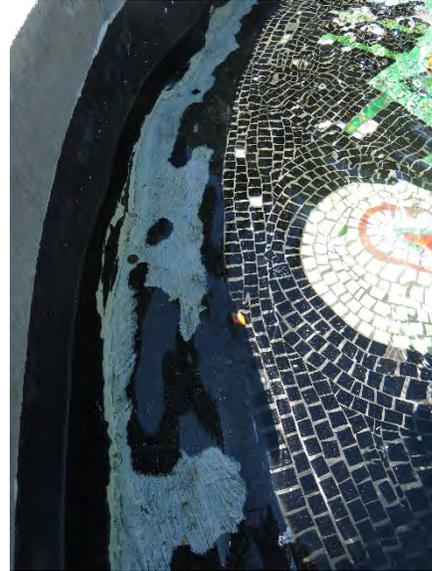
- Loss of tile work, mostly the black border tiles. Estimate no more than 5% loss of tiles. A few loose tiles can be seen within the fountain.
- Deterioration of black paint finish on horizontal and vertical surfaces, with flaking and significant loss.
- Efflorescence on interior vertical concrete surfaces.
- Cracking of mortar at most joints of concrete capstones, with loss of adhesion at sides.

Typical of loss of black paint finishes around perimeter.

1. Drain fountain and allow surfaces to dry.
2. Gather dislodged and loose tiles and reset using same Mapei-brand mortar and grout. Replace missing tiles as needed, with colors matching the existing design. Hold discussions with artist to obtain information for suitable replacement tiles.
3. Wash surfaces with a dilute solution of a pH-neutral, conservation-grade detergent (Orvus WA Paste or comparable) in potable water and rinse thoroughly.
4. Remove old mortar and repoint capstone joints to match original in strength, profile, and color.
5. Seal interior surfaces of pool with appropriate pool-grade black paint.
6. Look to improving water quality by installing a non-chlorinated, de-

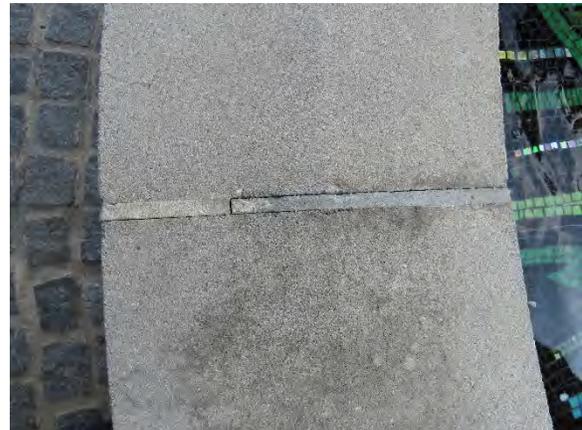
Two colors of mortar indicate repointing work.

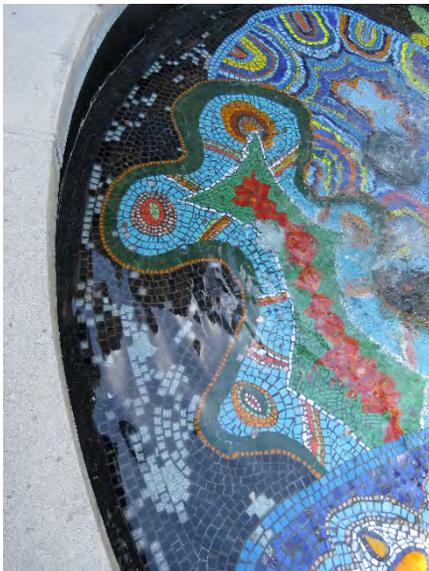
Loss of tiles are most prominent around the black border.

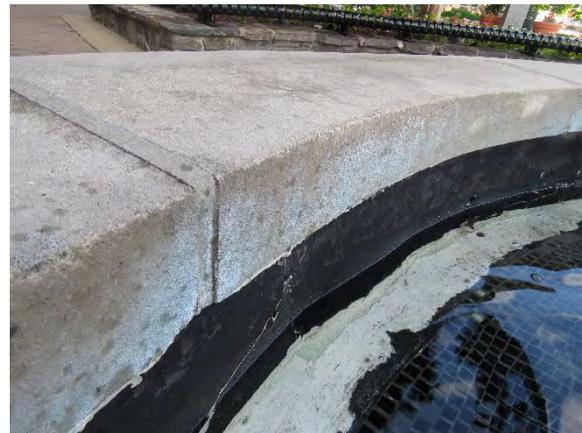
Efflorescence on interior vertical concrete surfaces.

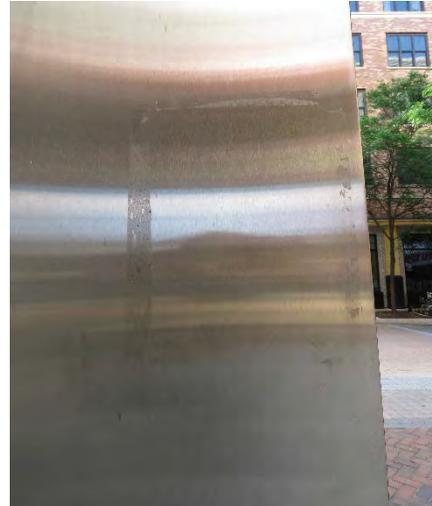
- Tape residue from a posted sign.
- Corrosion is found on the back corners of a bottom bracket. The purposeful bending of the metal is most likely promoting the localized corrosion here on all the columns.

Tape adhesive residue from a posted sign.

4. Use mild organic solvents in localized areas to remove tape and adhesive residues.
5. Using cotton swabs, apply a mild citric or oxalic acid cleaner to reduce areas of corrosion on the stainless steel plate, should washing alone not address the condition.

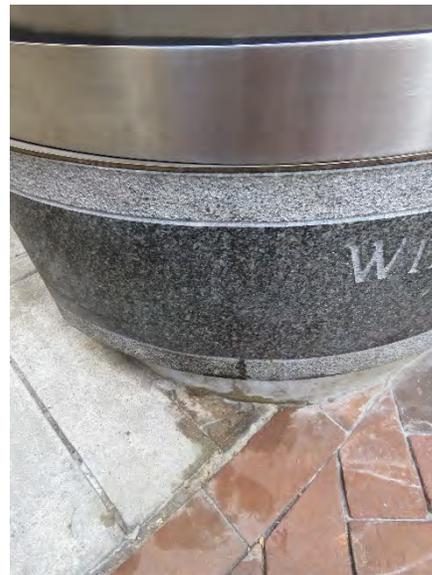
- Spider webs, bird droppings, and other accretions, which have discolored the stainless steel. The granite base has staining caused by dog urine.
- Scratches, some heavy with corrosion. Scuff marks/scratches on sides could be from people pushing carts/objects and scratching the surfaces of the metal.

Dog urine on central column.

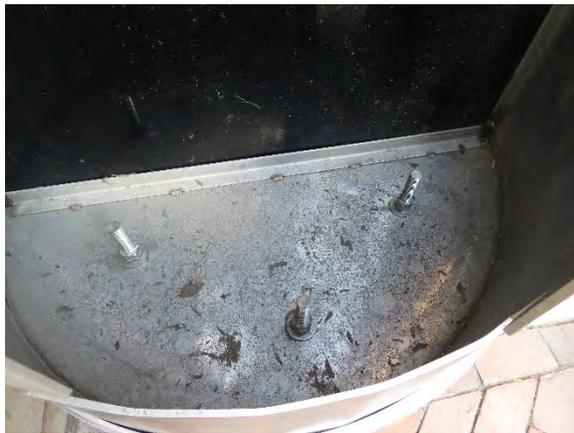
Typical dirt and debris within one of the columns.

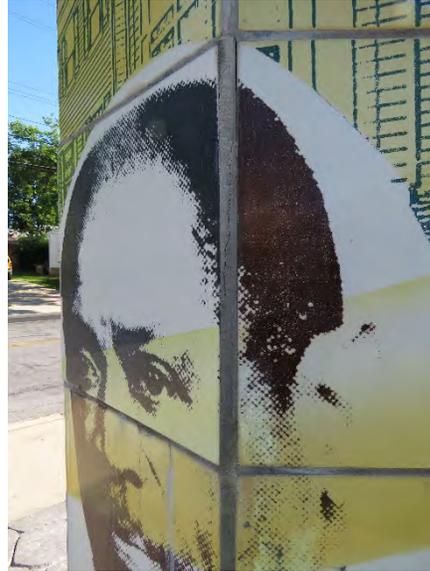
Cracking at mortar joint is making the tile unstable.

5. Reduce efflorescence with a mild citric acid cleaner.
6. Use solvent to remove accretions as needed.
7. Reset loose tile with color-matching mortar.
8. Inject a conservation-grade micro-injection grout within hairline cracks. Use Jahn products or comparable.
9. Remove existing sealant from base and seal perimeter with appropriate sealant, color to match existing or as approved by the City of Rockville.

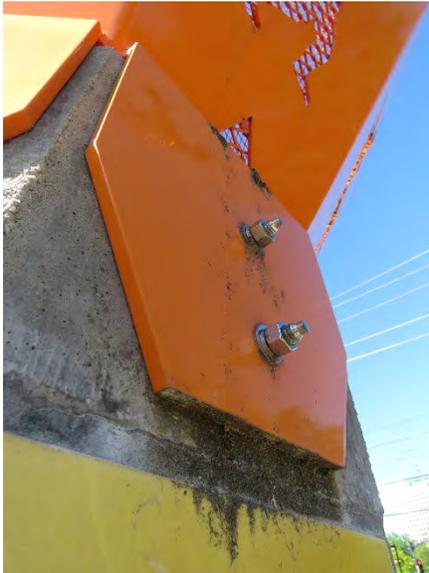
- General atmospheric soiling throughout. Concentration of dirt at upper steel section, with some of it washing down the sides. Biological growth can be observed on the concrete directly below the steel in these areas.
- Minor unknown accretion on ceramic tile.
- Some cracking at mortar joints. One tile has the potential to loosen from the substrate.
- Sealant at base joint is mostly lost, with voids and biological growth in these areas.
- Localized efflorescence on joints and tile. Some cracking and minor loss of tile near area of efflorescence.
- Efflorescence on concrete surfaces, both at the base and at the section where it meets the steel top.
- Impact damage and association hairline cracking on one tile.

Typical of washing down of dirt and debris from upper steel section and biological growth on concrete surfaces. Some of the growth can be observed on the tile.

thoroughly. Apply biocide such as non-toxic, biodegradable D2 Biological Solution in localized areas, as needed.

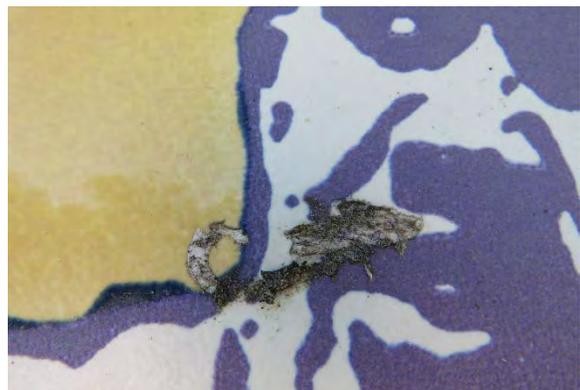
Accretion on tile.

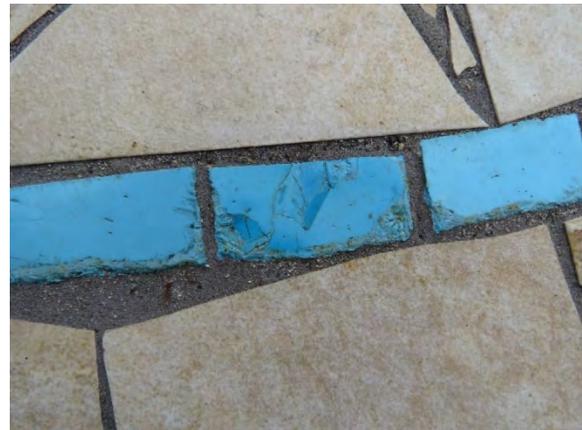
Typical of losses in the colored tiles.

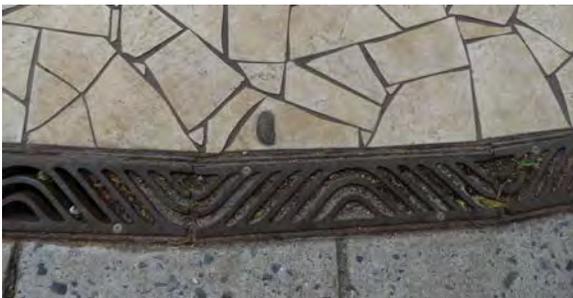
Accretions are mainly gum adhered to the tiles.

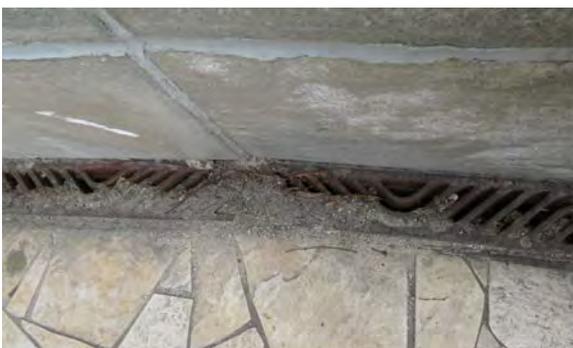
Accumulation of silty dirt at perimeter grates.

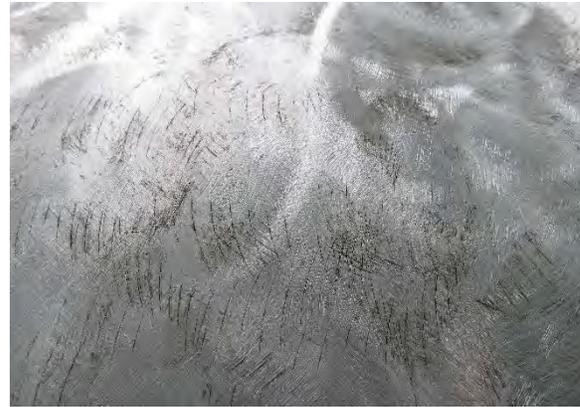
Corrosion within the brush marks may be iron based due to the use of a steel wire wheel.

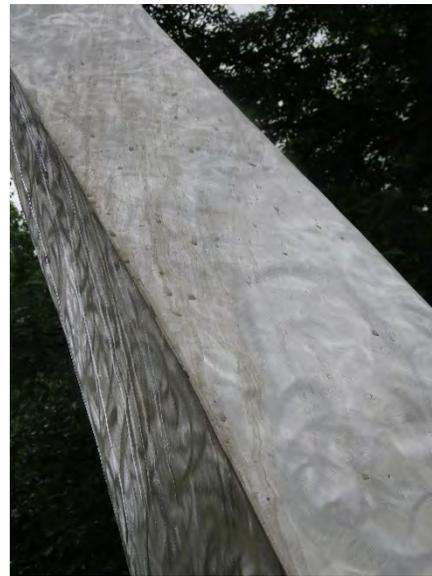
Drip marks from dirt washing down surfaces.

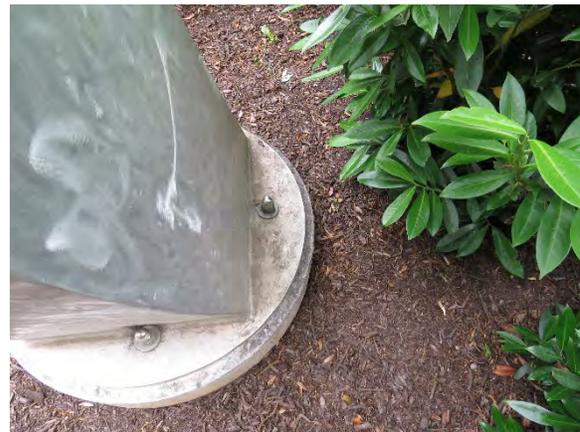
Concentration of dirt at the base. Note the encroachment of nearby plants.

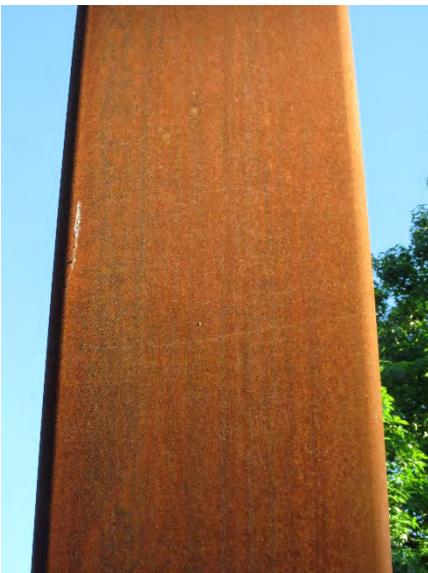
Corrosion pattern on beam with bird dropping.
